**Asset #05600**(Routine, NSTM)  
**SH 109 over ARKANSAS RIVER**  
**Location: 1.5 MI SO JCT 194**

**Team Lead: Casey Pratt Inspection Date: 04/15/2024**

Routine and NSTM inspections of 05600 were conducted on these dates from South to North utilizing the Aspen A 62-t under bridge inspection unit. All spans were inspected using the UBI unit except for 29-40. Due to the bridge's low clearance and heavy vegetation in these spans, the snooper's access was limited, and the inspection was conducted on foot from the ground. All defects were noted and quantified in the "elements" section of the report, and all components were rated according to their condition at the time of this inspection.

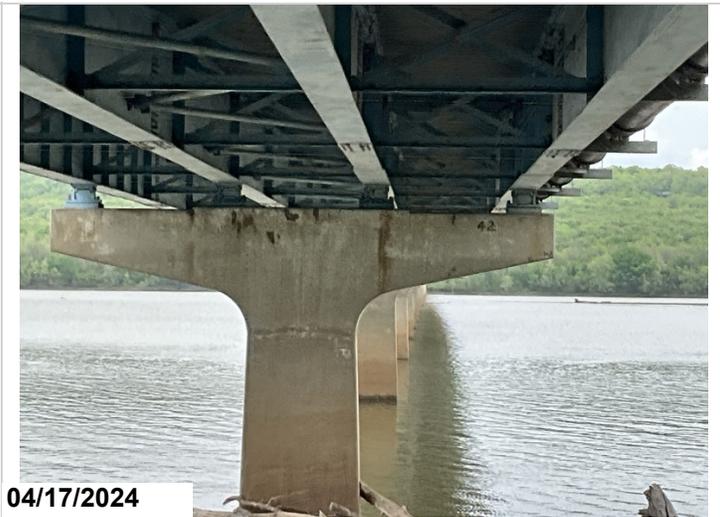
Walked to inspect spans 29 - 40 due to vegetation growth restricting access to the Aspen 75.

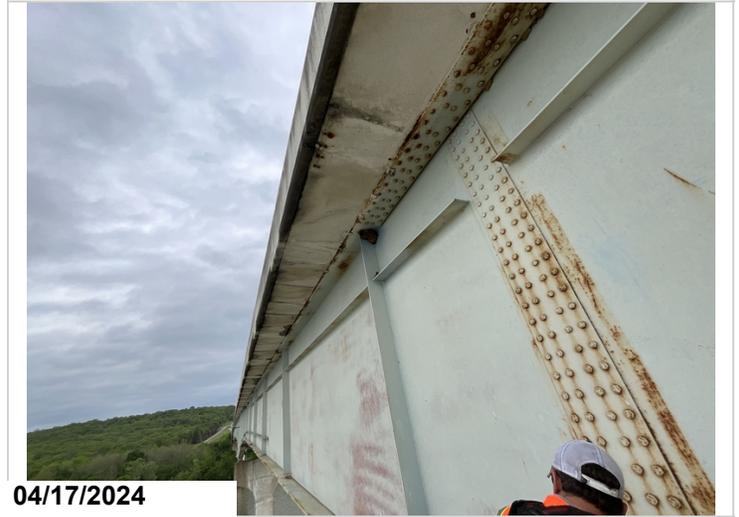
Span 56, left, Overhang: has cracking at 3' spacing with heavy spalls. 2 SF CS3

Span 56, left, Overhang: has cracking at 3' spacing with heavy spalls. 2SF CS3

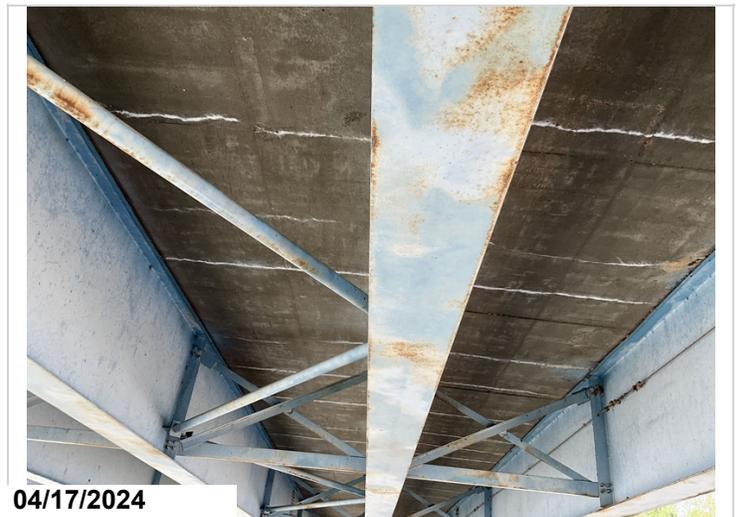
Approach spans: have an average of 7' spacing for efflorescence. 17226SF CS2

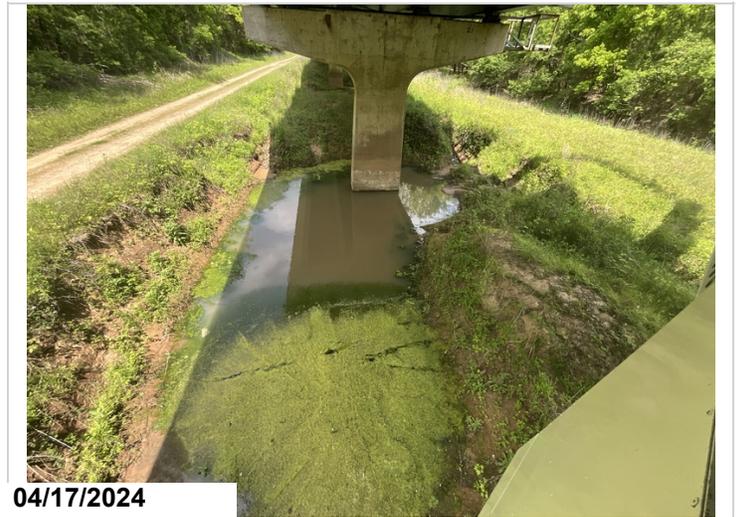
Span 20: Has a large scour hole.

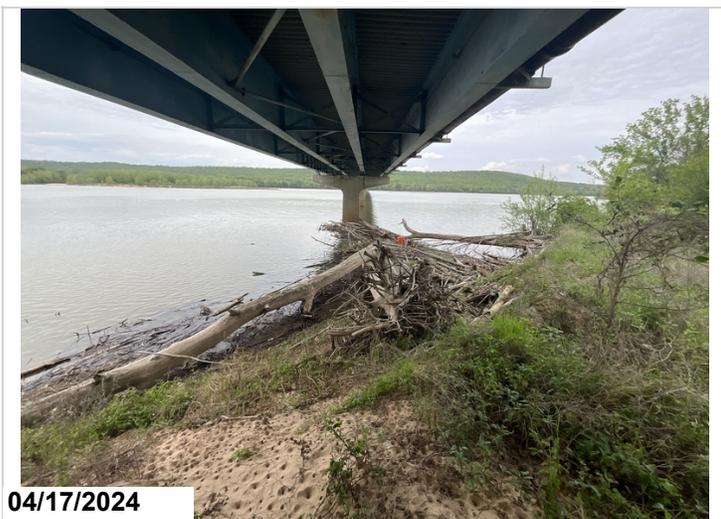
Span 41: Has debris and cutting of the channel bank.

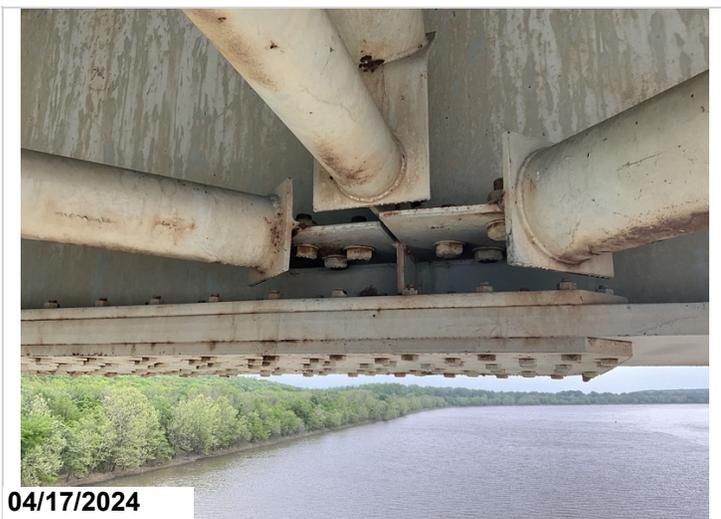
E details main span. Lateral brace to girder welds. Main spans. These details were checked for CIF susceptibility. They are fully welded all the way around, eliminating the crack-like detail that would put them in a CIF category.

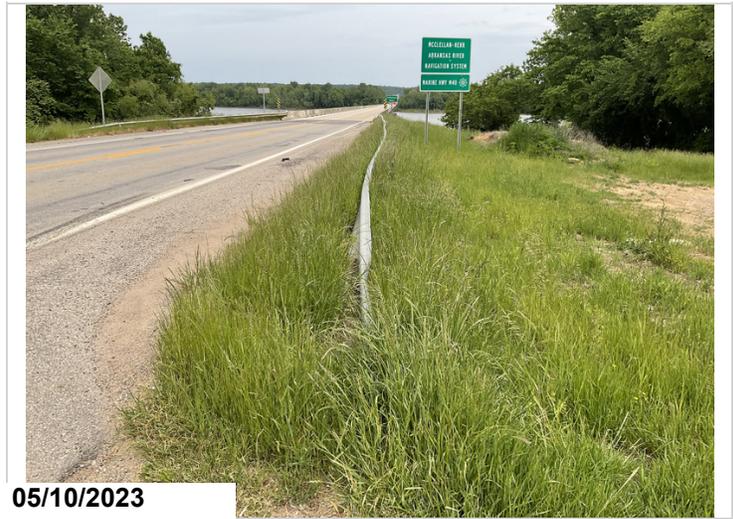
Approach Railing, right side, beginning of structure: has minor collision damage. CS2

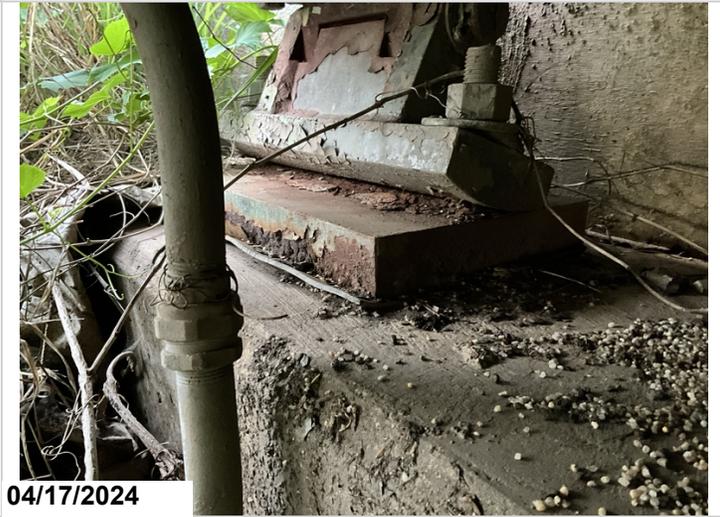
Abutments: Have corrosion in bearings. CS3

Typical corrosion in bearings at the abutments. CS3

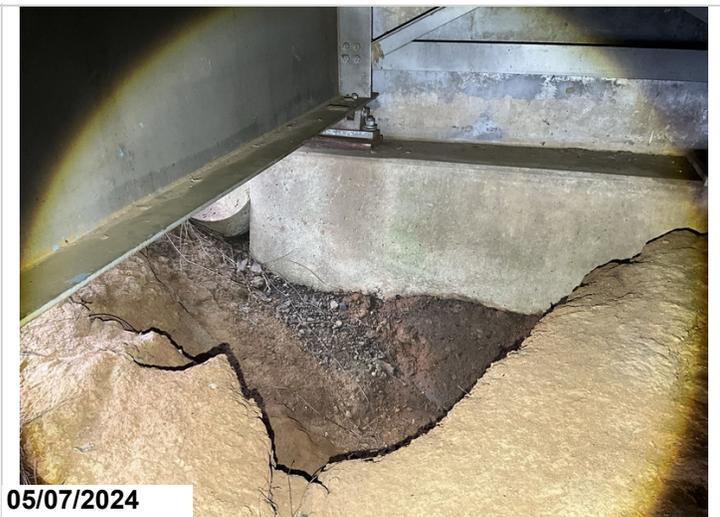
Abutment 1: has a scour hole on the right side that exposes the entire abutment face for 10', beginning at the right edge and traveling toward the center.

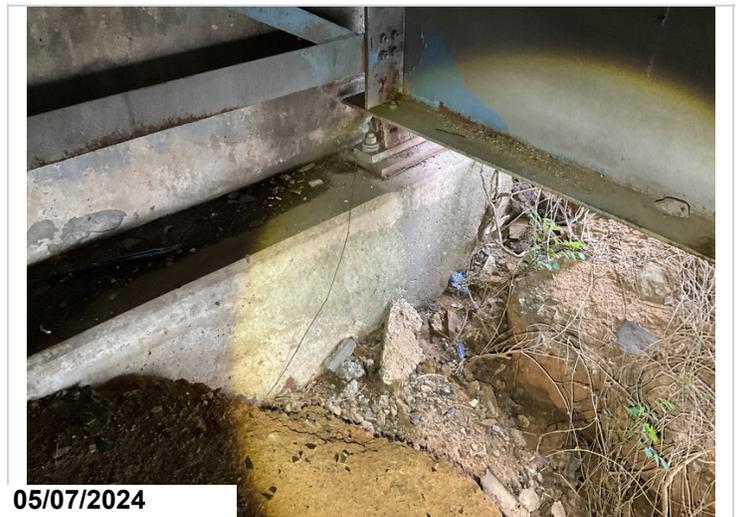
Abutment 1, left: Scour exposing 3' of the cap face vertically. Scour begins at the left edge and travels toward the center for 8'.

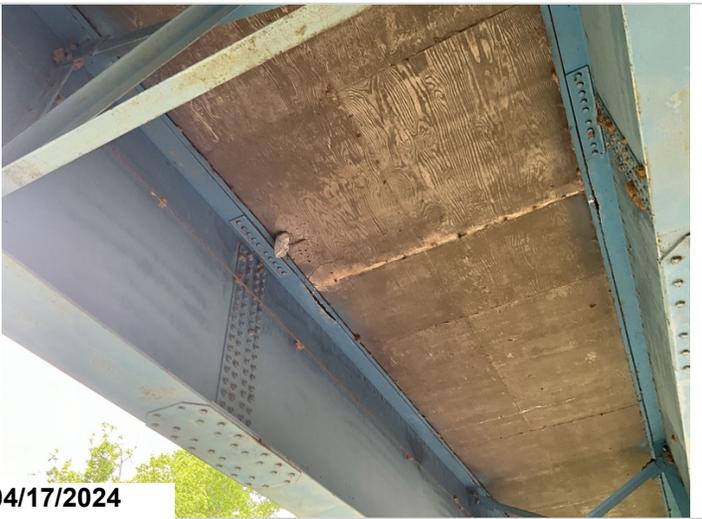
Span 39, bay 1, 1st splice: Has spalls with exposed rebar. 2SF CS3 There are delaminations adjacent to this area. 2SF CS2

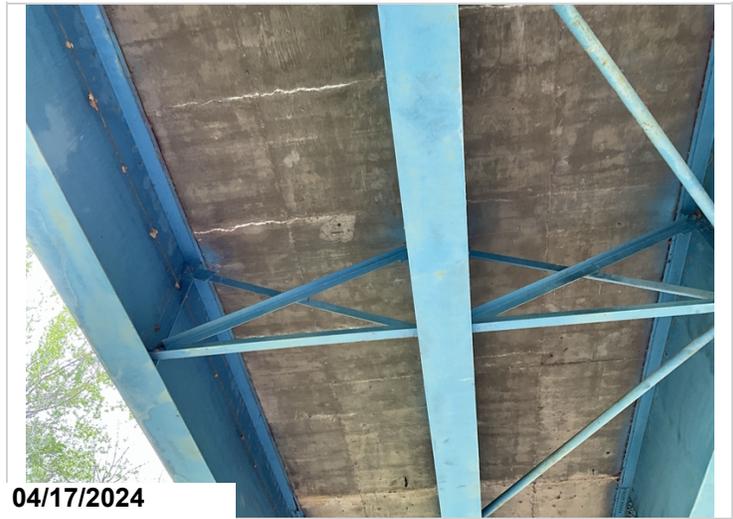
Span 33, bay 1, Diaphragm 4: There is a spall to the undersurface with exposed rebar. 1LF CS3

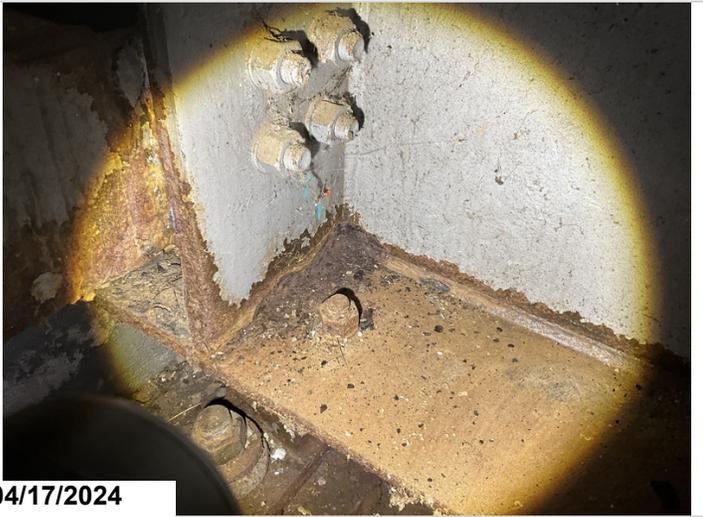
Abutment 1, girder 2, right: Has section loss over the bearing at the diaphragm connection, up to 1/16". Girder 3: Has a similar defect. 2LF CS3

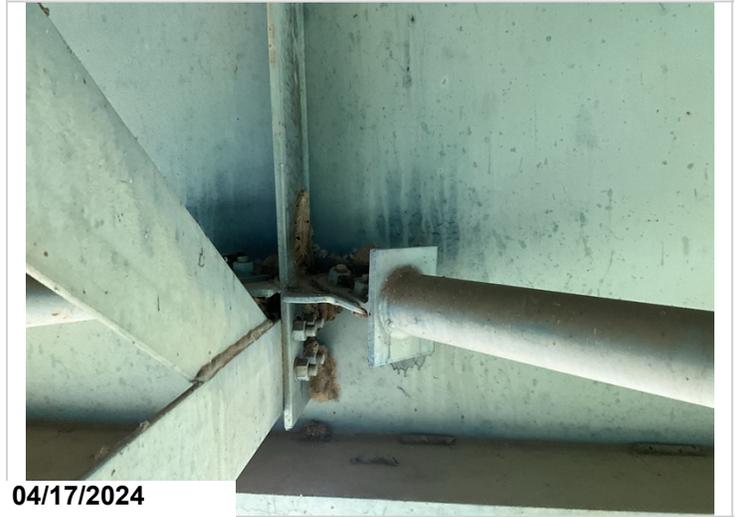
Span 60, bay 2, diaphragm 5, back, right: has distortion.

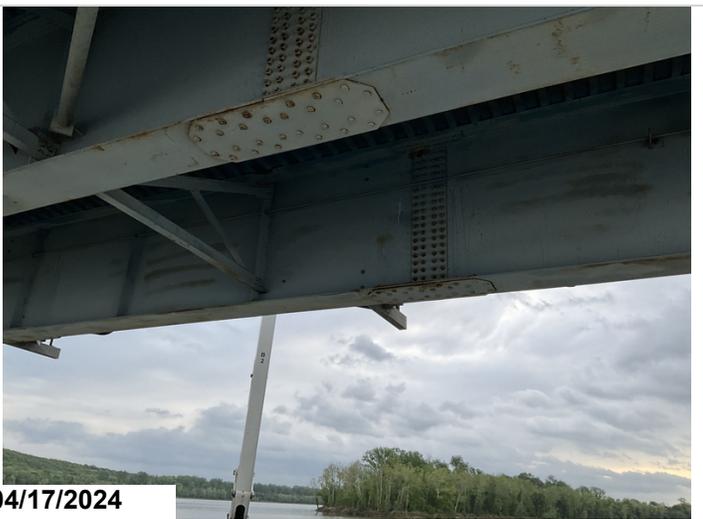
Span 46, girder 4, splice 1: Has distortion and pack rust between the splice plates. 1LF CS3

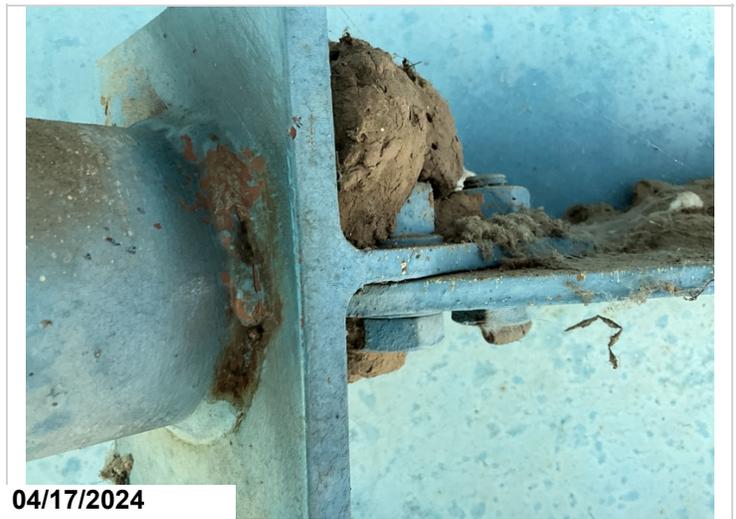
Span 21, girder 2, right, first connection back of bent 22: The weld to the lateral bracing is cracked.

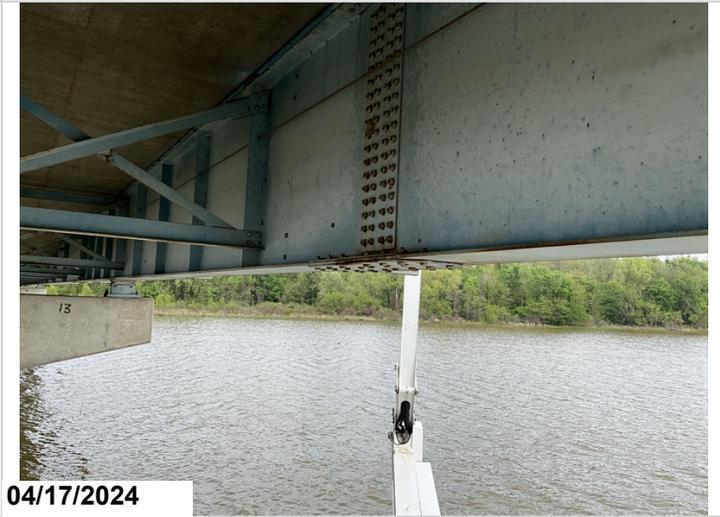
Minor pack rust at several splice locations.

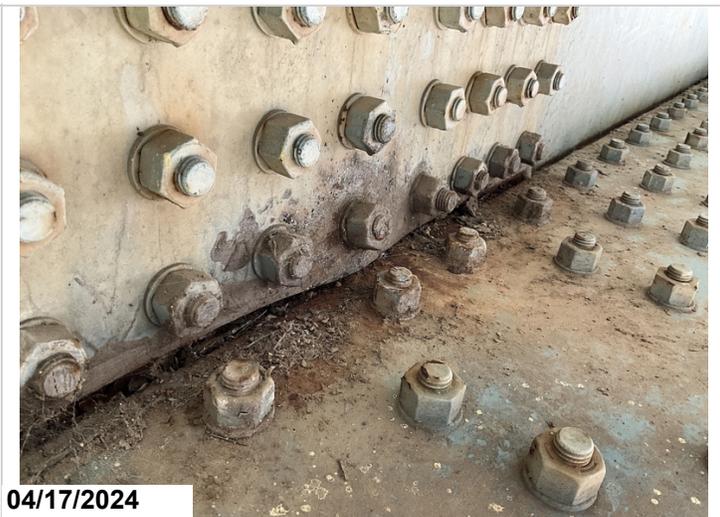
Span 57, girder 2 left, 3rd splice: Has a bulge at the bottom of web splice plate. 1LF CS2

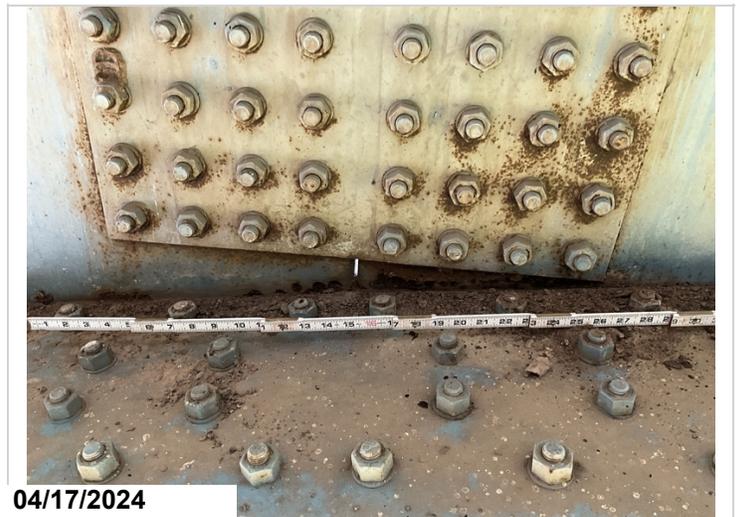
Span 58, girder 1, right, splice 1: Has 1/16" x 28" section loss to the lower web between the web and bottom flange splice plate. 3LF CS3

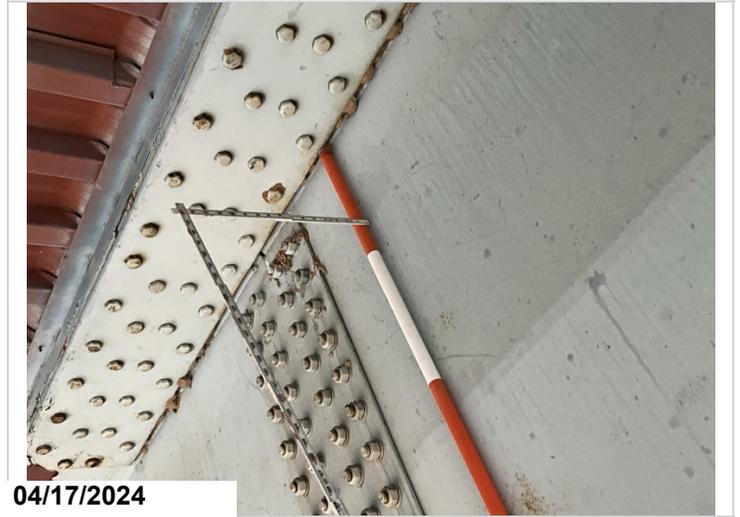
Span 56, girder 3, splice 2: Has up to 1/2" out-of-plane bending at the top of the web. CS2

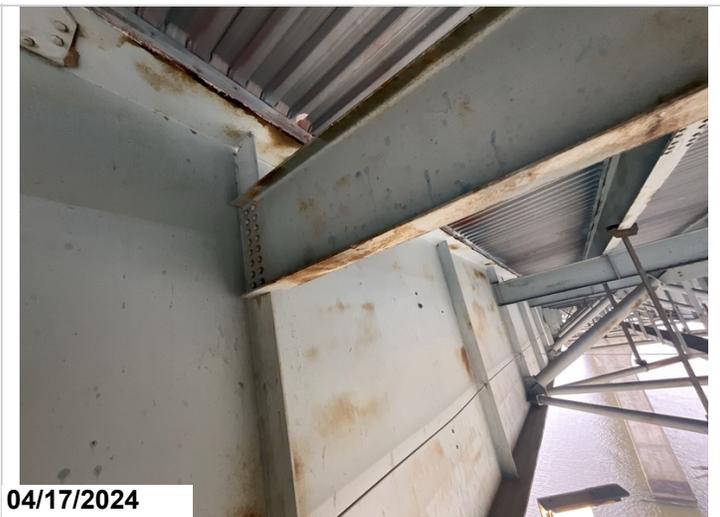
Typical corrosion along the top flange of girders. CS3

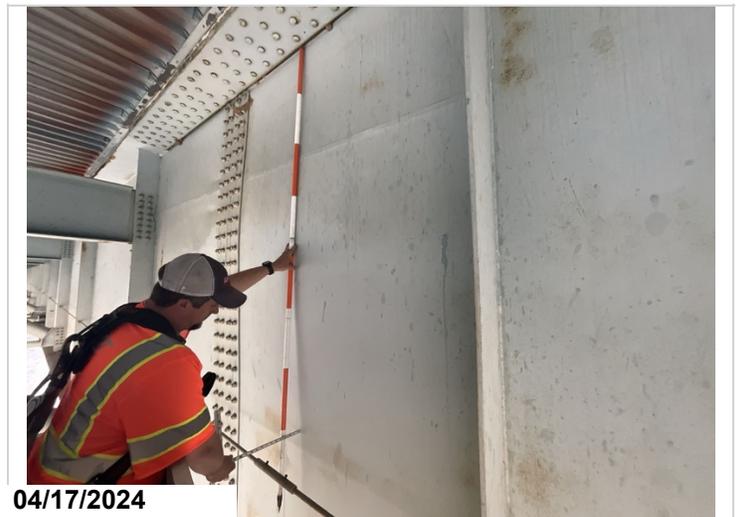
Span 56, girder 2, left, splice 1: Has up to 1.5" of out-of-plane bending to web. 5LF CS2

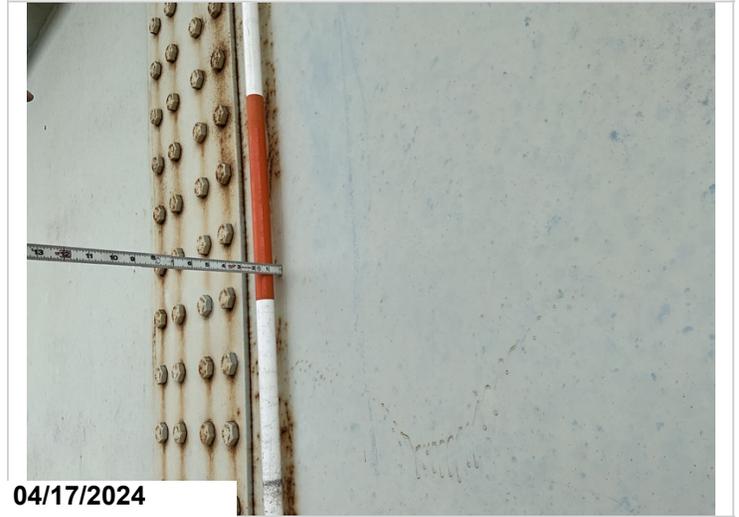
Span 56, girder 1, 1st splice: Out of plane bending of web. The middle section of the web measures 3/4" out and increases to 1" at the bottom. 6LF CS2

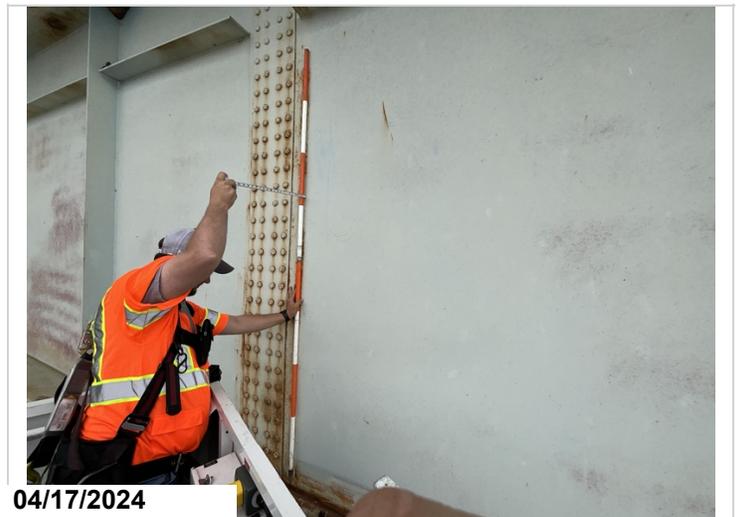
Span 56, girder 1, 1st splice: Out of plane bending of web. The middle section of the web measures 3/4" out and increases to 1" at the bottom. 6LF CS2

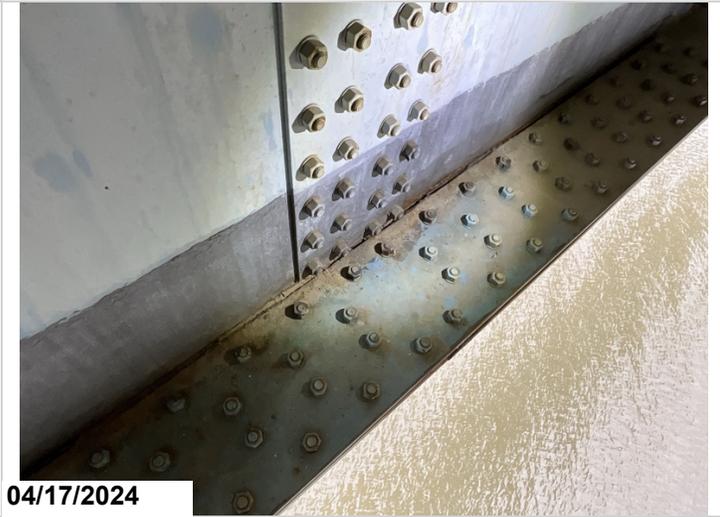
Span 56, girder 1, right, splice 1: Has active corrosion with up to 1/8th of section loss for the length of the splice. 6LF CS3

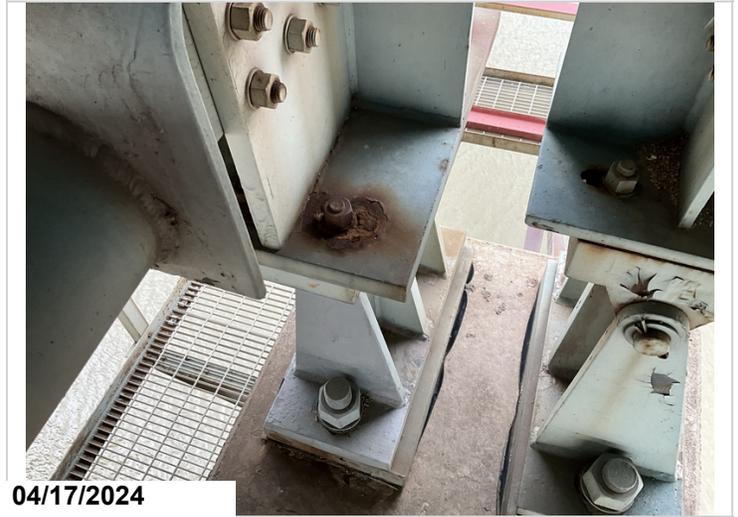
Span 56, Bent 56, girder 2, left: The bearing connections have section loss around the bolt hole. 1/8" typical. Girder 1 at this bent is similarly deteriorated. 2LF CS3

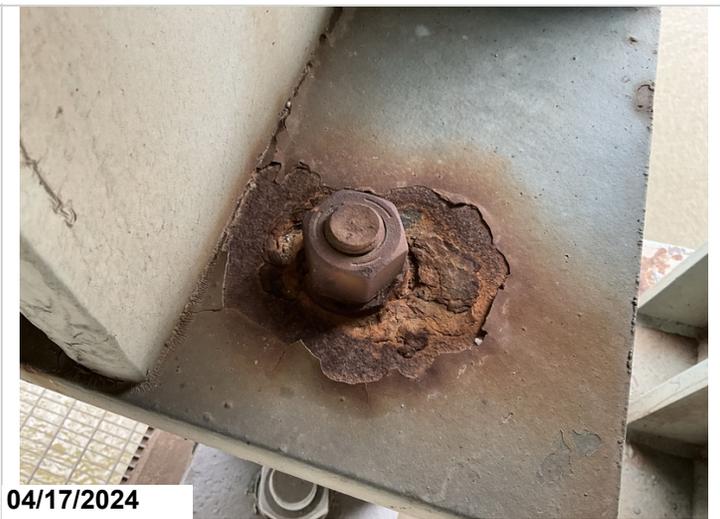
Span 56, Bent 56, girder 2, left: The bearing connections have section loss around the bolt hole. 1/8" typical. Girder 1 at this bent is similarly deteriorated. 2LF CS3

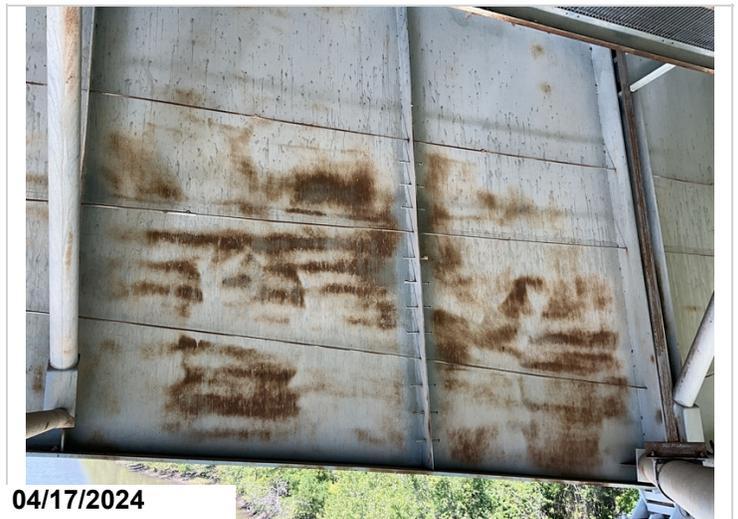
Span 57, pier 58, girder 1, right: Typical paint system failure and surface corrosion. CS3

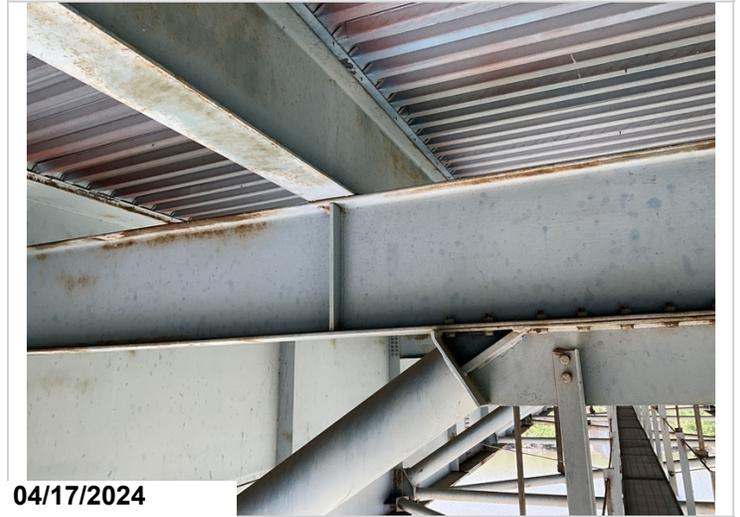
Span 56, floor beam 2: typical surface corrosion to floor beams. CS2

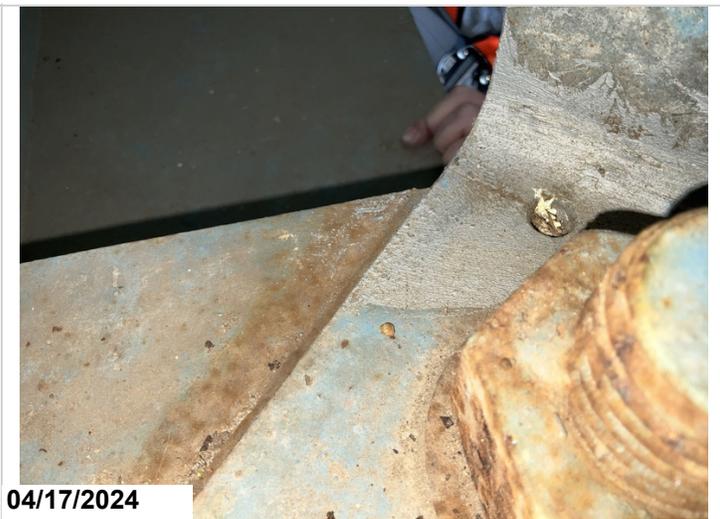
Span 56, girder 1, floor beam 1: 1" crack in base plate at lateral brace connection has been arrested. 1LF CS2

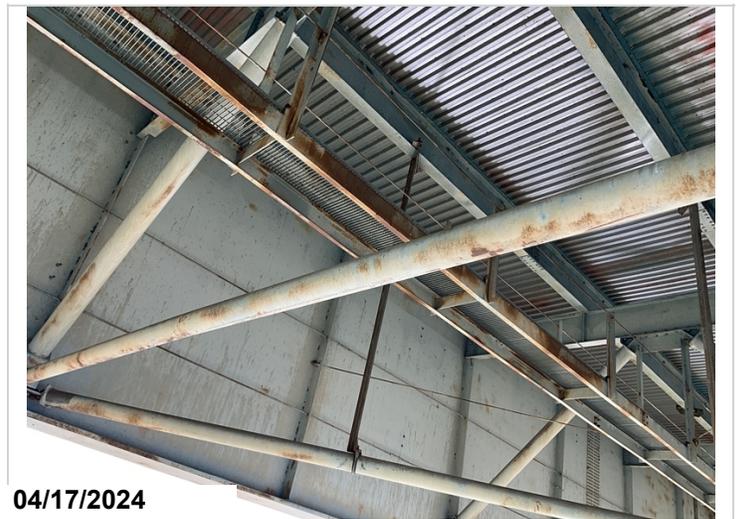
Span 57, lower chord of floor beam 8: typical failing paint and corrosion. CS2

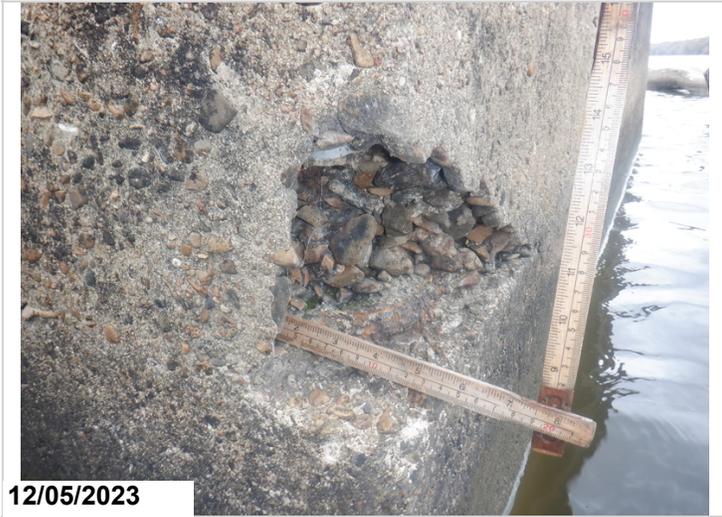
Bent 56, column 2: Spall with exposed rebar on the northeast corner, 25% section loss to the reinforcing steel. 2SF CS3

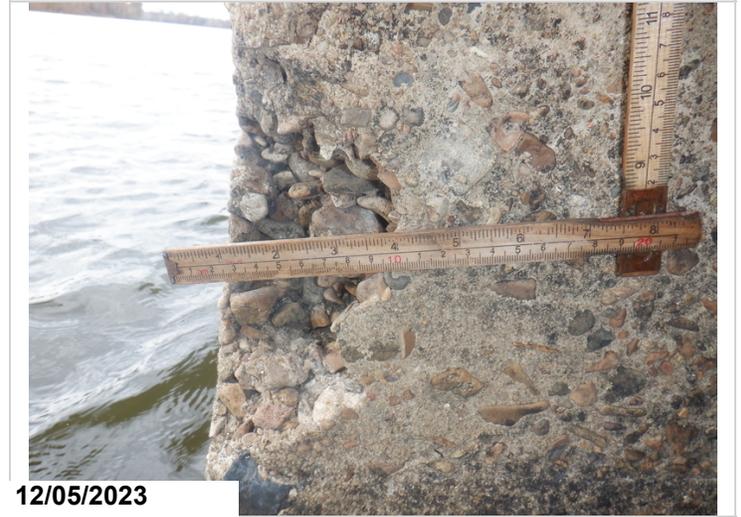
Bent 56, column 2: Spall on the southeast corner. 2SF CS3

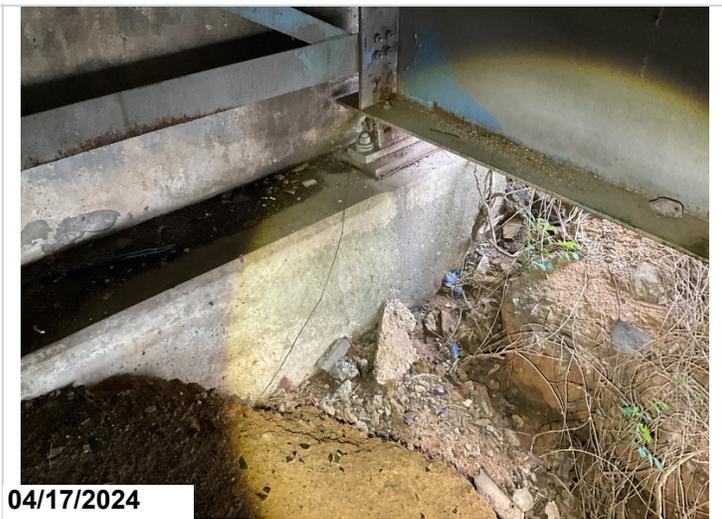
Abutment 1, left: Scour exposing 3' of the cap face vertically. Scour begins at the left edge and travels toward the center for 8'.

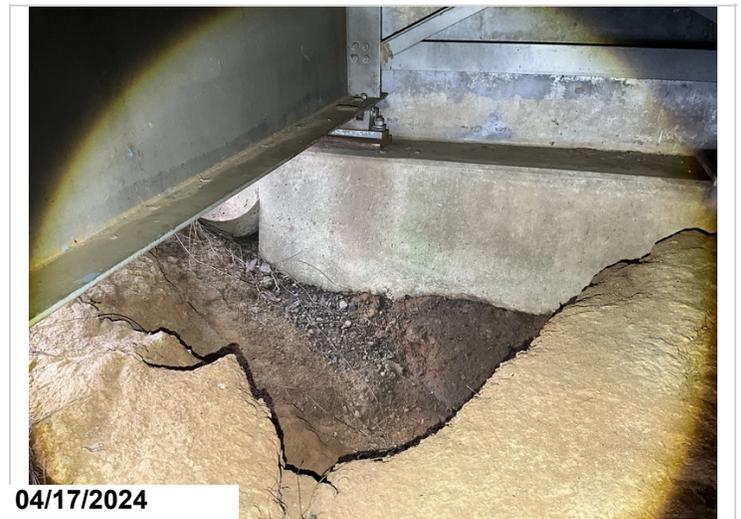
Abutment 1: has a scour hole on the right side that exposes the entire abutment face for 10', beginning at the right edge and traveling toward the center.

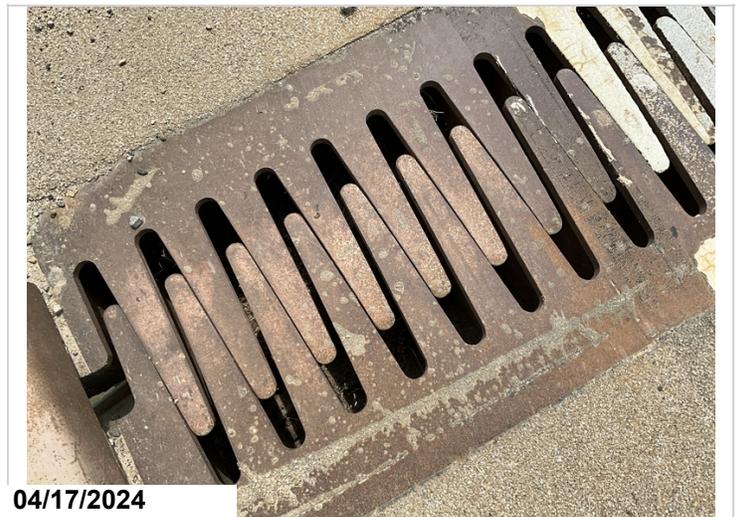
Typical joints are full of dirt and debris throughout.

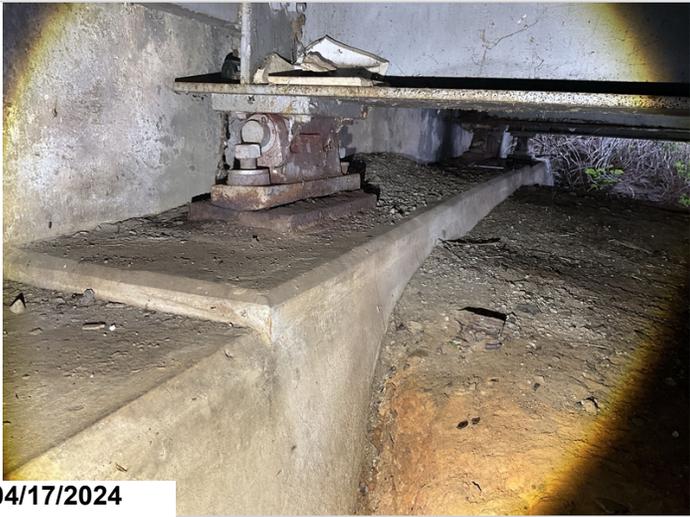
Abutment 1, bearings: Corrosion is present at the sole plate and in the rocker area at all bearings at this abutment. 4EA CS3

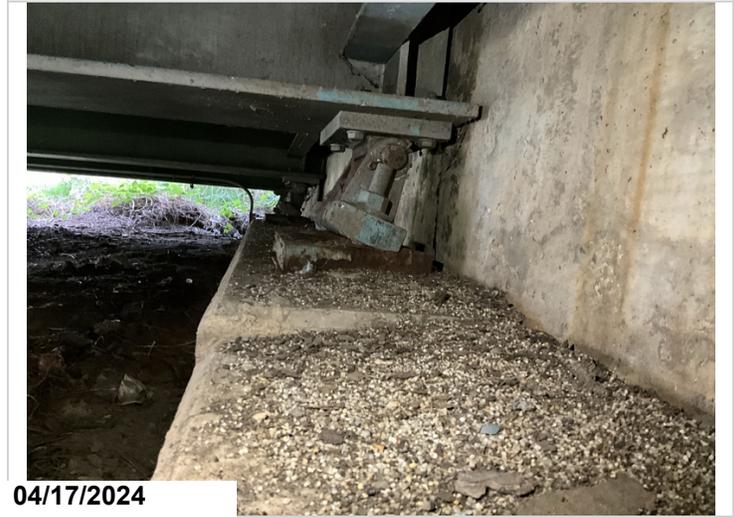
Abutment 2: All bearings fully extended to the north. 4EA CS3

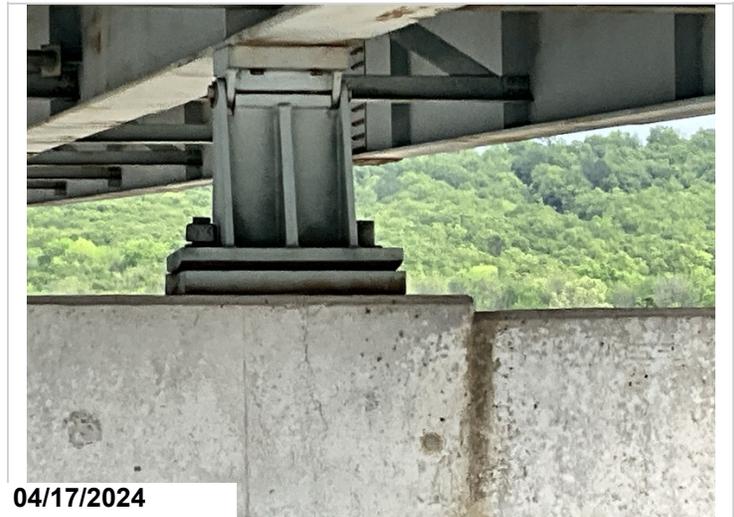
Bent 52, girder 3, bearing 3, right: The east anchor nut is missing. 1EA CS3

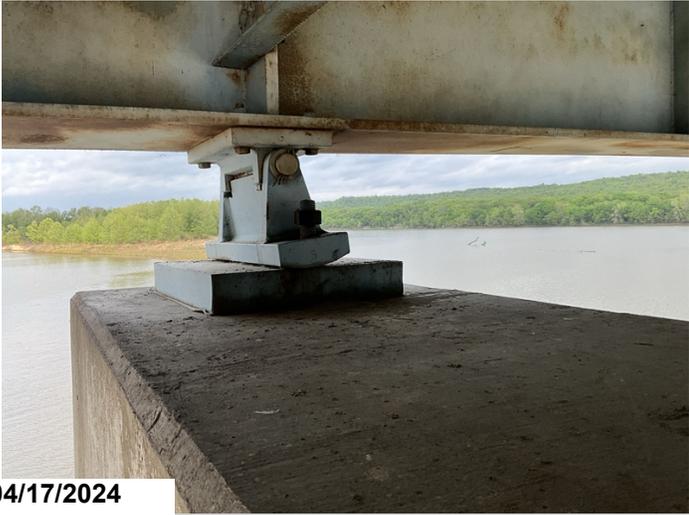
Bent 50, bearing 1: Is near full rotation at 69 degrees. 1EA CS3

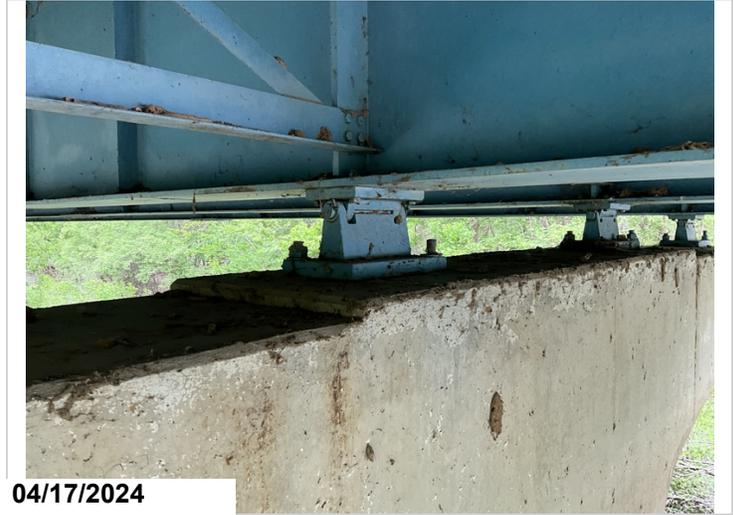
Span 28, bent 29, back: Bearing 2 has its right nut missing. 1EA CS3

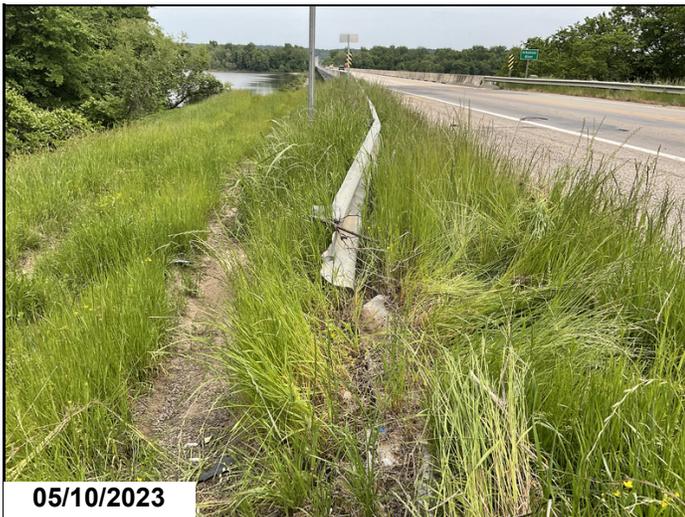
Approach Railing left side beginning of structure has collision damage first 25'. Railing is torn apart and detached in this area with missing, and bent post.
