Asset #03643(Routine)

US 64 over Illinios Bayou

Location: 6.59 M E Johnson Co. line

Team Lead: William Wood Inspection Date: 08/24/2022

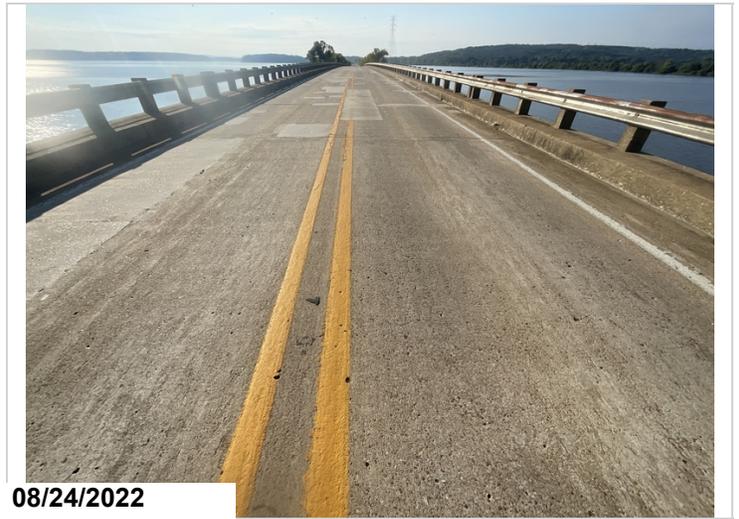
Typ. Condition of Deck.

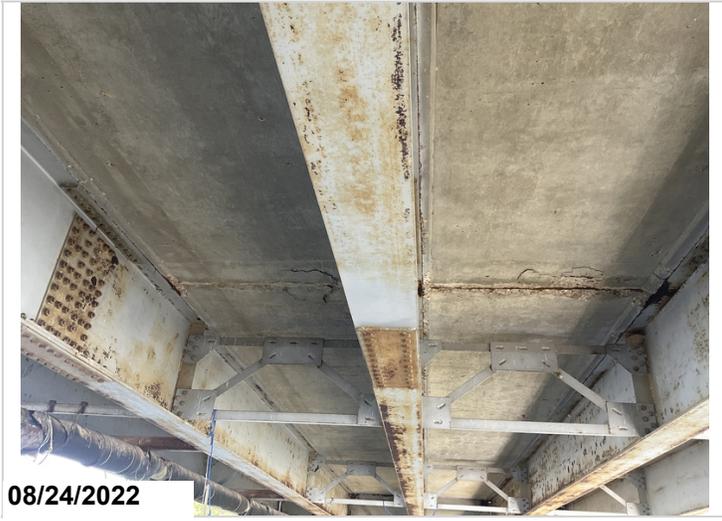
Typ. Condition of Soffit.

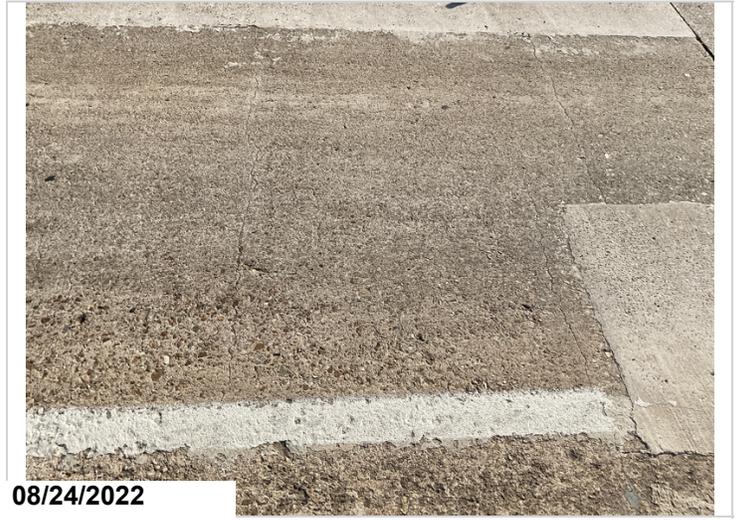
Typ. Cracking in Deck.

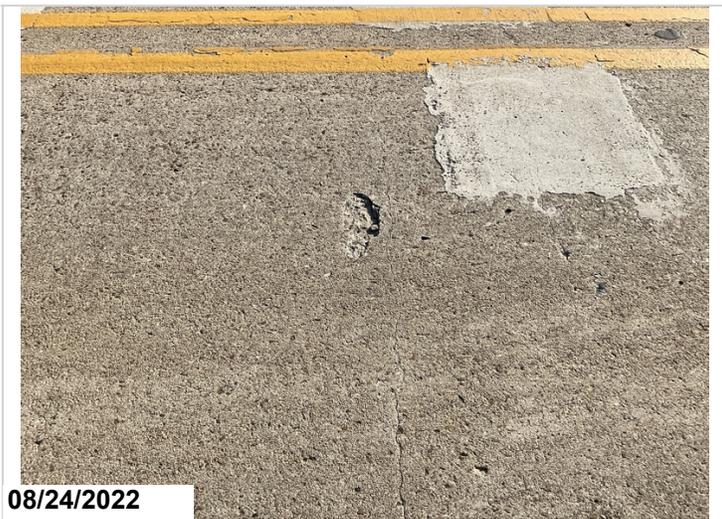
Typ. Delam & Spalling in Deck.

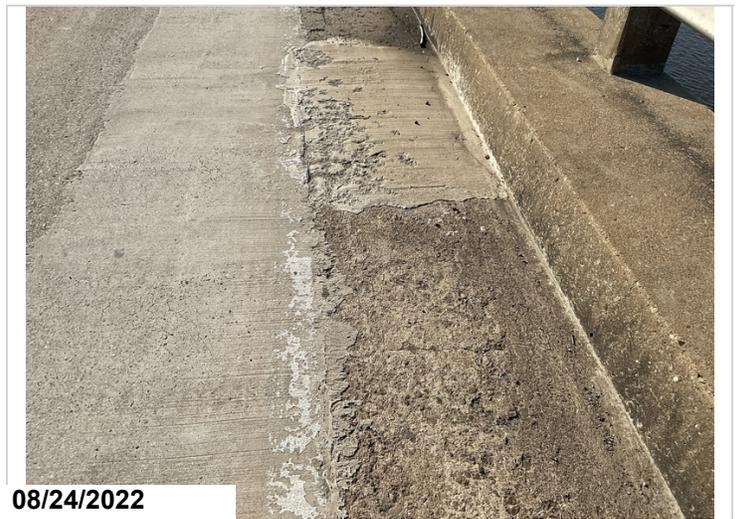
Typ. Scale in Gutters & Patched Areas in Gutters. Rt. Side.
Spans 3 & 5.

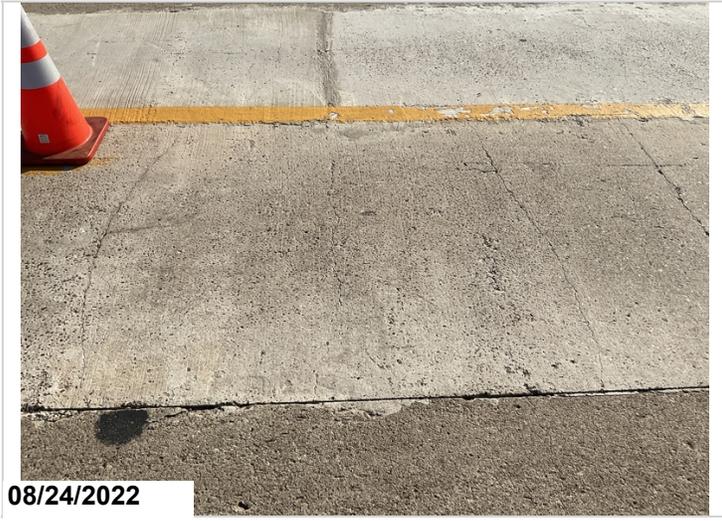
Typ. Condition of Patched Areas.

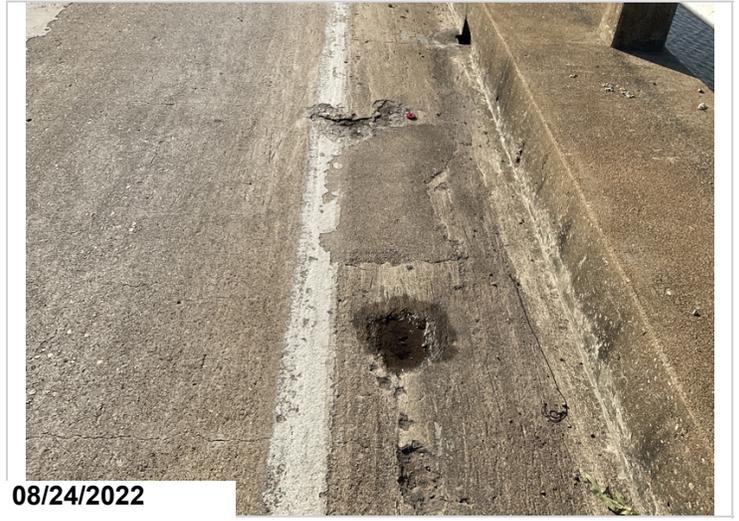
Typ. Delam & Spalling in Gutter. Rt. Side.

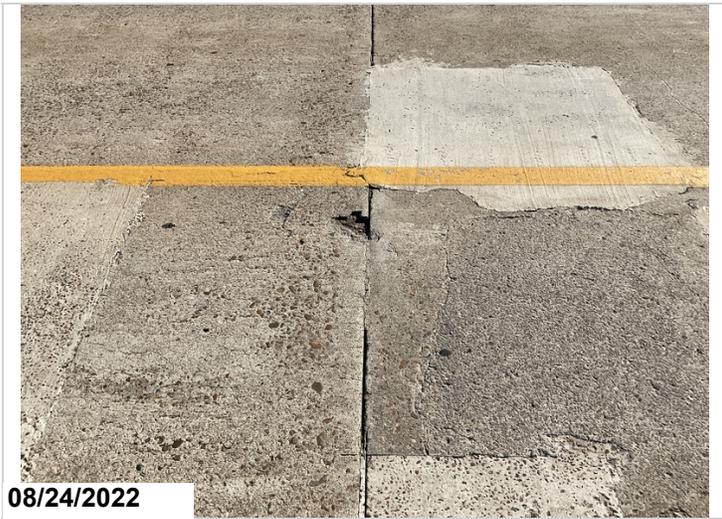
Typ. Delam & Spalling at Saw Joints in Span 7.

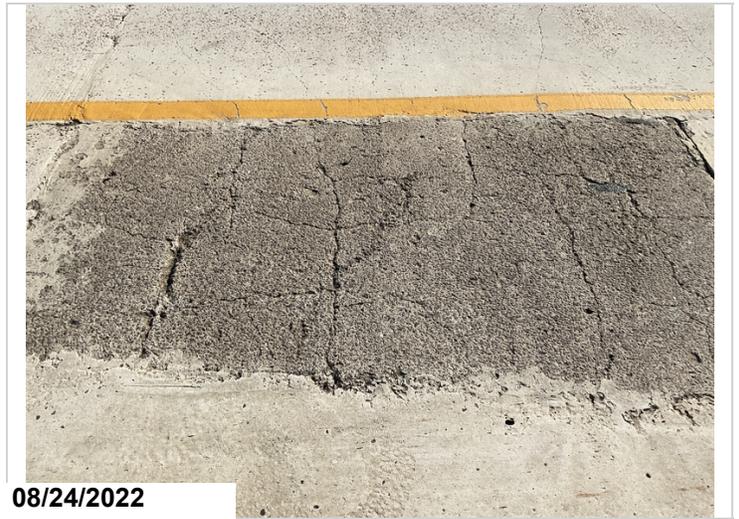
Typ. Condition of Old Patches. Span 8

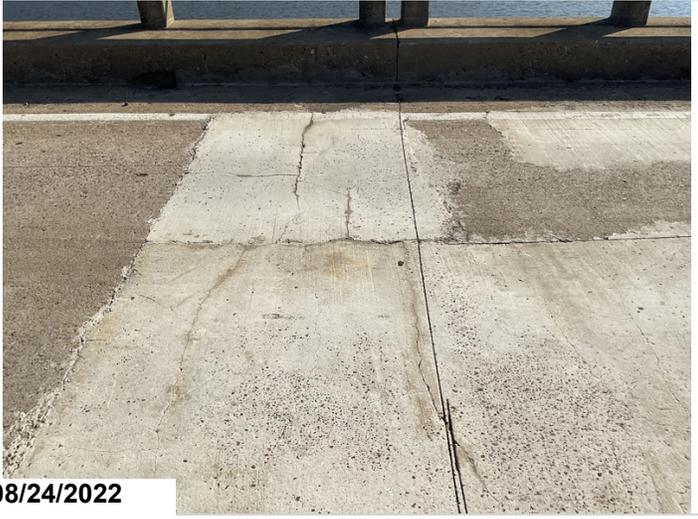
Typ. Cracking in Patched Areas. Span 8

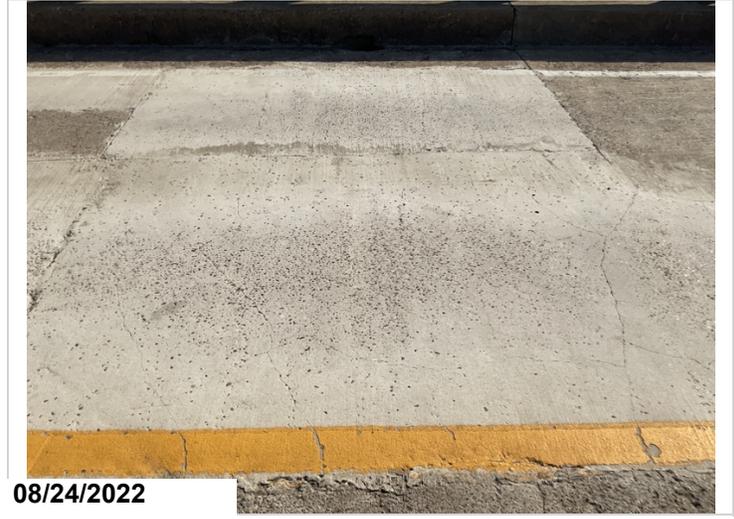
Typ. Cracking in Patched Areas. Span 8

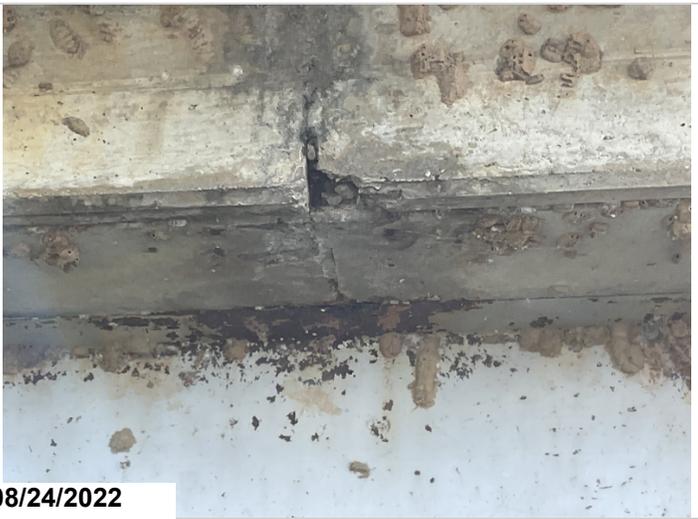
Delam & Spalling in Overhang Span 1 Rt. Side at Saw Joint.

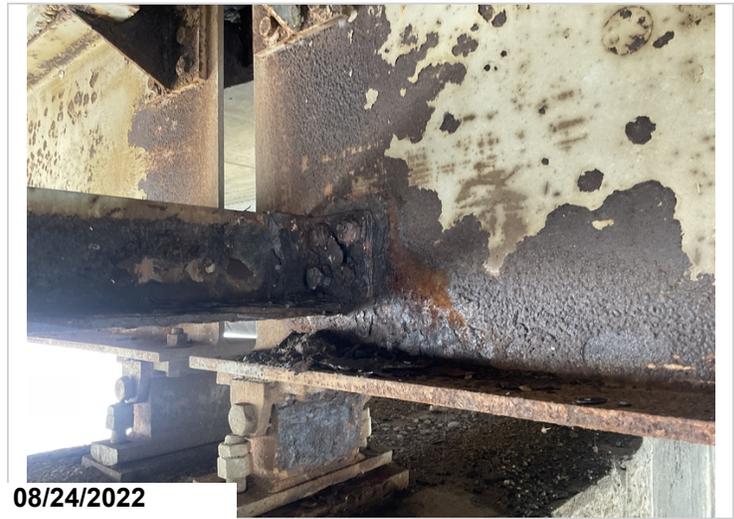
5 BEAM PAINTED STEEL MULTI BEAM - MODERATE BUBBLING & PEELING OF PAINT THROUGHOUT BEAMS. MODERATE SURFACE & FRECKLED RUST THROUGHOUT BEAMS. MODERATE RUST & MINOR SECTION LOSS AT VARIOUS LOCATIONS THROUGHOUT BEAMS. MINOR TO MODERATE RUST & SECTION LOSS ON BEAM 2 IN SPAN 3 (TOP FLANGE), BEAMS 4 & 5 IN SPAN 4 (TOP FLANGE) & BEAM 3 AT PIER 5 BK SIDE (END OF BEAM). HOLES RUSTED THRU DIAPHRAGMS ON BEAM 3 BK. & AHD SIDES AT PIER 5.

Typ. Rust & Section Loss on End of Beam 3 Pier 5 Bk. Side.
Up to 3/8" Section Loss on Lower Web at Diaphragm Connection

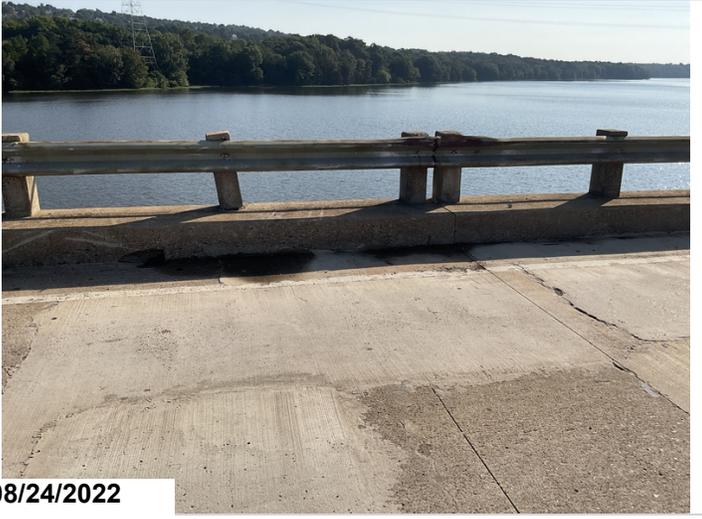
RAIL - MINOR RUST ON RAIL. MINOR DELAM, CRACKING, SCALING & SPALLING W / REBAR EXPOSED AT VARIOUS LOCATIONS THROUGHOUT CURBS. MINOR IMPACT DAMAGE TO RAIL & POST AT PIER 7 LT. SIDE & ABUTMENT 9 LT. SIDE.

Impact Damage to Rail & Post at Pier 7 Lt. Side.

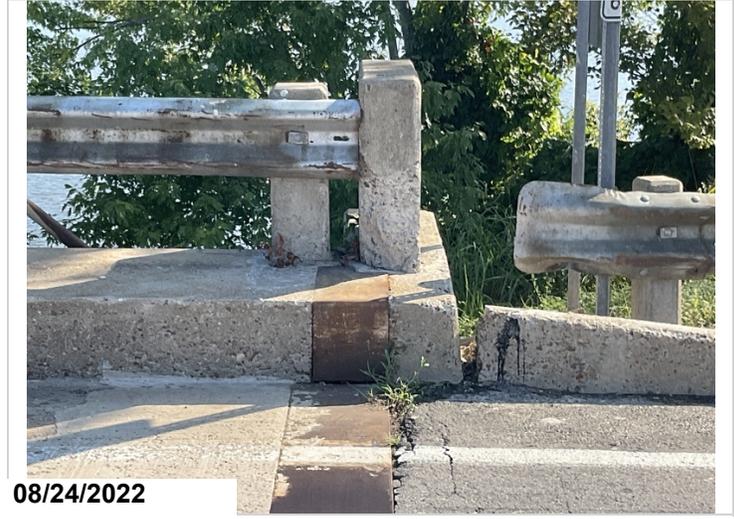
Impact Damage to Rail & Post at Abutment 9 Lt. Side.

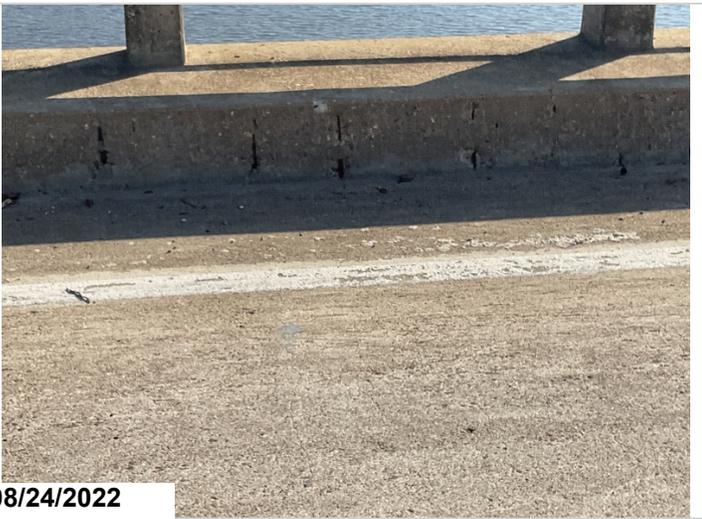
Typ. Delam & Spalling W / Rebar Exposed in Curbs.

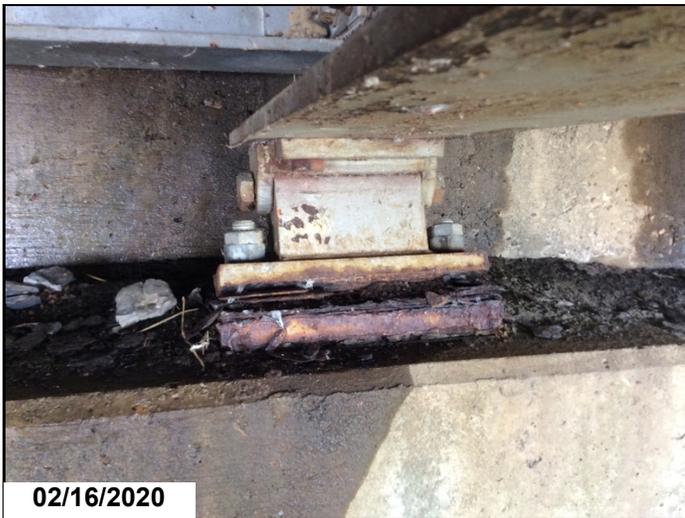
Bare metal is exposed. surface and freckled rust is common on Beams.
Minor to Moderate Rust & Pack Rust on Bearings.

Typ. Rust on Bearings.

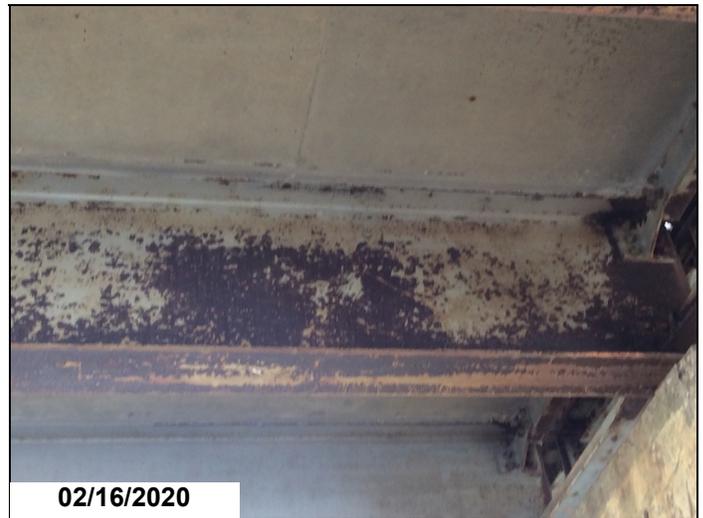
Typ. Rust on Beams.

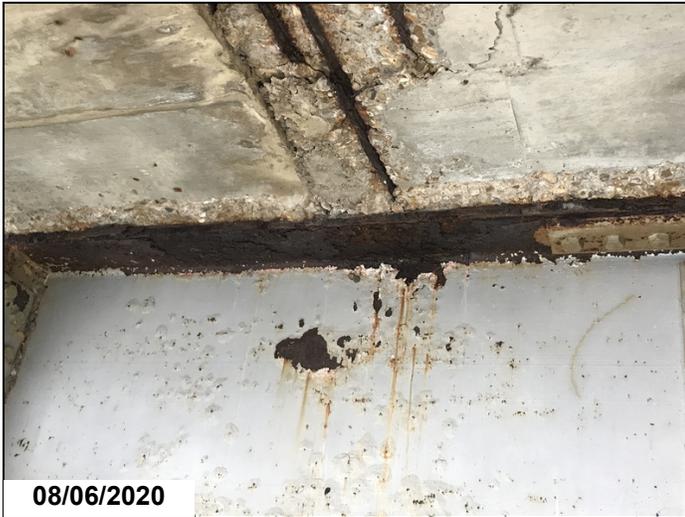
8/5/2020 Span 4 girder 5 has moderate section loss in top flange at the first splice plate. Bent 5 span 4 girder 3 has approximately 1/4" section loss in the haunch area. The web is 5/8" thick. Also web at diaphragm connection has 3/16" section loss. Protective coating has lost its effectiveness.

Span 4 girder 5 has moderate section loss in top flange at the first splice plate.

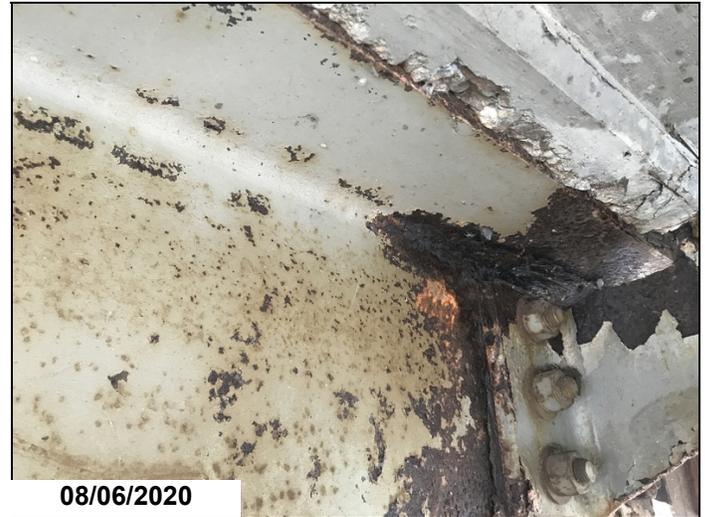
Bent 5 span 4 girder 3 has approximately 1/4" section loss in the haunch area. The web is 5/8" thick. Also web at diaphragm connection has 3/16" section loss.

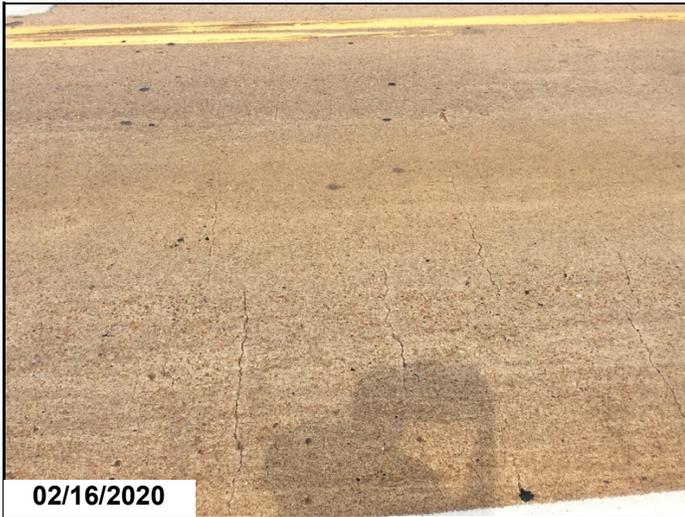
Minor to Moderate Delam, Cracking & Spalling W / Rebar Exposed.

Typ. Cracking in Deck.

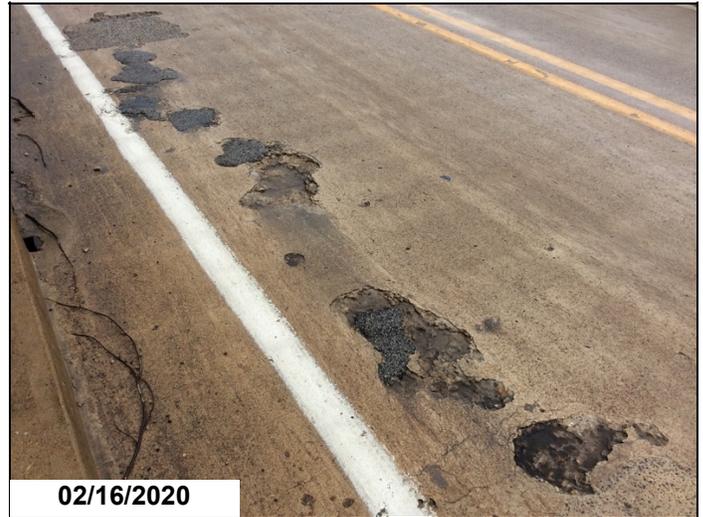
Typ Patched Areas & Spalling in Deck.

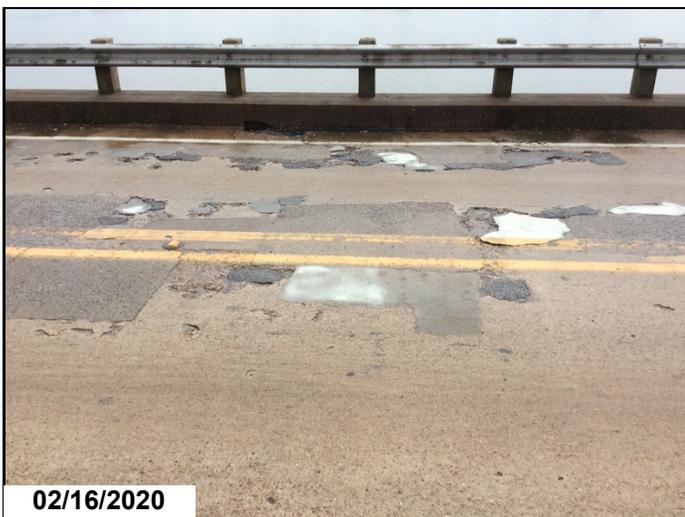
Typ. Patched Areas & Spalling Areas in Deck.

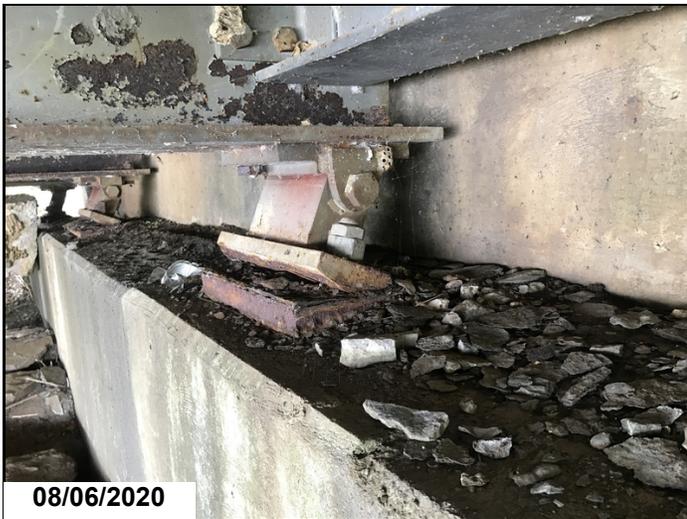
Movable bearings at both abutments are at full tilt.

Bent 1 bearings are full of pack rust and are fully tilted.

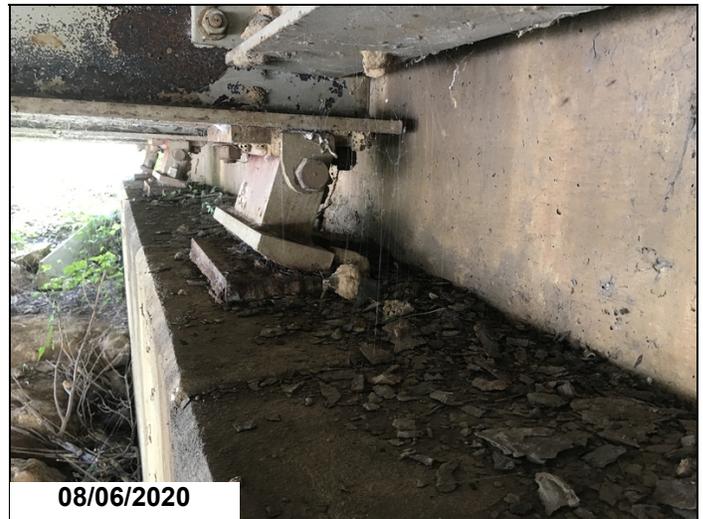
Moveable bearings at bent 8 are fully extended.

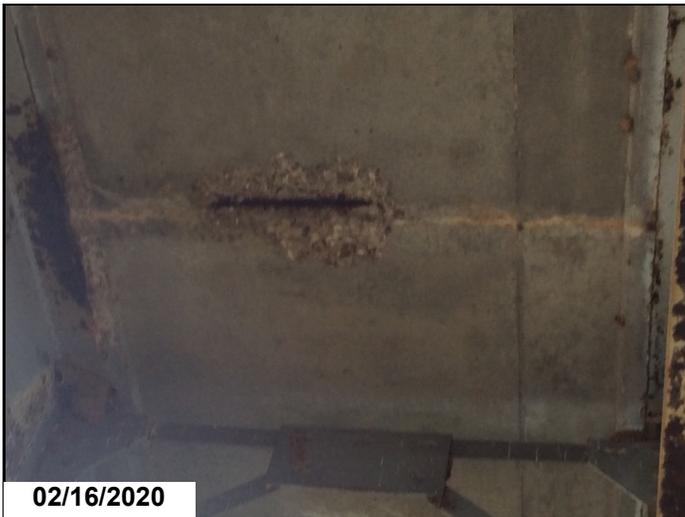
Underside of bridge deck.
Spalling w / rebar exposed.

Typ. Spalling in Soffit.

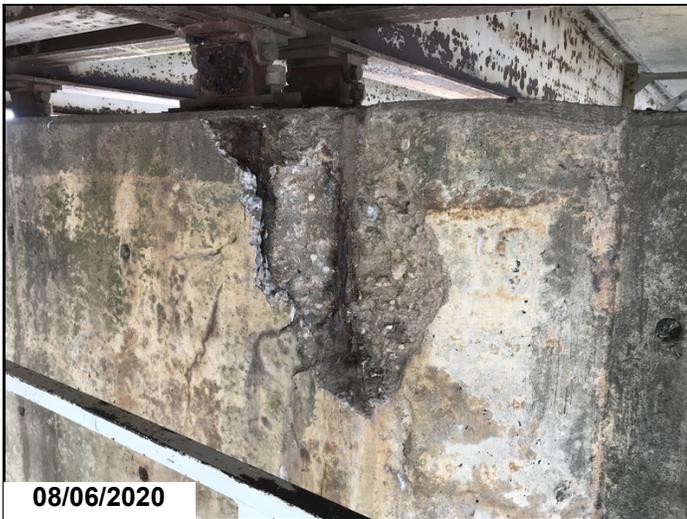
Bent 5 back side has a large spall with exposed reinforcing steel with section loss.
