Route:28 Section:02 Log:6.938

Arnold Road ID:63x28x2xA, Arnold Log mile:6.93

District 04, 127 - Scott County

(4) Place Code	0
(6) Features Intersected	Fourche La Fave River
(7) Facility Carried	State Highway 28
(9) Location	6.94 MI E OF US 71 JCT
(11) Mile Point	6.938 mi

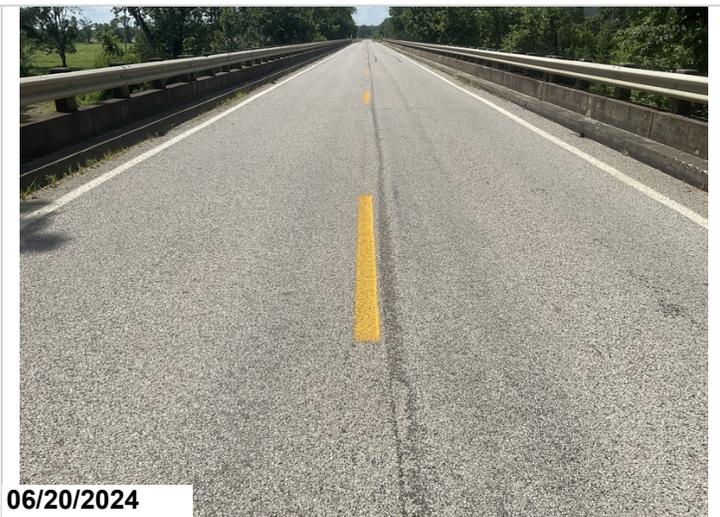
Driving surface: typical.

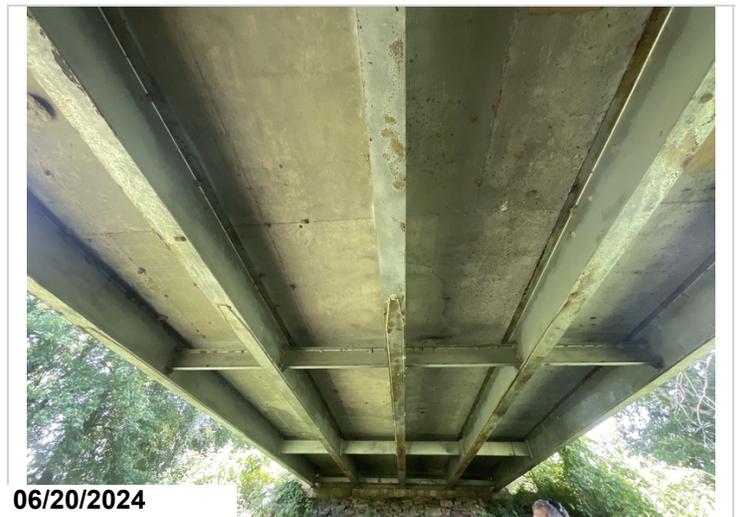
Undersurface, span # 1: typical.

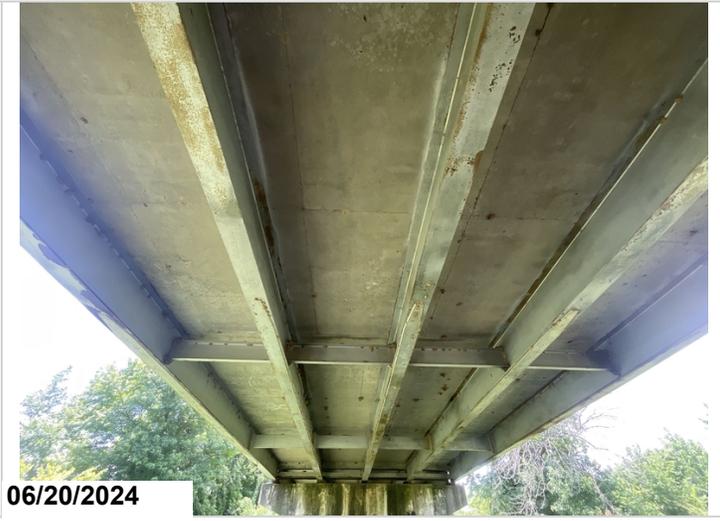
Undersurface, span # 2: typical.

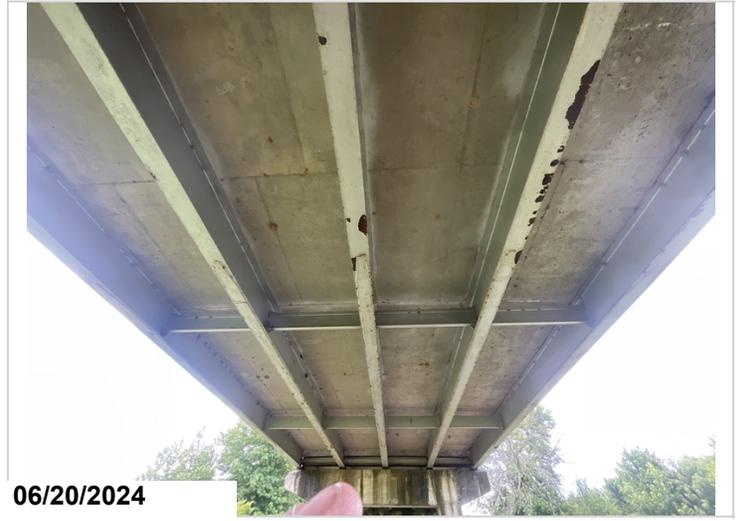
Undersurface, span # 3: typical.

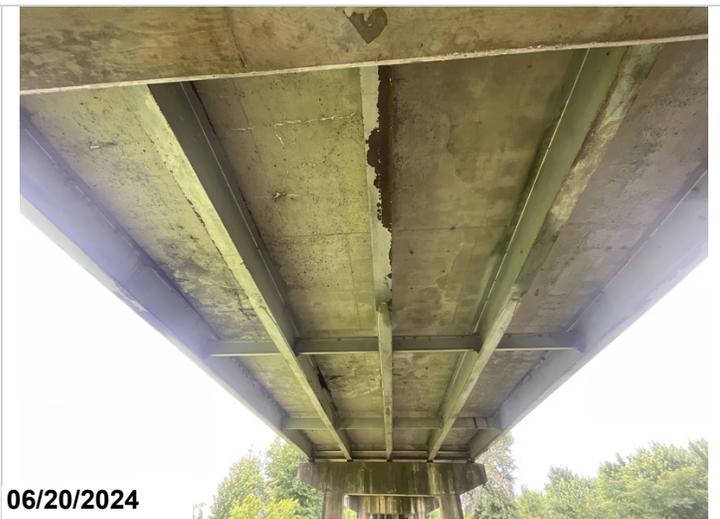
Undersurface, span # 4: typical.

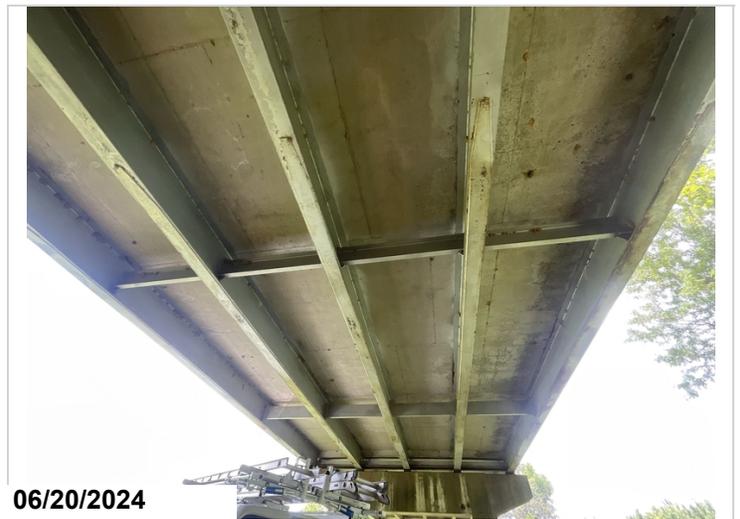
Undersurface, span # 5: typical.

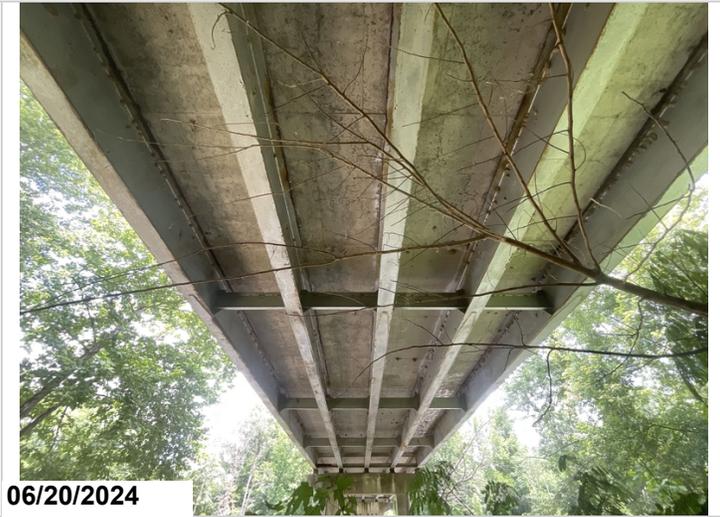
Undersurface, Span # 6: typical.

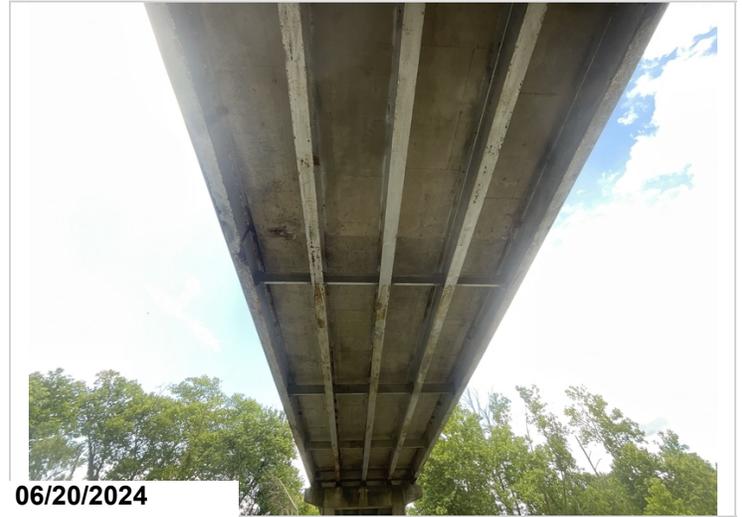
Undersurface, Span # 7: typical.

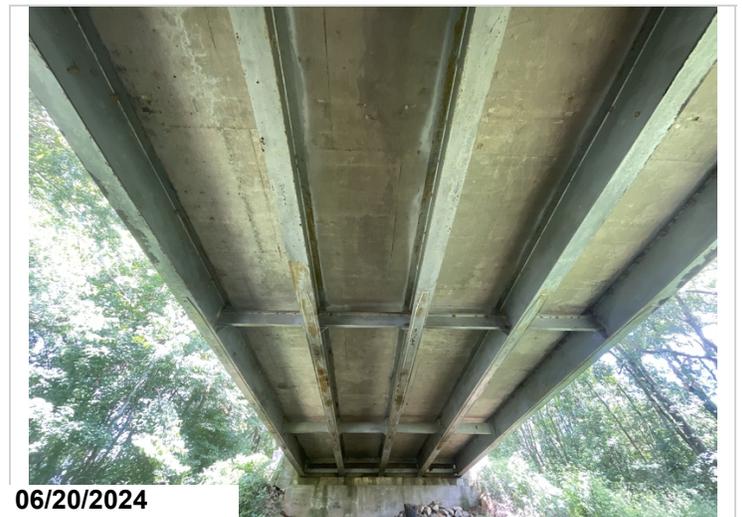
Undersurface, span # 9: typical.

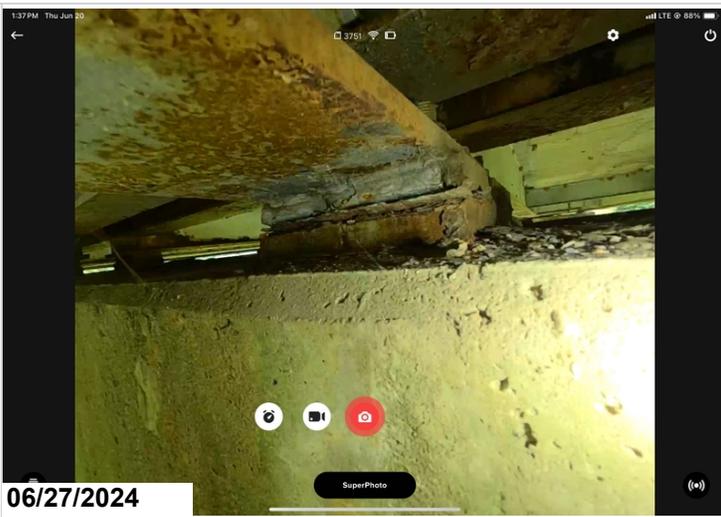
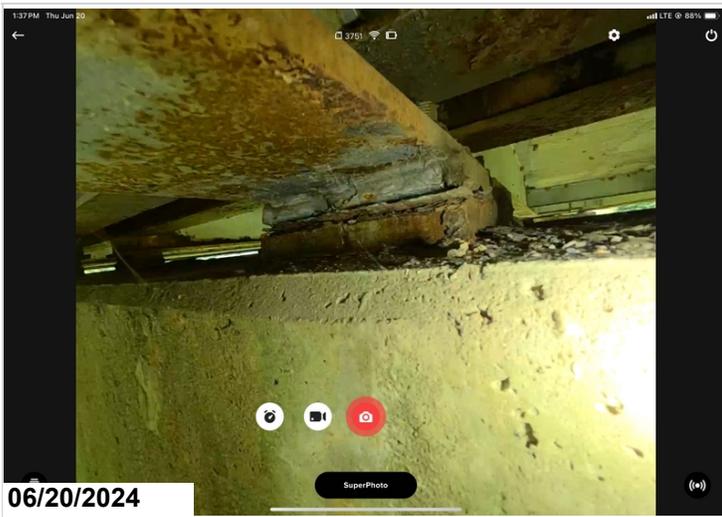
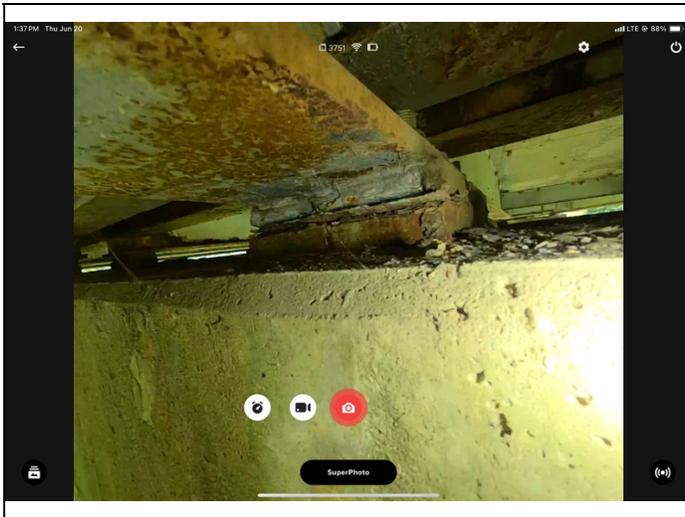
Bearings have active corrosion and layers of rust.

Bent # 5, bearing # 2, ahead: active corrosion and pack rust.

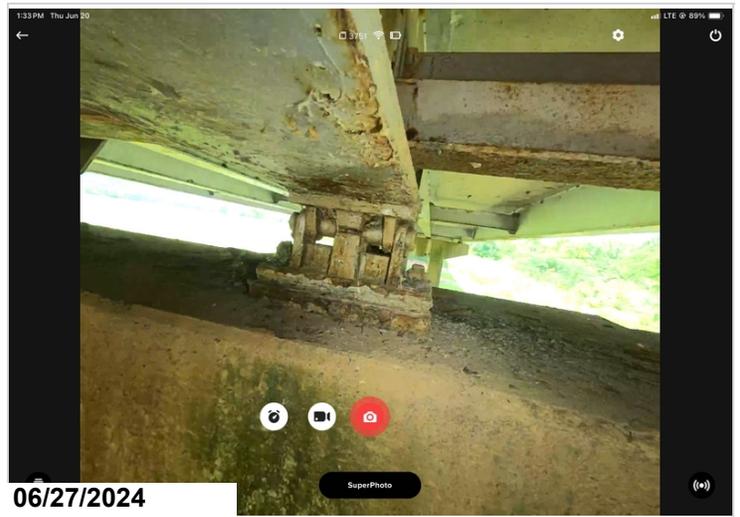
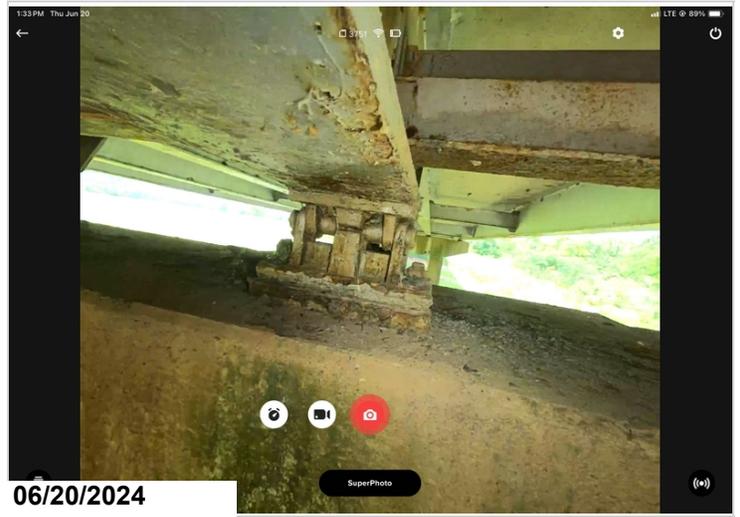
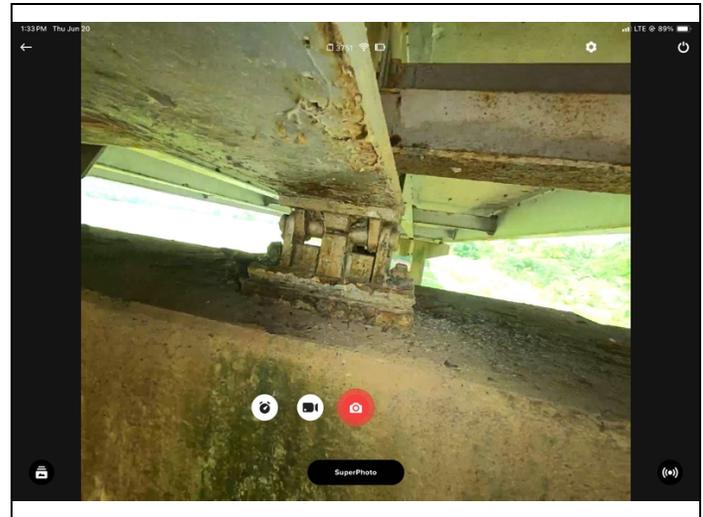
Bent # 6, bearing # 2, ahead: active corrosion and pack rust.

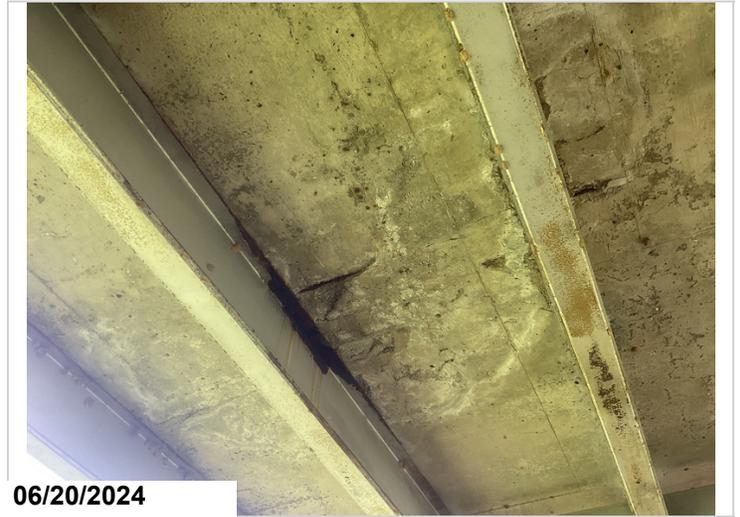
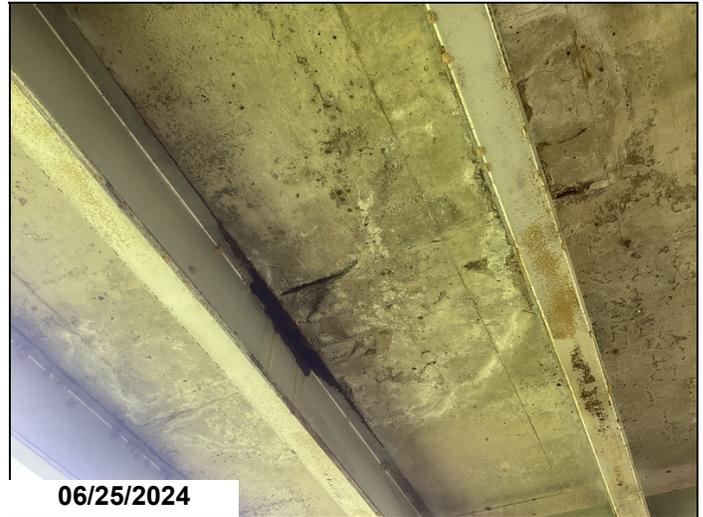
- Span # 4 undersurface in bay # 3 near mid-span has a 5' long x 3' wide delaminated area with a 16" spall with exposed reinforcing steel in the affected area. Exposed reinforcing steel has an estimated 50% section loss.

Span # 4 undersurface in bay # 3 near mid-span has a 5' long x 3' wide delaminated area with a 16" spall with exposed reinforcing steel in the affected area. Exposed reinforcing steel has an estimated 50% section loss.

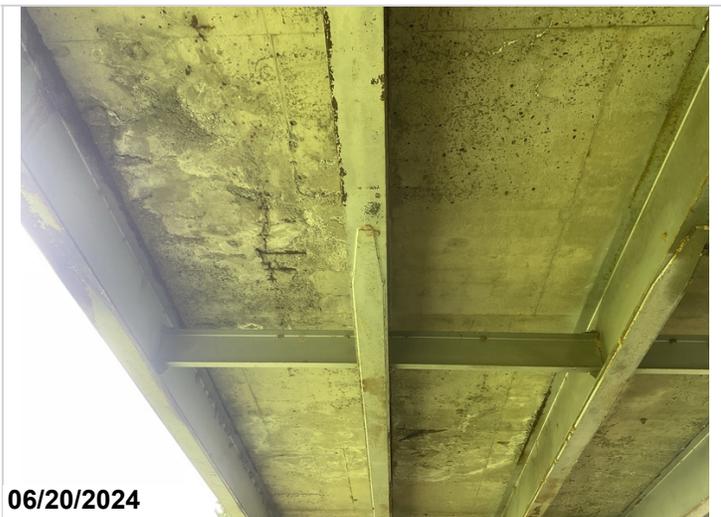
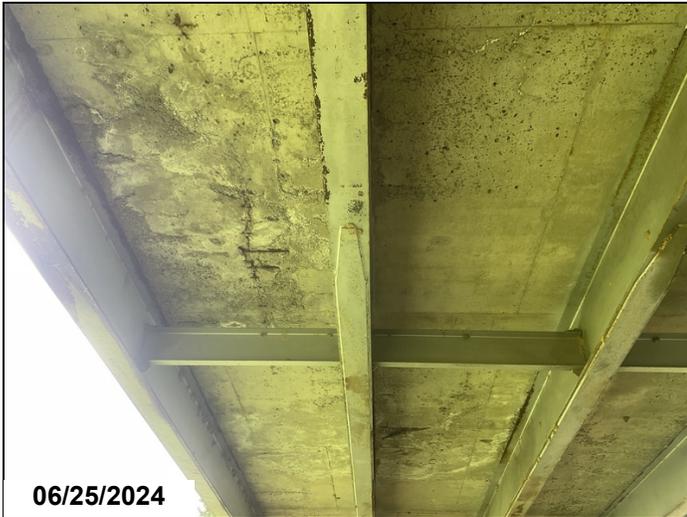
- Span # 4 undersurface has large areas of leaching, map cracking and 2" deep concrete deterioration with exposed reinforcing. Span # 4 undersurface in bay # 4 approximately 15' from bent # 5 has an area approximately 10' long x 4' wide that is delaminated with spalling that exposes the reinforcing steel. The delaminated area appears to be sagging in areas. Exposed longitudinal reinforcing steel is corroded into with a 6" long section of the bar missing.

Span # 4 undersurface has large areas of leaching, map cracking and 2" deep concrete deterioration with exposed reinforcing. Span # 4 undersurface in bay # 4 approximately 15' from bent # 5 has an area approximately 10' long x 4' wide that is delaminated with spalling that exposes the reinforcing steel. The delaminated area appears to be sagging in areas. Exposed longitudinal reinforcing steel is corroded into with a 6" long section of the bar missing.

Span # 4 undersurface in bay # 4 approximately 15' from bent # 5 has an area approximately 10' long x 4' wide that is delaminated with an area of spalling that exposes the reinforcing steel. The delaminated area appears to be sagging in areas. Exposed longitudinal reinforcing steel is corroded into with a 6" long section of the bar missing. Span # 4 undersurface in bay # 3 near mid-span has a 5' long x 3' wide delaminated area with a 16" spall with exposed reinforcing steel in the affected area. Exposed reinforcing steel has an estimated 50% section loss.

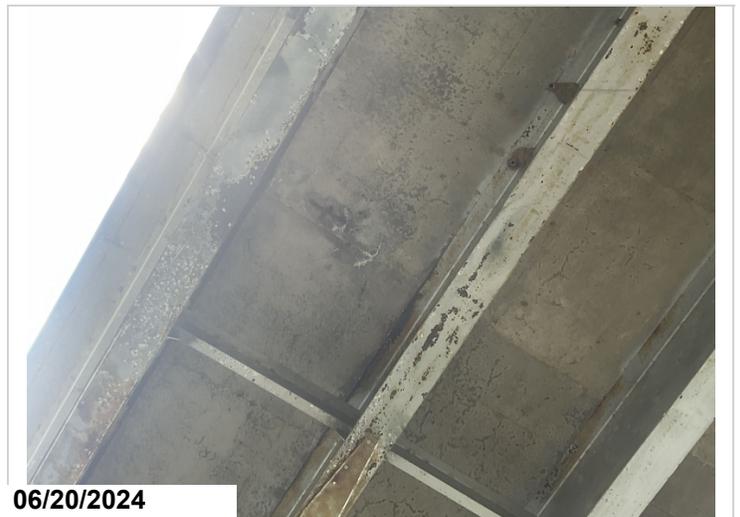
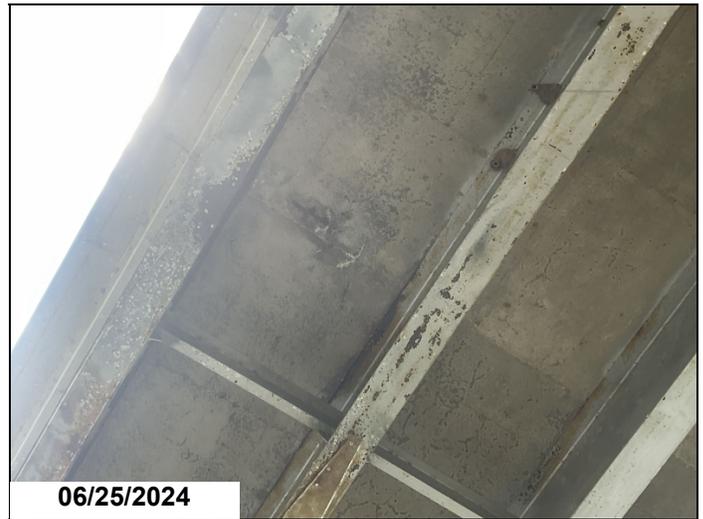
- Span # 7 undersurface in bays # 1 and 4 has areas of light scaling. Span # 7 undersurface in bay # 4 approximately 15' from bent # 8 has a 15" x 8" spall with exposed reinforcing steel. The areas surrounding the spall is delaminated with efflorescence and leaching.

Span # 7 undersurface in bay # 4 approximately 15' from bent # 8 has a 15" x 8" spall with exposed reinforcing steel. The areas surrounding the spall is delaminated with efflorescence and leaching.

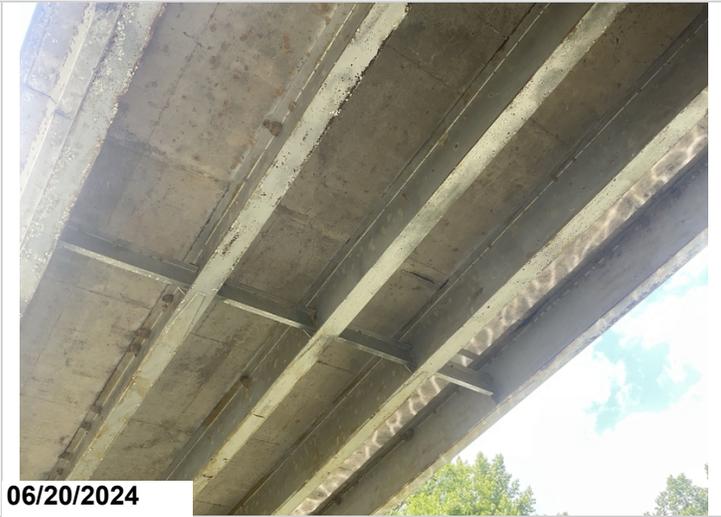
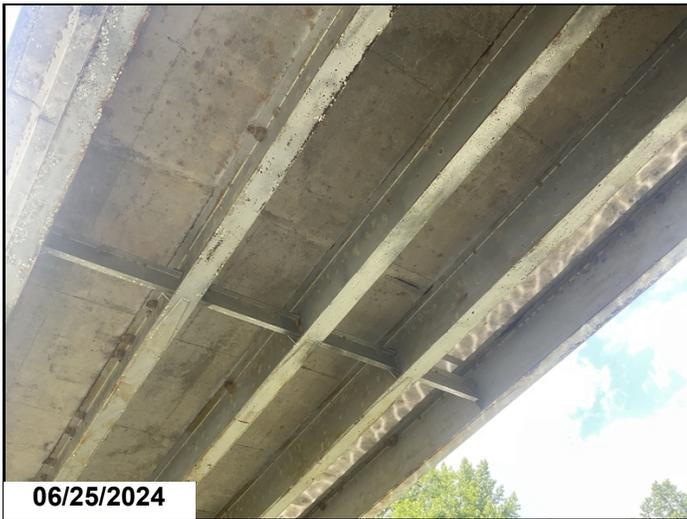
- Span # 8 undersurface in bay # 3 has an 18" x 5" spall with exposed reinforcing steel located approximately 15' from bent # 8 and a 3' long delaminated area located approximately 15' from bent # 9. Bay # 4 undersurface approximately 15' from bent # 9 has an 8" x 4" spall with exposed reinforcing steel. The area surrounding the spall is delaminated.

Span # 8 underside in bay # 3 has an 18" x 5" spall with exposed reinforcing steel located approximately 15' from bent # 8 and a 3' long delaminated area located approximately 15' from bent # 9.

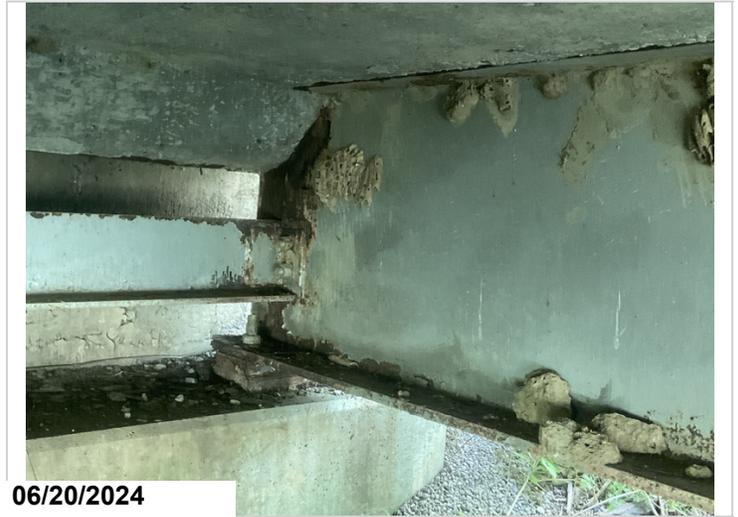
Abutment # 1, girder # 1: active corrosion and pack rust.

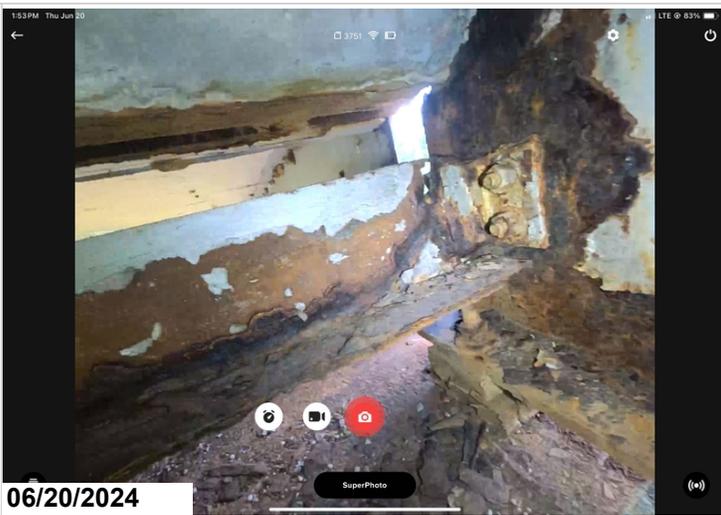
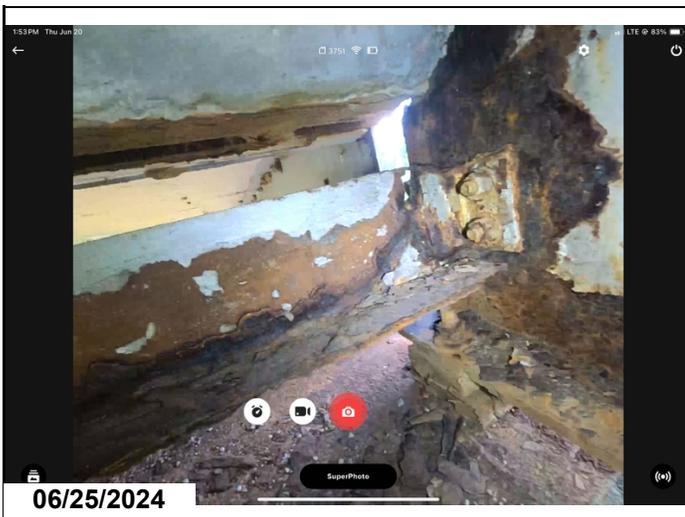
Bent # 3, girder # 5, back: active corrosion and pack rust with a hole in the diaphragm over Bent # 3.

Superstructure has isolated areas of active corrosion at the ends of beams and near the deck drains. Some areas have flaking rust. The diaphragms have holes rusted through in locations.

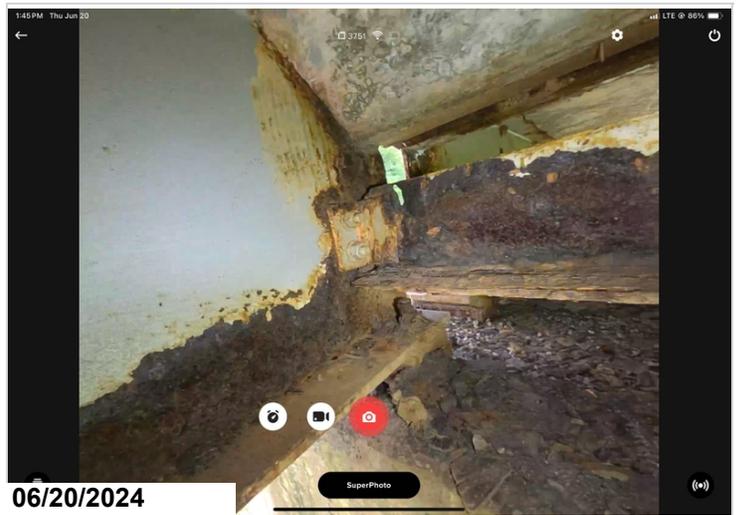
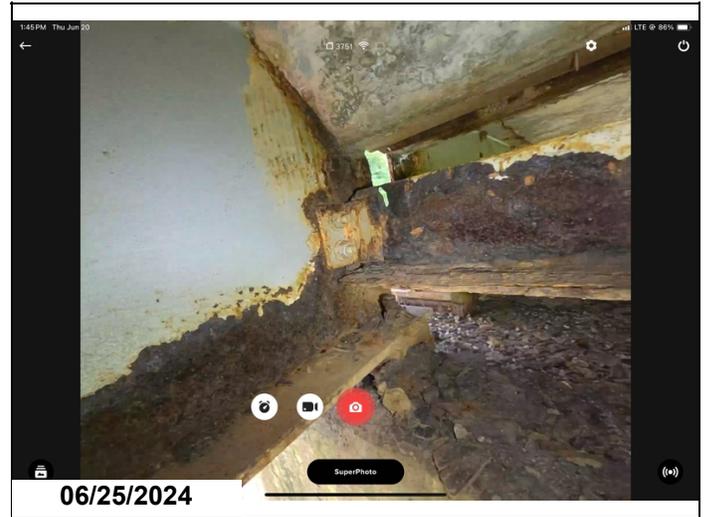
Bent # 4, , girder # 1, back: active corrosion and pack rust with a hole in the diaphragm over Bent # 4.

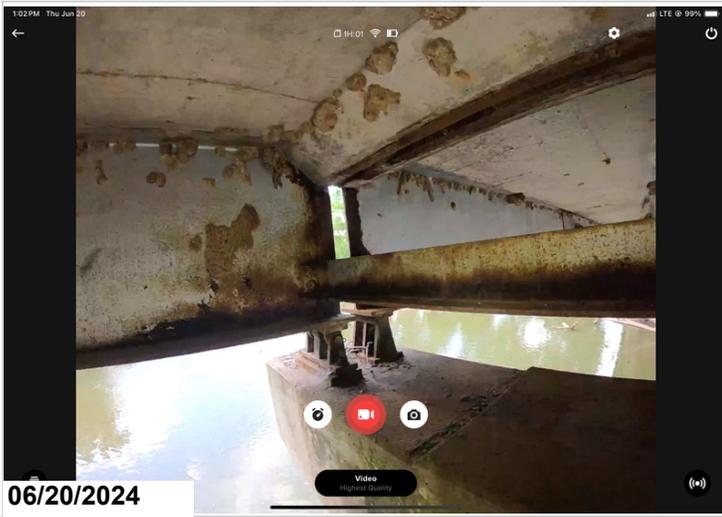
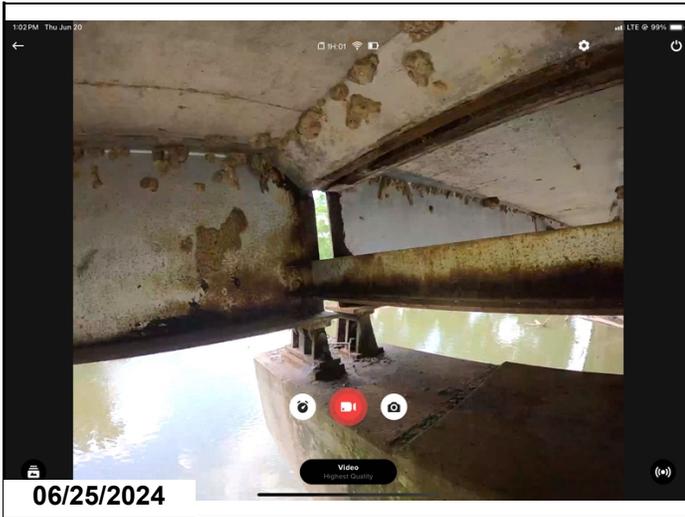
Bent # 8, girder # 5, ahead: active corrosion and pack rust.

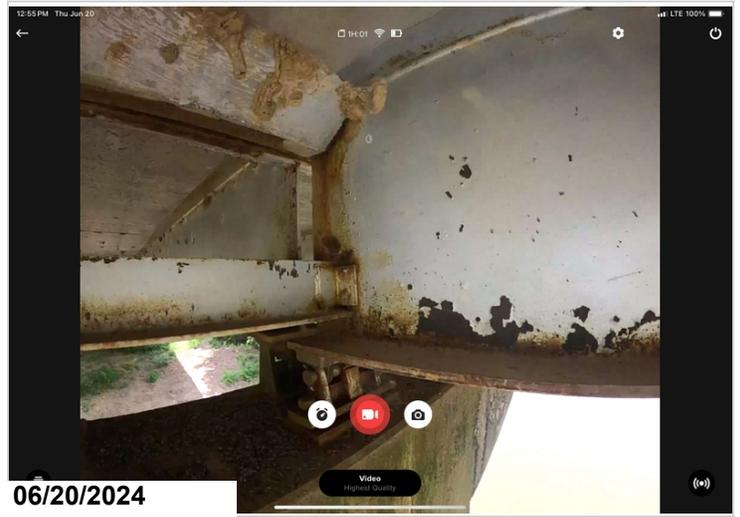
Bent # 7, girder # 2, ahead: active corrosion with pack rust.

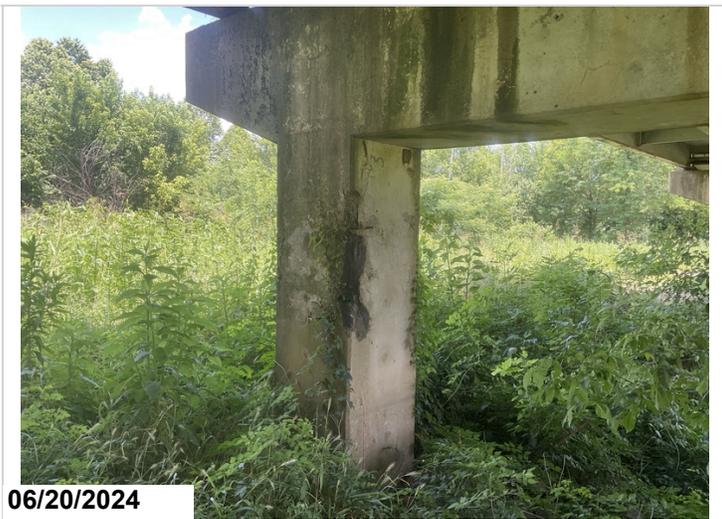
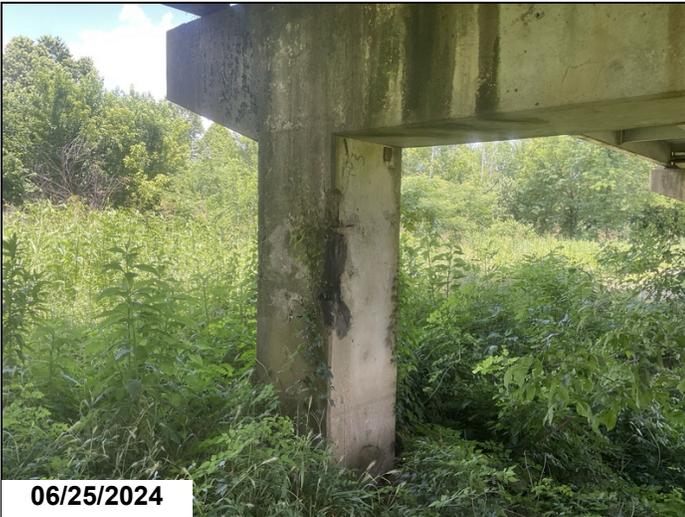
Bent # 2 has a 4' vertical spall in the Left column that has been covered with caulking as a type of repair. Concrete is delaminated adjacent to the caulked repair.

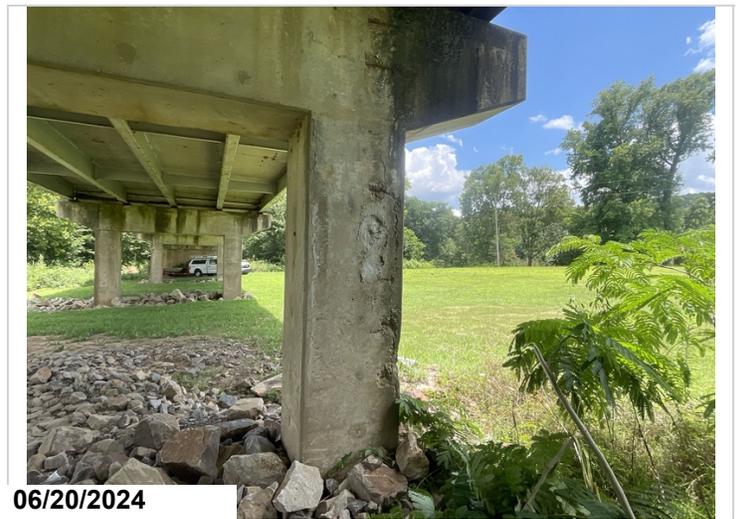
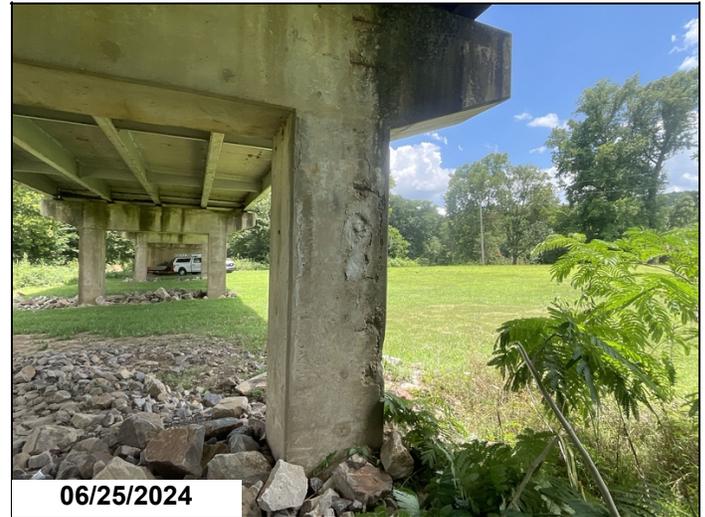
Bent # 3 has a 6' vertical delaminated area with spalls in the Right column that has been covered with caulking as a type of repair.

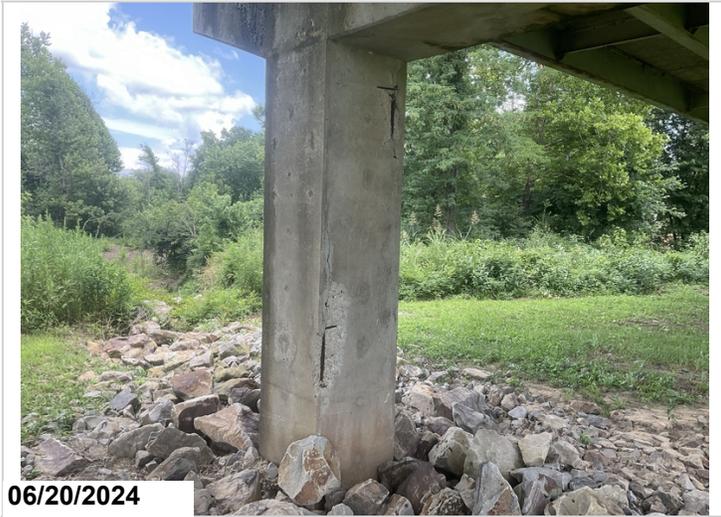
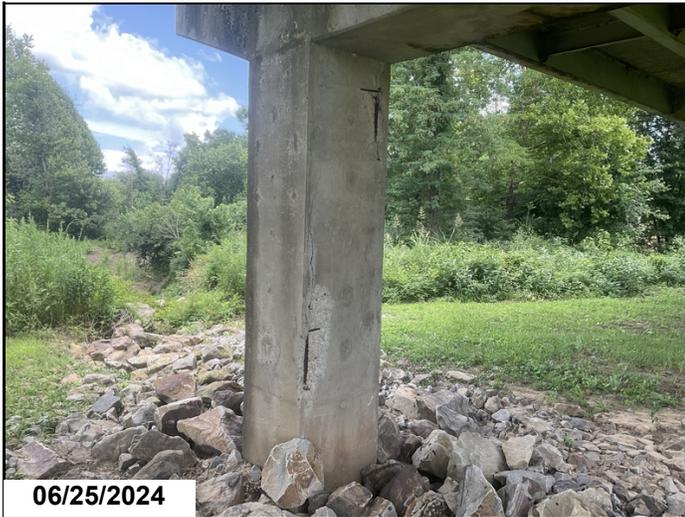
Bent # 4 has vertical cracks with spalls that have exposed reinforcing steel in both columns.

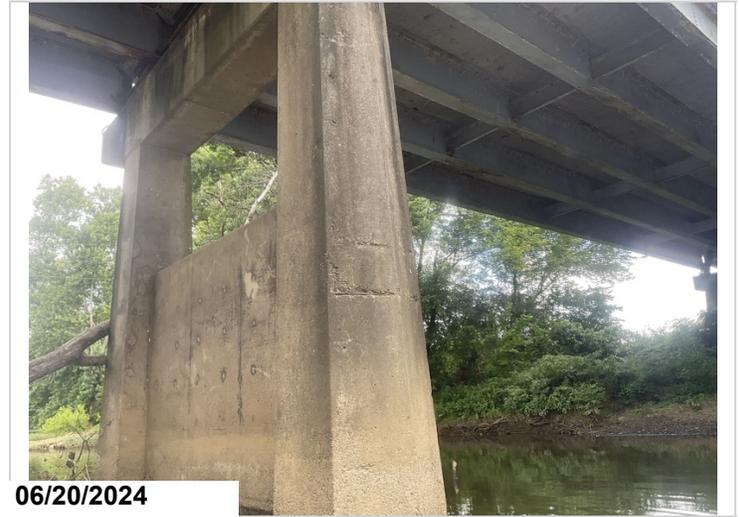
Bent # 7, Column # 1 has two 24" horizontal spalls with exposed reinforcing steel located approximately 12' below the base of cap in the Lt column.

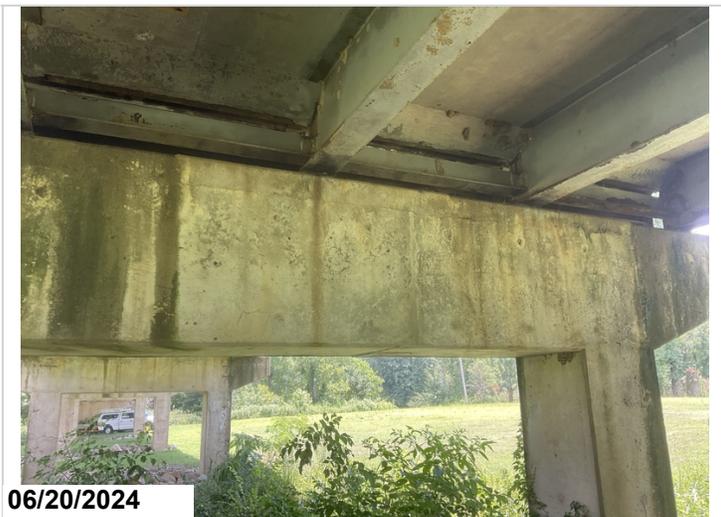
Bent # 2 has a 10' horizontal crack located approx. 6" below the top of cap.

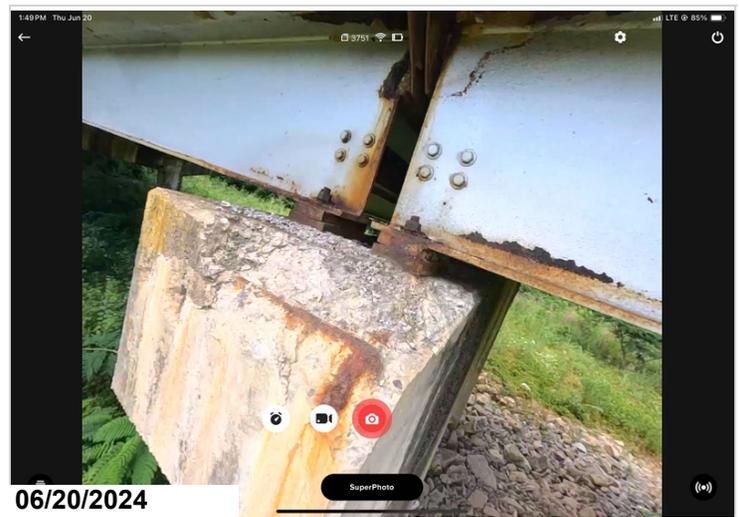
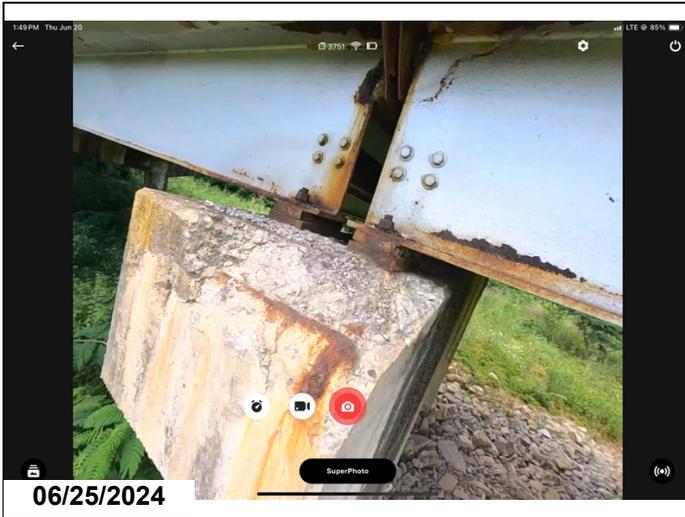
Bent # 3, right: concrete deterioration with exposed reinforcing steel adjacent to girder # 5 on the exterior top surface with up 4" of concrete section loss.

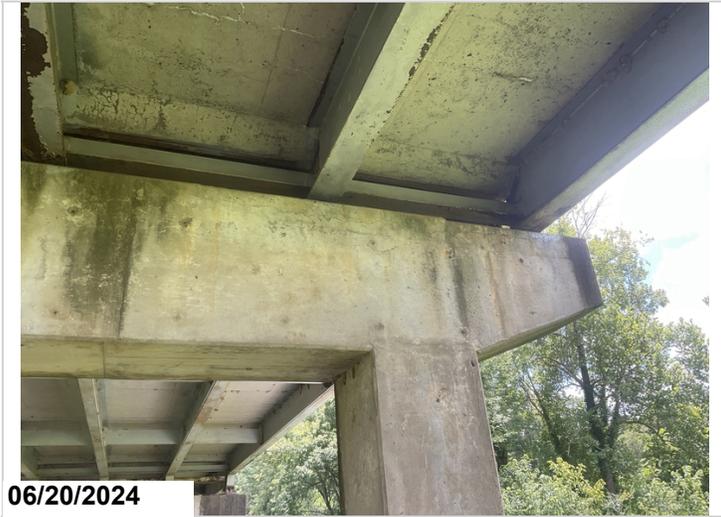
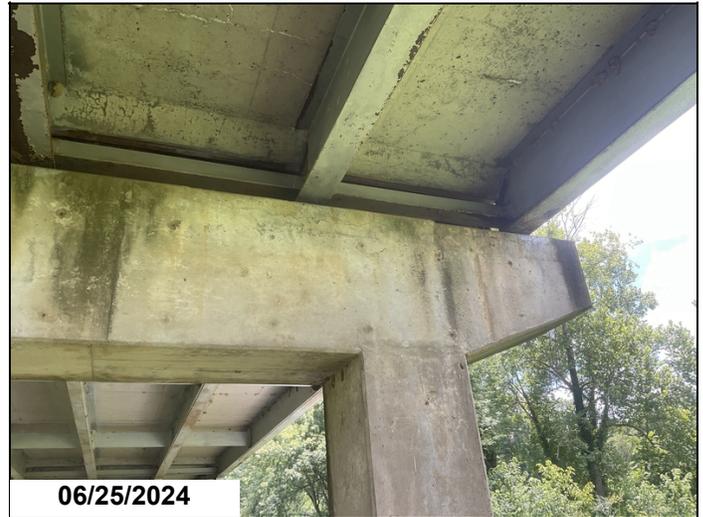
Bent # 5 has horizontal cracking approximately 6" below the top of the cap on the Span # 4 side.

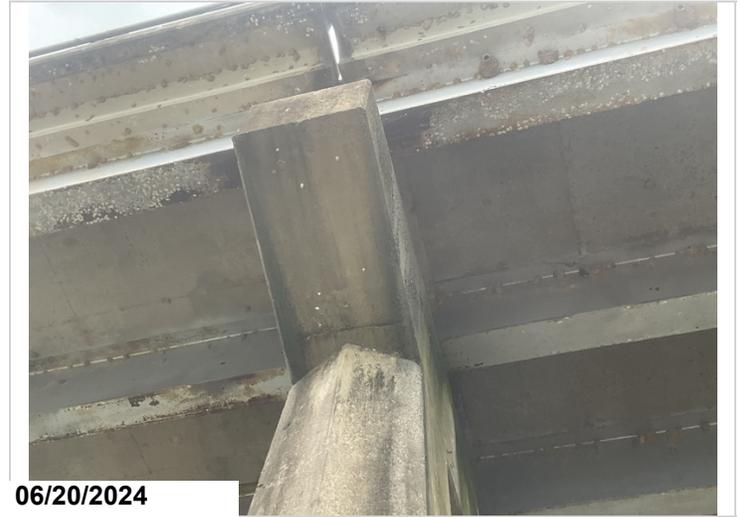
Bent # 7, left has an 18" spall with exposed reinforcing steel in the Lt underside of cap.

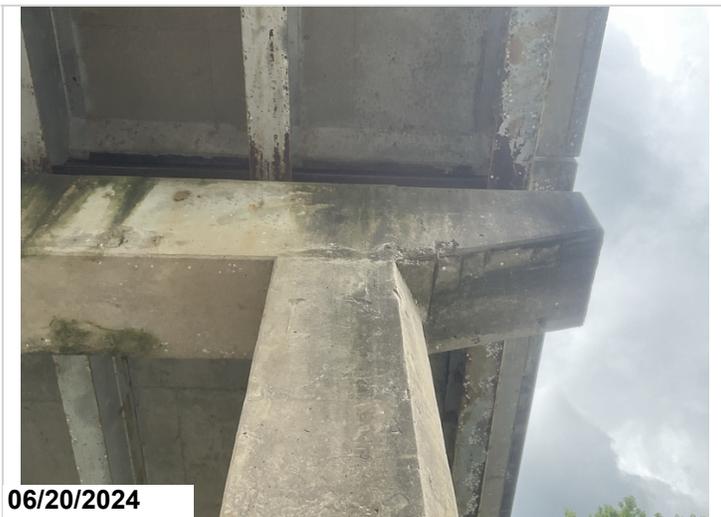
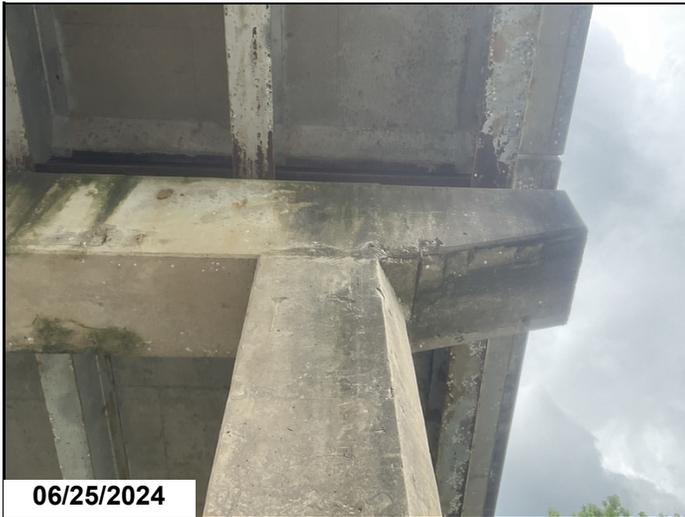
Bent # 8 has spalling with exposed reinforcing steel on the underside of the right side of the cap and on the Span # 7 face approximately 3' from Column # 2.

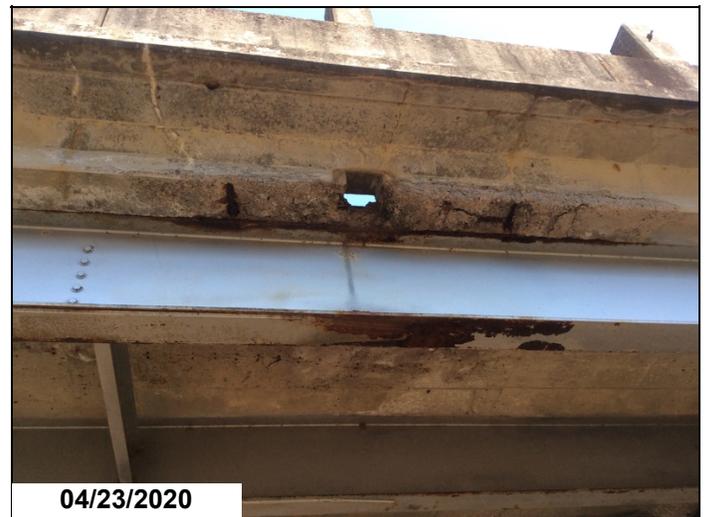
Span # 4 adjacent to beam # 5 active corrosion in the beam.

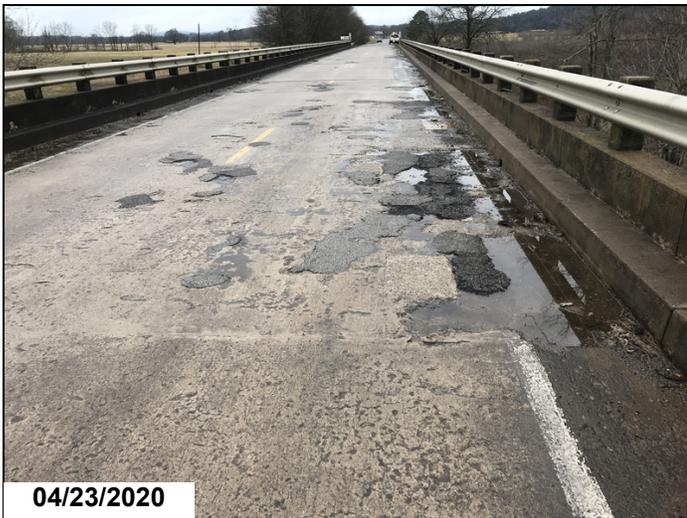
Span # 6 with numerous failing temporary repairs.

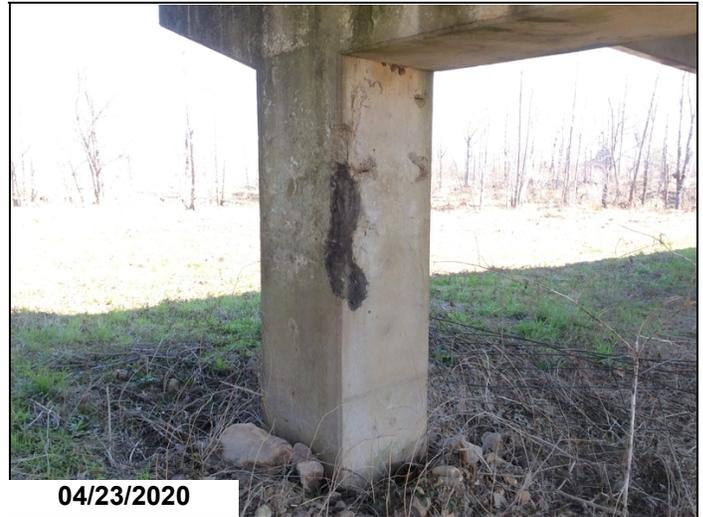
Bent # 2 Column # 1 vertical spalling filled with caulking as a type of repair.

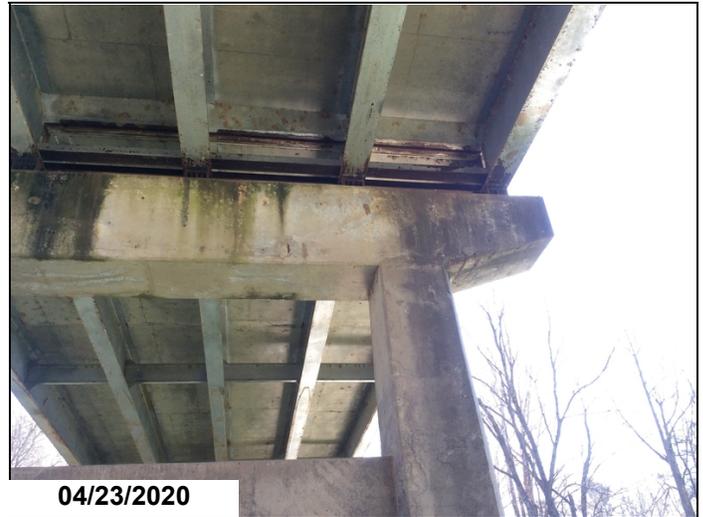
Bent # 8 spalling with exposed reinforcing steel.
