Asset #02466(Routine, NSTM)

US 79-B S-4 LM 2.2 over OUACHITA RIVER

Location: 1.08 MI NE JCT SH 7

Team Lead: Anthony Wood Inspection Date: 10/03/2022

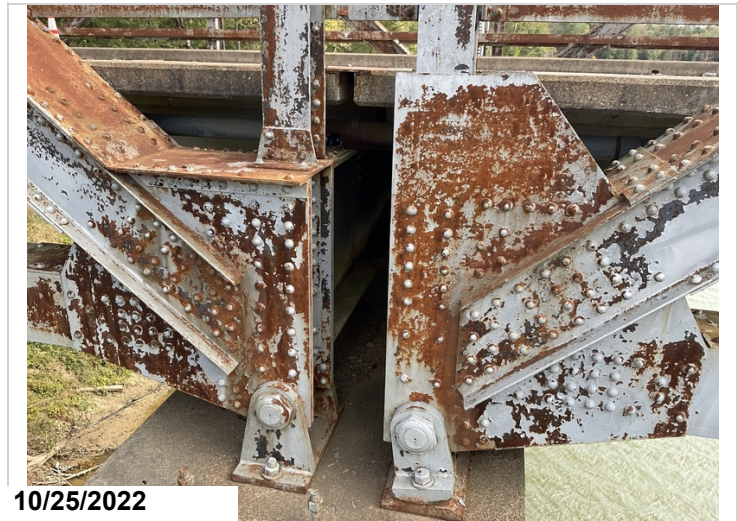
Minor active corrosion on gusset plates.

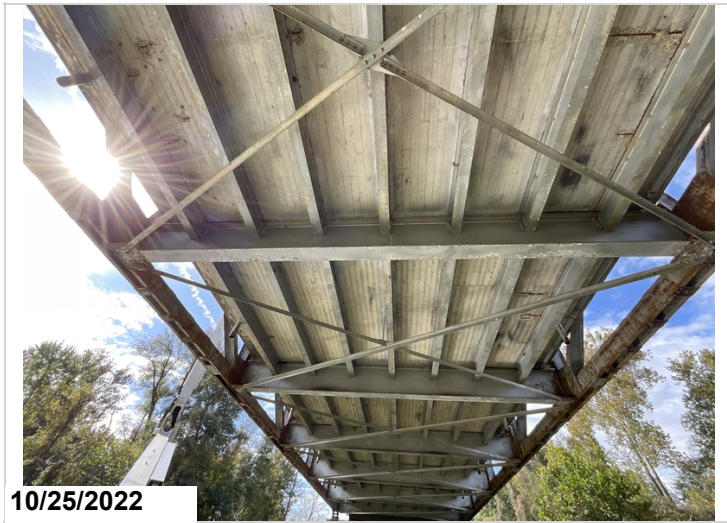
Truss Spans: Typical undersurface.

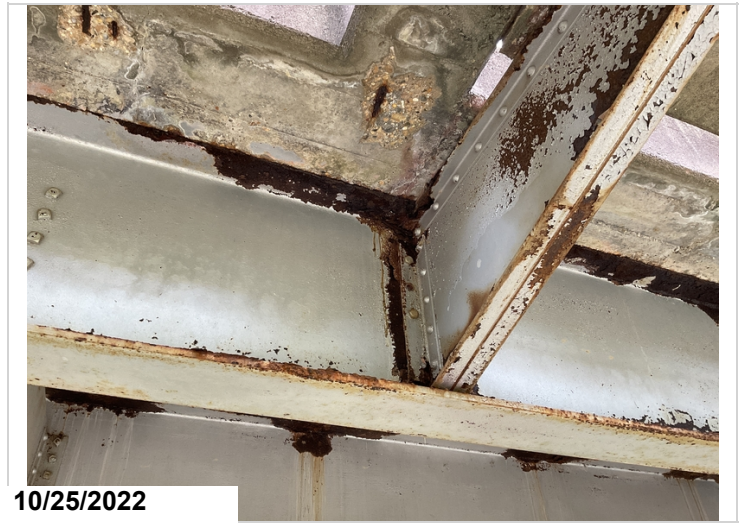
Span 6, Girder 1, 3rd Sidewalk Support: 1 missing bolt and top bolt sheared.

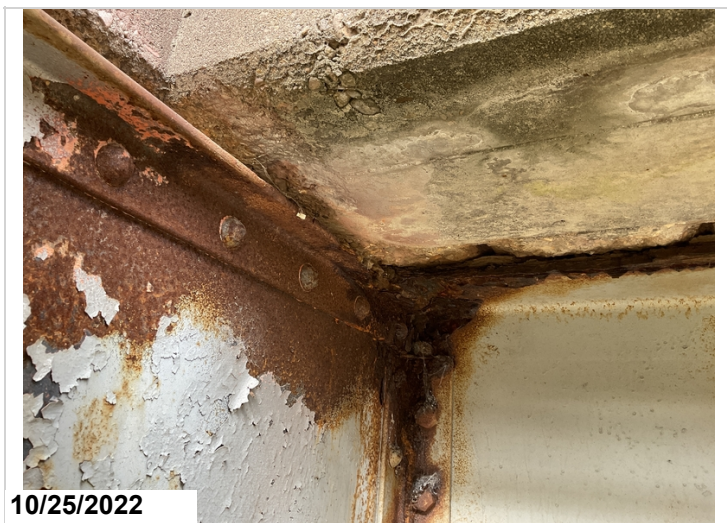
Span 6, Top Flange @ Sidewalk Supports: Active corrosion with knife edge section loss.

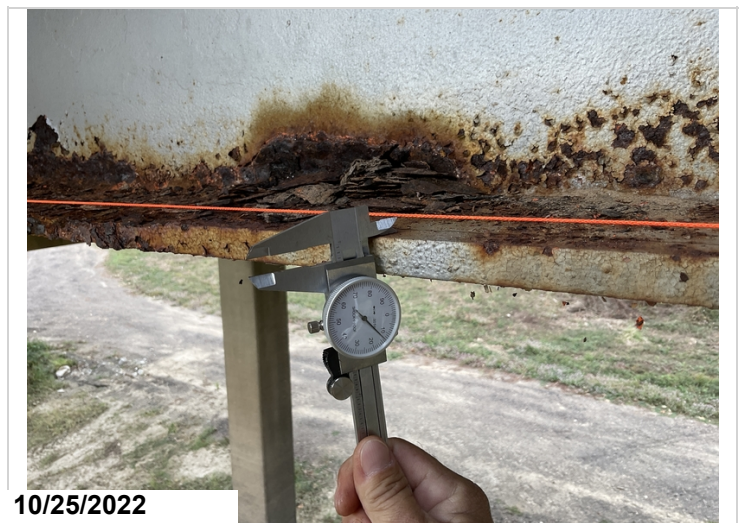
All spans have approximately 0.31" of sag in girders.

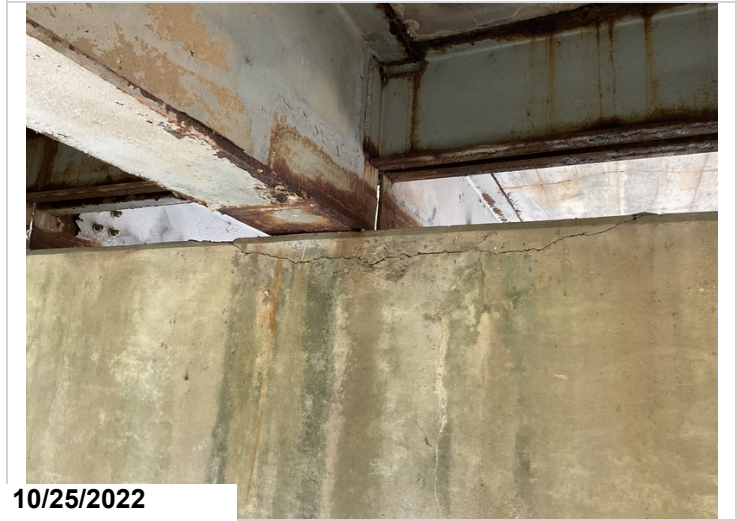
Bent 2, Back, Girder 2: Cracking.

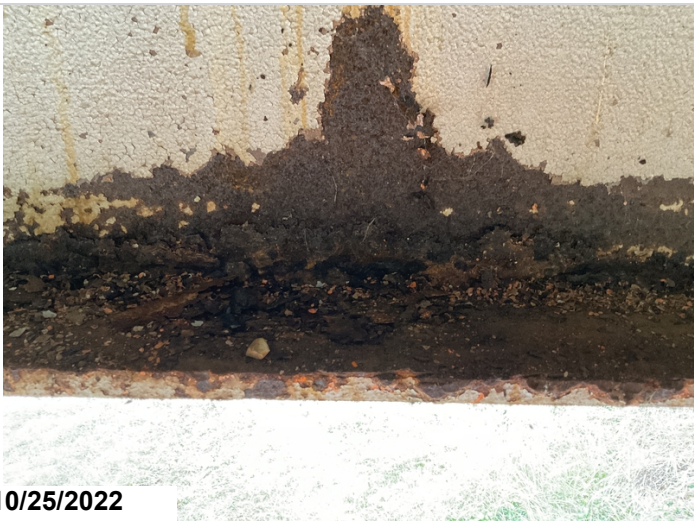
Span 1, Girder 4 & 5: Active corrosion with section loss in bottom flange. Approximately 6' back of Bent 2.

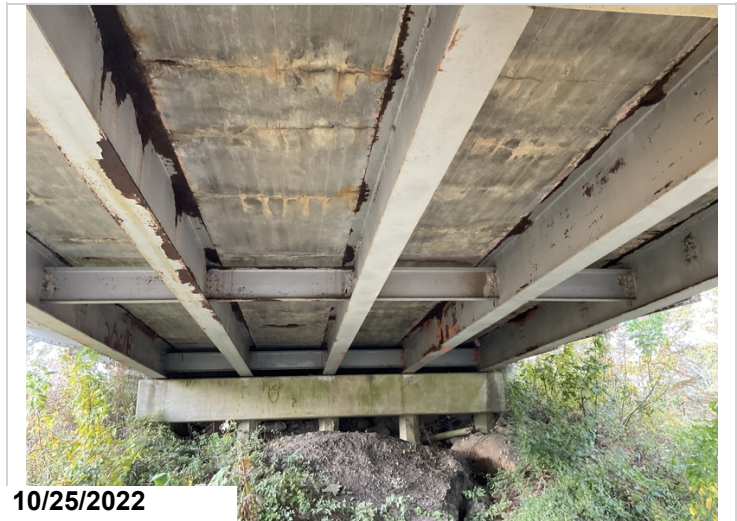
Span 1: Typical active corrosion with section loss on top flanges.

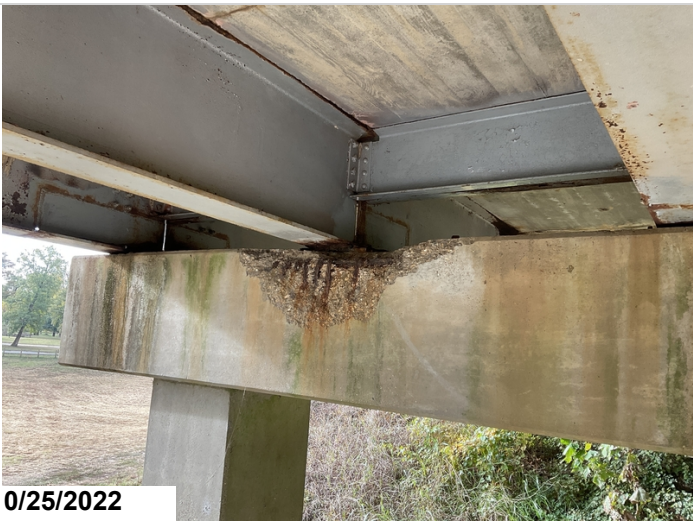
Bent 2, Ahead, Girder 4: Spalling with exposed reinforcing steel with section loss.

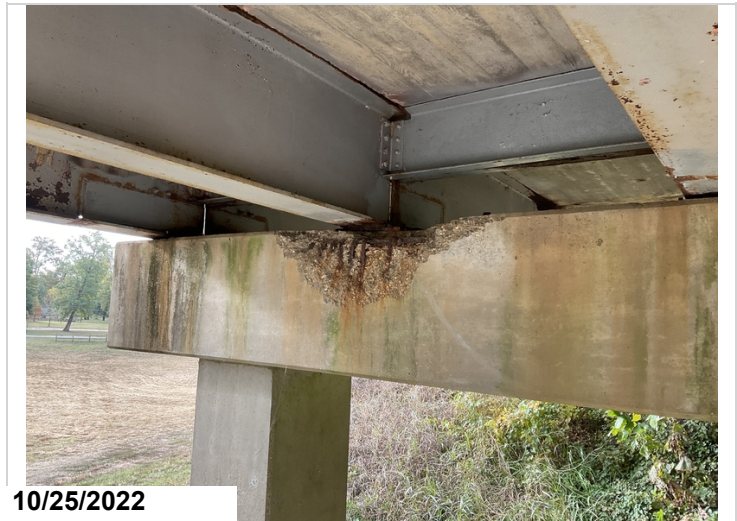
Spalling on each side of exposed reinforcing steel.

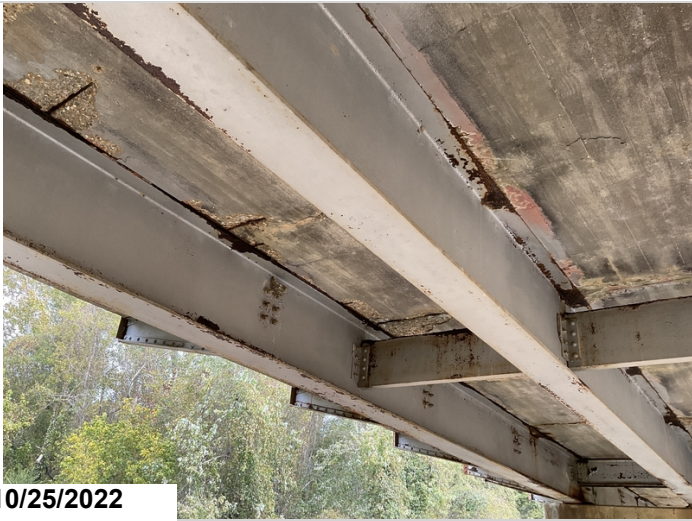
Span 2: Typical active corrosion with section loss on top flanges.

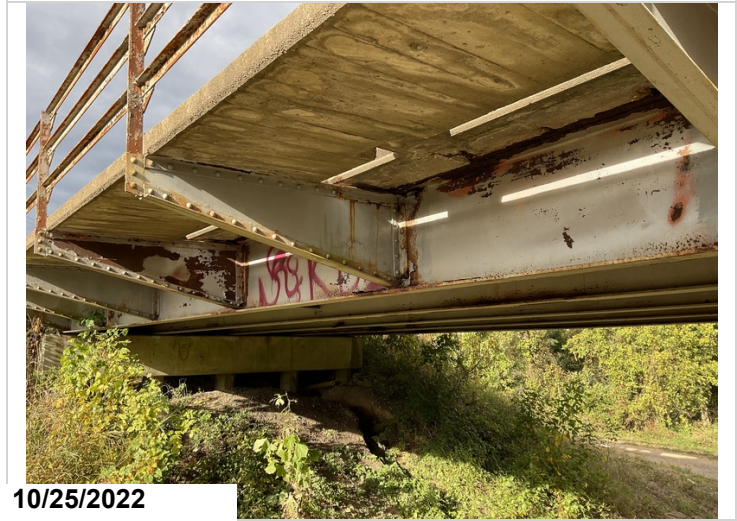
Typical active corrosion with flaking rust in cantilever brackets.

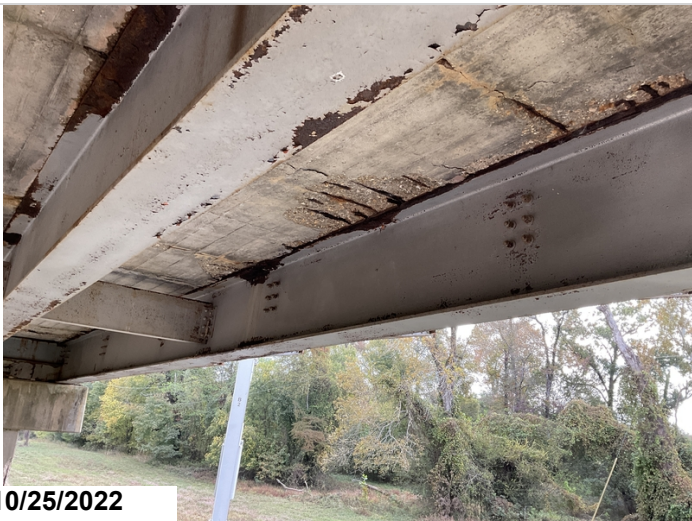
Span 4: Typical active corrosion with section loss on top flanges.

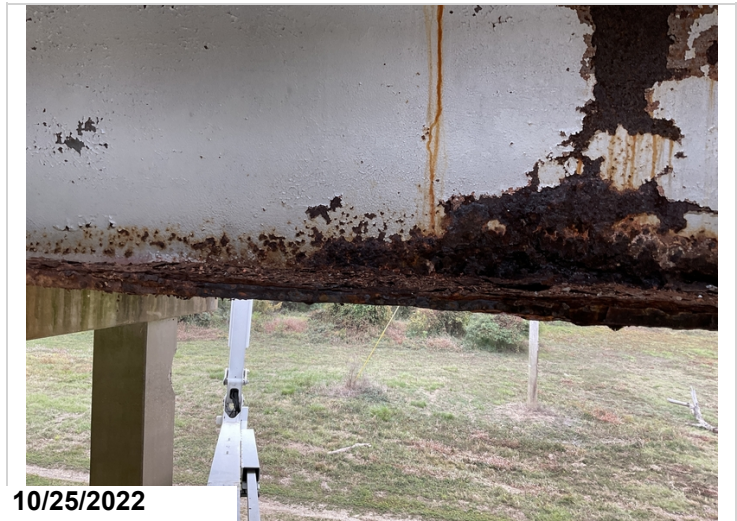
Span 4, Girder 1, 10' Back from Bent 11: 1/4" section loss to bottom flange.

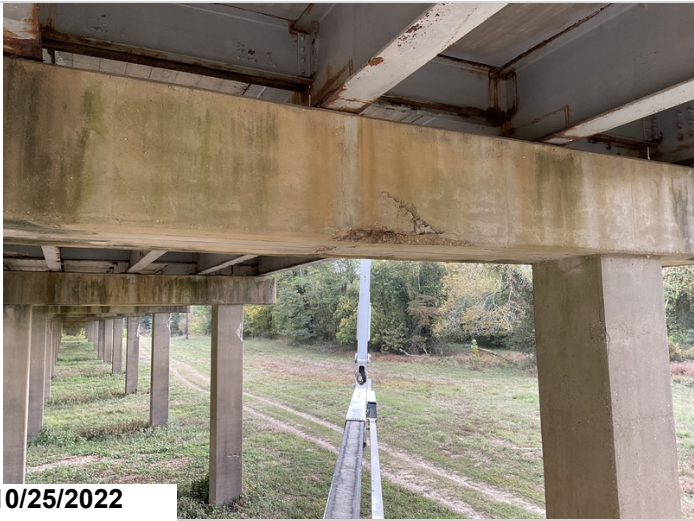
Bent 4, Back, Girder 3: Spalling with exposed reinforcing steel with section loss.

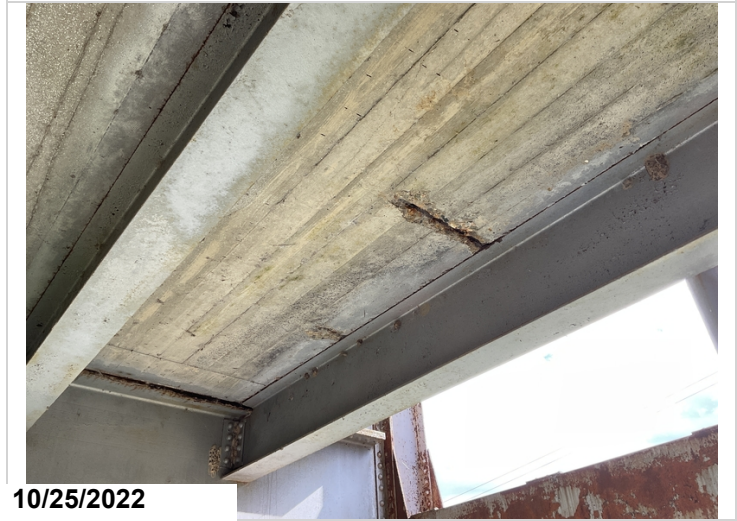
Typical exposed reinforcing steel with section loss in truss spans.

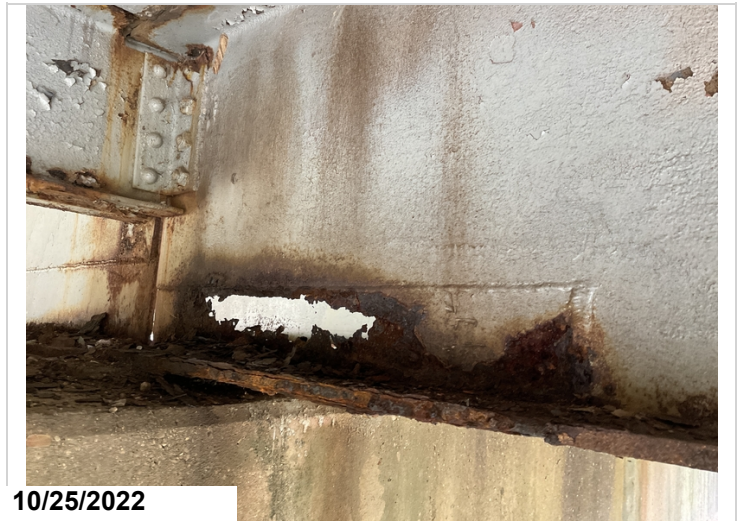
Bent 13, Span 13, Girder 3: Hole rusted through web, 16" long X 3" tall.

- Bent 9 (ahead & back) all girders sec. loss @ bearing area.
- Bent 10 (ahead & back) all girders sec loss @ bearing area.
- Bent 13 (Span 13) Girder 3 has a hole rusted through the t-splice repair.

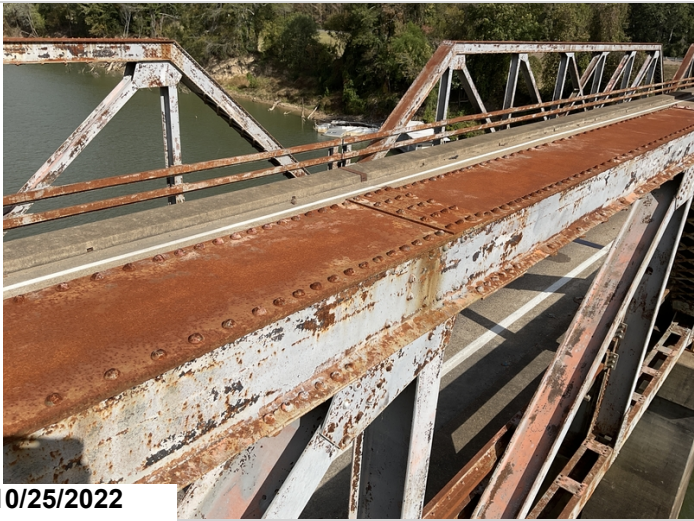
Minor active corrosion in top chord.

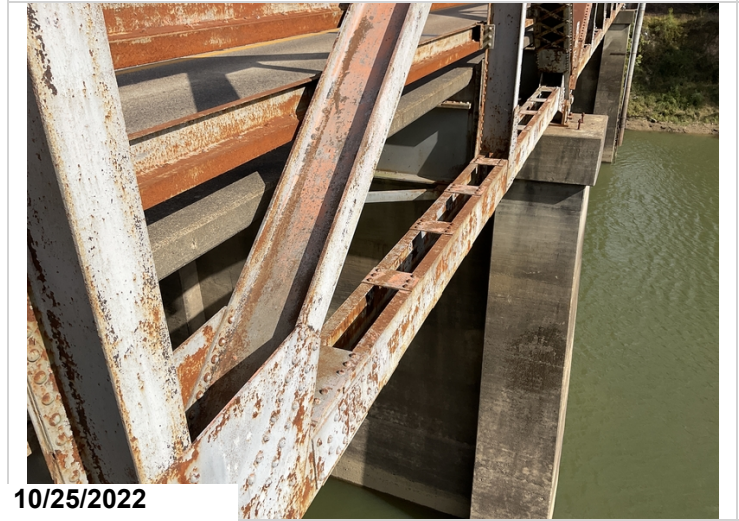
Minor active corrosion in bottom chord.

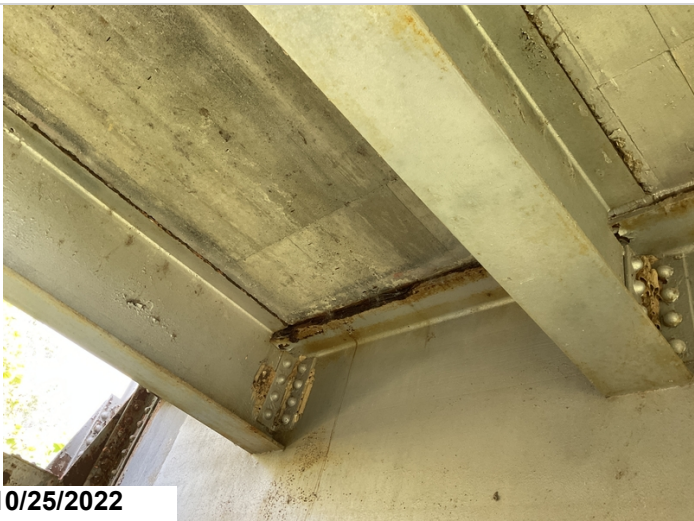
Truss Span 1, PP 1: Active corrosion with flaking rust.

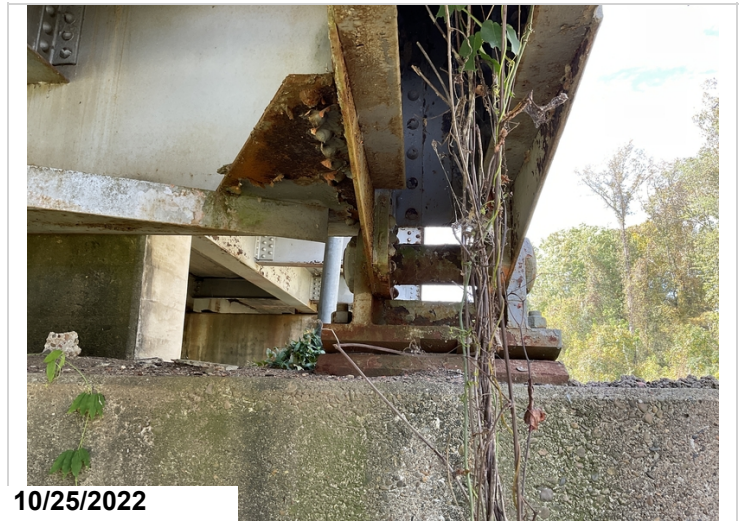
Pier 1, Bearings: Minor active corrosion.

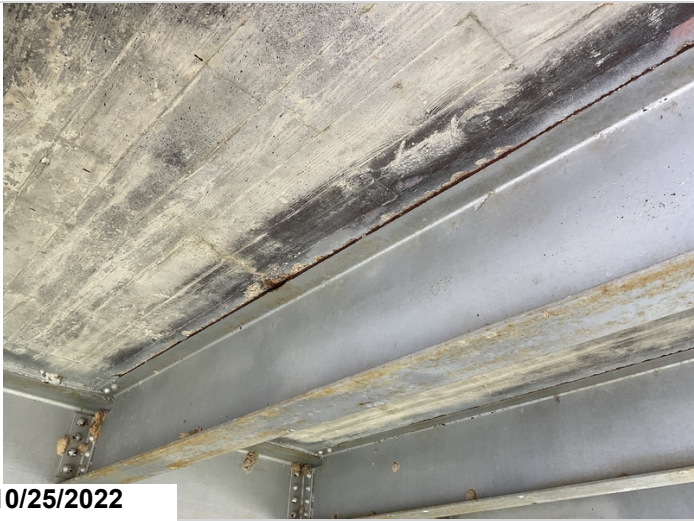
Typical minor active corrosion on top flanges.

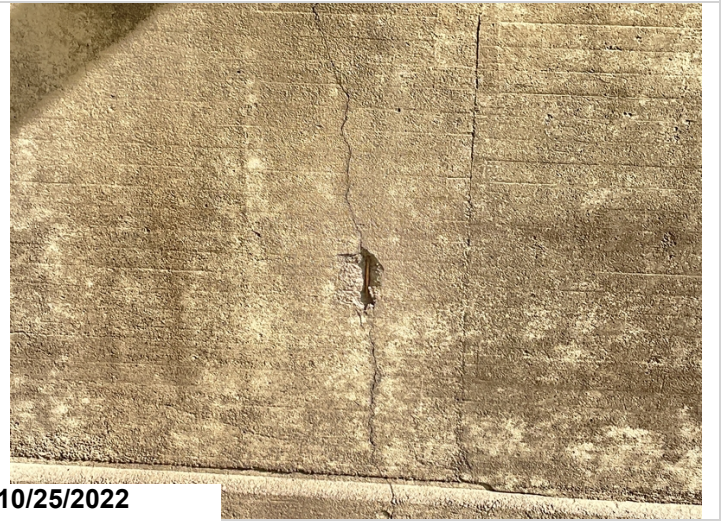
Pier 2, Back: Spalling with exposed reinforcing steel with section loss.

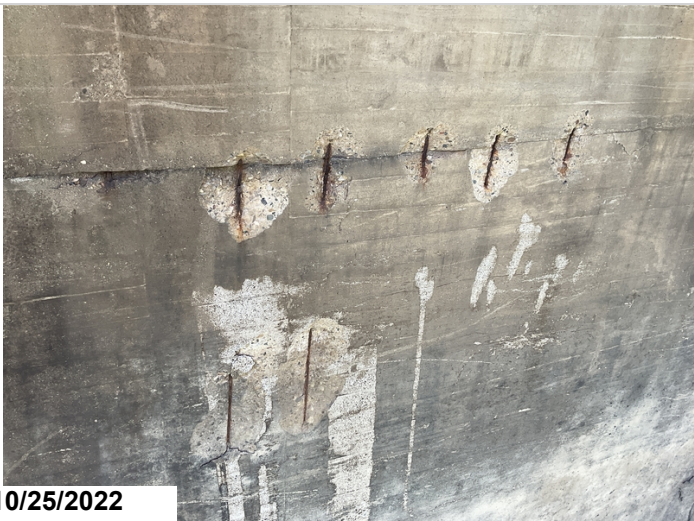
Pier 2, Ahead: Spalling with exposed reinforcing steel with section loss.

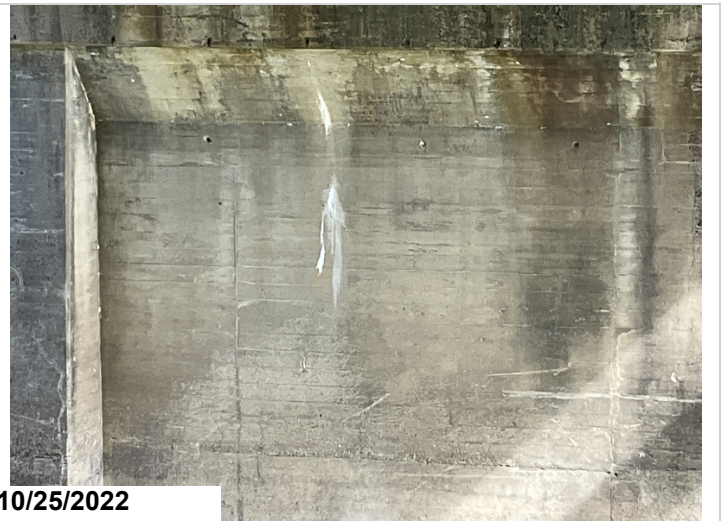
Pier 3, Back: Cracking with efflorescence.

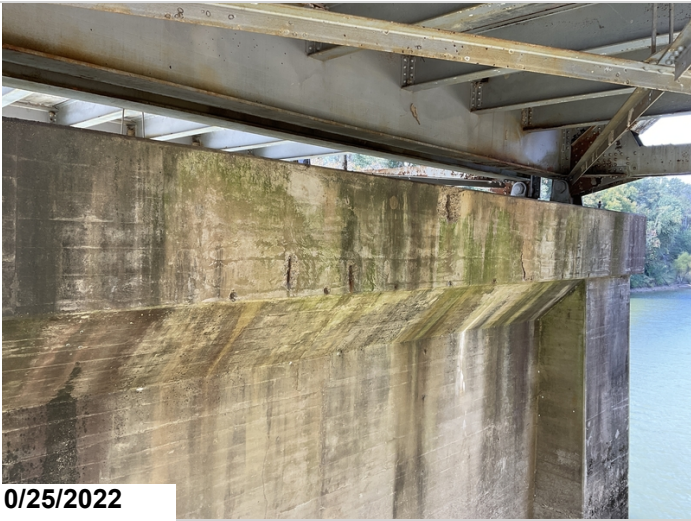
Pier 3, Ahead: Spalling with exposed reinforcing steel with section loss.

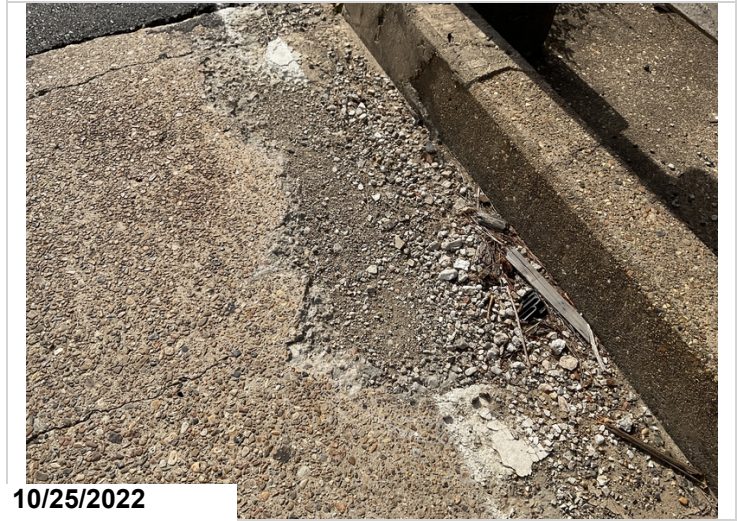
Span 1, Left: Spalling.

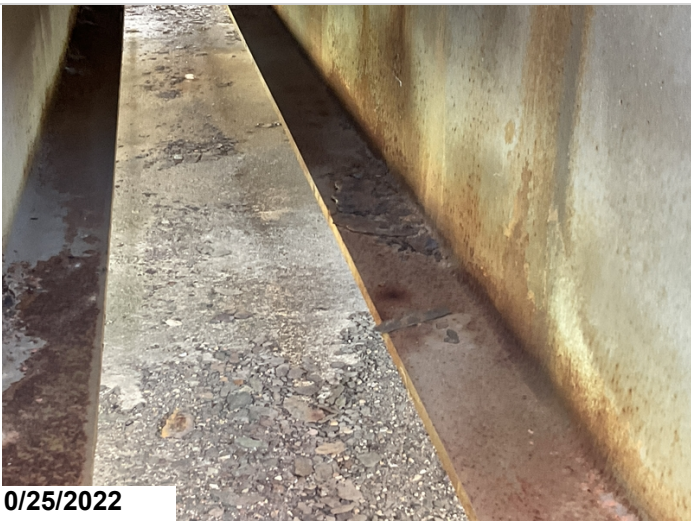
Typical active corrosion with flaking rust at joints.

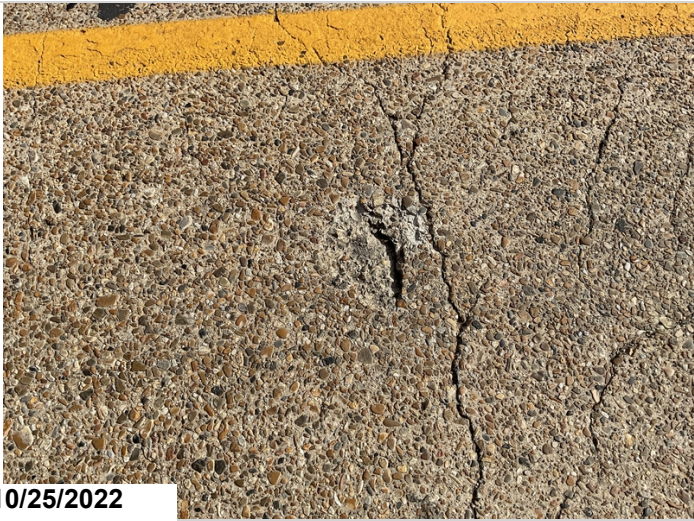
Span 1: Spalling.

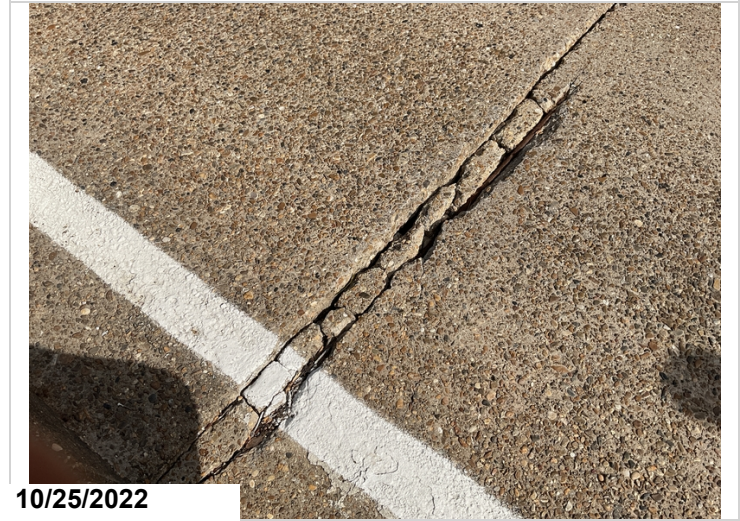
Bent 2: Spalling.

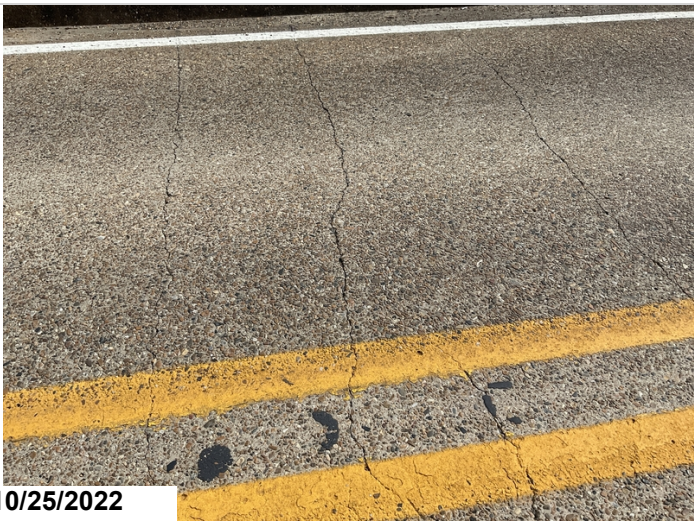
Typical cracking.

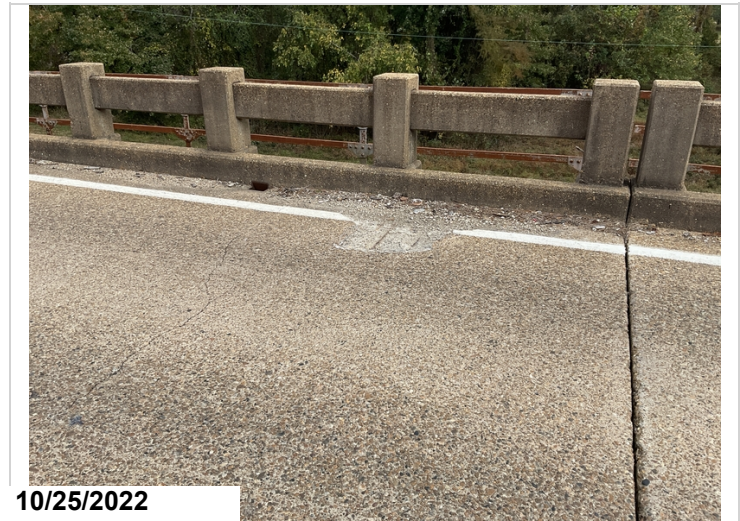
Span 8, Right: Spalling with exposed reinforcing steel with section loss.

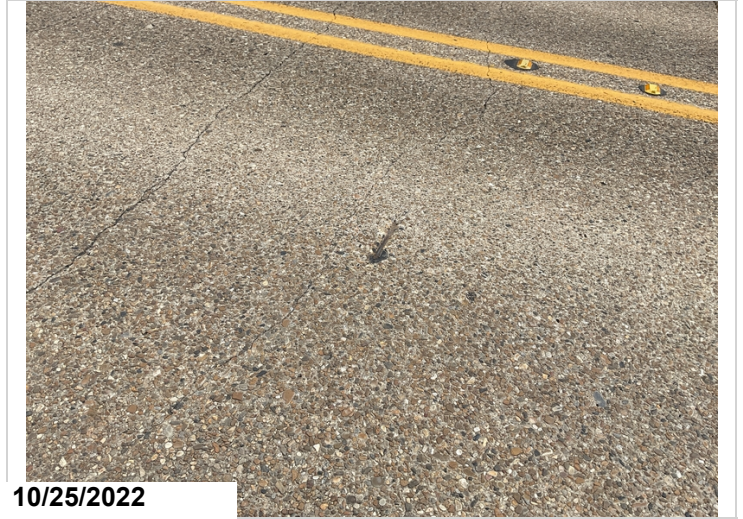
Span 13: Spalling with exposed reinforcing steel with section loss.

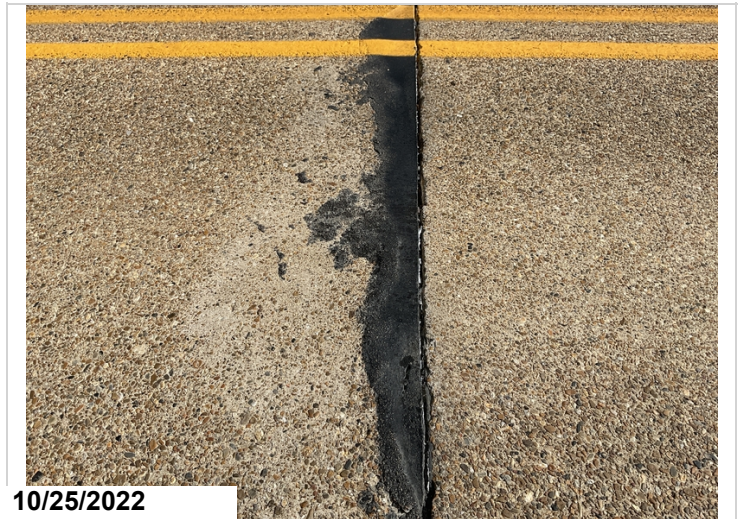
Bent 3: Repair.

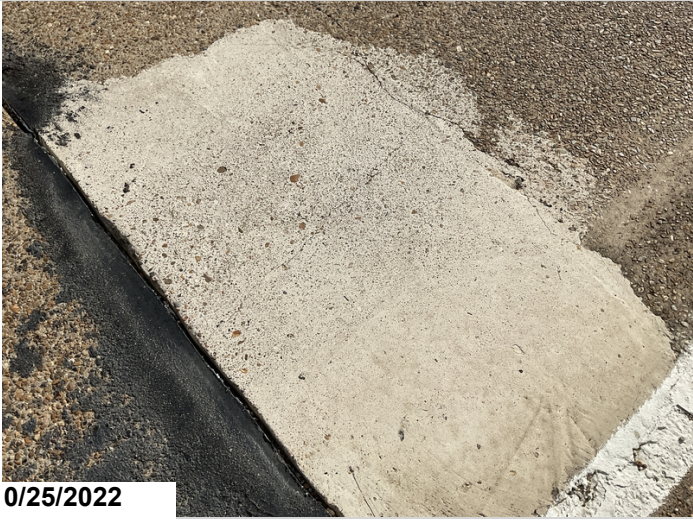
Bent 4, Span 3: Repair.

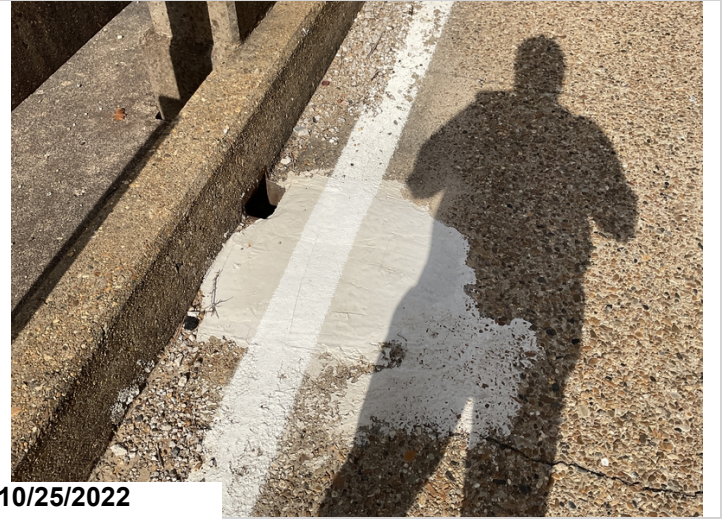
Span 4: Repair.

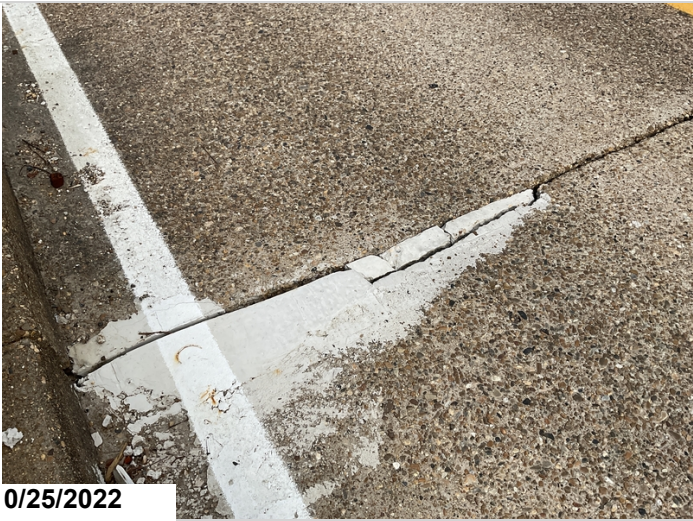
Bent 5, Span 4: Failed repair.

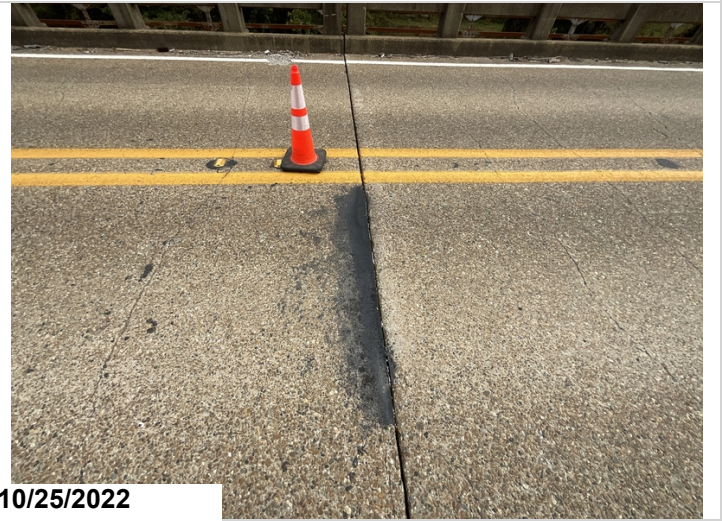
Bent 9, Span 9: Repair.

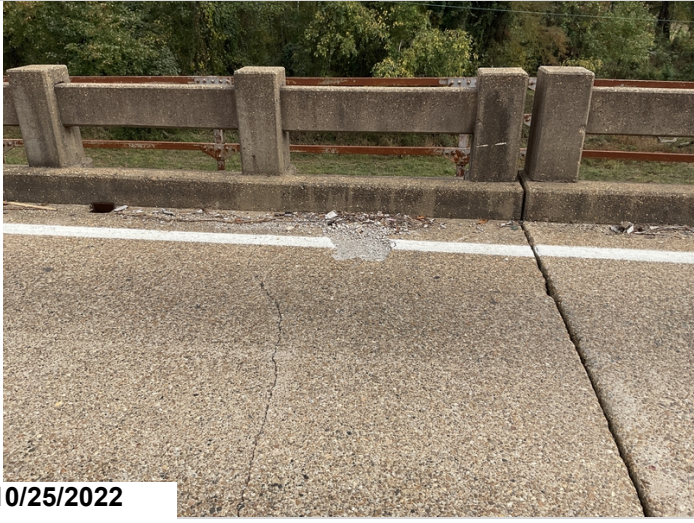
Span 9, Right: Spalling.

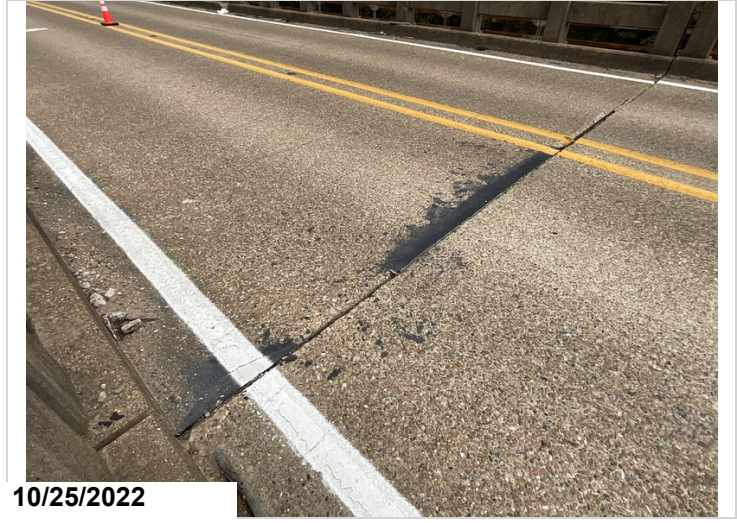
Bent 10, Span 10: Repair.

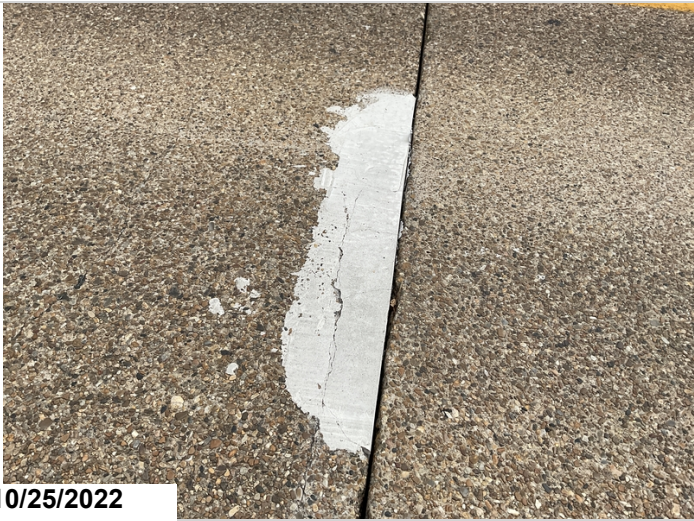
Bent 11, Span 11: Failing repair.

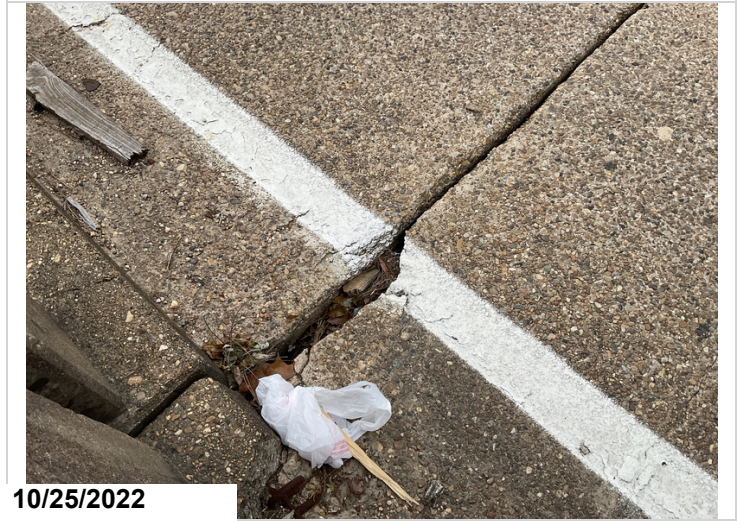
Bent 11, Span 11: Spalling.

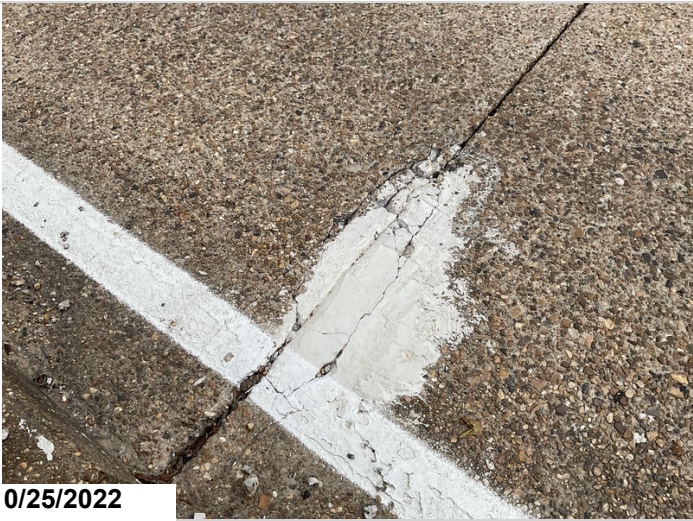
Bent 12, Span 11: Repair failing.

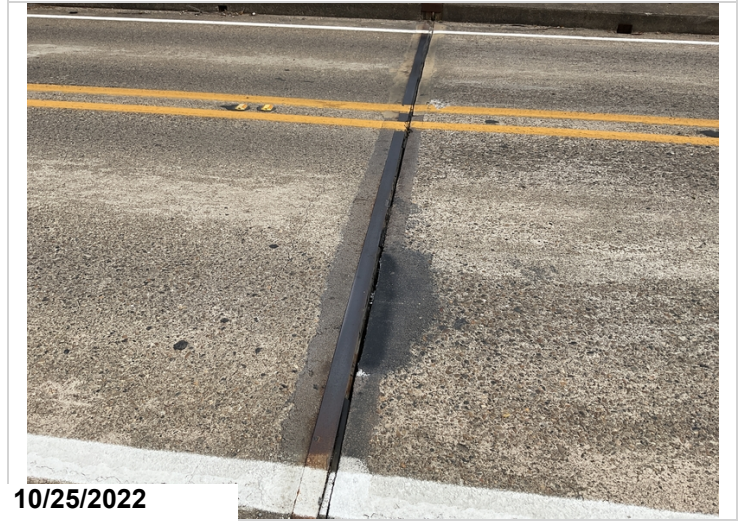
Bent 16: Repair.

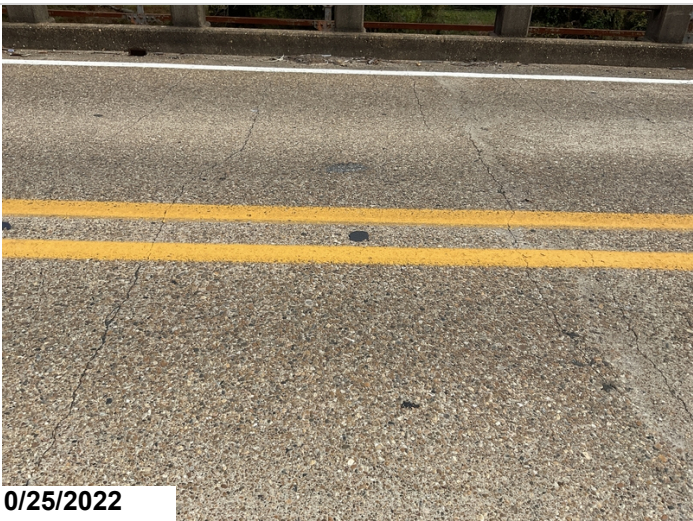
Typical cracking.

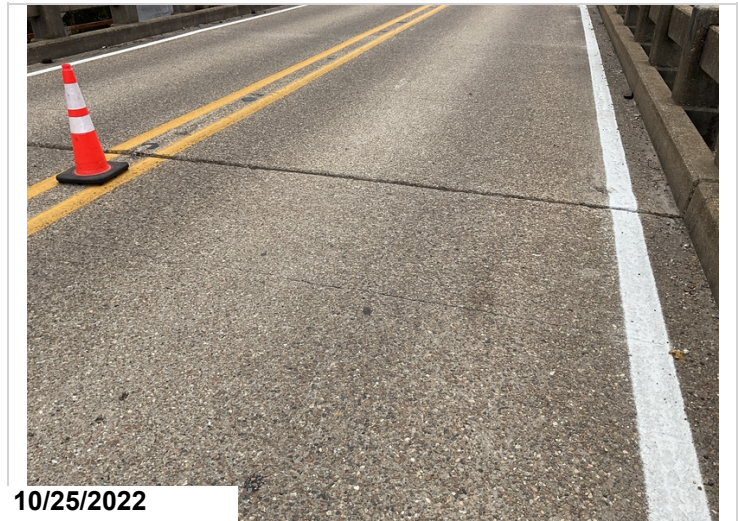
Typical abrasion.

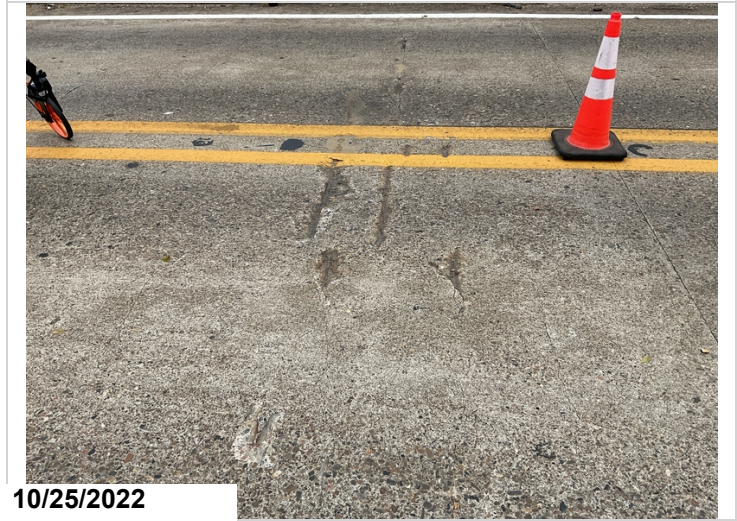
Truss Span 1: Spalling with exposed reinforcing steel with section loss.

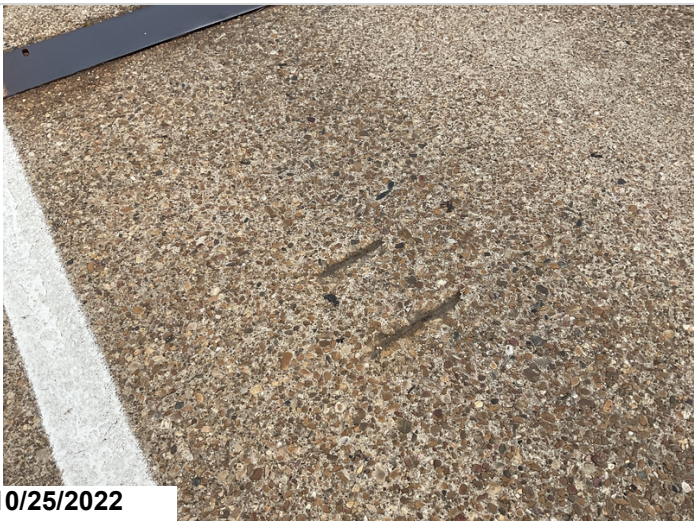
Truss Span 2: Spalling with exposed reinforcing steel with section loss.

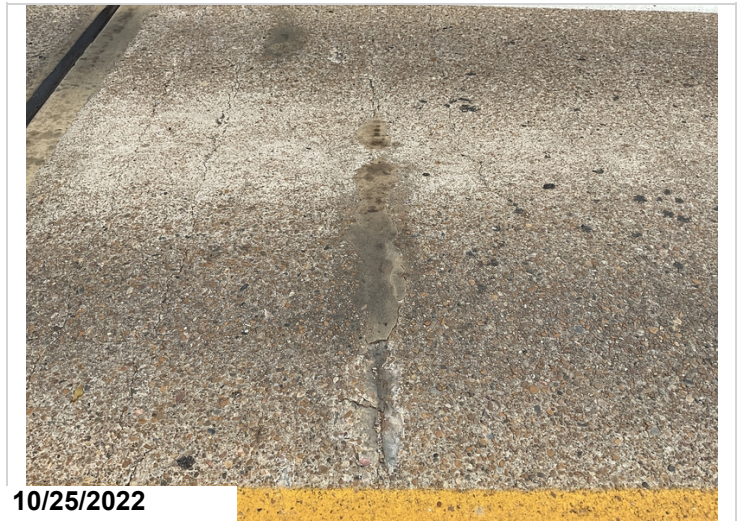
Truss Span 3: Spalling with exposed reinforcing steel with section loss.

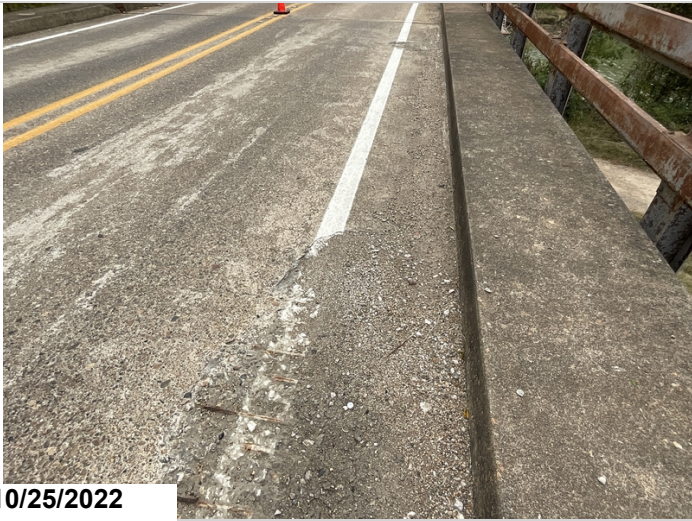
Span 17: Spalling with exposed reinforcing steel with section loss.

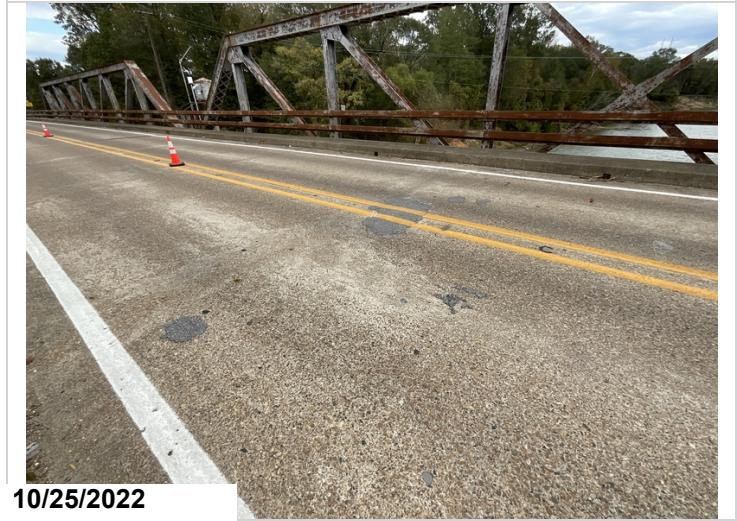
Truss Span 2: Spalling with asphalt repairs.

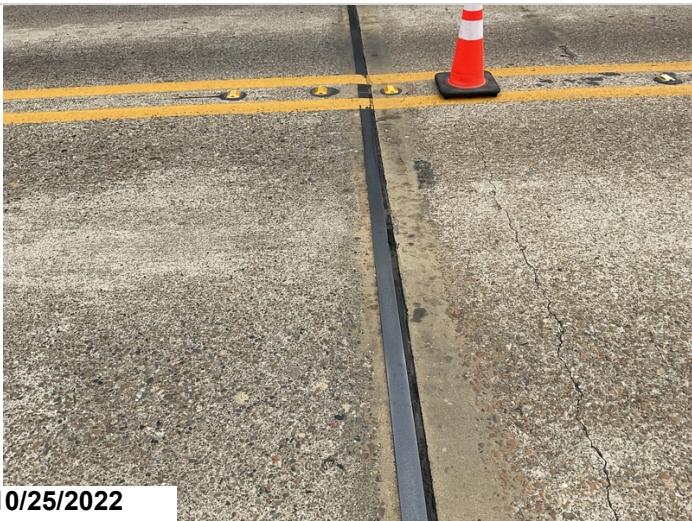
Pier 4, Joint: Loss of adhesion.

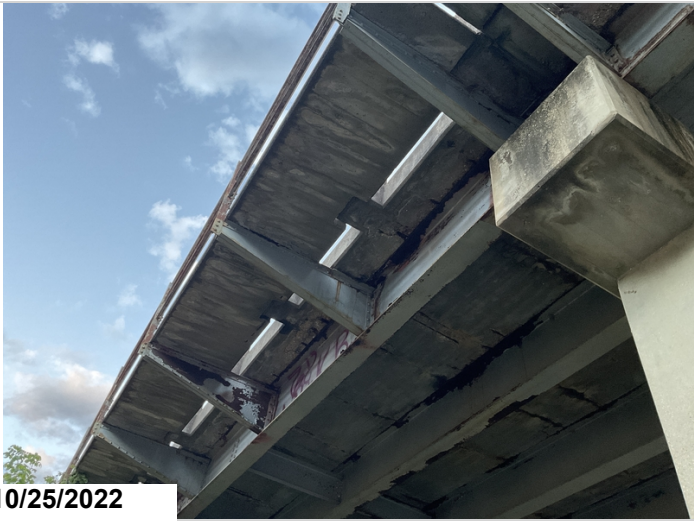
Typical spalling with exposed reinforcing steel with section loss

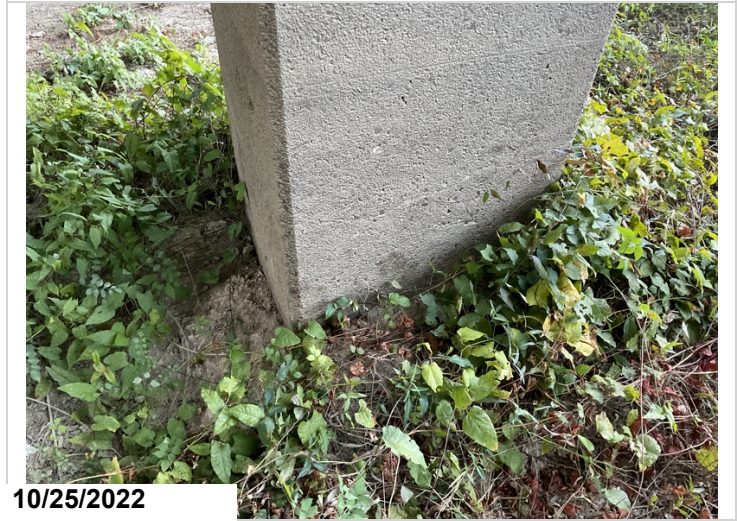
Bent 2, Column 2: Cracking.

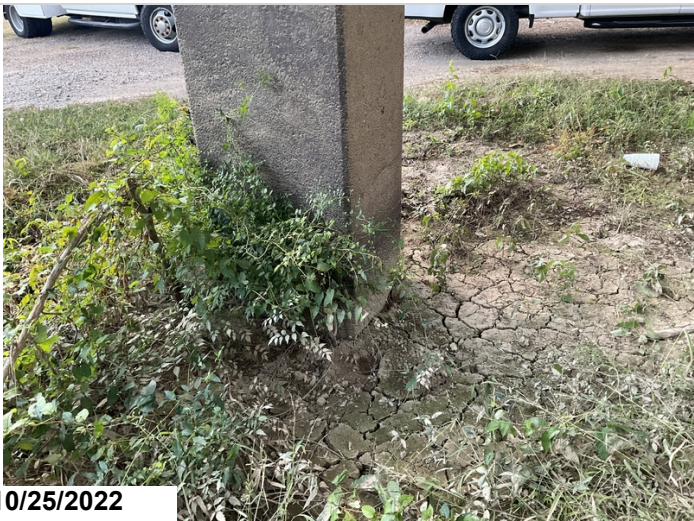
Typical abrasion.

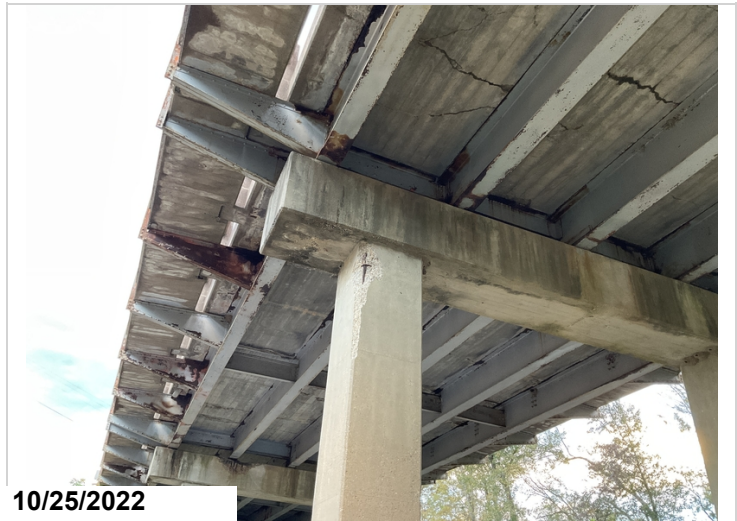
Bent 3, Column 2: Spalling with exposed reinforcing steel with section loss.

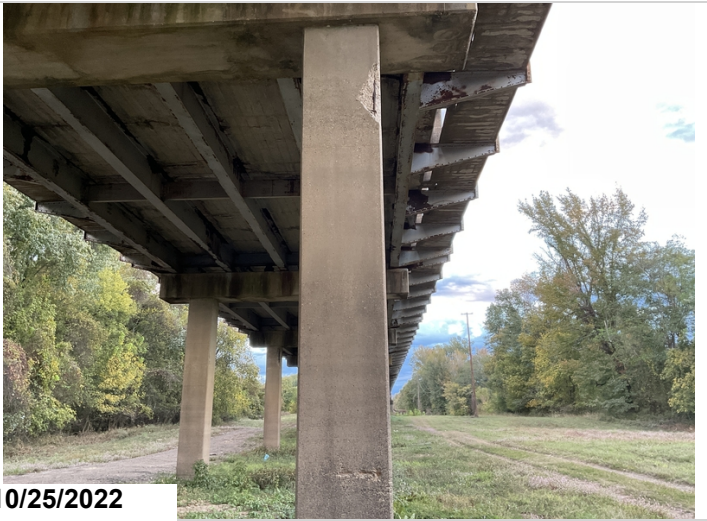
Bent 4, Column 2: Spalling with exposed reinforcing steel with section loss.

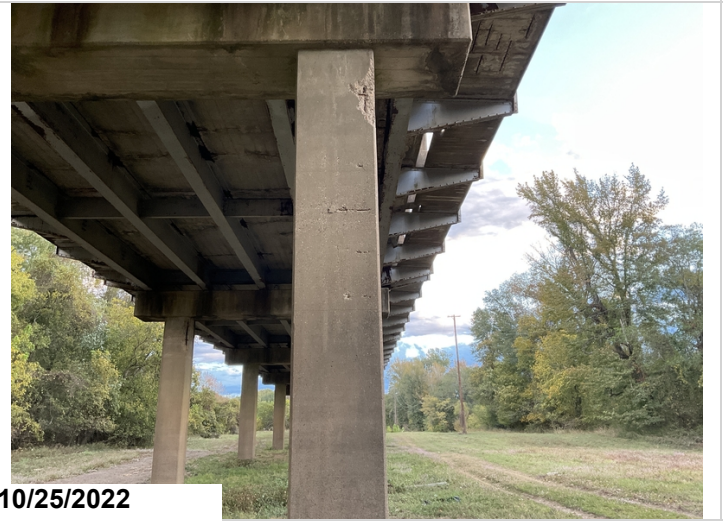
Bent 5, Columns 1 & 2: Spalling with exposed reinforcing steel with section loss.

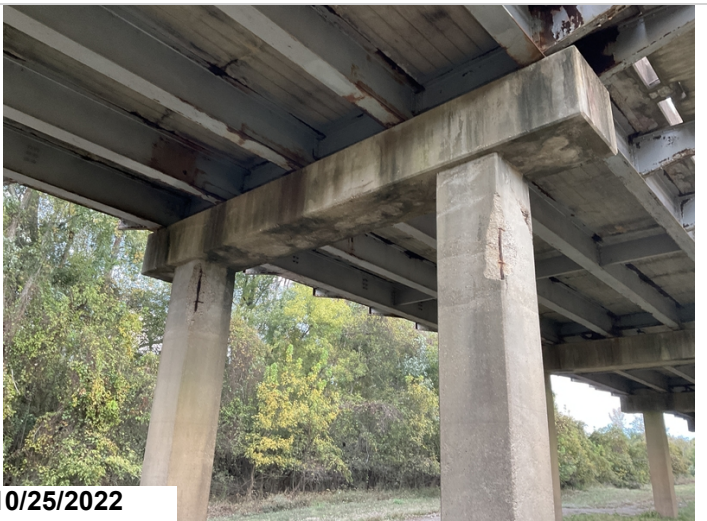
Bent 7, Columns 1 & 2: Spalling with exposed reinforcing steel with section loss.
