Asset #02466(Routine, NSTM)

US 79-B S-4 LM 2.2 over OUACHITA RIVER

Location: 1.08 MI NE JCT SH 7

Team Lead: Anthony Wood Inspection Date: 10/03/2022

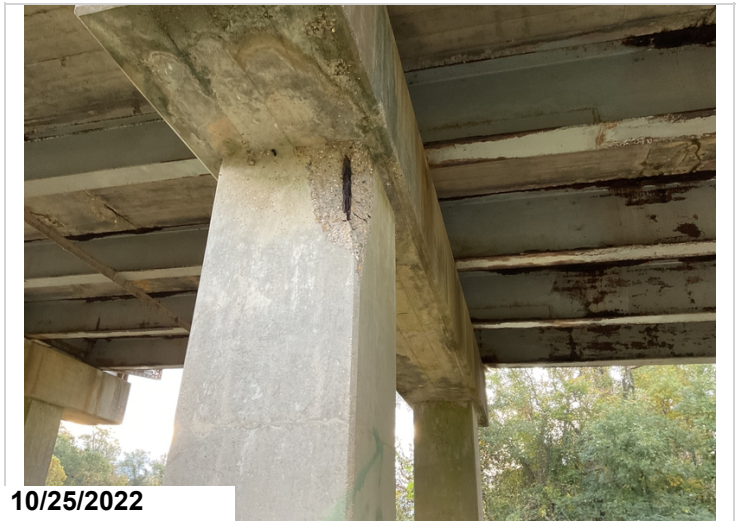
Bent 14, Column 1: Spalling with exposed reinforcing steel with section loss.

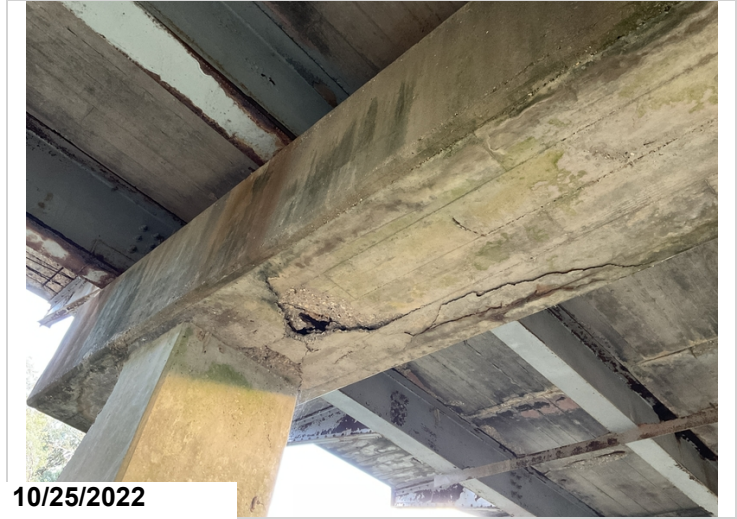
Bent 14: Spalling with exposed reinforcing steel with section loss.

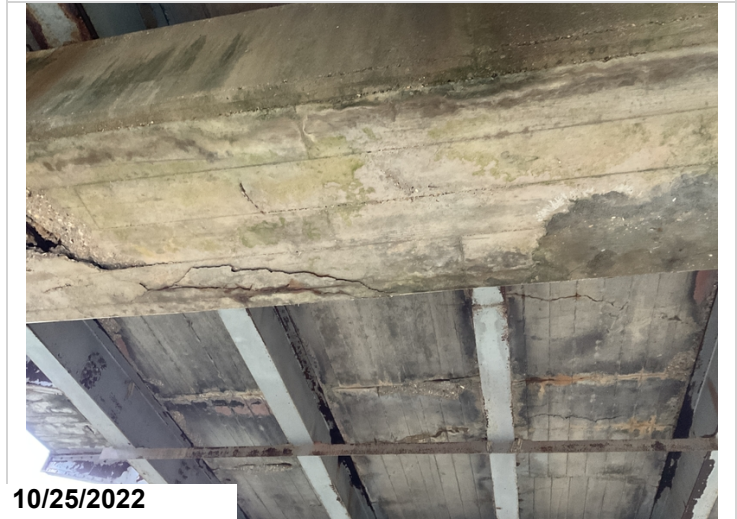
Bent 14: Delam.

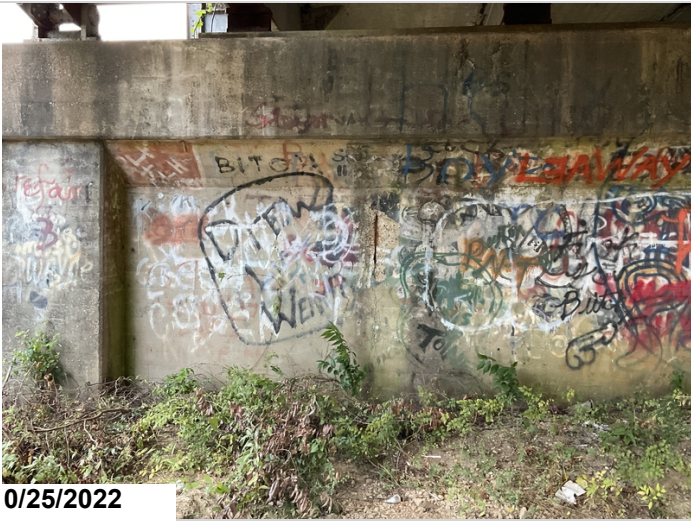
Pier 4, Back: Spalling with exposed reinforcing steel with section loss.

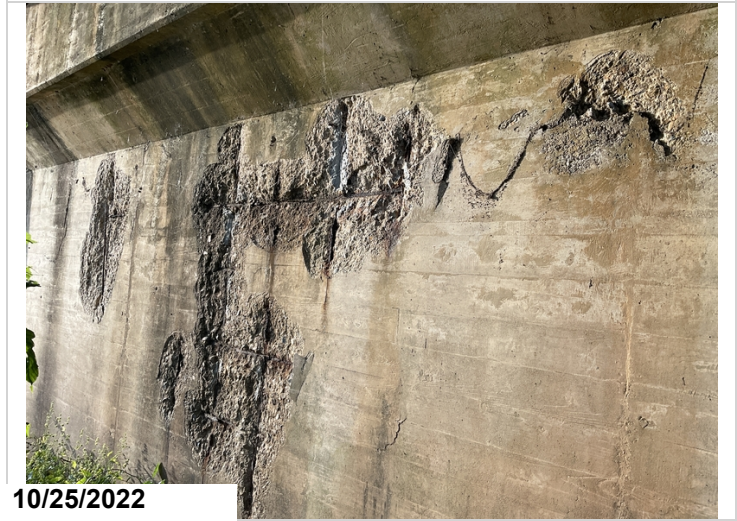
Pier 1, Ahead: Spalling with exposed reinforcing steel with section loss.

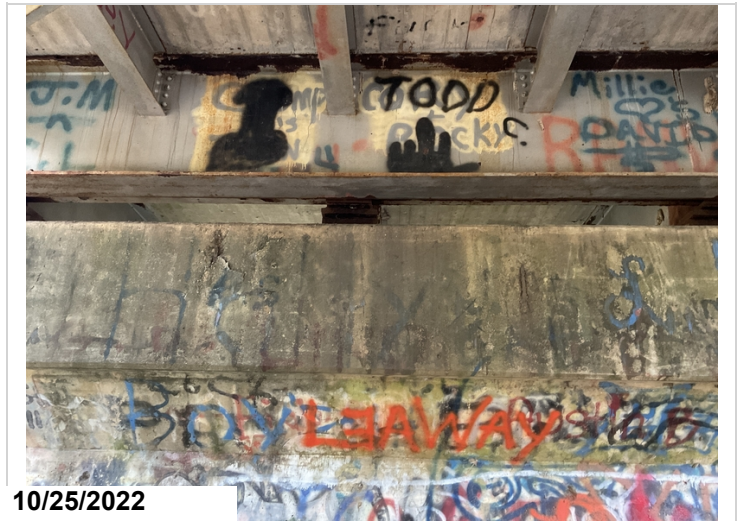
Pier 4, Back: Spalling with exposed reinforcing steel with section loss.

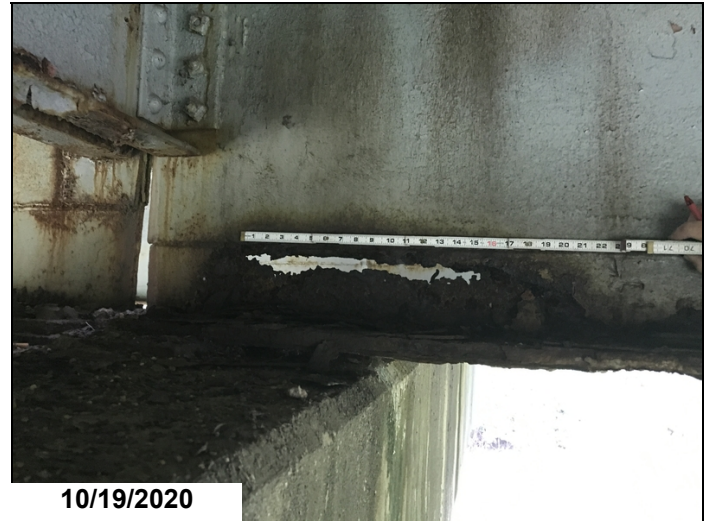
Span 13 bent 13 Girder 3 has a hole rusted through the t-splice repair.

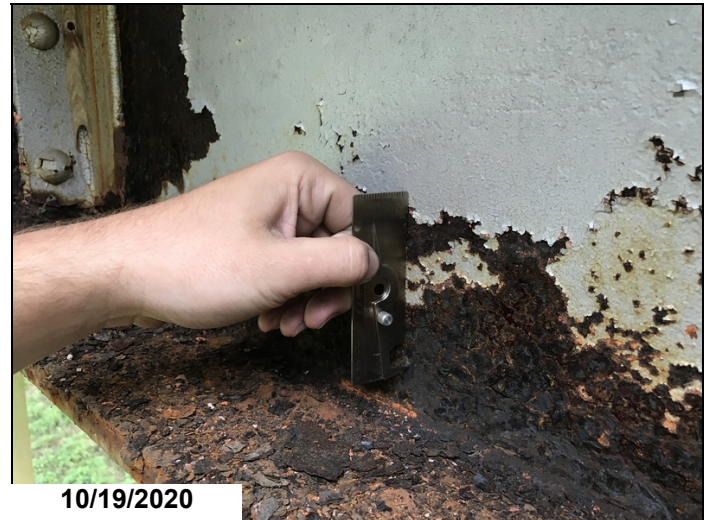
Typical corrosion
