Asset #03476(Routine)

SH 53 SEC.02-0.001 over LITTLE MISSOURI RIVER

Location: 2.8 MI NE JCT SH 53 & 24

Team Lead: Jared Kegley Inspection Date: 02/26/2024

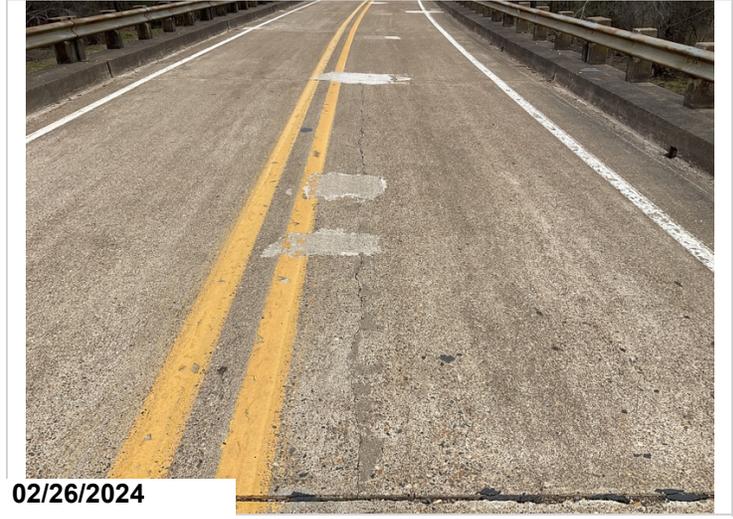
Approach span 4, Northbound lane, 30' longitudinal deck cracking, CS3

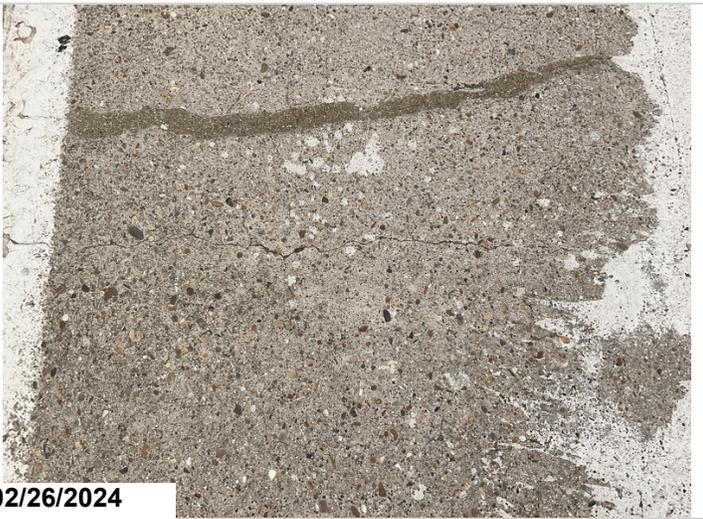
Main span 1, Southbound lane, Deck cracking, CS2

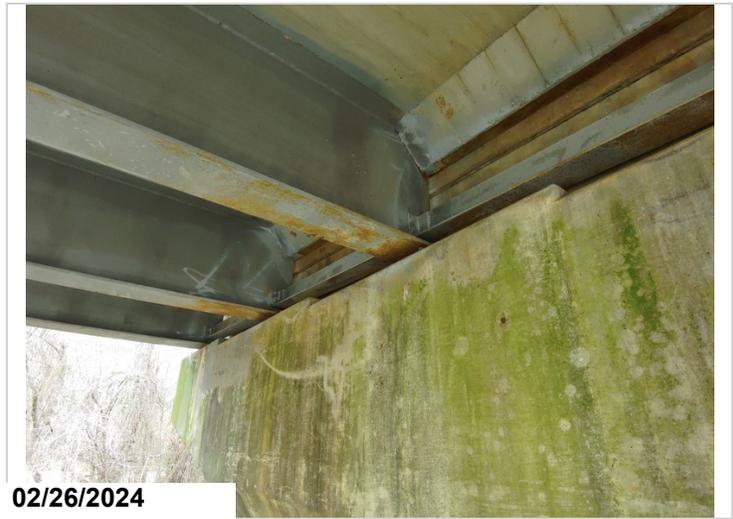
All beam ends need to be painted.

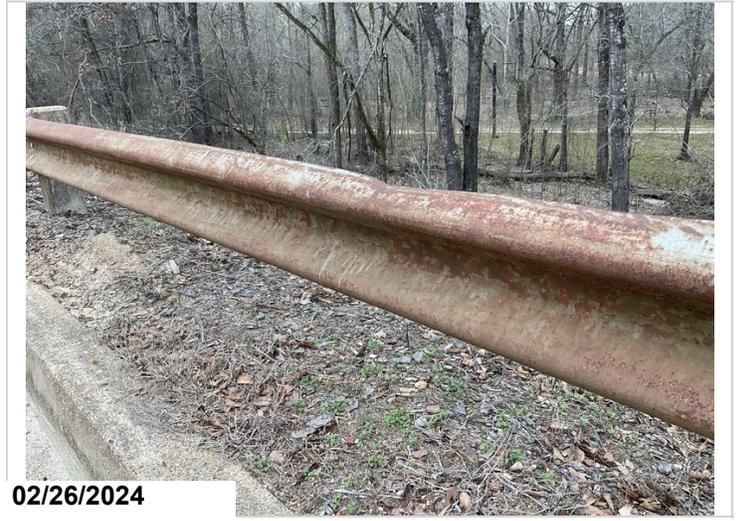
Corrosion and minor damage to bridge railing transition, typical in various locations

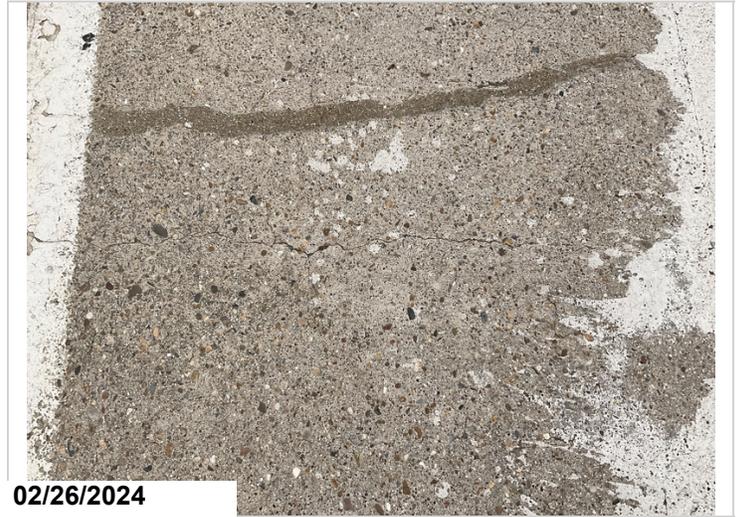
Main span 1, Southbound lane, Deck cracking, CS2

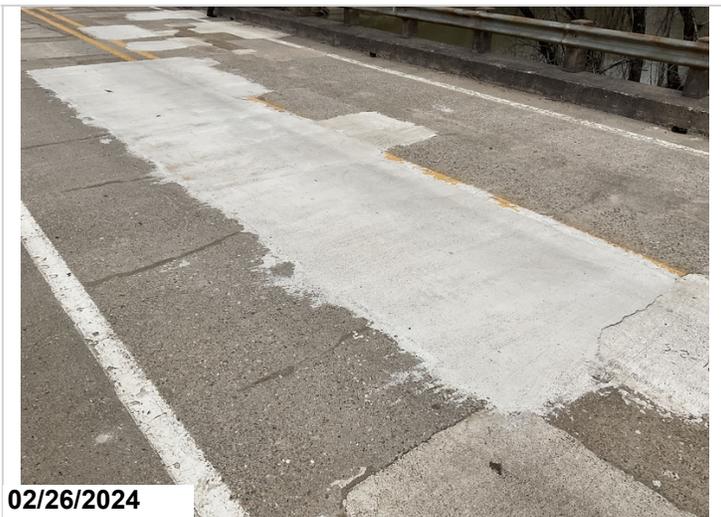
Main span 1, Southbound Lane, Large patched area, 63 Sq Ft, CS2

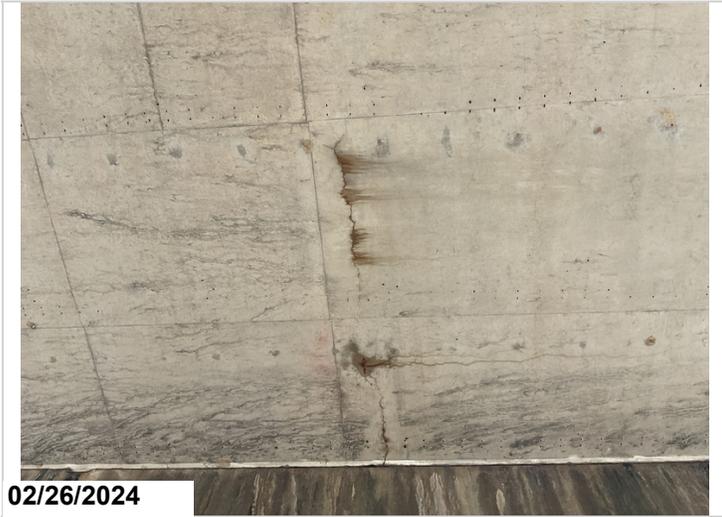
Approach span 3, Underside of deck, Efflorescence with rust staining, CS3

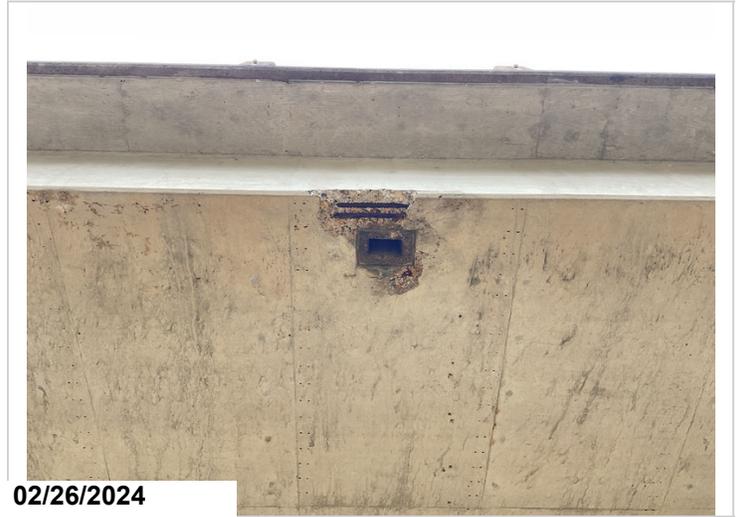
Approach span 3, Underside of deck, Right side, Exposed rebar at drain, 1 Sq Ft, CS3

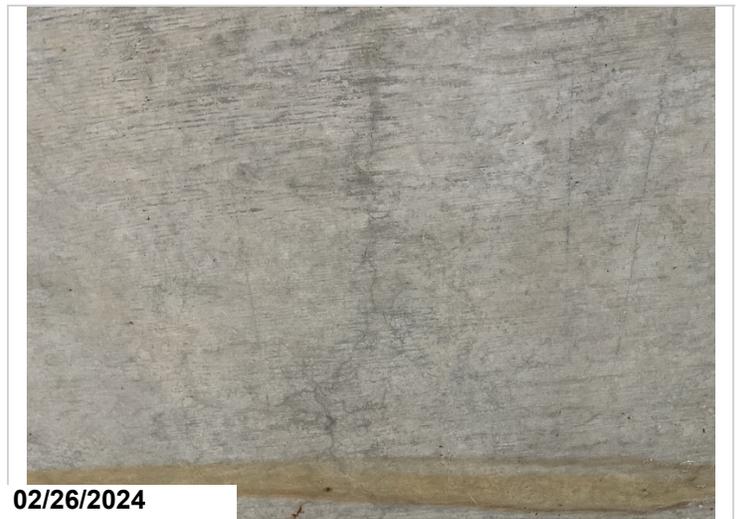
Approach span 1, Underside of deck, Deck cracking, CS2

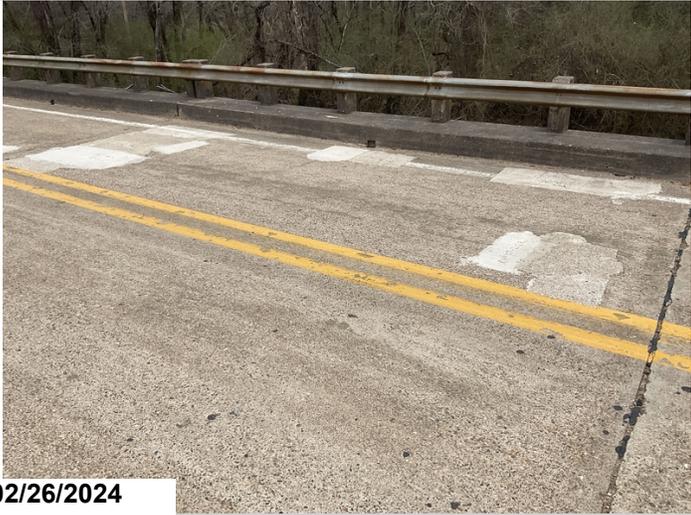
Approach span 15, Northbound lane, Patched areas, CS2

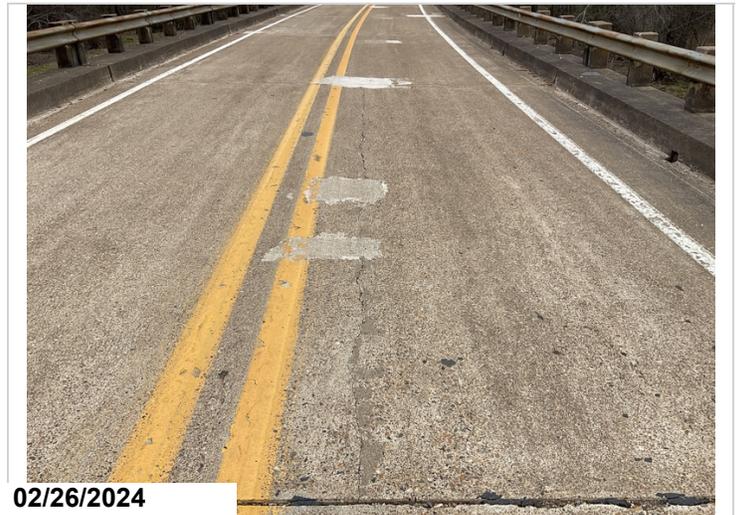
Approach span 4, Northbound lane, 30' longitudinal deck cracking, CS3

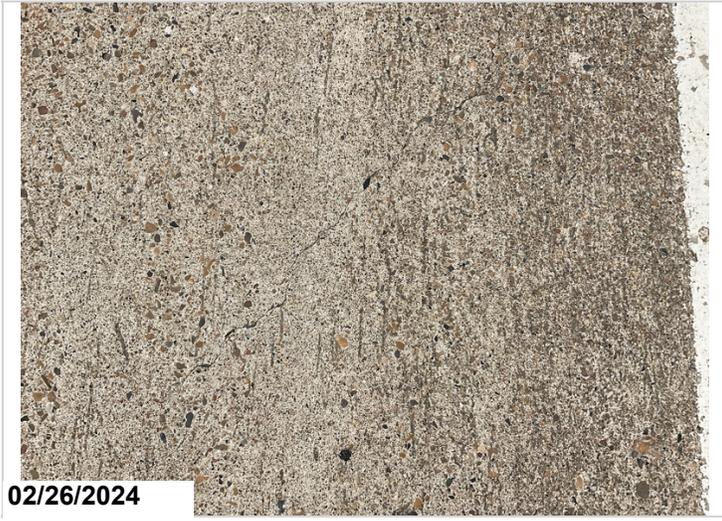
Approach span 3, Northbound lane, Deck cracking, CS2

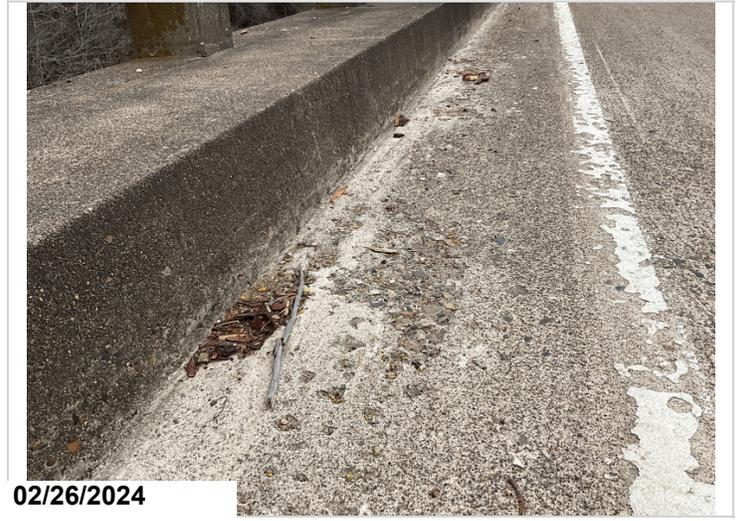
Approach span 2, Southbound lane, Abrasion along gutterline, CS2

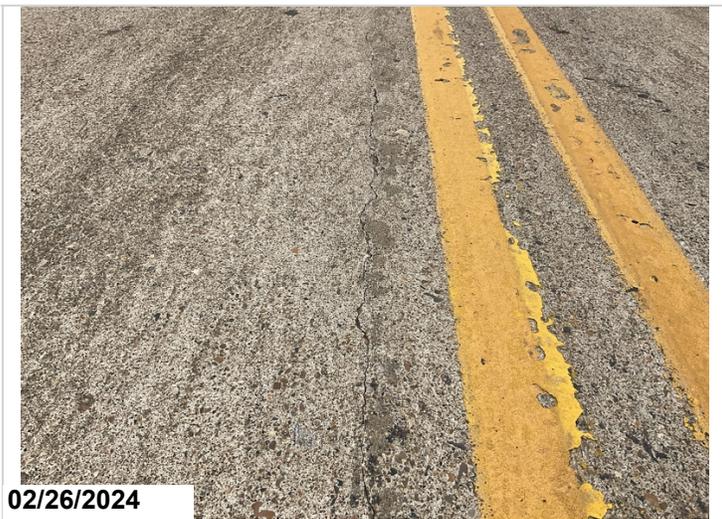
Approach span 1, Southbound lane, Longitudinal deck cracking in all spans, CS3

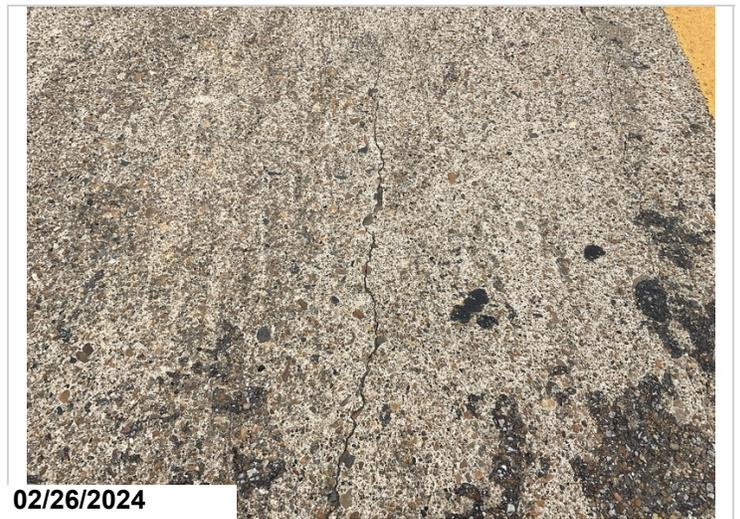
Approach span 1, Northbound lane, Longitudinal deck cracking in all spans, CS2

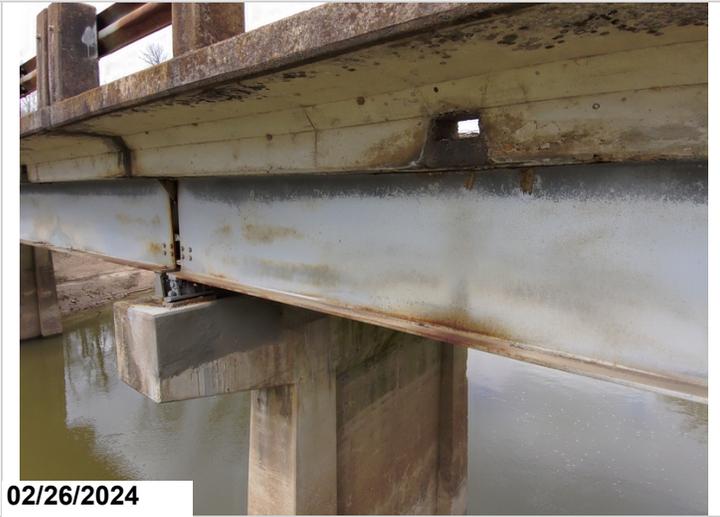
Beam 5 near pier 2, corrosion on steel beams, CS2.

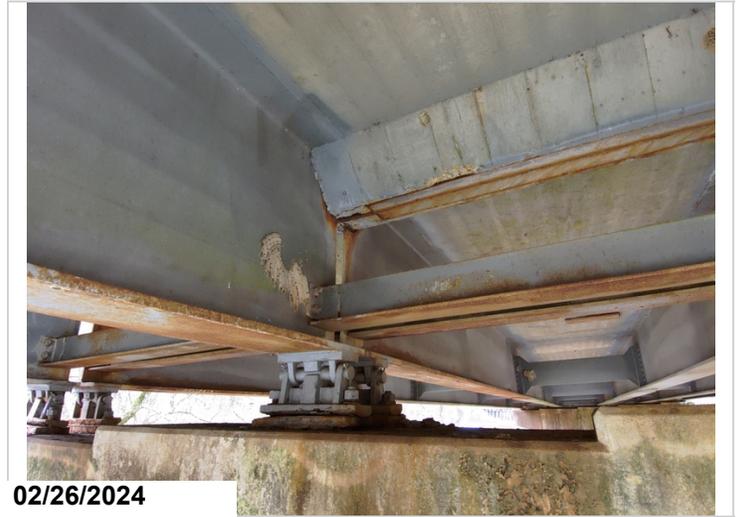
Various locations of beam end corrosion, CS2.

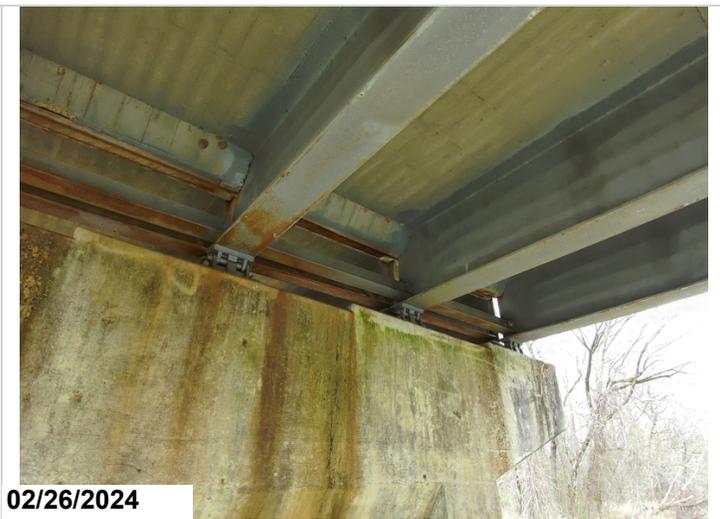
Various locations of beam end corrosion, CS2.

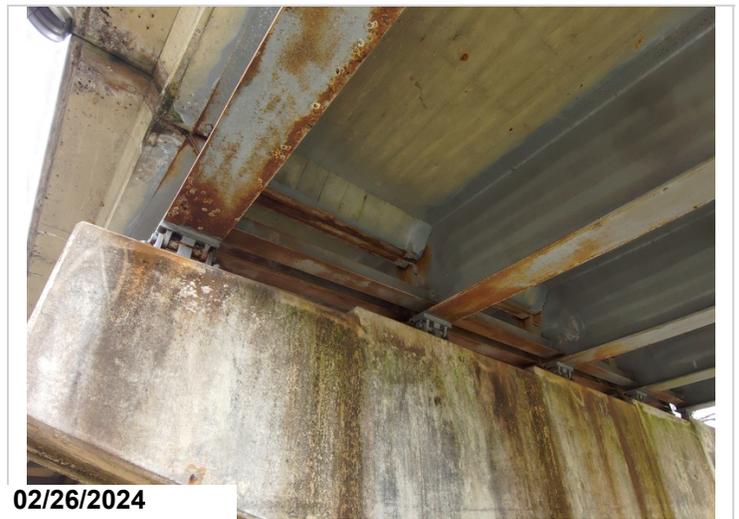
Various locations of beam end corrosion, CS2.

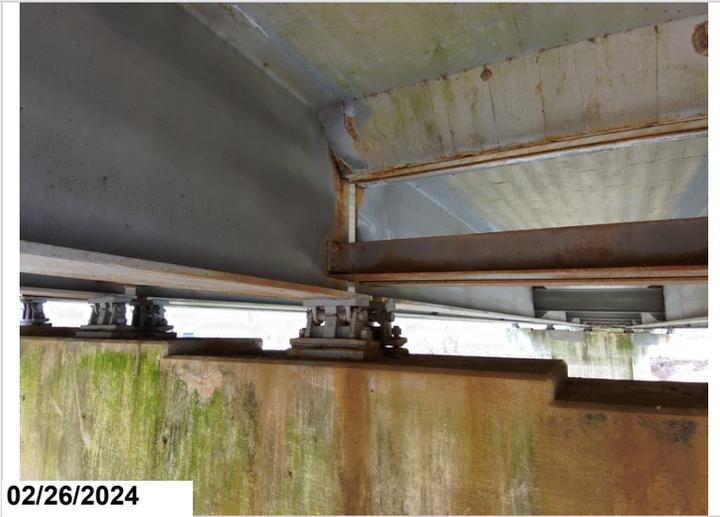
Various locations of beam end corrosion, CS2.

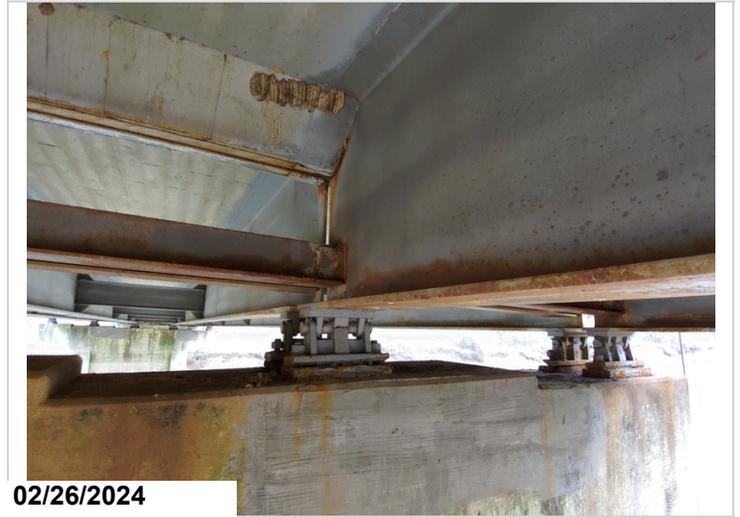
Various locations of beam end corrosion, CS2.

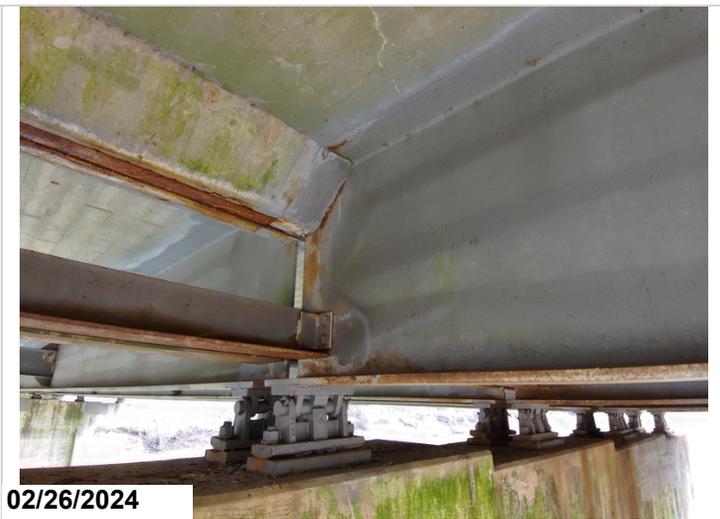
Pier 2 beam end corrosion, CS2.

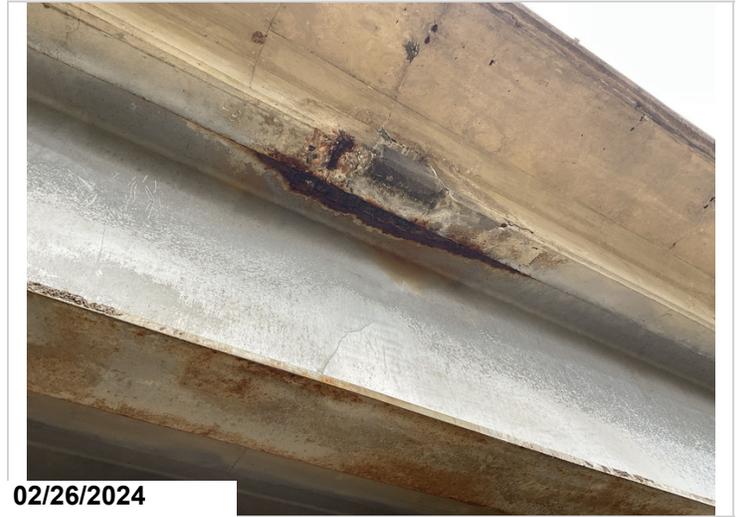
Main span 1, Beam 5, Corrosion to top flange, 1 Sq Ft, CS3

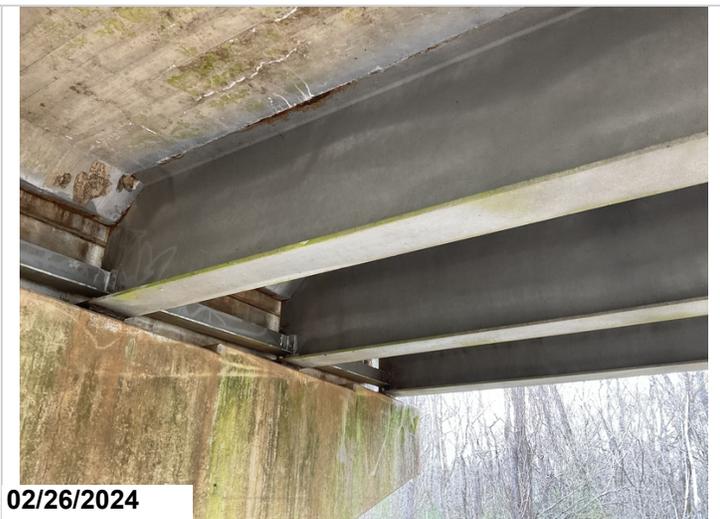
Main span 1, Beam 3, Corrosion to bottom flange, 2 Sq Ft, CS2

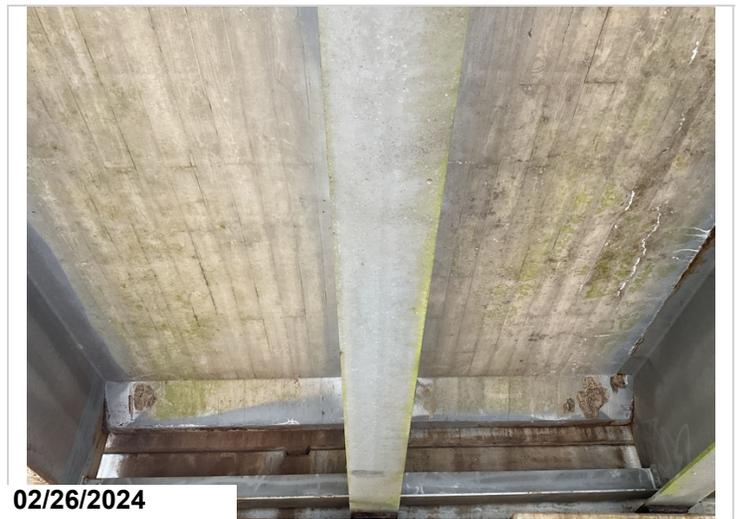
Main span 1, Beam 4, Corrosion to bottom flange, 2 Sq Ft, CS2

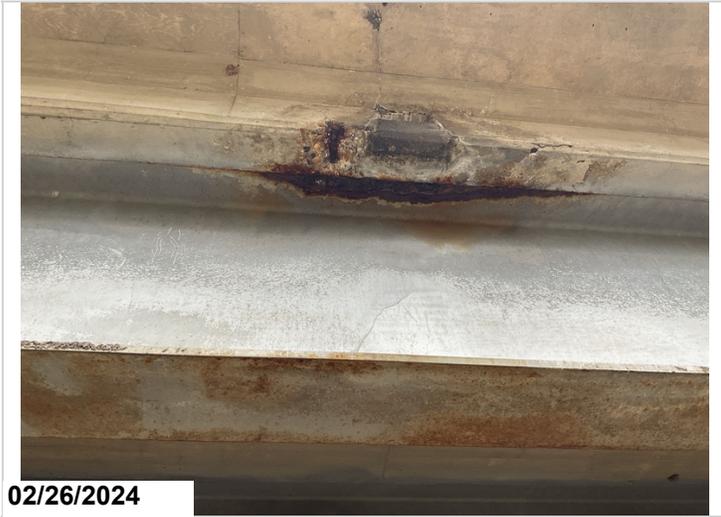
Main span 1, Outside of beam 5, Loss of effectiveness, 1 Sq Ft, CS4

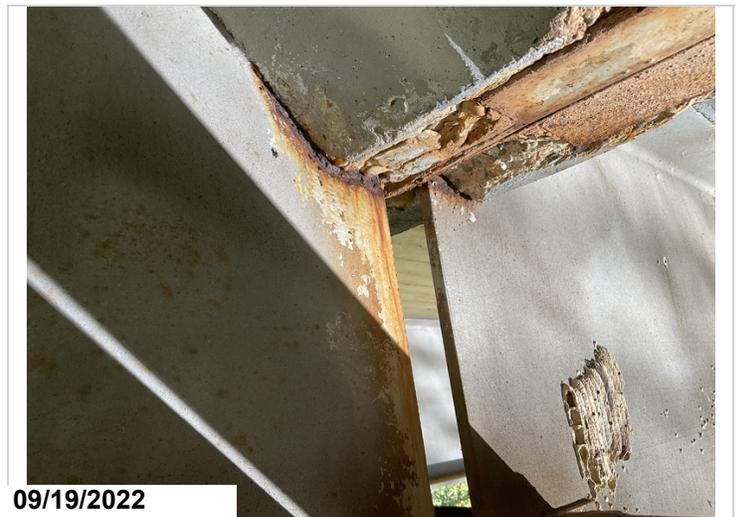
Main span 2 at pier 2, Beam 3, Corrosion on beam end, CS3

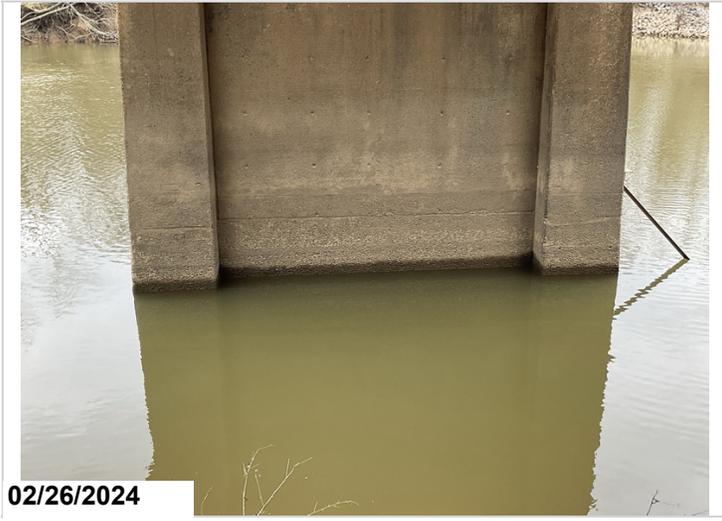
Main span, Pier 2, Looking ahead, Abrasion to both columns 1 & 2, CS2

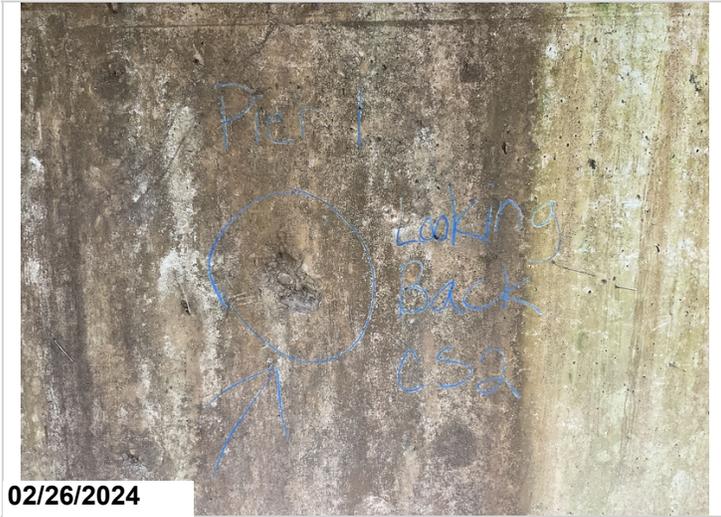
Main span, Pier 1, Looking back, Spalling, 1 LF, CS2

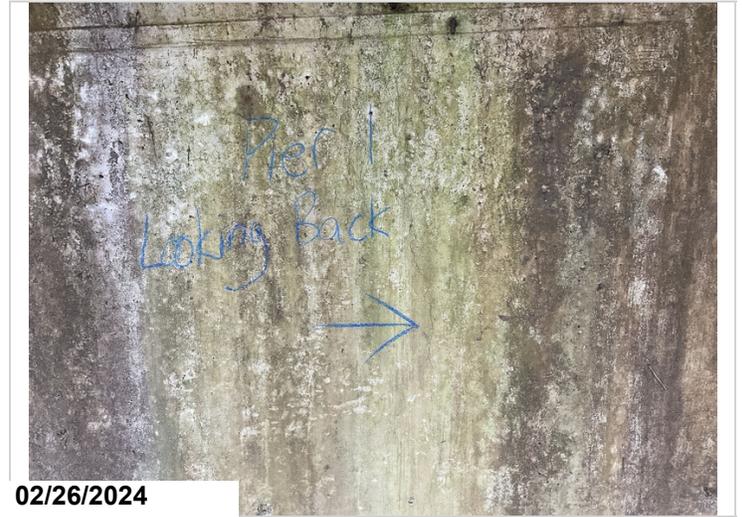
Main span, Pier 1, Looking back, Cracking, 1 LF, CS2

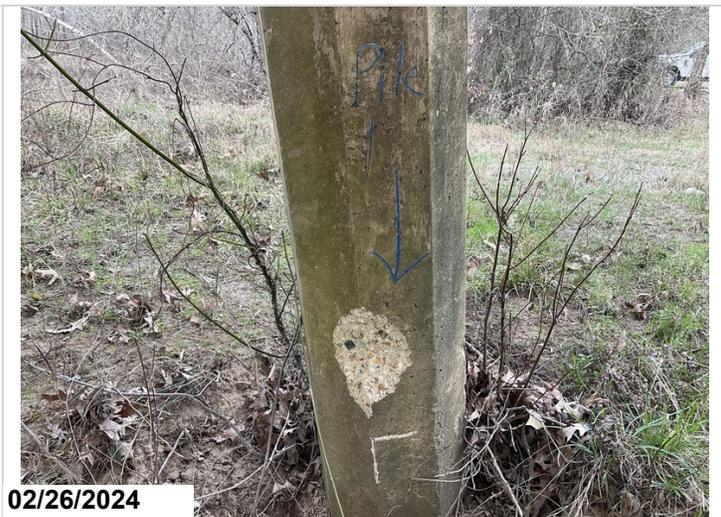
Approach span, Bent 24, Spall on pile 1, CS2

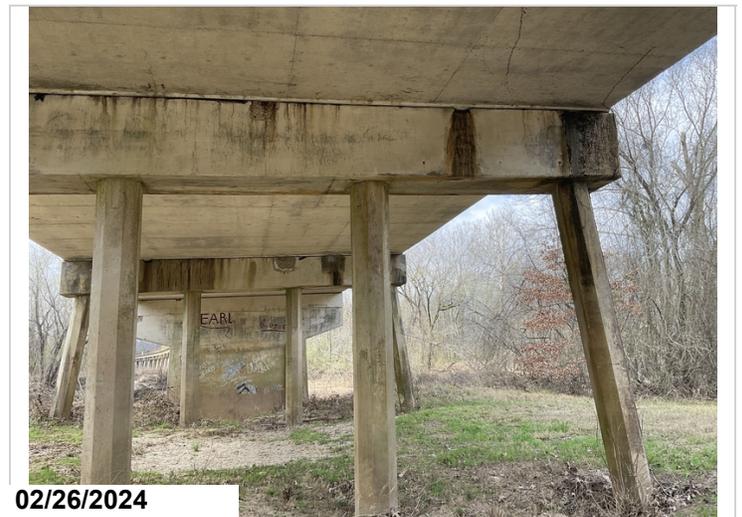
Approach span, Bent 24, Pier cap, Looking back, Spall between piles 2 & 3, 1 LF, CS2

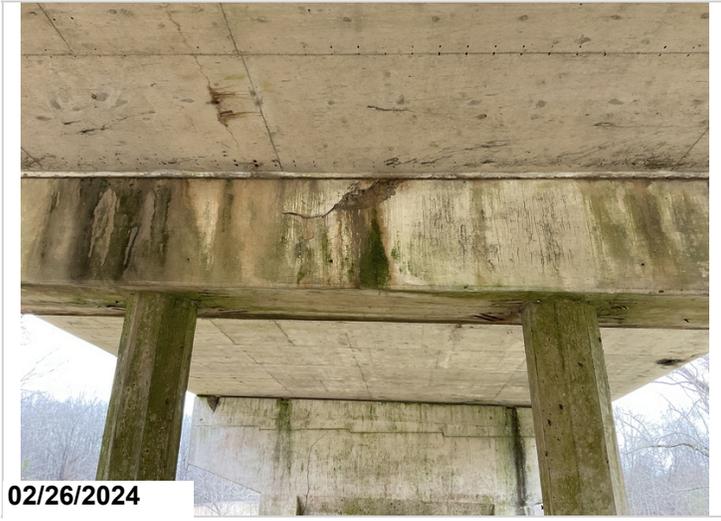
Approach span, Bent 23, Pier Cap, Looking ahead, Spalling between piles 2 & 3, 2 LF, CS2

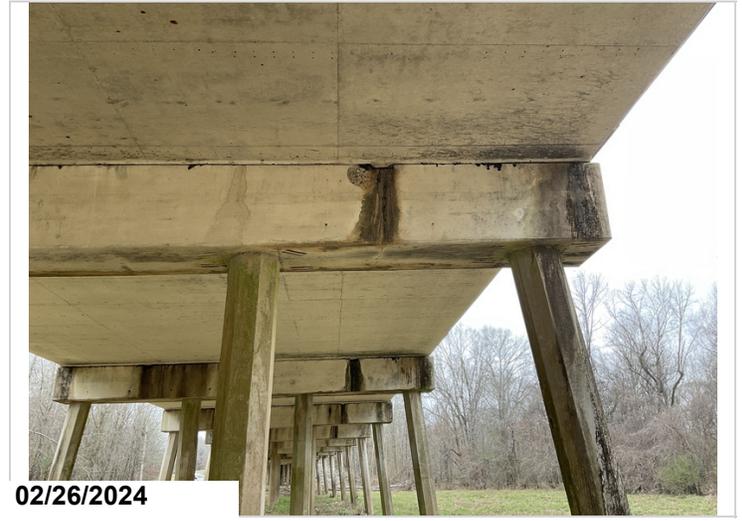
Approach span, Bent 13, Pier Cap, Looking back, Spalling between piles 1 & 2, 1 LF, CS2

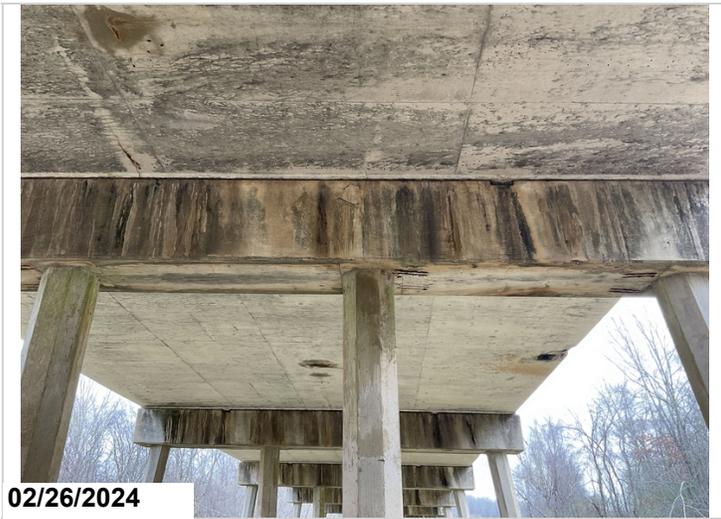
Approach span, Bent 6, Pier Cap, Looking ahead, Delam above pile 3, 1 LF, CS2

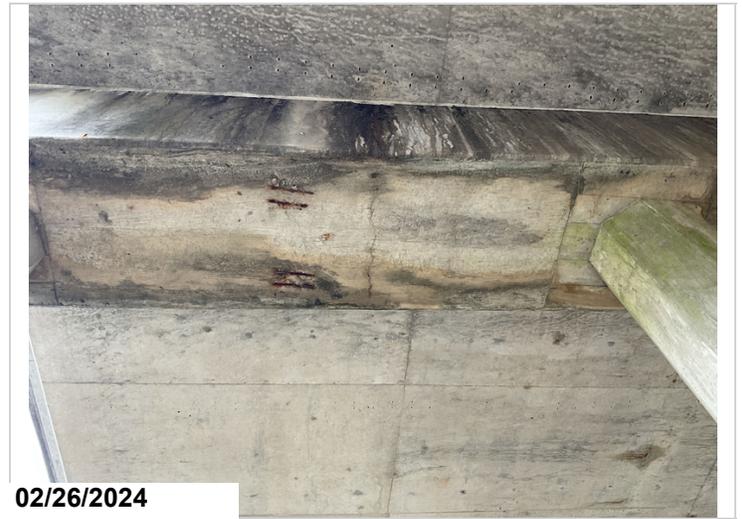
Approach span, Bent 3, Pier Cap, Cracking on underside, 1 LF, CS2

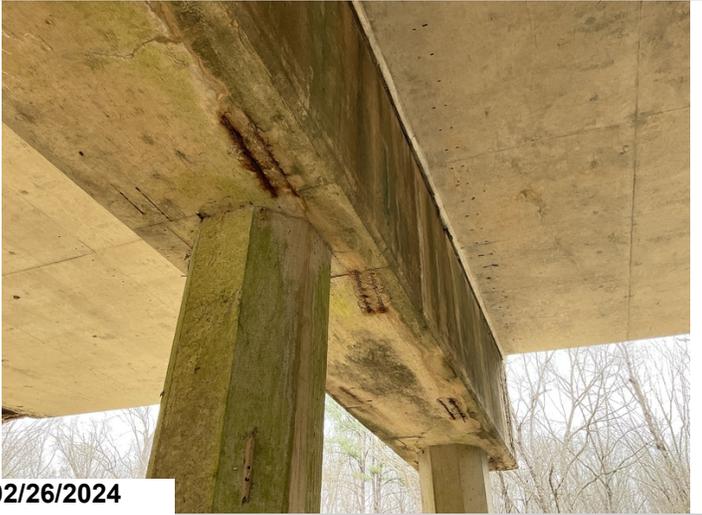
Approach span, Bent 2, Pier Cap, Exposed rebar on underside of cap, CS2

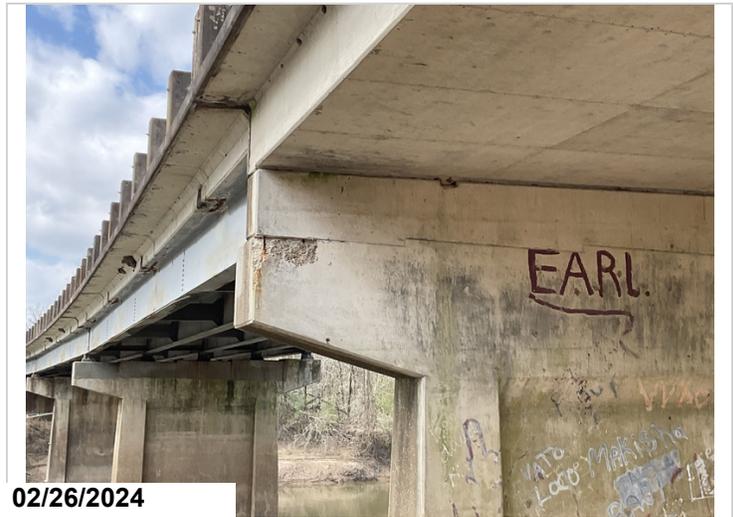
Main span, Pier 4, Looking back, Cracking on right side, 1 LF, CS2

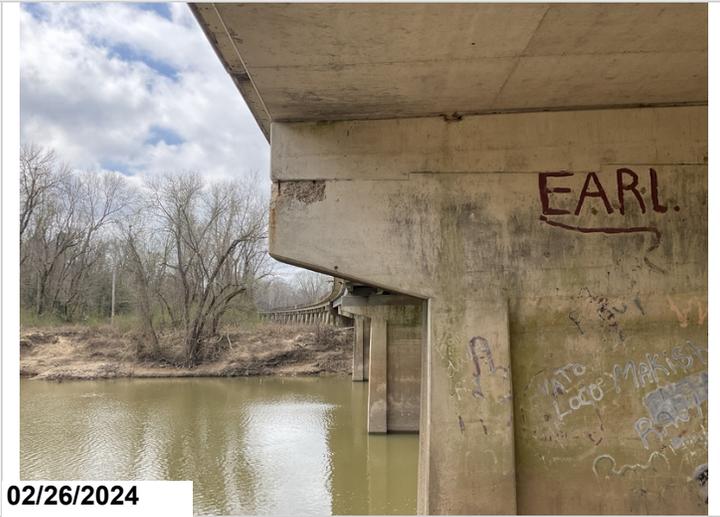
Main span, Pier 4, Looking back, Rebar exposed on right side, 1 LF, CS3

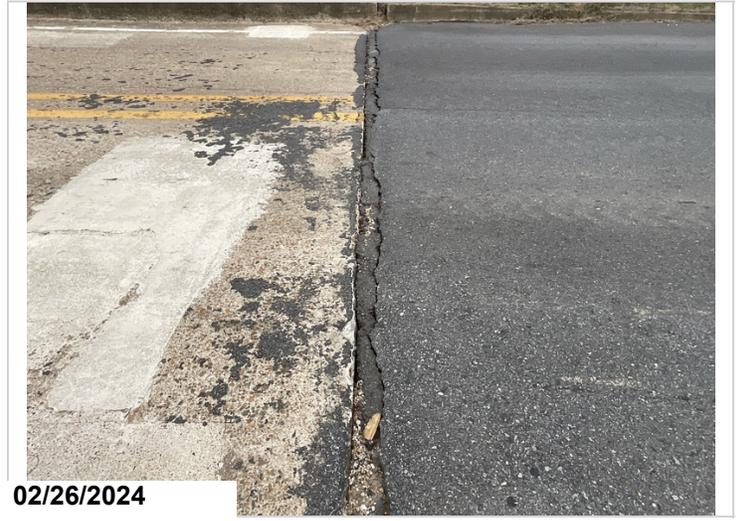
Approach span bent 29, asphalt overlay impacting joint, CS3

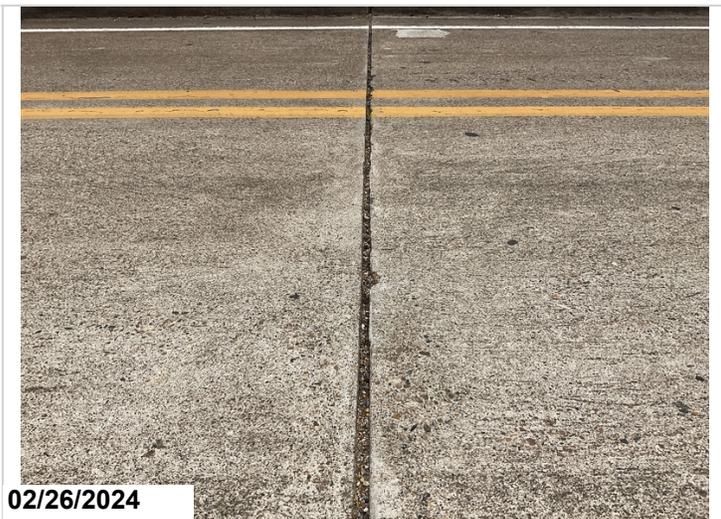
Approach span bent 3, missing joint material, CS4

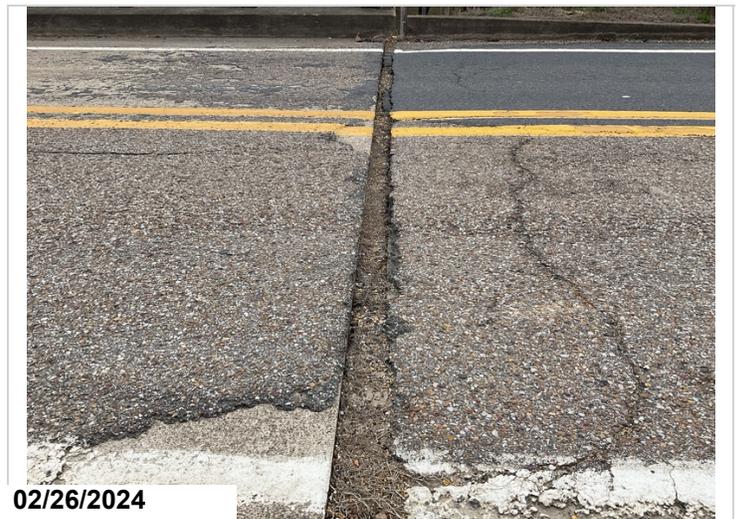
Approach span bent 1, missing joint material, CS4

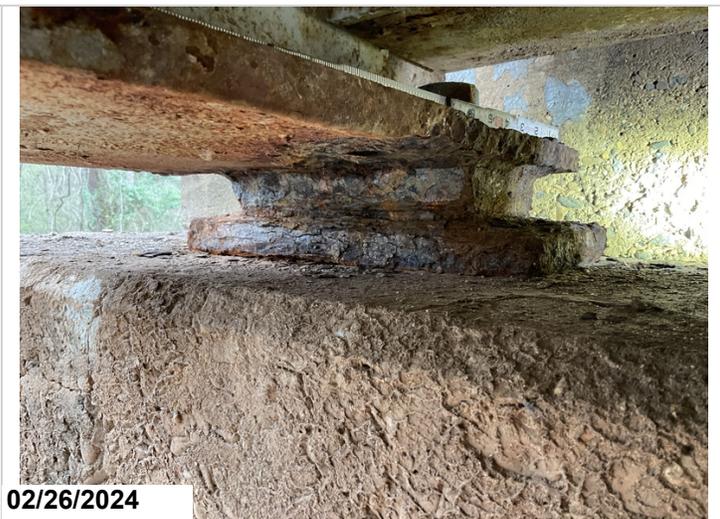
Main span 1, Pier 1, Bearing 5, Active corrosion, CS3

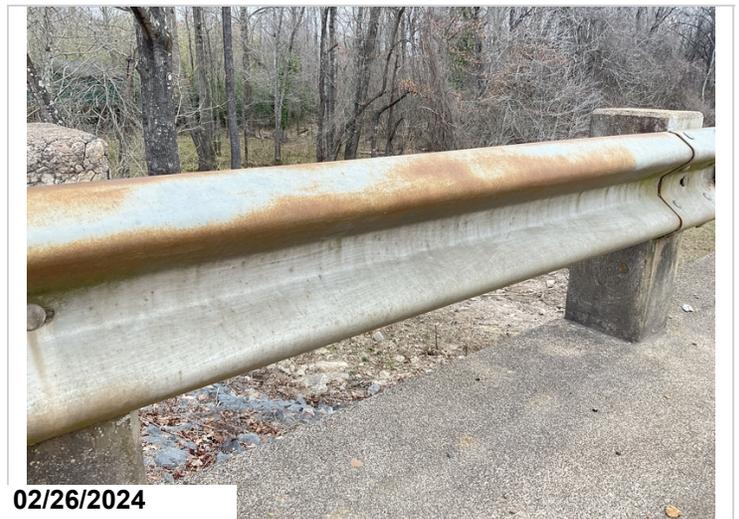
Both right and left sides of approach spans, corrosion, CS2

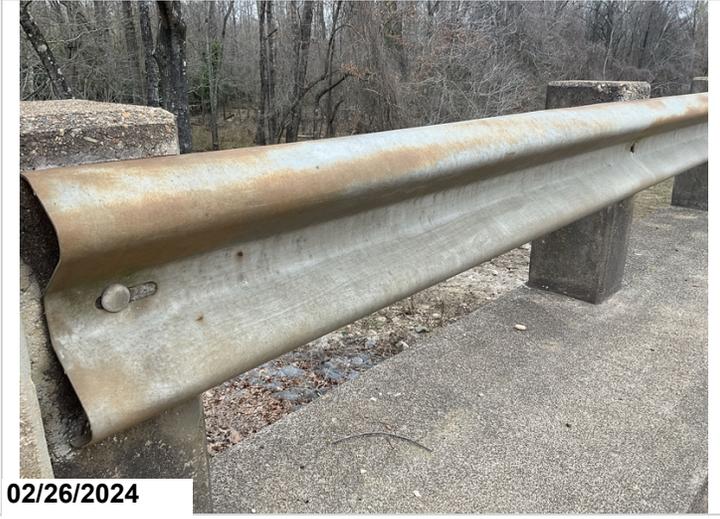
Both right and left sides of approach spans, corrosion, CS2

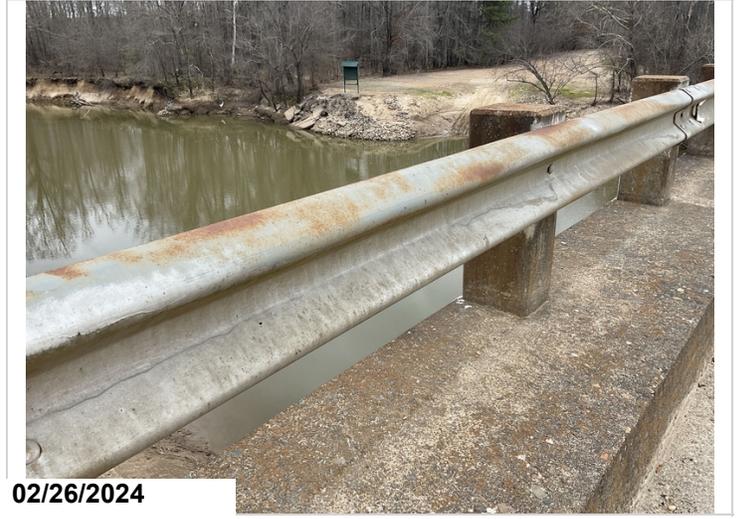
Both right and left sides of main spans, corrosion, CS2

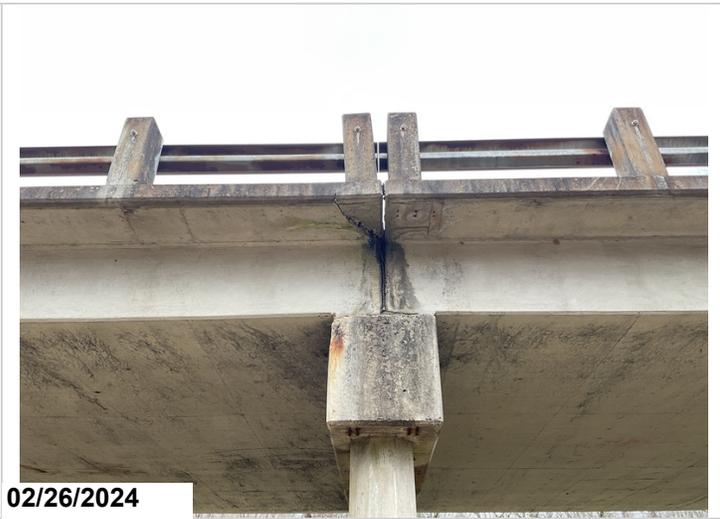
Approach span at right side of bent 17, spalling, 1 Sq Ft, CS3

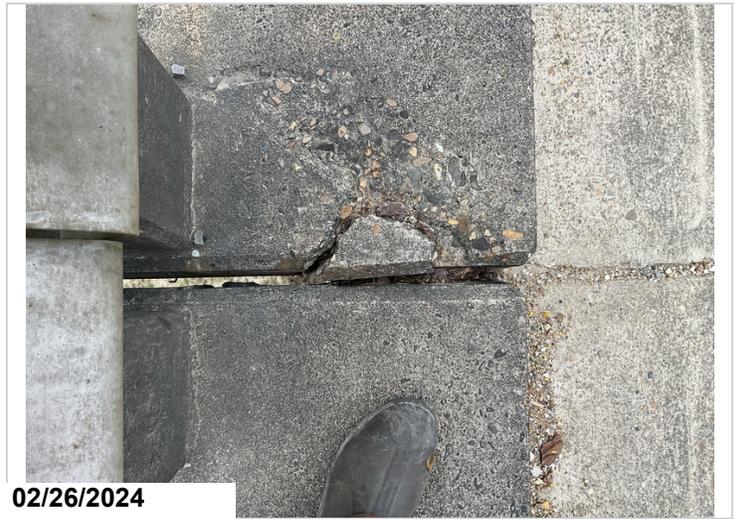
Approach span at right side of bent 17, spalling, CS3

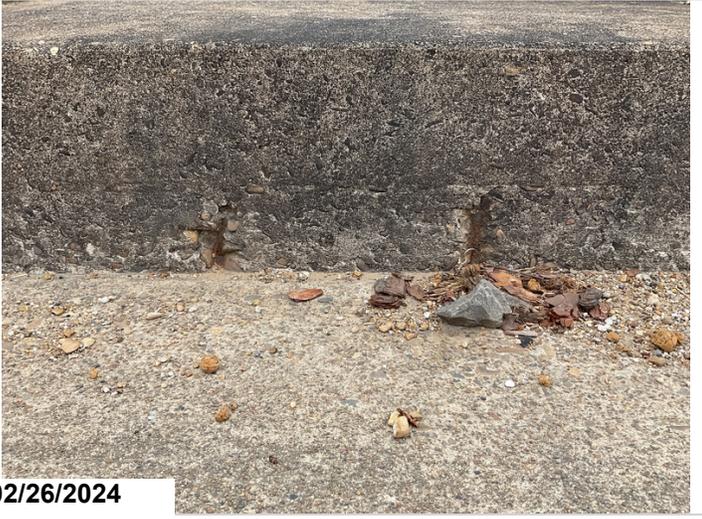
Main span 2, Northbound lane, Exposed rebar along gutter line, CS2

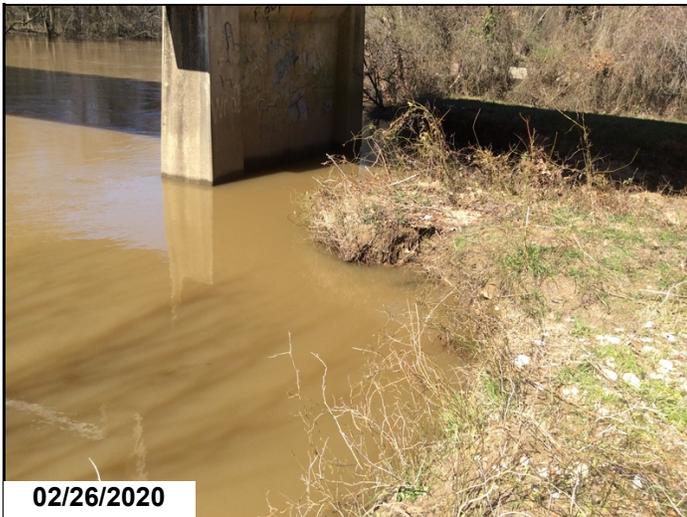
EROSION AT PIER #1&3 HAS STARTED AROUND AND BEHIND COLUMNS/WALLS.

(HBM) 03/2022 It is recommended to install engineered countermeasures along the north bank to mitigate additional erosion and help contain flow through the bridge site.

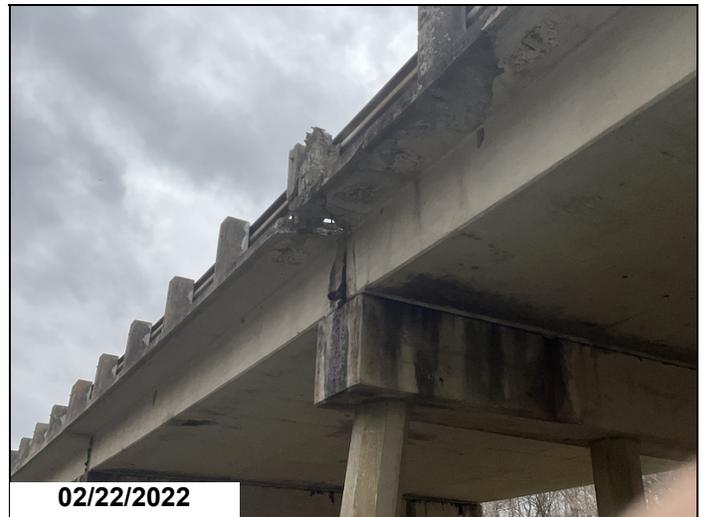
BT 18 overhang... 2/22/22

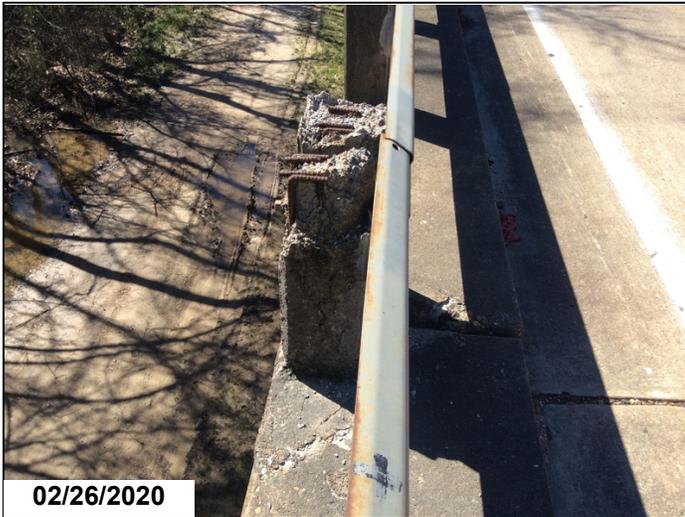
Span 17,18 Lt side post spalled and curb spalled

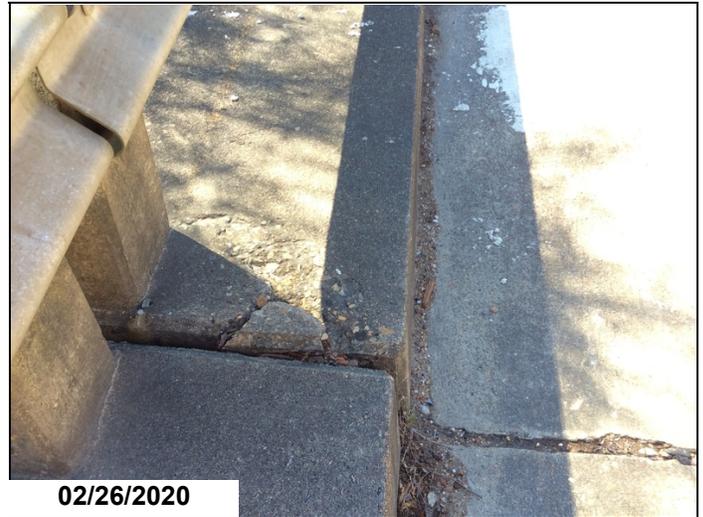
Span 17 Lt side curb spalled

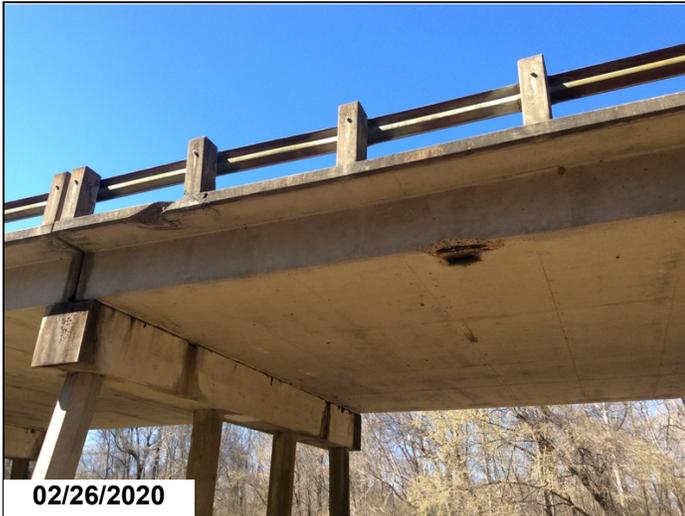
Span 19 spall at drain and over hang spalled and cracked
Lt side

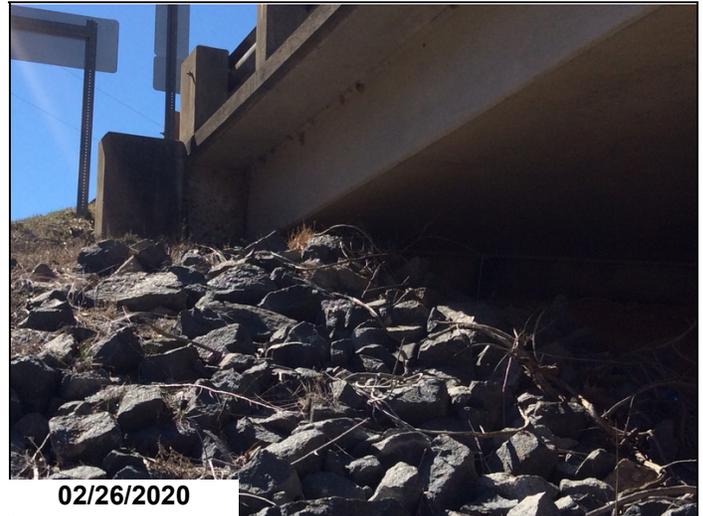
End bridge spall lt side

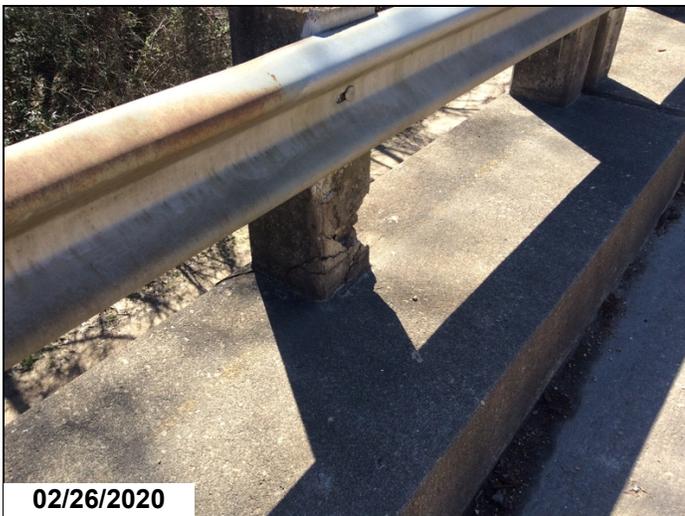
Span 19 Lt side post spalled

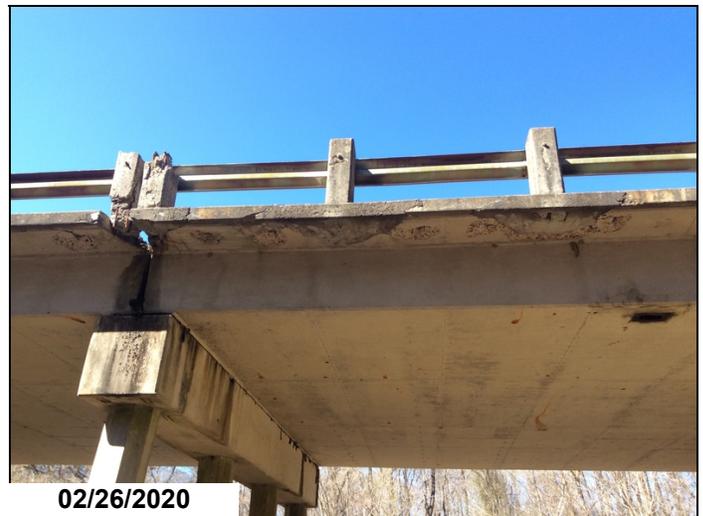
BT 18 over hand spalls cracks and rebar exposed

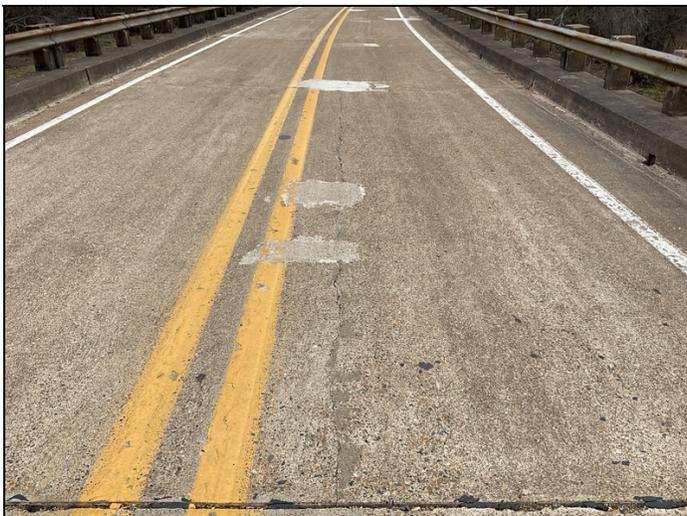
Approach span 4, Northbound lane, 30' longitudinal deck cracking, CS3

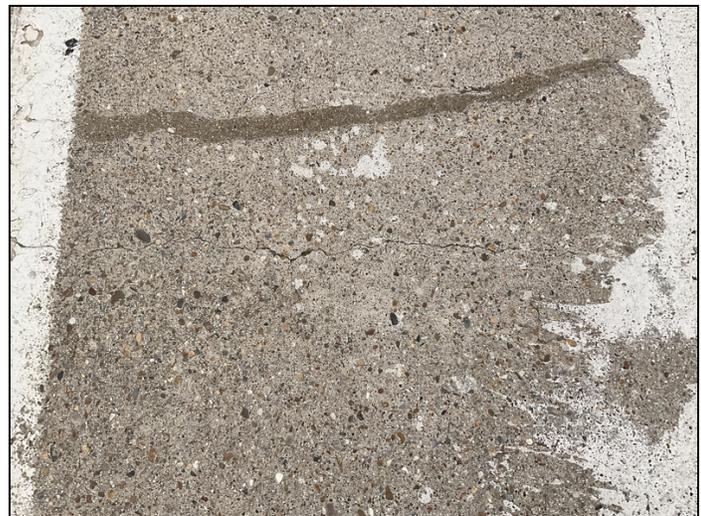
Main span 1, Southbound lane, Deck cracking, CS2
