Asset #A3424(Routine)

I-30 WB Log 97.06 over Ouachita Rvr& Riverview

Location: 1.0 MI SO I-30 & 270

Team Lead: Chris Doggett Inspection Date: 07/22/2024

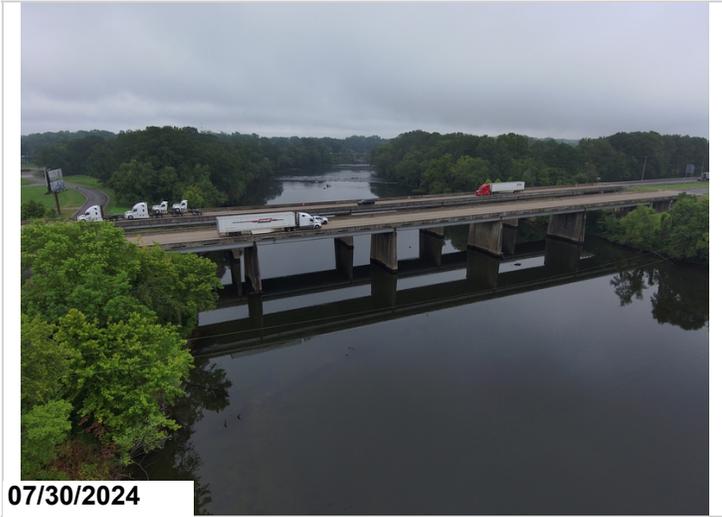
Elevation

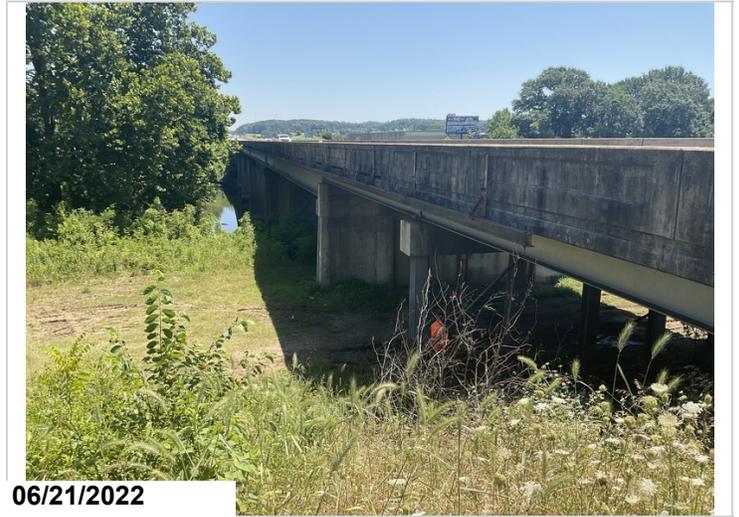
Elevation.

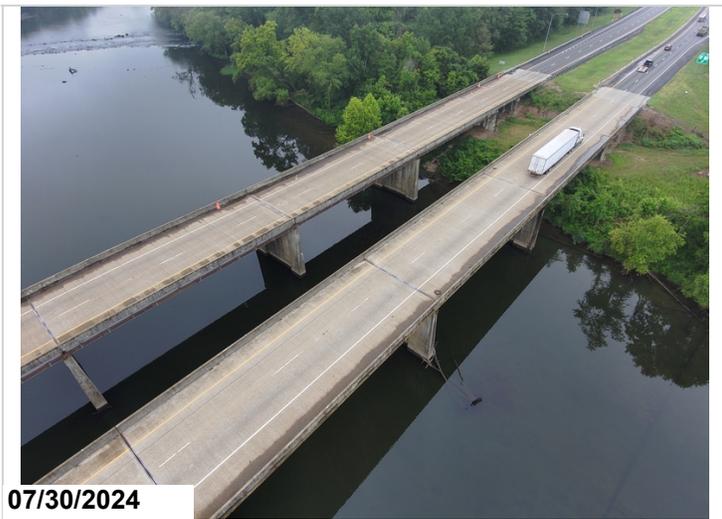
Deck view.

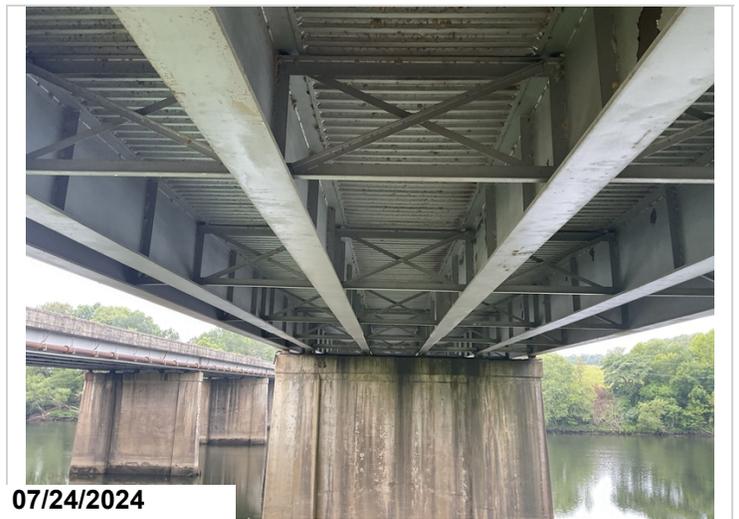
Under surface view

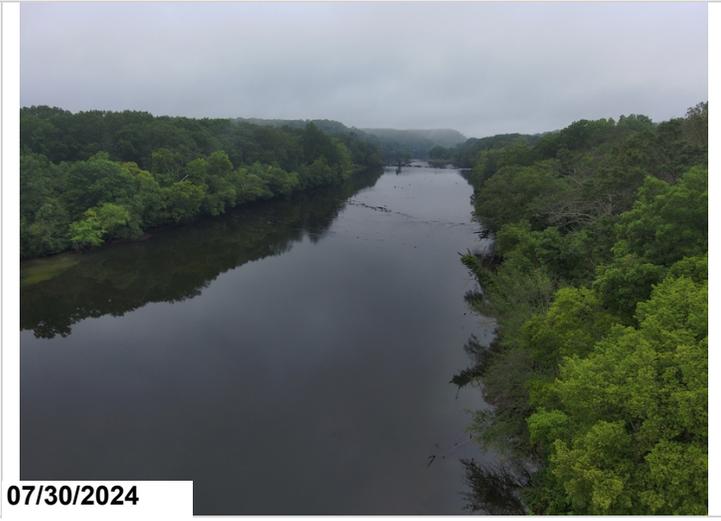
Channel looking upstream.

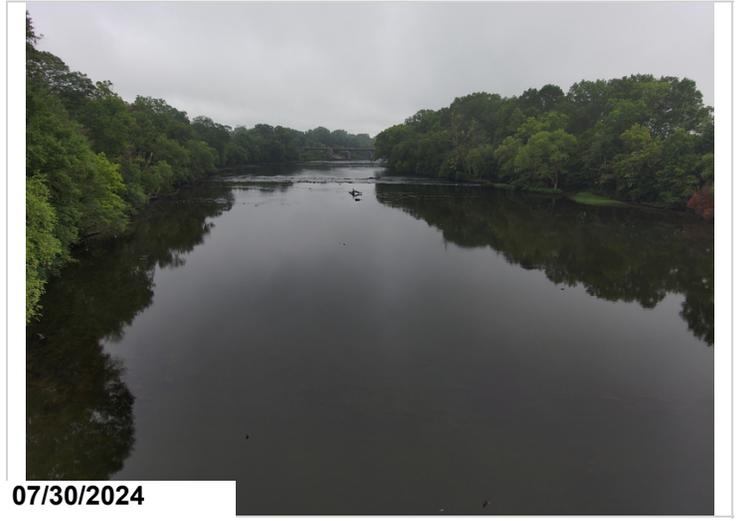
Channel looking down stream.

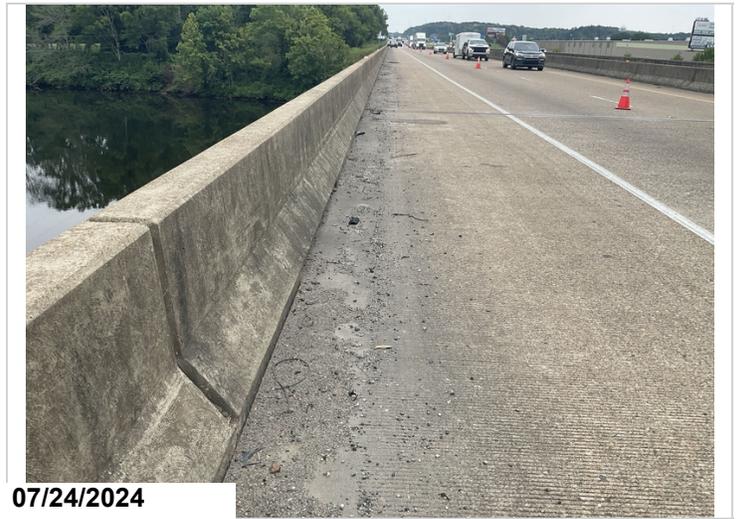
Dirt and debris in the gutter line of the deck.

A-55 - Deck Washing Needed (Yes)

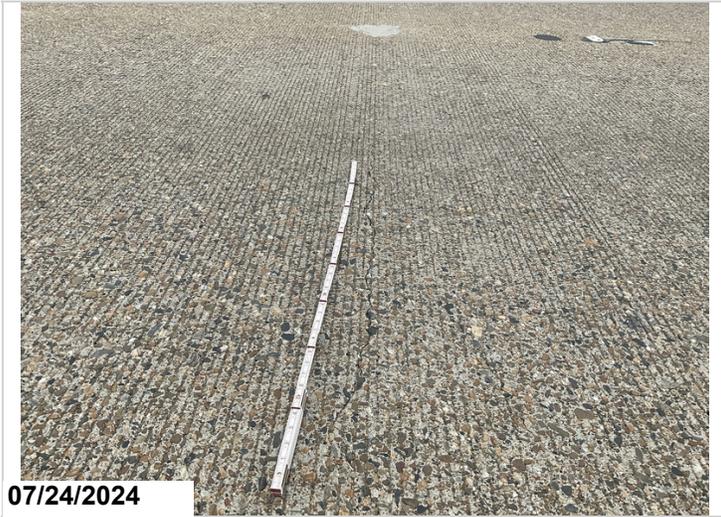
Span 5: unsealed transverse crack (0.020")

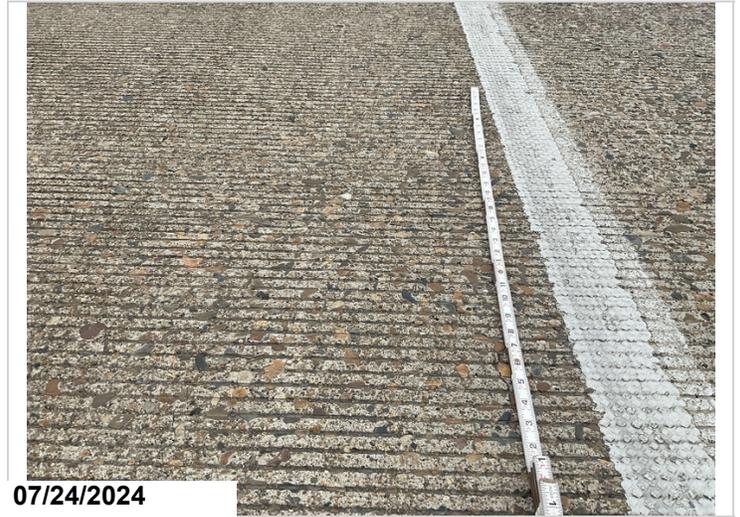
Span 4: unsealed longitudinal crack. (0.020")

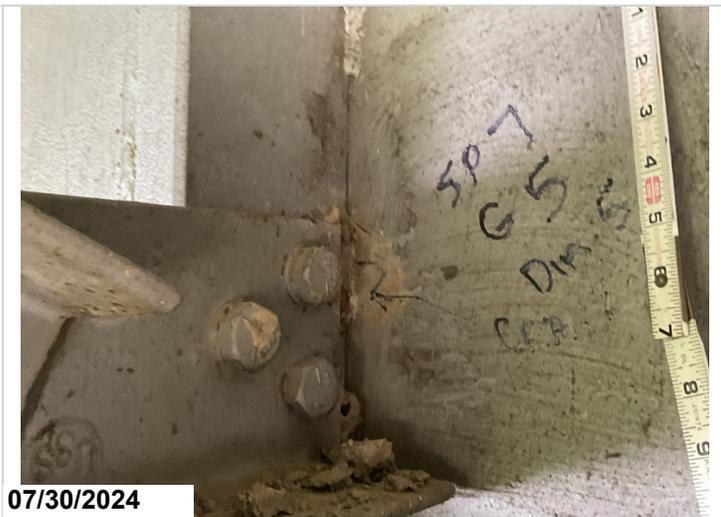
Span 7, girder 5, diaphragm 5: Cracked weld. CS4-1

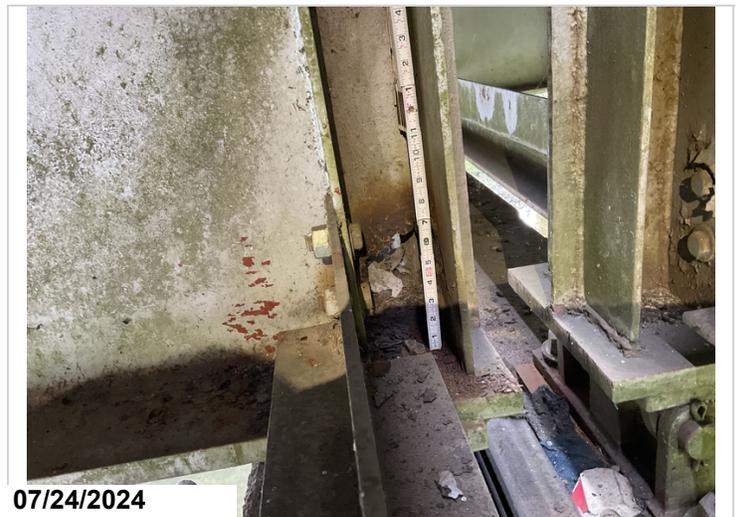
Girder 4: 3"x 3" hole in the web between the stiffeners above the bearing at pier 2. CS4-1'

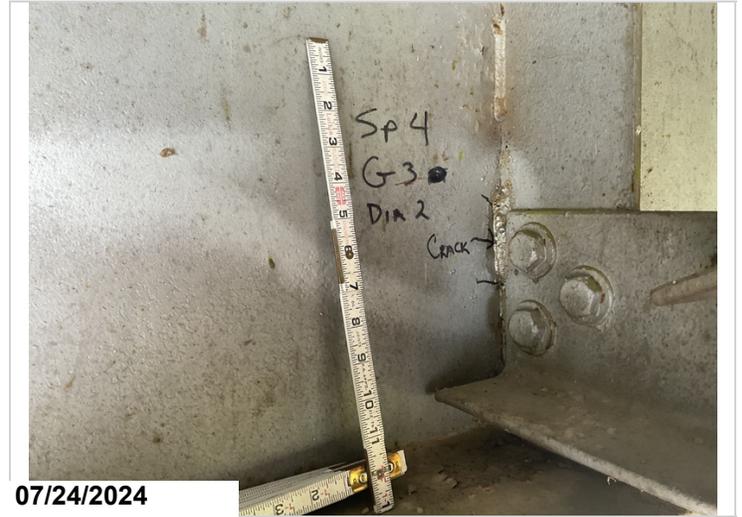
Span 4, girder 3, diaphragm 2: a 2" crack in the weld. CS4-1'

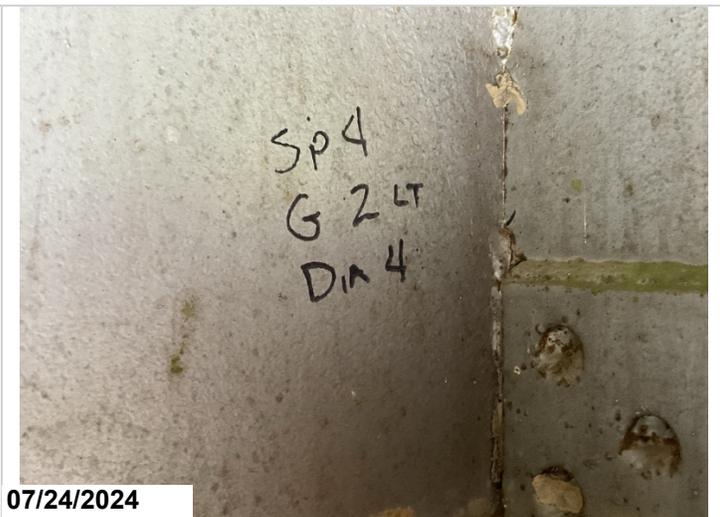
Span 4, girder 2, diaphragm 4: a 1/2" crack at the toe of the weld.
CS4-1'

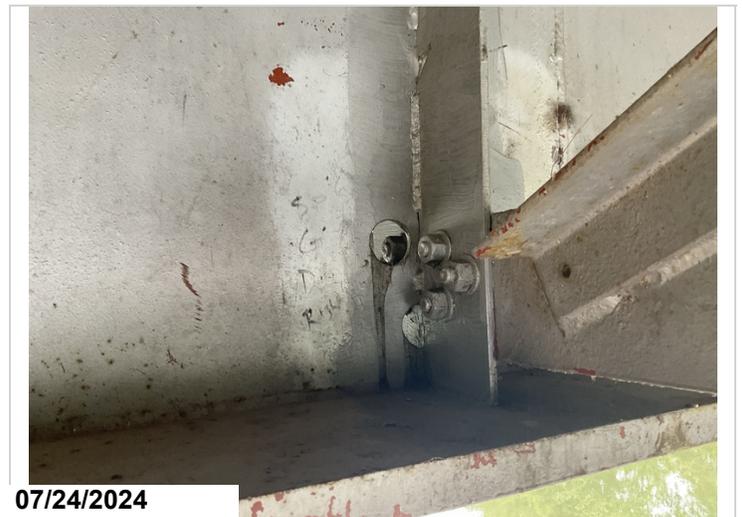
Span 6, girder 3, diaphragm 3; HBM repaired previous crack into the web. Common to all spans that have had previous cracks that propagated into the web.

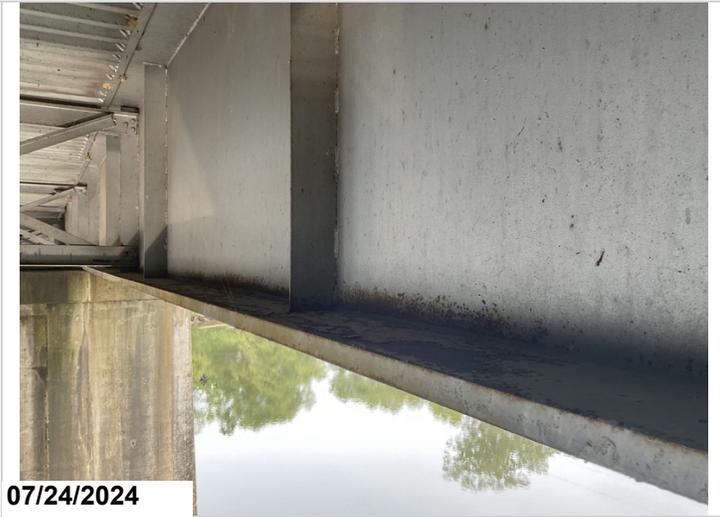
Span 6, girder 2: scattered freckled rust to the top of bottom flange and lower web. Common to all beams.

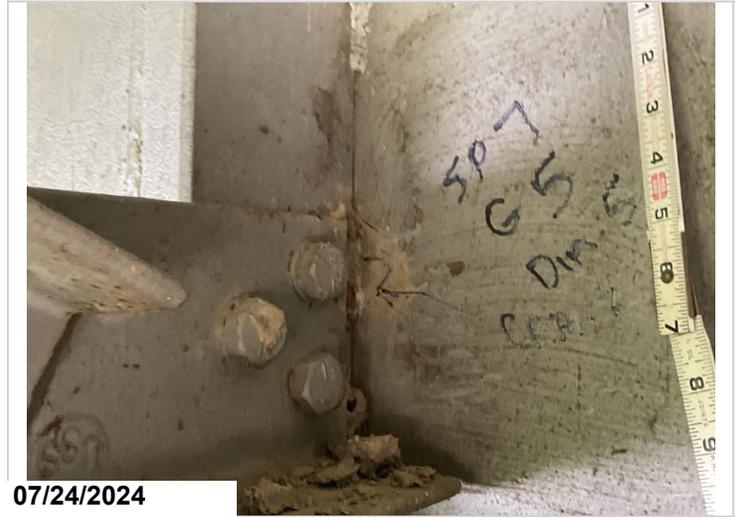
Span 7, girder 5, diaphragm 5: Cracked weld. CS4-1

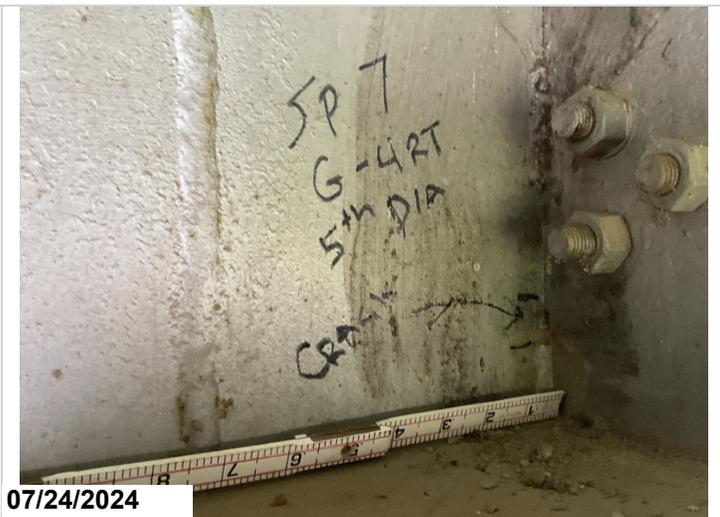
Span 7, girder 4, diaphragm 5: 1" crack in weld. CS4-1'

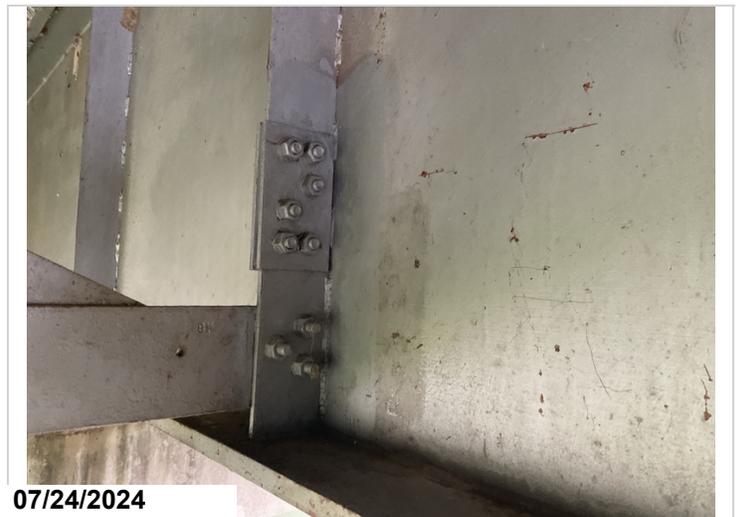
Span 7, girder 3, 6th diaphragm: previous cracked weld has been repaired. CS2-1'

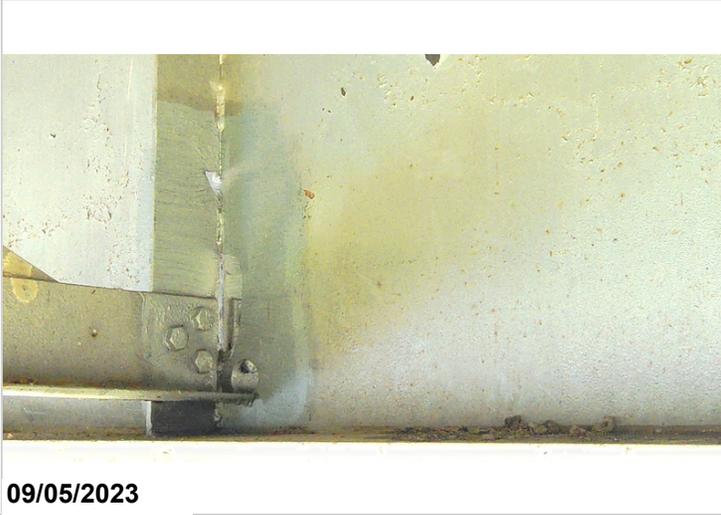
Span 4, girder 3, diaphragm 4: crack has been arrested.
CS2-1'

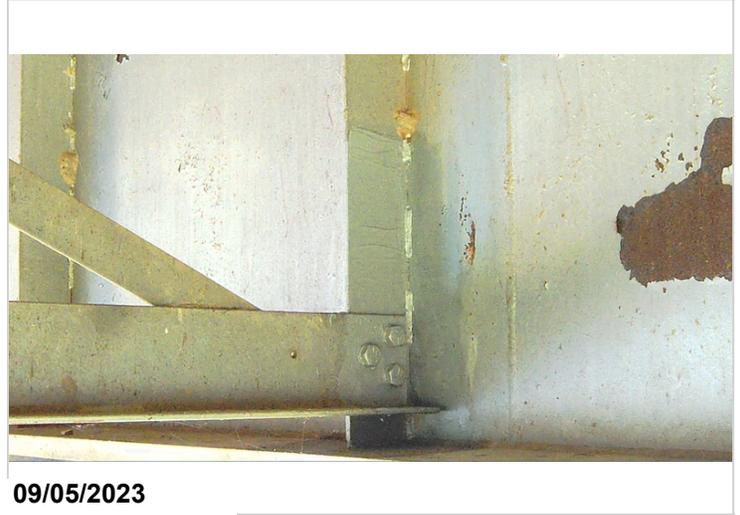
Span 5, girder 4, diaphragm 4: broken weld has been repaired.
CS2-1'

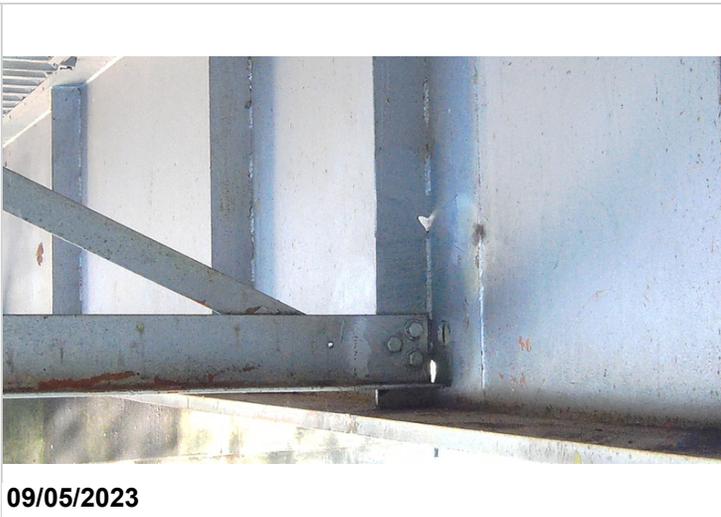
Span 5, girder 5, diaphragm 4: crack has been arrested.
CS2-1'

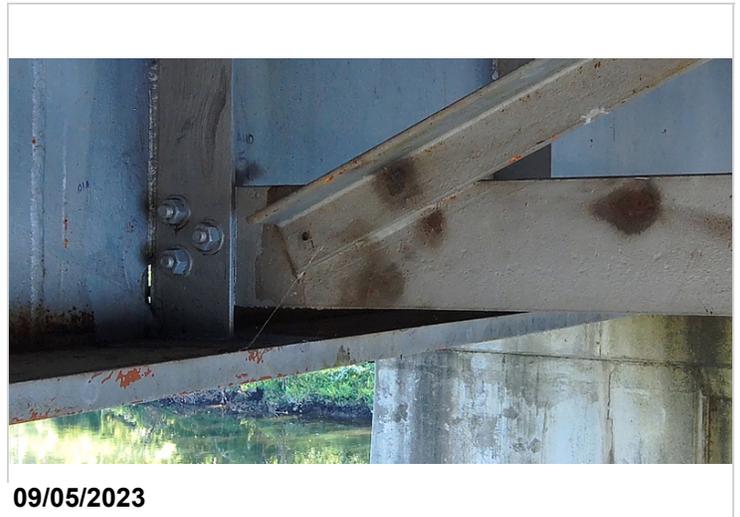
Span 5, girder 3, diaphragm 5: crack has been arrested.
CS2-1'

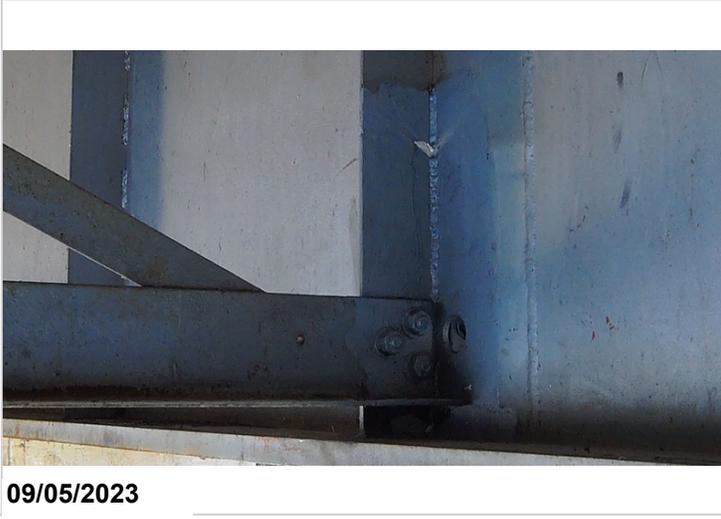
Span 7, girder 3, diaphragm 4: crack has been arrested.
CS2-1'

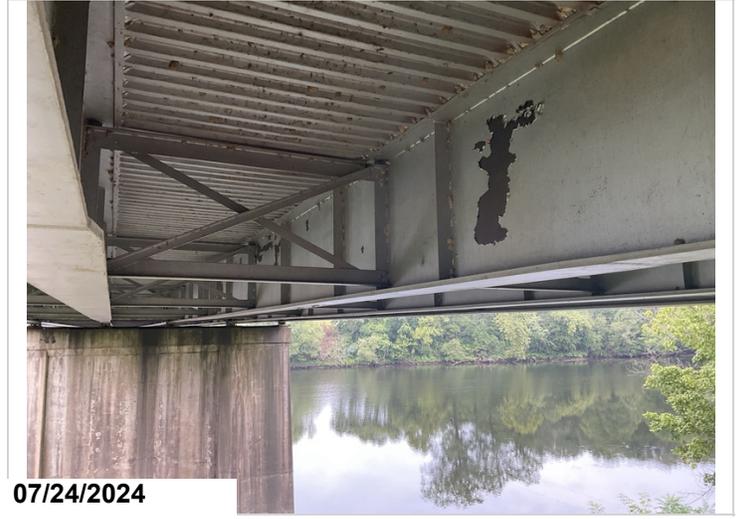
Span 7, girder 3: paint flaking

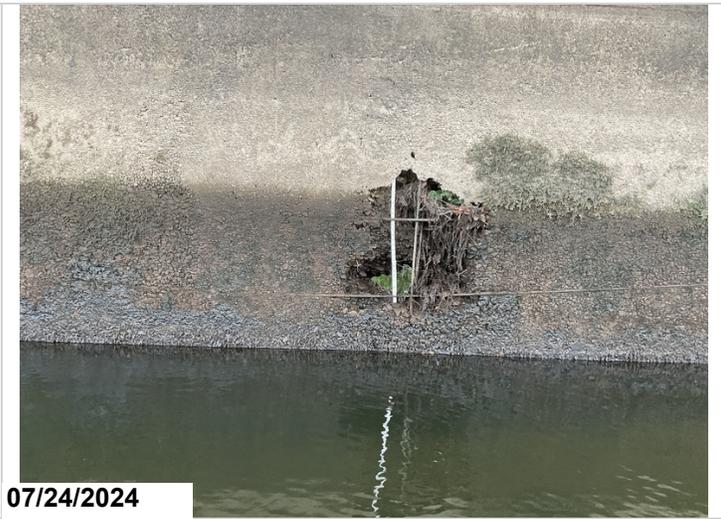
Pier 5: at the centerline of the pier a large spall with exposed rebar that is believed to be a previous location for utility pipe.

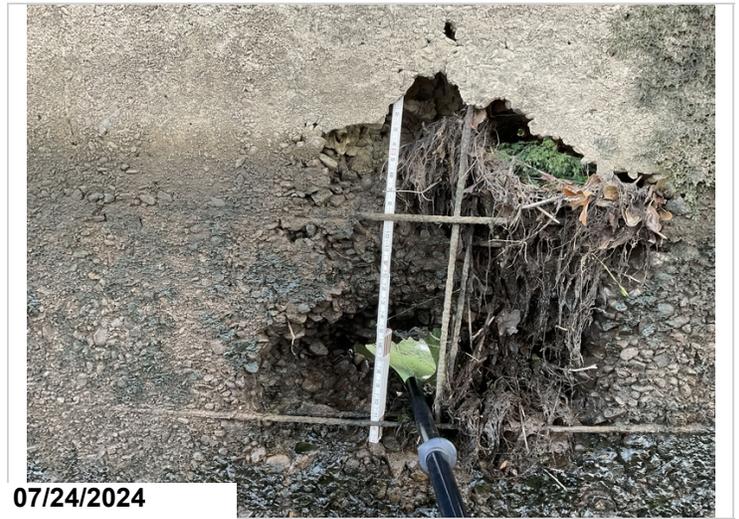
Pier 5: at the centerline of the pier a large spall with exposed rebar that is believed to be a previous location for utility pipe.
(1 1/2' x 1') CS4-1'

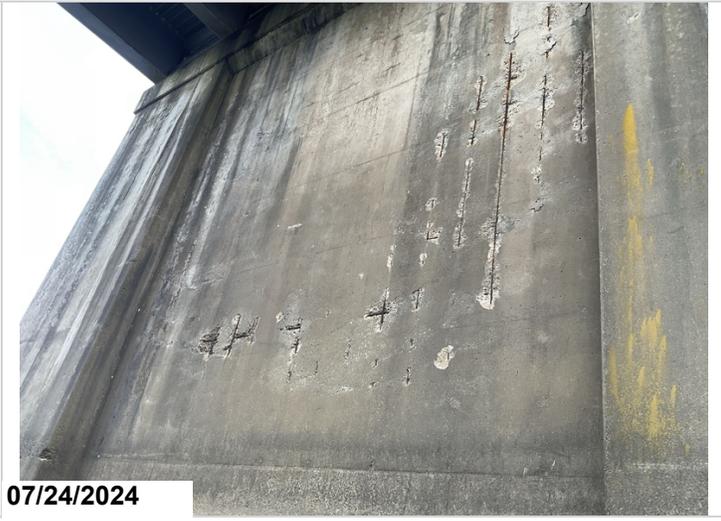
Backside of pier 4: numerous spalls with exposed rebar to the pier wall. CS3-10'

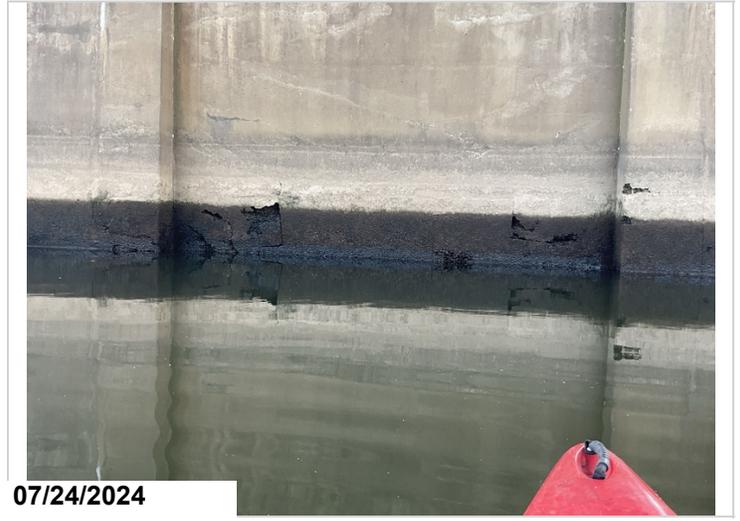
Backside Pier 3: multiple spalls due to abrasion and previous utility location. CS3-15'

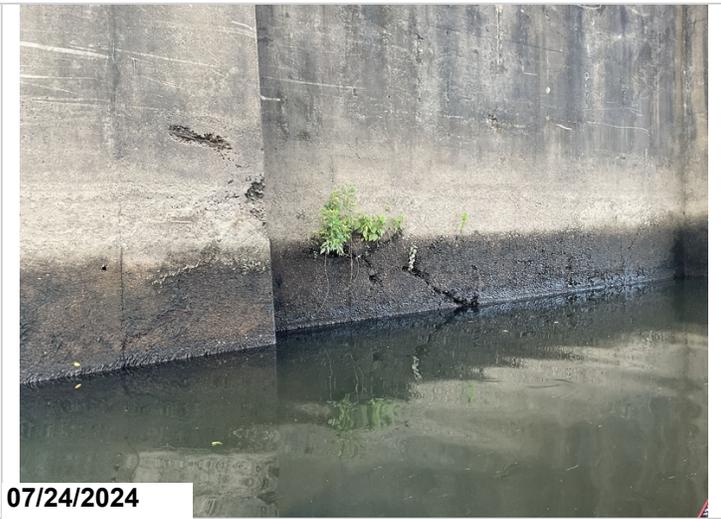
Ahead side pier 2: severe abrasion at the water line. CS3-11'

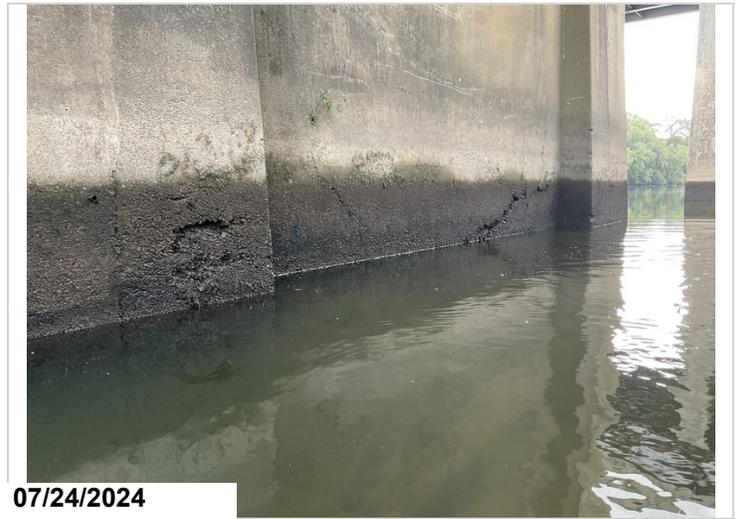
Backside Pier 2: 8' severe abrasion has created spalls CS3-5'

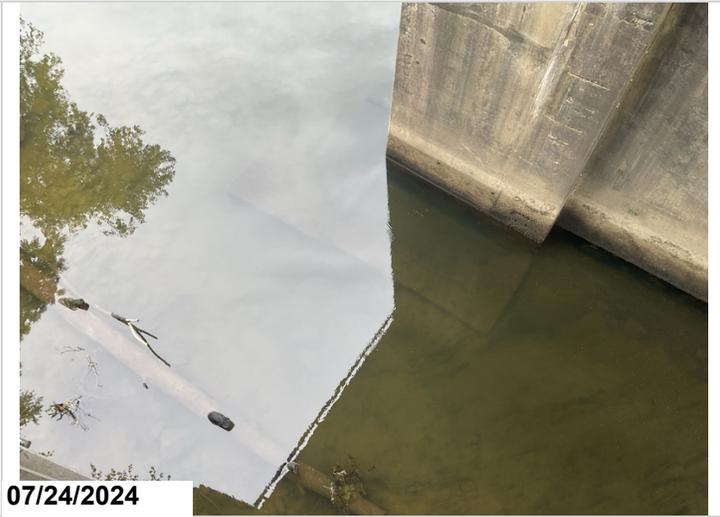
Pier 5: footing is exposed.

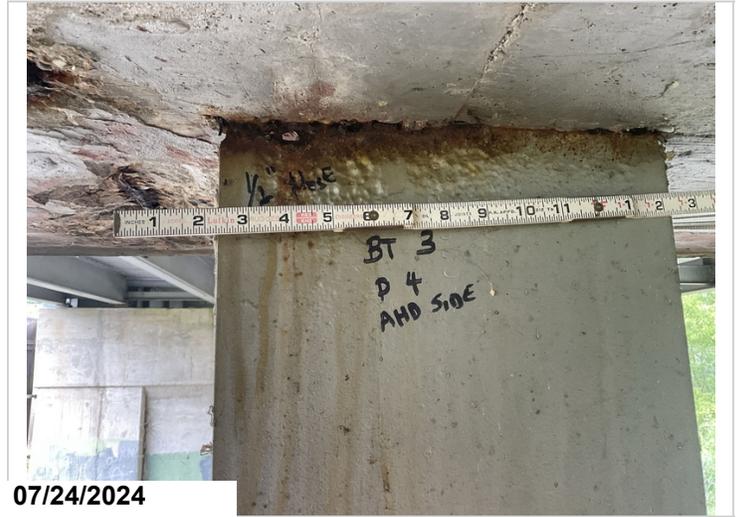
Bent 3, pile 4 ahead: The flange has a 1/2" hole and the remainder has approximately 3/16" section loss adjacent from the cap. CS4-1

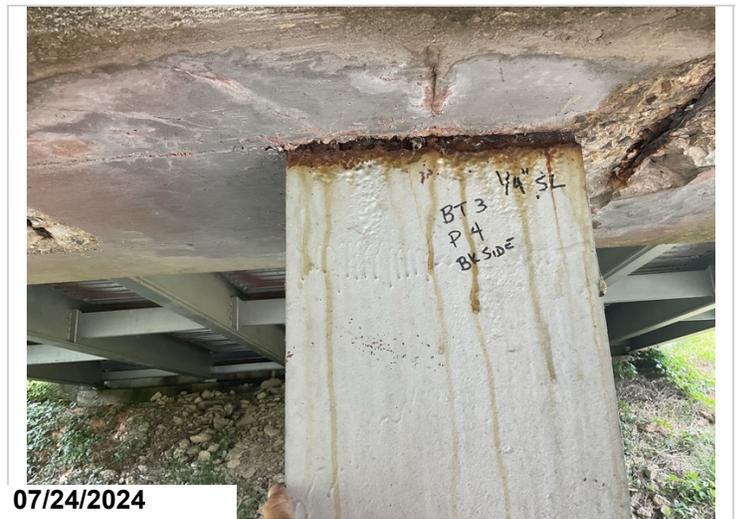
Bent 3, pile 4 backside: the entire flange adjacent to the cap has up to 1/4" section loss. CS3-1

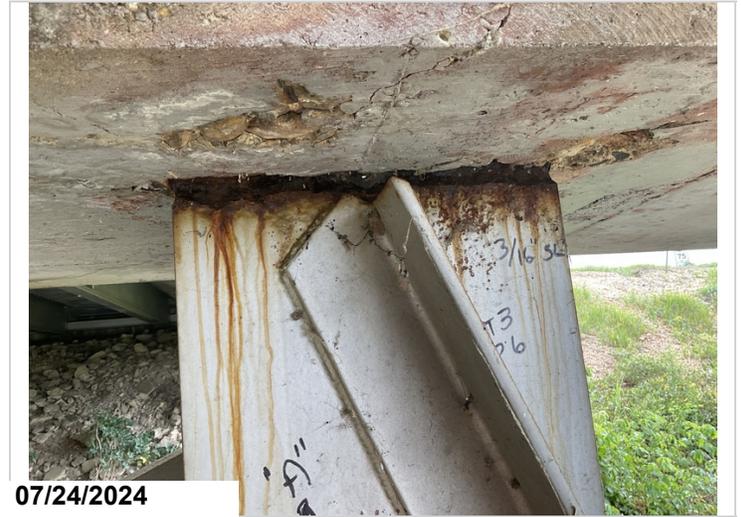
Bent 3, pile 6 backside: the entire flange adjacent to the cap has up to 3/16" section loss. CS3-1

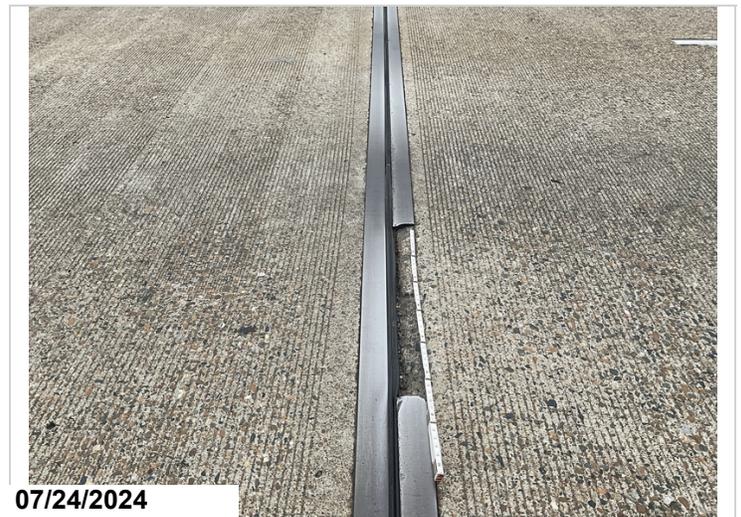
Pier 7: 3' of joint armor missing in the right west bound lane

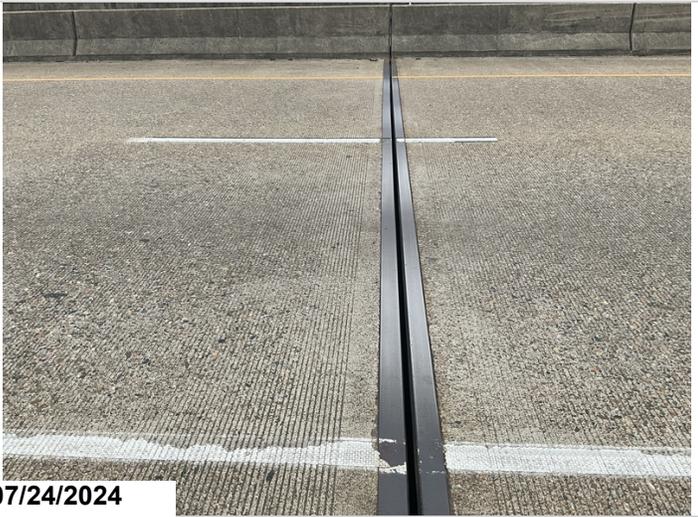
Bent 3: entire compress seal has fallen out.

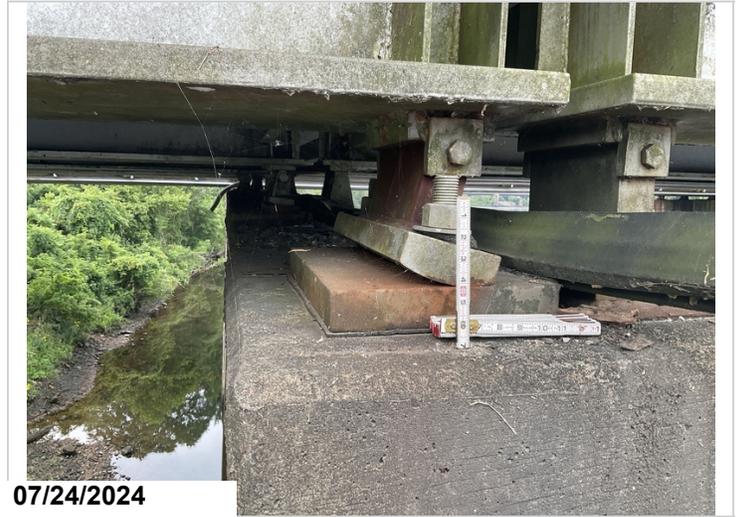
Pier 5, girder 1: bearing rocked back. Common to all bearings at this span.

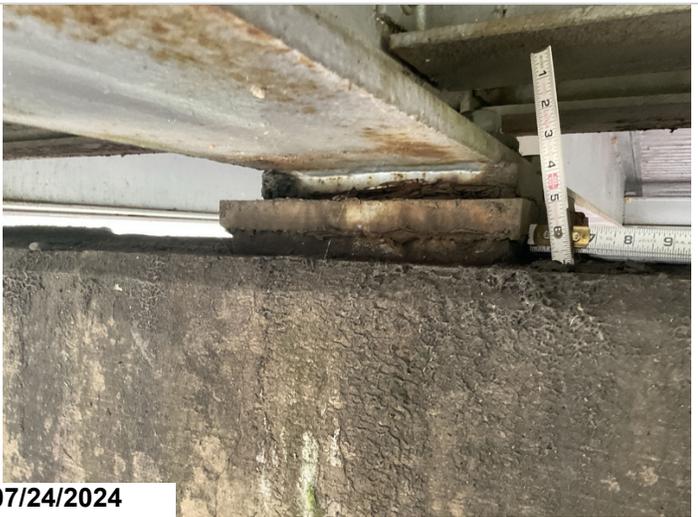
Bent 2, span 2, girder 4: bearing with some pack rust. Worst case.

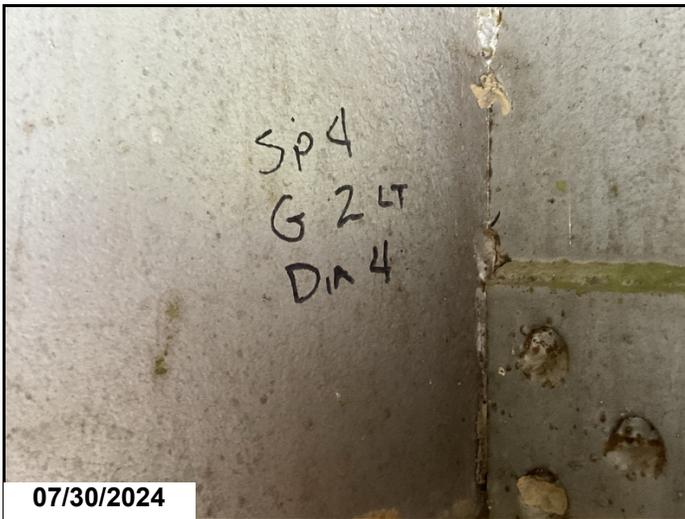
Span 4, girder 2, diaphragm 4: a 1/2" crack at the toe of the weld.
CS4-1'

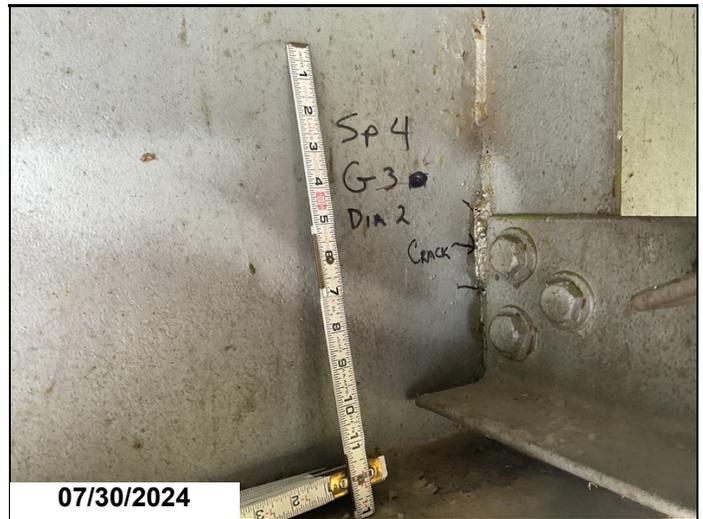
Span 4, girder 3, diaphragm 2: a 2" crack in the weld.
CS4-1'

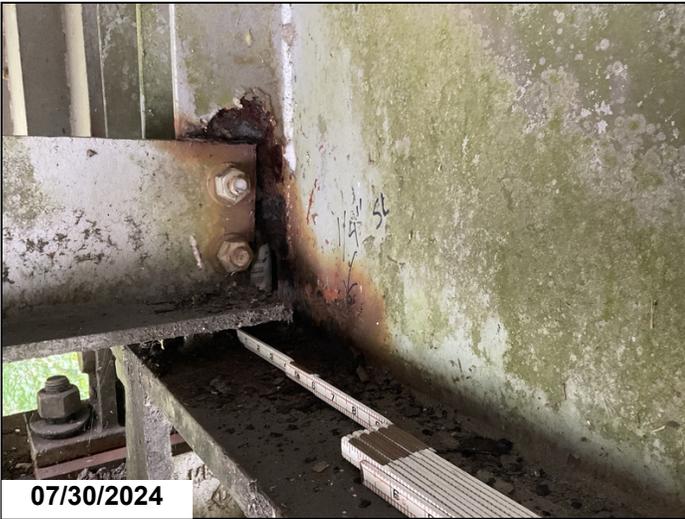
Girder 2, Pier 2, span 4: up to 1/4" section loss to the lower web. (4"x2" area) Large hole in the adjacent stiffener. CS3-1'

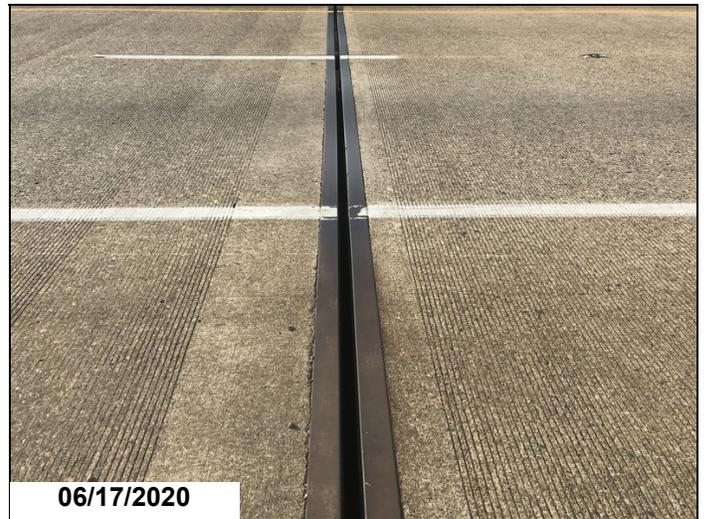
Pier 4, missing joint seal.

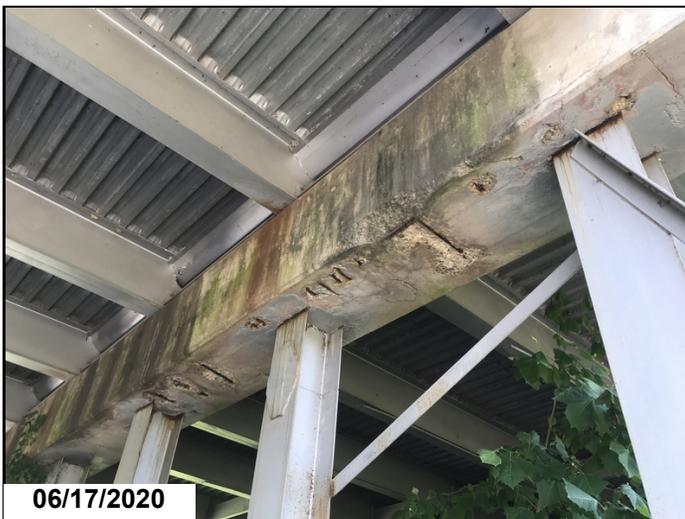
Bent 3, spalls with exposed rebar on the cap.

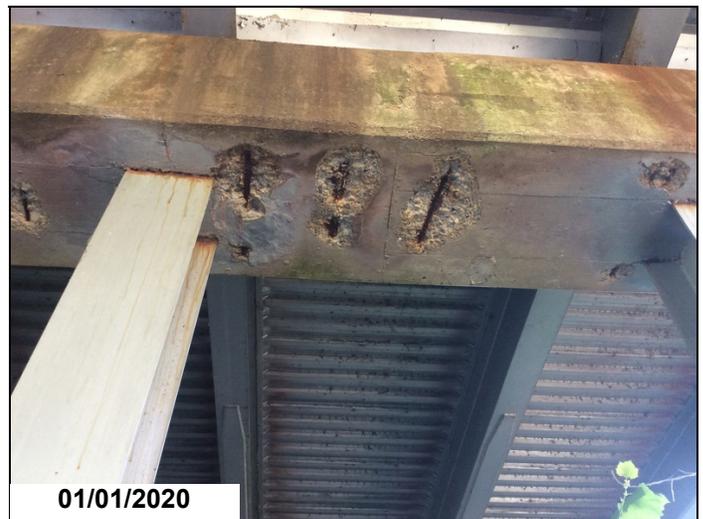
Bent 3 between piles 4 and 5 spalls with exposed reinforcing steel.

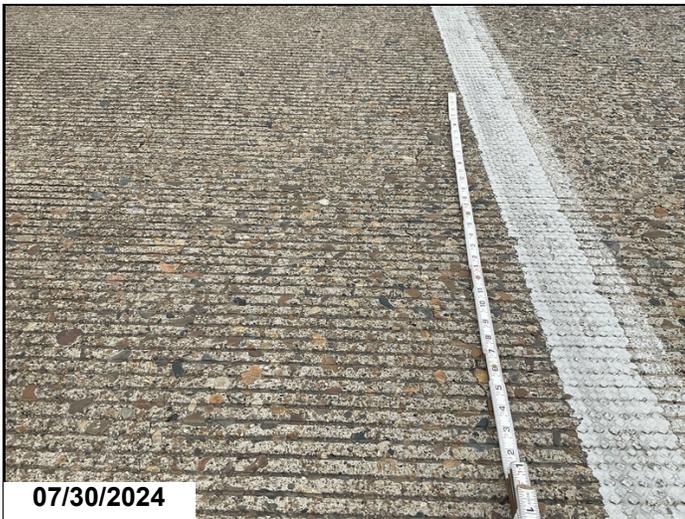
Span 4: unsealed longitudinal crack. (0.020")

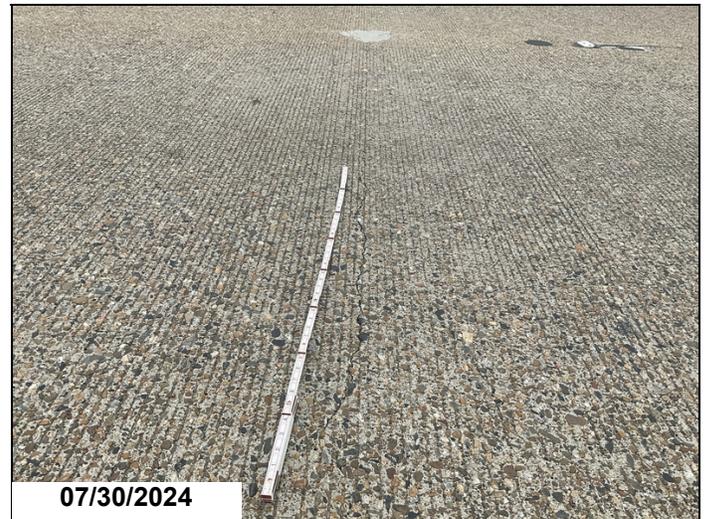
Span 5: unsealed transverse crack (0.020")

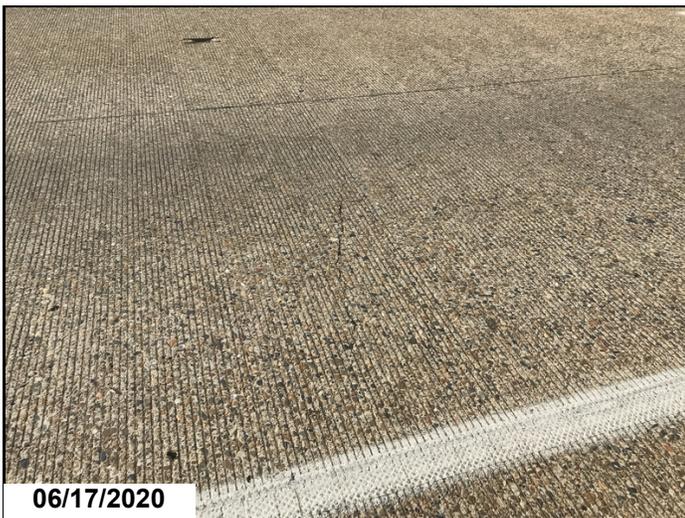
Span 7, large transverse cracks.

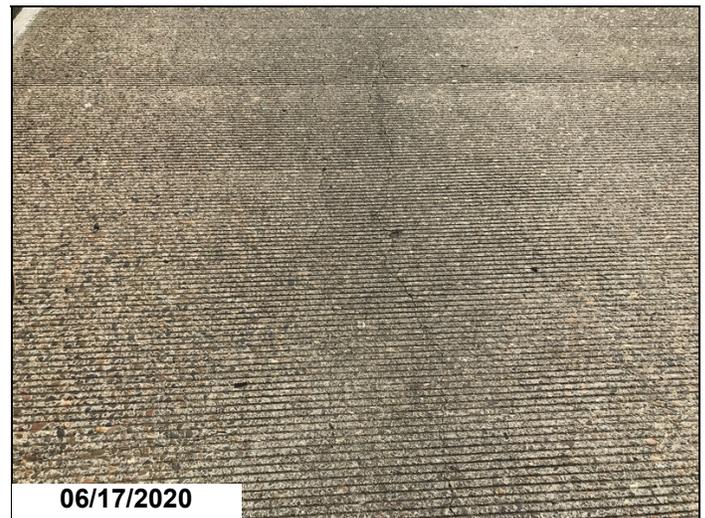
Span 9 longitudinal cracks.

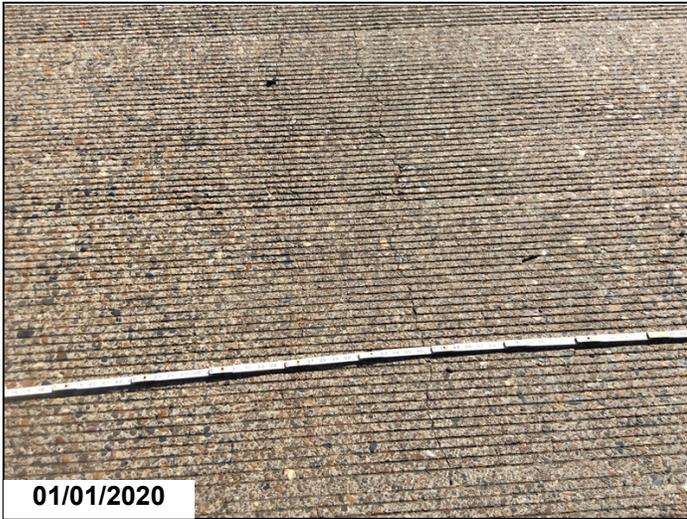
Span 8, longitudinal & transverse cracks up to .020".

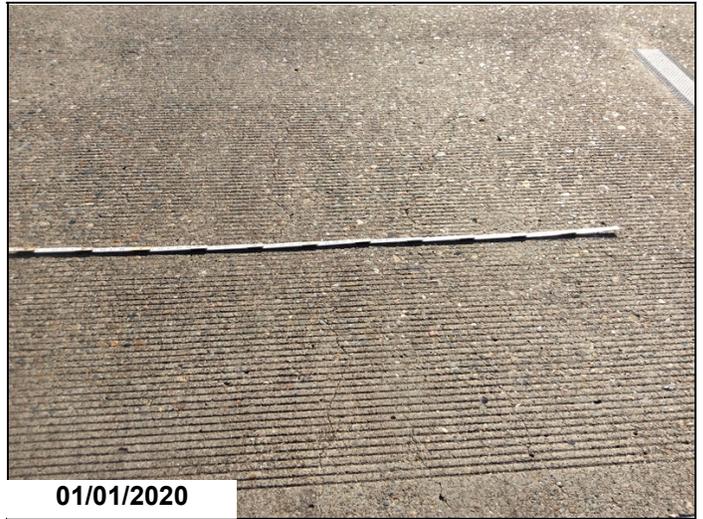
Span 3, longitudinal cracks up to .025".

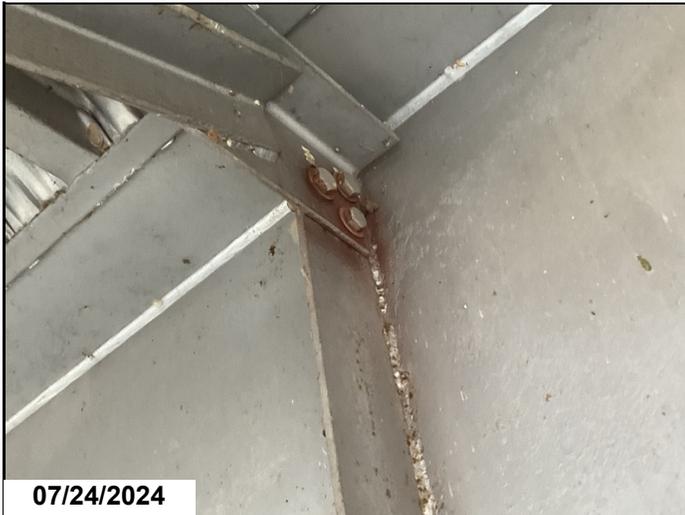
Span 5, girder 2, dia 4: loose bolts.

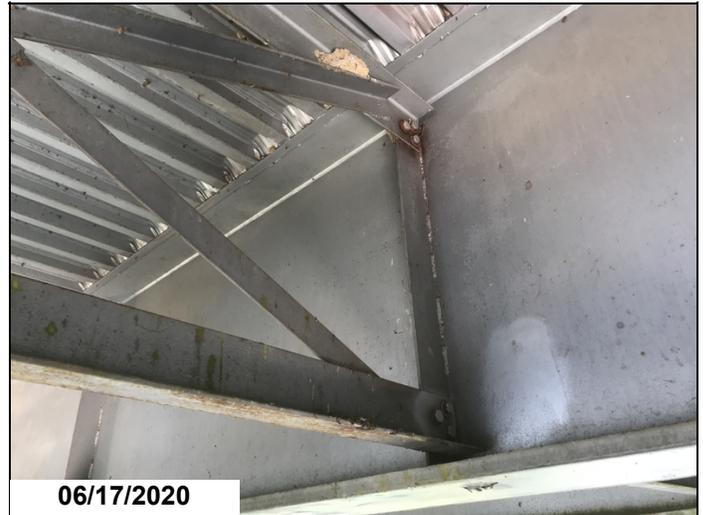
Span 5, loose bolts in top of diaphragm

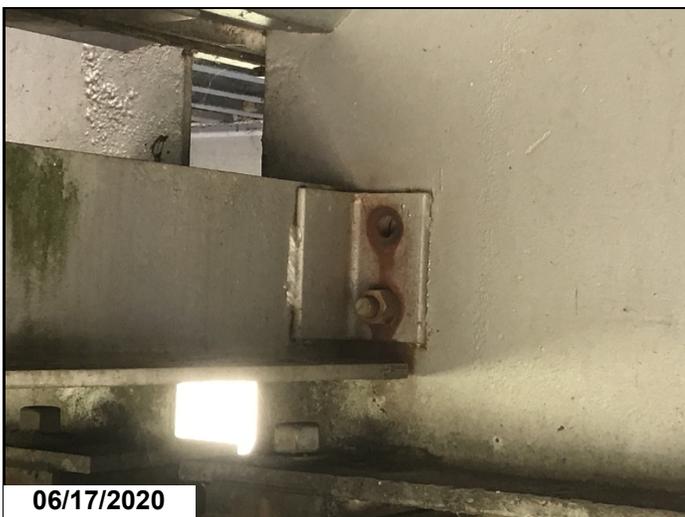
Span 2 girder 3, missing bolt.

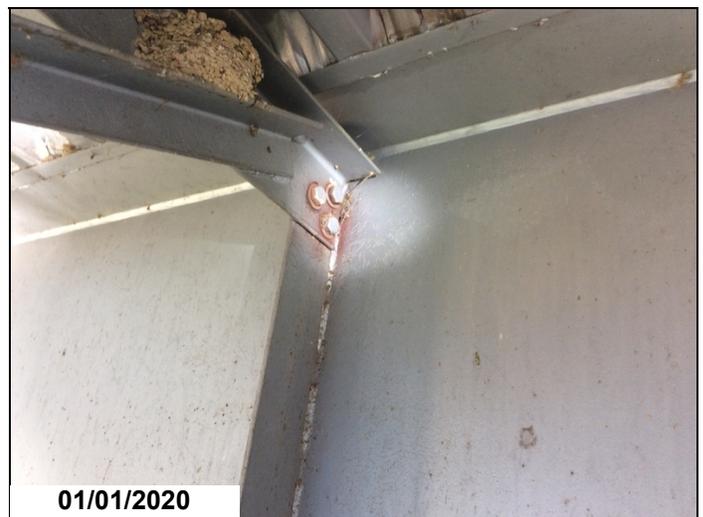
Span 5 girder 2 right, diaphragm 4, bolts are loose at top.

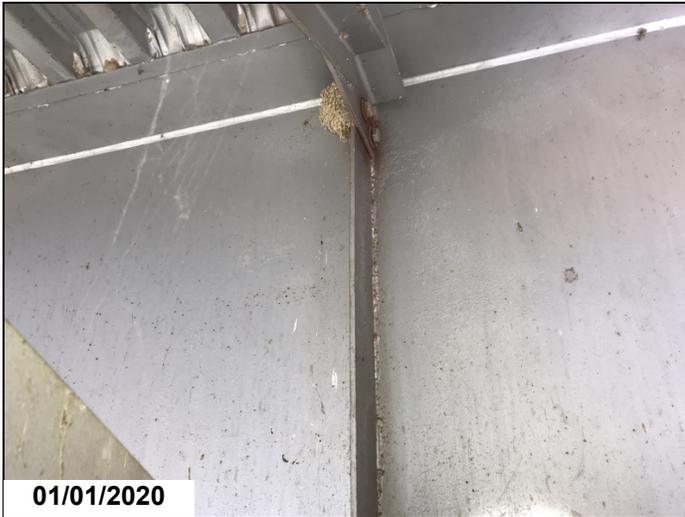
Span 5 g2 dia 4 loose bolts

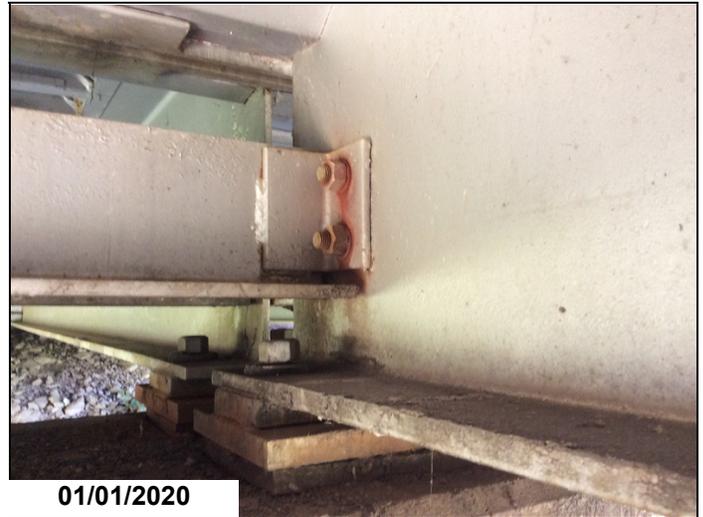
Bent 2 girder 3 ahead side loose bolts in diaphragm connection.

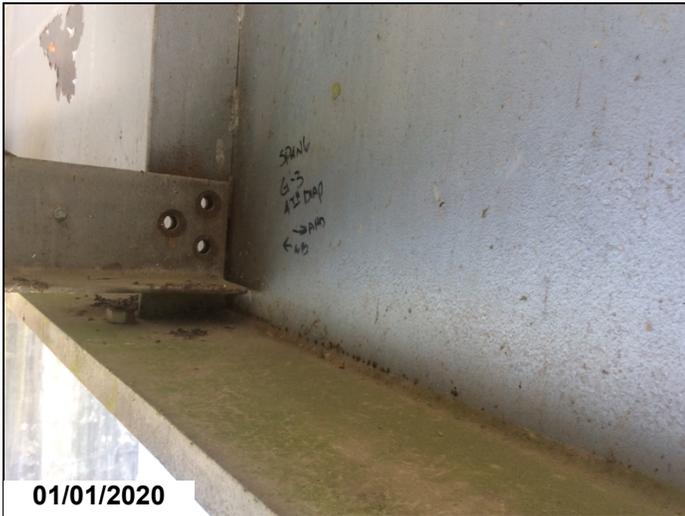
Span 6 girder 3 4th diaphragm has missing bolts

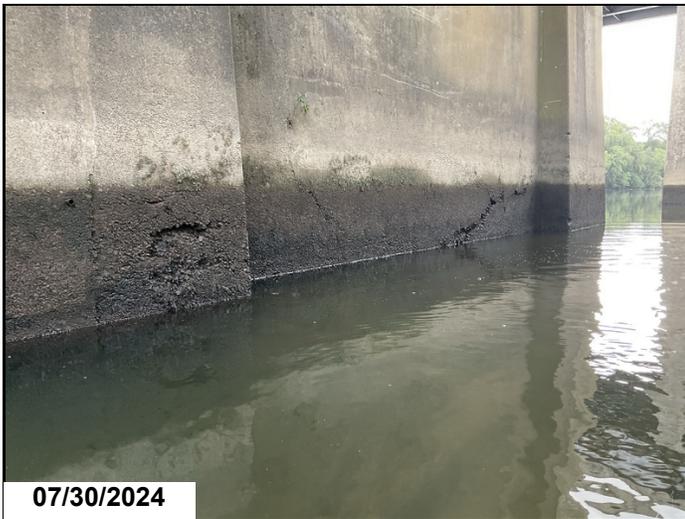
Backside Pier 2: 8' severe abrasion has created spalls CS3-5'

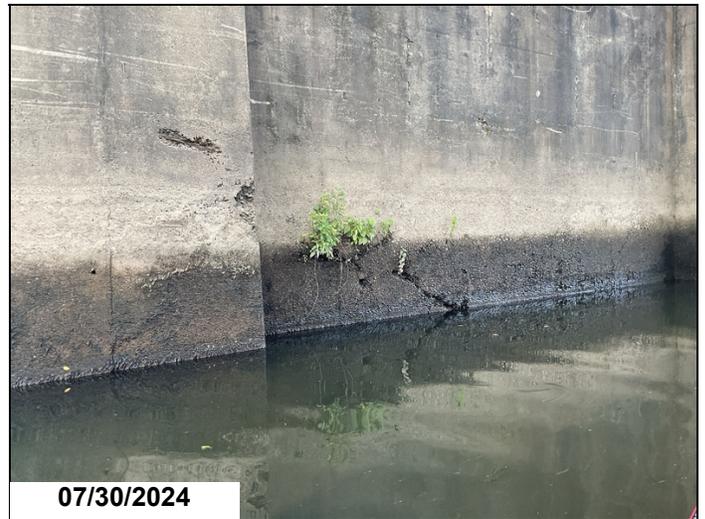
Ahead side pier 2: severe abrasion at the water line. CS3-11'

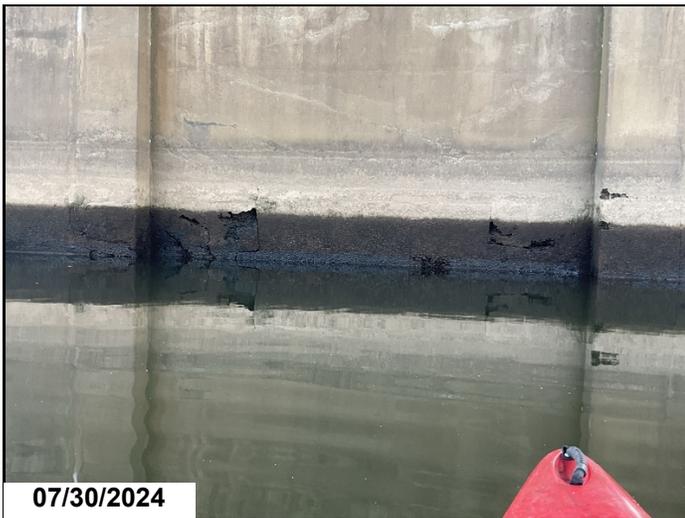
Backside Pier 3: multiple spalls due to abrasion and previous utility location. CS3-15'
