Asset #A3424(Routine)

I-30 WB Log 97.06 over Ouachita Rvr& Riverview

Location: 1.0 MI SO I-30 & 270

Team Lead: Chris Doggett Inspection Date: 07/22/2024

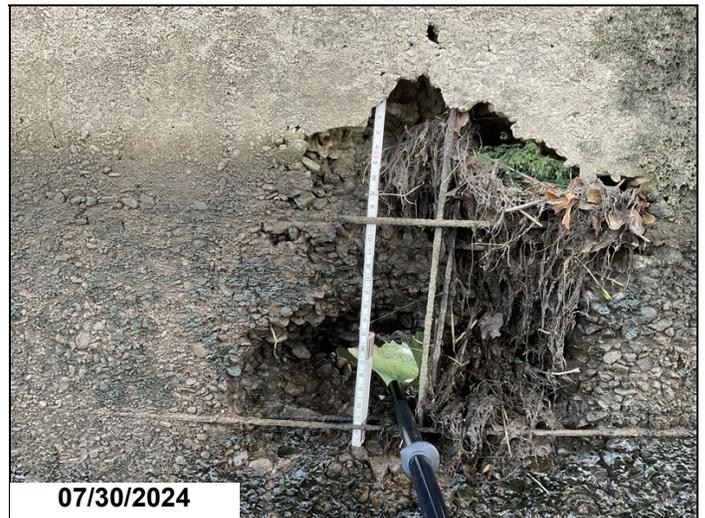
Pier 5: at the centerline of the pier a large spall with exposed rebar that is believed to be a previous location for utility pipe. (1 1/2' x 1') CS4-1'

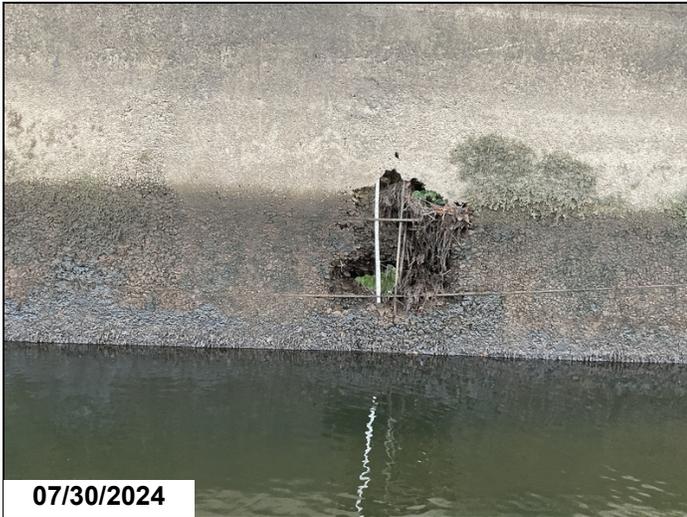
Pier 5: at the centerline of the pier a large spall with exposed rebar that is believed to be a previous location for utility pipe.

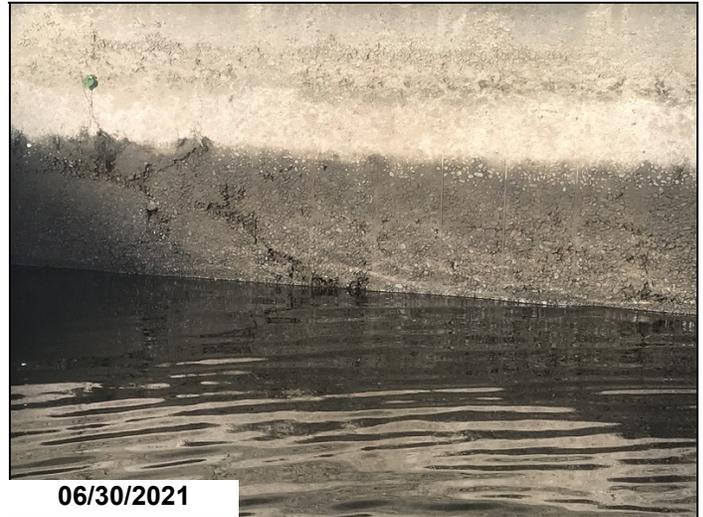
Pier 2 ahead abrasion with exposed rebar to pier wall.

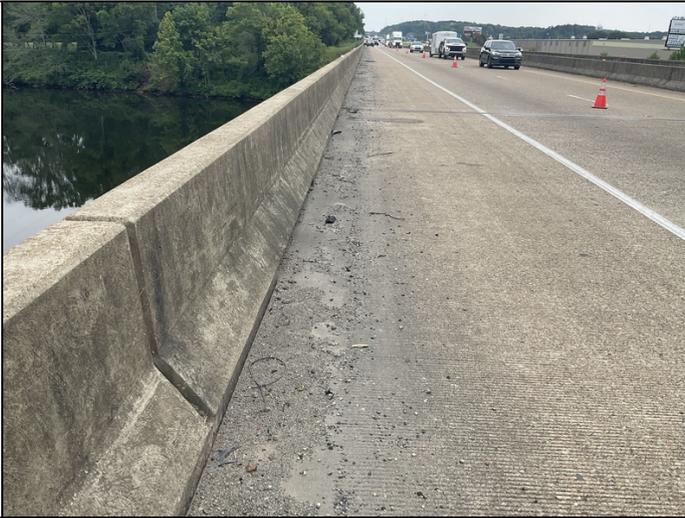
Dirt and debris in the gutter line of the deck.

A-55 - Deck Washing Needed (Yes)
