Asset #03896(Routine)

SH 283-3 Log 0.25 over I-30 Log 82.59

Location: 1.14 MI N JCT US 67

Team Lead: Keith Harris Inspection Date: 07/22/2024

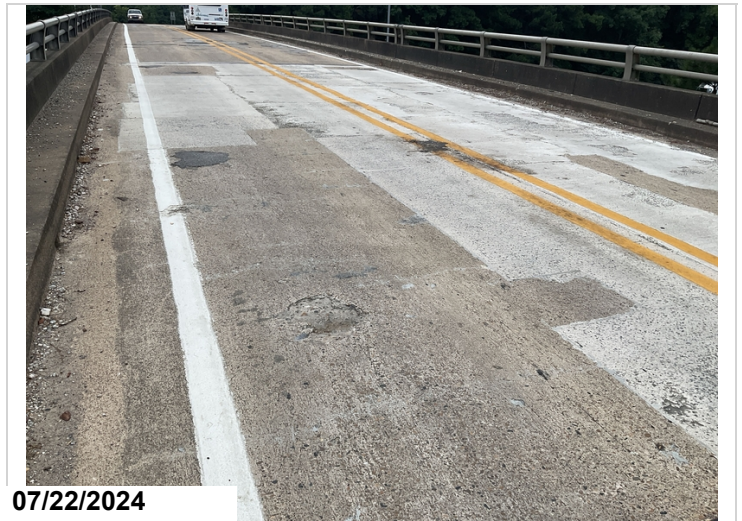
Deck overview

Overall, the deck is in poor condition. Deck has numerous spalls, spalls filled with asphalt, cracks and patched areas.

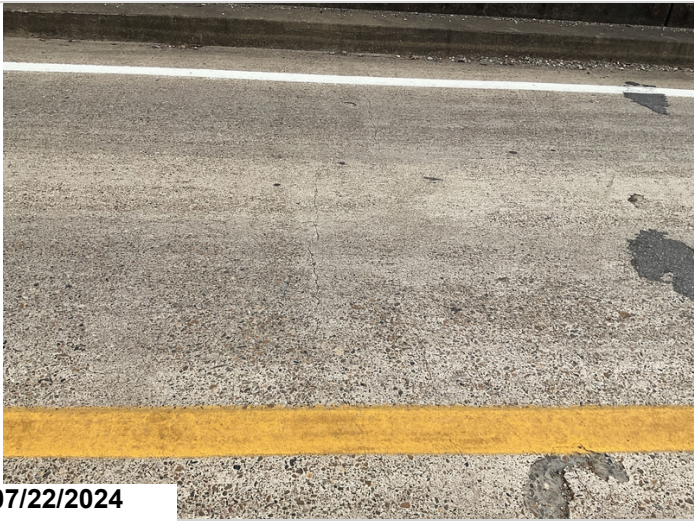
Span 2 unsealed transverse cracks up to 0.080". CS3

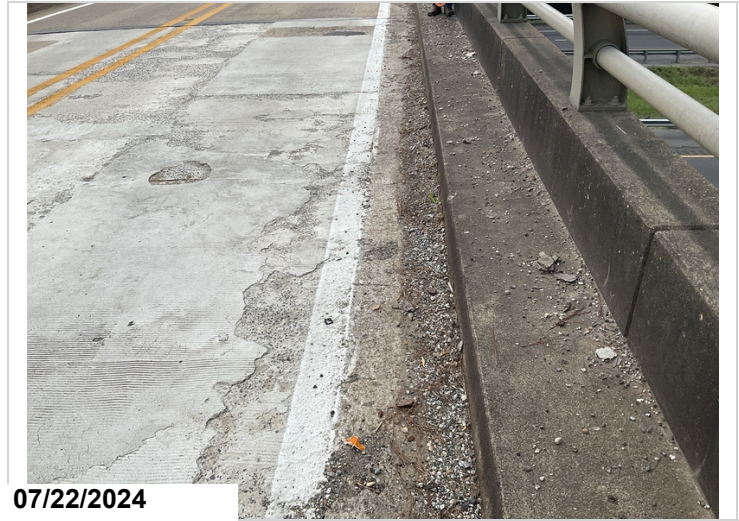
Both shoulders have debris

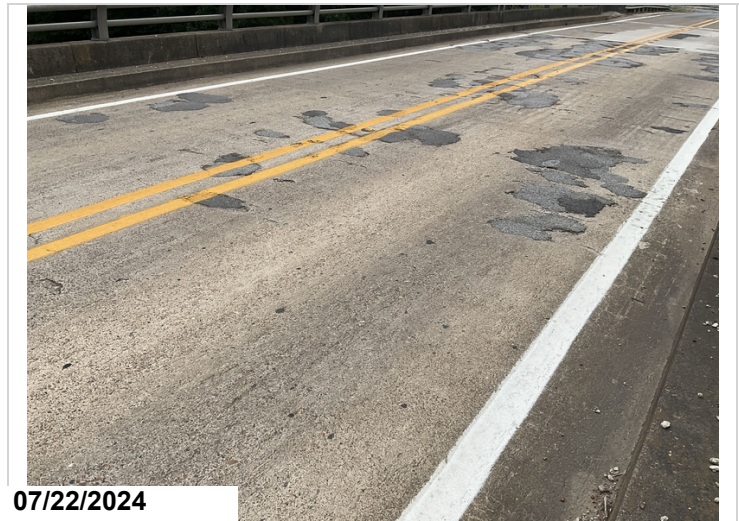
Span 3, spalls, spalls filled with asphalt and patched area.
CS3

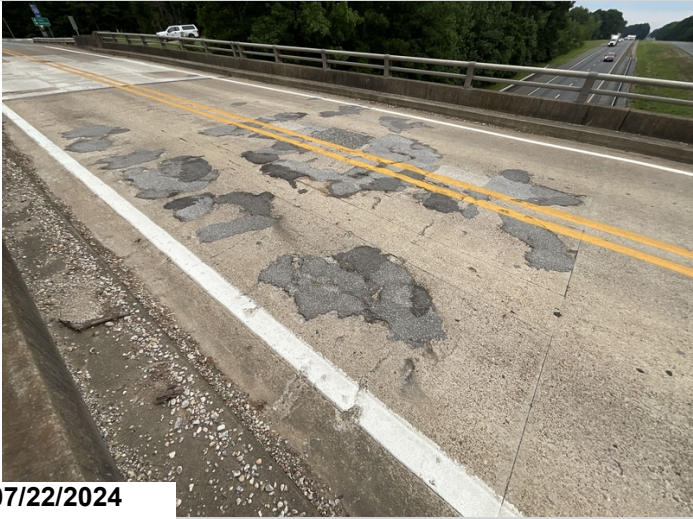
Span 2, spalls, spalls filled with asphalt and patched area.
CS3

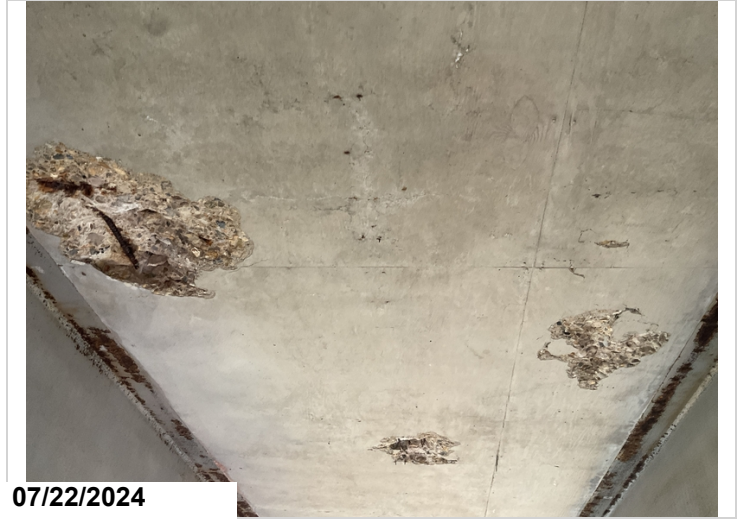
Span 1 bay 1 spalls with exposed rebar on under surface.
CS3

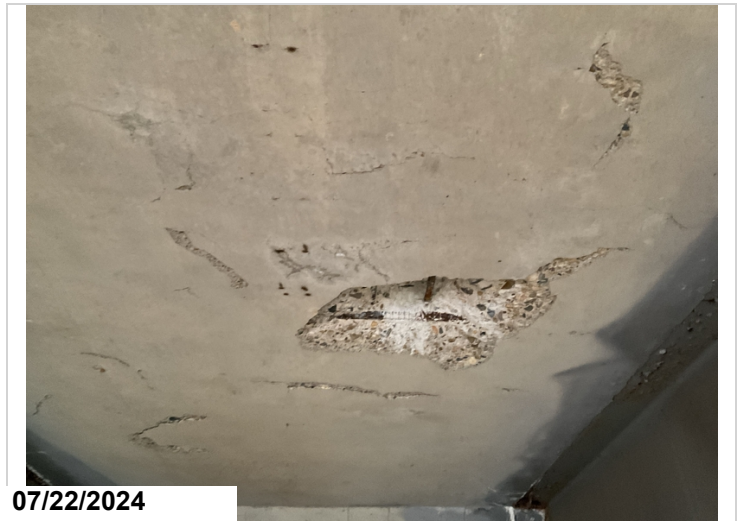
Span 4 bay 4 at bent 5, spall with exposed rebar in under
surface.CS3

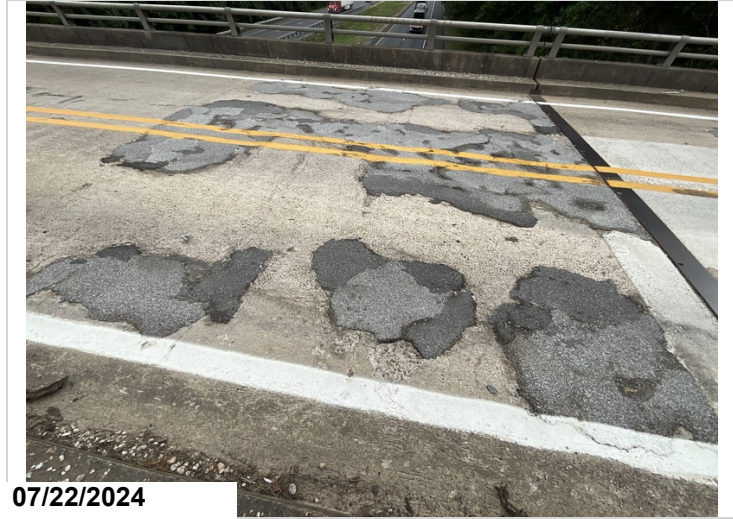
Span 3 at bent 4, numerous spalls filled with asphalt. CS3

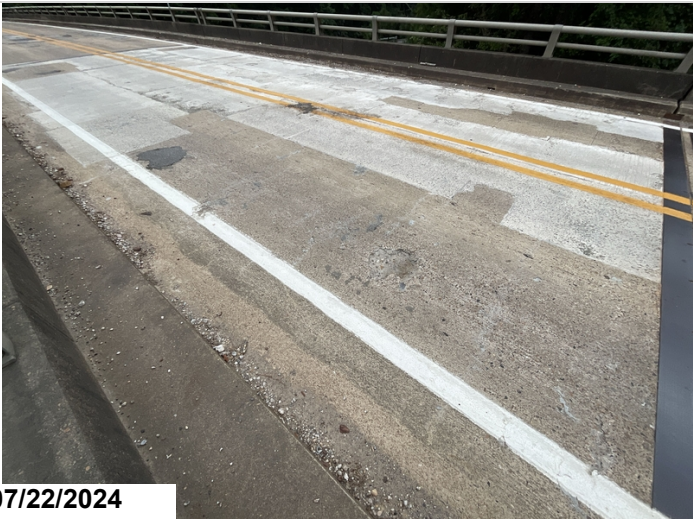
Span 1, spall with exposed rebar, spalls filled with asphalt and patched area. CS2 CS3

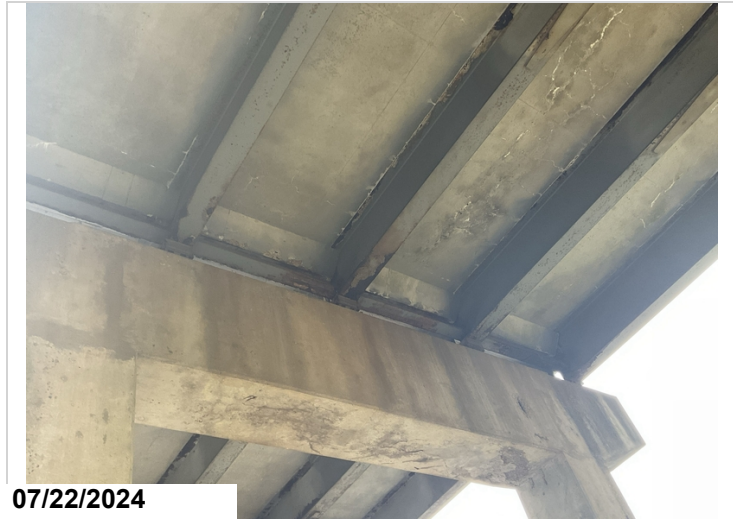
Bent 2, span 1, all girders have measurable section loss to the upper web at the haunch, lower web and bottom flange. CS3

Girder ends need to be cleaned and repainted.

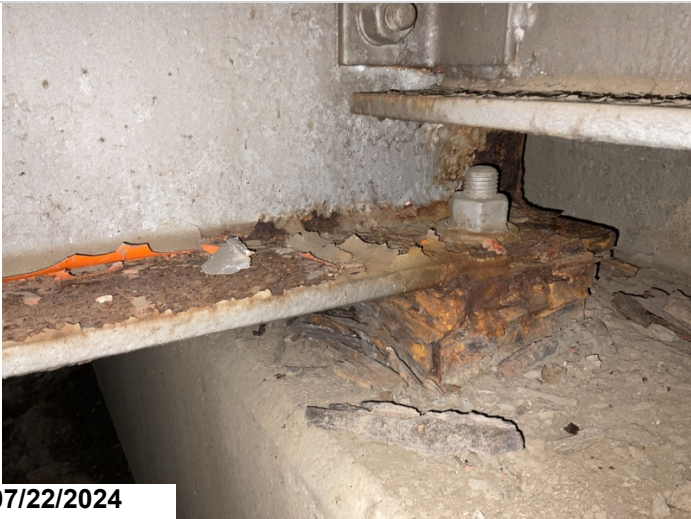
Span 4 girder 2 at bent 5, laminating rust with section loss on girder end. CS3

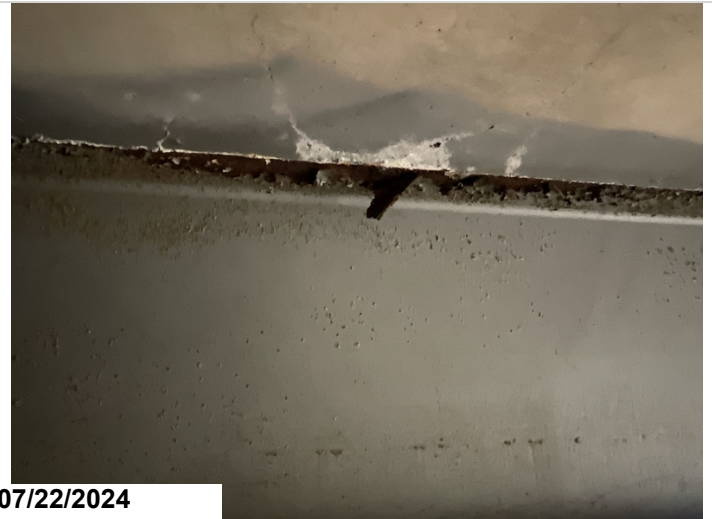
Span 4 girder 3 corrosion with minor section loss to top flange. CS3

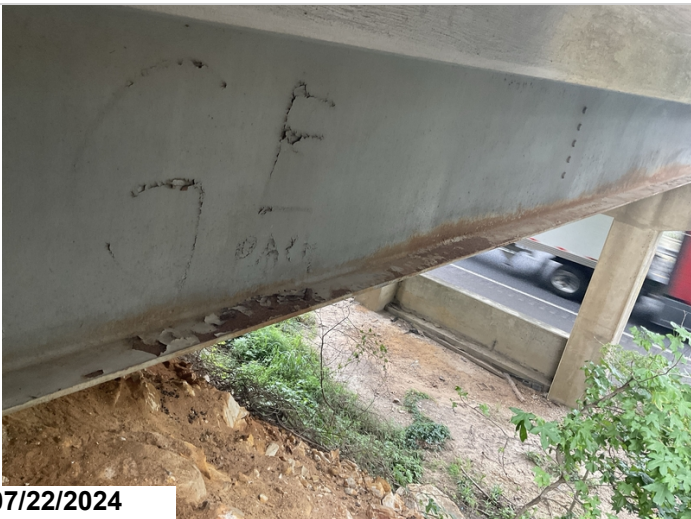
Paint system is failing.

Span 4 girder 1 paint condition

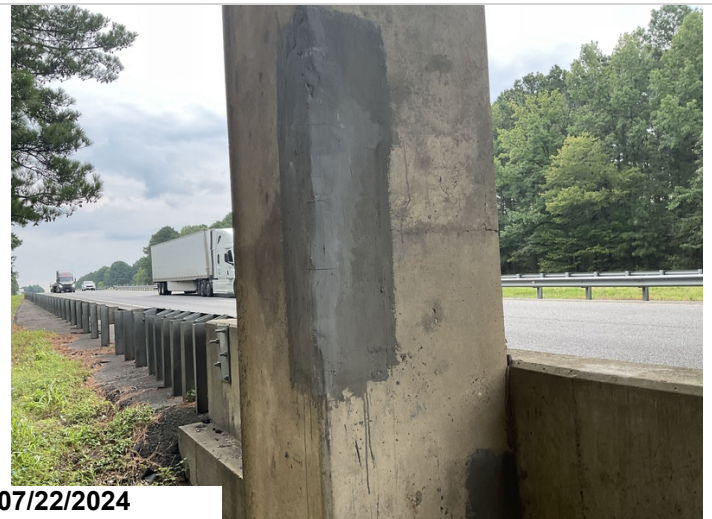
Bent 2 column 1, spalls have been patched. Common column 2. CS2

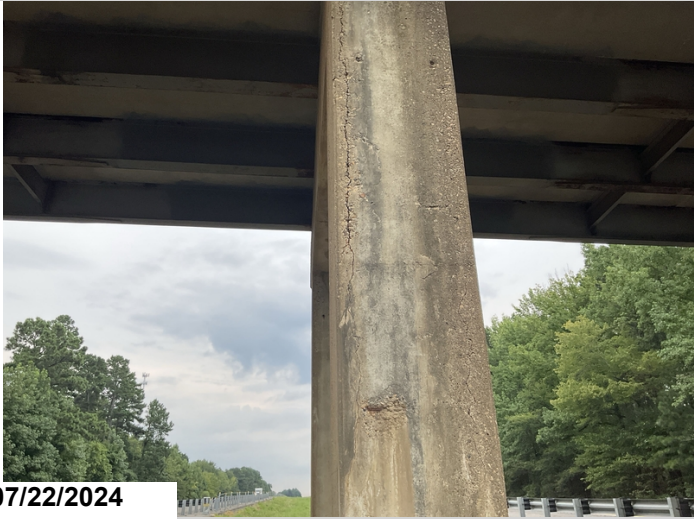
Bent 3 column 2, large crack on corner up to 1/4" and spall with exposed rebar. CS3

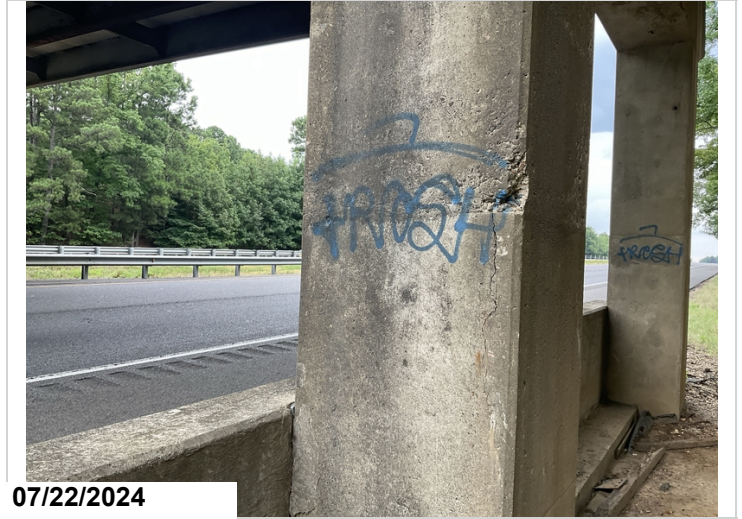
Bent 4 column 2, spall and crack up to 0.060" CS3

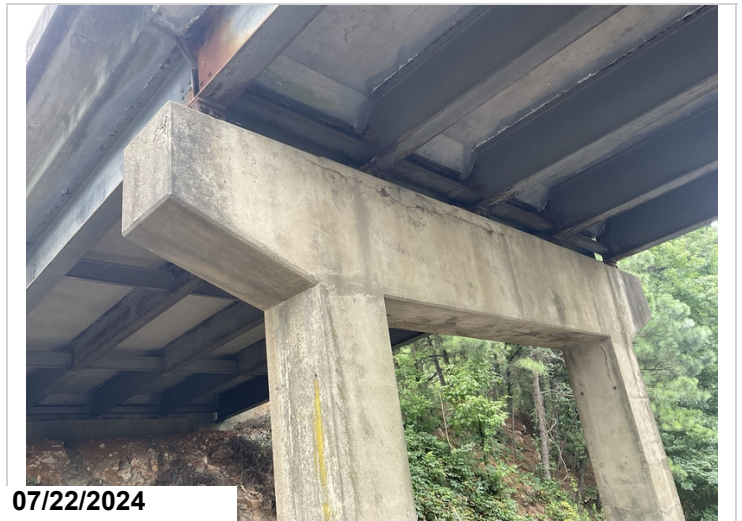
Bent 4 crack on backside. CS3

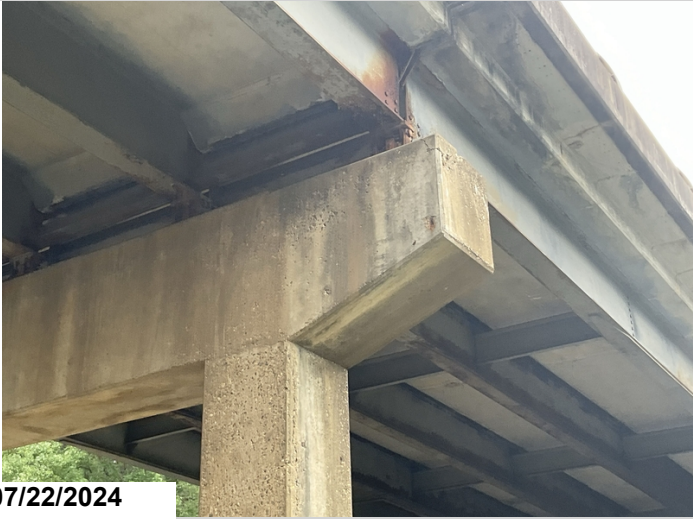
Bent 3 back right corner of cap has a delam. CS2

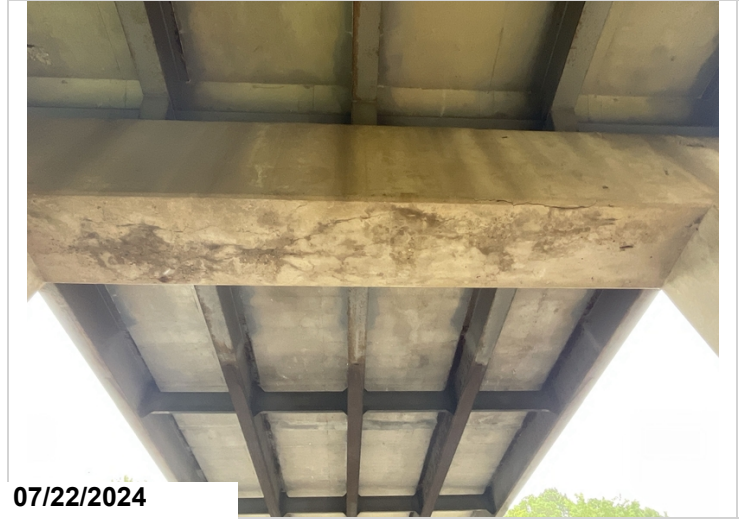
Bent 4 crack in between columns. CS3

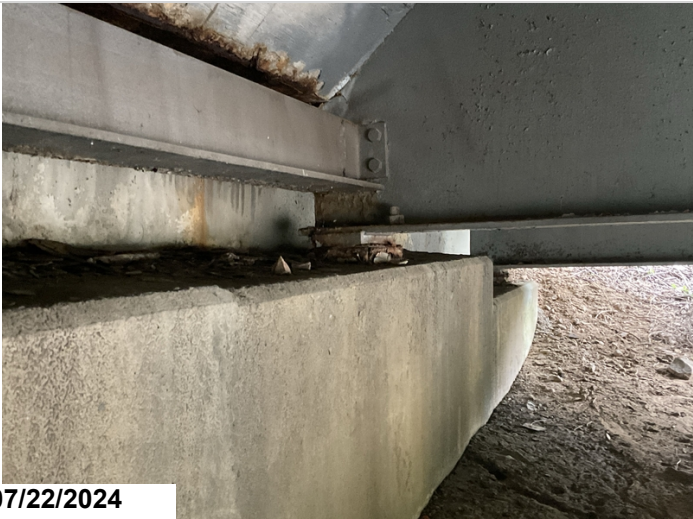
Bent 5 girder 4 has a broken anchor bolt.

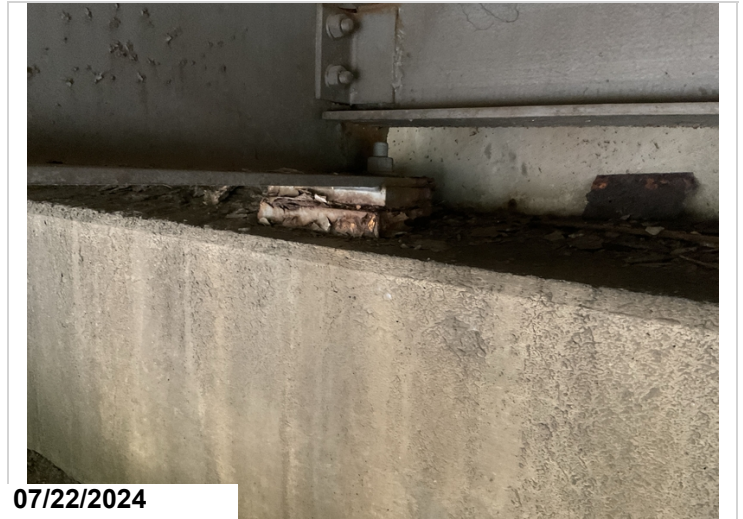
Bent 5 bearing 3, laminating rust. CS3

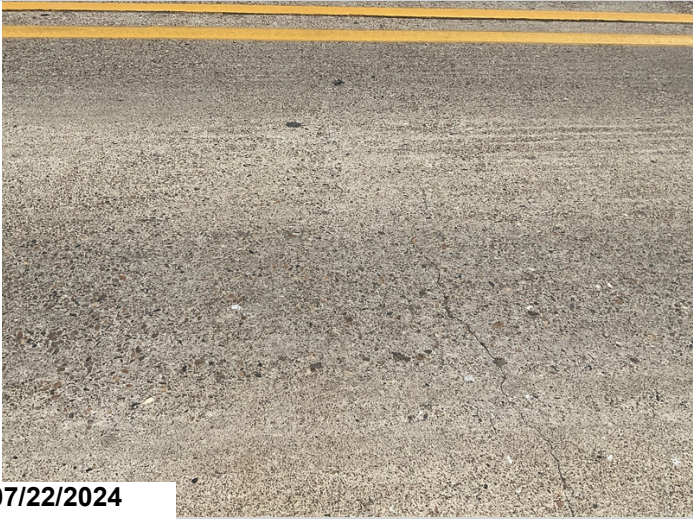
South Approach slab, transverse crack up to 0.070". CS3

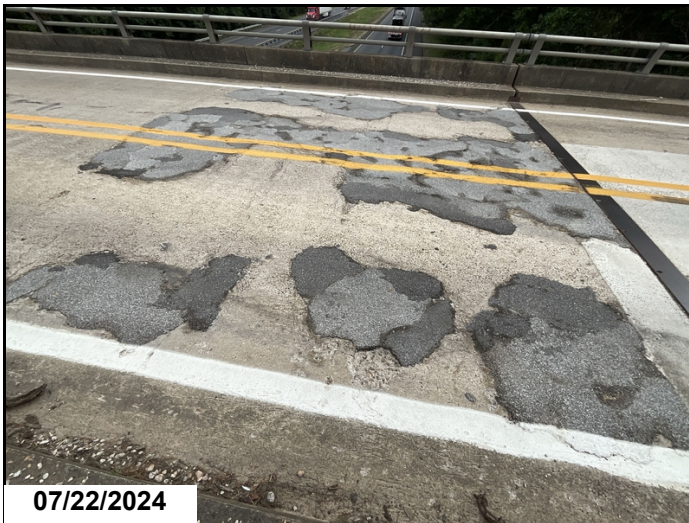
Span 3 at bent 4, numerous spalls filled with asphalt.
CS3

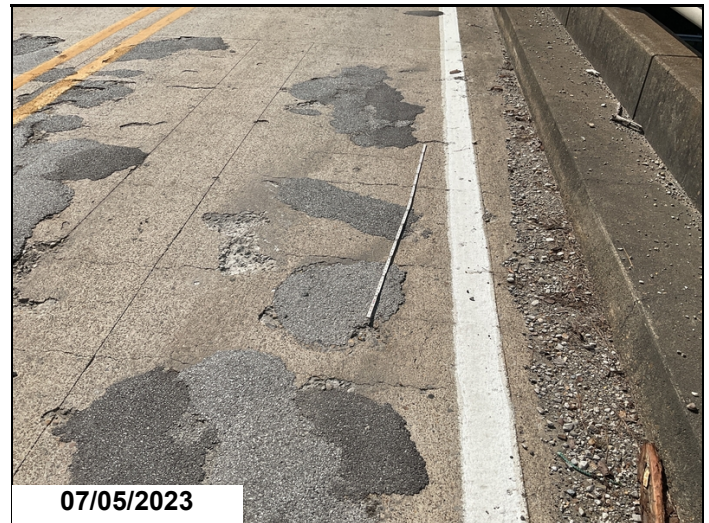
Span 2, right lane: numerous spalls and large unsealed transverse cracks at average 3' spacing. 2023

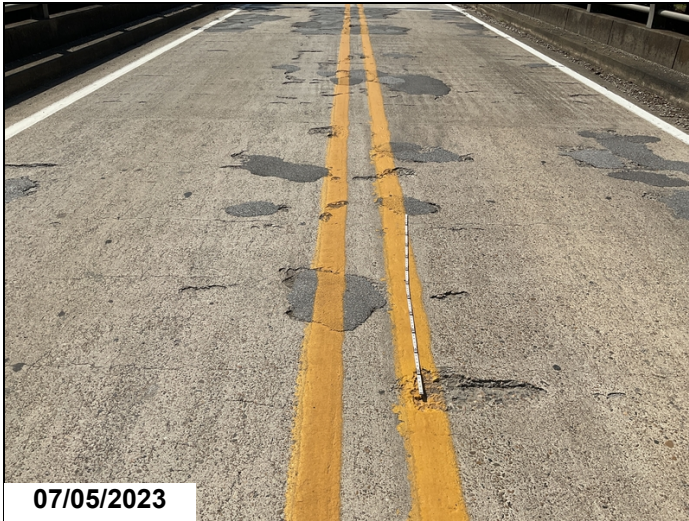
Span 3: numerous open spalls and large unsealed transverse cracks. 2023

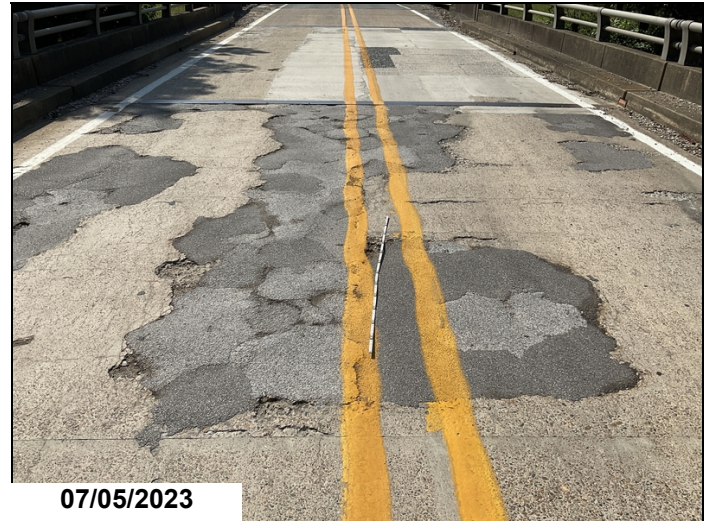
Span 3: Approximately 260sf of spalls filled with asphalt. 2023

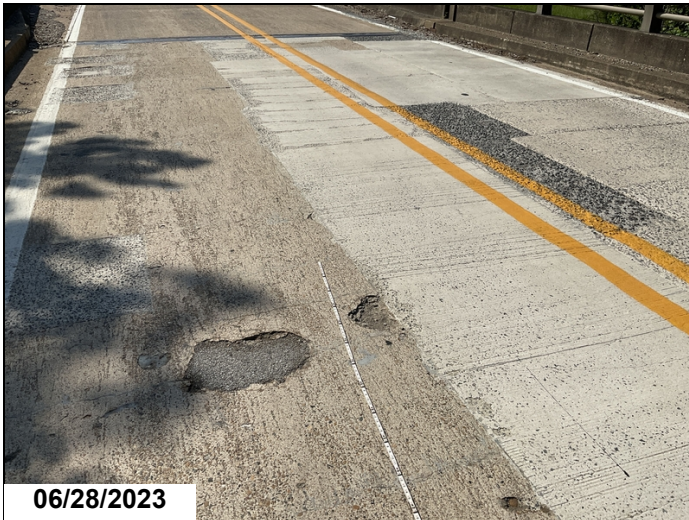
Span 4: couple of open spalls and spalls filled with asphalt. 2023

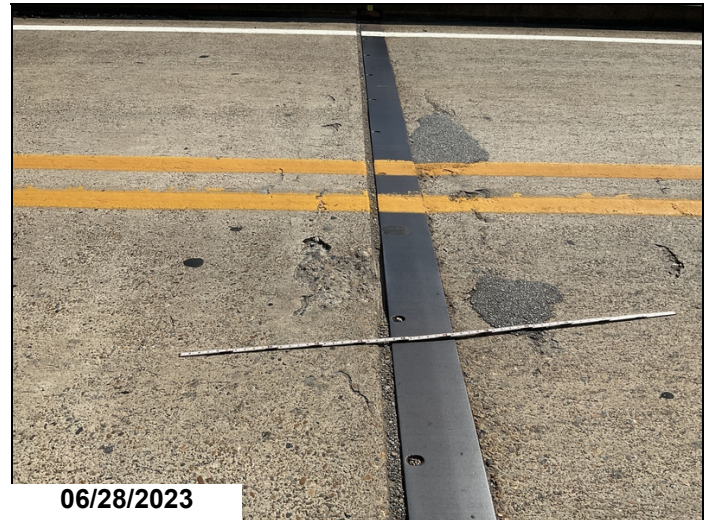
Span 2 at bent 3: spalls adjacent to the joint. 2023

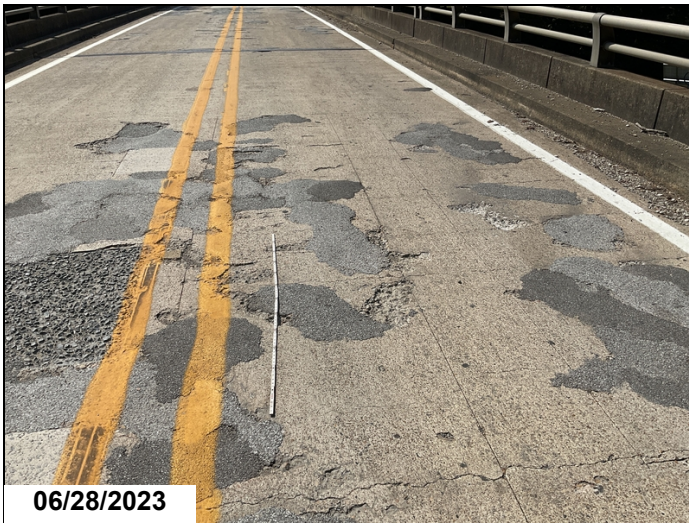
Span 2: numerous spalls filled with asphalt and open spalls.
2023

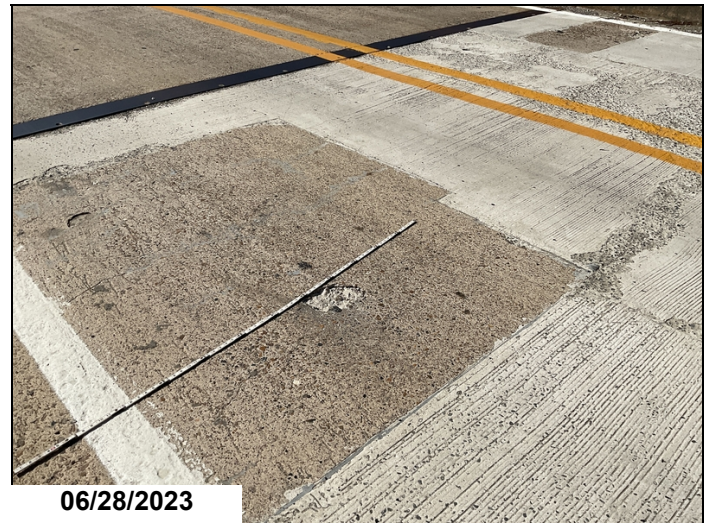
Span 1: small open spall in the right lane.
2023

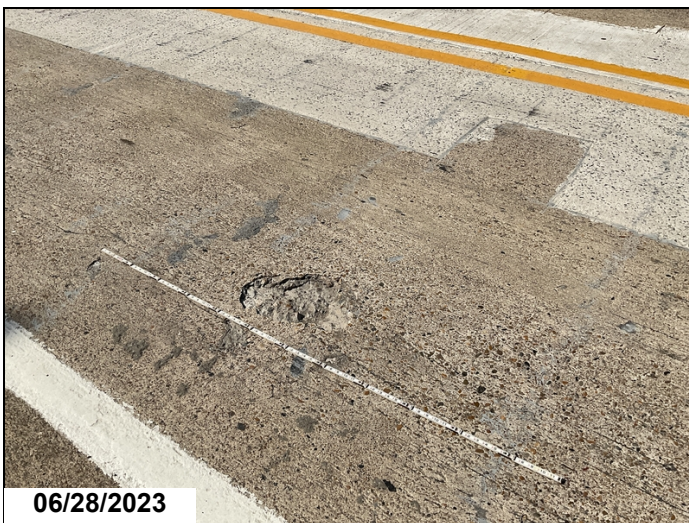
Span 1: open spall
2023

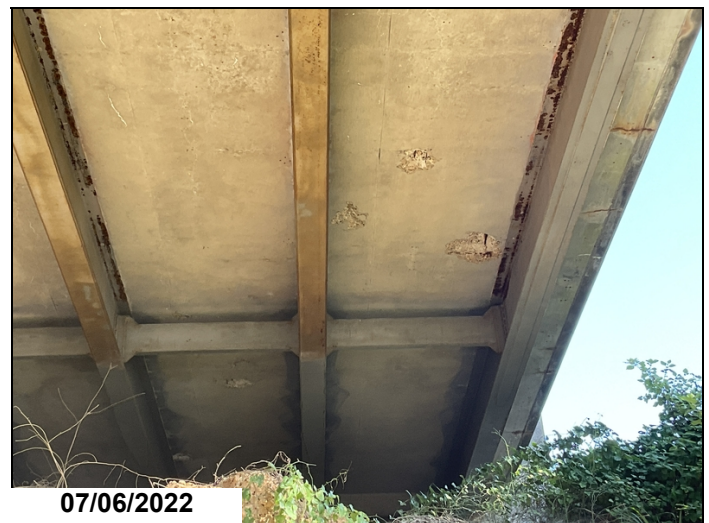
Span 1: few spalls in the soffit

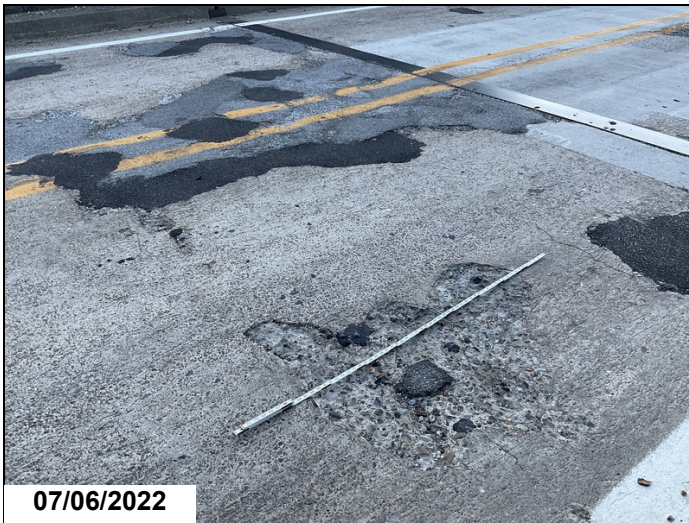
Span 3: couple of large open spall in the travel lane.
2022

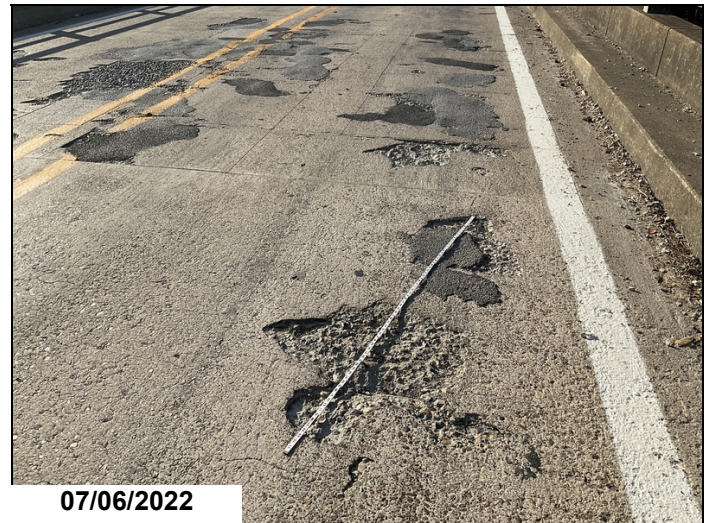
Span 2: Multiple large open spalls. 2022

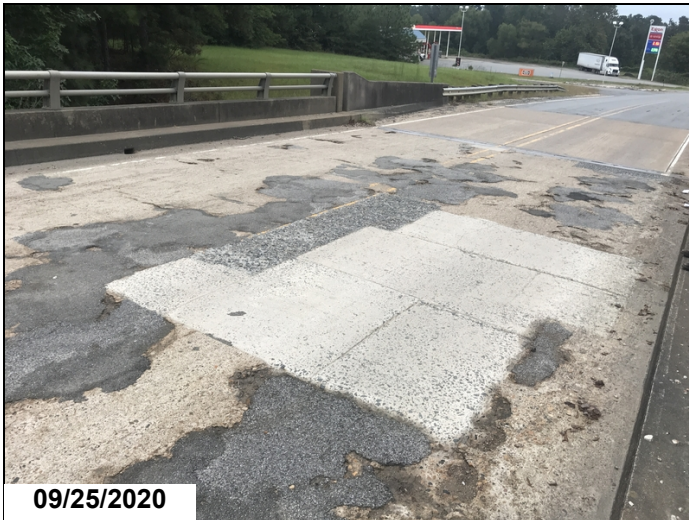
Span 4 deck has spalls and spalls filled with asphalt.

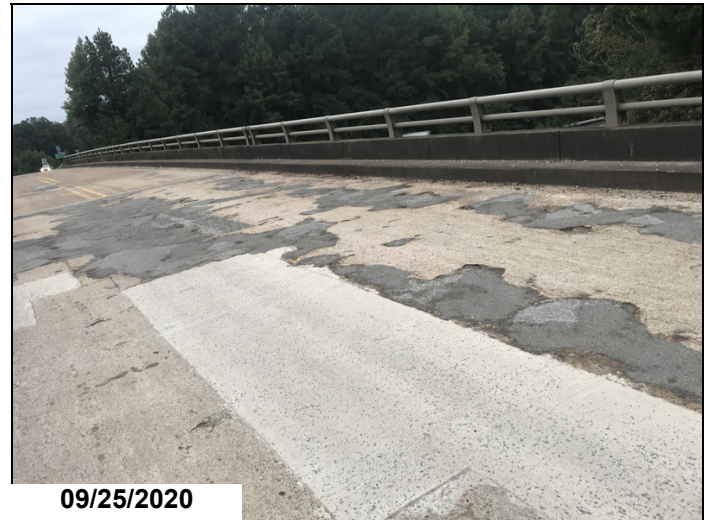
Spalls and spalls filled with asphalt in deck span 1.

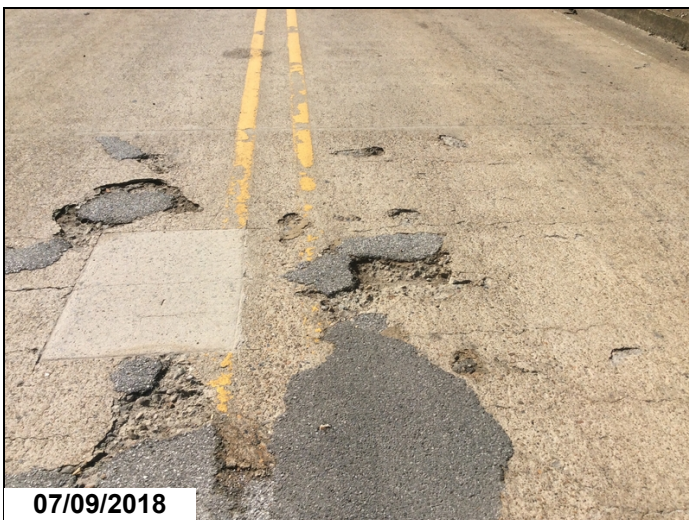
Span 3 right lane spall with exposed reinforcing steel.

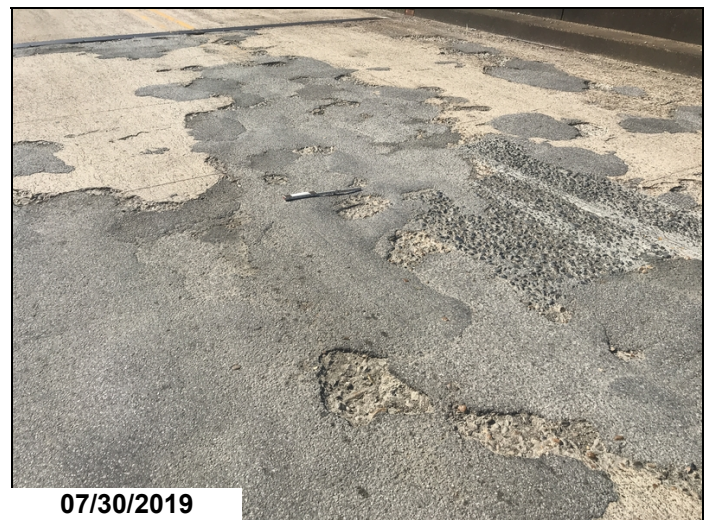
Span 1 has large spalls, spalls with asphalt and spalls
with rebar

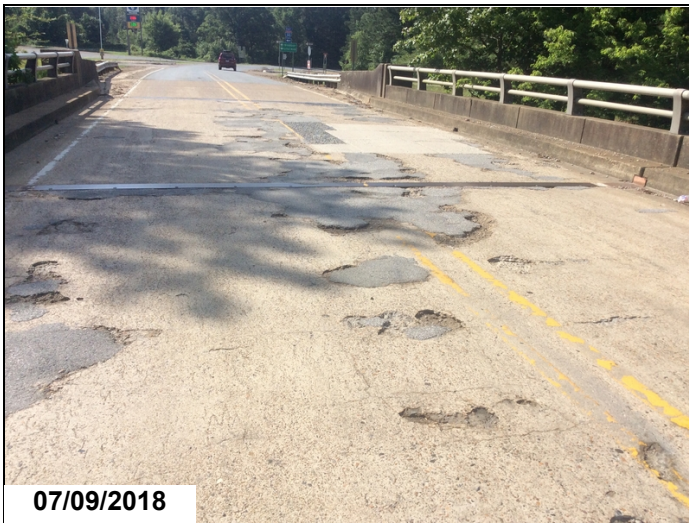
Span 3 failed asphalt patches.

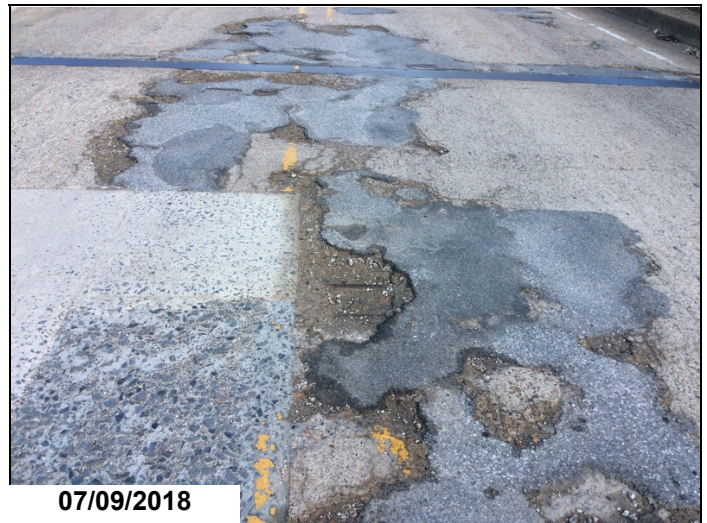
Span 4 spall with exposed reinforcing steel at center line.

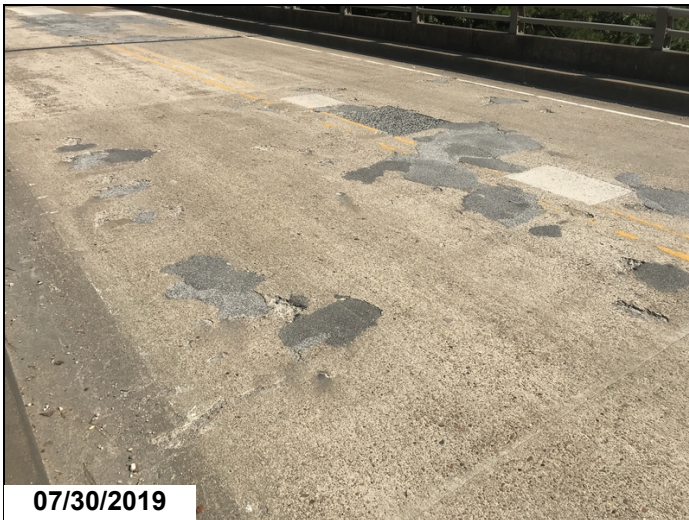
Span 2 has large spalls filled with asphalt and large patched areas

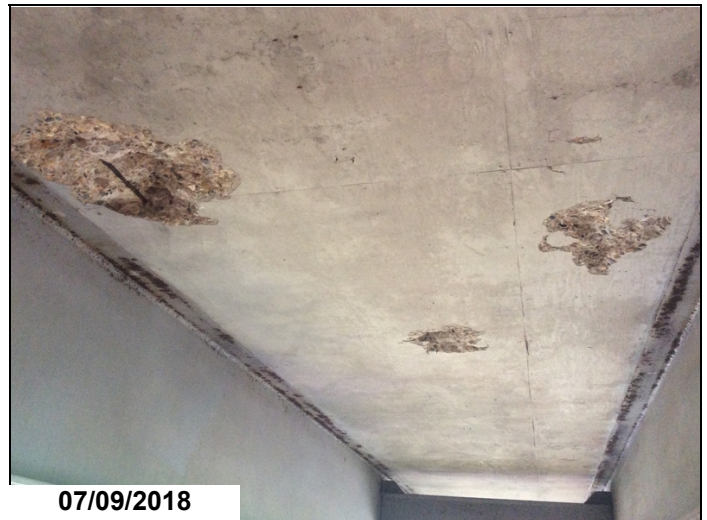
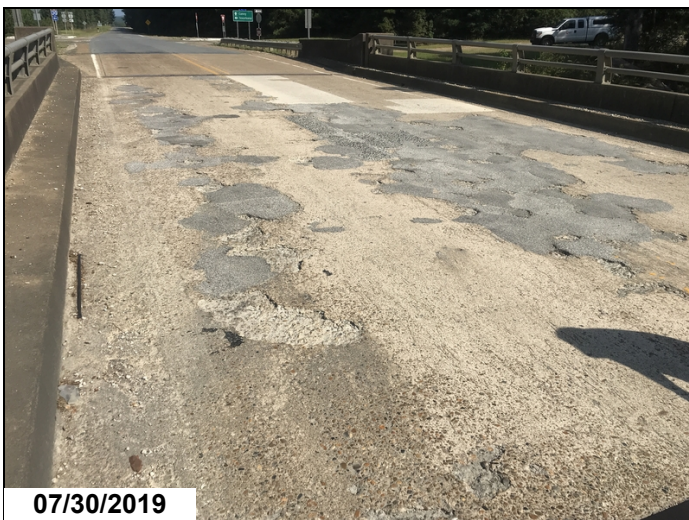
Span 1 has large spalls, spalls with asphalt and spalls with rebar

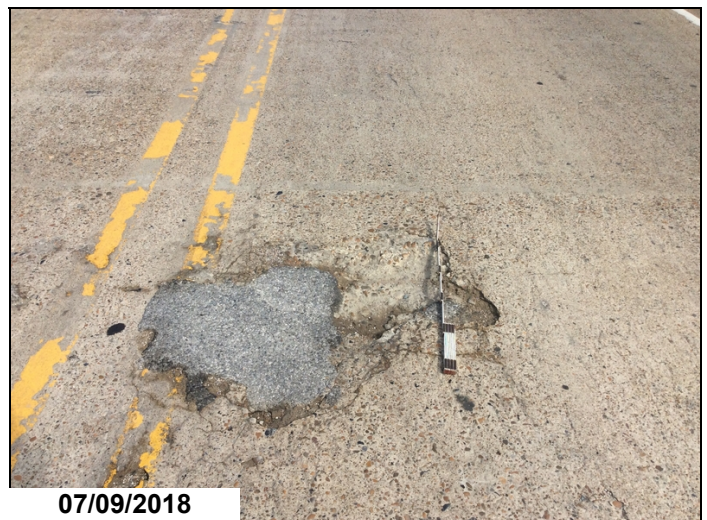
Span 3 has 6' of spall with exposed reinforcing steel at center line.

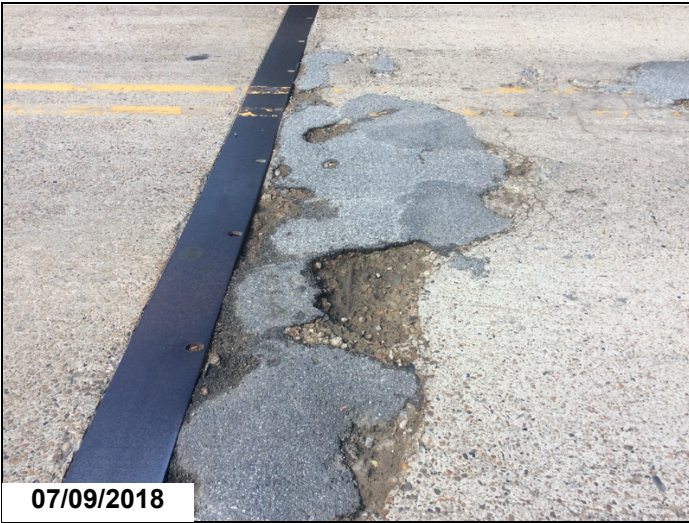
Span 1 left lane spall with exposed reinforcing steel.

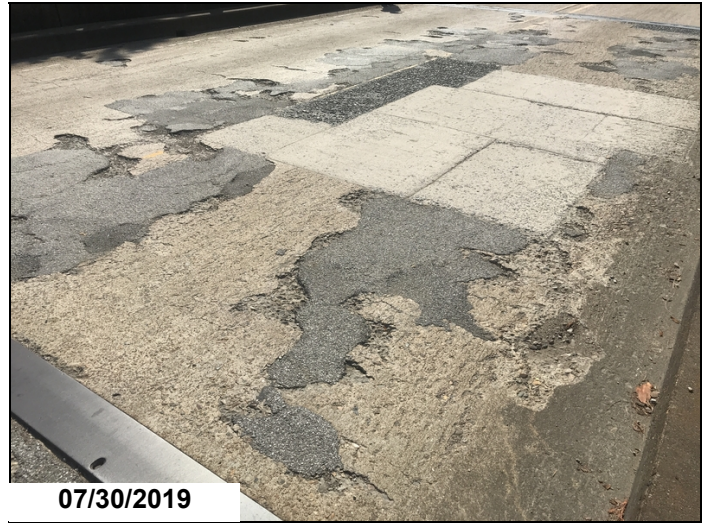
Span 4 has large spalls, spalls with asphalt and large patched areas

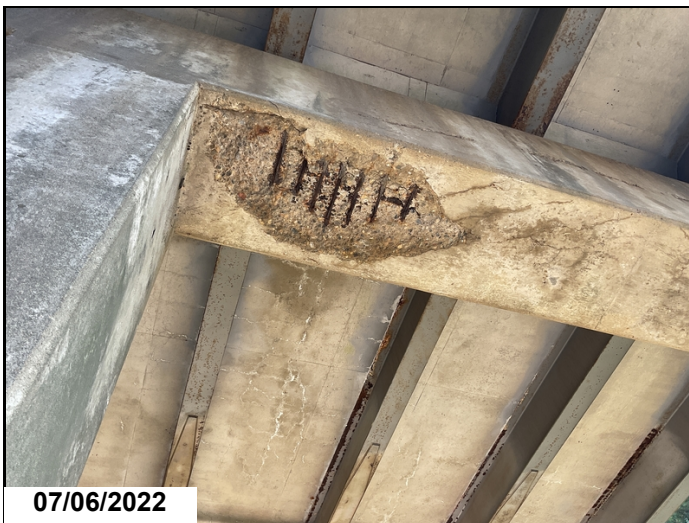
Bent 2: large spall with exposed rebar at the bottom of cap.

Spall has been patched by state forces.

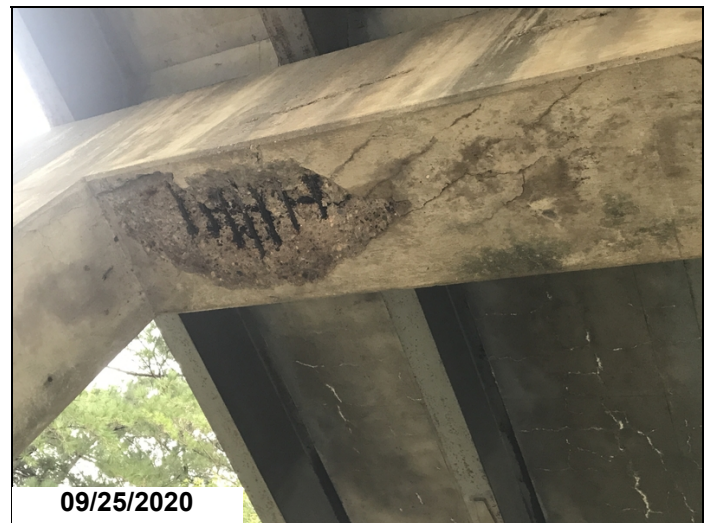
Bent 2 cap bottom has spall with exposed rebar.

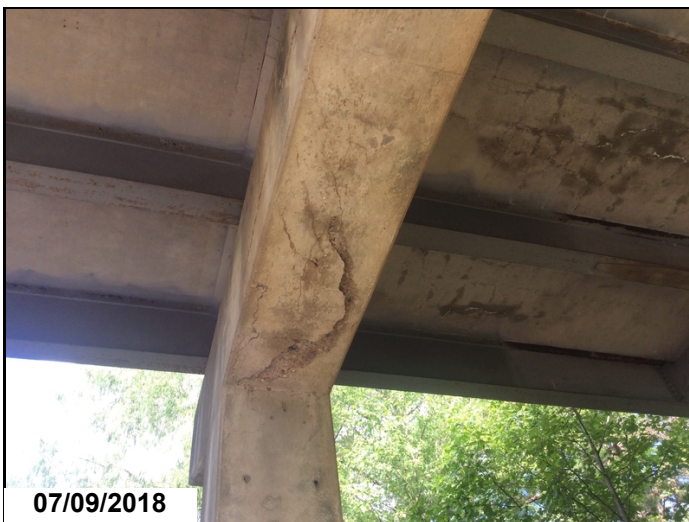
Large spall and delaminated area at bent 2 underside of cap.

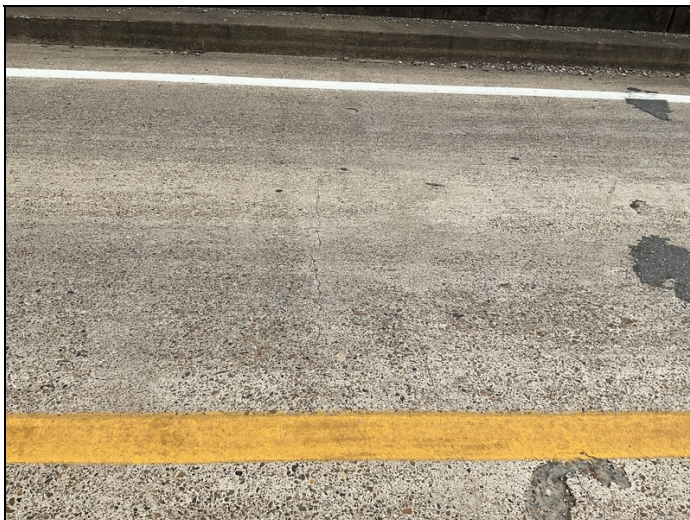
Span 2 unsealed transverse cracks up to 0.080". CS3

A-54 - Sealable Deck Cracks (Yes)

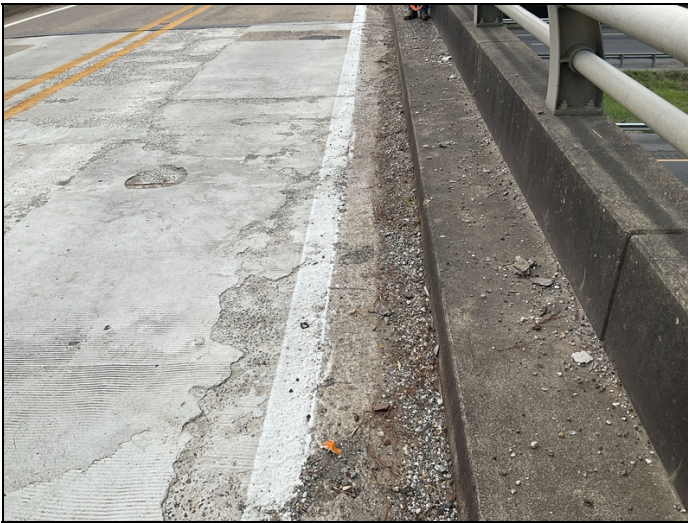
Both shoulders have debris

A-55 - Deck Washing Needed (Yes)

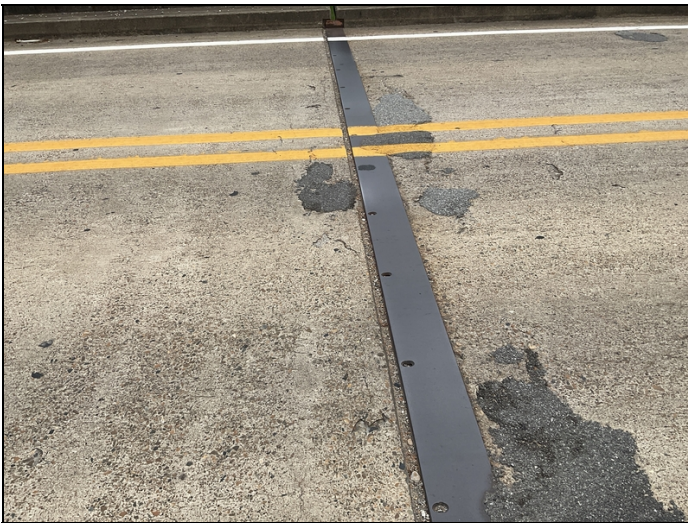
Bent 3, joint is half full of debris

A-56 - Joint Cleaning/Flushing Needed (Yes)
