Asset #03130(Routine)

Sh-191/Sec-1/L1.24 over I-40/Sec-52/L-278.20

Location: Jct Sh 191 & I-40

Team Lead: Myron Futrell Inspection Date: 09/27/2022

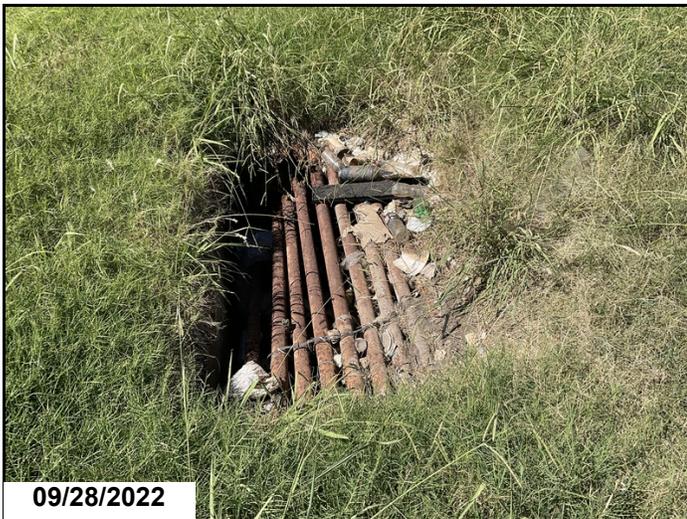
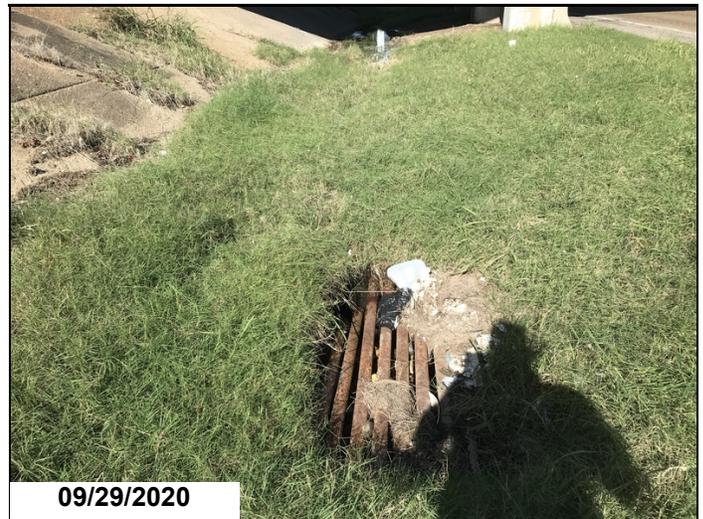
Span #1 just right of bridge ground drain under bridge grate has rusted out and is failing.

Span #1 just right of bridge, ground drain under bridge grate has rusted out and is failing.

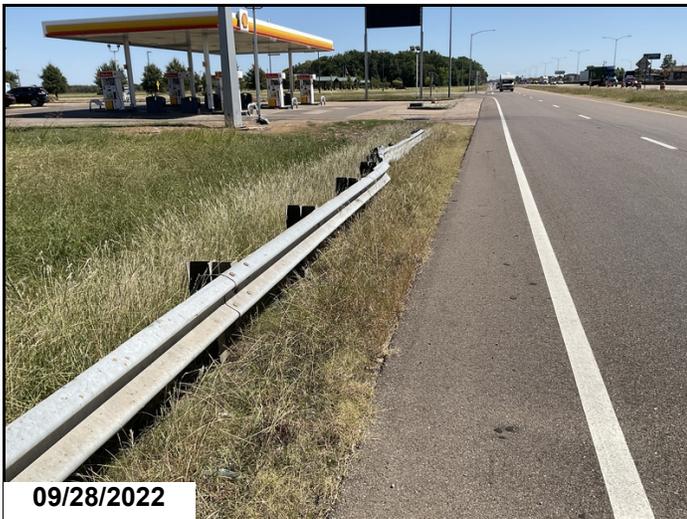
West bound service road right guard rail has collision damage.

West bound service road right approach rail has collision damage

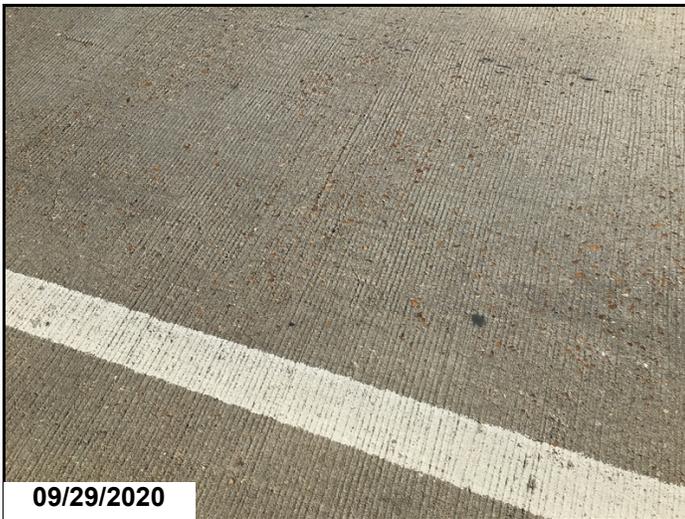
Deck has transverse and longitudinal open cs2 cracks each span five to six feet apart.

Typical deck crack

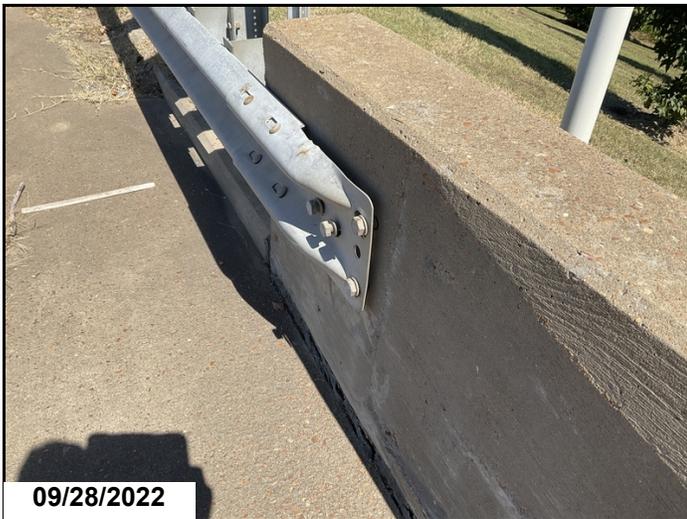
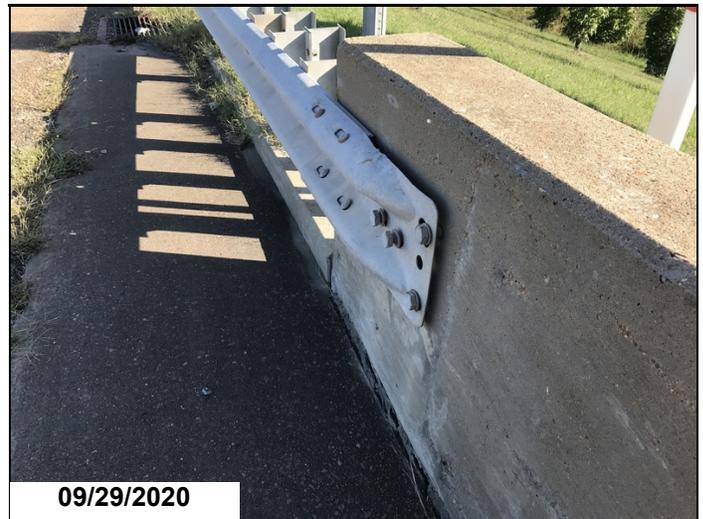
Abutment #2 right approach rail attachment to bridge has several loose bolts.

Loose bolts at abutment #2 right approach rail connection

Abutment #2 rt. approach rail attachment to bridge has several loose bolts.

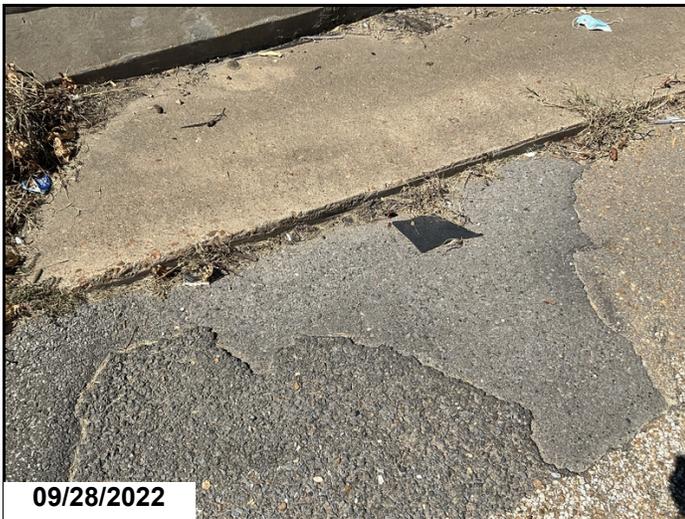
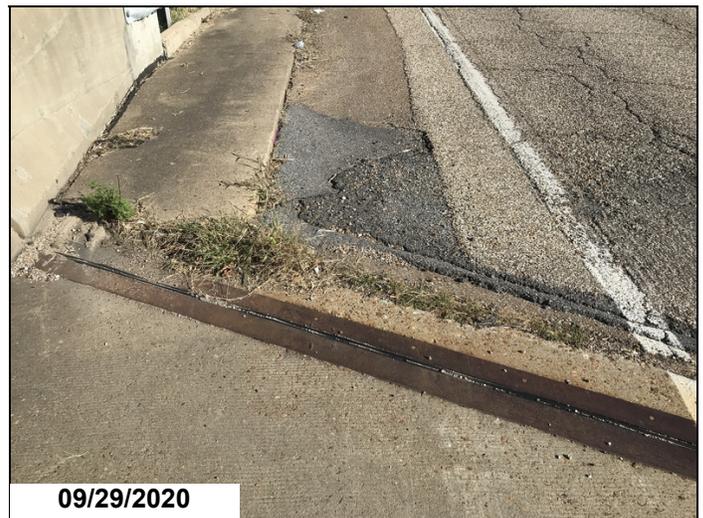
Abutment #2 left and right approach shoulder has settled two inches at bridge end.

Abutment #2 left approach shoulder settlement

Abutment 2 left approach shoulder has settled 2 " at bridge end.

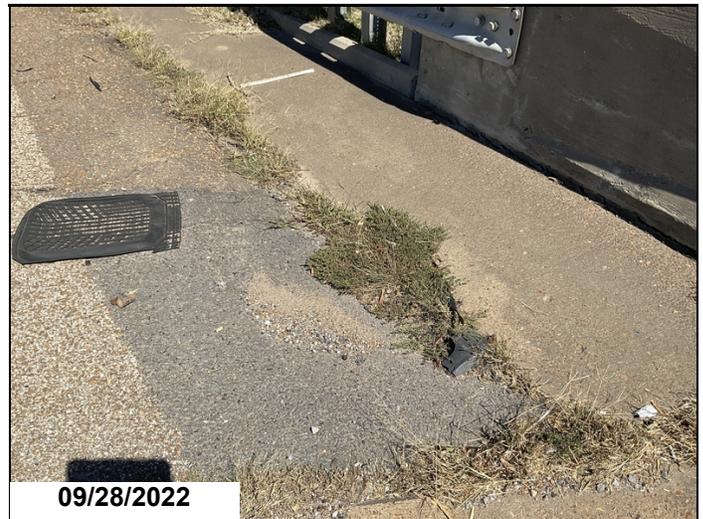
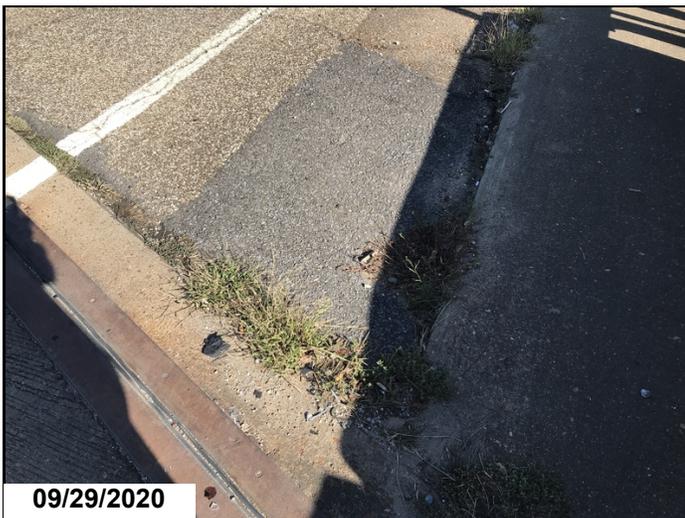
Abutment #2 right approach shoulder settlement

Abutment 2 right approach shoulder has settled 2 " at bridge end.

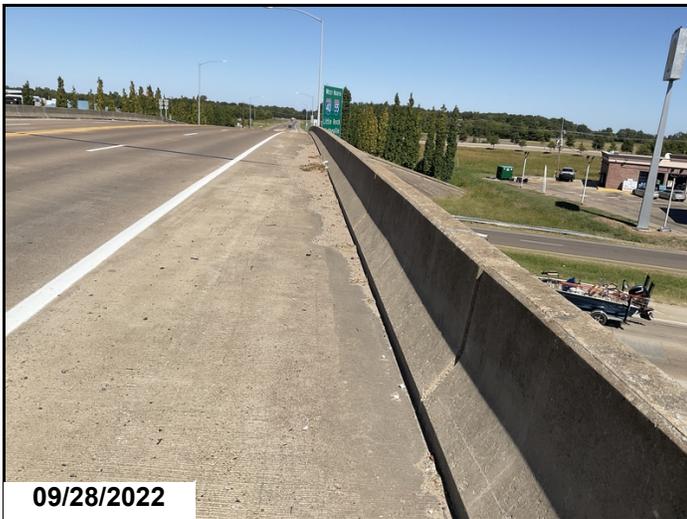
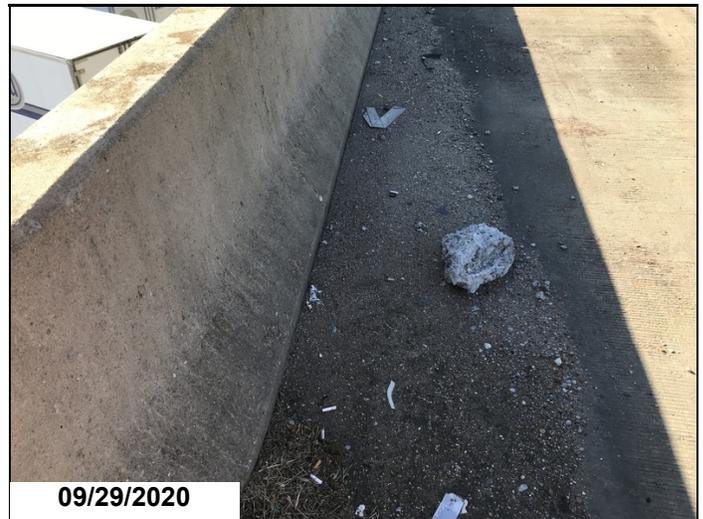
Gutters have dirt and debris in them.

Dirt and debris in gutters

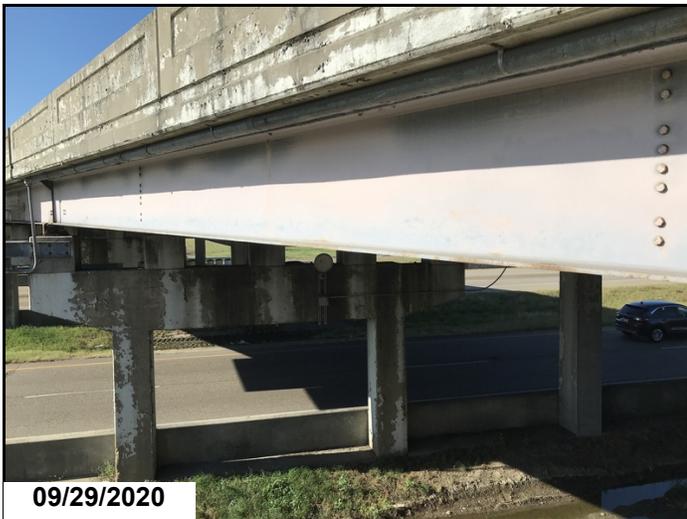
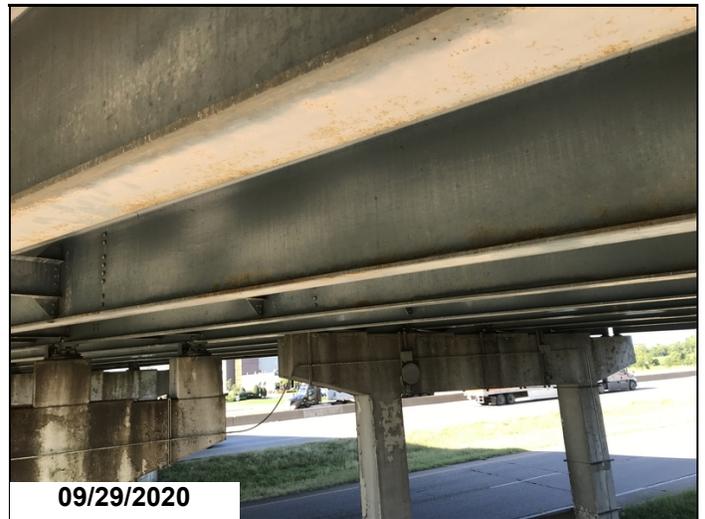
All girders, paint is chalky loss of pigment with spotted rust 10% being bare steel.

Typical outside girder paint condition.

Typical interior girder paint condition

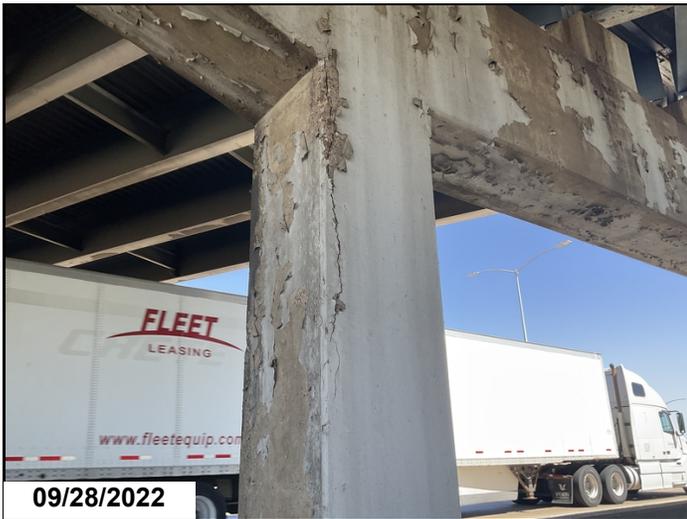
09/28/2022

Bent #3 column #3 left back corner cracked and delaminated for five feet.

Bent #3 column #3 left back corner cracked and delaminated for five feet. Cs3

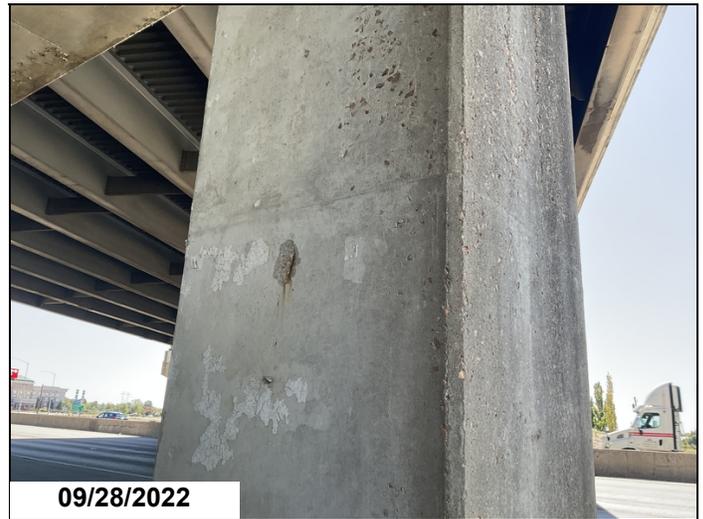
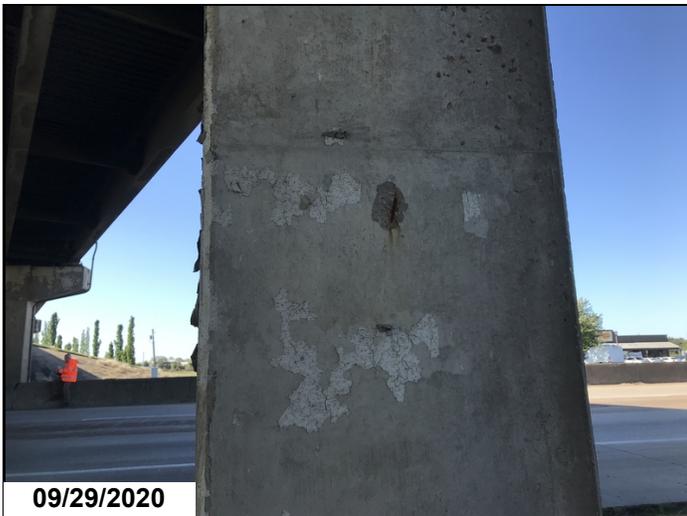
09/28/2022

Bent #5 column #1 has six inch spall with exposed rebar on ahead face six feet up from ground no section loss.

Bent #5 column 1 has 6" spall exposed rebar on front face 6' up from ground no section loss.

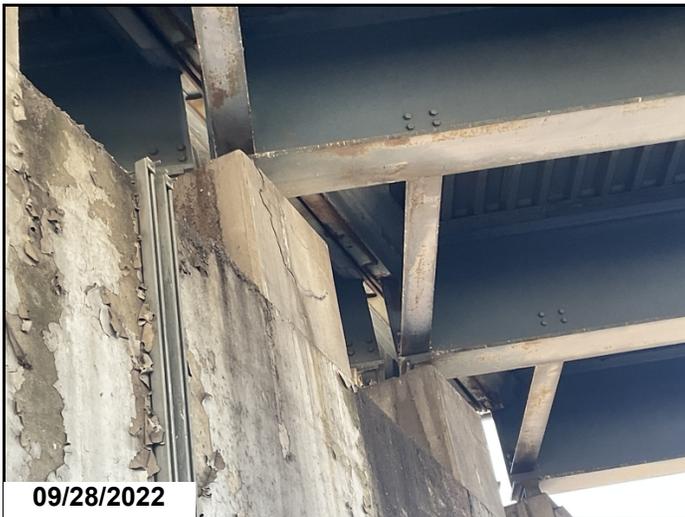
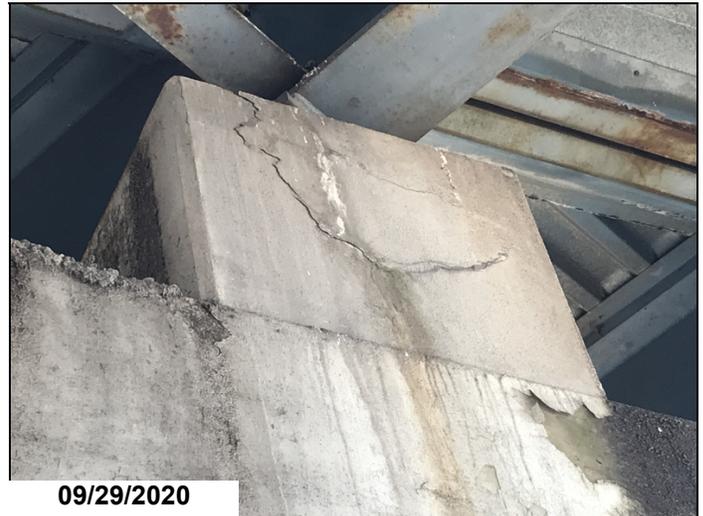
Bent #6 girder 8 riser on back face has two foot delamination.

Bent #6 girder 8 riser on back face has 2' delamination.

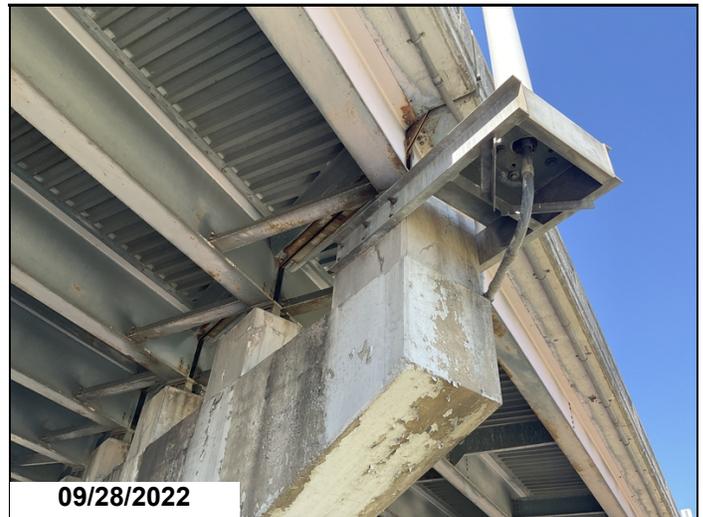
Bent #6 risers under girders #6, 7, #9 and #10 are cracked on back face verticals.

Bent #6 risers under girders #6, #9 and #10 are cracked on back face verticals.

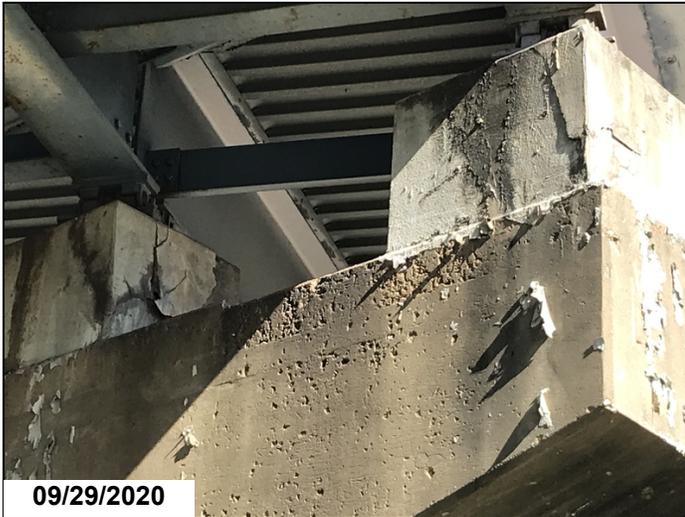
Bent #3 cap back face bearing risers at girders #9,10 on right sides are cracked and delaminated.

Bent #3 cap back face bearing risers girders #9,10 right sides are cracked and delaminated.

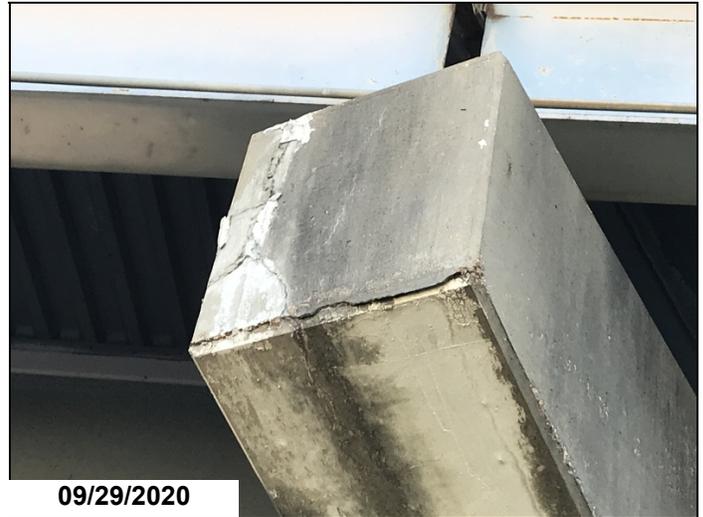
Bent #3 cap lt. end and back face of cap are cracked.

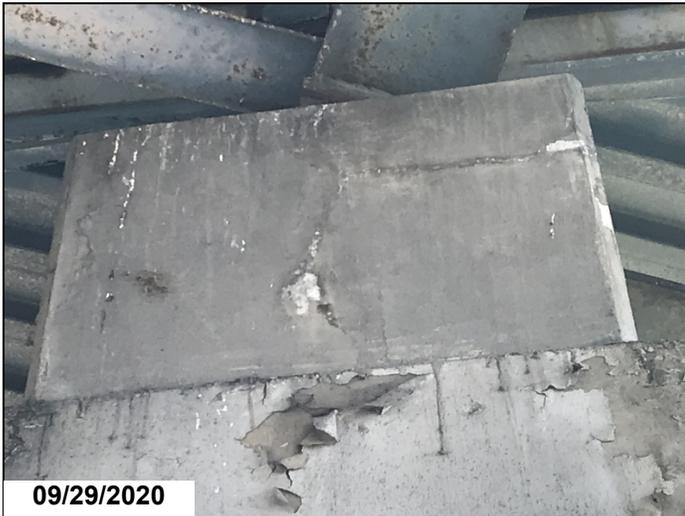
Typical vertical crack on bearing risers.

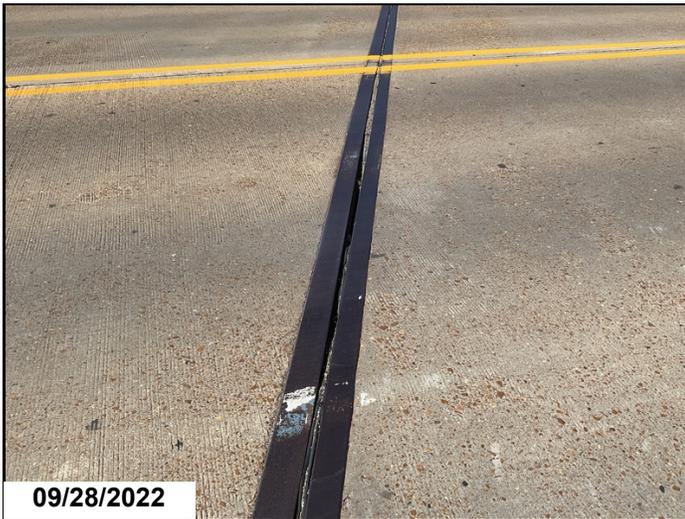
All seals torn and weathered.

Bent #3 joint seal sagging

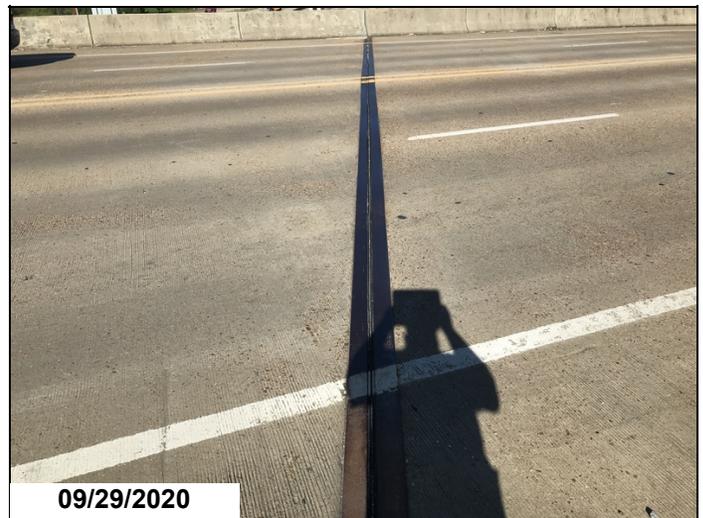
Bent #5 joint has twenty feet in left lane seal has partial adhesion.

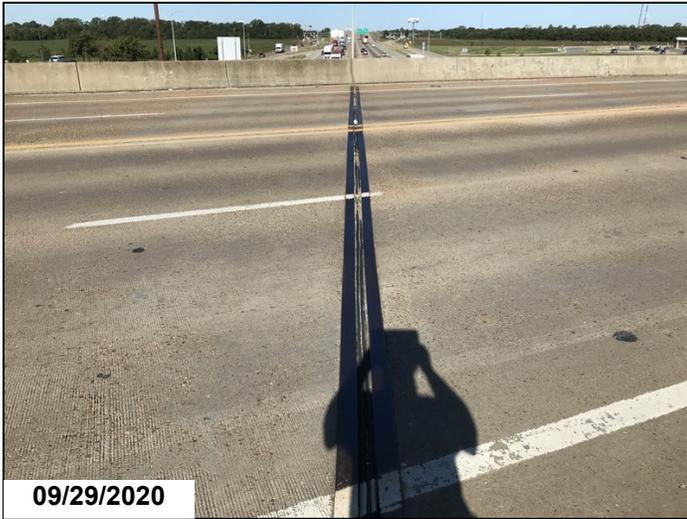
Bent #4 joint seal has eight feet of seal with no adhesion and twenty five feet of partial adhesion.

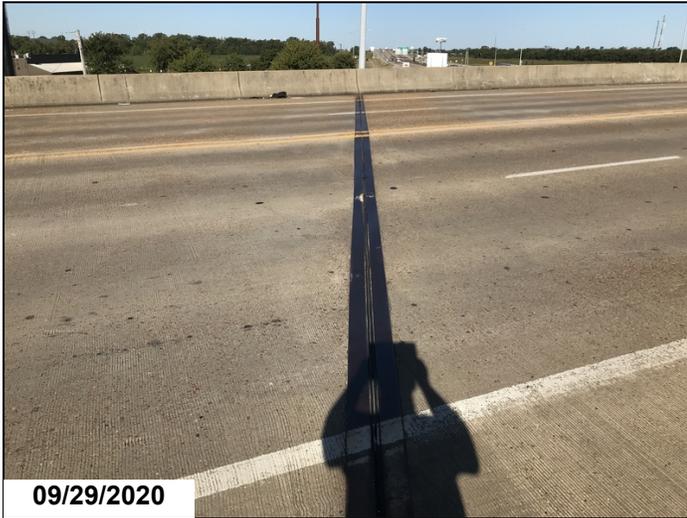
Bent #2 joint seal has lost adhesion for eight feet and is sagging.

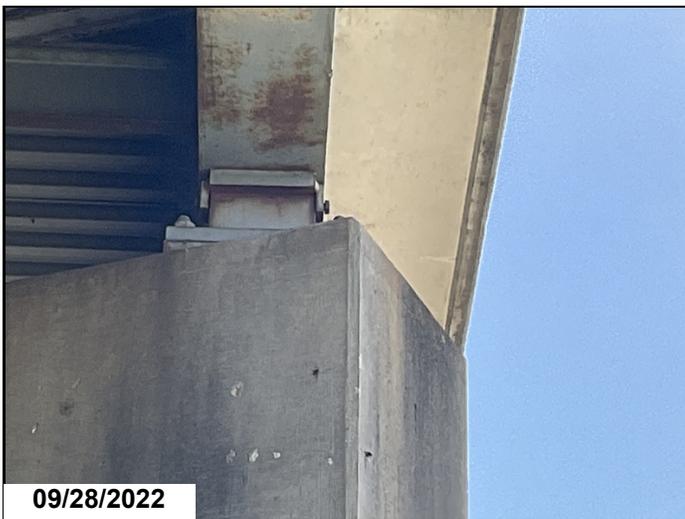
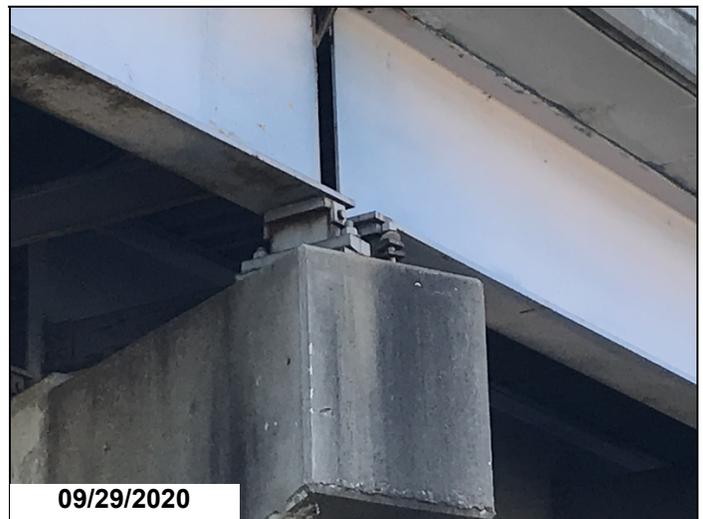
09/28/2022

Movable bearing at bent #5 girder #1 span #5 left side has loose bolt, backed out a quarter of an inch.
Fixed bearing at bent #5 girder #1 span #4 right side has a loose anchor nut.

Movable bearing at bent #5 girder #1 span #5 left side has loose bolt, backed out quarter of an inch.

Bent #5, girder #1 span 5 left side loose bolt backed out 1/4", and in span 4 anchor nut loose.

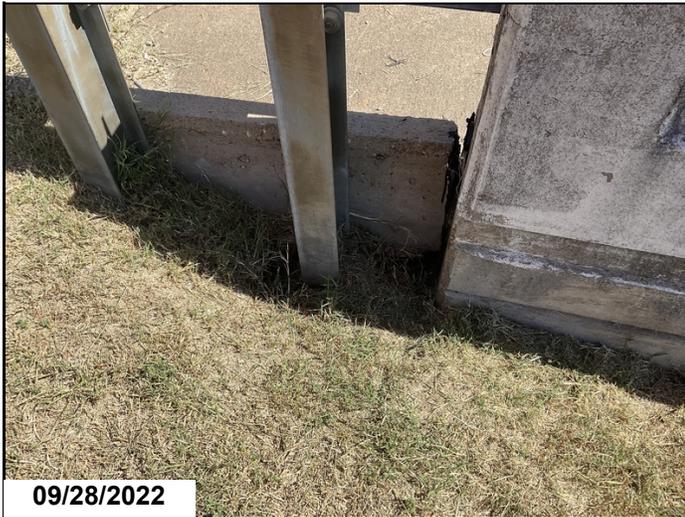
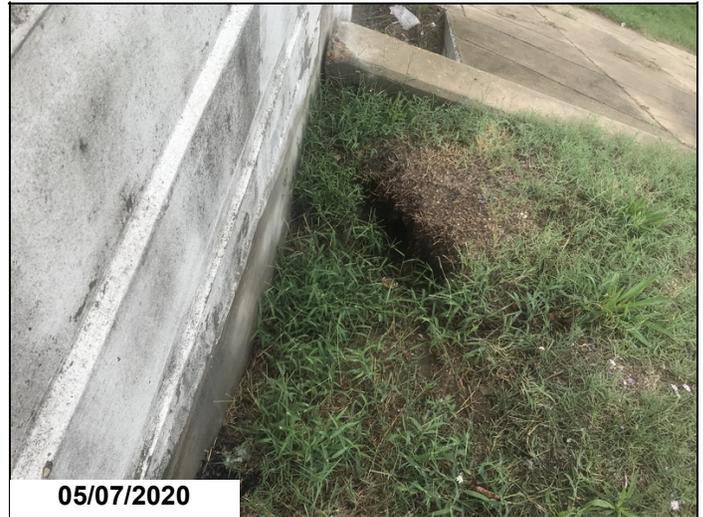
Abutment 2 left side at bridge end and parapet wall has 2' hole.

10/3/2022-Hole has filled in small void left under approach gutter.

Hole at abutment #2 left side

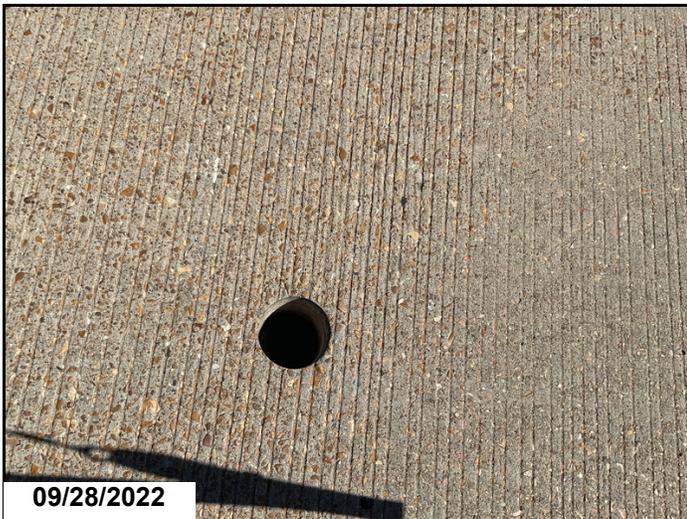
Span #3 left lane has open 3" hole bored through deck.

Span #3 left lane has three inch hole bored through deck
