Asset #05122(Routine, Underwater type 2)

Sh-191/Sec-1/L0.99 over Creek

Location: 0.99 Mile North Jct Sh 70

Team Lead: Drew Melton Inspection Date: 01/08/2024

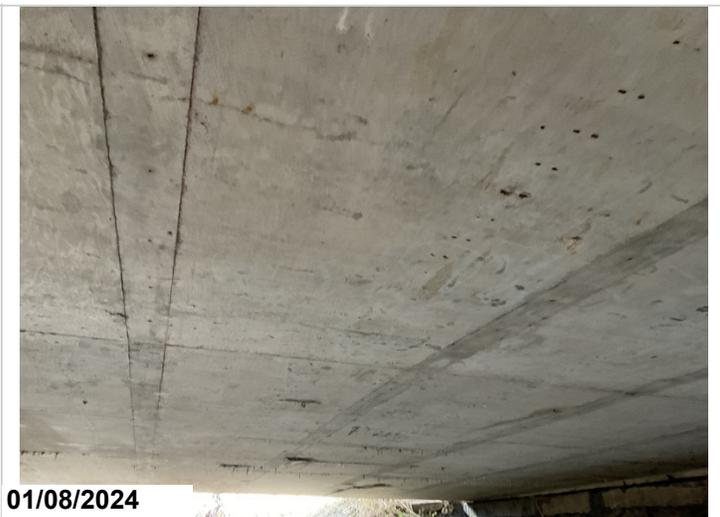
Deck is a slab so deck and superstructure are rated the same. Deck is in fair condition with wide cracks, and some repaired areas. Soffit-under surface has cracks with rust stains, spalls with exposed rebar and some delaminated areas.

Typical soffit under surface

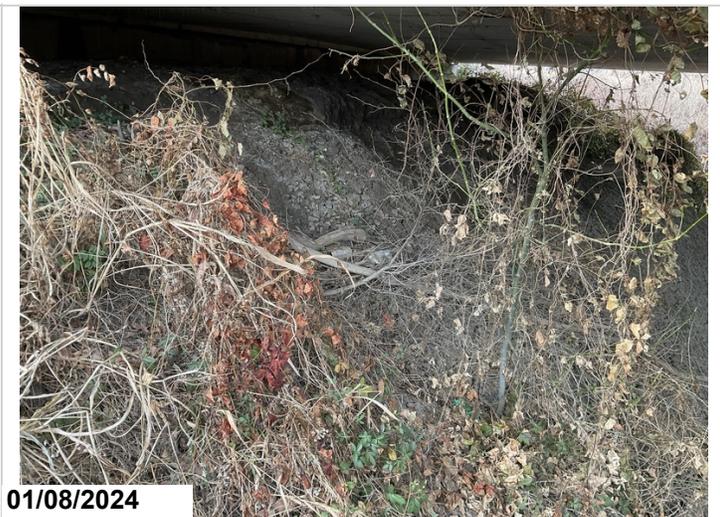
Abutment #1 slope has some erosion veins running down slope up to 2' deep.

Abutment #1 slope

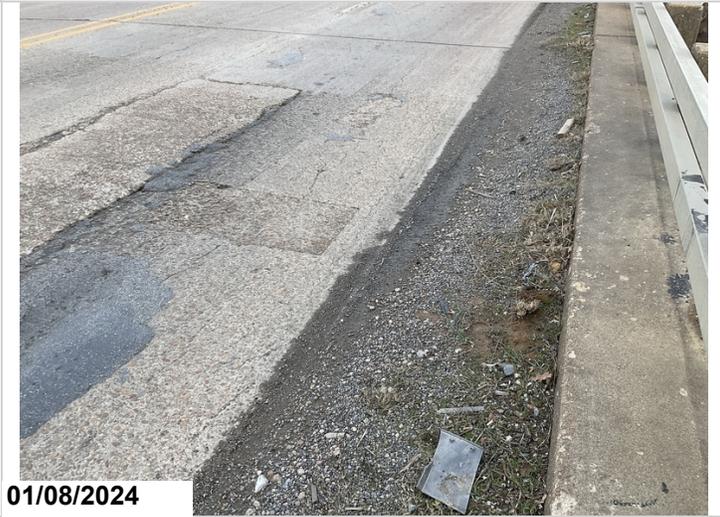
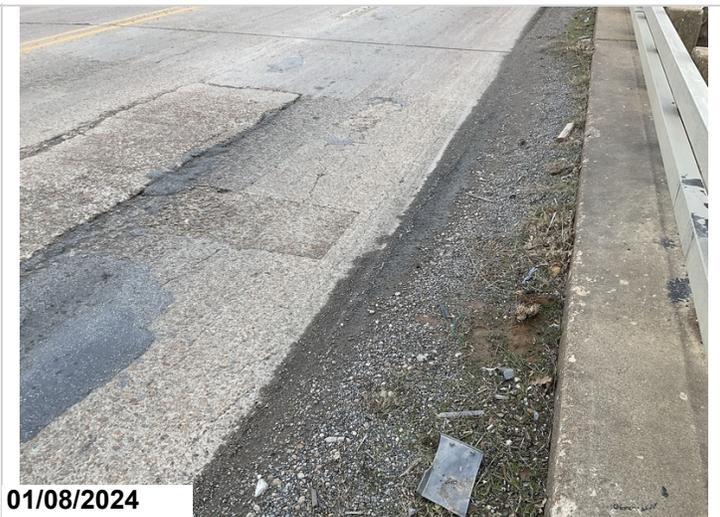
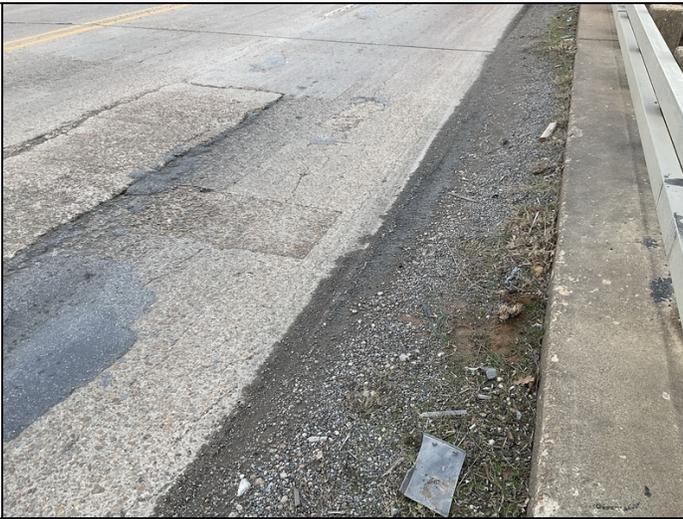
Gutters have dirt and debris.

Typical debris in gutters

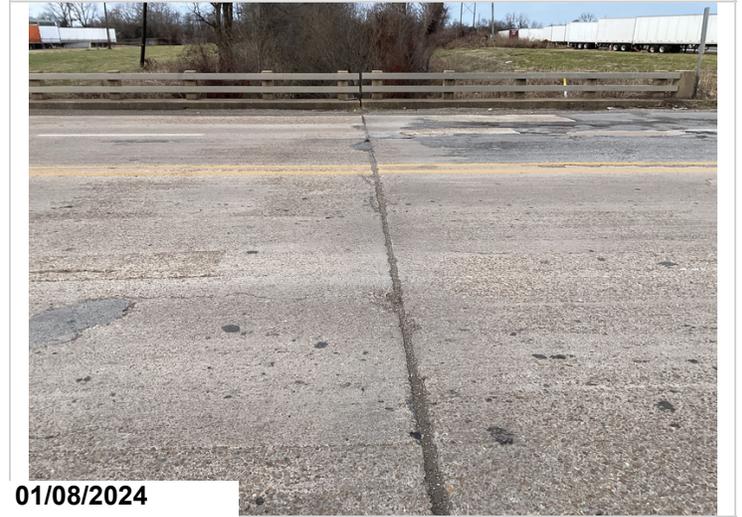
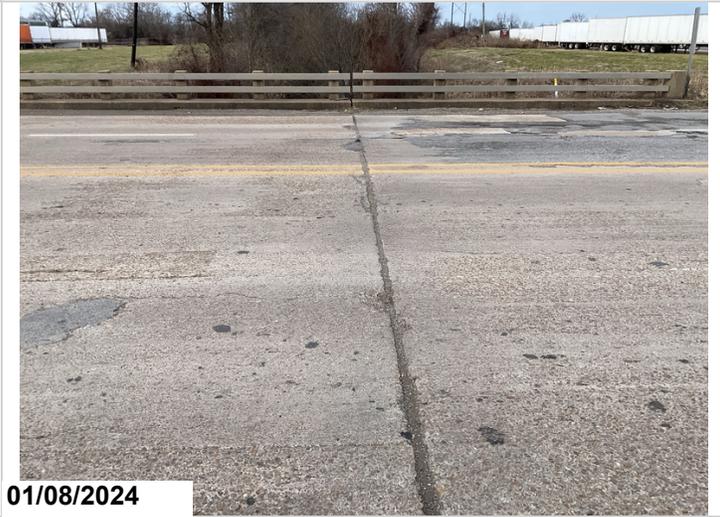
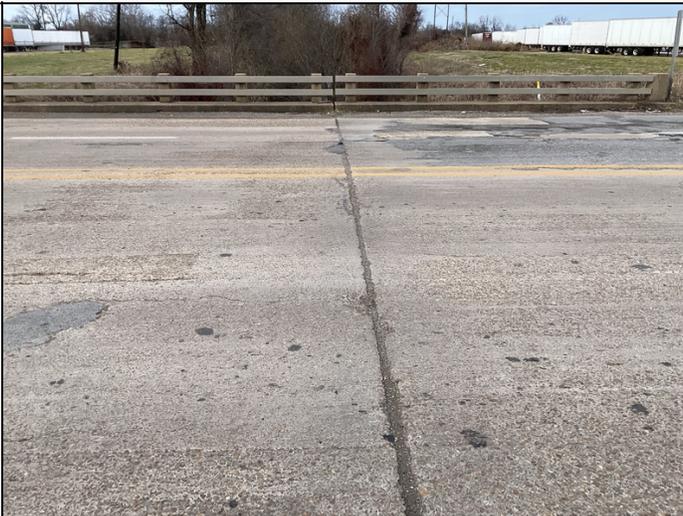
All deck joints are full of non-compressible material.

Typical joint

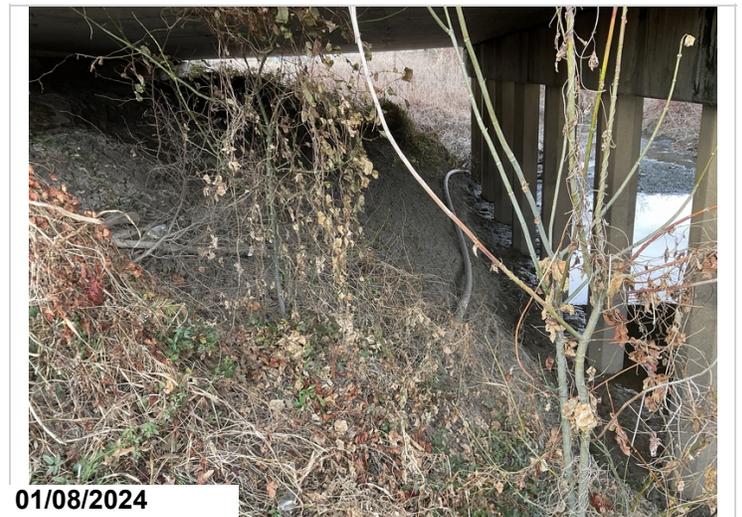
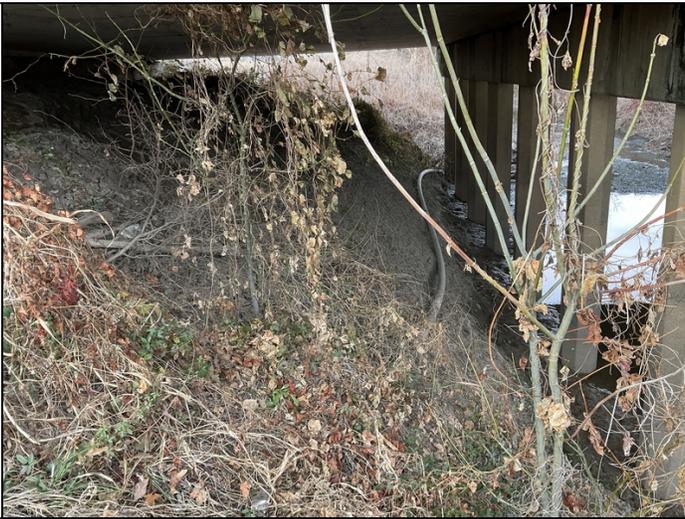
Abutment #2 left and right sides have vegetation growing beside bridge.

Typical vegetation

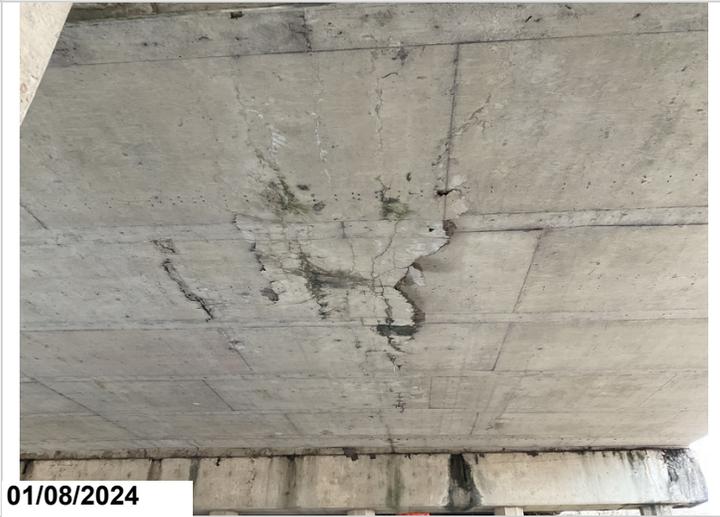
Span #2 soffit-under surface delaminated area.

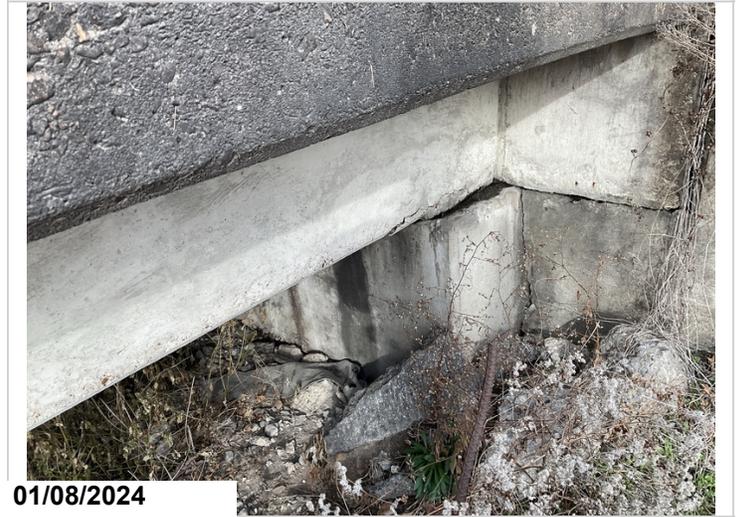
Slab right side at abutment #2 bottom edge has a 1' long crack delaminated area.

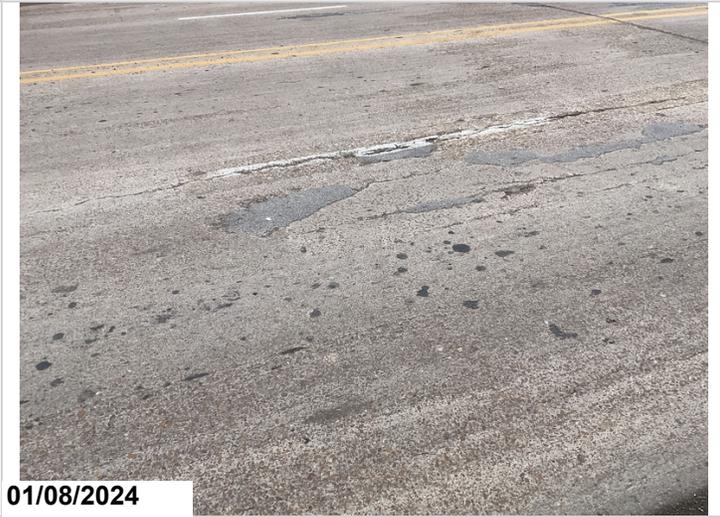
Typical deck cracks

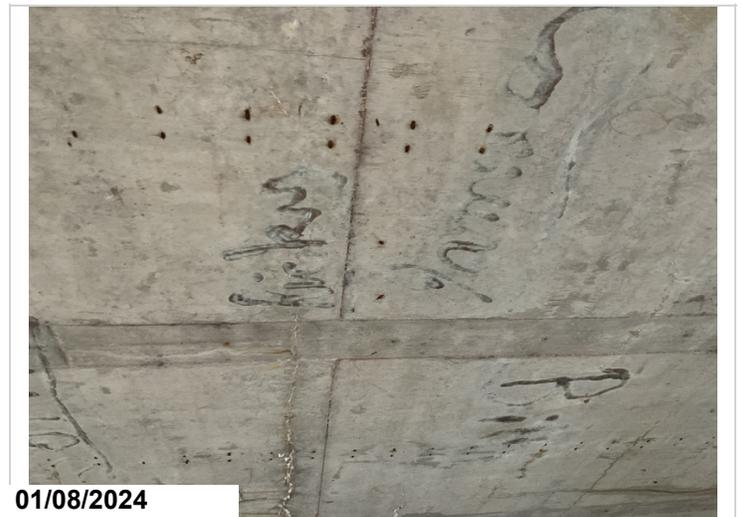
Soffit-under surface has some graffiti on it.

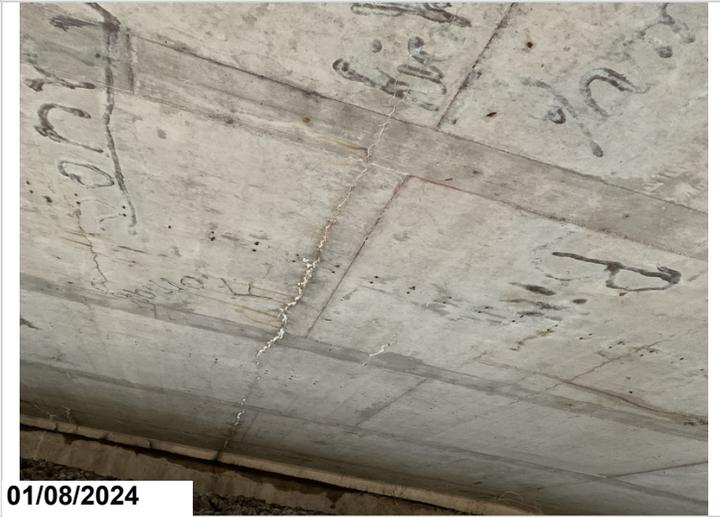
Typical soffit-under surface cracks.

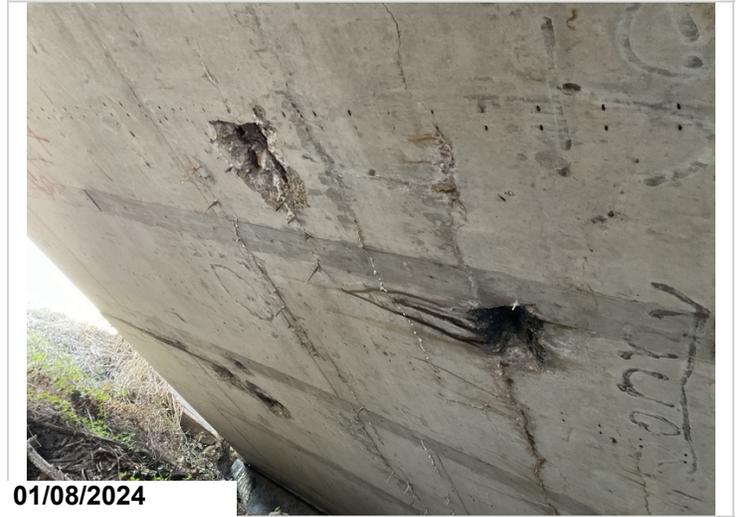
Span #1 soffit-under surface spalls with exposed rebar.

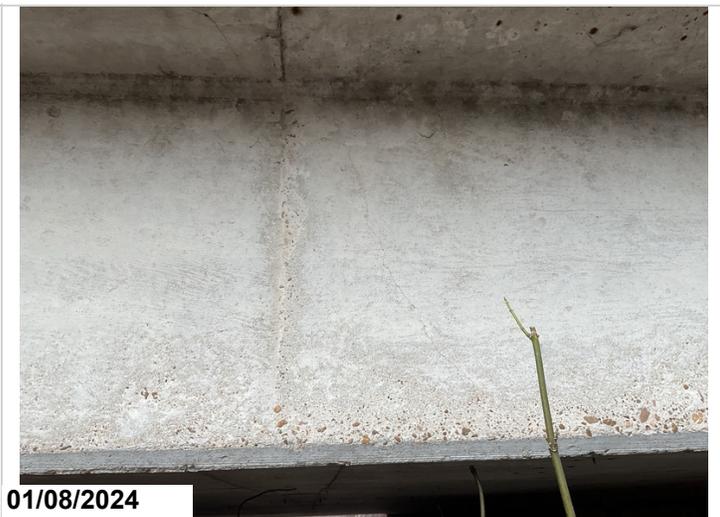
Superstructure is a slab so deck and superstructure are rated the same. Super structure is in fair condition with some vertical cracks on sides of slab.

Typical cracks on sides of slab

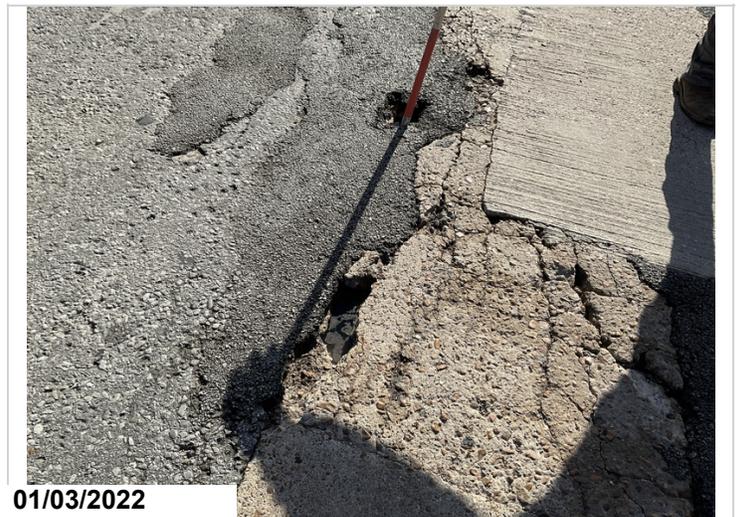
Span #3 left side between lanes has several areas spalled into the sona tube voids

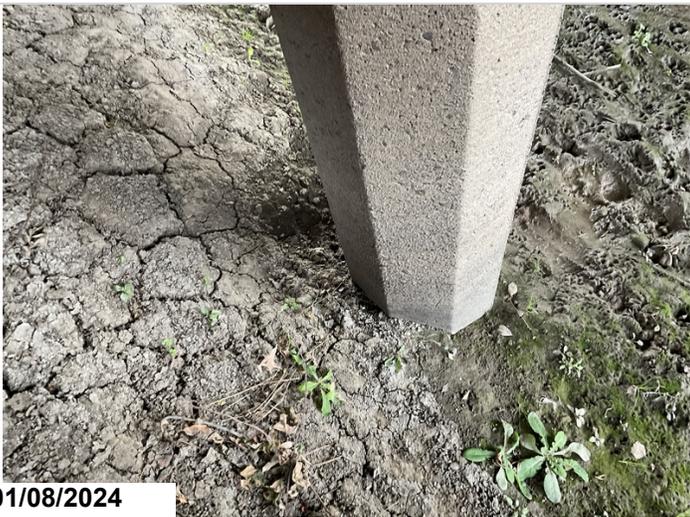
Typical abrasion on piles

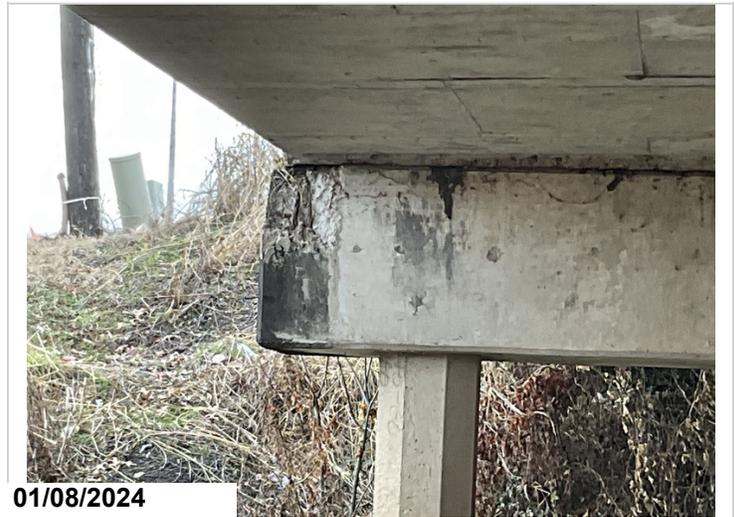
Substructure is in good condition with some minor spalls and cracks in the caps.

Bent #2 cap typical spall on ahead face

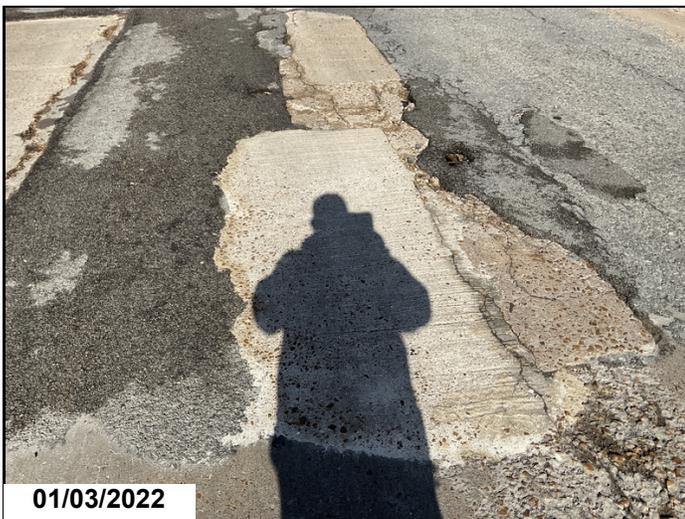
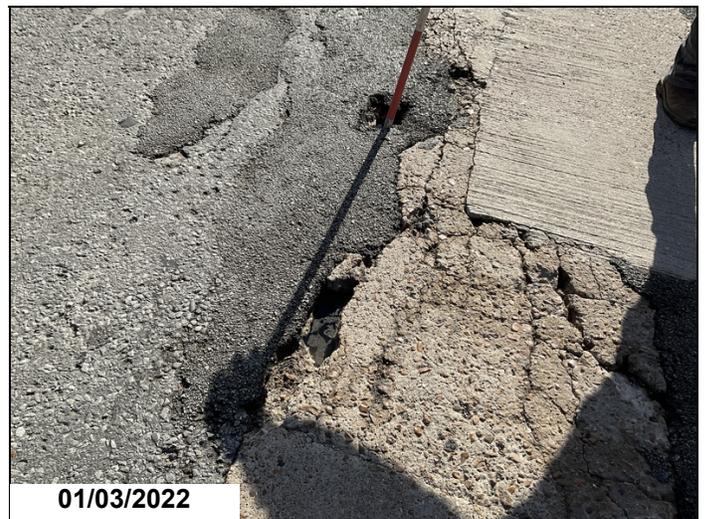
Span #3 left lanes have twenty-five feet of failing patches with two holes spalled into sona tube voids allowing them to fill with water.

Span #3 left side between lanes has several areas spalled into the sona tube voids

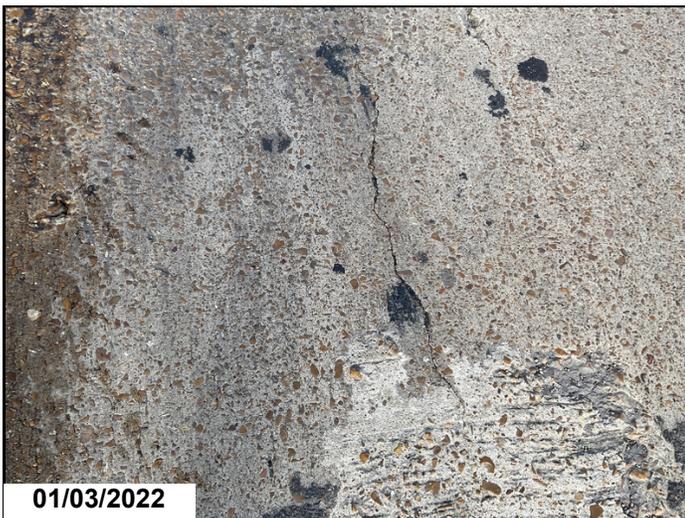
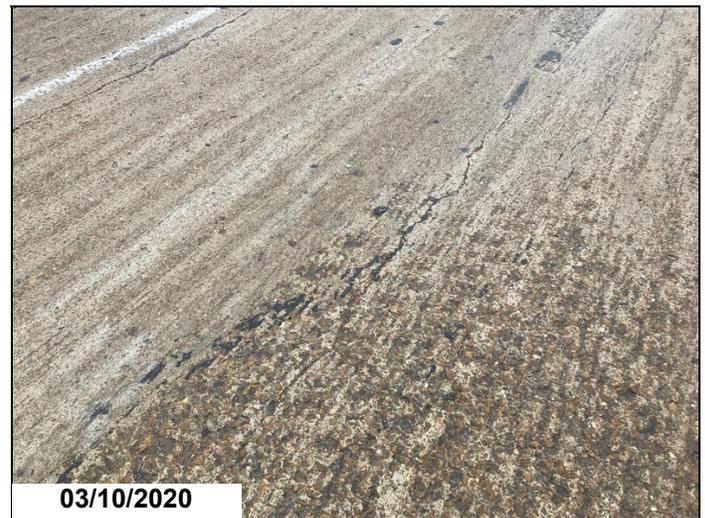
Deck has several open longitudinal wide cracks each span.

Typical longitudinal deck crack

Typical longitudinal crack in deck.

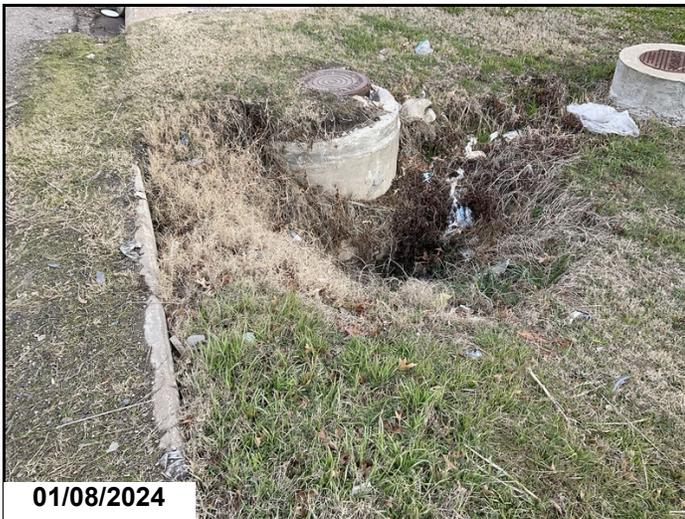
Abutment #2 right side approach shoulder

Abutment #2 right side twenty feet from bridge end next to roadway has large sunken in area.

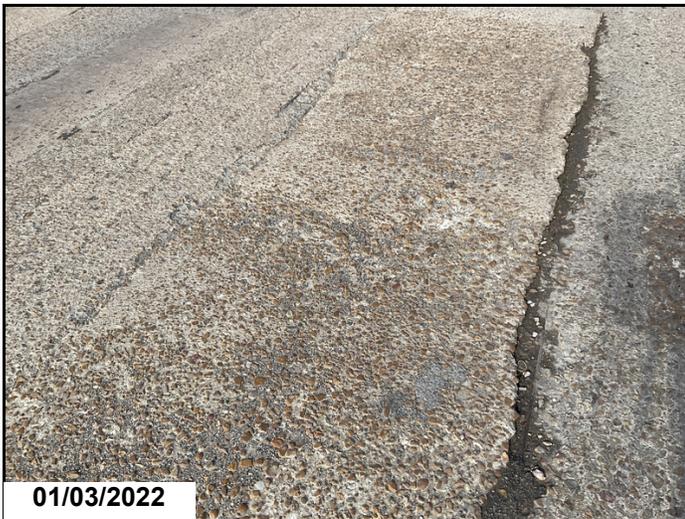
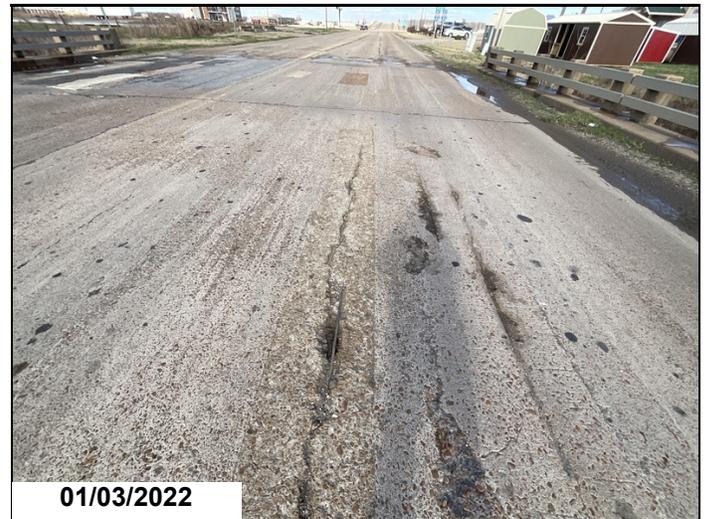
Spans #1 and 2 have several feet of exposed rebar each.

Exposed rebar in span #1 deck right lane.

Span #2 exposed rebar in right lane

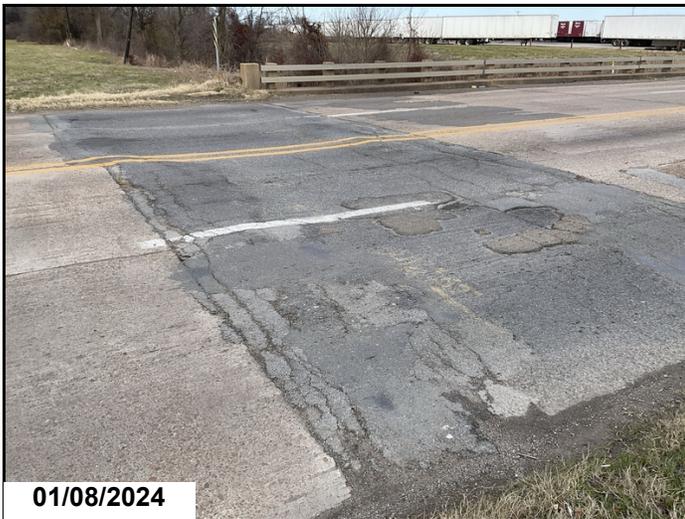
Abutment #1 approach roadway overlay is cracked, spalled, and failing.

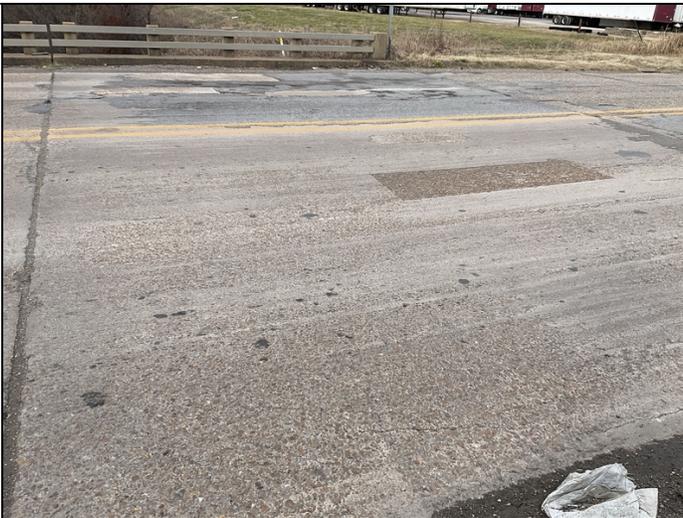
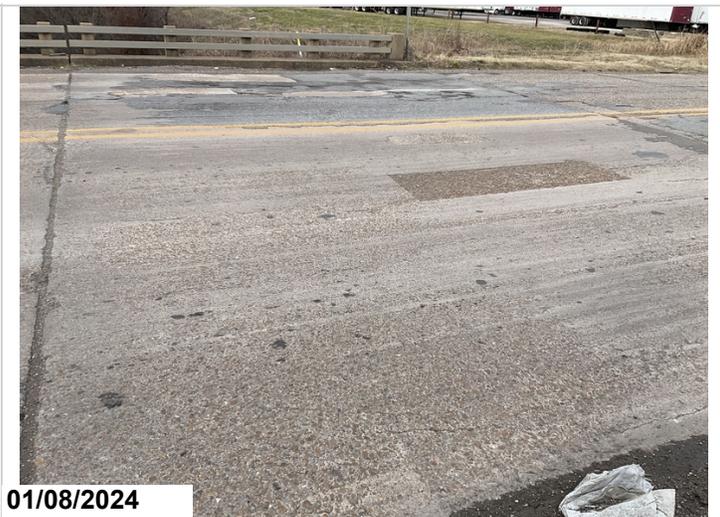
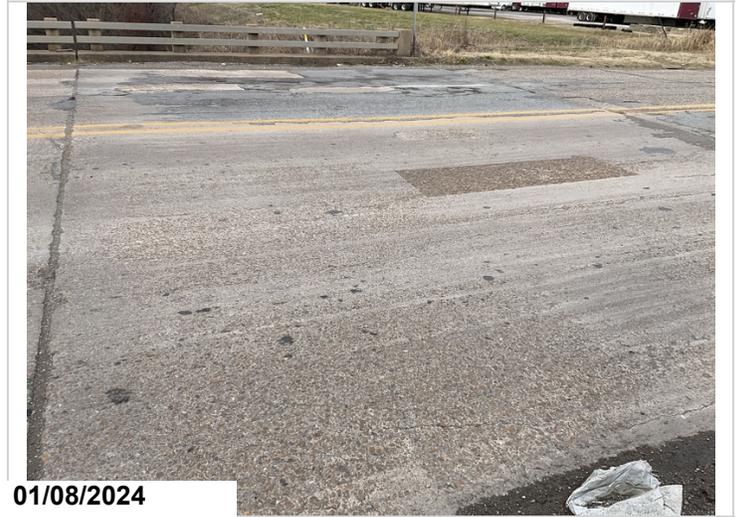
Deck has wide cracks, repaired areas, and spalls.

**A-62 - Hydro and LMC Advised (Yes)**  
Deck has wide cracks, repaired areas, and spalls.
