INTEROFFICE MEMORANDUM

TO: BRIDGE DESIGN PERSONNEL
FROM: Veral Pinkerton, Bridge Engineer
SUBJECT: Changes in Detailing Practices

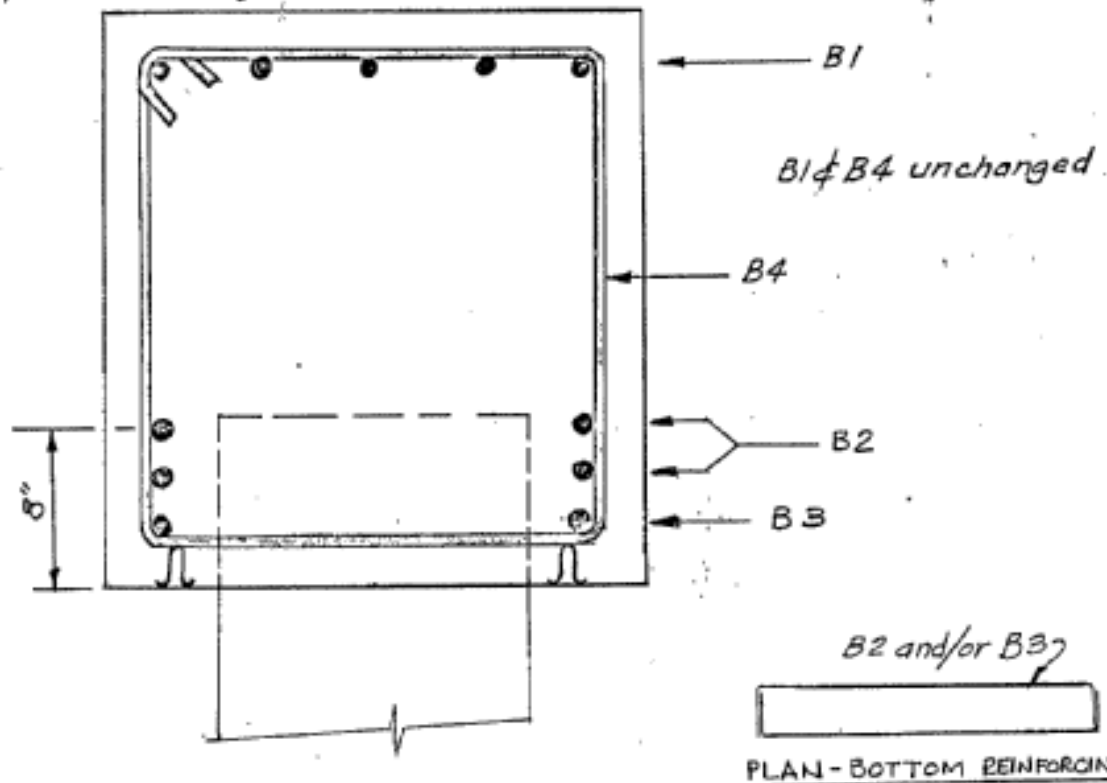
CAP SECTION
INT. BENT

Field Inspections by Federal Highway Administration personnel has brought to my attention the fact that difficulty has been experienced in holding in place the four reinforcing bars in the bottom of pile bent caps which are shown near the piles and lapped at the ends.

Bars B2 and B3 should be alike if practical, and be U bars. Lap at ends. For End Bents vary laps so bars may be alike.

On future details show the bars adjacent to the ties as shown on the attached sheet. Also add dimensions to set the location of these bars vertically.

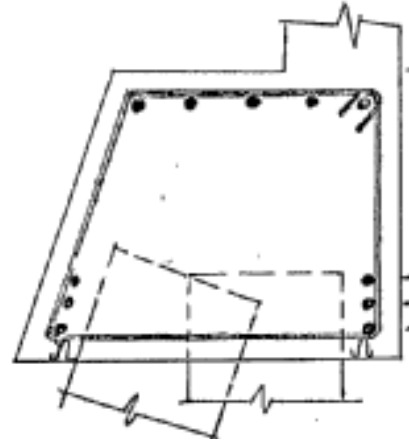
END BENT

B2 & B3 marked for location and will not be same length as Int. Bent.

Straddle all bars
