ARKANSAS DEPARTMENT OF TRANSPORTATION

SUBSURFACE INVESTIGATION

HWY. 295 SLIDE REPAIRS (MADISON CO.) (S)

SUBJECT: Internal Job No. D09220
Highway 295 Slide
Route 295, Section 0, L.M. 1.20
Madison County

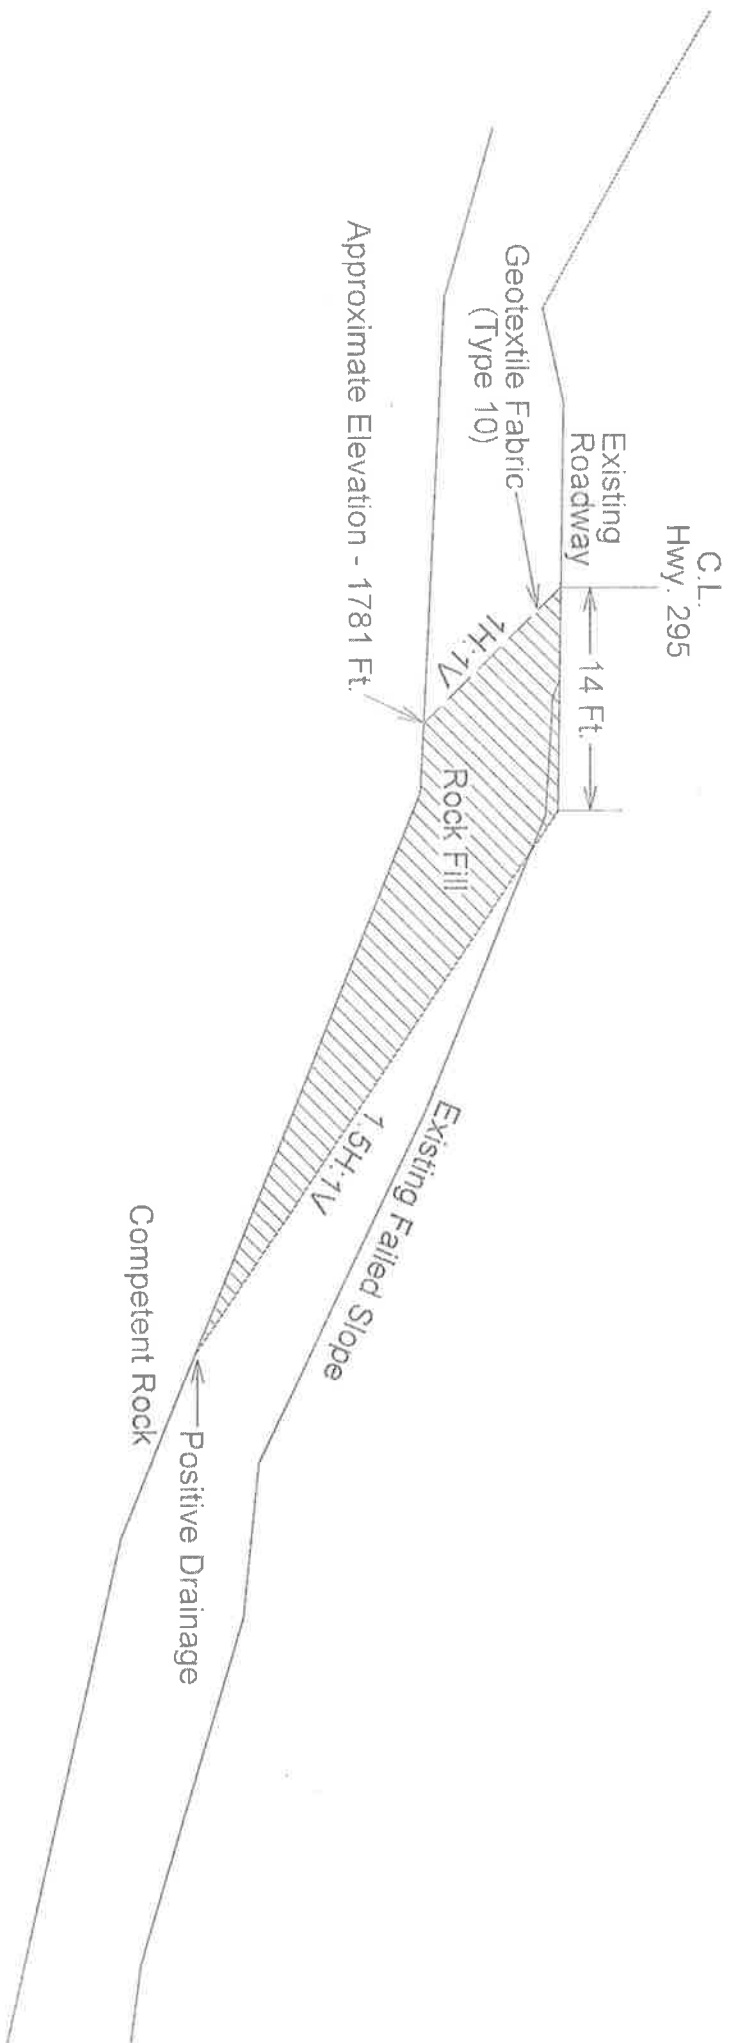
Figure 1 - Rock Buttress

The Geotechnical Section conducted a subsurface investigation for the embankment failure south of Elkins on Highway 295, Section 0, Log Mile 1.20. Due to heavy rain events the slope on the south side of the roadway has moved, causing the southbound lane to drop several inches and large tension cracks to develop in the roadway. This resulted in the southbound lane being closed to traffic.

It is recommended that a rock buttress be constructed to support the existing roadway. The repair should be made to establish the original driving lane configuration. All failed material should be excavated for the total width of the failure, approximately 110 feet, on a 1H:1V slope from the centerline of the existing highway down to competent Shale at approximate elevation 1781, based on the cross-sections provided. The embankment should be reconstructed with Rock Fill.

The recommended configuration of the buttress should consist of a minimum top width of 14 feet to provide adequate stability to the remaining roadway segment and a width to re-establish the southbound travel lane and shoulder. The front face of the buttress should be constructed on a maximum 1.5H:1V slope. The buttress design is based on a drained condition for the full depth of the rock buttress. Therefore, positive drainage must be established at the base of the buttress either by leaving rock exposed or installing pipe drains. Figure 1 illustrates the proposed cross-section.
