Asset #06957(Routine)

SH 14-14- LM 5.93 over DRAINAGE DITCH NO. 10

Location: 5.05 MI E JCT SH 1

Team Lead: Tim Myrick Inspection Date: 06/08/2022

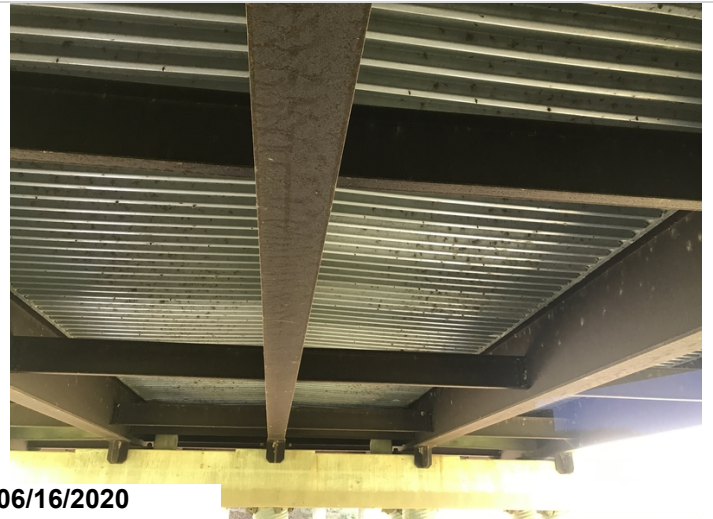
Span 1 soffit

Weathering steel superstructure members are dark brown in color and in very good condition.

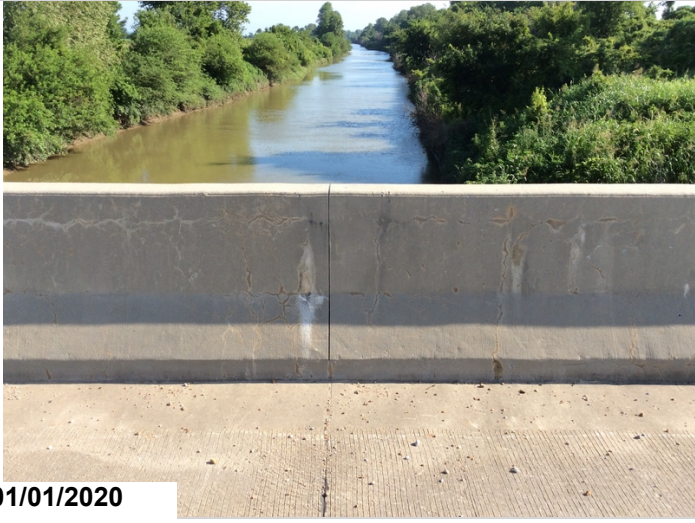
Bridge rails have several cracks with efflorescence.

Spans 2 and 3 Left Bridge Rail

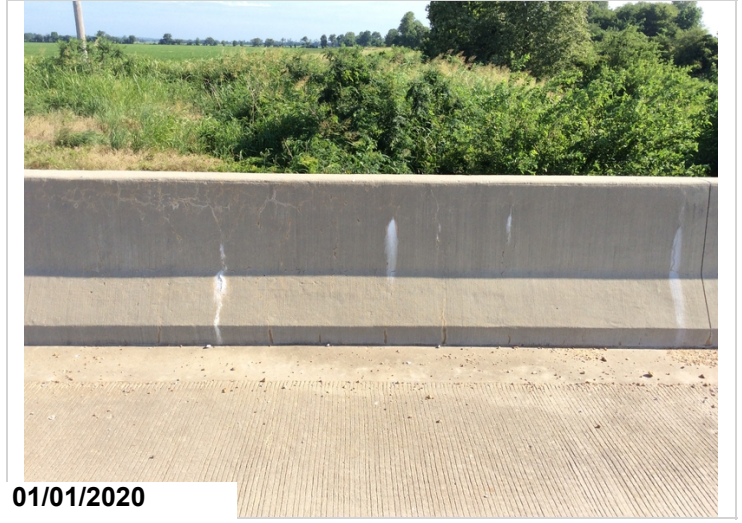
Span 1 Left Bridge Rail
