Asset #00579(Routine, Underwater type 2)

SH 14-14- LM 8.72 over DITCH 11

Location: JCT SH 373 & 14

Team Lead: Richard Jones Inspection Date: 05/20/2024

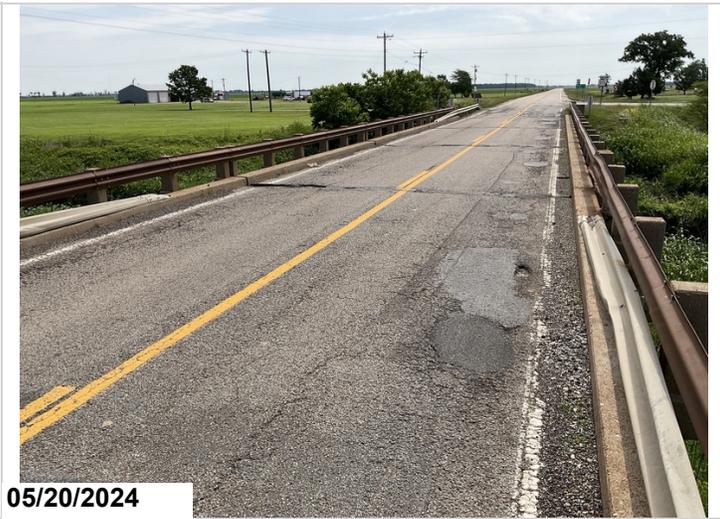
Wearing surface

Asphalt wearing surface has map cracking with some rutting in outside wheel path and gutters. Asphalt is cracked, delaminated and spalling up to 2 in. deep out over all joints.

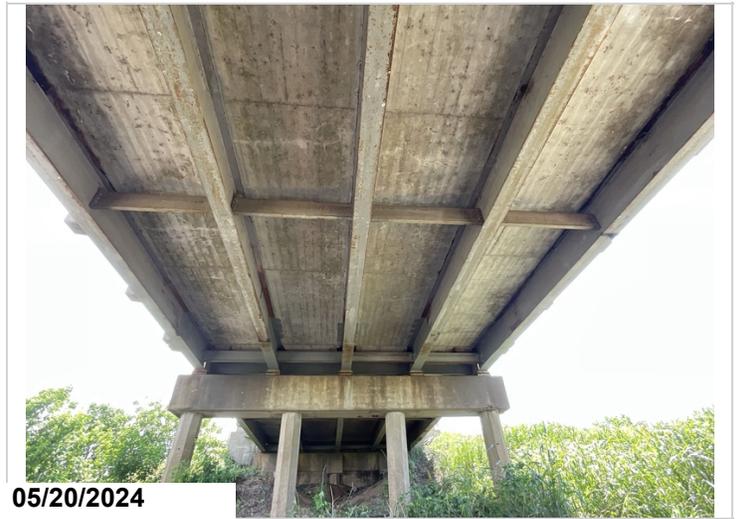
mostly satisfactory condition. Undersurface has cracks with efflorescence.

Under surface

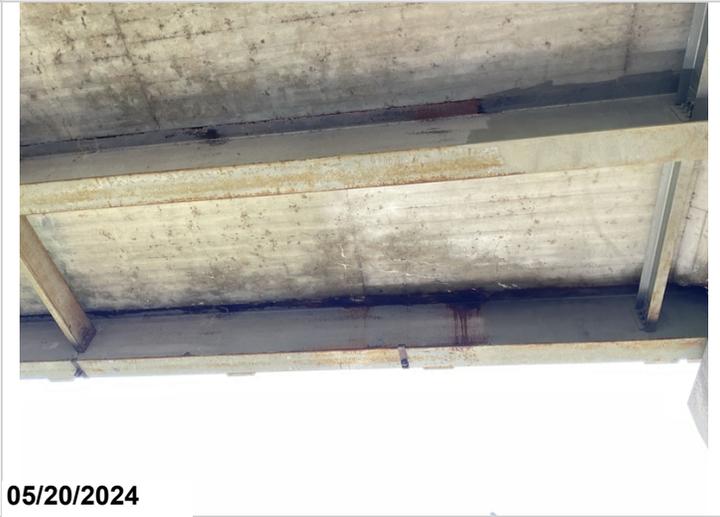
Efflorescence in exterior bays

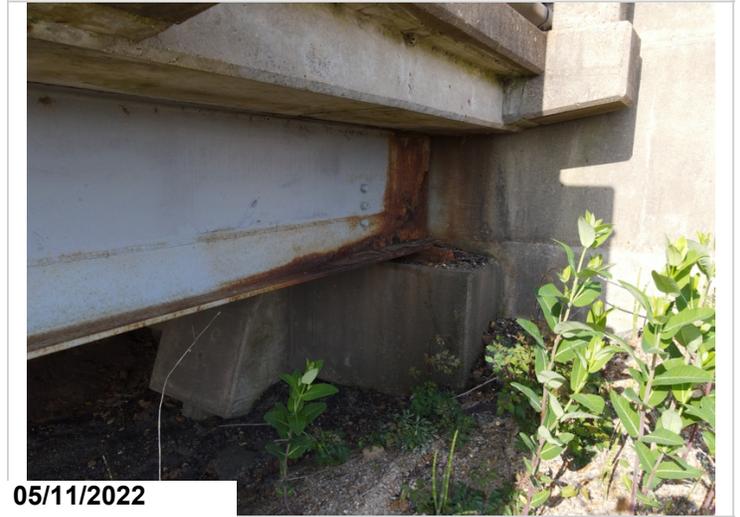
<p>(107) Span 1 bent 1 girders 1 - 5 were t spliced in 2021. Girder 1 has some flaking rust along bottom of web. Girders 3 and 4 have gaps at bearings and are moving under traffic.</p> <p>Span 1 bent 2 girder 1 was t spliced in 2021.</p> <p>Span 1 bent 2 girders 2 and 3 have welded plates at web below haunch.</p> <p>Span 1 bent 2 girder 5 was t spliced in 2021.</p> <p>Rockers were replaced with channels and round stock.</p> <p>Span 2 bent 2 girder 1 was t spliced in 2021.</p> <p>Span 2 bent 2 girders 3 and 4 have welded plates at web below haunch.</p> <p>Span 2 bent 2 girder 5 was t spliced in 2021.</p> <p>Span 2 bent 3 rockers were replaced.</p> <p>Span 2 bent 3 girders 1, 3, and 4 have full height welded web splices at end.</p> <p>Span 2 bent 3 girder 5 was t spliced in 2021.</p> <p>Span 3 bent 3 girder 1 was t spliced in 2021.</p> <p>Span 3 bent 3 girders 2 and 3 have bolted plates at web below haunch.</p> <p>Span 3 bent 4 girders 1, 2, 4, and 5 were t spliced in 2021. Girder 3 has a full height welded web splice.</p> <p>Rockers were replaced with channels and round stock.</p> <p>Span 4 bent 4 girders 1 and 5 were t spliced in 2021. Girders 2 and 4 have full height welded web splices. Girder 3 has a welded web splice and welded plates at haunch.</p> <p>Rockers were replaced with channels and round stock.</p> <p>Span 4 bent 5 girders 1 - 3 were t spliced in 2021. Girders 2 - 4 have bolted plates at haunch. Girder 5 has a t splice with bolted bottom flange plate.</p>

Span 1 bent 1 girder 1 t splice has some flaking rust

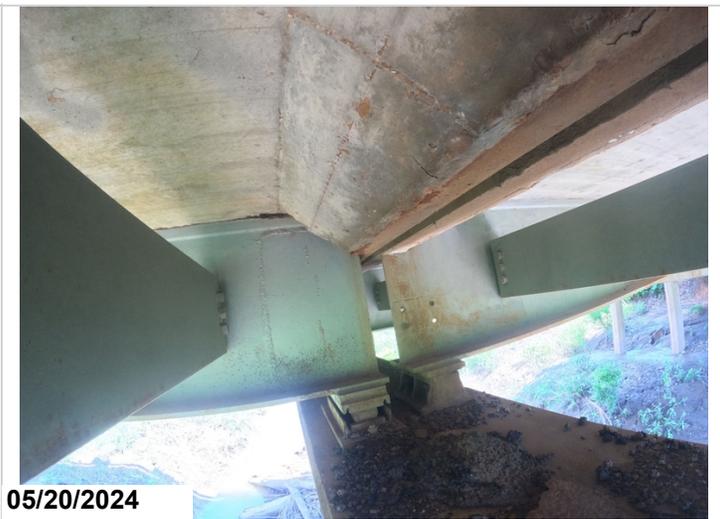
Typical full height welded web splice

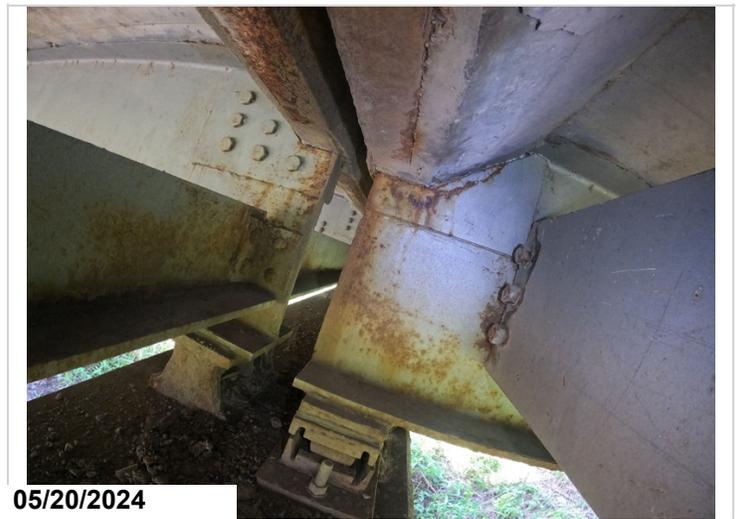
Typical welded & bolted haunch repairs

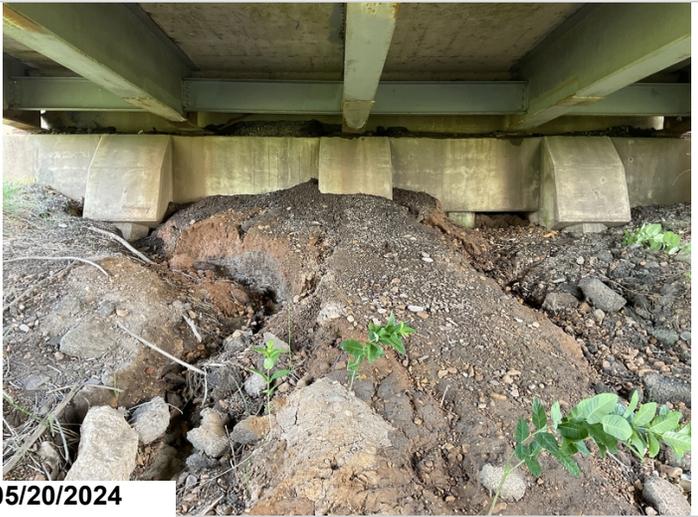
Bent 1 tops of 3 piles are exposed. Embankment has minor erosion.

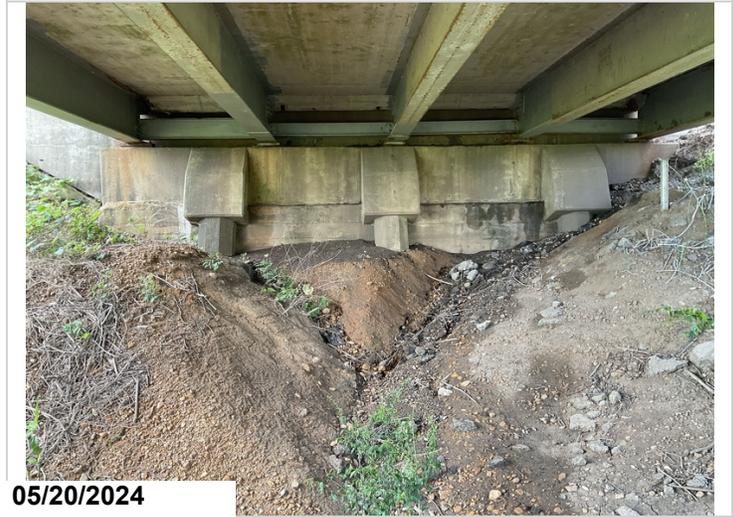
Bent 5 abutment has 3 battered piles exposed. Scour repair below abutment has deterioration & spalling on left end.

ELEMENTS	DESCRIPTION	UNITS	TOTAL	CS1	CS2	CS3	CS4
(215) Scour repair portion of bent 5 has some concrete deterioration/spalls. CS2 and CS3							
227	Reinforced Concrete Pile	EA	18	14	4	0	0
1130	Cracking (RC and Other)	EA	1	0	1	0	0
1190	Abrasion/Wear (PSC/RC)	EA	3	0	3	0	0

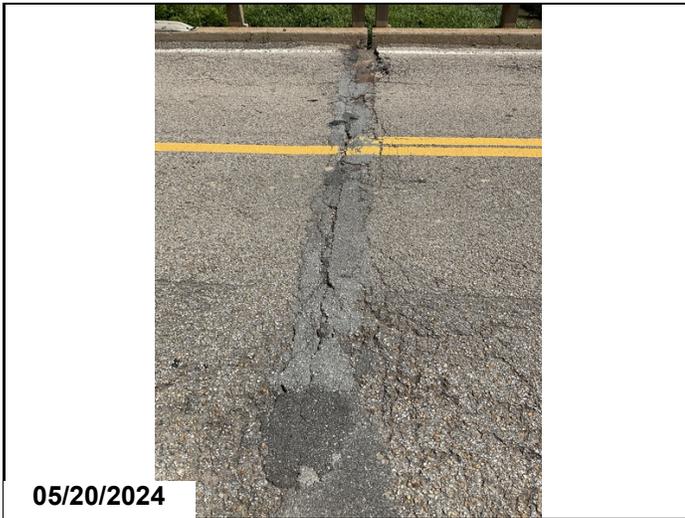
Typ joint

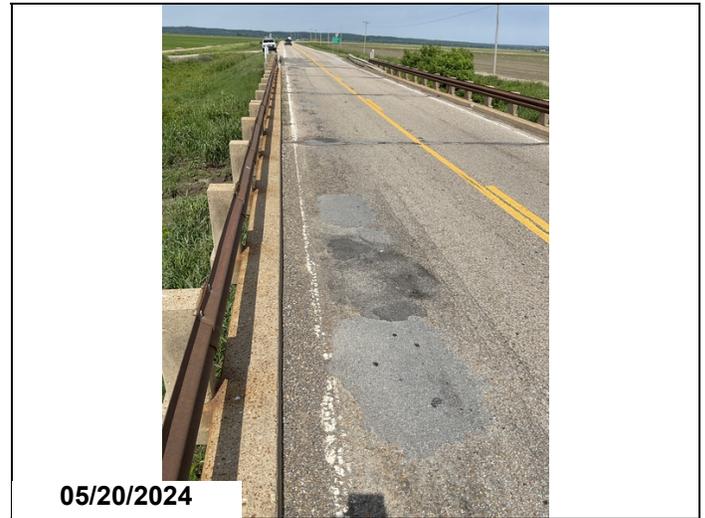
Typ wheel path cracks and spalls

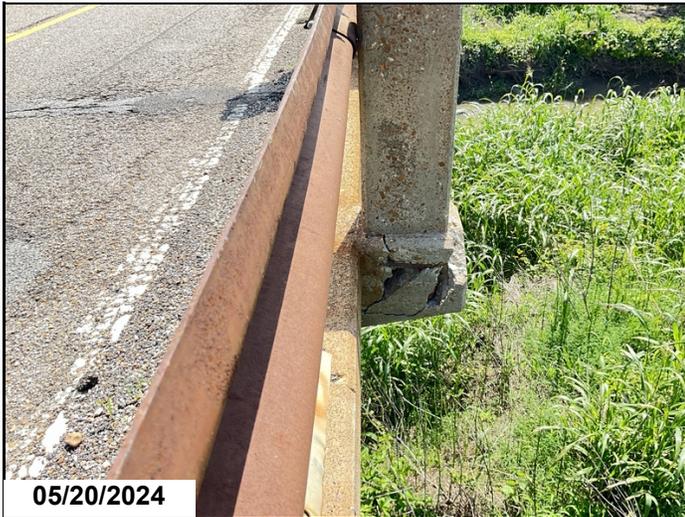
Several bridge rail posts are cracked, spalled or broken at bottom. Some have rebar exposed. Metal rails have surface rust throughout.

Span 1, Right side: 5th post broken at bottom

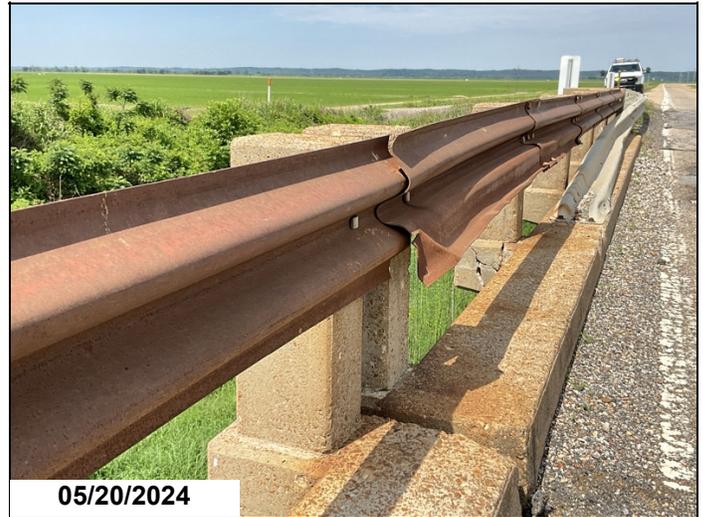
Span 1, Right side: bridge rail damage over bent 2

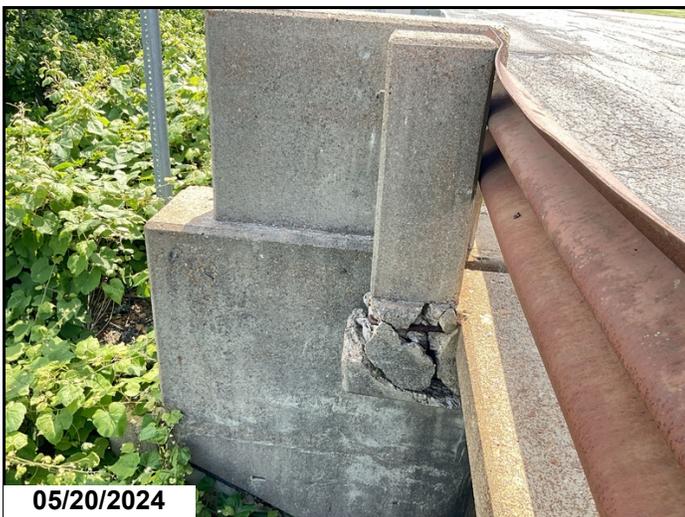
8 ft. of rail is loose & moving under traffic load at southwest corner.

Span 4, Left side: last bridge rail post

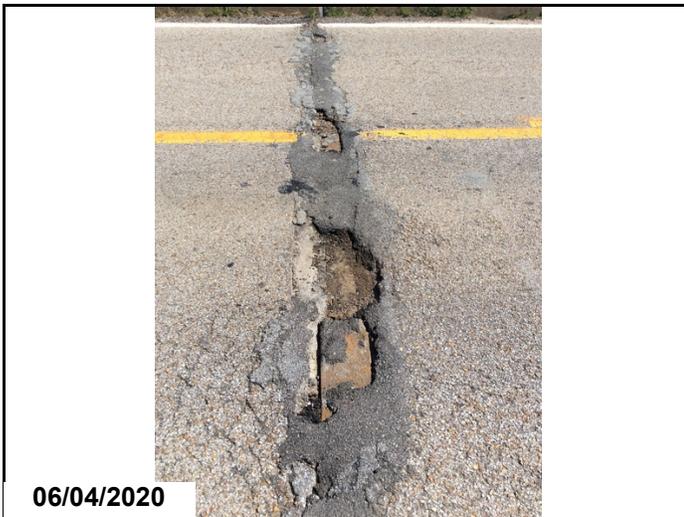
Bent 3 slide plate is loose and cracked into near center line and center of Rt lane.

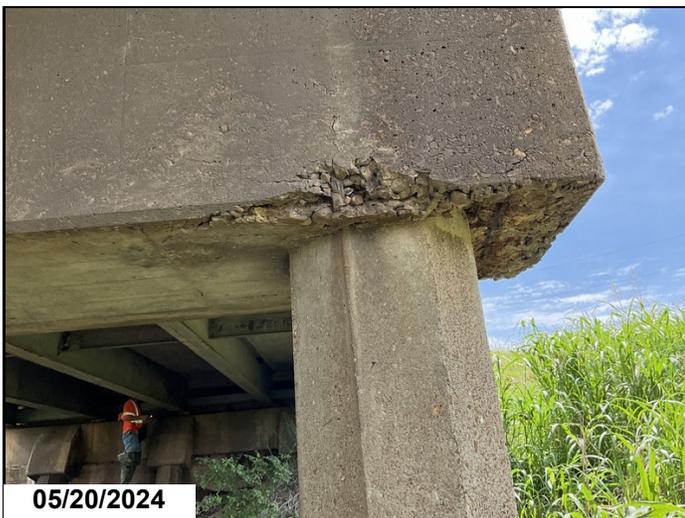
Bent 4 cap has a spalled & delaminated area with exposed rebar near pile 4 and right end has spall with rebar exposed and a vertical crack at bottom of cap.

Bent 4, Right side: spall & rebar exposed near pile 4

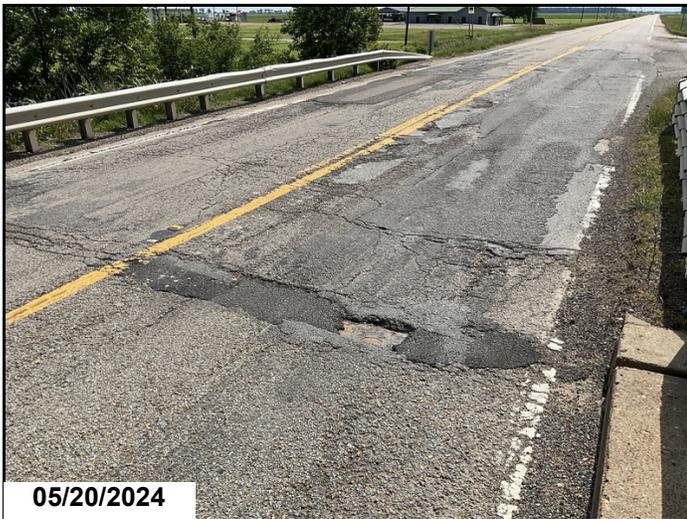
Bent 5 approach

Approach roadways have settlement with areas of map cracking and a few potholes.

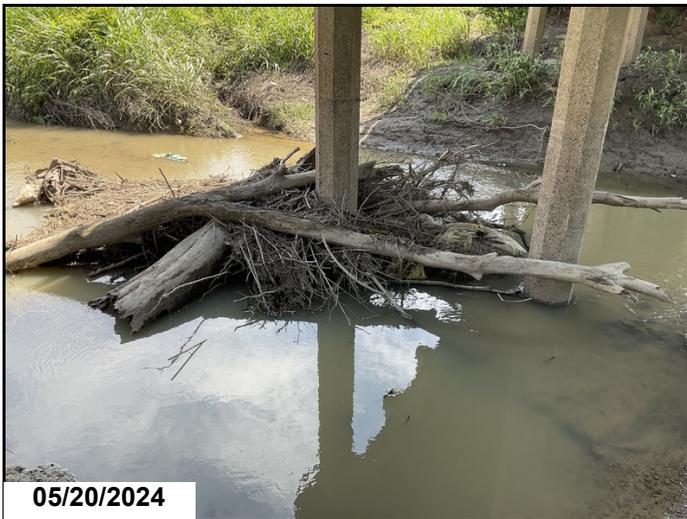
Bent 3 drift

Drift is built up at bent 3.

Type of Work: Channel Work/Drift Removal
