Asset #02594(Routine)

SH 14-14- LM 5.46 over DITCH 1

Location: 4.57 M E SH 1

Team Lead: Richard Jones Inspection Date: 05/20/2024

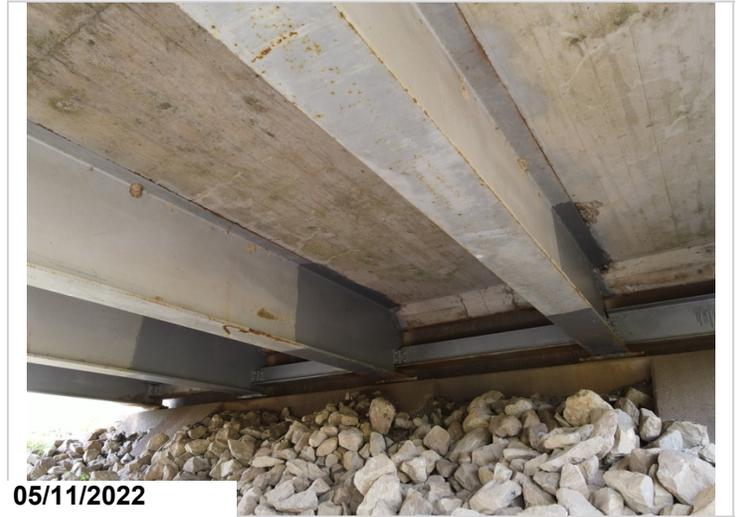
Several girder ends were repaired in 2022.

Bent 1 girder repairs

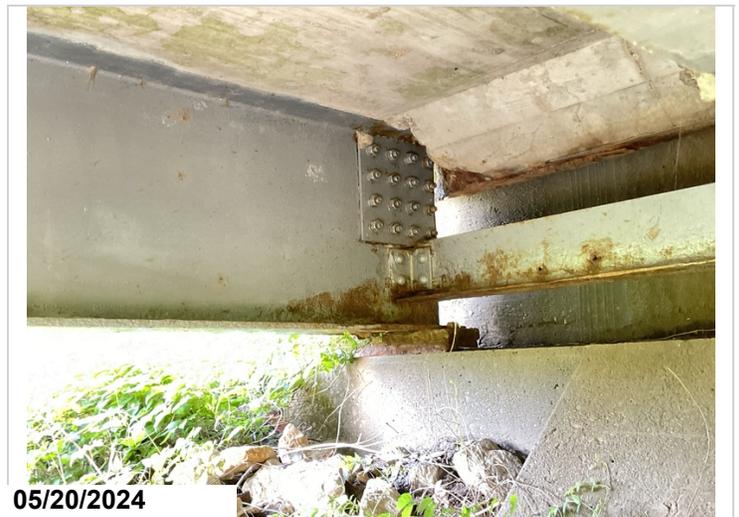
Span 1 bent 1 girder 5

Span 1 bent 1 girder 5 has bolted plates at web below haunch.
Span 1 bent 2 girder 1 has a full height bolted web plate.
Span 2 bent 3 girders 4 and 5 have bolted plates at web below haunch.
Defect locations listed above don't match up with current field conditions or repairs; probably mislabeled.

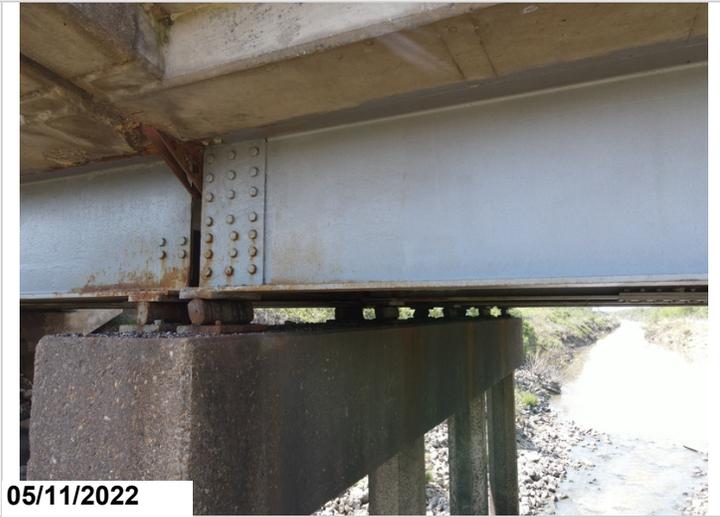
Span 1 bent 2 girder 1 repair

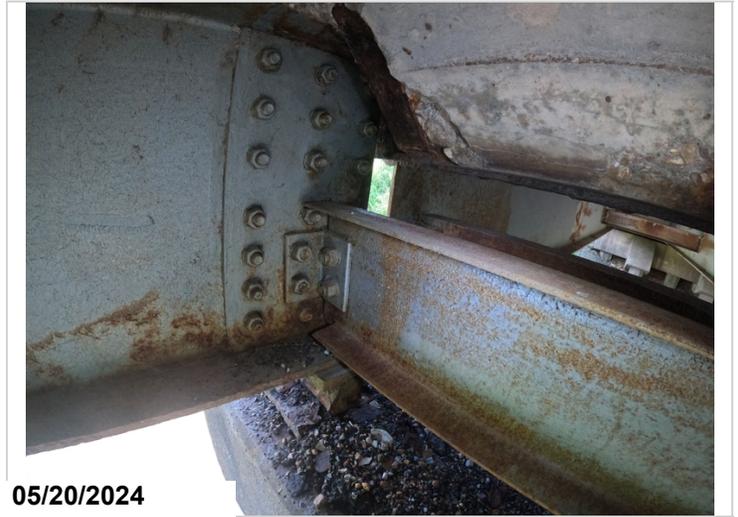
Span 1, Bent 2, Girder 1: bolted web splice

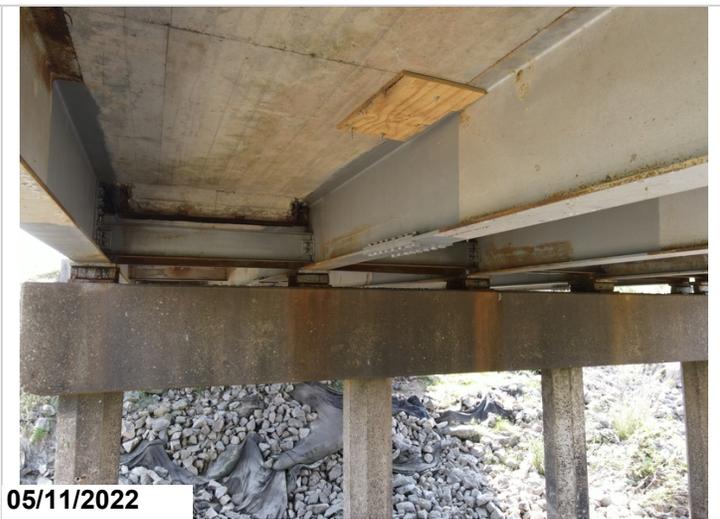
Bent 2 girder repairs

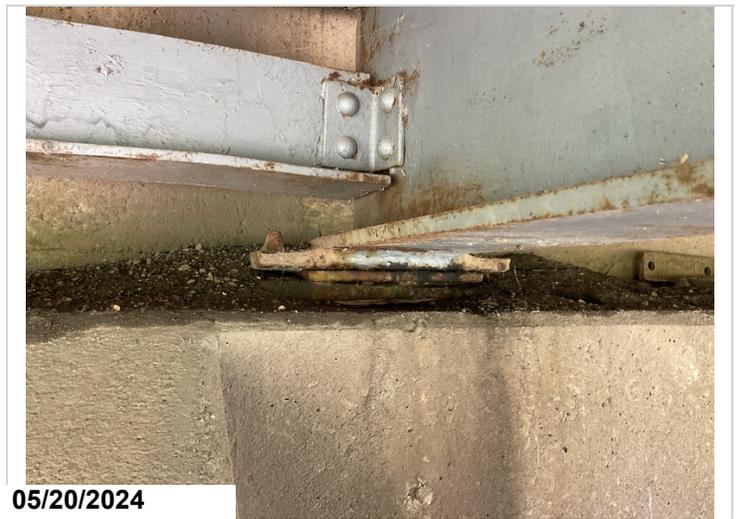
(313) Bearings have pack rust and section loss. Span 2 bent 3 bearing 2 was shimmed in the past.							
330	Metal Bridge Railing	LF	140	0	0	140	0
1000	Corrosion	LF	140	0	0	140	0
515	Steel Protective Coating	SF	476	0	0	0	476
3440	Effectiveness (Steel Protective Coatings)	LF	476	0	0	0	476

Span 2 bent 3 bearing 2

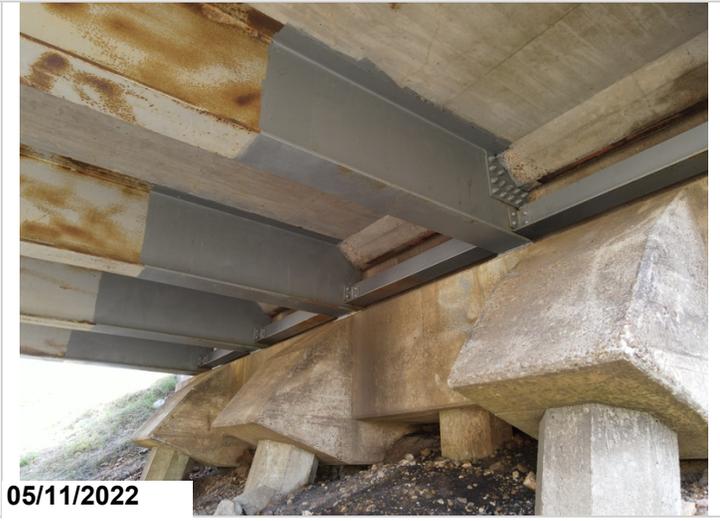
Bent 3 girder repairs

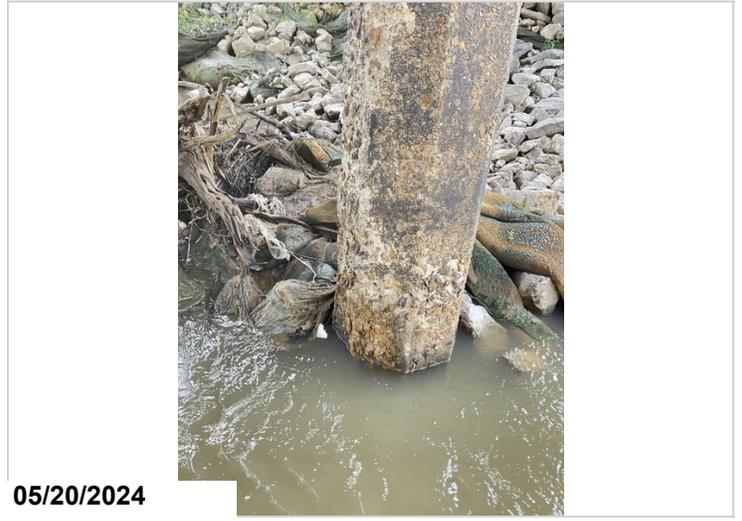
Bent 2 pile 3

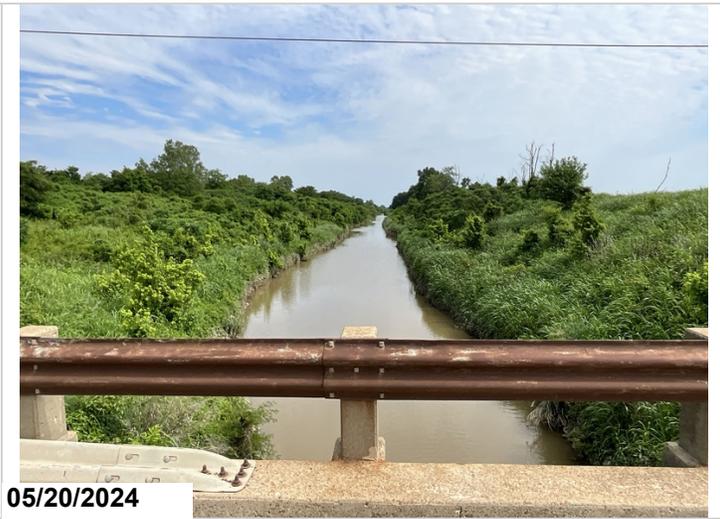
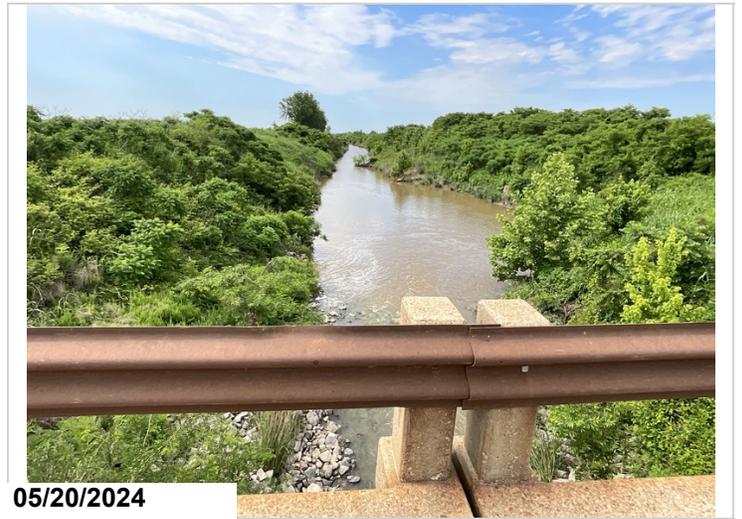
Rip rap was placed across channel in the past, but has some displacement with filter fabric exposed under span 2.

Left side, upstream: channel

Right side, downstream: channel

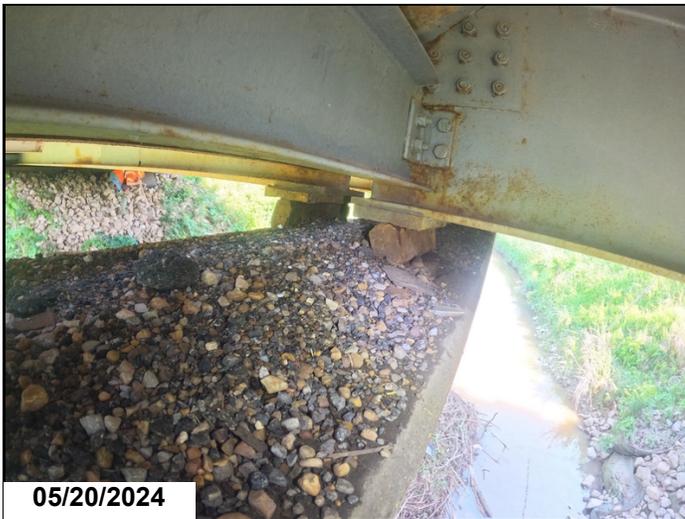
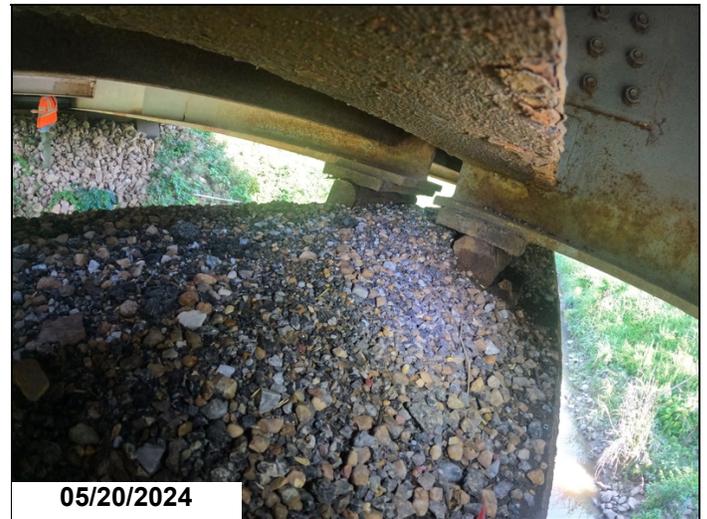
Span 2 bent 2 bearings 3 and 4 have advanced rotation. Bearing 4 rocker is loose.

Span 2, Bent 2, Girder 4: bearing rotation

Span 2, Bent 2, Girder 3: bearing rotation

Type of Work: Bearing Repair/Replacement

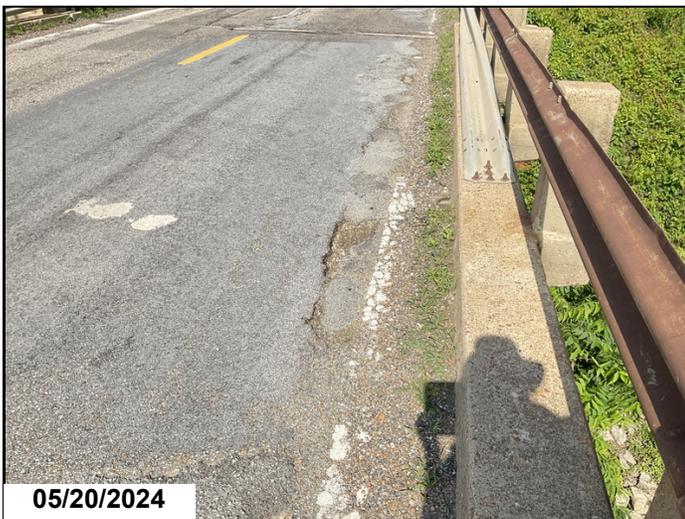
Approach roadways are severely cracked and spalled.
Asphalt wearing surface has several cracks and spalls. Asphalt is raveling out along gutters and over joints.

Typical gutter

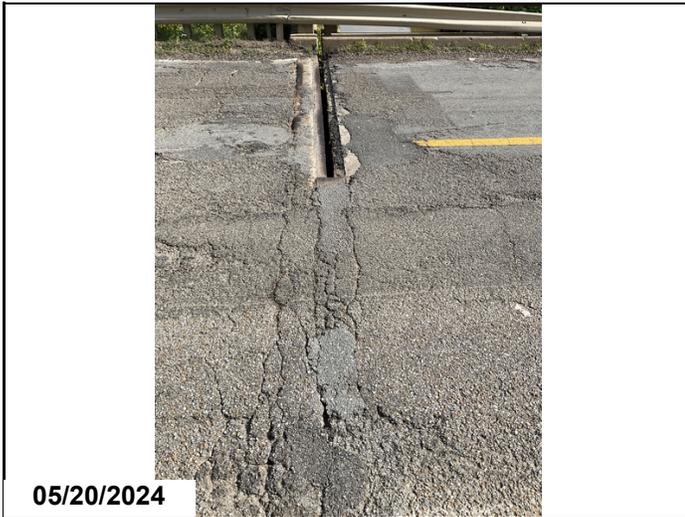
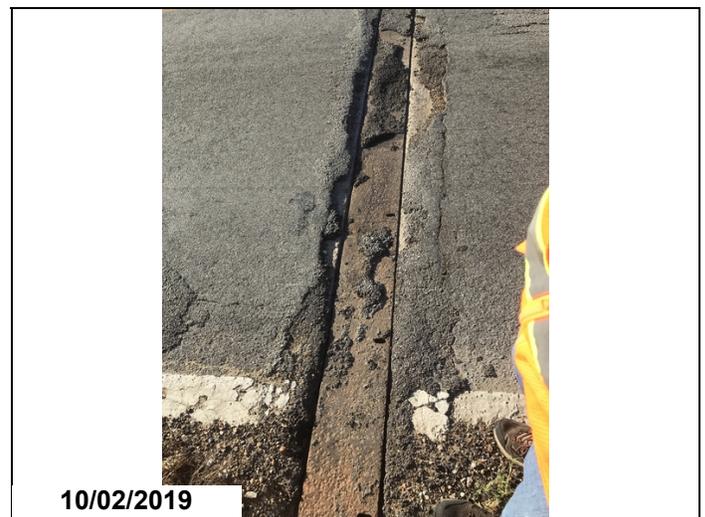
Bent 1 joint has 13' of slide plate missing.

Bent 1 joint

Bent 1 joint 2019

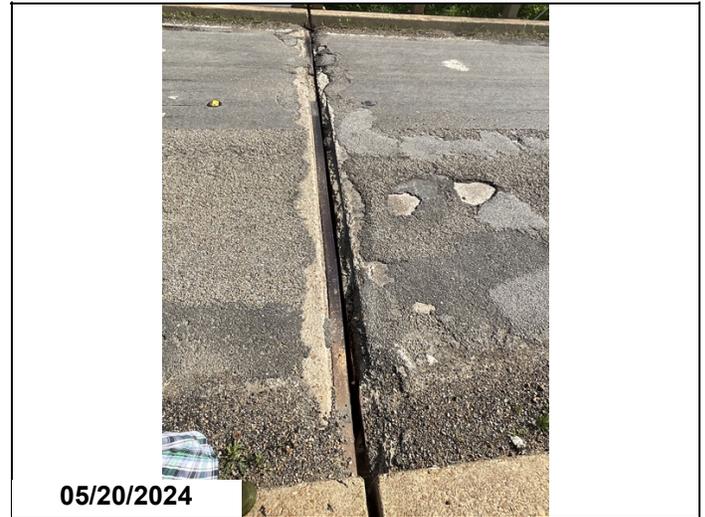
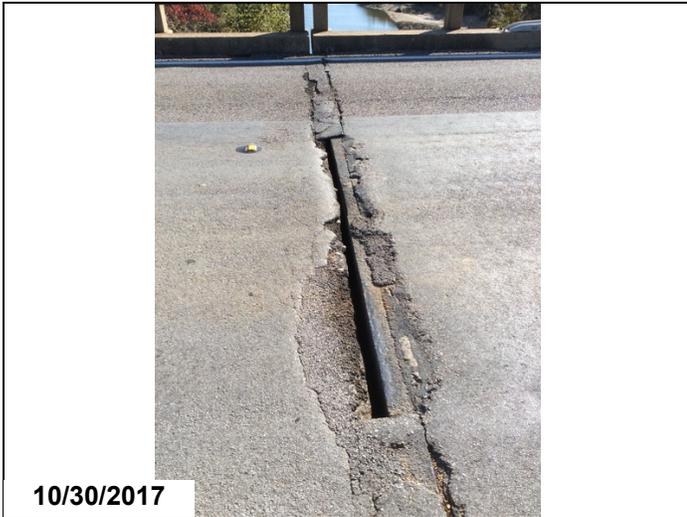
Bent 2 joint has all of slide plate missing, and several areas of joint armor missing. Deck is spalled along joint.

Bent 2 joint

bent 2 2017

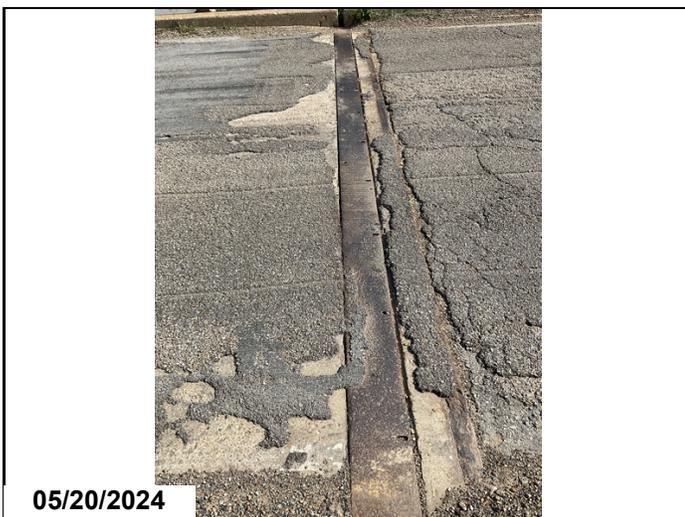
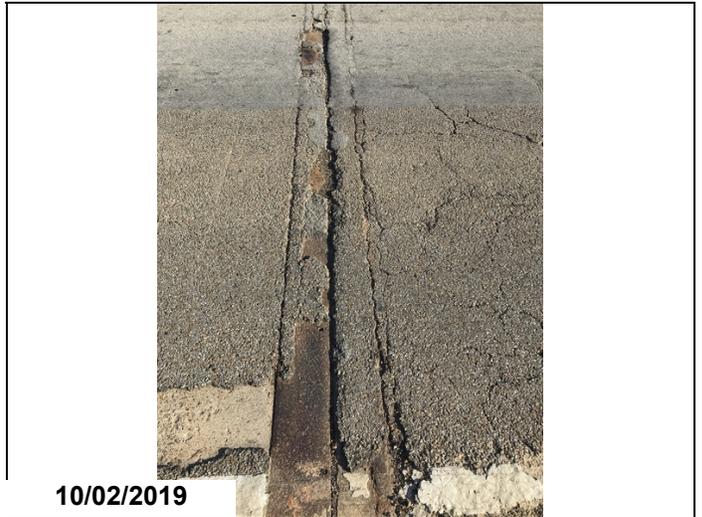
Bent 3 slide plate joint is loose and moving under traffic.

Bent 3 joint slide plate loose

Bent 3 joint 2019

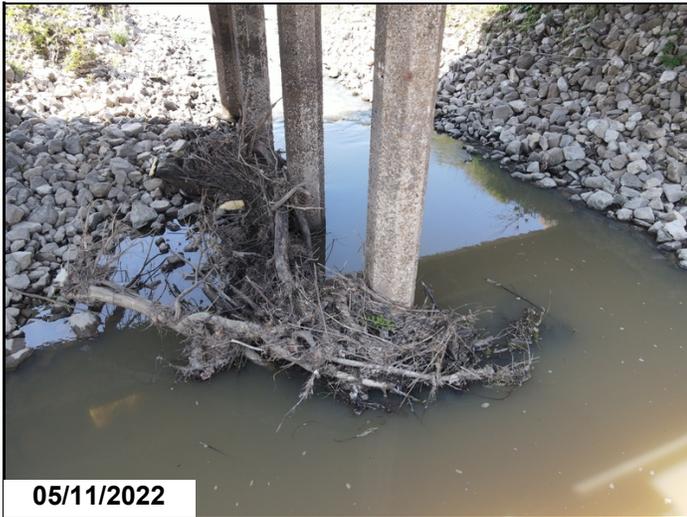
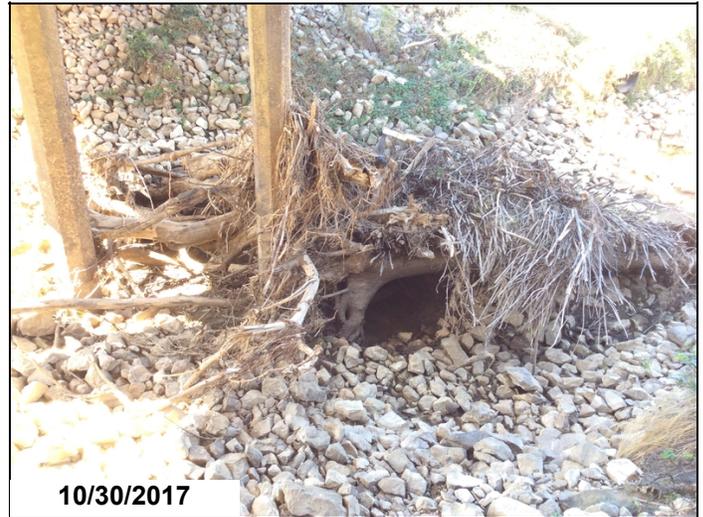
Small drift and limb on bent 2.

b2 drift

Poinsett Co Crew for removal. KAW 12/8/17

to Poinsett Co Crew for removal KAW 1/17/20

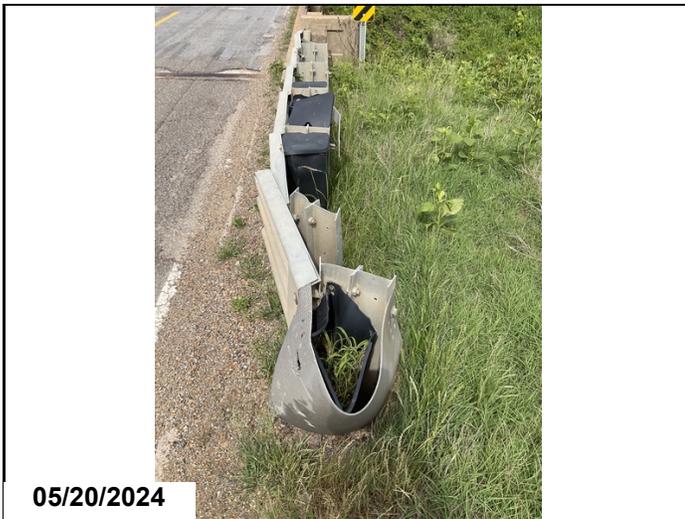
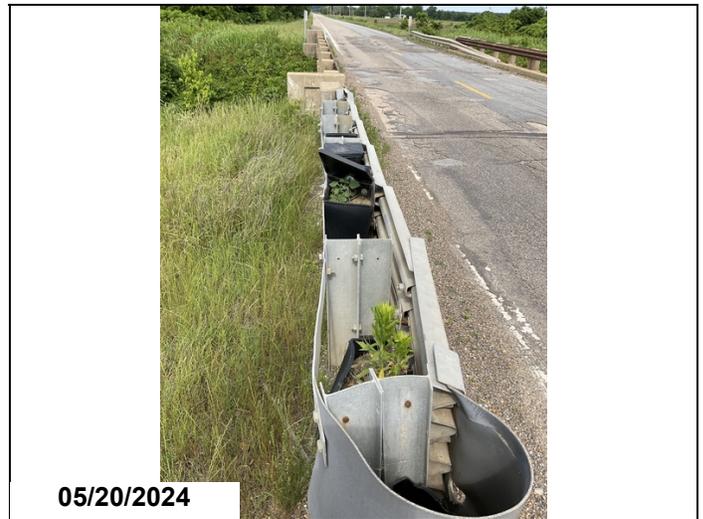
Crash attenuators at bent 3 Lt and Rt sides have minor collision damage. Lt side end treatment tension cable is broken.

Bent 3 Lt

Bent 3 Rt

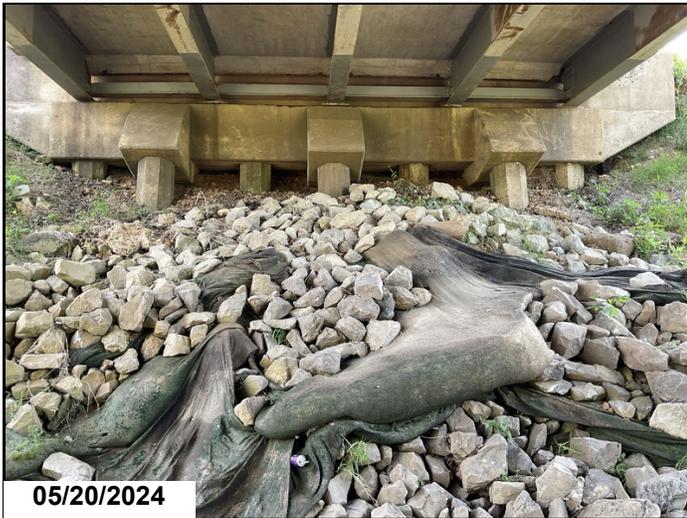
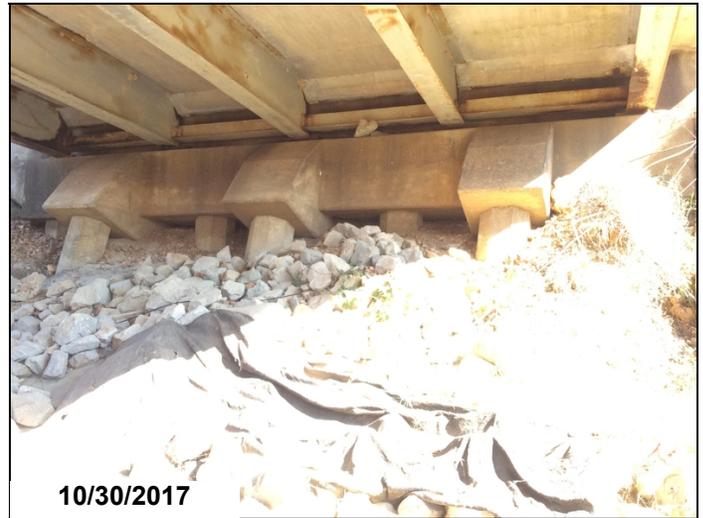
Bent 3 abutment is undermined up to 1.5' below and 2' back under with tops of 7 piles exposed.
Rip rap was placed across channel in the past, but has some displacement with filter fabric exposed under Span 2.

Bent 3
