Arnold Road ID:38x412x6BxA, Arnold Log mile:1.327

**Asset #06544(Routine)**  
**US 412-6B- LM 1.32 over US 67**  
**Location: US 412 over US 67**

**Team Lead: Richard Jones Inspection Date: 08/16/2023**

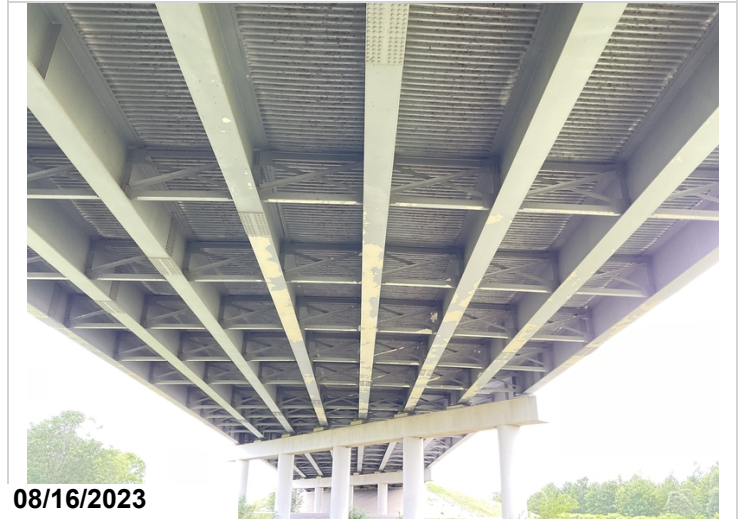
Span 6

Steel girders have areas of peeling paint, especially at span 6.  
Splice bolts have a few areas of peeling paint with surface rust.

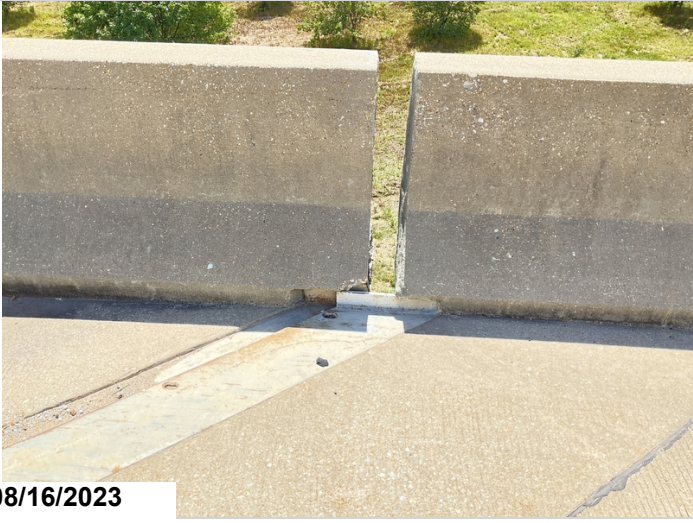
5" gap at Rt rail over bent 5

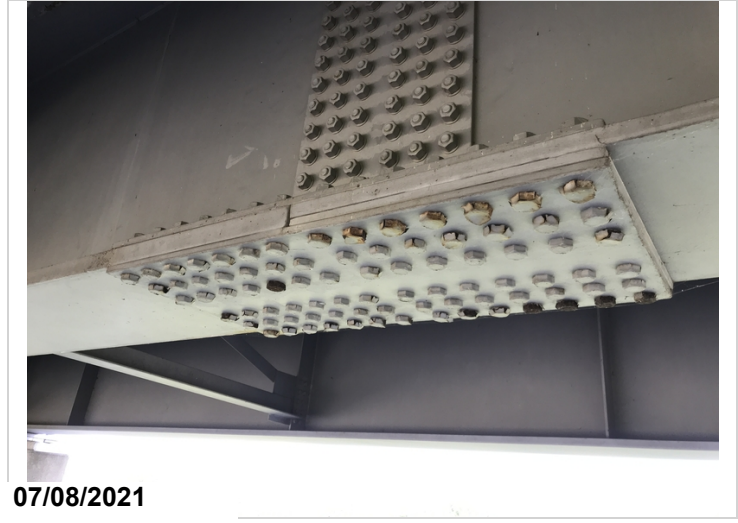
Typical paint flaking and corrosion at splice

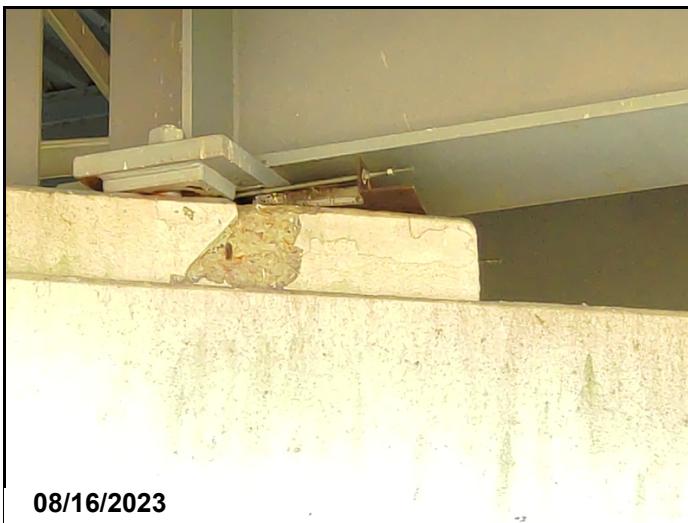
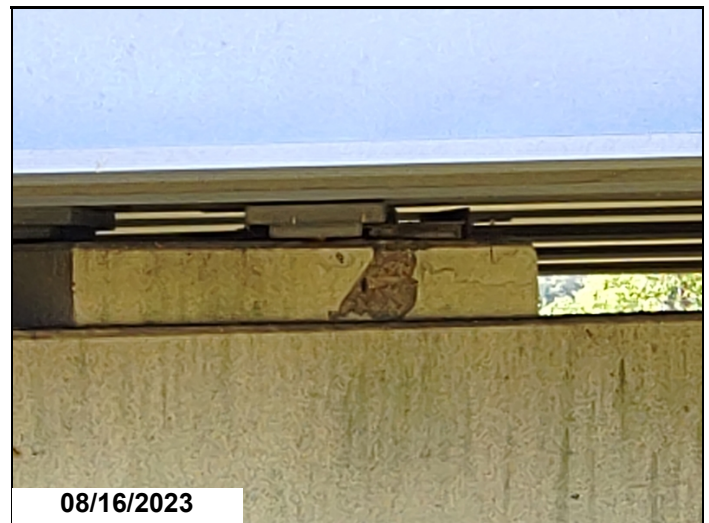
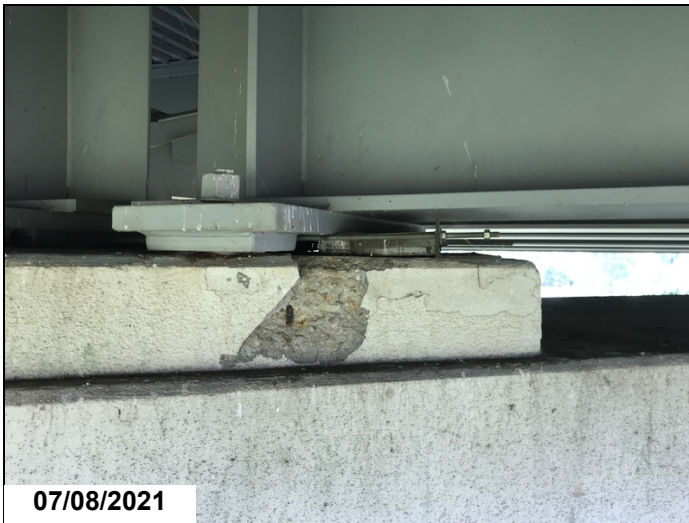
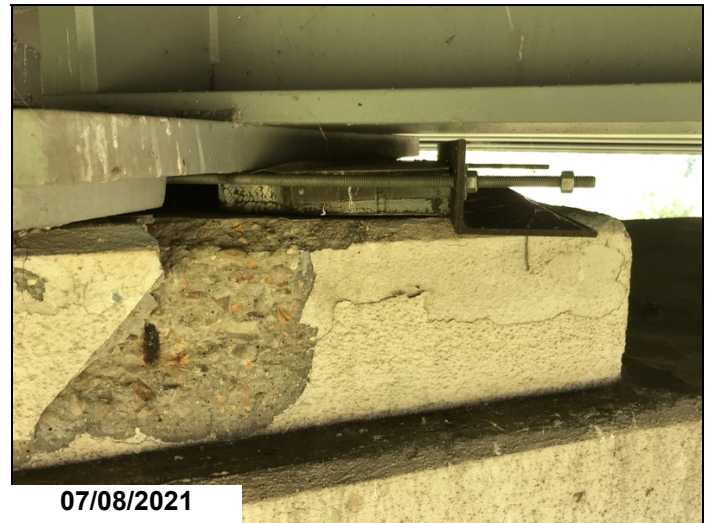
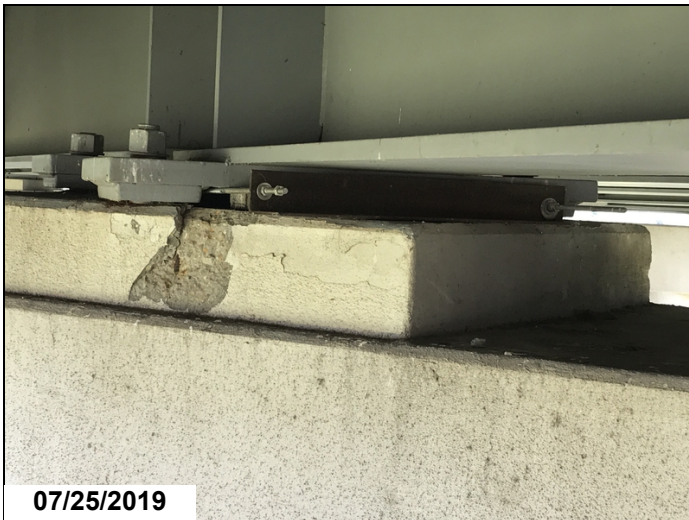
Span 4 bent 5 bearing 3 2023

(303) minor debris impaction							
310	Elastomeric Bearing	EA	80	73	0	5	2
2220	Alignment	EA	7	0	0	5	2
(310) Span 1 bent 1 bearing 8 elastomeric pad has rotated and shifted up to 6" under sole plate. Pad is still under sole plate, but misaligned. Span 4 bent 5 bearing 3 elastomeric pad has rotated out from under sole plate. Pad has shifted and only 2" remains under sole plate. Angles placed at bearing to hold pad in place are loose. Span 4 bent 5 bearing 4 elastomeric pad has shifted 2" from under sole plate. Angles were placed around bearing to hold pad in place in the past. Span 4 bent 5 bearing 8 elastomeric pad has shifted 6" from under bearing plate. Span 5 bent 5 girder 6 elastomeric pad has only a 3" corner remaining under sole plate, pad has almost completely rotated out from under plate. Angles placed at bearing to hold pad in place are unattached. Span 5 bent 5 girder 8 elastomeric pad has shifted/rotated 2" from under sole plate.

Span 4 bent 5 bearing 3 elastomeric pad has rotated out from under sole plate. Pad has shifted and only 2" remains under sole plate. Angles placed at bearing to hold pad in place are loose.

**Type of Work:** Bearing Repair/Replacement

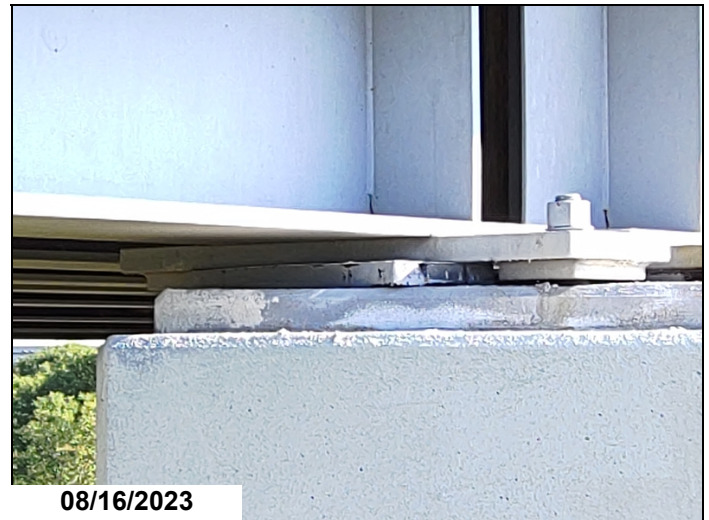
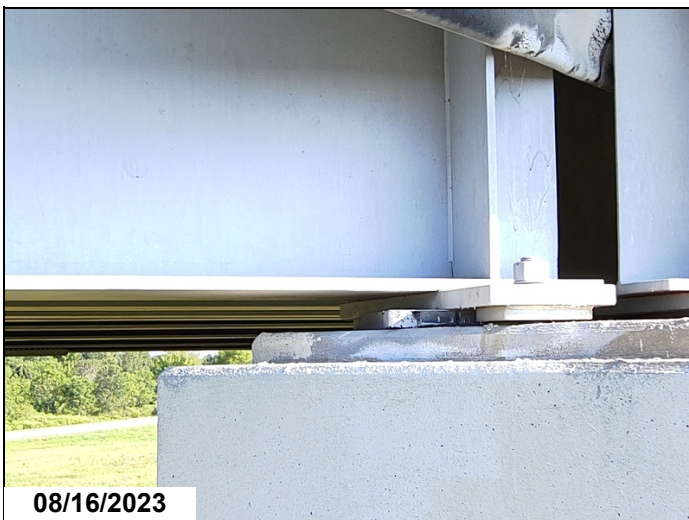
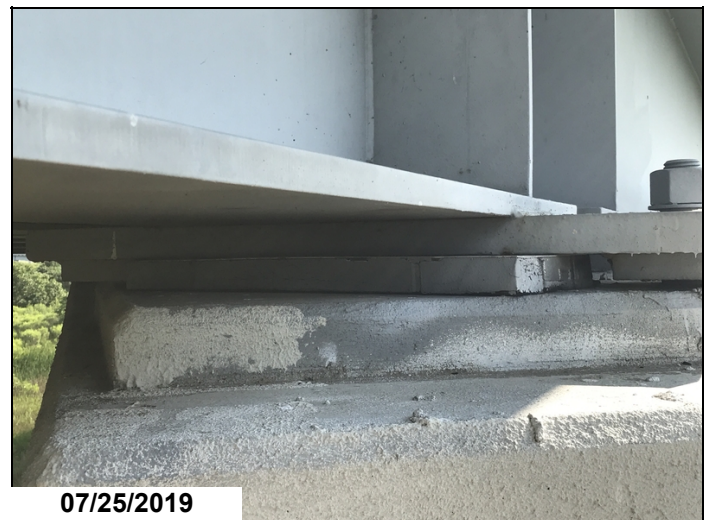
Span 4 bent 5 bearing 8 2023

Span 4 bent 5 bearing 8 elastomeric pad has shifted 6" from under bearing plate.

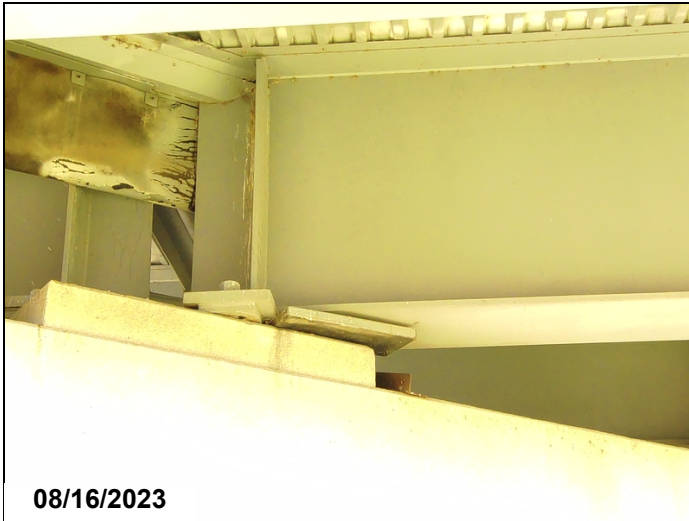
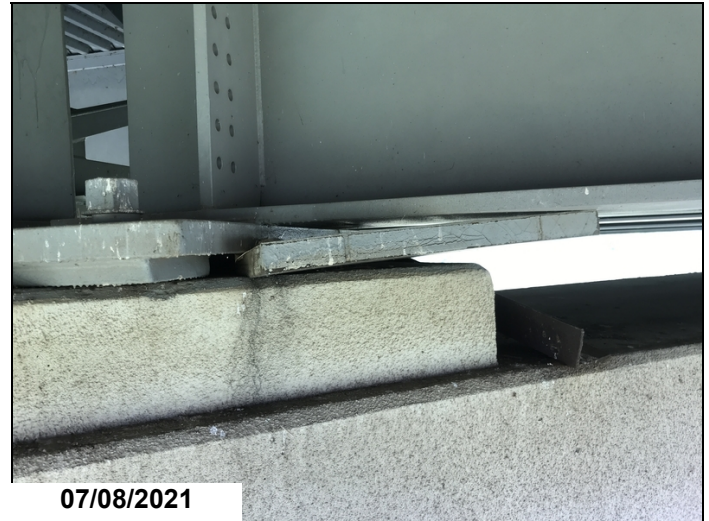
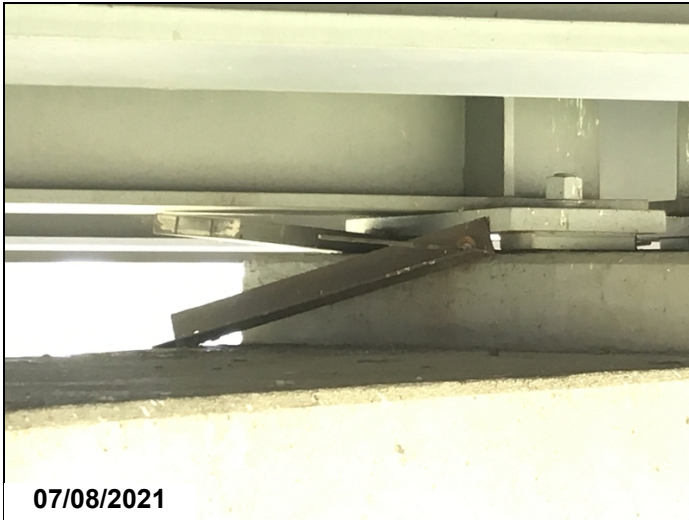
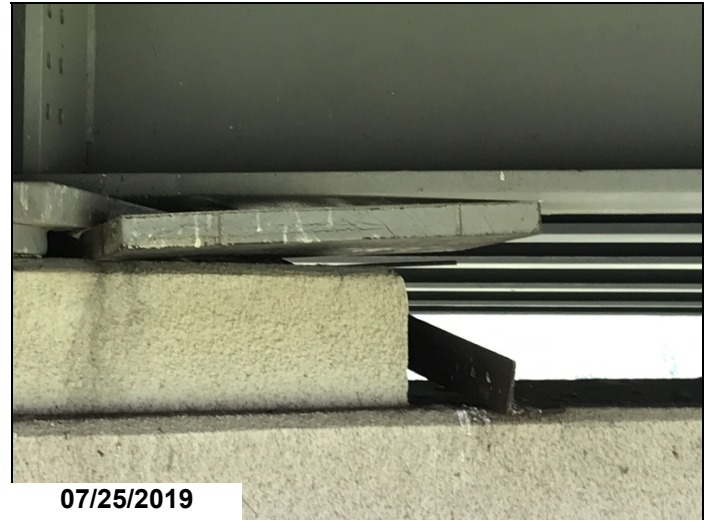
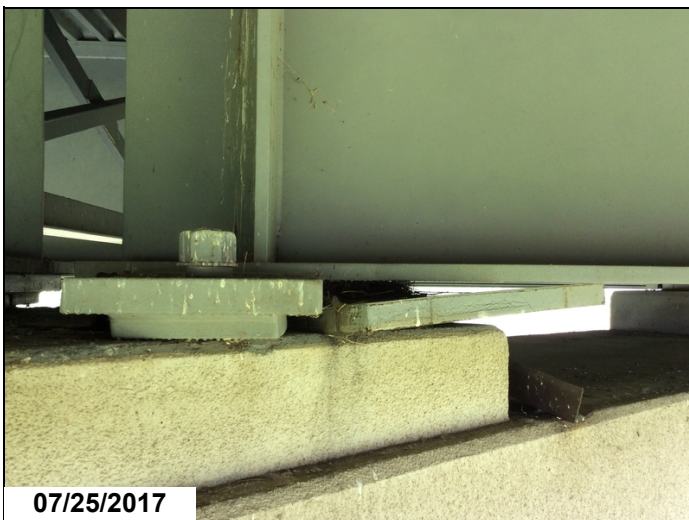
Span 5 bent 5 bearing 6 2023

Span 5 bent 5 girder 6 elastomeric pad has only a 3" corner remaining under sole plate, pad has almost completely rotated out from under plate. Angles placed at bearing to hold pad in place are unattached.

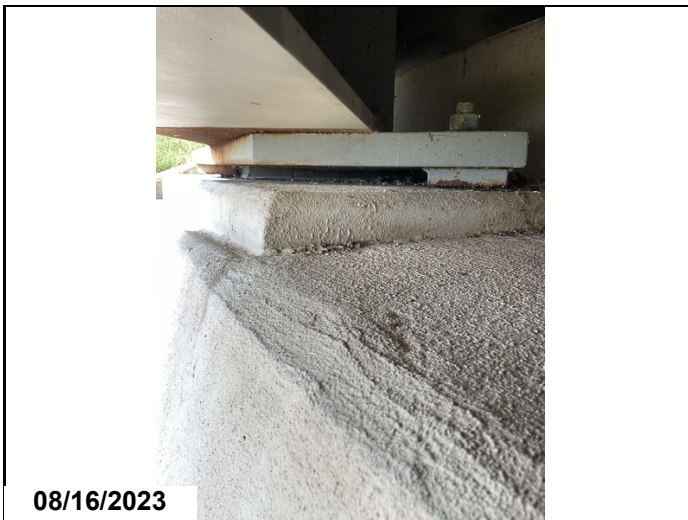
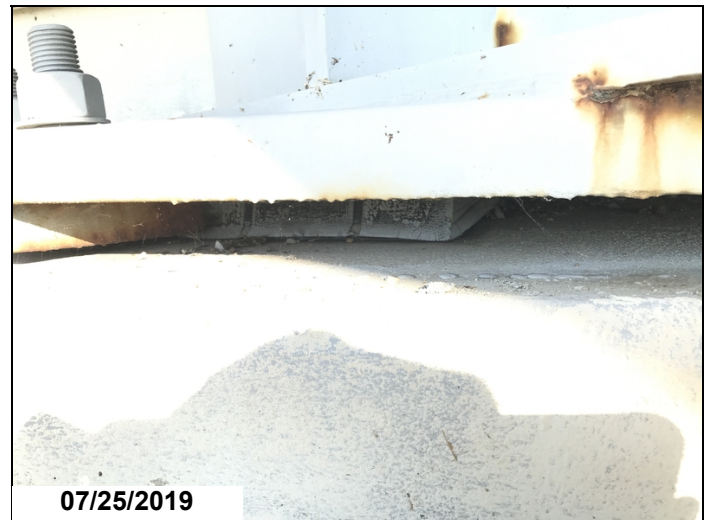
Span 1 bent 1 bearing 8 2023

Span 1 bent 1 bearing 8 elastomeric pad has rotated and shifted up to 6" under sole plate. Pad is still under sole plate, but misaligned.

Span 1 Bent 1 bearing 8 twisted 2019

**Type of Work:** Bearing Repair/Replacement

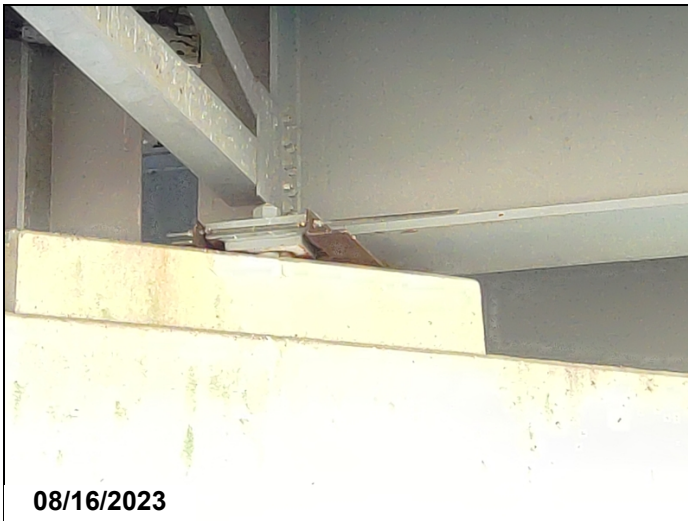
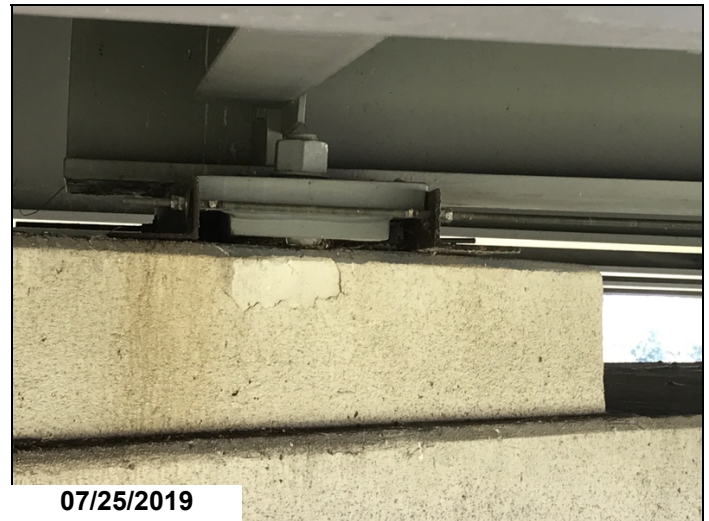
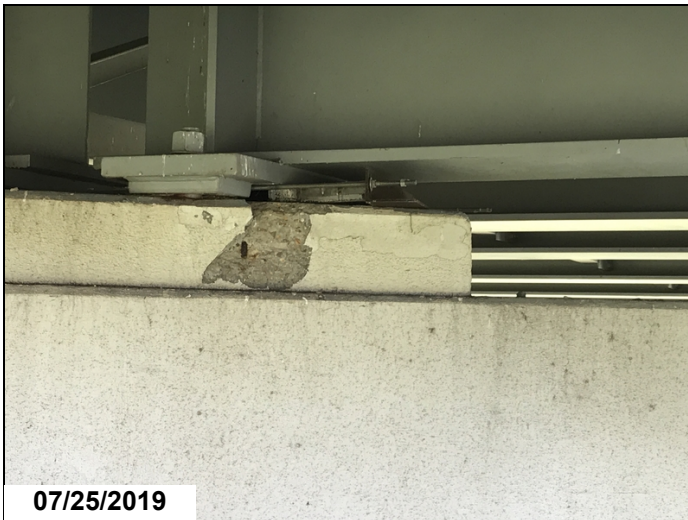
Span 4 bent 5 bearing 4 2023

Span 4 bent 5 bearing 4 elastomeric pad has shifted 2" from under sole plate. Angles were placed around bearing to hold pad in place in the past.

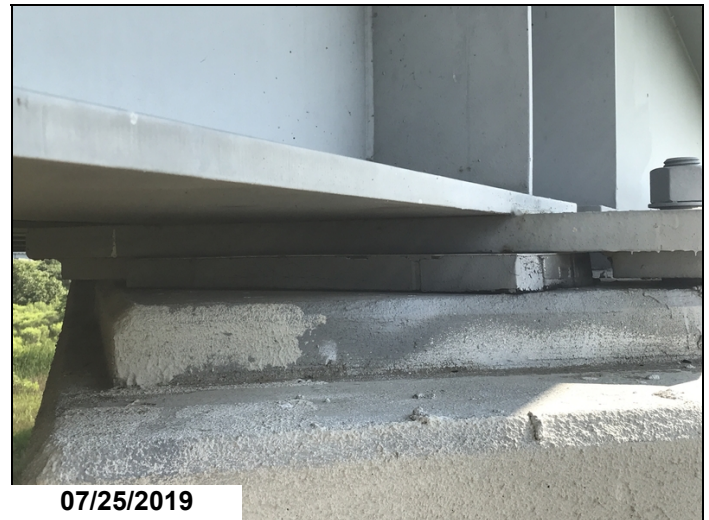
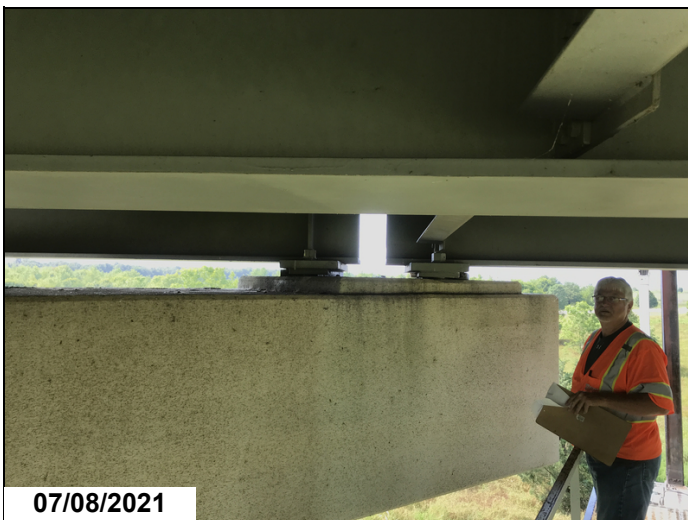
Span 4 bent 5 bearing 8 both moving 2021

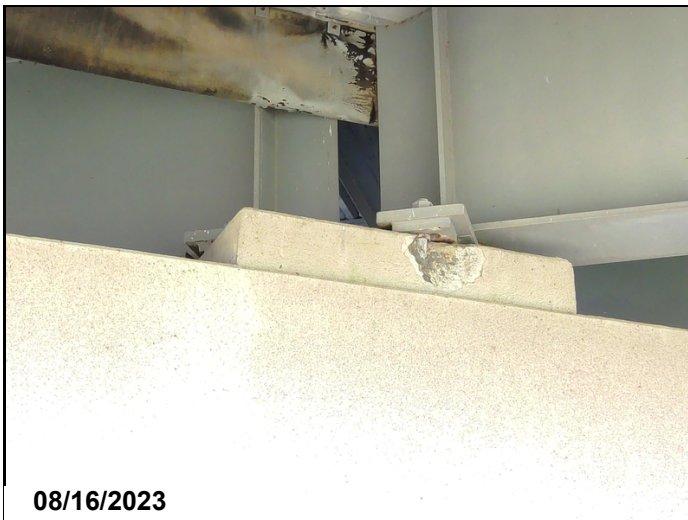
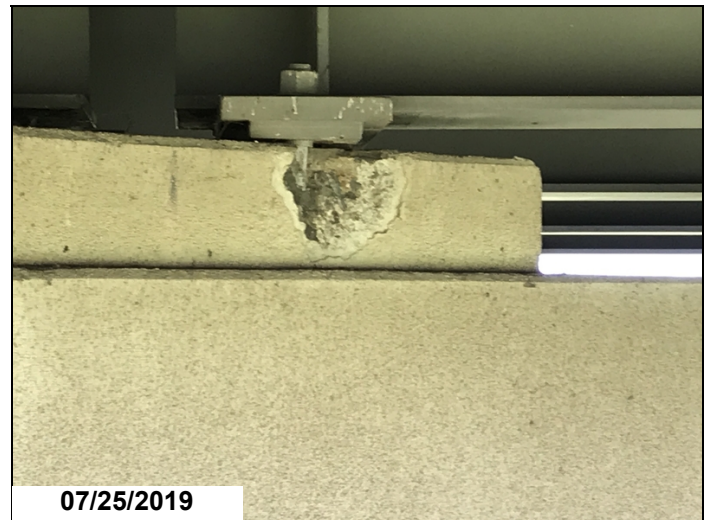
Span 5 bent 5 girder 4 - 2023

Bent 5 riser under girder 4 on ahead side has a 1' x 6" spall with a portion of anchor bolt exposed.

Type of Work: Repair (General)

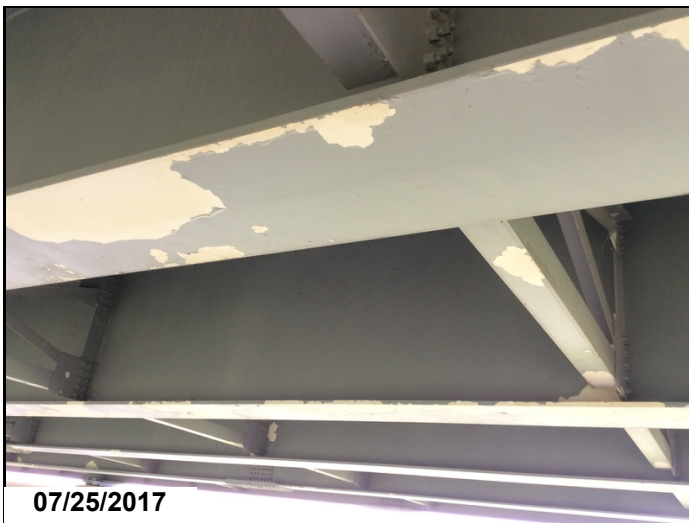
07/25/2017

peeling paint

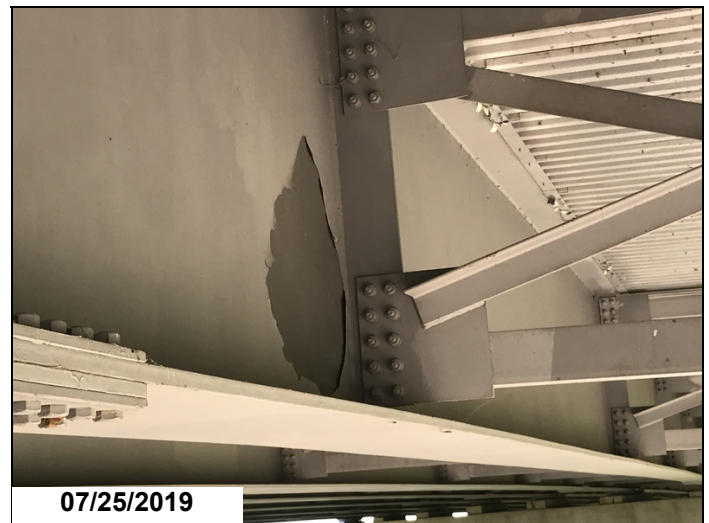
07/25/2019

Span 3 girder 7 near splice paint 2019

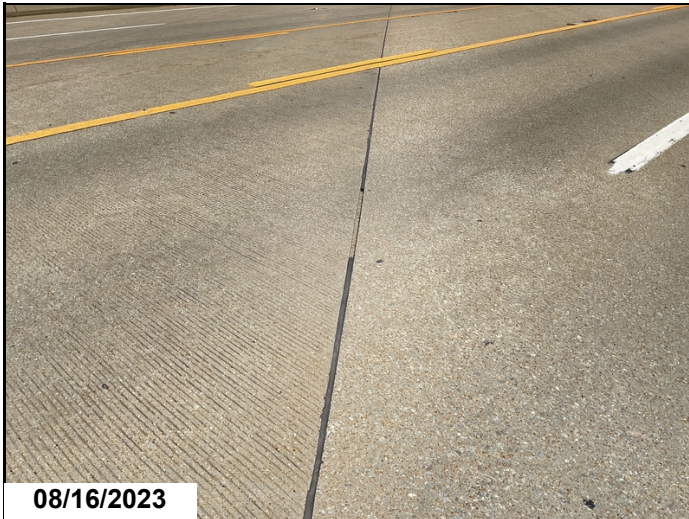
Saw cut joint

Deck has several minor unsealed cracks. Deck has areas of minor abrasion in wheel path and a few scattered pop outs. Poured joint material over saw cut joints has loss of adhesion with some sections missing. SIP forms have areas of rust and section loss under saw cut joints

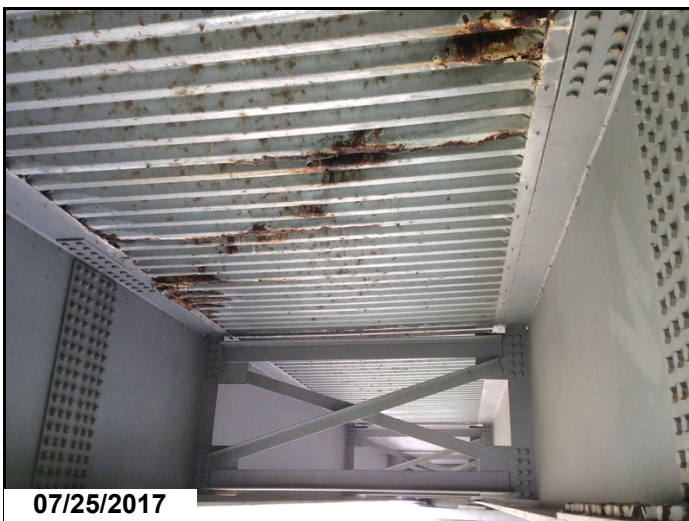
typical soffit under saw cut joints

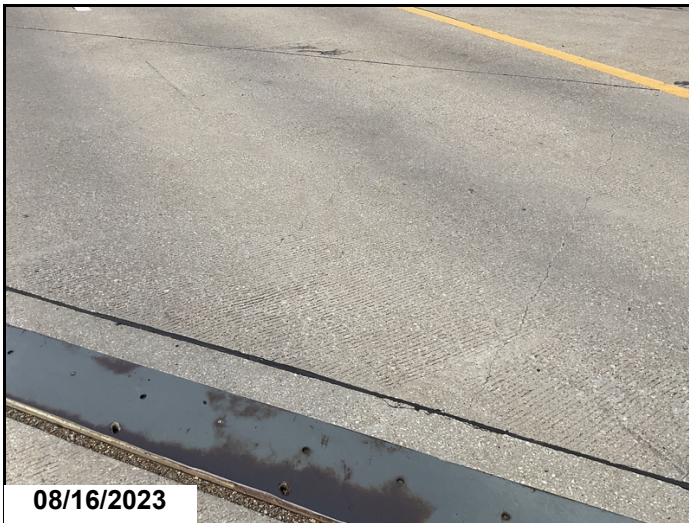
Approach slabs have numerous unsealed diagonal cracks.

Approach slab cracks

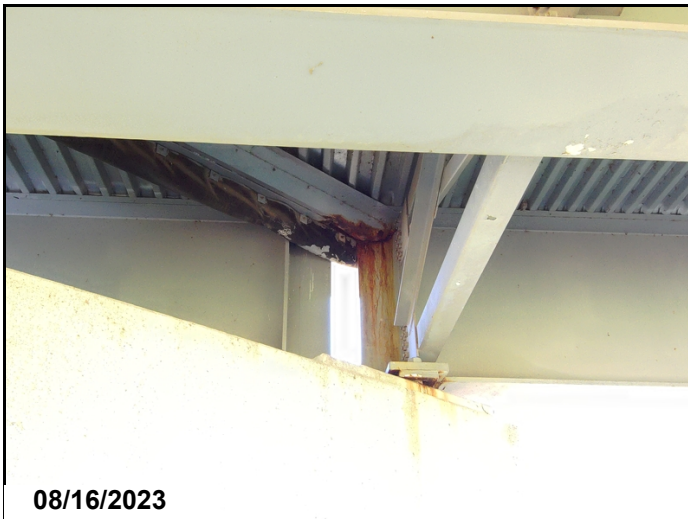
Span 5 bent 5 girder 1 has streaking rust at end of web. Web below haunch has flaking rust with some section loss.

Bearing sole plate has some corrosion.
