**Asset #05726**(Routine, Underwater type 2)

**US 412-06B-LM 2.18 over SWAN POND DITCH**

**Location: 2.18 MI E US 63**

**Team Lead: Richard Jones Inspection Date: 07/05/2023**

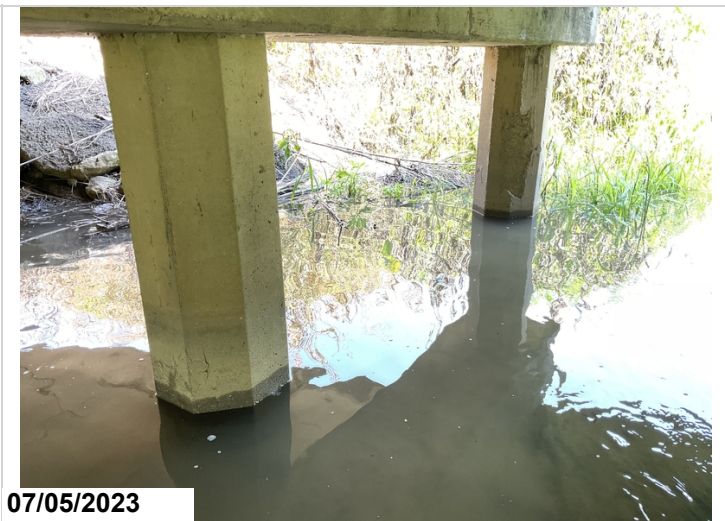
Bent 2 piles 1 and 2

(227) A few piles have chips/edge spalls.							
234	Reinforced Concrete Pier Cap	LF	93	83	4	6	0
1130	Cracking (RC and Other)	LF	10	0	4	6	0
(234) Caps have a few minor cracks.							
301	Pourable Joint Seal	LF	182	10	172	0	0
2320	Seal Adhesion	LF	172	0	172	0	0

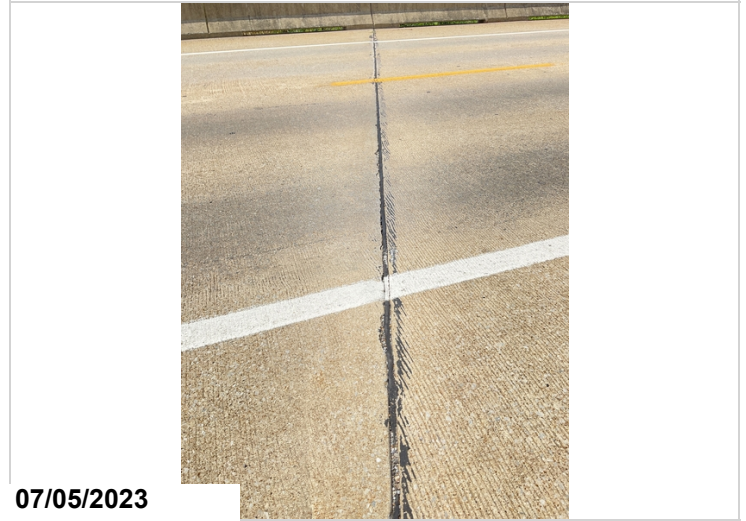
Bent 3 joint

(301) Poured joint material has loss of adhesion. Slabs have a few small spalled areas along joints.							
321	Reinforced Concrete Approach Slab	SF	1080	903	125	52	0
1080	Delamination/Spall/Patched Area	SF	1	0	0	1	0
1130	Cracking (RC and Other)	SF	111	0	60	51	0
1190	Abrasion/Wear (PSC/RC)	SF	65	0	65	0	0

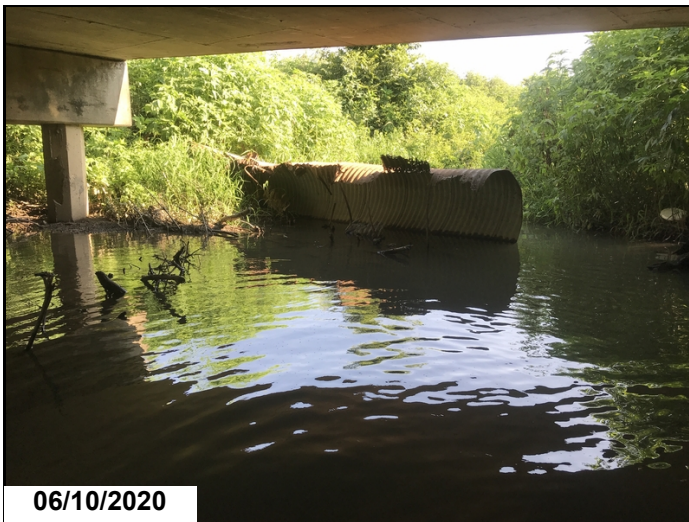
Span 2 pipe LT SIDE

Large drift upstream side backed up about 30' and beaver damn upstream of brush pile restricting flow. Brush and debris under Bridge Spans 1&2.

To Lawrence Co crew for removal this fall KAW 7/30/19

Drift and pipe have been removed. observed during routine inspection. RRJ

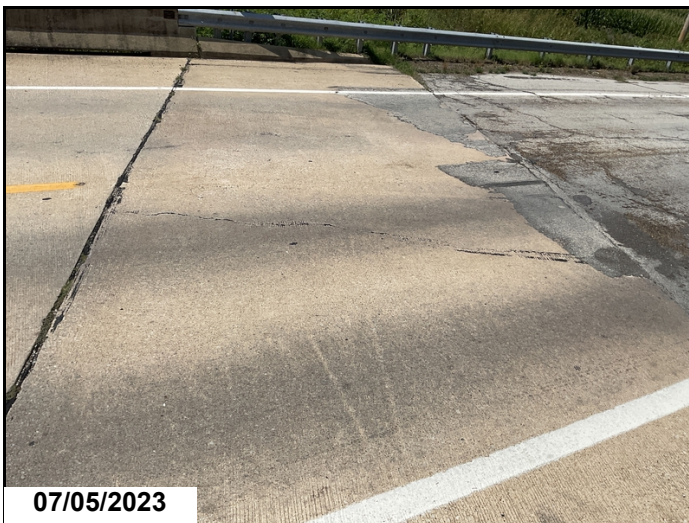
Bent 1 approach slab

Approach slabs have few unsealed longitudinal cracks and areas of abrasion.

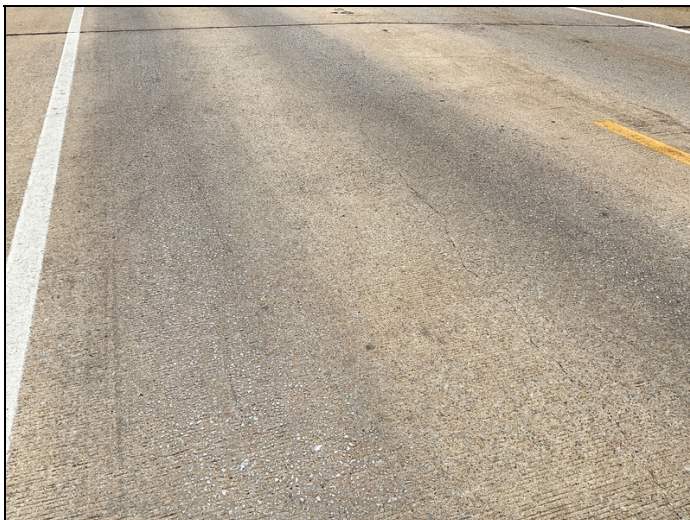
Span 1

(38) Top of slabs have several unsealed longitudinal cracks. Slabs have widespread abrasion, especially in wheel paths.							
Soffit portion of slabs has several delaminated areas or spalls with rebar exposed along edges. Slabs have a few longitudinal cracks with efflorescence or rust stains.							
215	Reinforced Concrete Abutment	LF	104	11	0	93	0
6000	Scour	LF	93	0	0	93	0

### A-54 - Sealable Deck Cracks (Yes)

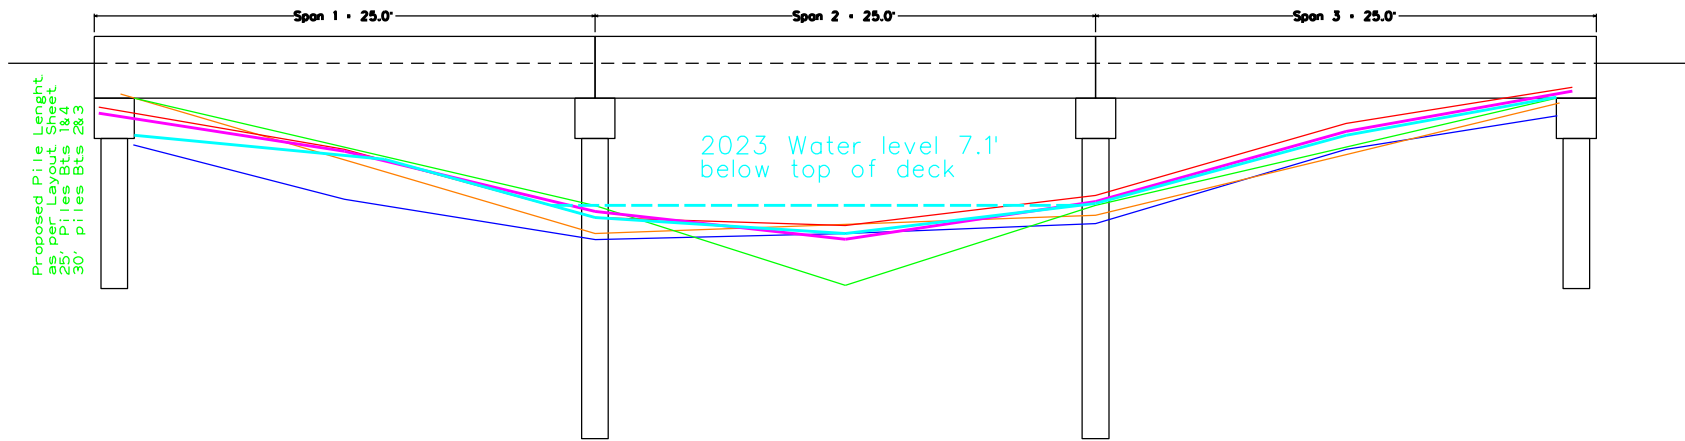
05726 Overall Length=75.0'

Channel Sounded From Top of Deck, UPSTREAM, LEFT SIDE  
 Green Sounding Readings are From Lay Out Sheet  
 Blue Sounding Readings are From 8-20-1990 (First Time)  
 Gold Sounding Readings are From 7-23-2009  
 Red Sounding Readings are From 7-03-2014  
 Purple Sounding Readings are From 7-8-2019  
 Light Blue Sounding taken 7-5-2023
