Route:412 Section:06 Log:0.89

Arnold Road ID:38x412x6BxA, Arnold Log mile:0.892

**Asset #05725**(Routine, Underwater type 2)  
**US 412-06B-LM 0.89 over RUNNING WATER CREEK**  
**Location: .89 MI E US 63**  
**Team Lead: Richard Jones Inspection Date: 07/05/2023**

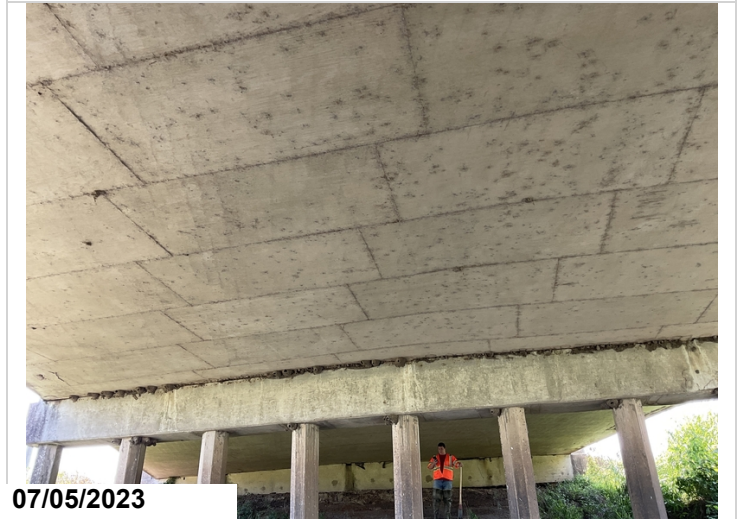
Span 2 soffit

(38) Top of slabs have several unsealed longitudinal cracks. Slabs have widespread abrasion, especially in wheel paths. Soffit portion of slabs has several delaminated areas or spalls with rebar exposed along edges. Slabs have a few longitudinal cracks with efflorescence or rust stains.							
215	Reinforced Concrete Abutment	LF	122	71	1	50	0
1130	Cracking (RC and Other)	LF	1	0	1	0	0
6000	Scour	LF	50	0	0	50	0

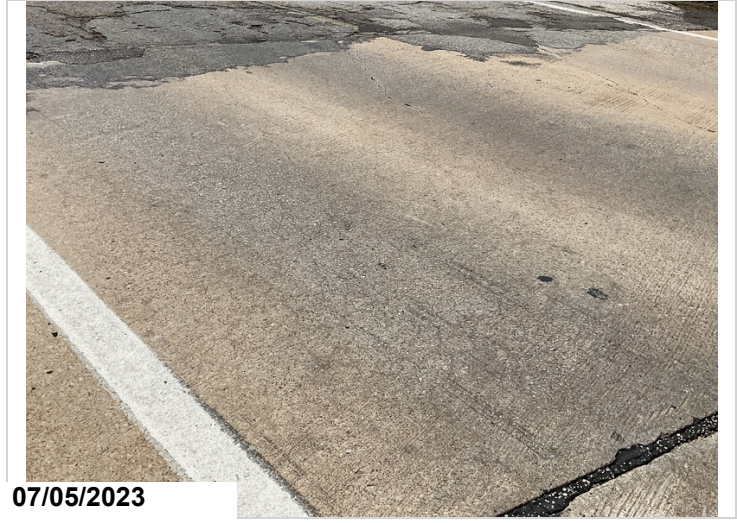
Bent 4 approach slab

(321) Approach slabs have few unsealed longitudinal cracks.

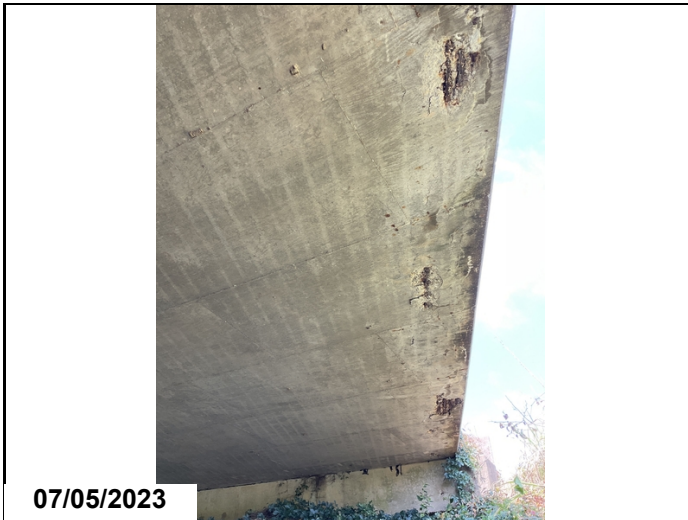
Span 1 Lt

Soffit portion of slabs has several delaminated areas or spalls with rebar exposed along edges. Slabs have a few longitudinal cracks with efflorescence or rust stains.

**Type of Work:** Repair (General)

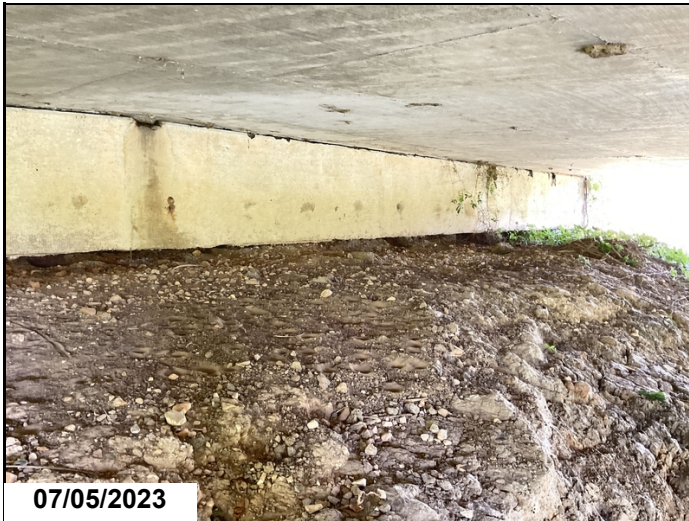
2023 - Bent 1

Bent 1 abutment is undermined up to 1' below and 2.5' back under. Some riprap was added to embankment on Lt end sometime in the past.

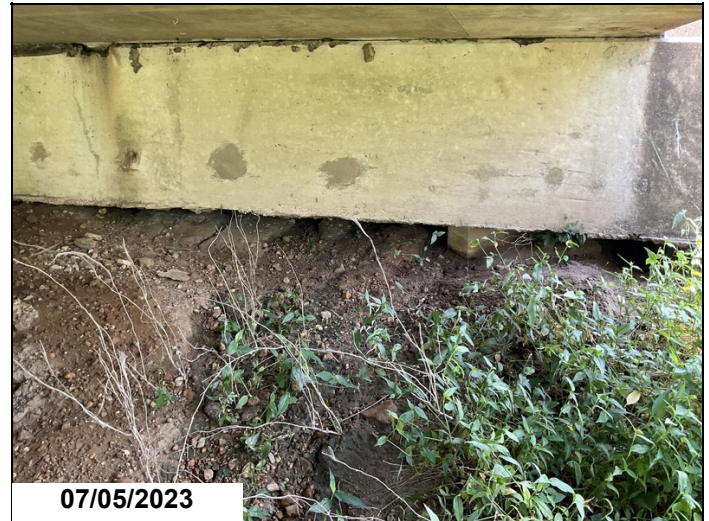
2023 - Bent 4

Bent 4 abutment is undermined near Rt end up to 1' below and 2.5' back under.

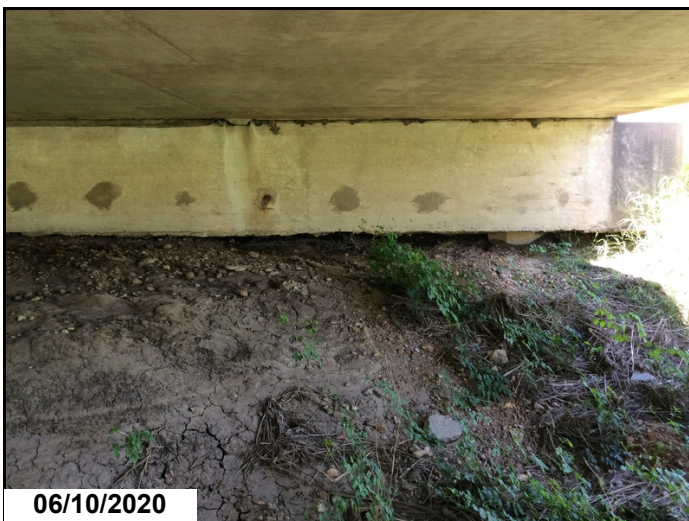
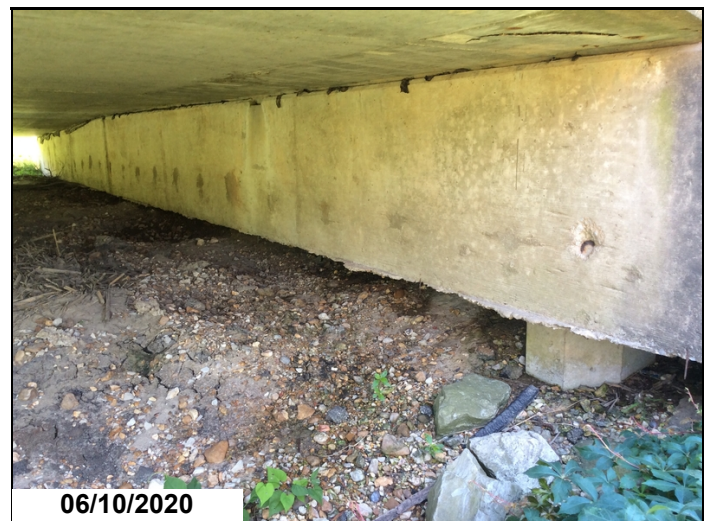
undermining

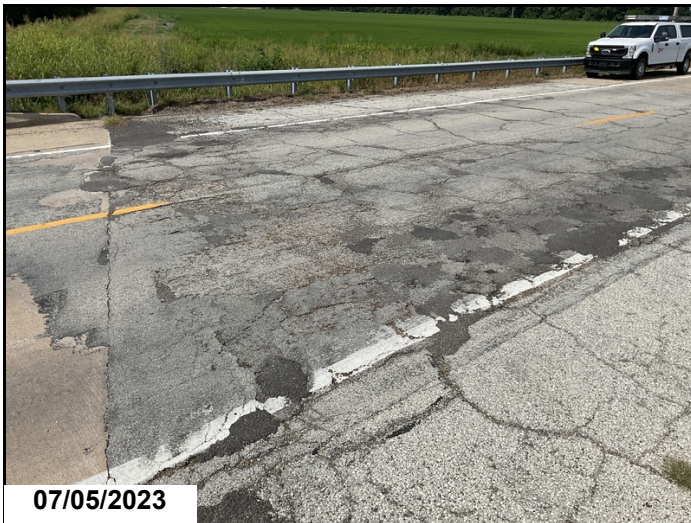
Approach roadway asphalt has settlement at ends of approach slabs. Asphalt is cracked with several potholes.

Bent 1 approach at end of approach slab

**Type of Work:** Approach Leveling/Maintenance

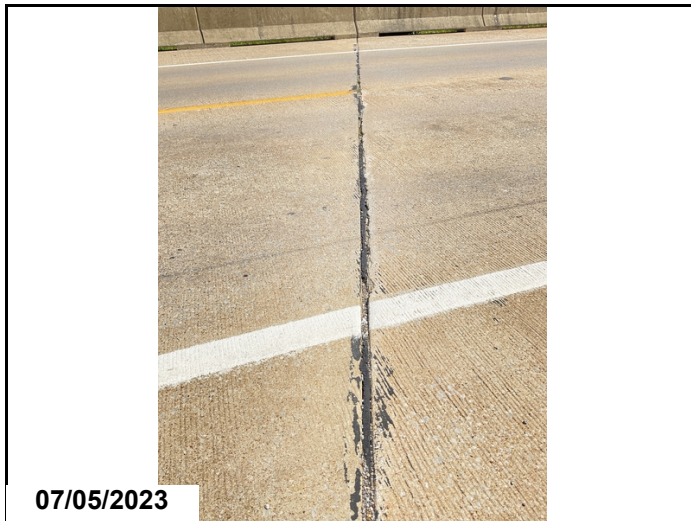
Bent 3 joint

Poured joint material has loss of adhesion with some sections missing.

**A-59 - Joint Repair Needed (Yes)**

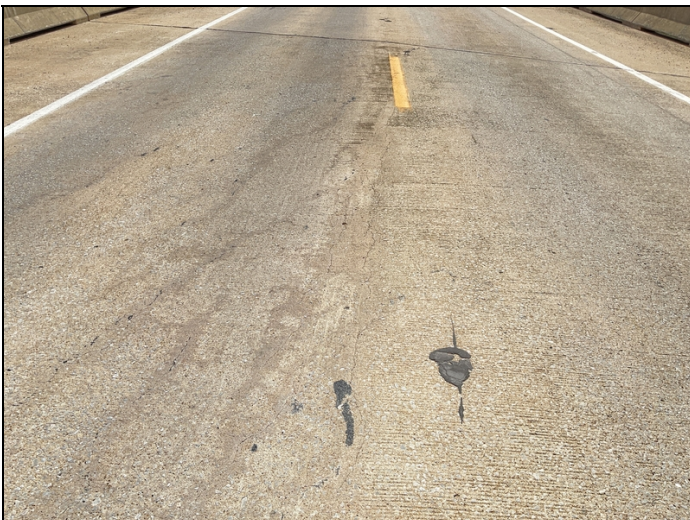
Span 1

### A-54 - Sealable Deck Cracks (Yes)

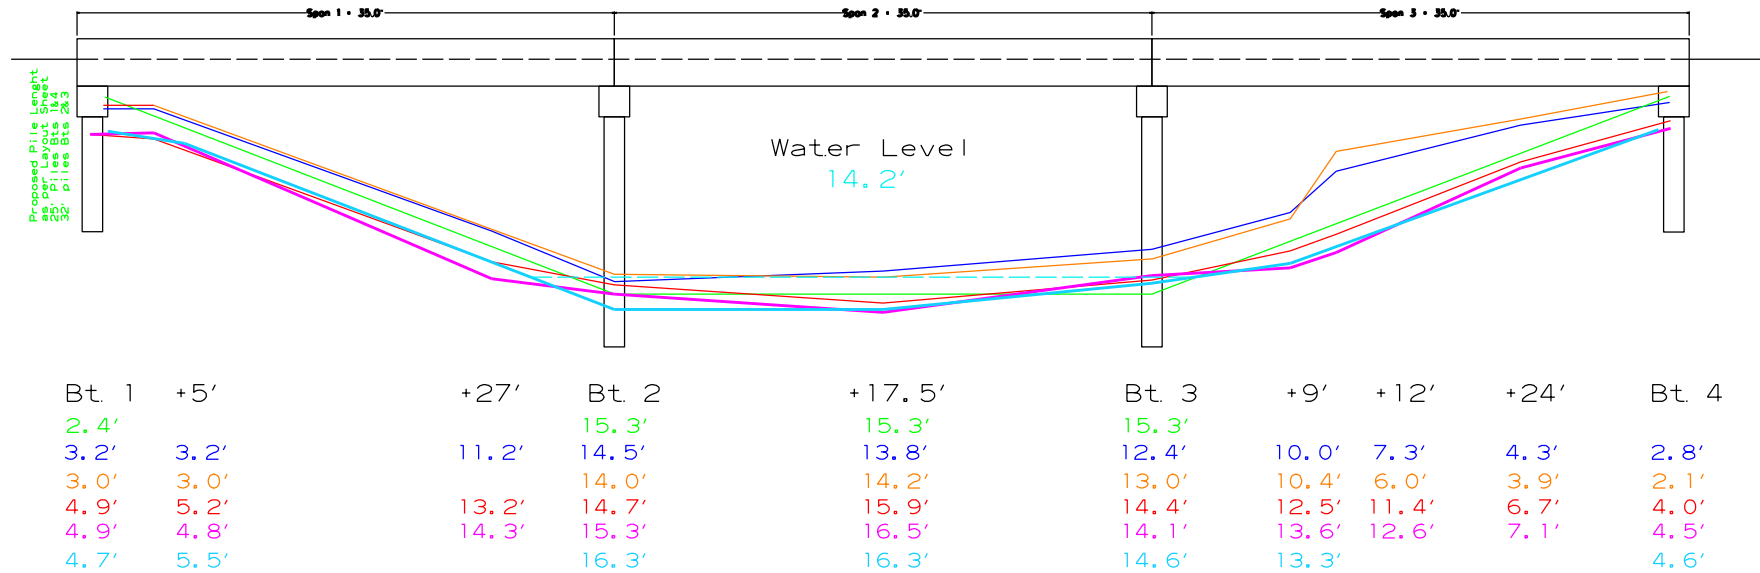
05725 Overall Length=105.0'

Channel Sounded From Top of Deck, LEFT SIDE, UPSTREAM  
 Green Sounding Readings are From Lay Out Sheet  
 Blue Sounding Readings are From 8-20-1990 (First Time)  
 Gold Sounding Readings are From 7-23-2009  
 Red Sounding Readings are From 7-03-2014  
 Loss of Pile Penetration Since 2009: Bt.1=2.9', Bt. 4=2.9'  
 Purple Sounding Readings are From 7-8-2019  
 Light Blue Sounding taken 7-5-2023
