**Asset #05727**(Routine, Underwater type 2)

**US 412-06B-LM 3.11 over COON CREEK**

**Location: 3.11 MI E US 63**

**Team Lead: Richard Jones Inspection Date: 09/18/2023**

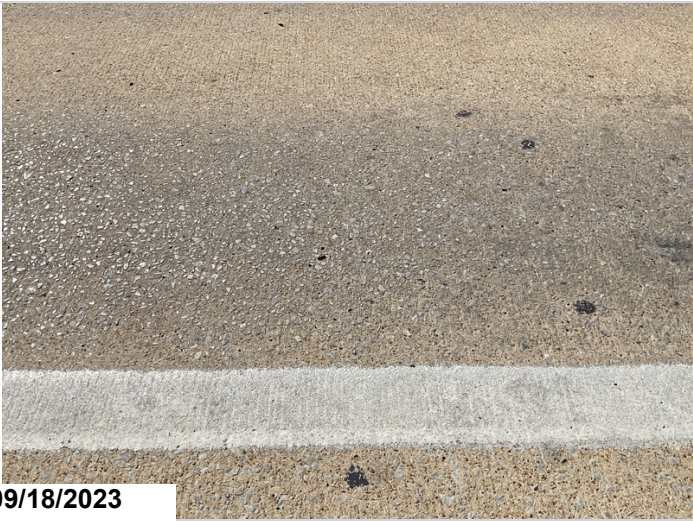
Abrasion

Slabs have unsealed cracks and areas of abrasion.

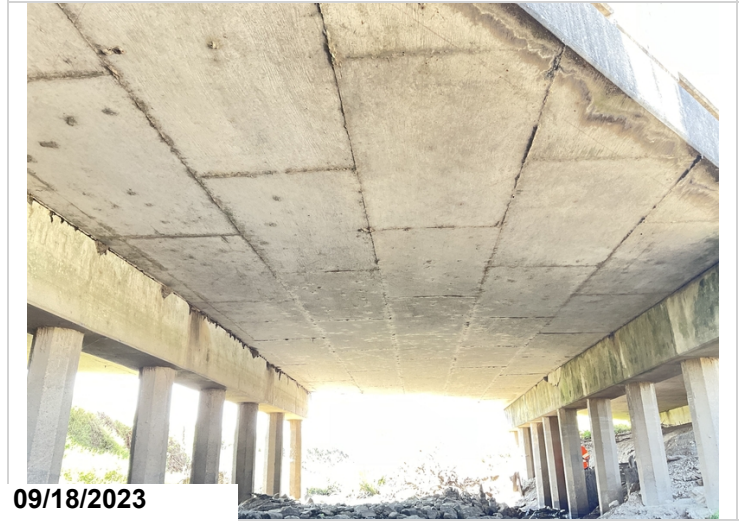
Soffit

Slab soffit has a few minor delaminated areas, mostly along outside edges.

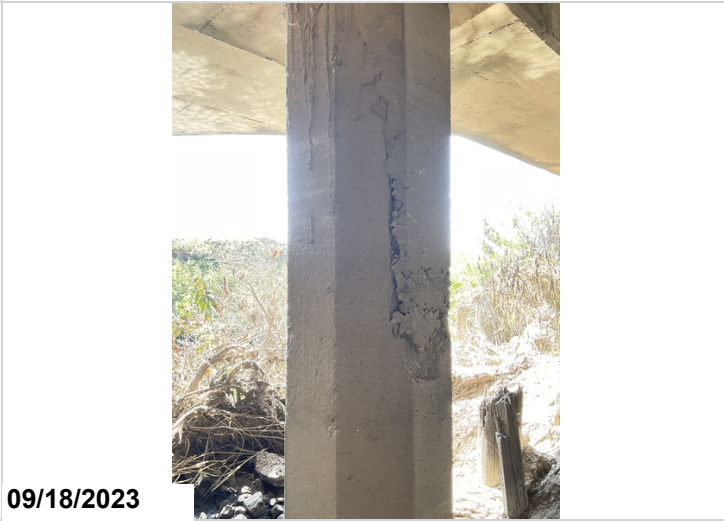
(227) A few piles are exposed at end bents from erosion. Bent 2 pile 7 has a 1' honey/delaminated area.							
234	Reinforced Concrete Pier Cap	LF	126	115	0	11	0
1080	Delamination/Spall/Patched Area	LF	11	0	0	11	0

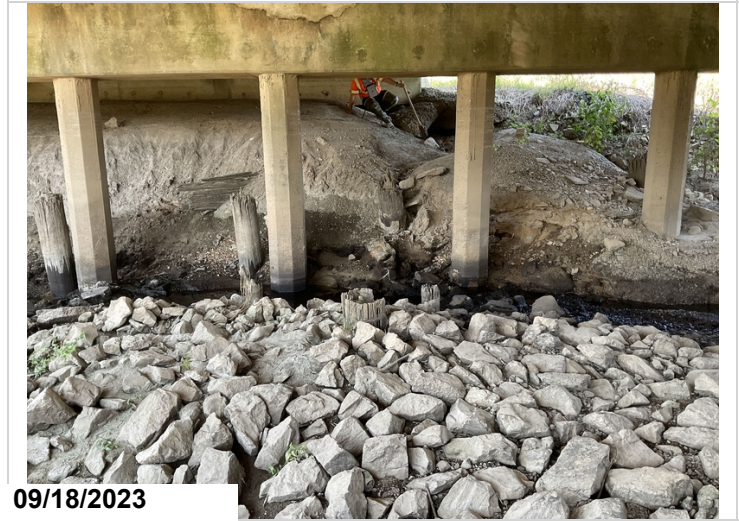
Embankment near bent 2

Embankment has minor erosion at toe of slope near bent 2.

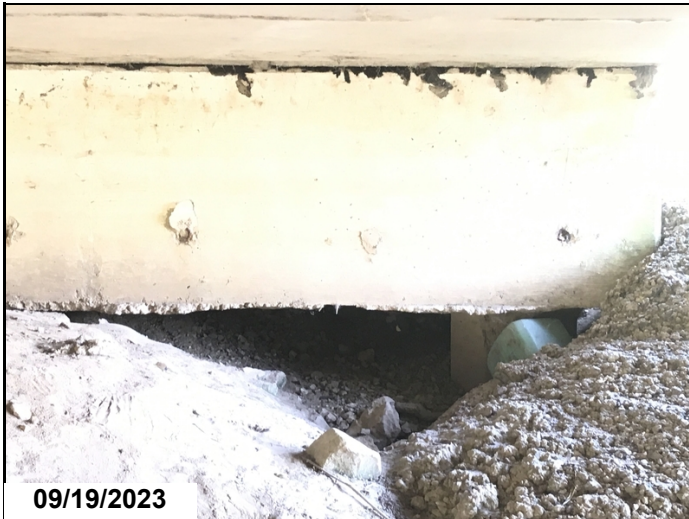
2023 - Bent 1 Lt

Bent 1 abutment is undermined for 6' on Lt end up to 2' below cap.

**Type of Work:** Channel Work/Drift Removal

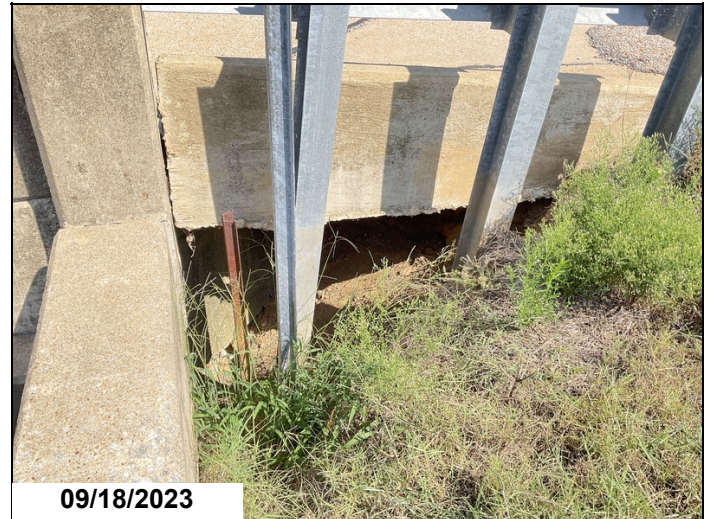
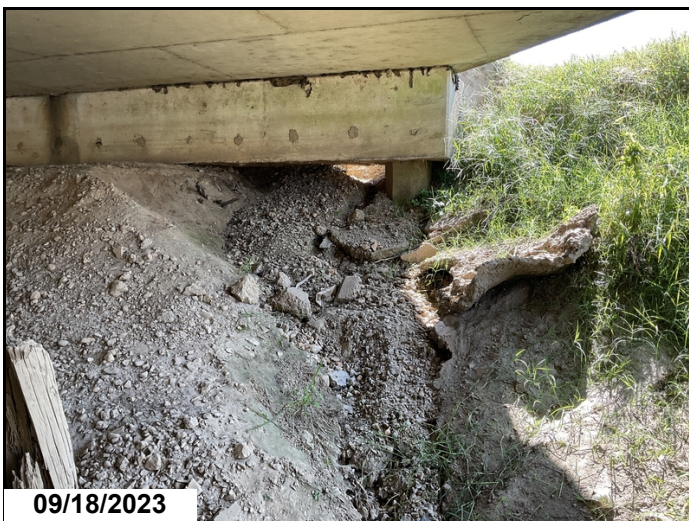
2023 - Bent 4 Rt

Bent 4 abutment is undermined for 8' on Rt end up to 2' below abutment and up to 6' back under. Embankment has eroded back under Rt approach gutter.

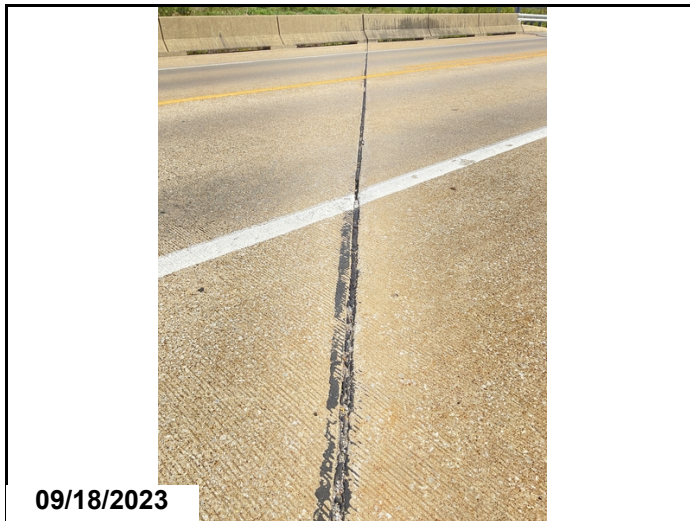
Typical joint

Joint material has loss of adhesion with a few sections missing.

**A-59 - Joint Repair Needed (Yes)**

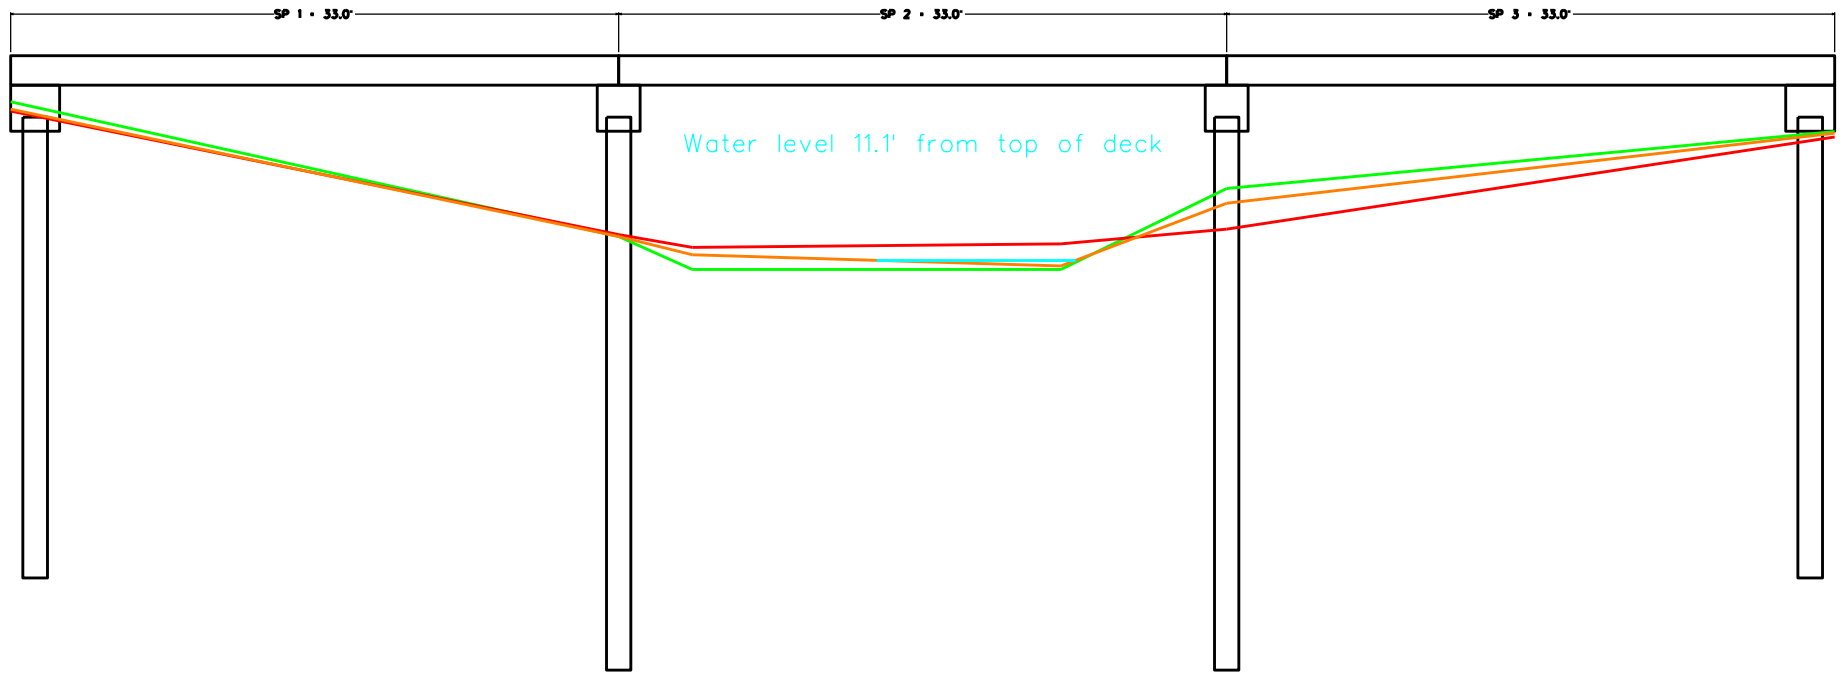
Channel sounded from top of deck, LEFT SIDE

Green soundings taken on 8-20-1990

Red soundings taken on 9-4-2019

Orange soundings taken on 9-18-2023
