Asset #05748(Routine, Underwater type 2)

Sh147/Sec-1/L10.23 over Ten Mile Bayou

Team Lead: Drew Melton Inspection Date: 01/08/2024

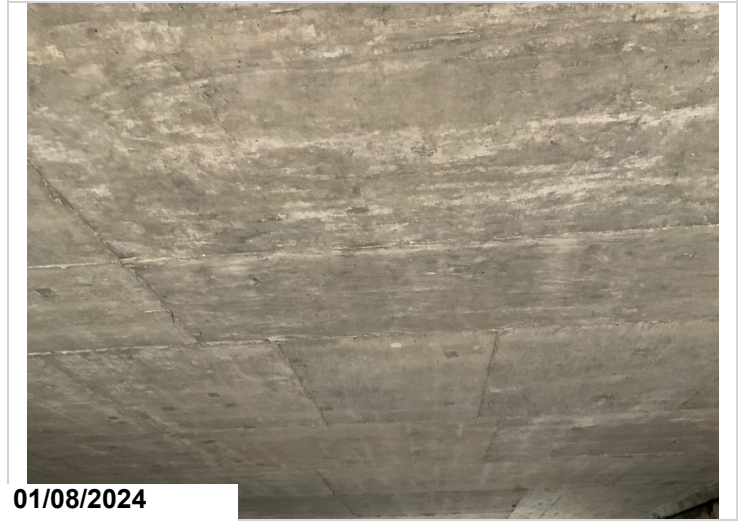
Deck is a slab so deck and superstructure are rated the same. Deck is in good condition with an asphalt overlay. Soffit-under surface has minor cracks.

Typical soffit-under surface

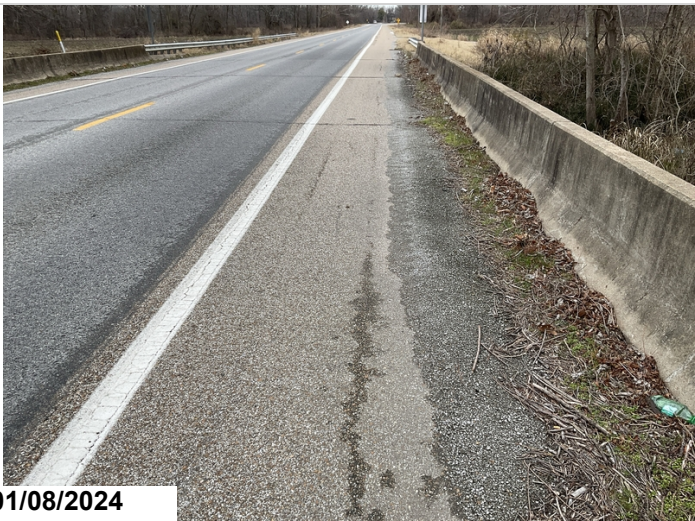
Typical deck

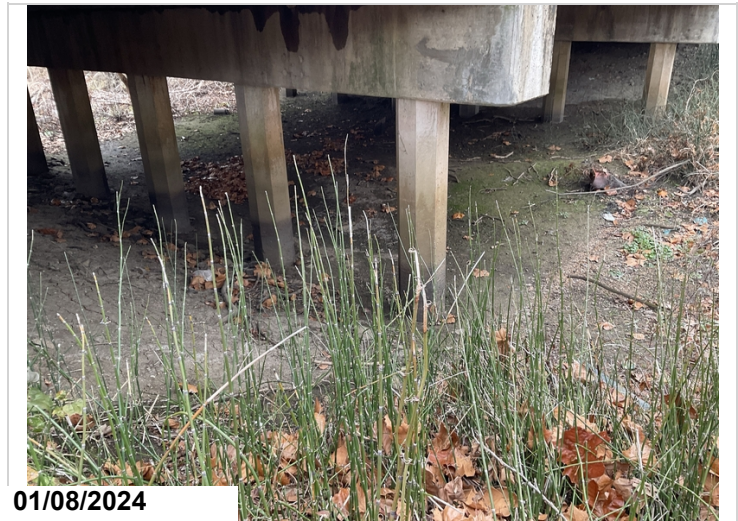
61 - Channel/Channel Protection (6 - Bank is beginning to slump. River control devices and embankment protection have widespread minor damage. There is minor stream bed movement evident. Debris is restricting the channel slightly.)
Channel has good alignment with structure. Banks are vegetated and are in good condition. Channel has vegetation and debris in it with some restriction to water flow rate.

Channel under bridge

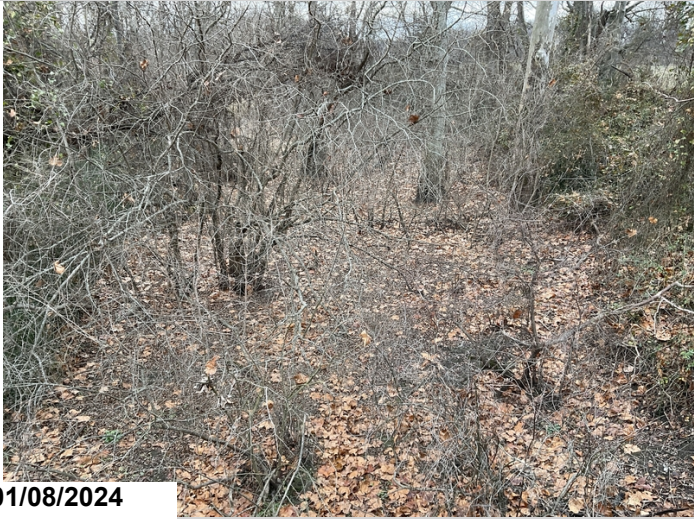
Channel right side

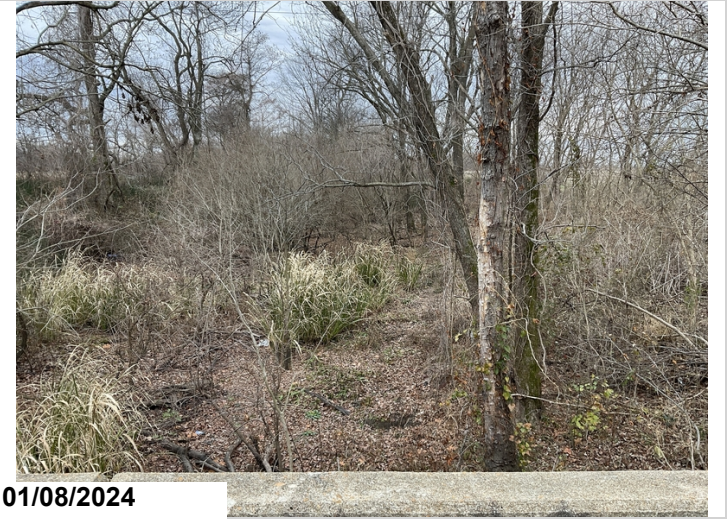
Channel left side

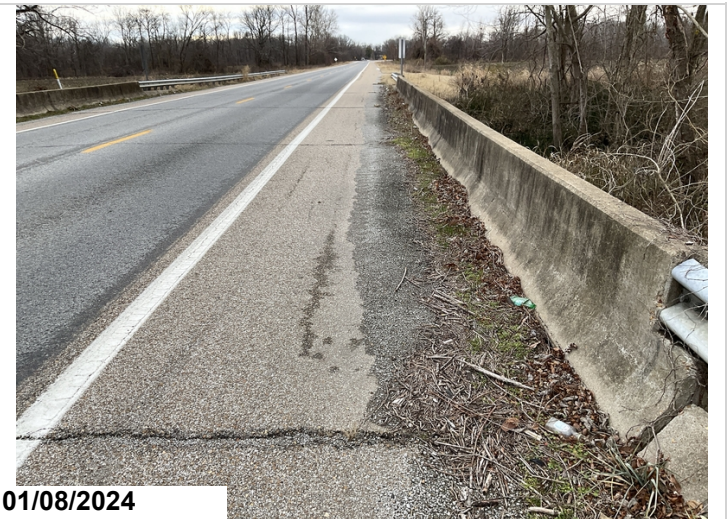
Gutters have dirt and debris in them with drains blocked not allowing water to run off of bridge.

Typical debris in gutters

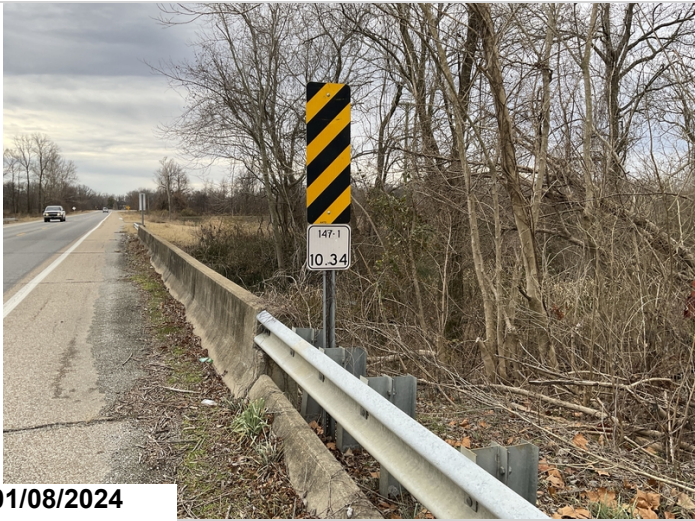
Log mile signs are incorrect and should read Sh-147, Section-1, Log mile 10.23.

Typical log mile sign

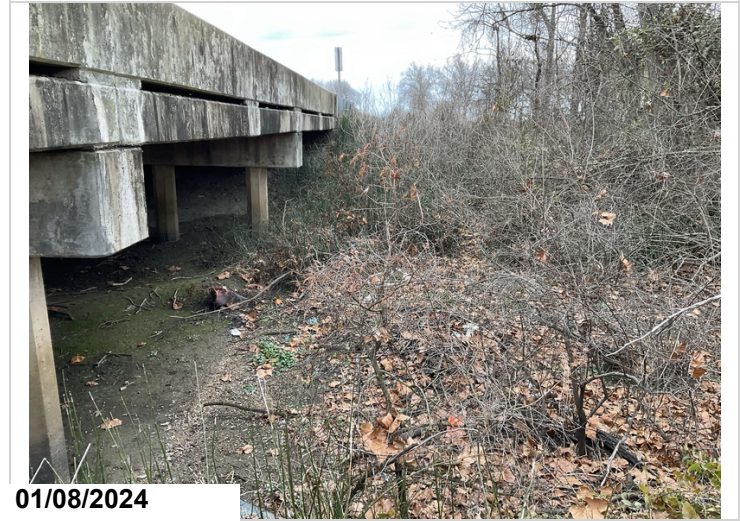
Small trees and vegetation is growing beside and under bridge.

Typical vegetation

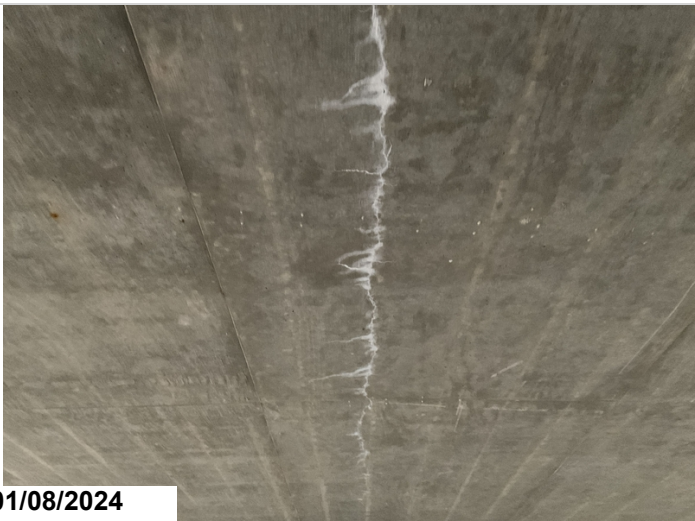
(38) Asphalt is cracked at bents and have several shallow spalls at joints.							
All spans have open longitudinal crack at center line with areas of light efflorescence in soffit-under surface. Slabs at bents have diagonal cracks with efflorescence Sides of slabs have vertical hairline cracks spaced one foot apart. Span #3 slab right side at bent #3 has small spall.							
215	Reinforced Concrete Abutment	LF	109	94	15	0	0
6000	Scour	LF	15	0	15	0	0

Typical soffit-under surface crack in center with efflorescence

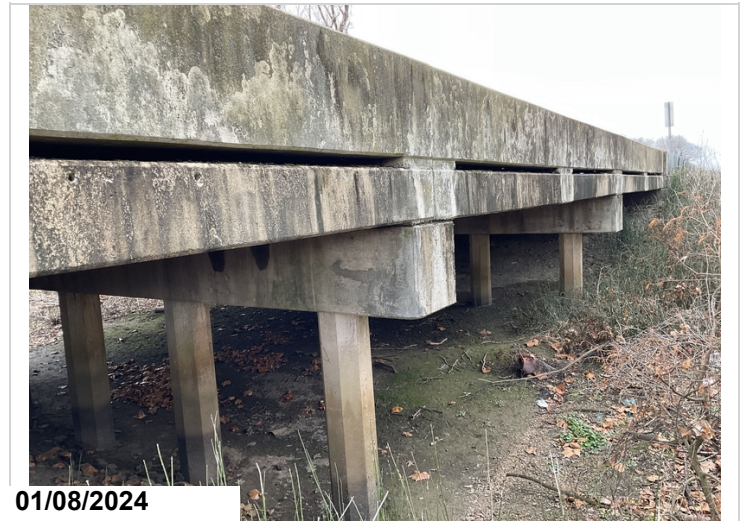
Typical side of slab crack at bents.

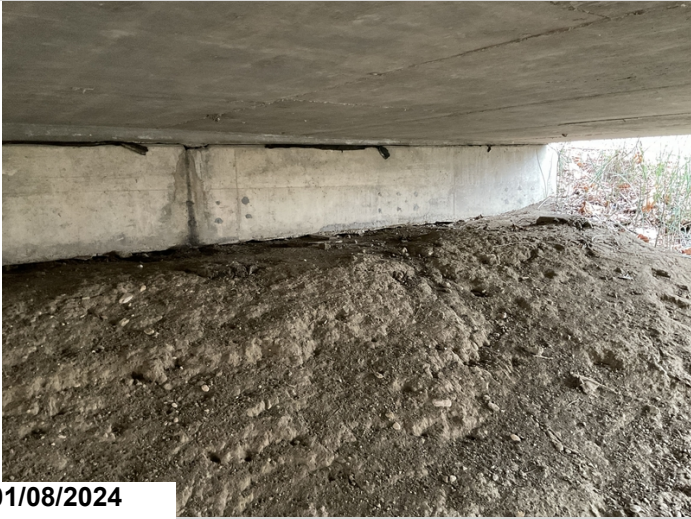
(215) Abutment #1 cap left side undermined up to two-inches for fifteen feet.							
227	Reinforced Concrete Pile	EA	12	12	0	0	0
234	Reinforced Concrete Pier Cap	LF	85	81	4	0	0
1080	Delamination/Spall/Patched Area	LF	2	0	2	0	0
1090	Exposed Rebar	LF	2	0	2	0	0

Abutment #1 cap undermining

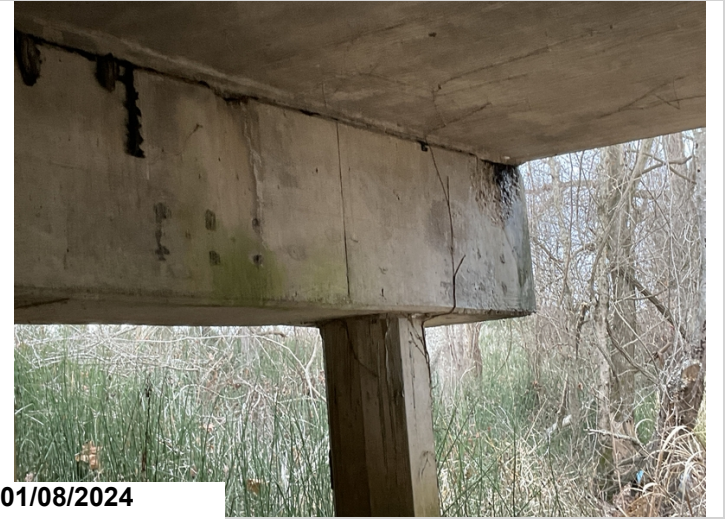
Bent #2 cap ahead face right end

(234) Bent #2 cap ahead face left end has two foot spall with exposed rebar. Bent #3 cap left end back face has a one foot delaminated area at top and right end , top corner is spalled with no exposed rebar.							
301	Pourable Joint Seal	LF	174	12	0	162	0
2350	Debris Impaction	LF	162	0	0	162	0

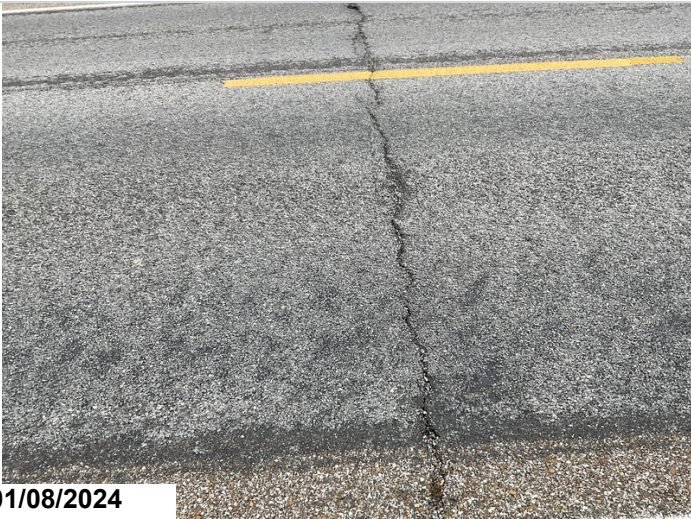
(301) Joint material has failed allowing non compressibles to enter.							
331	Reinforced Concrete Bridge Railing	LF	180	175	5	0	0
1080	Delamination/Spall/Patched Area	LF	1	0	1	0	0
1090	Exposed Rebar	LF	4	0	4	0	0

Typical joint

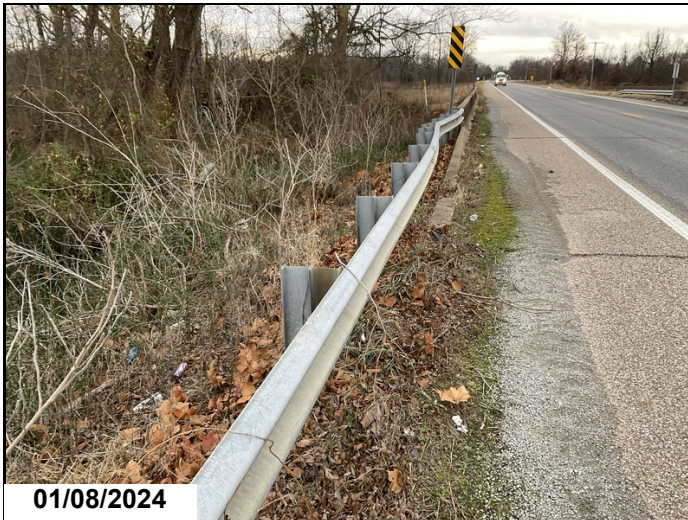
Abutment #2 left approach rail has collision damage sixty feet from bridge end and also at terminal end.
Abutment #2 right approach rail six feet from bridge end approach rail has collision damage.

Abutment #2 right approach rail

Type of Work: Replace (General)

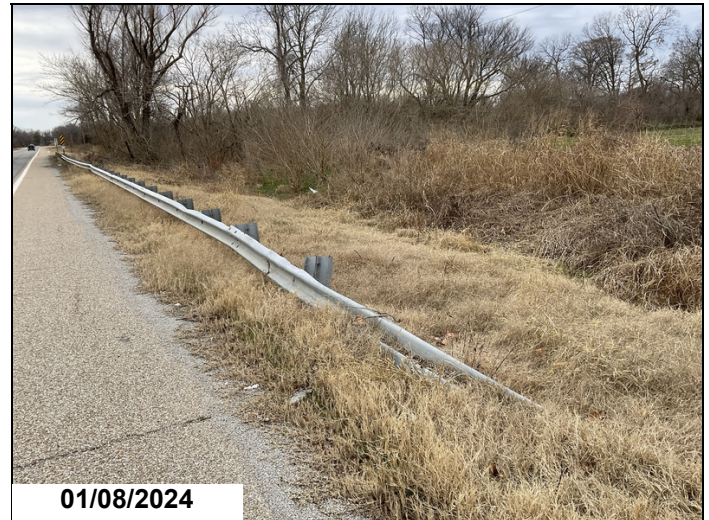
Abutment #2 left side approach rail

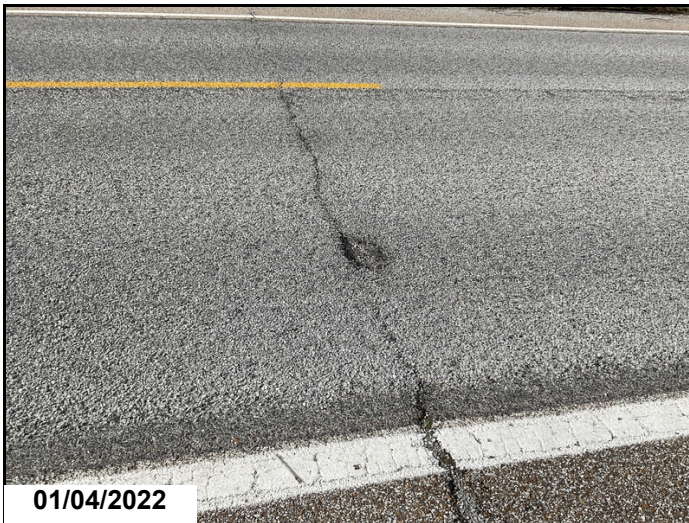
Overlay at joints has several shallow spalls.

Span #3 right lane overlay at joint has a one foot long by five inch wide shallow spall

Type of Work: Repair (General)

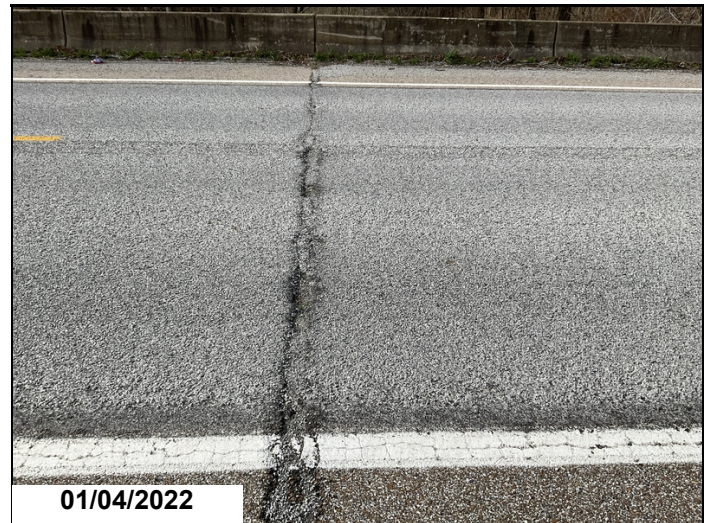
Bent #2 overlay at joint has several shallow spalls

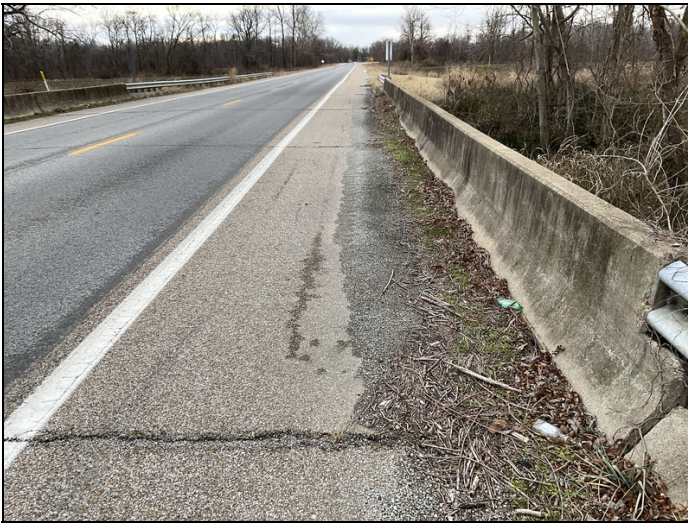
Gutters have dirt and debris in them with drains blocked not allowing water to run off of bridge.

Typical debris in gutters

A-55 - Deck Washing Needed (Yes)

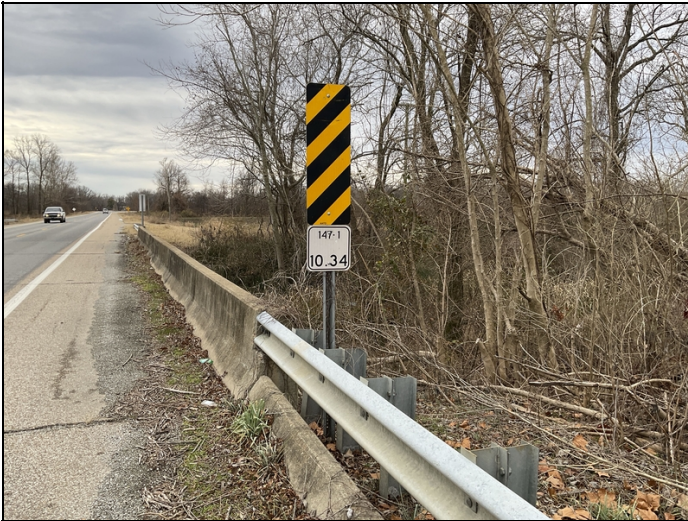
Log mile signs are incorrect and should read Sh-147, Section-1, Log mile 10.23.

Typical log mile sign

A-63 - Missing/Incorrect Log Mile Signage (Yes)

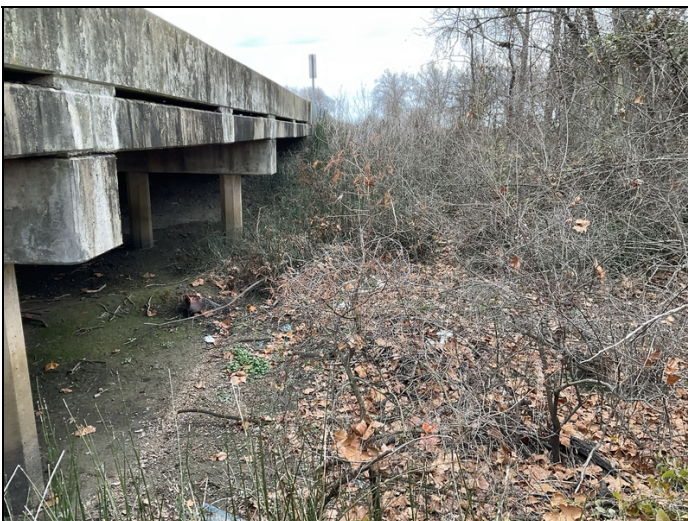
Small trees and vegetation is growing beside and under bridge.

Typical vegetation

A-64 - Vegetation Removal Requested (Yes)
