Asset #M3139(Routine)

Sh-38/Sec-2/L-2.59 over Slough

Location: 2.59 Mi E Jct Sh 33 & 38

Team Lead: Drew Melton, Inspection Date: 08/11/2022

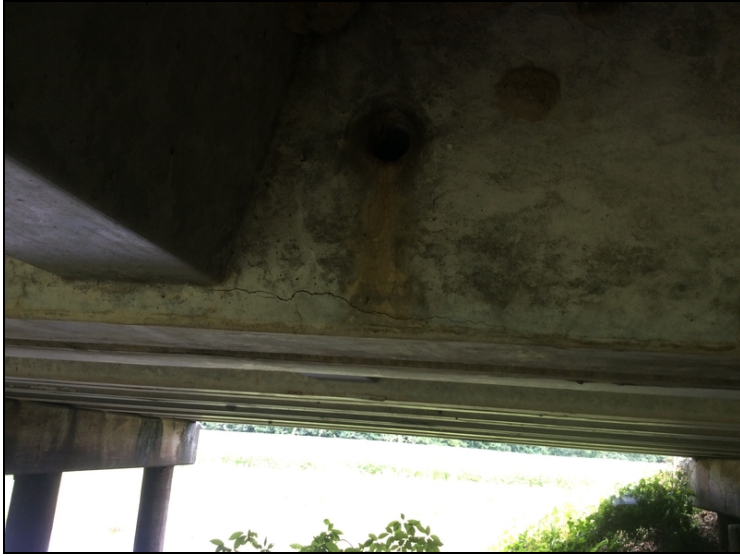
Span #3 unit #2 left leg has cs2, cs3 cracks full length with some rust stains on bottom and side.
Span #3 unit #3 right leg has cs2, cs3 cracks and delaminated for 12' starting at 1/4 span on side and bottom.
Span #3 unit #4 left leg has cs2 to cs4 cracks and delaminated full length on bottom and side with some rust stains.
Span #3 unit #5 left leg has cs2 cracks for 1' on bottom at bent #3.
Span #3 unit #5 right leg has cs2 cracks for 1' on side at bent #3.
Span #3 unit #6 right leg has cs2, cs3 cracks full length on bottom and side.
Span #3 unit #7 left leg has cs2 to cs4 cracks and delaminated full length on bottom and side with rust stains.
Span #3 unit #7 right leg has cs2 cracks for 10' in center span on bottom.
Span #3 unit #8 left leg has cs2 cracks for 12' on bottom and side with rust staining and light efflorescence.

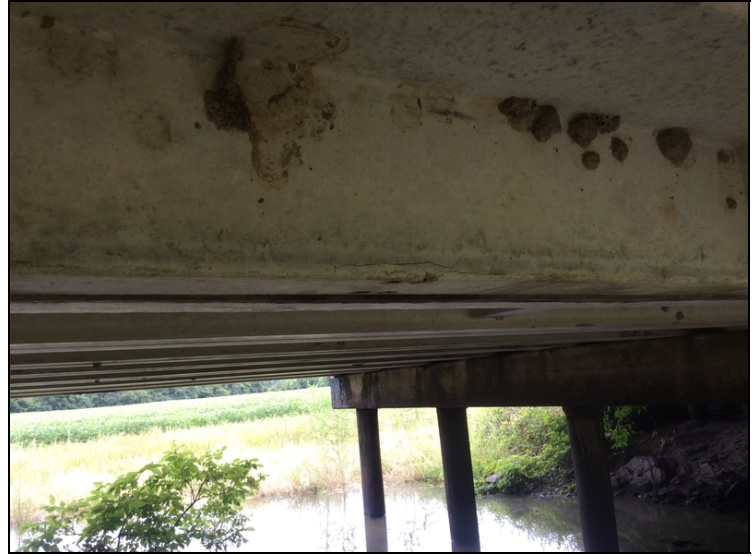
Span #2 unit #1 right leg bottom at bent #2 has cs2 cracks for 1'.
Span #2 unit #2 left leg has cs2 cracks full length on bottom and side.
Span #2 unit #2 right leg has cs2 cracks for 10' starting at 1/4 span on bottom.
Span #2 unit #3 left leg has 3 cs2 cracks 1' at bent #2 10' at center span and 2' at bent #3 all cracks are on bottom.
Span #2 unit #3 right leg has a cs2 crack for 1' just before center span and a 4' long cs3 crack at 3/4 span all are on bottom.
Span #2 unit #4 right leg has cs3 cracks for 2' at bent #2 on side and bottom, and a 1' cs2 crack on bottom at center span.
Span #2 unit #5 right leg has cs2 crack on bottom for 2' at bent #2.
Span #2 unit #5 left leg at bent #3 has cs3 cracks for 4' on bottom and side with 6" spall no exposed rebar.
Span #2 unit #6 left leg at bent #3 has cs3 cracks for 1' with a 1' spall with exposed rebar moderate section loss on bottom and side.
Span #2 unit #7 right leg has cs2 to cs4 cracks and delaminated full length with rust stains.

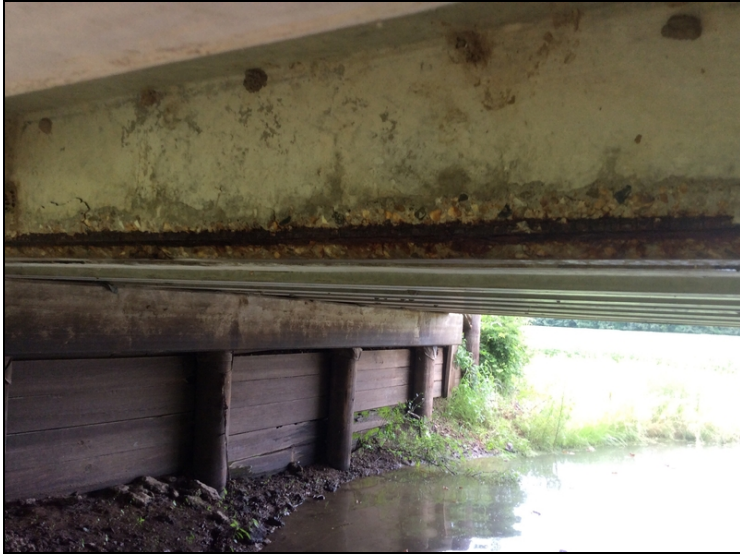
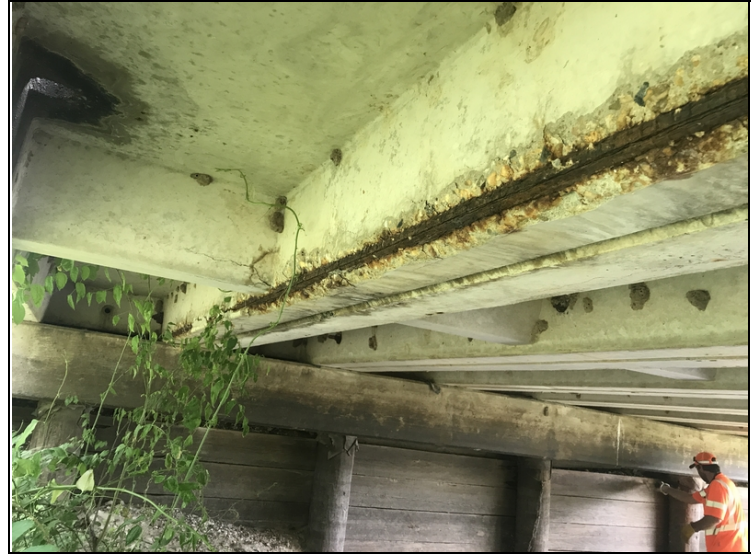
Span #1 unit #1 right leg has cs3 cracks for 3' with rust staining near center span on bottom.
Span #1 unit #2 left leg has cs3 cracks for 12' with rust staining on bottom and side.
Span #1 unit #7 right leg has cs2, cs3 cracks on bottom last half of span with rust stains.
Span #1 unit #8 left leg has cs3 cracks and is spalled full length with exposed rebar with moderate section loss on bottom and side unbonded rebar.

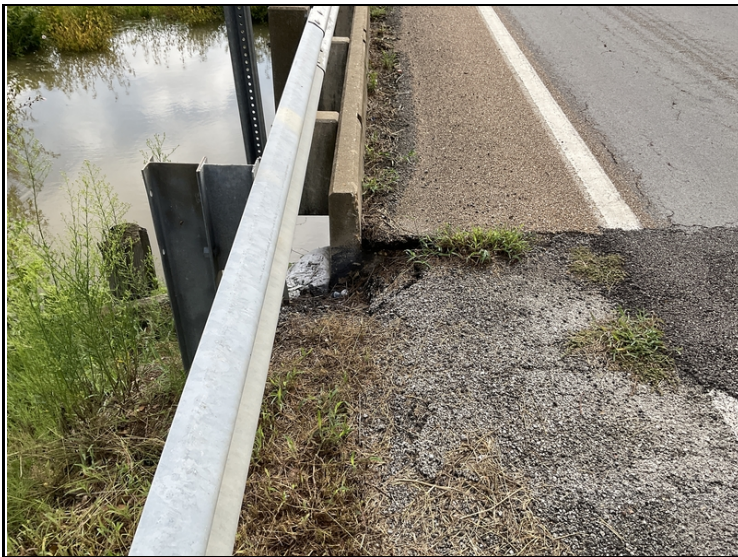
Abutment #1 left approach shoulder is eroded at bridge end.

Abutment #1 left approach shoulder is eroded at
bridge end.

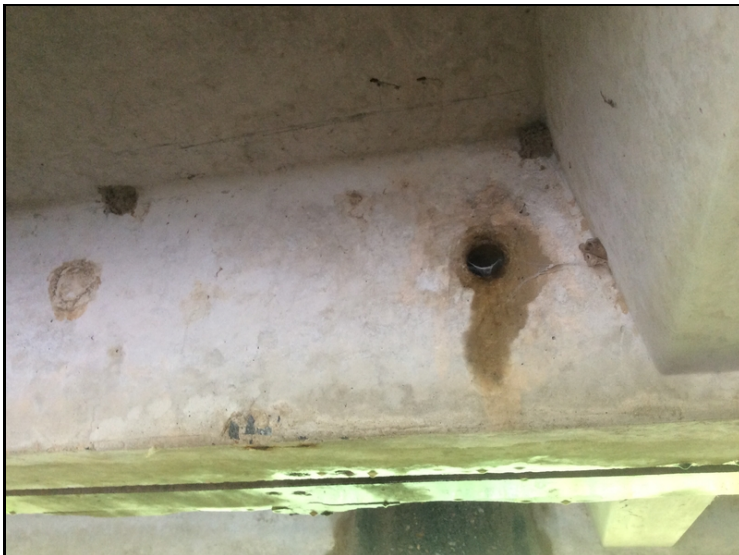
Span #1 unit 7 - 8 center connection bolt is missing.
Span #2 unit 5 - 6, 6 - 7, and 7 - 8 center connection bolt is missing.
Span #3 center connection bolts are missing.

Span #1 unit #7 to 8 center connection bolt is missing.

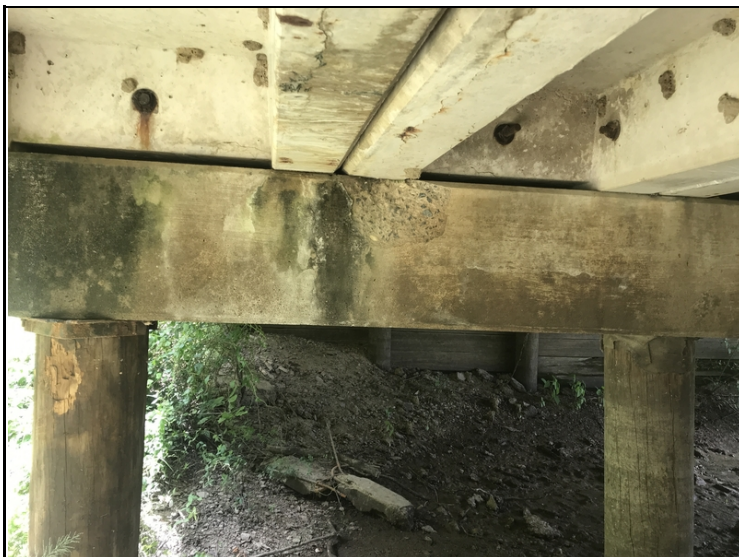
Bent #2 cap ahead face under unit #7 right leg has 1' spall with no exposed rebar.
Bent #3 cap ahead face at top has a one foot spall with no rebar exposed.

Bent #2 cap ahead face under unit #7 right leg has
1' spall with no exposed rebar.

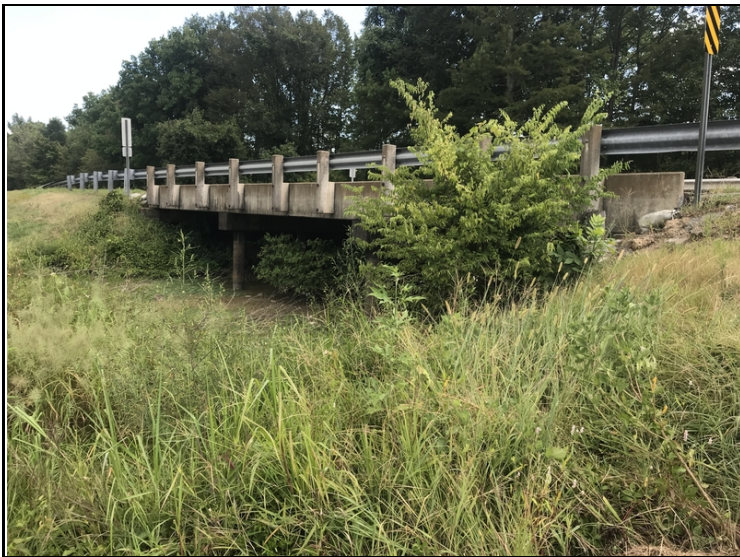
Small trees and vegetation growing under and beside bridge.

Trees and vegetation growing beside and under bridge.

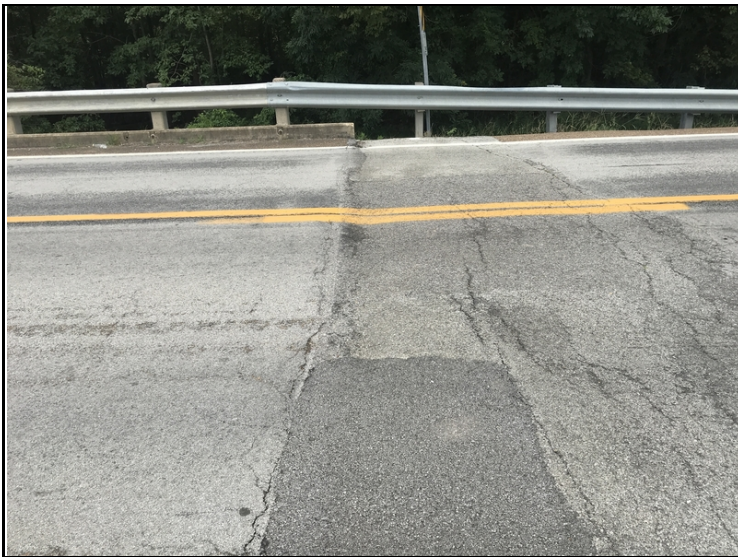
Abutment #1 approach roadway.

Abutment #1 approach roadway has settled up to 1 1/2" at bridge end.

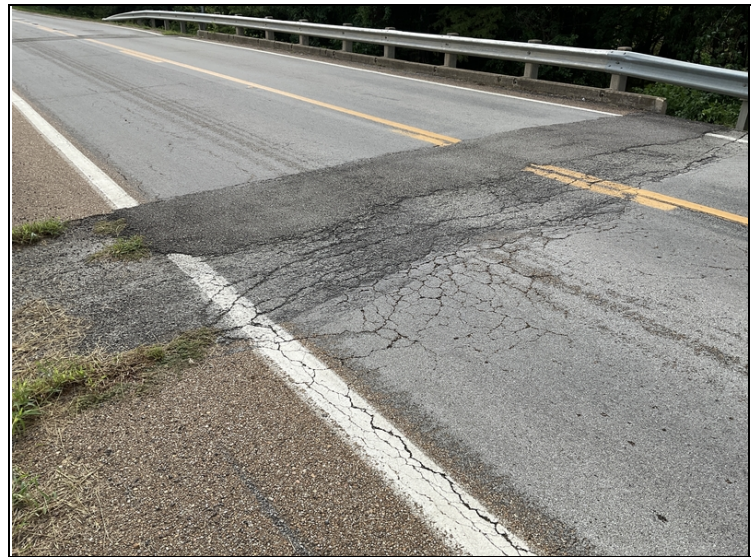
Abutment #1 approach roadway has been repaired

Approach roadway has been repaired since last inspection.
