Asset #M3138(Routine)

Sh-38/Sec-2/L-2.44 over Grine Lake

Location: 2.44 Mi East Jct Sh 33

Team Lead: Drew Melton, Inspection Date: 08/03/2022

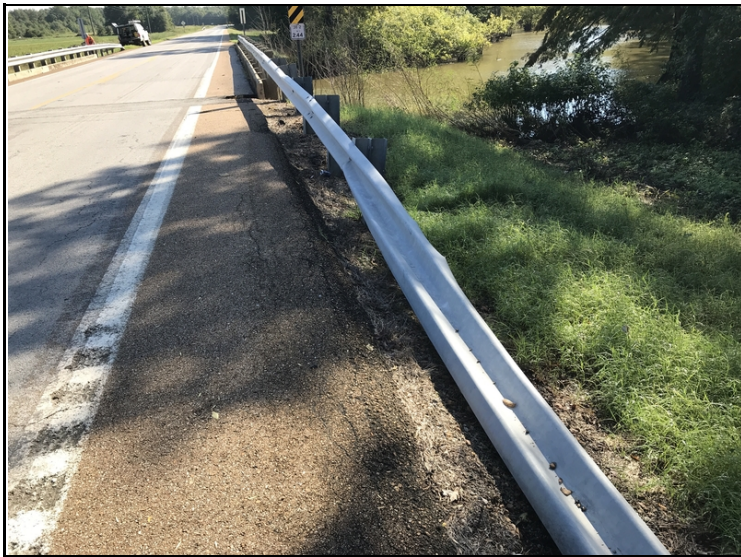
Abutment #1 right approach rail has minor collision damage.  
Abutment #2 left approach rail has minor collision damage.

Abutment #1 right approach rail turn down has collision damage.

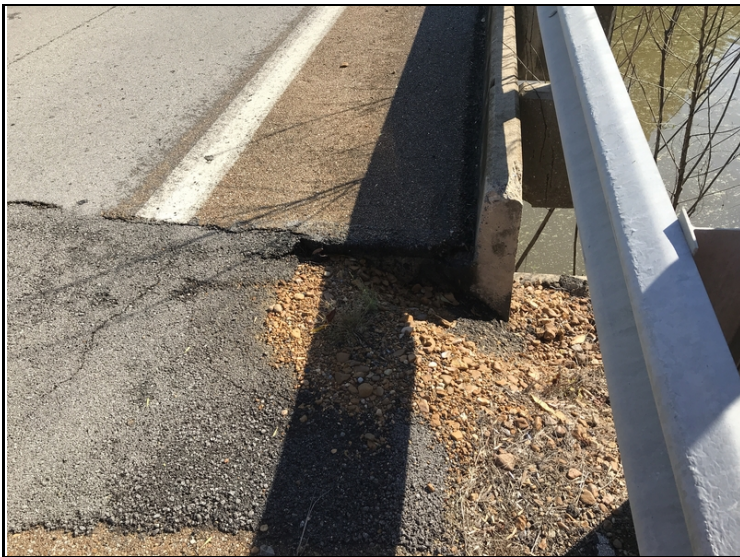
Abutment #1 right approach shoulder has eroded at bridge end.

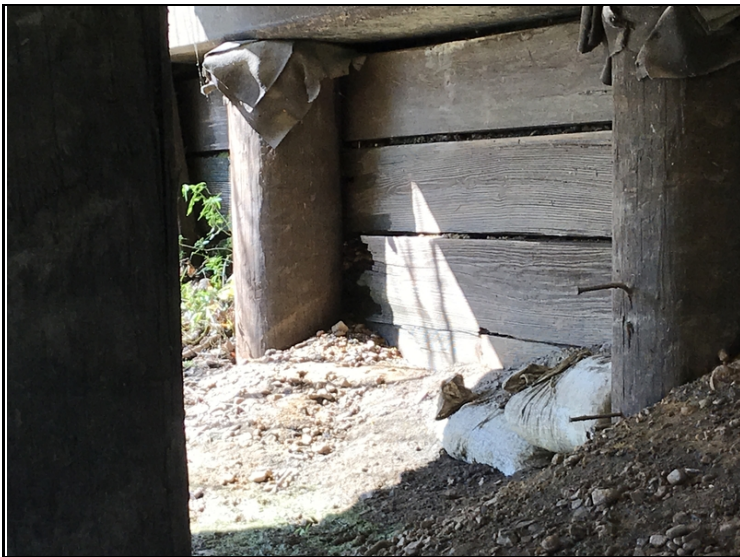
Abutment #1 back wall is decayed with areas of 100% section loss behind pile #5.

Abutment #1 back wall decay.

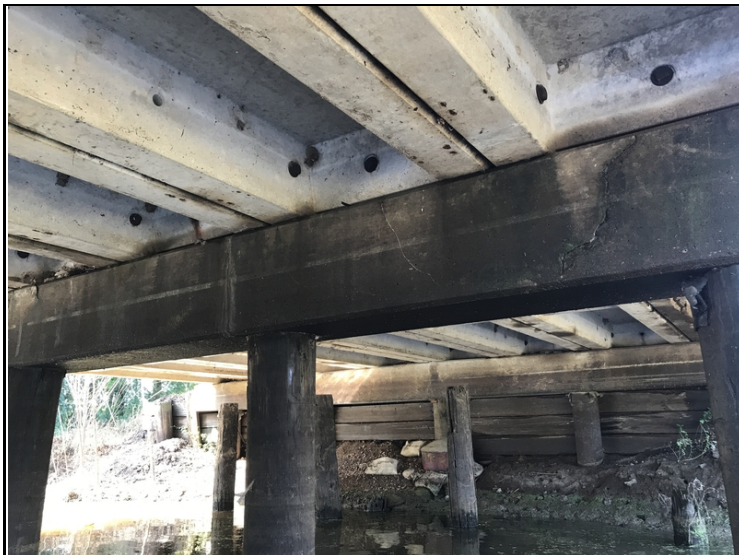
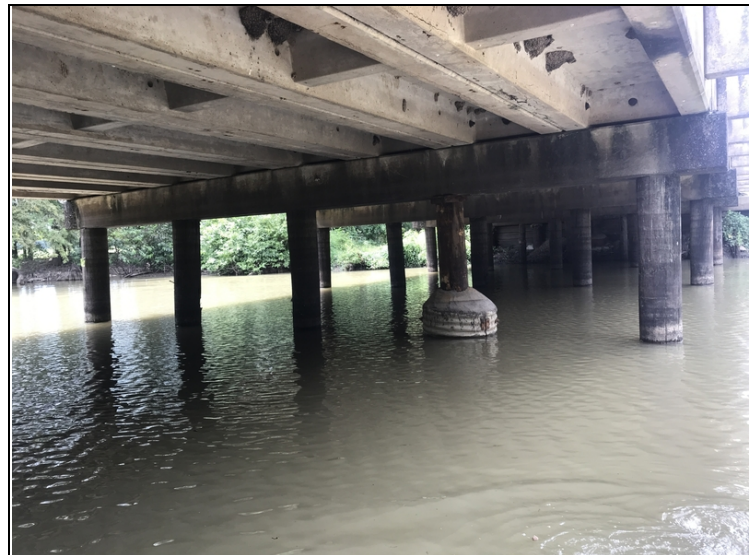
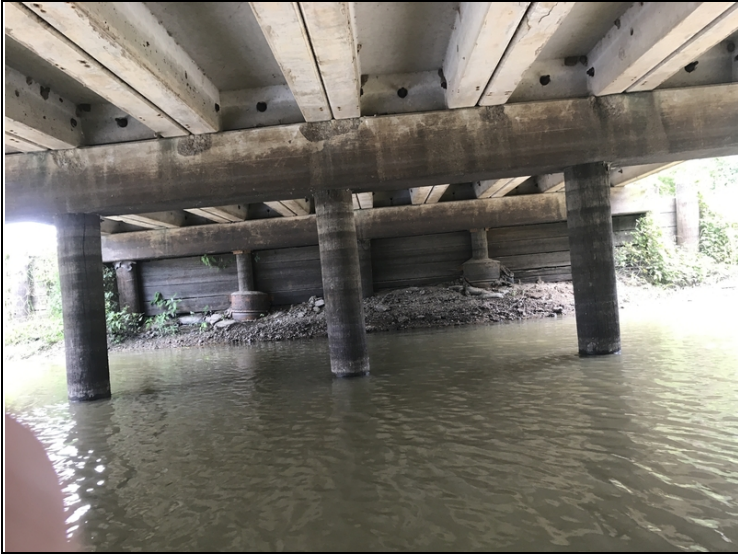
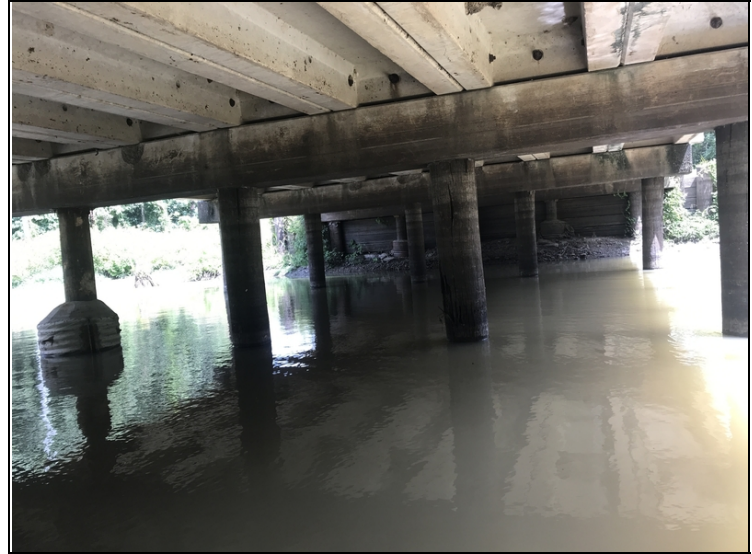
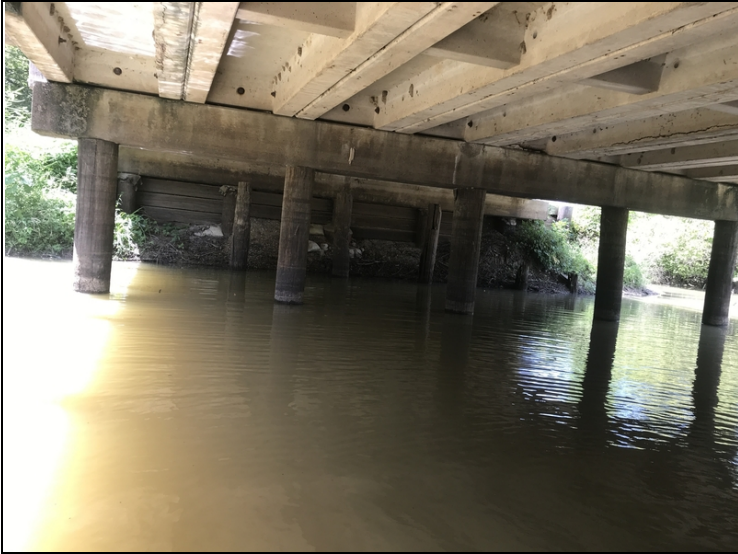
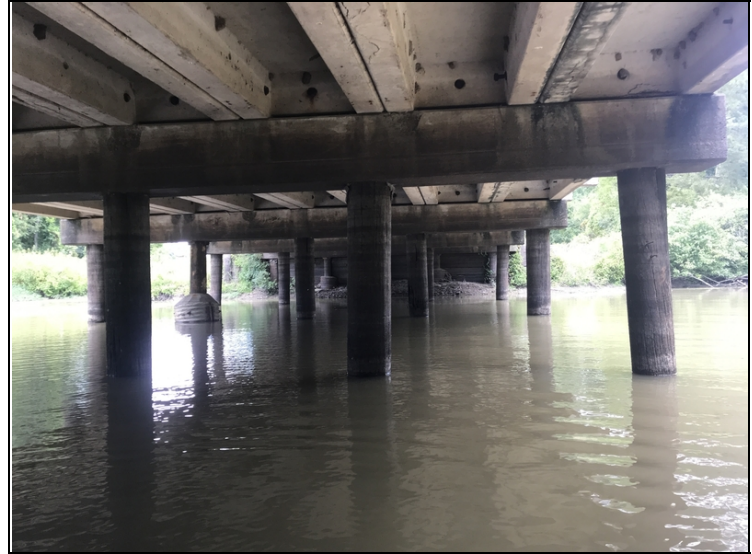
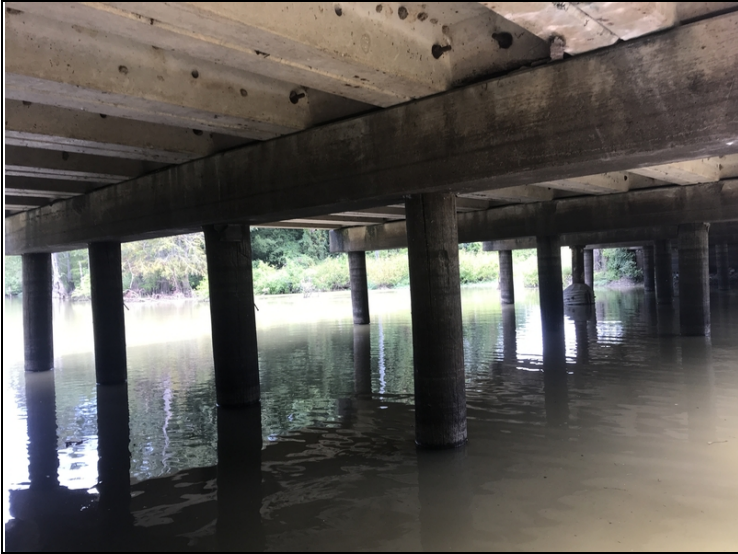
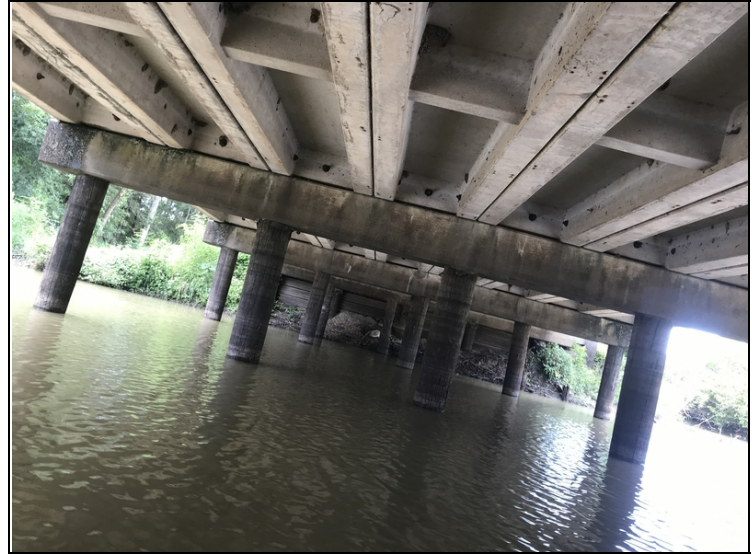
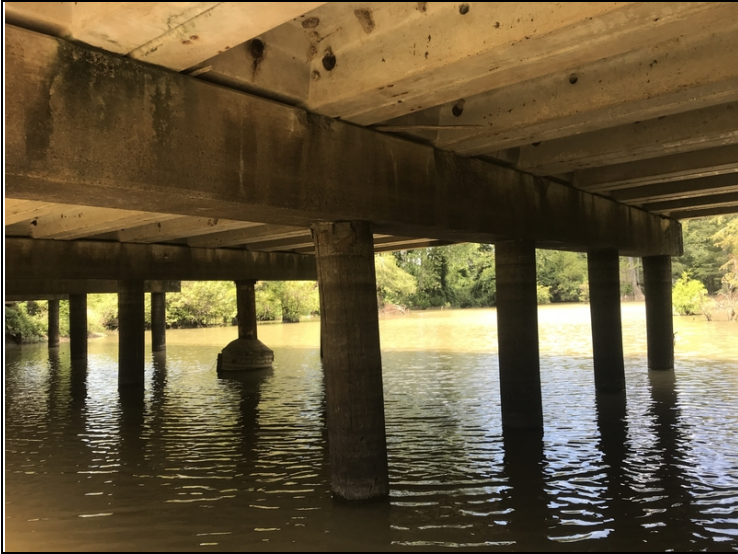
Bent #2 cap back face above pile #2 has a one foot spall with no rebar exposed.  
Bent #2 cap ahead face above pile #3 has a one foot spall with no exposed rebar, and a one foot delamination.  
Bent #2 cap ahead face has a one foot spall at top above pile #1, and a one foot delamination right of pile.  
Bent #3 cap back face above pile #3,4 each has a one foot spall with no exposed rebar.  
Bent #3 cap ahead face near left end has a two foot delamination.  
Bent #4 cap back face under first four units each have a one foot spall with no exposed rebar.  
Bent #4 cap ahead face has a vertical crack between units #2,3.  
Bent #5 cap back face has five one foot spalls with no exposed rebar at top.  
Bent #5 cap ahead face has four one foot spalls no rebar exposed at top, and a two foot delamination on the right side of pile #1.

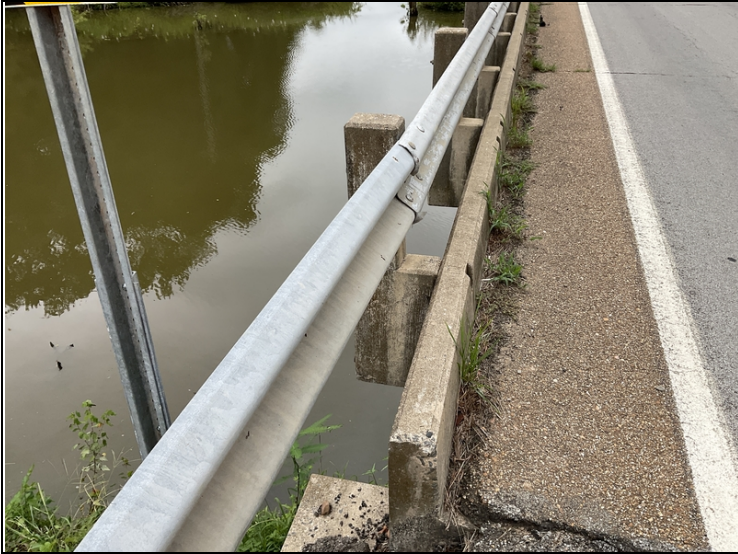
Span #1 first post left side is cracked.

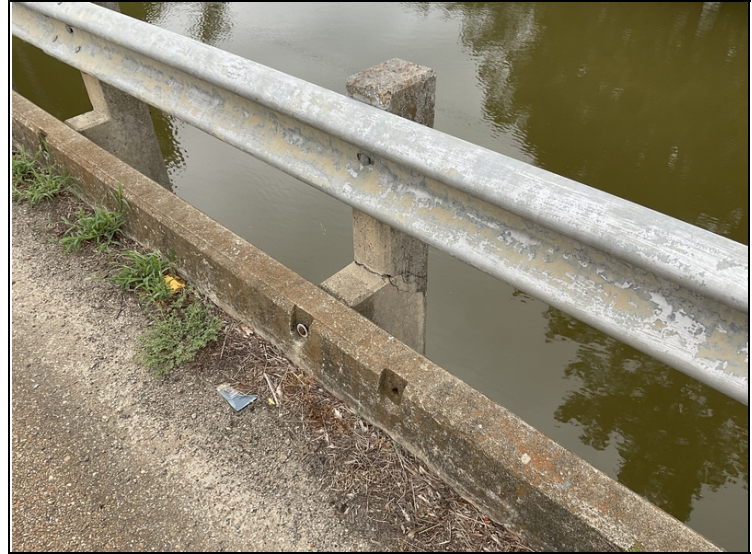
Span #2 second post right side is cracked.

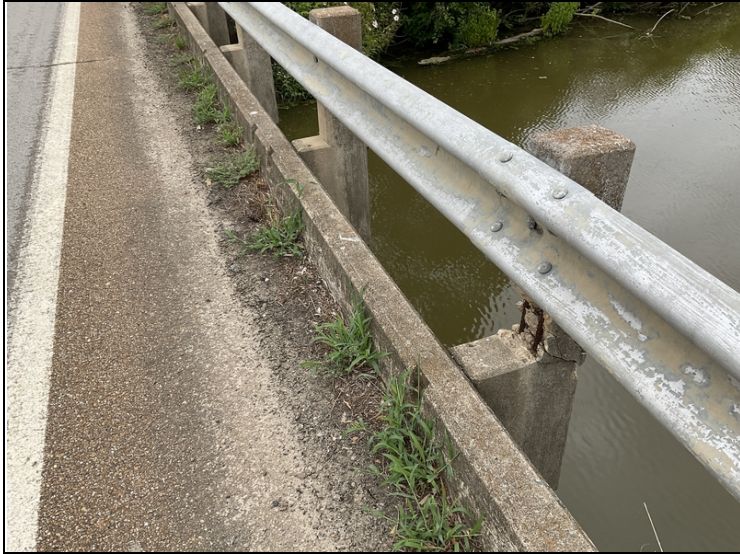
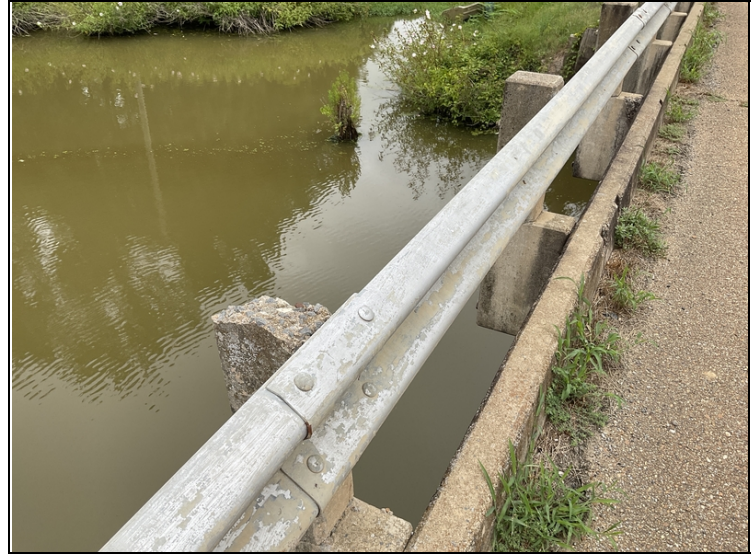
Span #1 first post left side is cracked.  
Span #2 second post right side is cracked.  
Span #4 second post is cracked.  
Span #4 first post right side is spalled.  
Span #4 third post both sides are cracked.  
Span #4 right side rail has minor collision damage.  
Span #3 right side last post bottom nut missing.

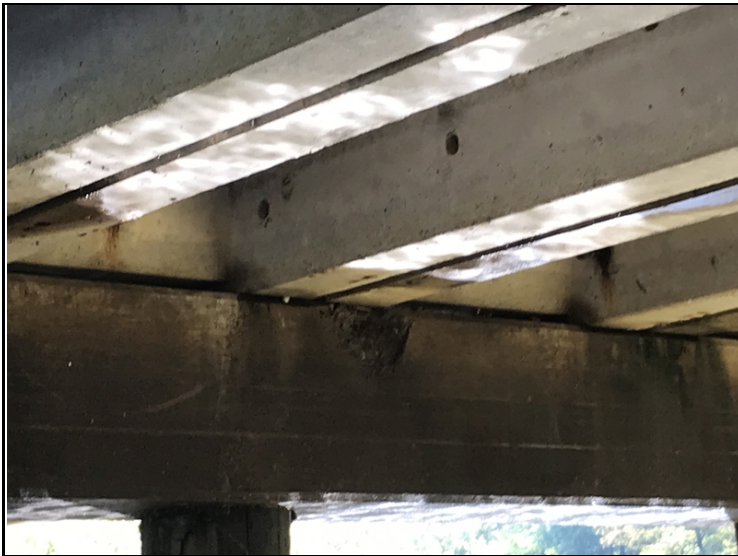
Span #2 bolts are missing from unit to unit between units #(2,3),(3,4),(6,7) at bent #3, and loose bolt between unit #7,8 at bent #3.

Typical bolt missing between units.

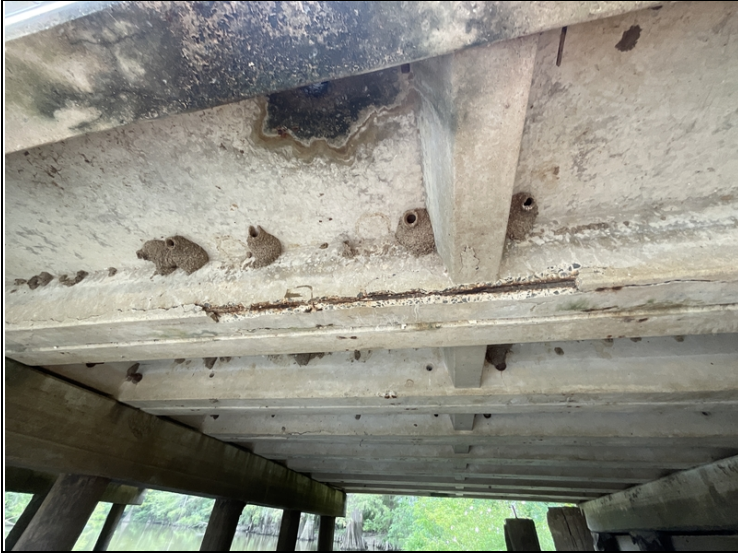
Span #1 girders

Span #1 unit #1 right leg has cs3 cracks and delaminated full length on bottom and side with four feet of exposed rebar in first half of span moderate section loss.

Span #1 unit #2 left leg has cs2 cracks 3' on bottom mid span.

Span #1 unit #2 right leg has cs2 cracks 2' on bottom mid span.

Span #1 unit #3 right leg has cs2, cs3 cracks on bottom for six feet with a 1' spall exposed rebar moderate section loss, and a 1' delamination near bent #2.

Span #1 unit #3 left leg has one foot cs3 crack on bottom at bent #1.

Span #1 unit #5 left leg has cs2, cs3 cracks on bottom and side full length.

Span #1 unit #5 right leg has cs2, cs3 cracks on bottom for full length.

Span #1 unit #6 right leg has cs3 crack 1' at 3/4 span, and 1' at 1/4 span.

Span #1 unit #7 right leg has cs3 crack on bottom for 8' in center with 1' spall with exposed rebar with moderate section loss.

Span #1 unit #8 left leg has cs2, cs3 cracks full length on bottom and side with several delaminations.

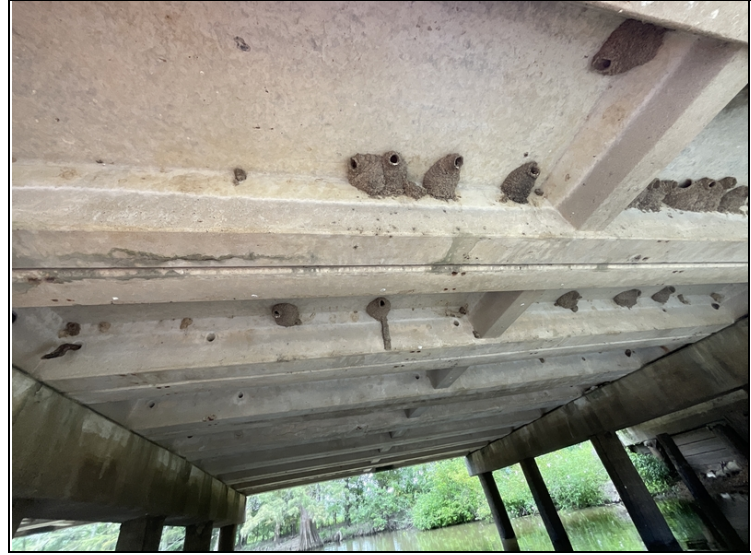
Span #2 girders

Span #2 unit #1 right leg has cs2 cracks on bottom full length.

Span #2 unit #1 left leg has a cs2 crack for 1' at mid span on bottom.

Span #2 unit #2 left leg has a 1' cs2 crack on bottom at bent #3.

Span #2 unit #3 right leg has cs2 cracks on bottom for 2' at 3/4 span.

Span #2 unit #4 left leg has cs4 cracks and delaminated on bottom and side full length with 2' of exposed rebar at 3/4 span with moderate section loss.

Span #2 unit #4 right leg has cs4 cracks and delaminated on bottom and side full length with 2' of exposed rebar at 3/4 span with moderate section loss.

Span #2 unit #6 right leg has cs2 cracks on bottom and side for 8' at mid span.

Span #2 unit #7 left leg has cs2 to cs4 cracks and delaminated 10' at three quarter span.

Span #2 unit #8 left leg has cs2 to cs4 cracks and delaminated full length on bottom and side with 2' of exposed rebar at 1/4 span and 1' at 3/4 span with moderate section loss.

Span #2 unit #8 right leg has cs2 cracks on bottom and side for 3' mid span.

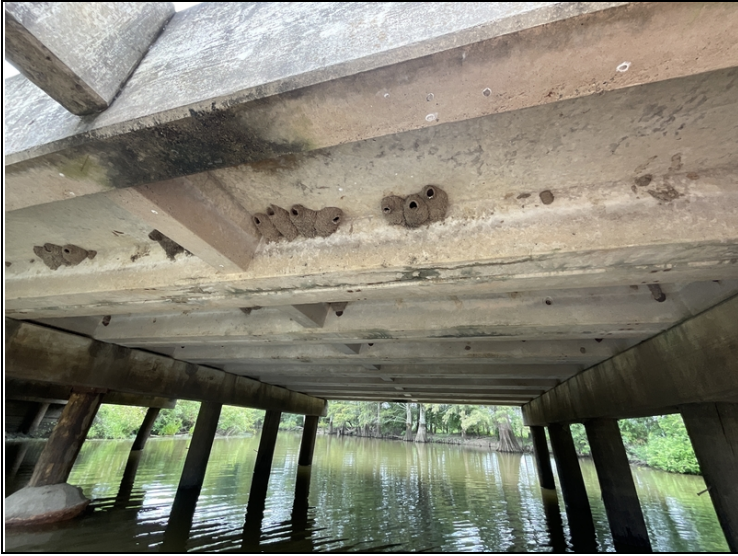
Span #3 girders

Span #3 unit #1 right leg has cs2,cs3 cracks on bottom full length.

Span #3 unit #2 left leg has cs2 cracks on bottom with rust stains for 3' starting at mid span.

Span #3 unit #2 right leg has cs2 cracks on bottom for 2' starting mid span.

Span #3 unit #3 left leg has cs2 cracks on bottom for 8' starting at 1/4 span.

Span #3 unit #4 left leg has cs2 cracks on bottom for 8' last half of span.

Span #3 unit #5 both legs starting at 1/4 span have cs2 cracks for 6'

Span #3 unit #6 left leg has cs2 cracks on bottom for 4' in center.

Span #3 unit #6 right leg has cs2 cracks on bottom for 8' starting at bent #3.

Span #3 unit #7 right leg has cs2, cs3 cracks on bottom for 12' starting at 1/4 span.

Span #3 unit #7 left leg has cs2, cs3 cracks on bottom for 16' starting at 1/4 span.

Span #3 unit #8 left leg has cs2, cs3 cracks and delaminated full length on bottom and side.

Span #3 unit #8 right leg has 1' cs2 cracks on bottom for 2' just ahead on mid span.

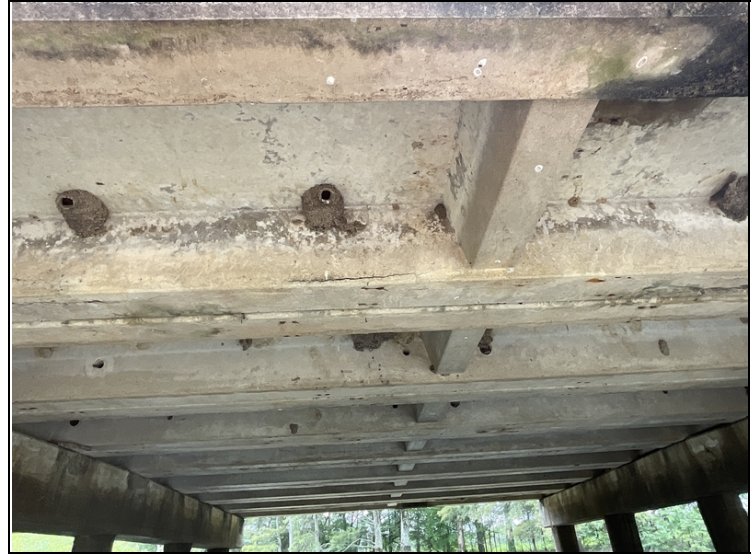
Span #4 girders

Span #4 unit #1 right leg has cs2 to cs4 cracks and delaminated full length on bottom and side with a 1' spall with exposed rebar at quarter span with moderate section loss.

Span #4 unit #2 left leg has cs2 crack on bottom for 1' at mid span.

Span #4 unit #5 right leg has cs2, cs3 cracks and delaminated on bottom for 8' starting at 1/4 span.

Span #4 unit #6 left leg has cs2, cs3 cracks and delaminated for 8' on bottom and side starting at mid span.

Span #4 unit #6 right leg has cs2 cracks on bottom for 4' starting at bent #4.

Span #4 unit #7 left leg has cs2 cracks on bottom for 4' at center.

Span #4 unit #8 left leg has cs2 to cs4 cracks and delaminated on bottom and side full length with a four foot spall with exposed rebar with moderate section loss at quarter span.

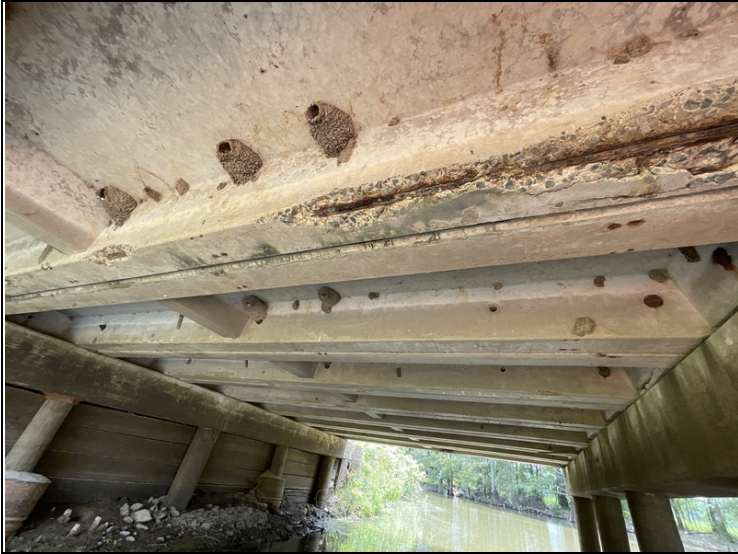
Span #5 girders

Span #5 unit #1 right leg has cs2, cs3 cracks and delaminated full length on bottom and side with 3 spalled areas 4' at bent #5, 1' at mid span, and 1' at 3/4 span all with exposed rebar with moderate section loss.

Span #5 unit #3 right leg has cs2 cracks on side at mid span for 2'.

Span #5 unit #4 right leg has a six inch spall no rebar exposed in center span on bottom.

Span #5 unit #6 right leg has cs2 cracks on bottom for 3' at mid span.

Span #5 unit #8 left leg has cs2 to cs4 cracks and delaminated on bottom and side full length.

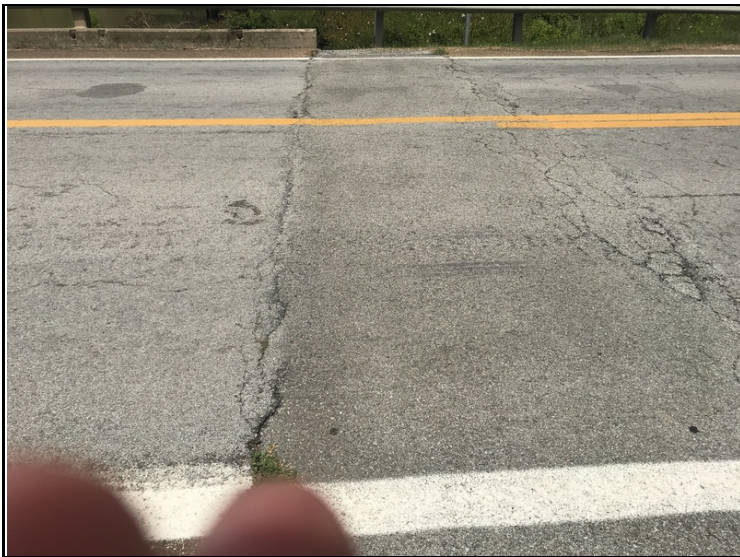
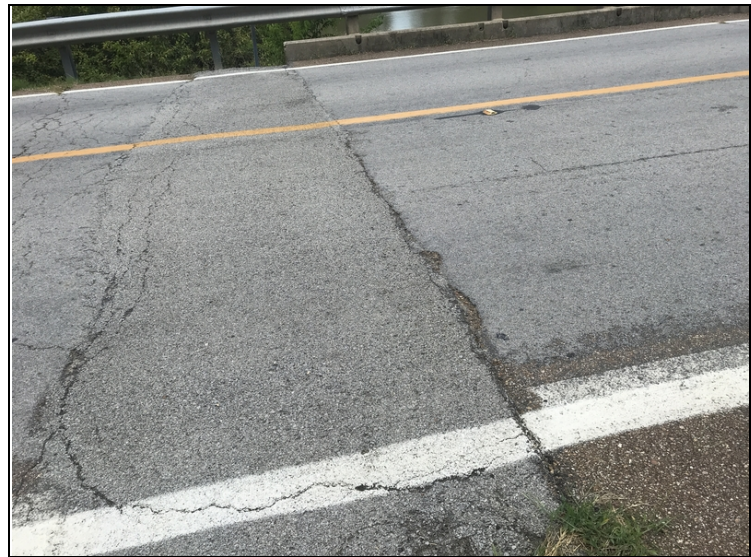
Abutments #1 and 2 approach roadway has settled up to 1" at bridge end.

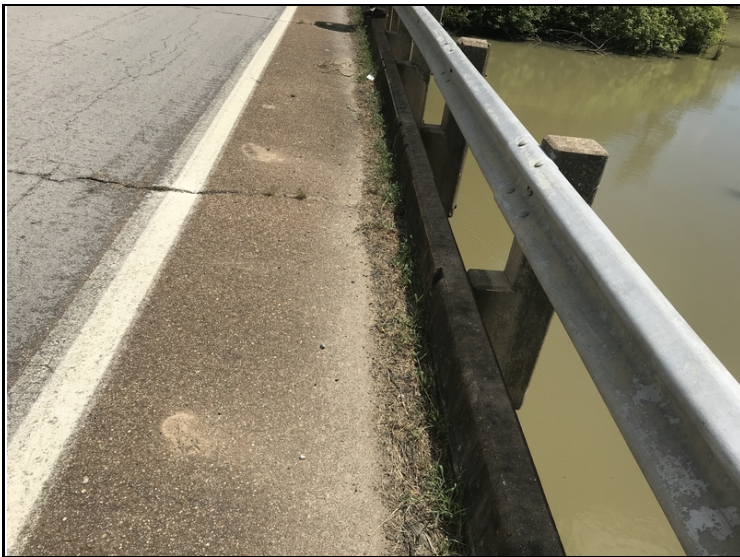
Gutters have dirt debris and vegetation in them.

Vegetation growing in gutters.

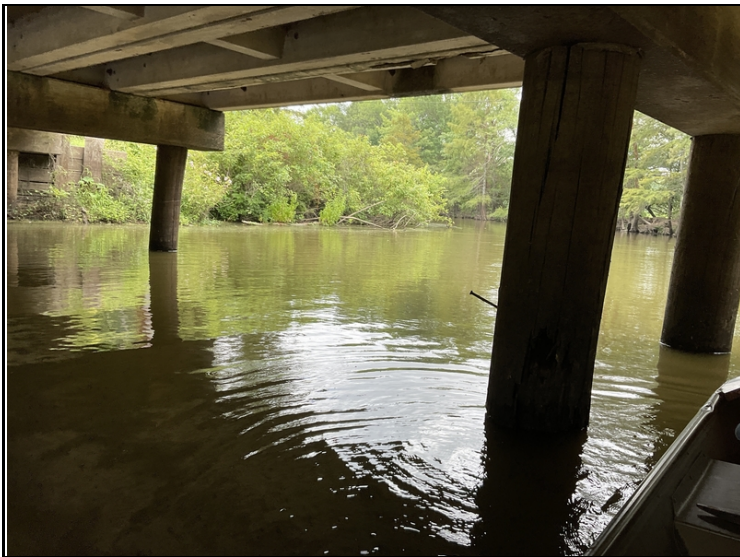
Bent #4 pile #4 has outer shell and core decay with severe hollow sound.
