Asset #X1665(Record Change)

Sh-38/Sec-2/L3.08 over Ditch

Location: 3.08 Mi E Jct Sh 33&38

Team Lead: Myron Futrell, Inspection Date: 03/21/2023

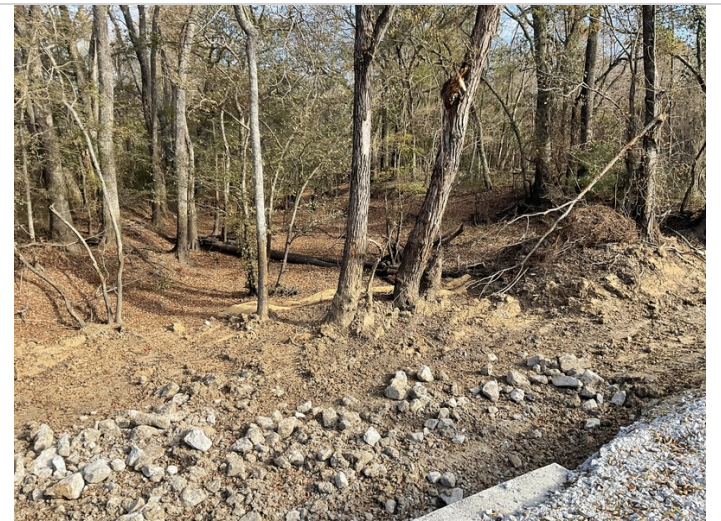
61 - Channel/Channel Protection (6 - Bank is beginning to slump. River control devices and embankment protection have widespread minor damage. There is minor stream bed movement evident. Debris is restricting the channel slightly.)

Comment: Channel banks have areas of slumping and channel has trees and debris in it restricting channel flow.

Channel left side

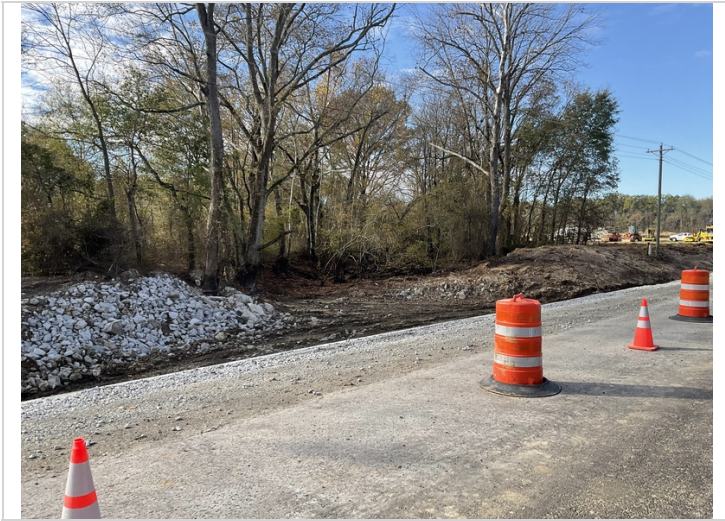
Channel right side

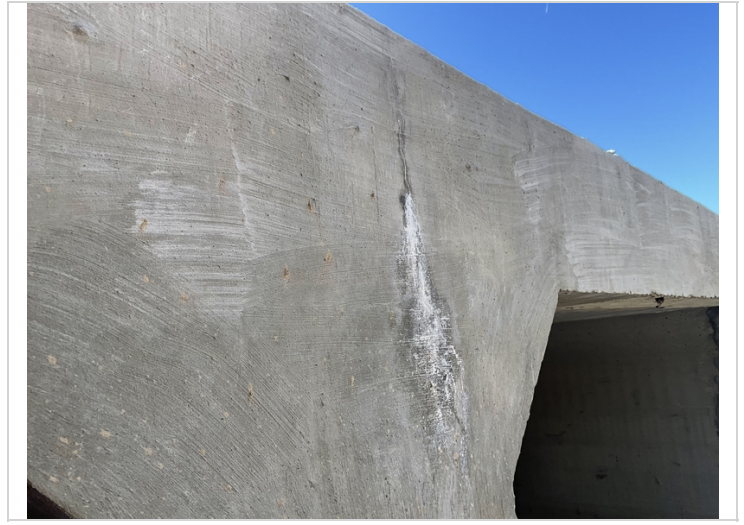
ELEMENTS	DESCRIPTION	UNITS	TOTAL				
				CS1	CS2	CS3	CS4
241	Reinforced Concrete Culvert	LF	396	381	13	2	0
1080	Delamination/Spall/Patched Area	LF	3	0	1	2	0
1120	Efflorescence/Rust Staining	LF	12	0	12	0	0
(241) Ends of culvert between barrels have hairline cracks with light efflorescence. Barrel #1 left end back wall has a 1' spall no rebar exposed. Barrel #6 left end back wall has two 6" spalls no rebar exposed. Barrel #8 left end back wall has a 6" spall no rebar exposed.

Ends of culvert between barrels have hairline cracks with light efflorescence.

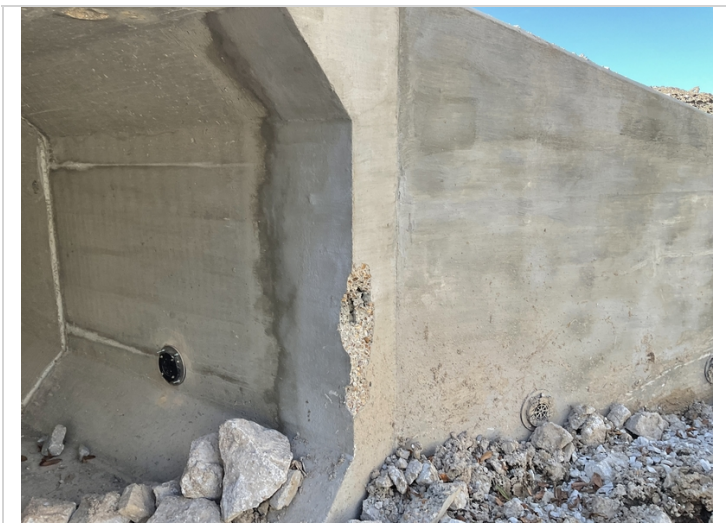
Comment: Culvert has minor spalling on left side at a few of the culvert walls no rebar exposed.

Barrel #1 left end back wall has a 1' spall no rebar exposed.

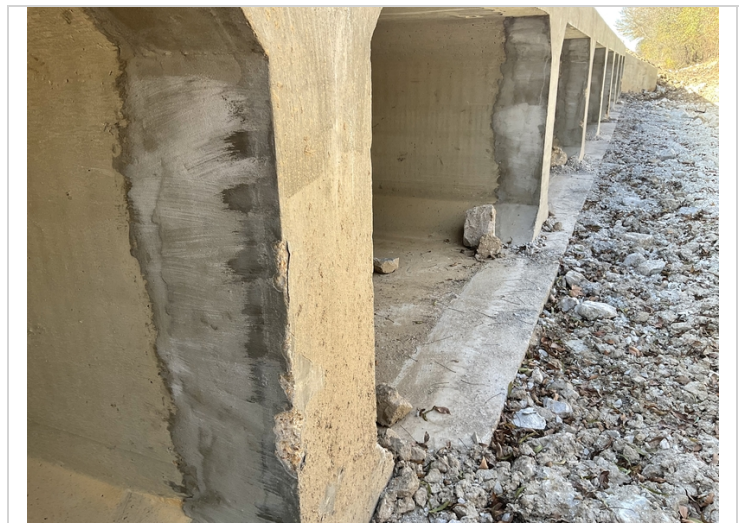
Barrel #6 left end back wall has two 6" spalls no rebar exposed.
Barrel #8 left end back wall has a 6" spall no rebar exposed.
