Asset #M1465(Routine)

Us-79/Sec-16/L9.89 over Ditch

Location: 10.11 Mi Ne Of Mariana

Team Lead: Austin Janes Inspection Date: 10/01/2024

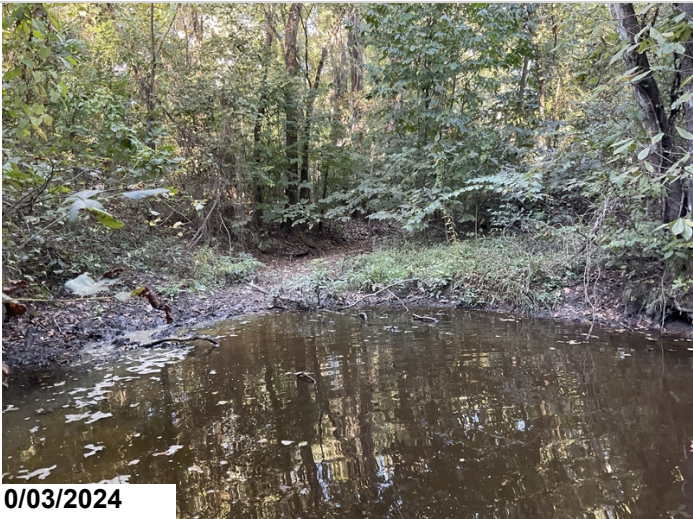
Left side channel.

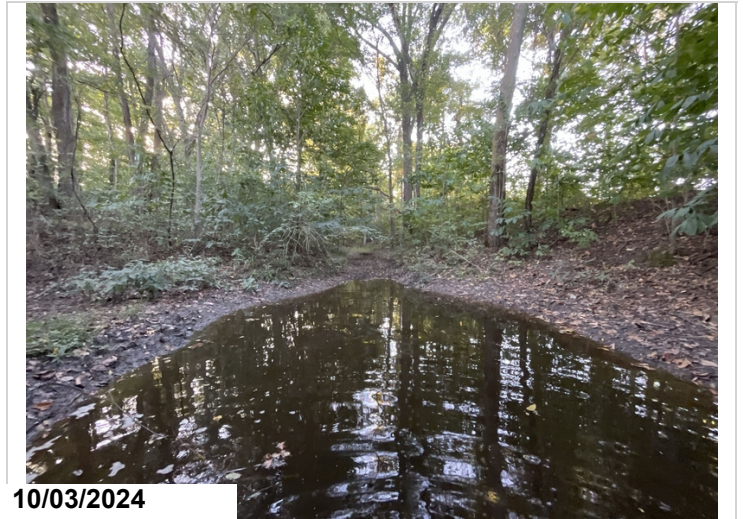
Right side channel.

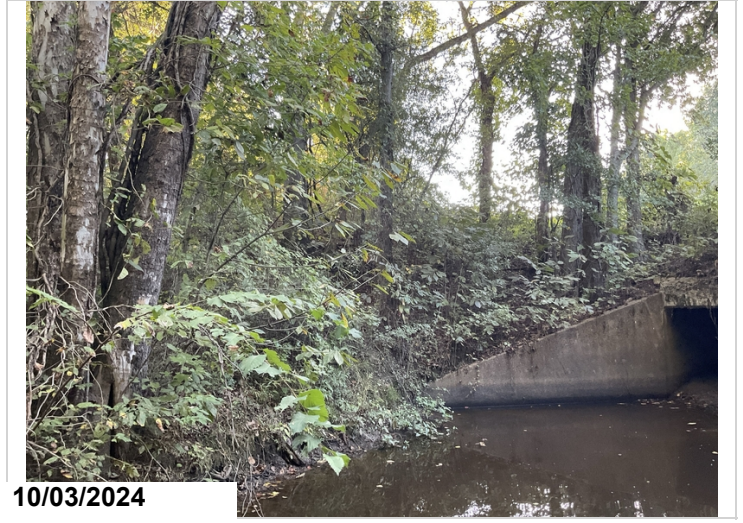
Culvert: heavy vegetation growth on both sides.

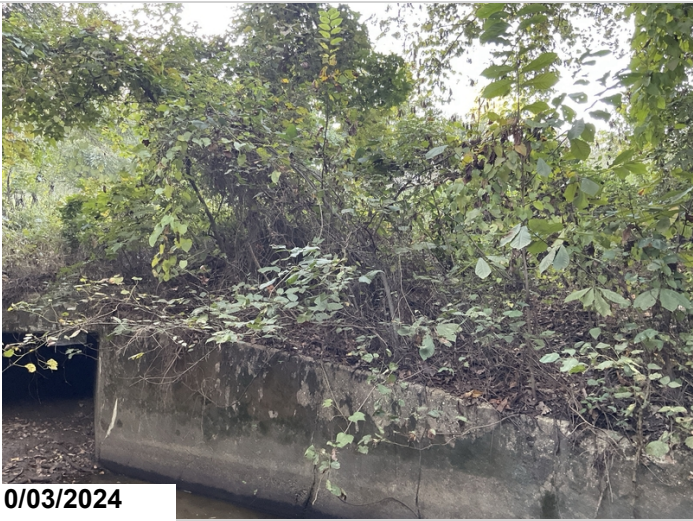
Culvert: heavy vegetation growth on both sides.

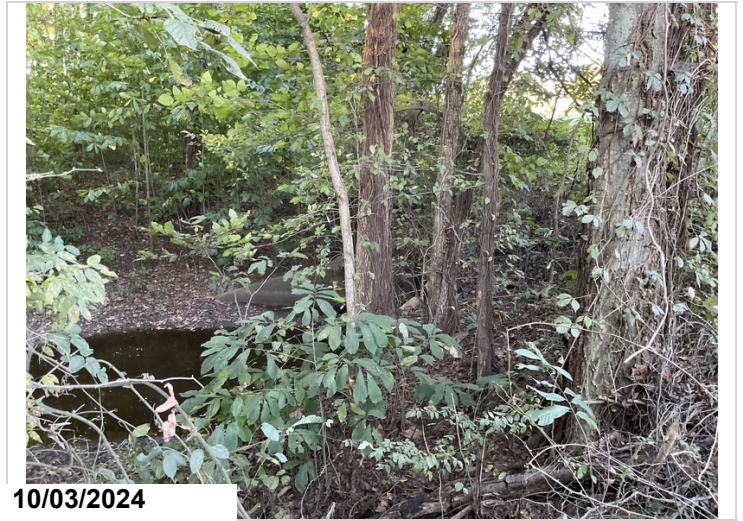
Culvert: buried in vegetation.

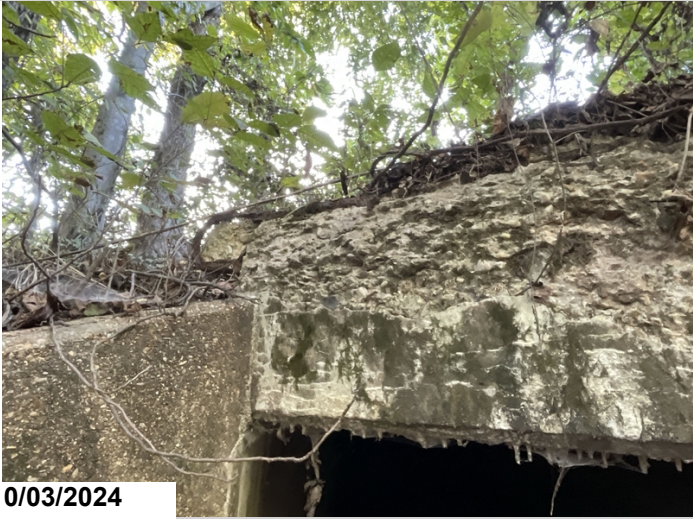
Barrel 2, end of structure, left side, head wall: spall with exposed reinforcing steel with 100% section loss. 1' CS4.

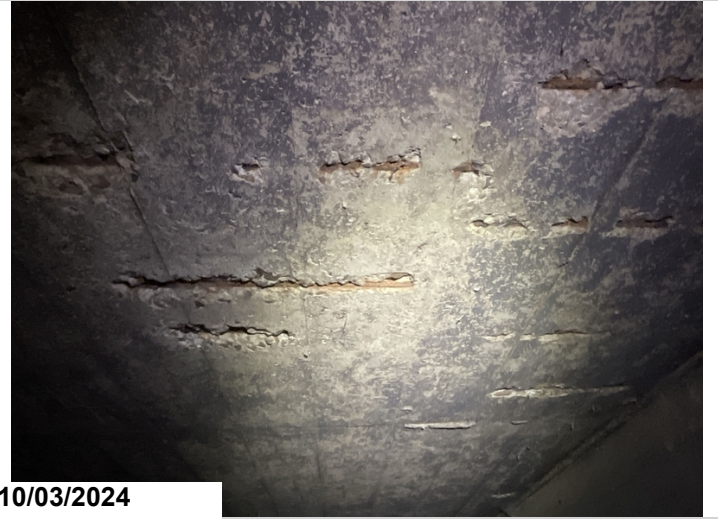
Barrel 2, 15' from left side: exposed rebar. 9 LF cs3

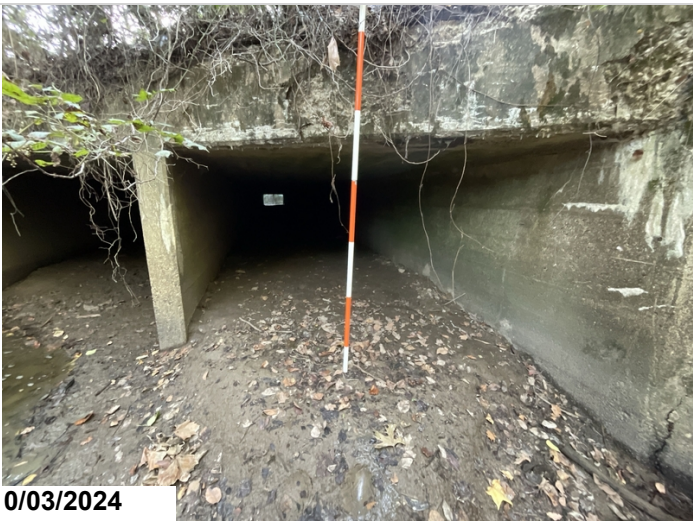
Barrel 2, left side: sediment build up.

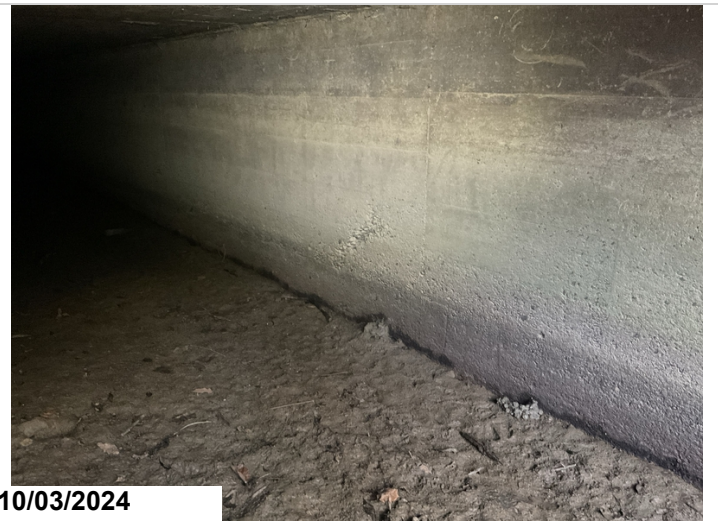
Barrel 2, intermediate wall, 20' from left end: abrasion with aggregate loss. 2LF CS3.

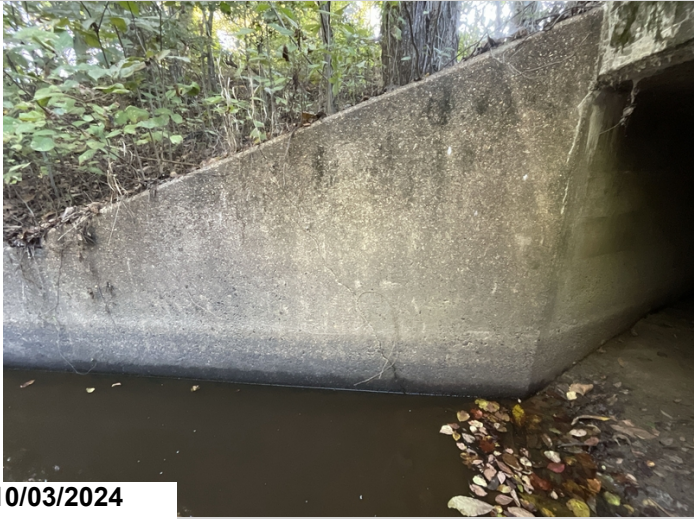
End of structure, left side, wing wall: diagonal crack.

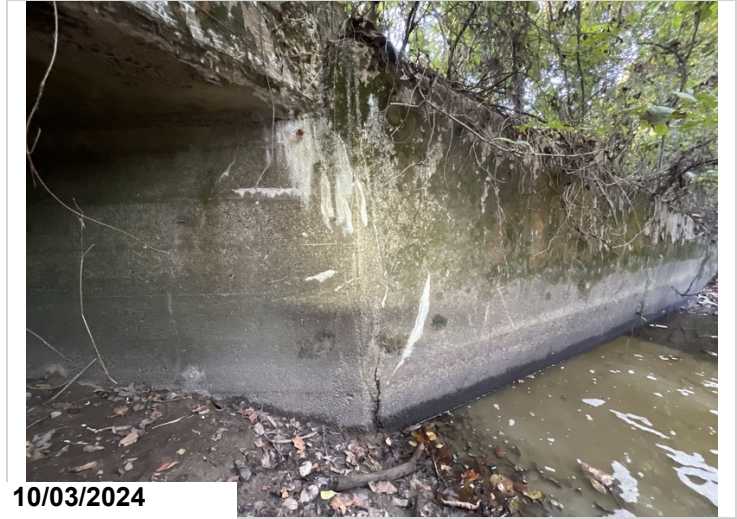
Beginning of structure, left side, wing wall: cracking and efflorescence.

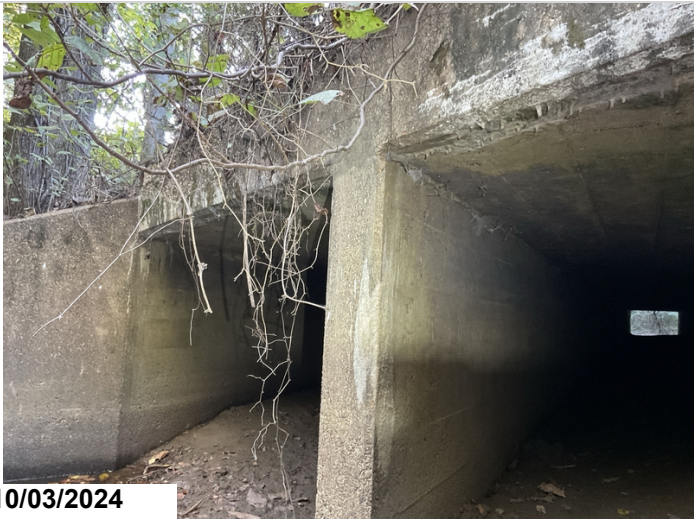
Left side: head wall is disintegrating with efflorescence and spalling. 1LF CS3.
Left side, intermediate wall efflorescence with build up. 1LF CS3.

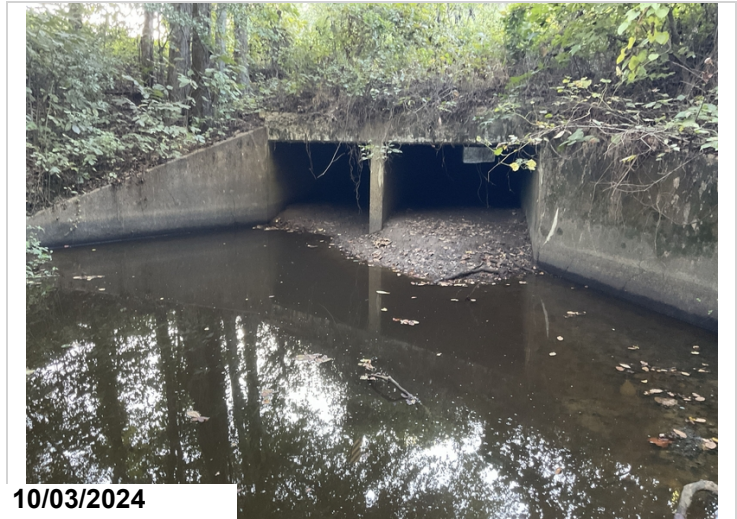
Left end of structure. Sediment accumulation in both boxes.

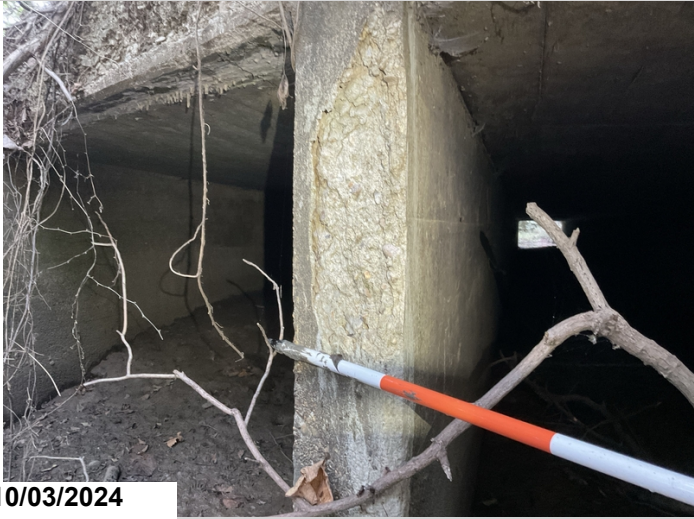
Intermediate wall, right side: spall. 1LF CS3.

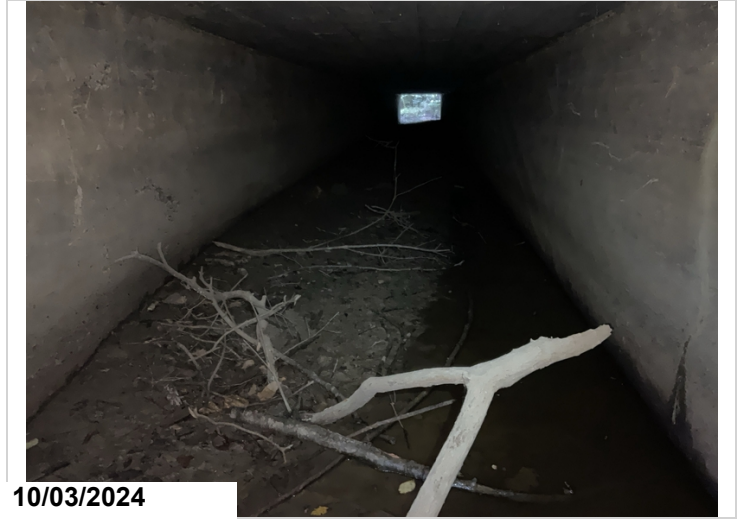
Barrel 2: sediment build up, up to 4 feet.

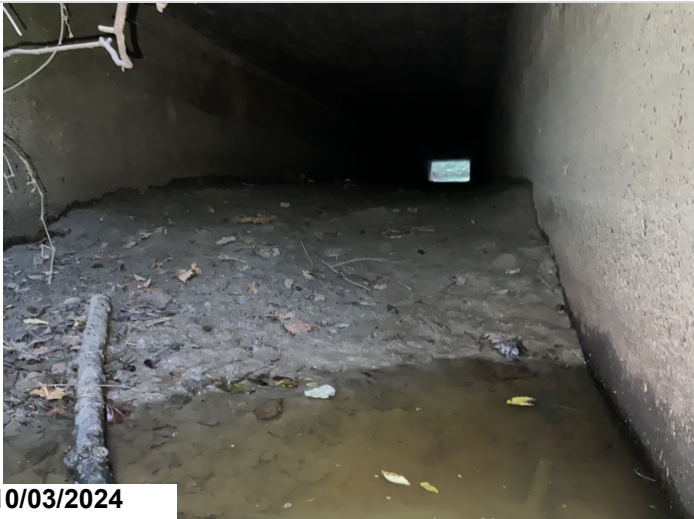
Barrel 1: sediment build up up to 4.5 feet.

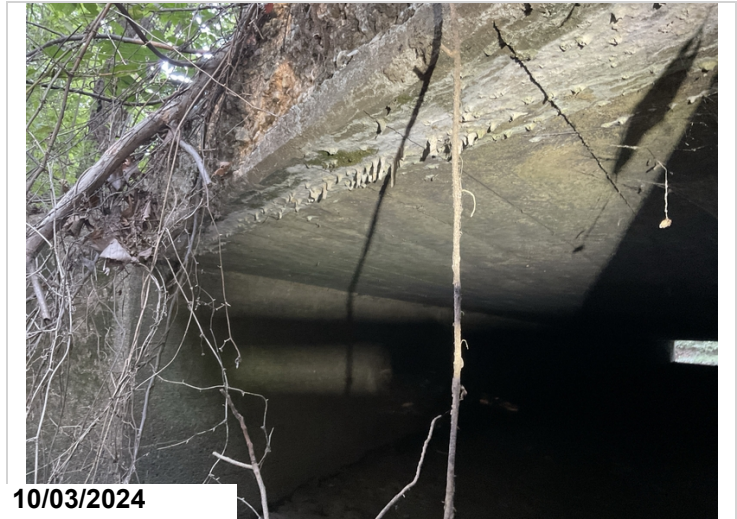
Barrel 1, right end: efflorescence with build up along top box edge. 1LF CS3.

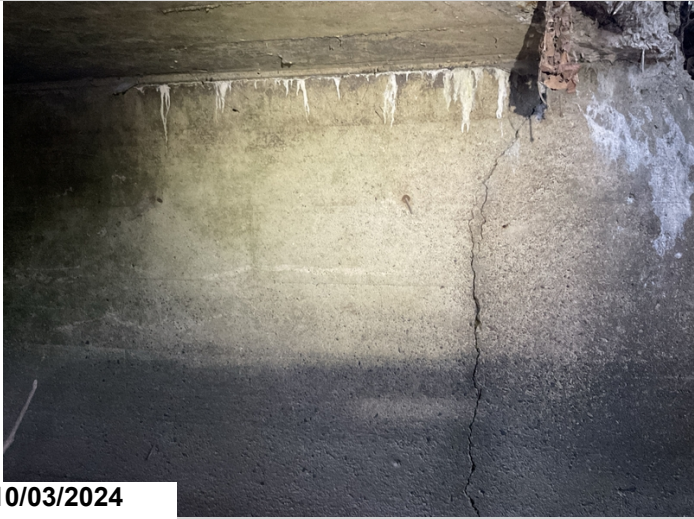
Barrel 2, right end: efflorescence along top corner. 4LF CS2.
Vertical crack. 1LF CS3.

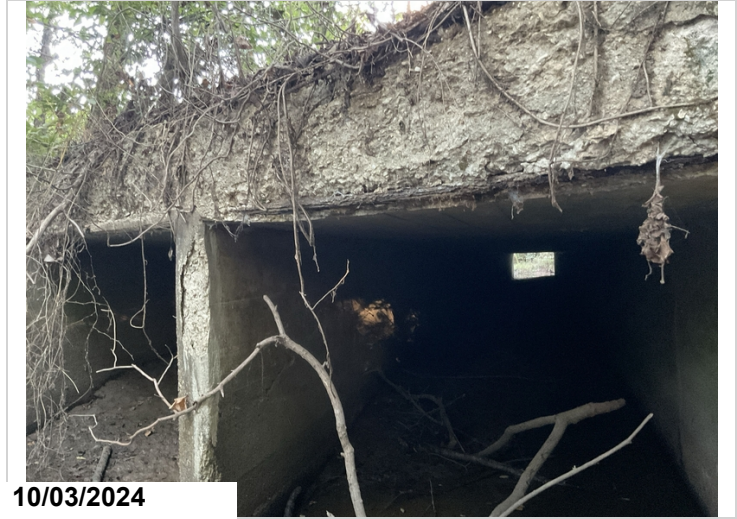
Barrel 2, right end: exposed rebar. 1LF CS3.

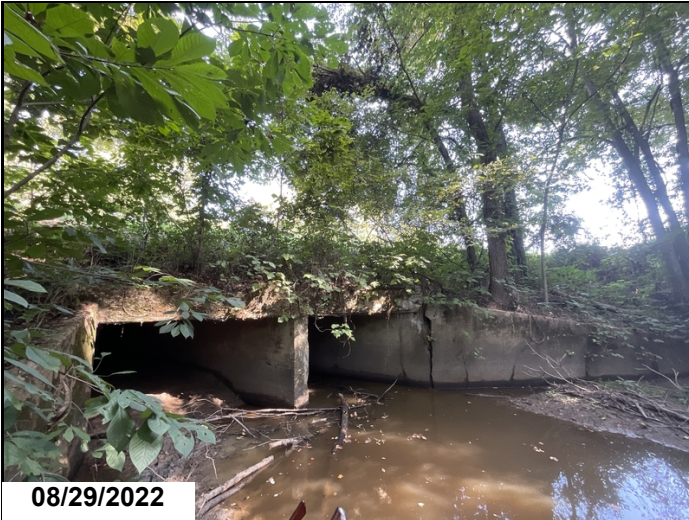
Large vegetation is growing on left & right sides of box and in channel.

Trees and vegetation growing behind wing walls and on top of culvert ends

Type of Work: Channel Work/Drift Removal

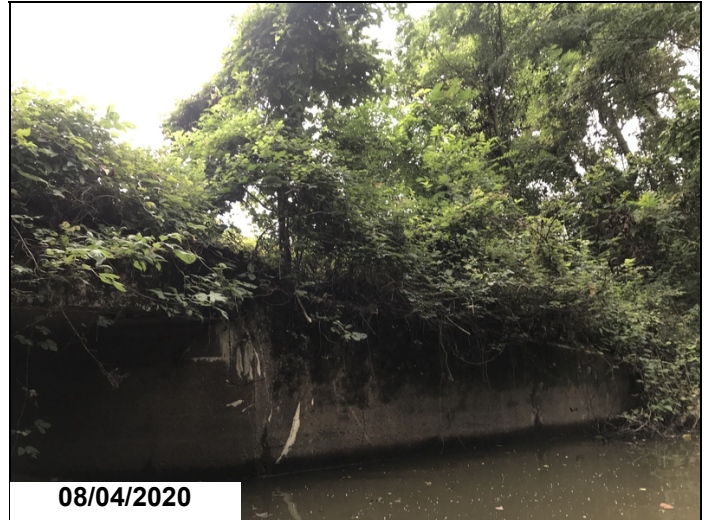
Vegetation and trees growing on wings.

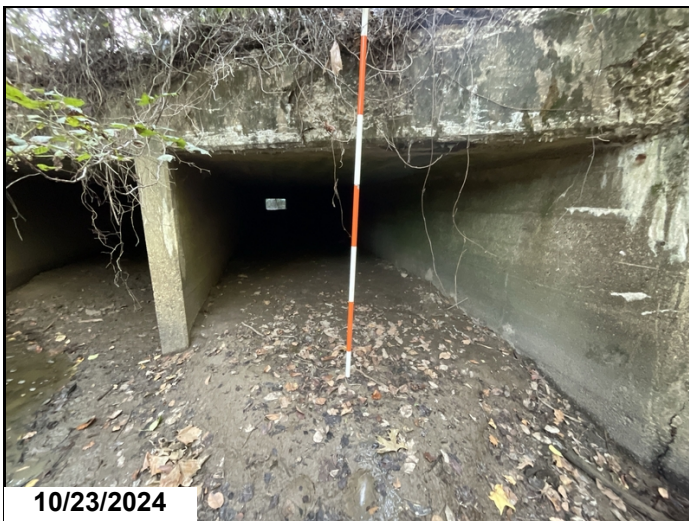
Barrel 2, left side: sediment build up.

Type of Work: Channel Work/Drift Removal

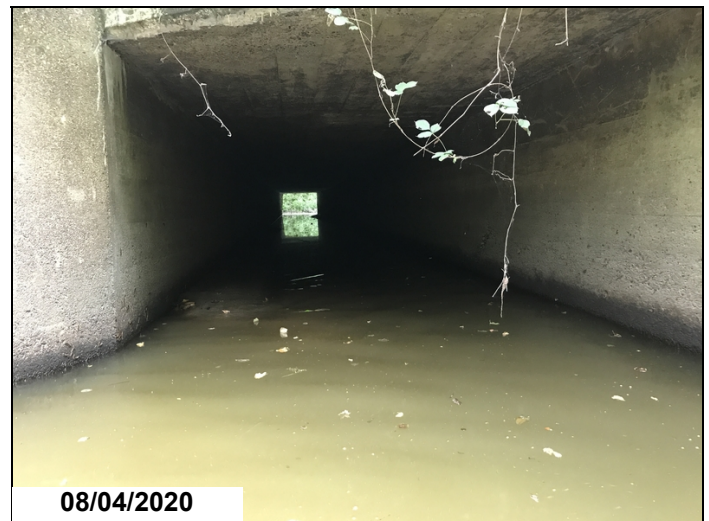
Barrel #2 has 3' of silt full length

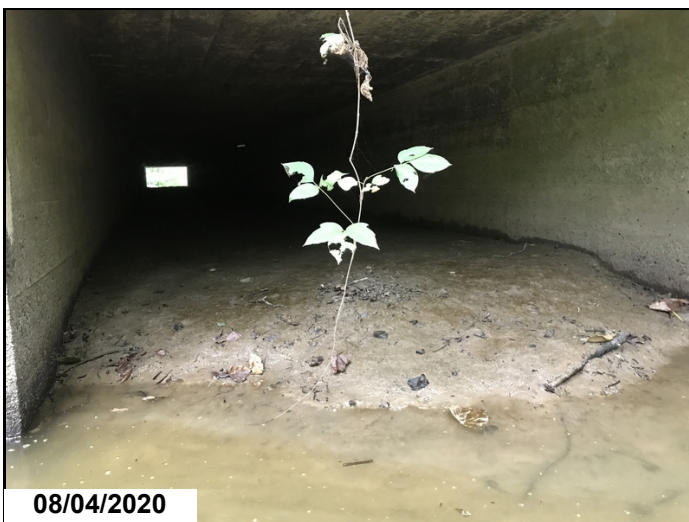
Barrel #1 has 4' of silt full length

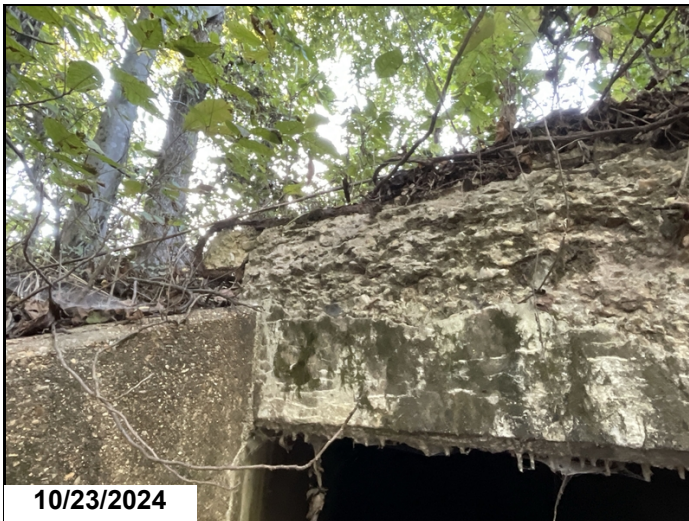
Barrel 2, end of structure, left side, head wall: spall with exposed reinforcing steel with 100% section loss. 1' CS4.

Type of Work: Repair (General)

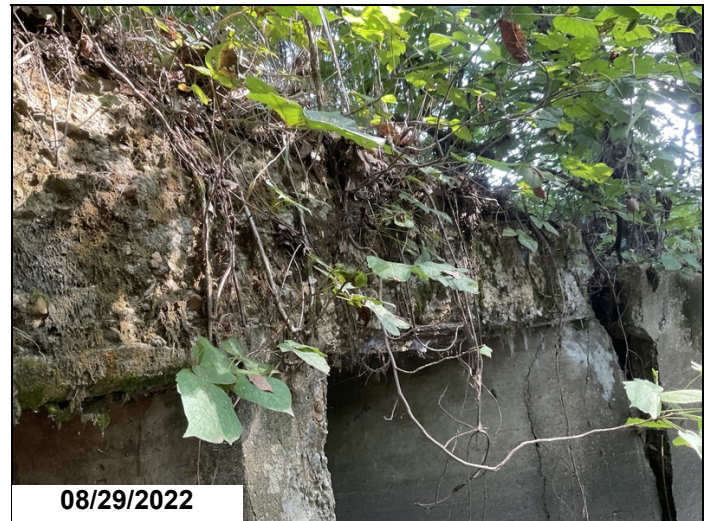
Right side head wall heavily scaled with exposed rebar with 100% section loss.

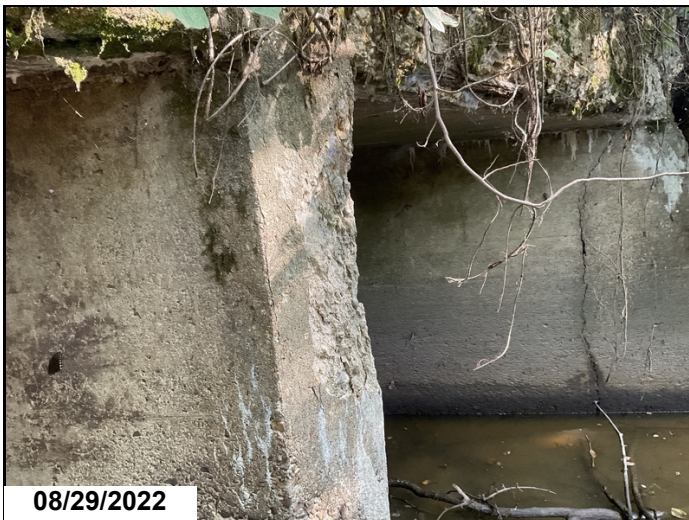
Interior wall right side spalled with no exposed rebar.

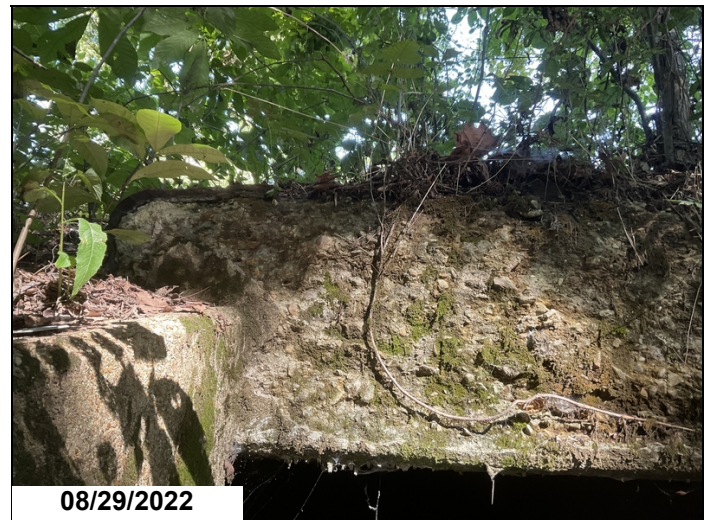
Exposed rebar right side head wall

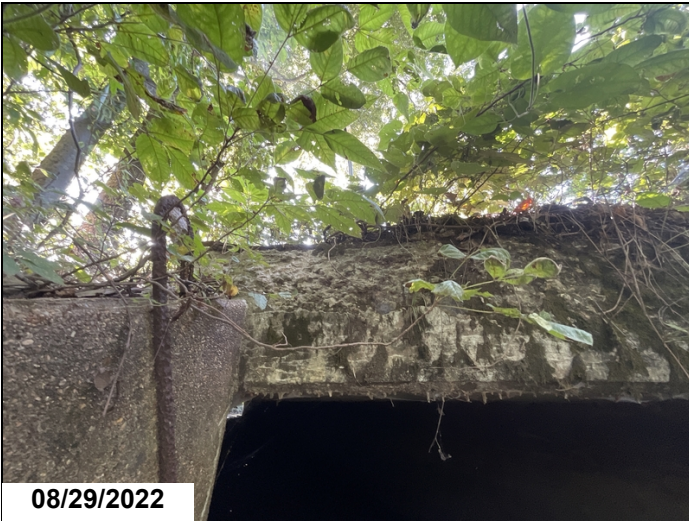
Left side head wall heavily scaled with exposed rebar with up to 100% section loss

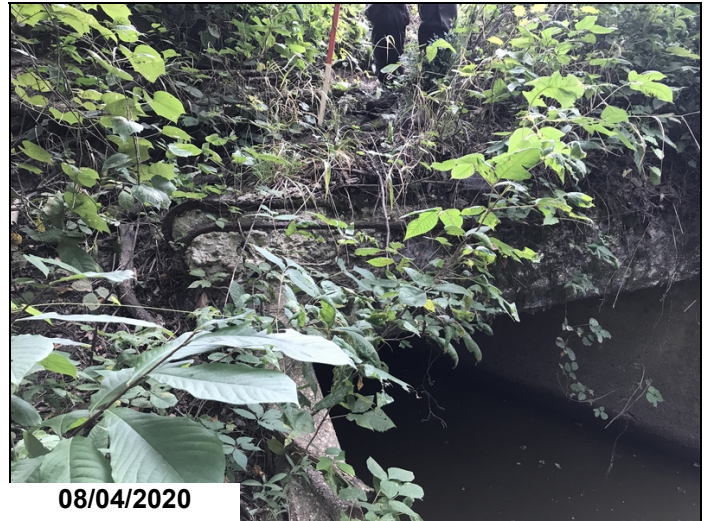
Left side at abutment #2 head wall exposed rebar with 5% section loss.

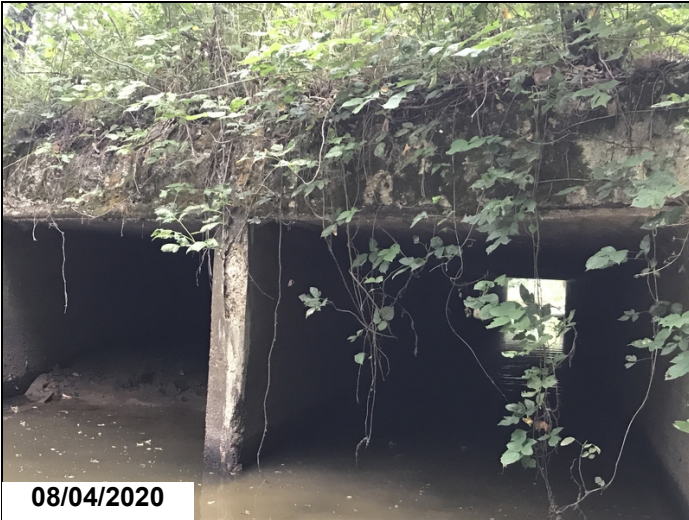
right side head wall

Barrels 1 & 2, Headwalls: Spalling with exposed reinforcing steel with up to 100% section loss. 2' CS3, 2' CS4.

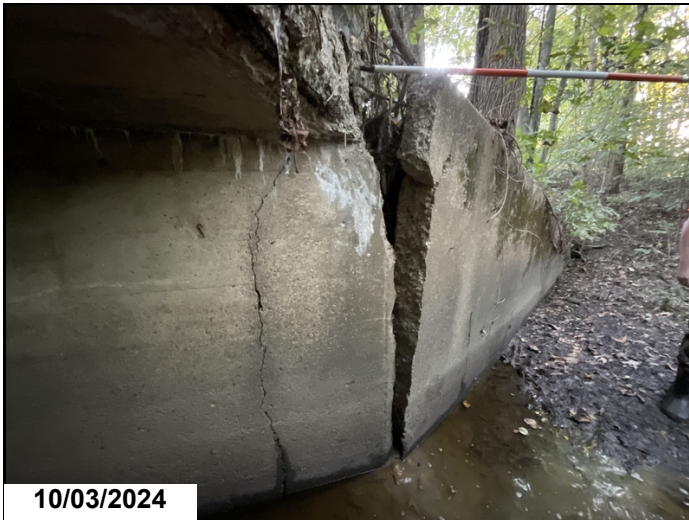
End of structure, right side wing wall: cracked and separated 1ft. at the top. due to large vegetation growing behind wing wall.

Type of Work: Repair (General)

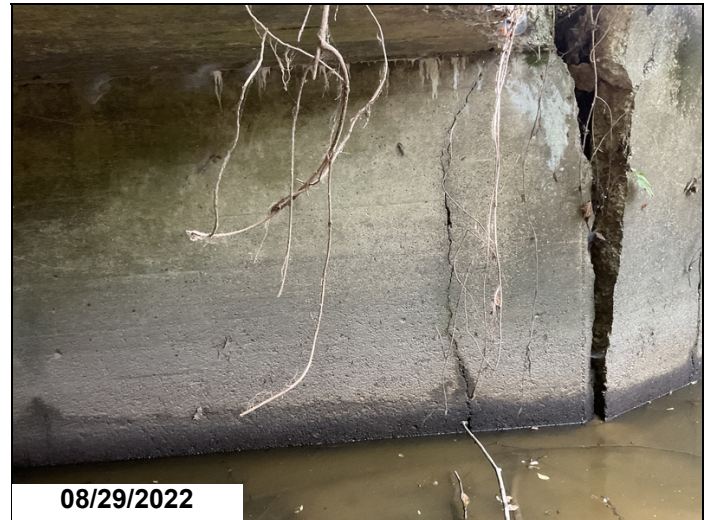
Cracking in barrel #2 outer wall right side

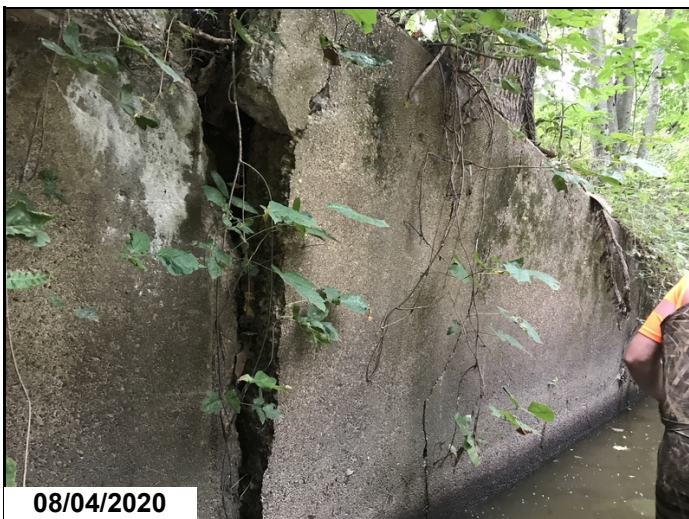
Right side abutment #2 wing

End of structure, right side wing wall: cracked and separated 1ft. at the top. due to large vegetation growing behind wing wall.

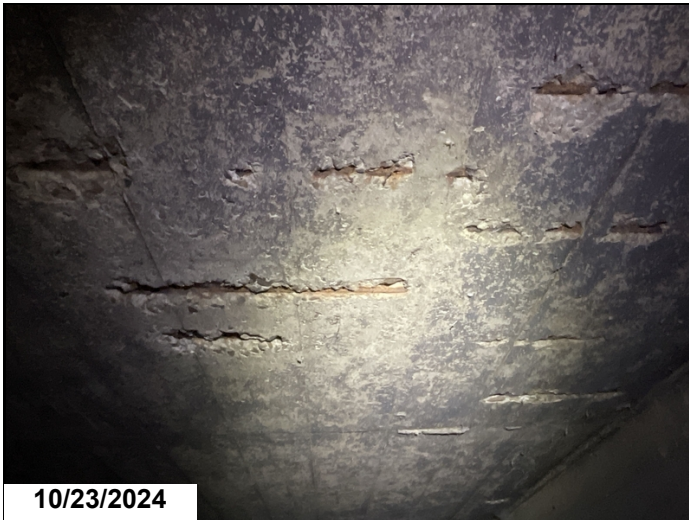
Barrel 2, 15' from left side: exposed rebar. 9 LF cs3

Type of Work: Repair (General)

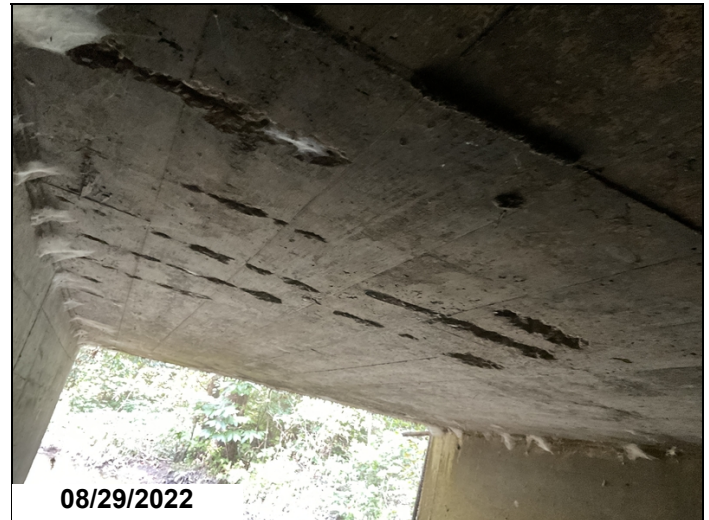
Exposed rebar barrel #2 left end.

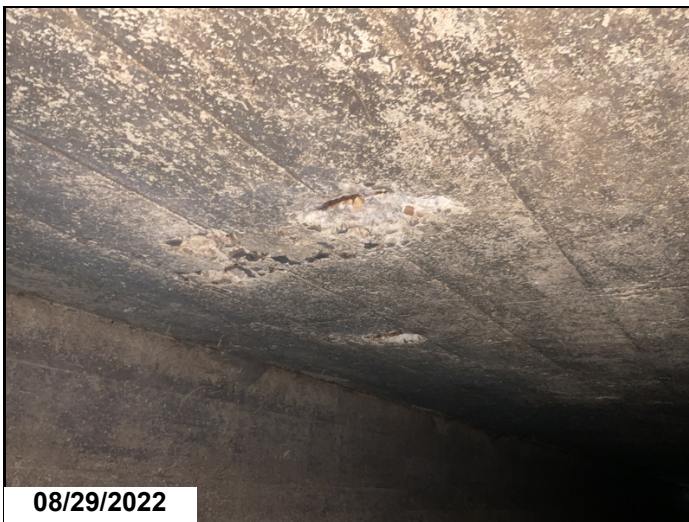
Exposed rebar barrel #1 soffit left side

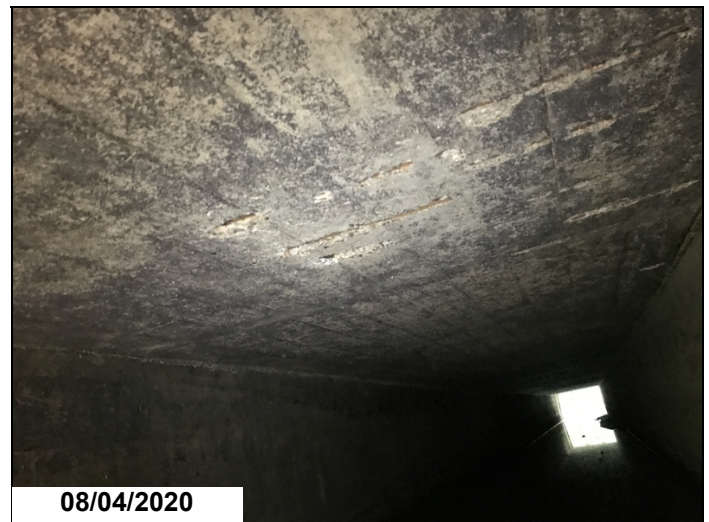
Span # 2 soffit has areas of delamination with small spalls on lt. end 15' - 20' inside and exposed rebar 8' total.

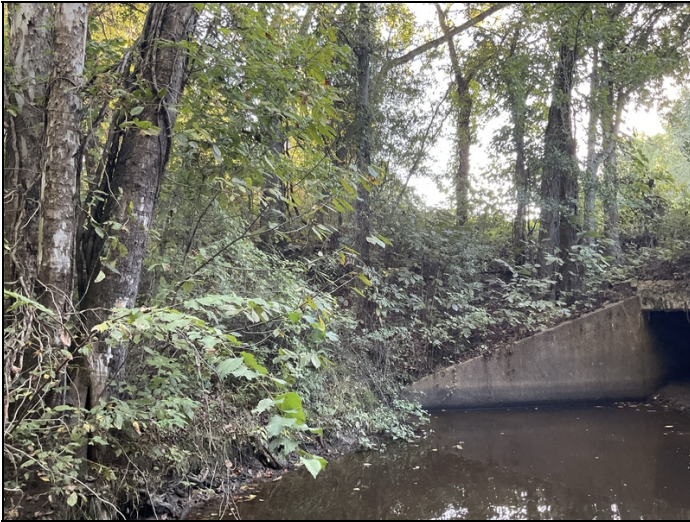
Culvert: heavy vegetation growth on both sides.

A-64 - Vegetation Removal Requested (Yes)

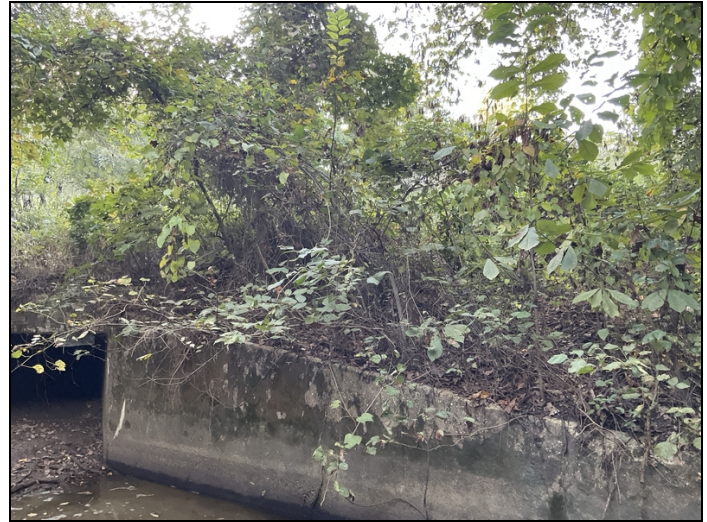
Culvert: heavy vegetation growth on both sides.

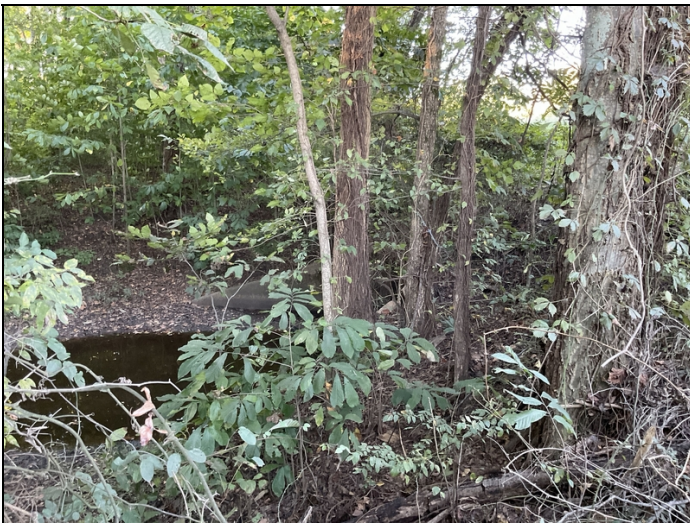
Culvert: buried in vegetation.
