Asset #05952(Routine, Underwater type 2)

Us-79/Sec-16/L9.44 over St Francis River

Location: 2 Miles Sw Jct Sh 131

Team Lead: Drew Melton Inspection Date: 04/10/2023

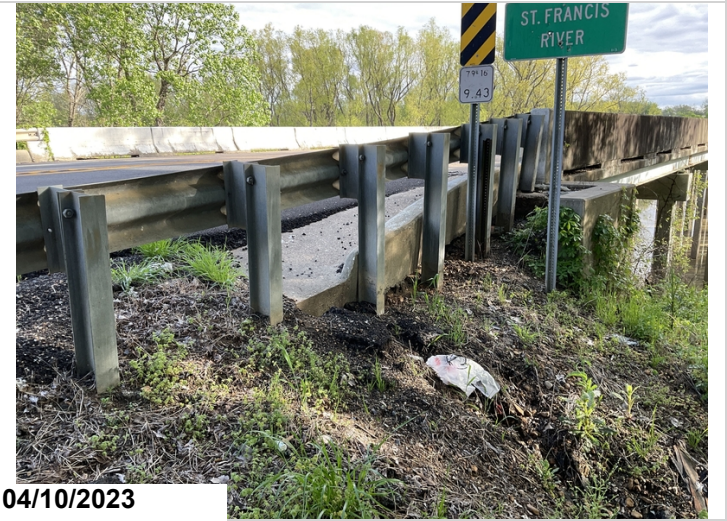
Approach gutter abutment #1 right side has large void under it and has settled.

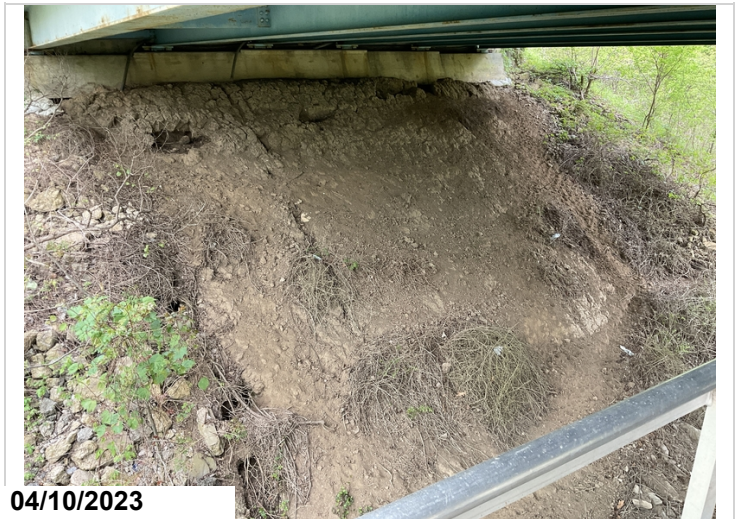
Abutment #1 slope

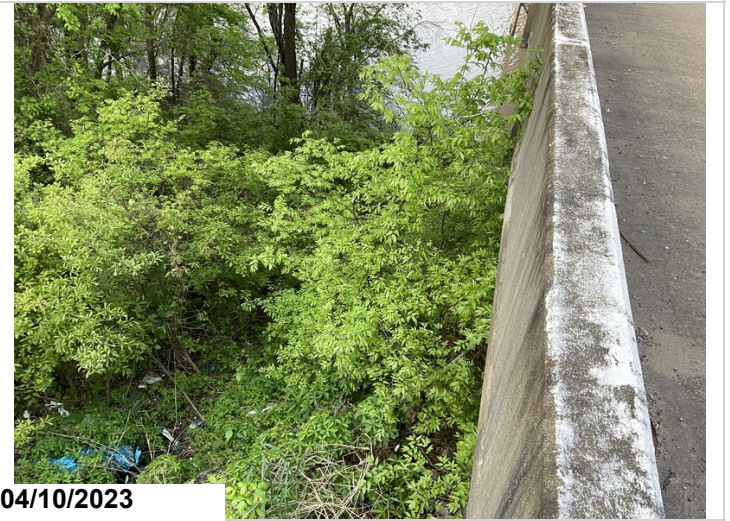
Typical vegetation

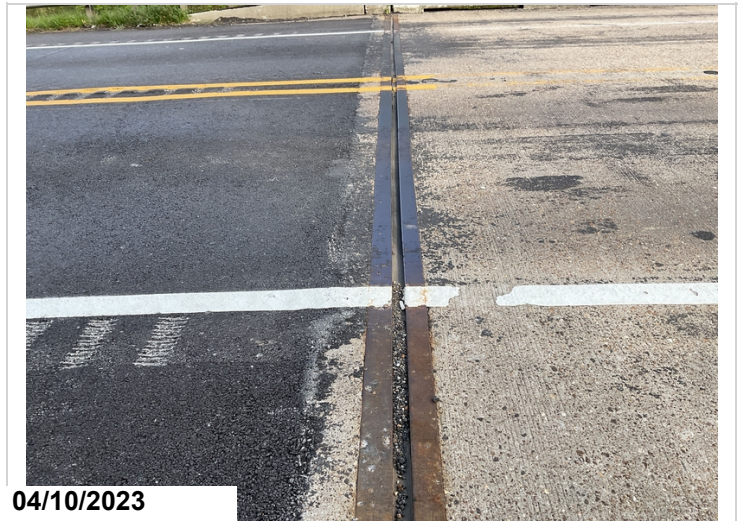
Abutment #1 joint seal has one 6" and a 2" tear in left lane and 1' of lost adhesion at center line.
Bent #5 joint seal has 4' of lost adhesion in right lane 1' of loss of adhesion in center, and 2 small holes.
Abutment #2 pourable joint seal has a 1" hole in right lane.

Abutment #1 joint

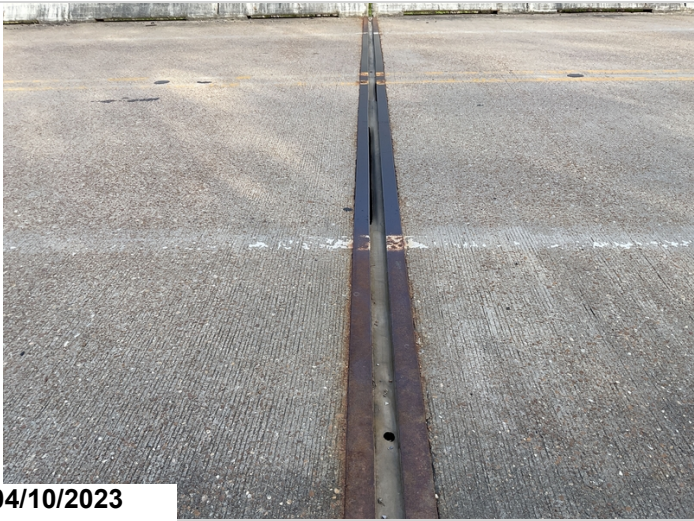
Bent #5 joint

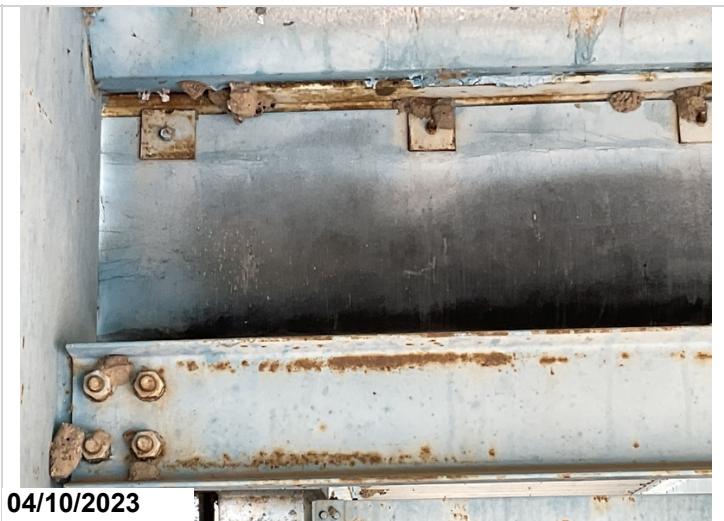
Bent #9 seal cracks and weathered

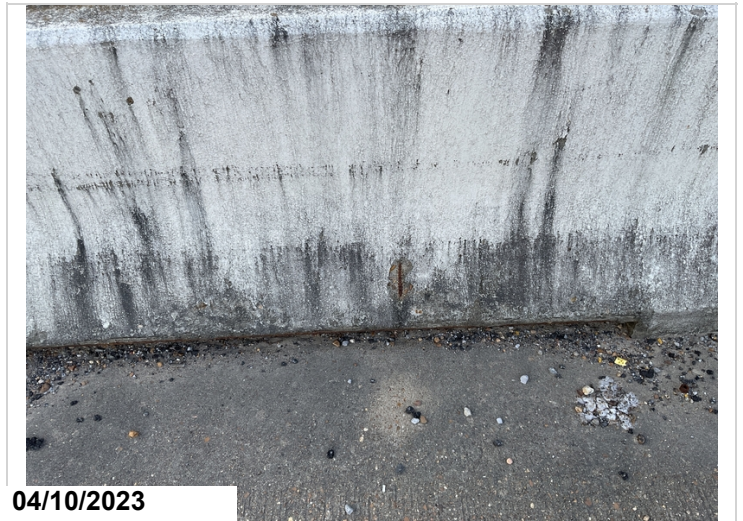
Typical exposed rebar on bridge rail

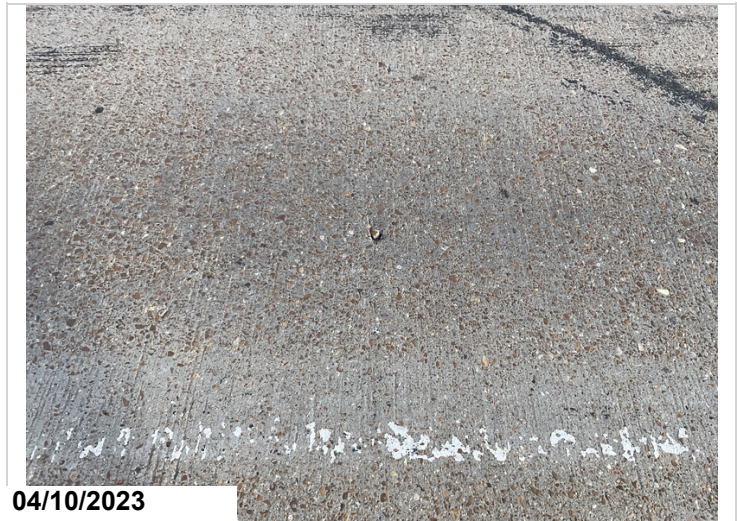
All spans have sealable deck cracks.

Typical deck cracks

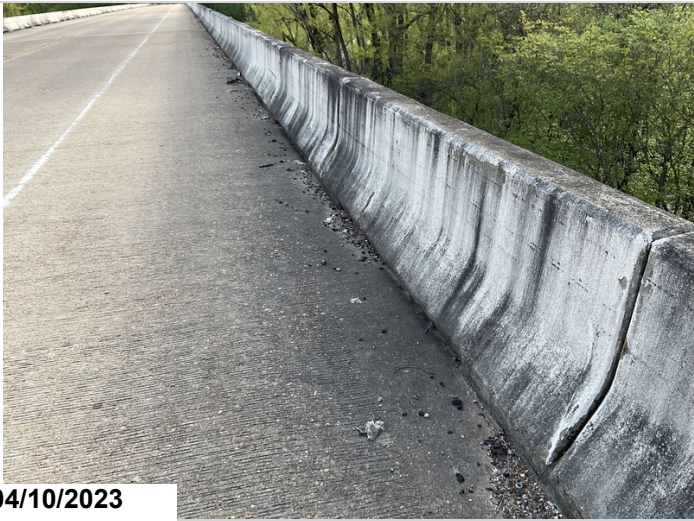
Deck has a small amount of debris in gutters.

Typical debris in gutters

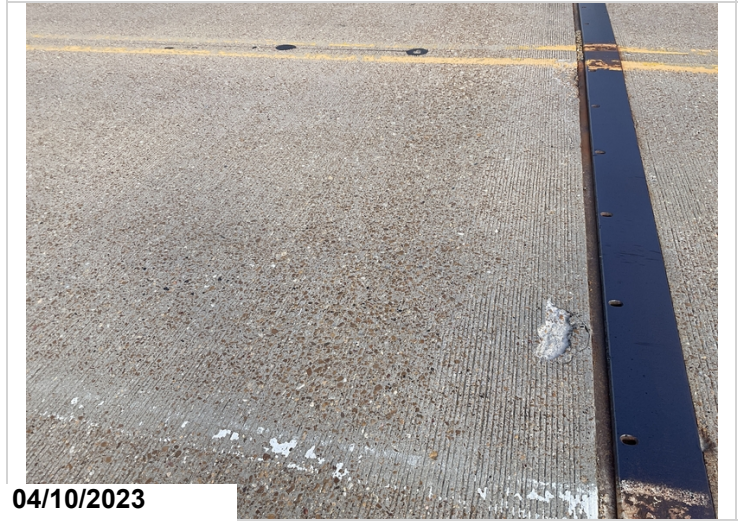
Span #8 at bent #9 center and right lane has 2 one foot shallow spalls each with no exposed rebar.

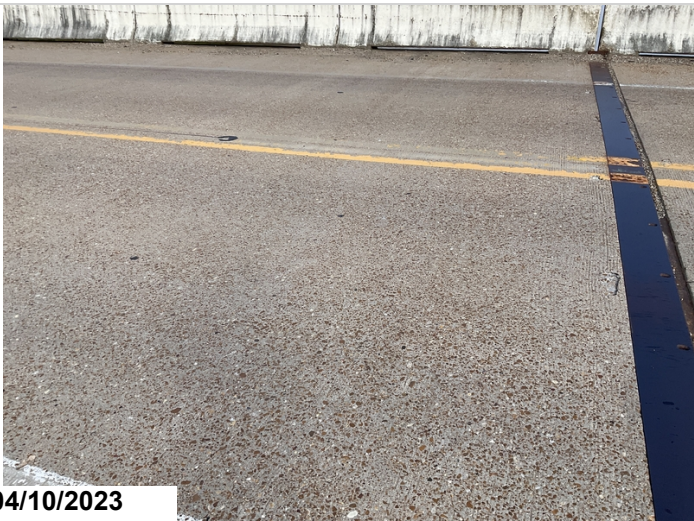
Span #11 at bent #12 joint has two six inch shallow spall in each lane with no exposed rebar.

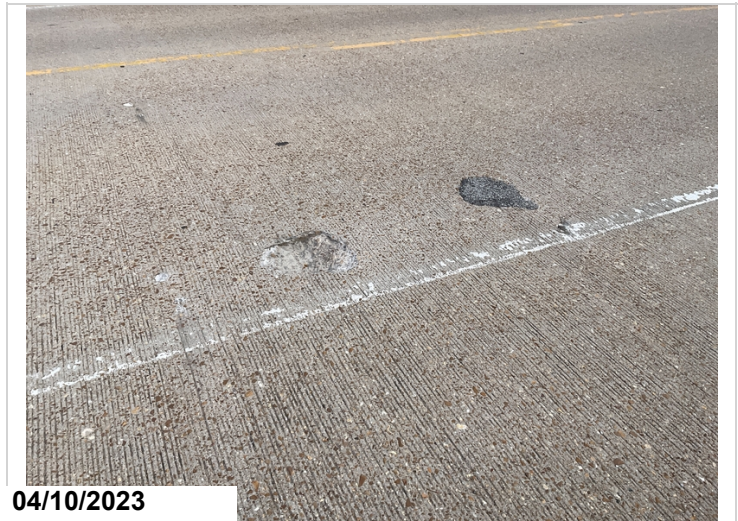
Span #13 right lane has a one foot achm patch.
Span #13 right lane has a 1' spall with exposed rebar.

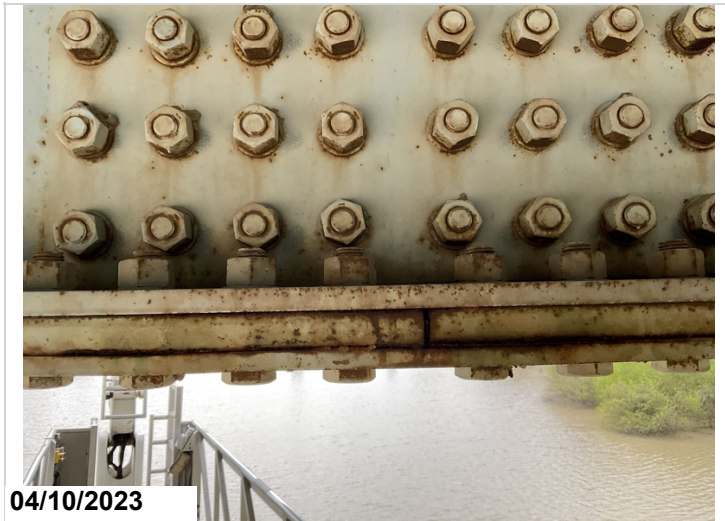
Field splices on bottom of bottom flange are beginning to form pact rust little to no section loss.

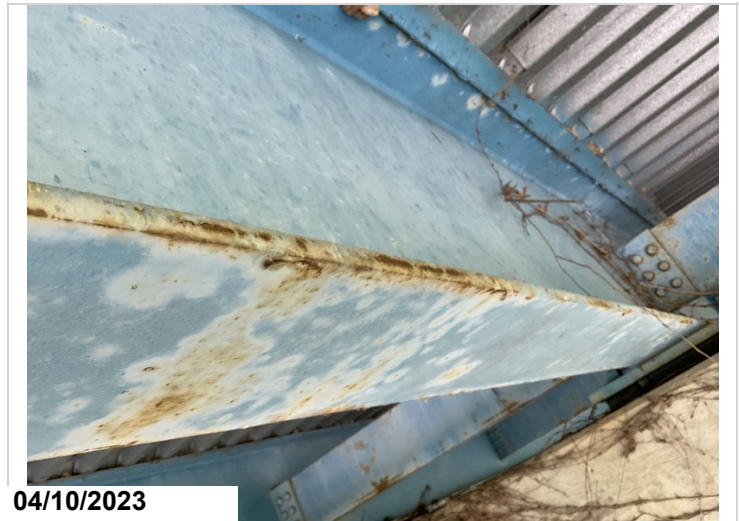
Typical area of delaminated on bottom flange of girder.

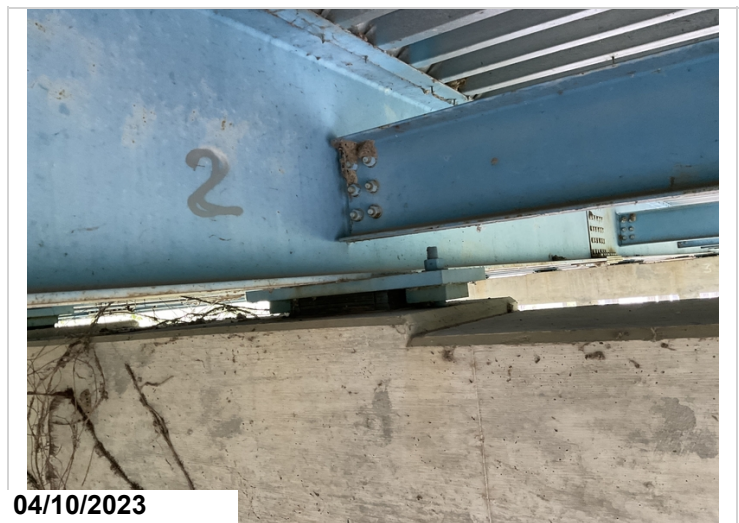
Girders have surface rust full length with no section loss some small areas of paint peeling. Rest of paint is chalky. Corrosion heaviest at bent on bottom flange Span #13 being the worst.

Typical interior paint condition

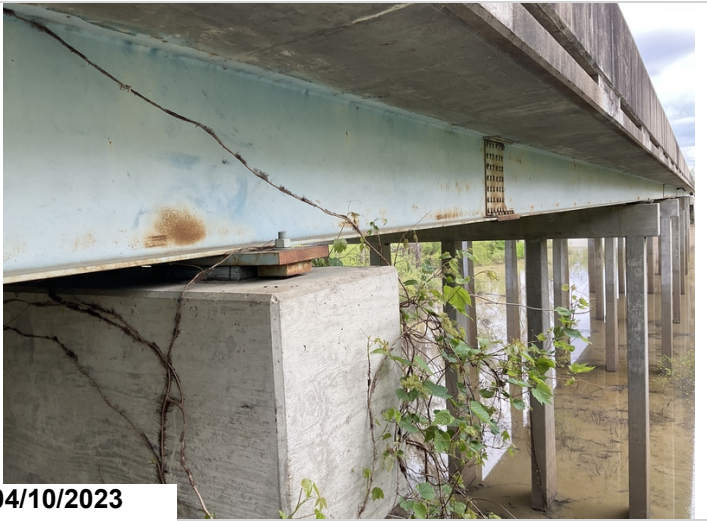
Typical outside girder condition

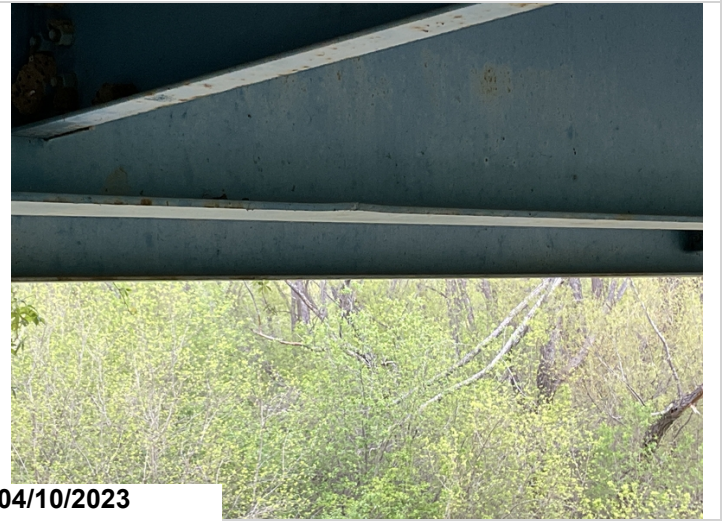
Span #2 girder #2 4' ahead of field splice has a small area bottom flange is bent upward slightly.

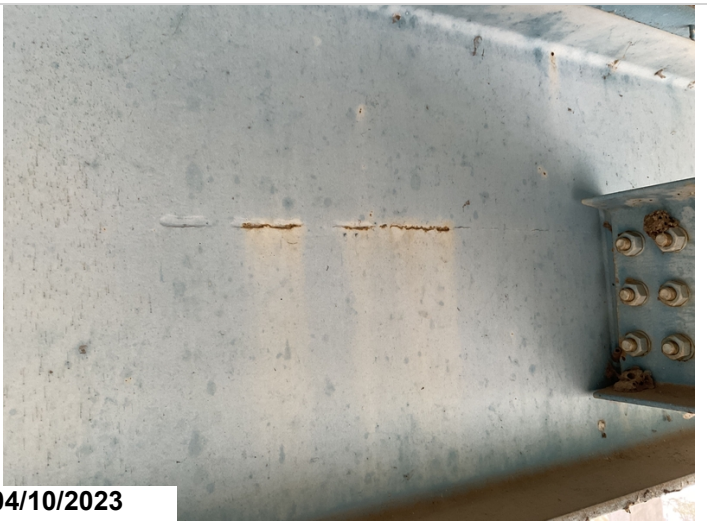
Span #7 girder #4 right side center span center of web has area of gouges where welds have been removed.

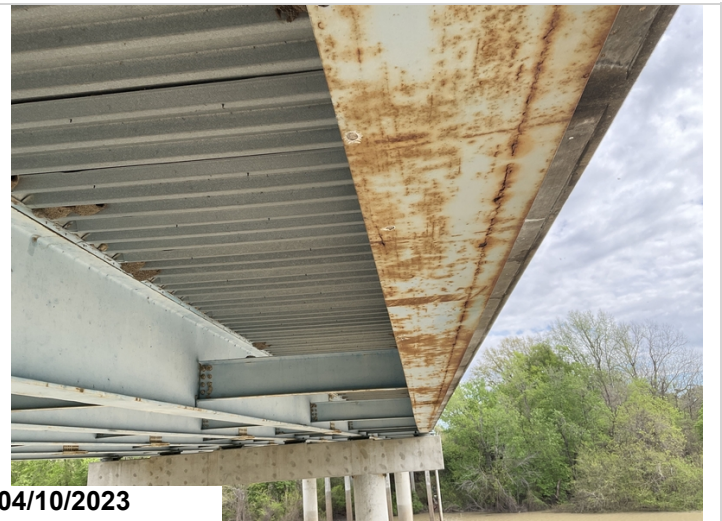
Span #10 girder #6 bottom flange has small ribbon of delamination in center section between field splices.

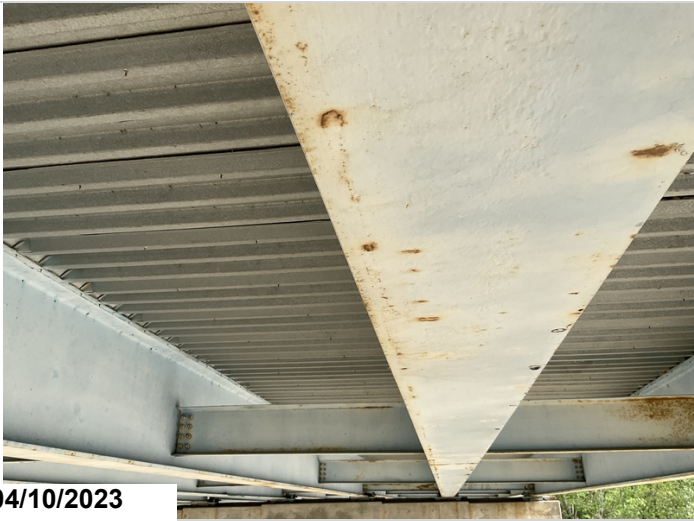
Span #11 girder #5 bottom flange has narrow ribbon of delamination full length.

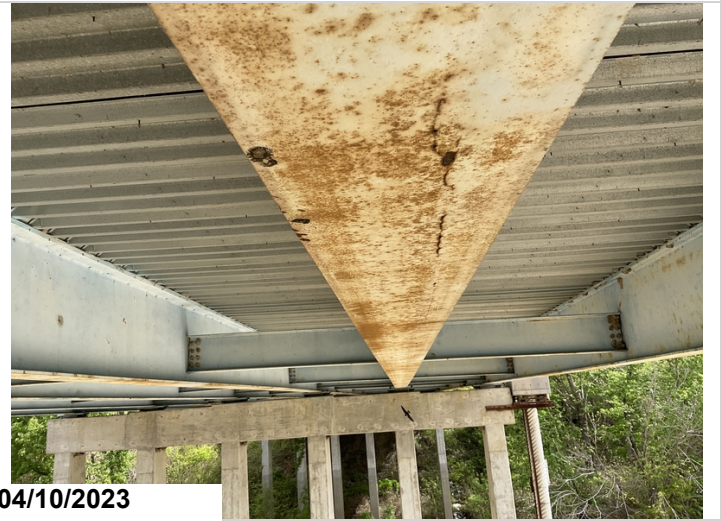
Span #12 girder #5 has an area a quarter span on bottom of bottom flange for two feet that a thin layer of metal is delaminated.

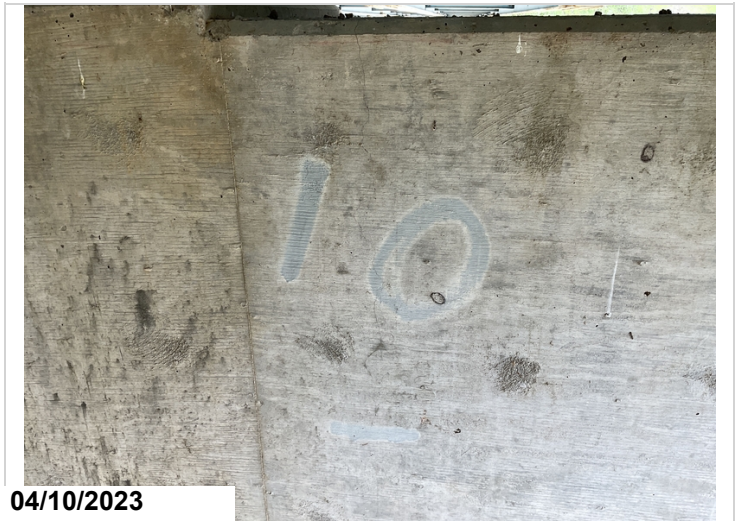
Typical crack in cap

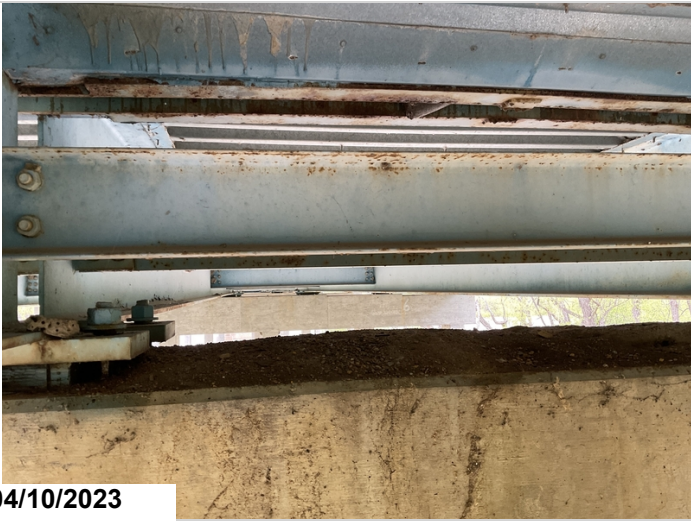
Bent #5 cap has six inches of dirt and debris full length.

Typical debris on cap bent #5

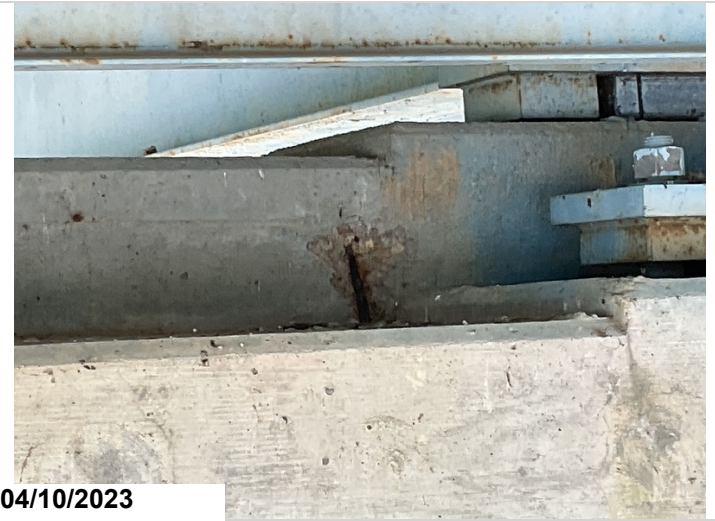
Bent #9 cap on step up between girders #5,6 has a 6" spall with exposed rebar.

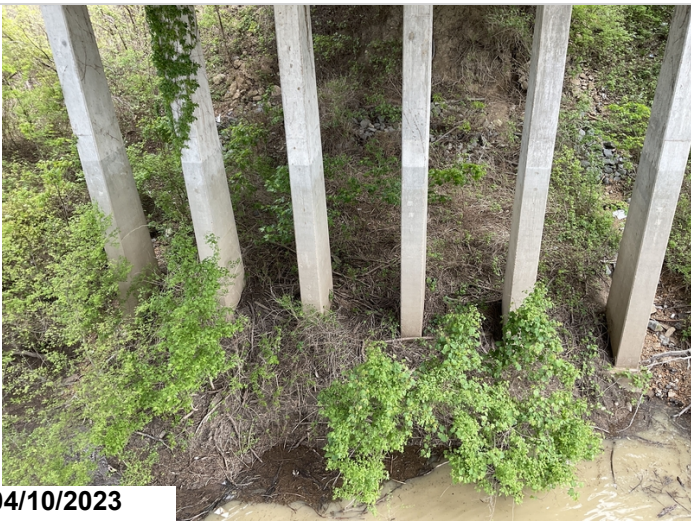
Bent #14 footing is exposed on each end for a few feet.

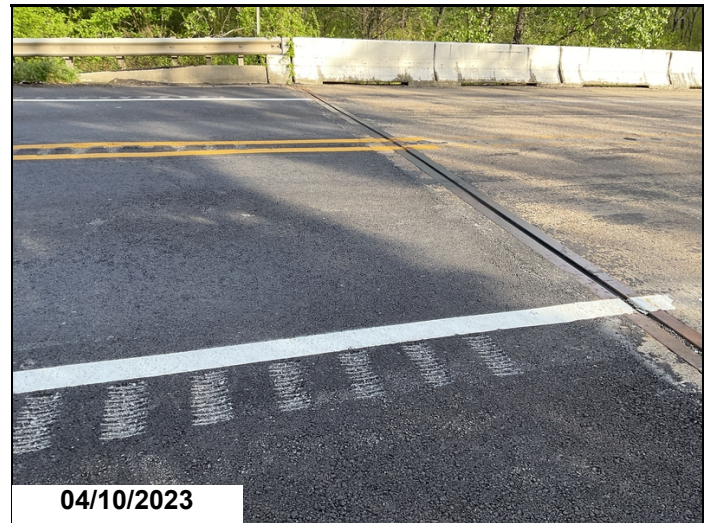
Abutment #1 approach roadway has settled 1"-2" increasing impact loading on bridge.

Abutment #1 approach roadway has been leveled since last inspection

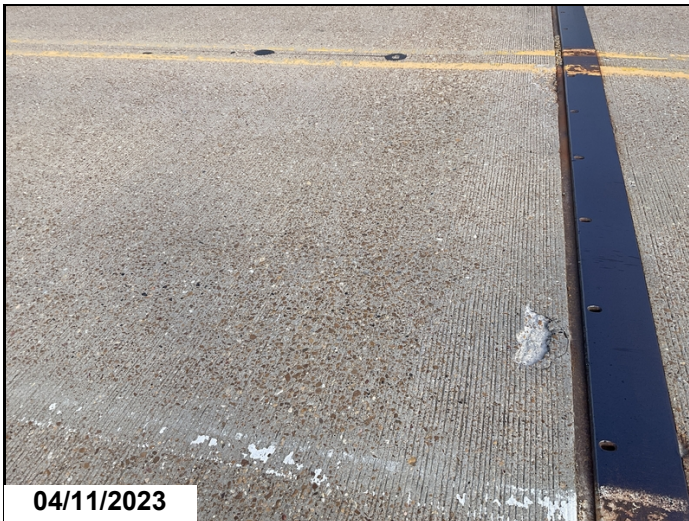
Span #8 at bent #9 center and right lane has 2 one foot shallow spalls each with no exposed rebar.

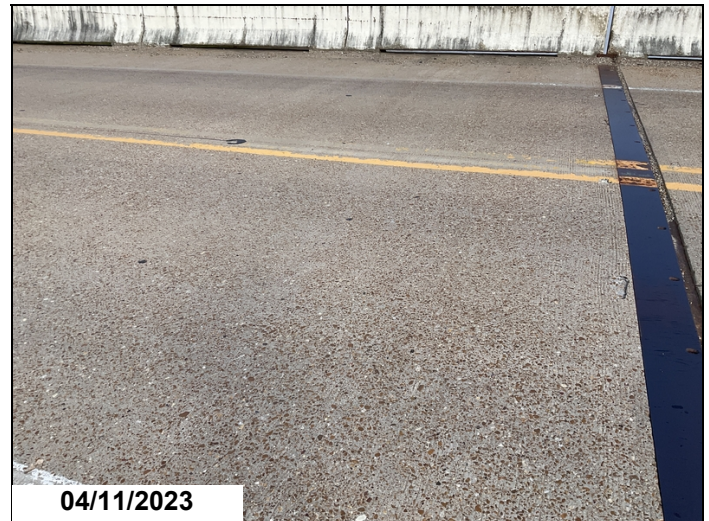
Span #11 at bent #12 joint has two six inch shallow spall in each lane with no exposed rebar.

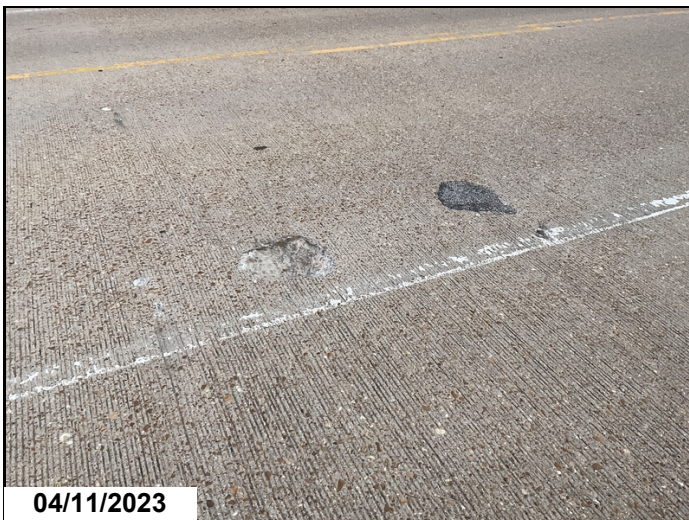
Span #13 right lane has a one foot achm patch.
Span #13 right lane has a 1' spall with exposed rebar.

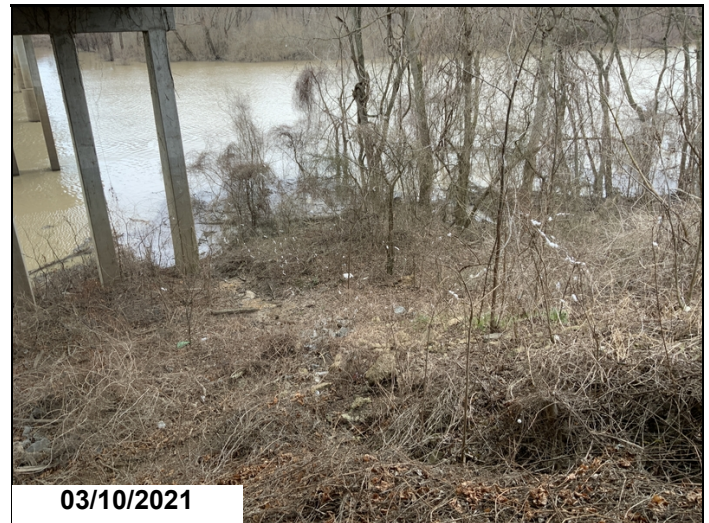
Small trees and vegetation are growing beside and under bridge.

Trees and vegetation growing beside and under bridge.

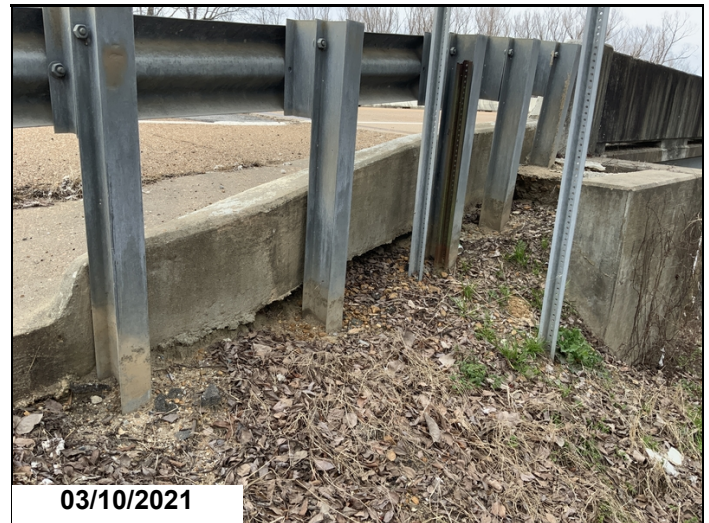
Approach gutter abutment #1 right side has large void under it and has settled.

Void underneath abutment #1 right approach gutter.

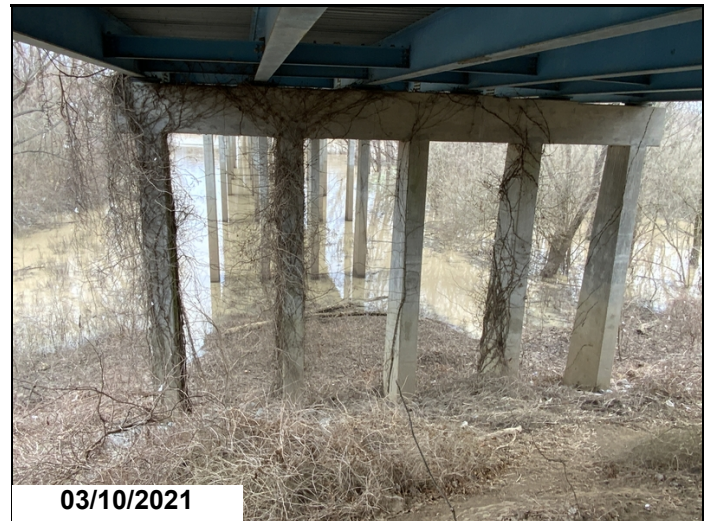
Bents # 2,14 back side have vines growing on columns and cap.

Vines growing up bent #2.

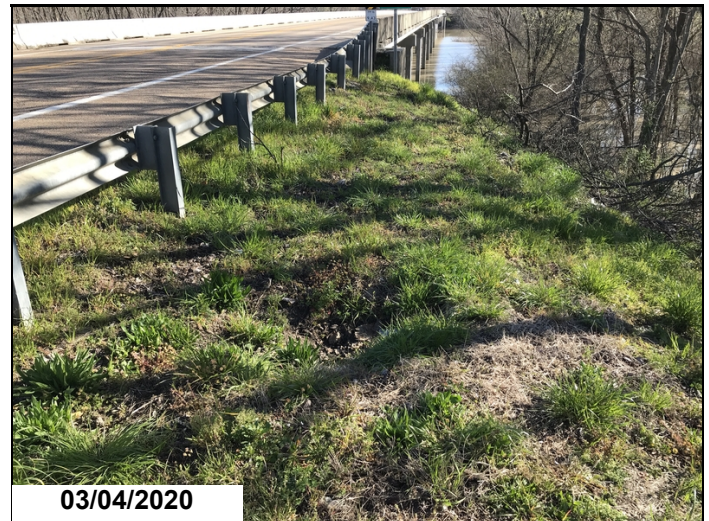
Two foot sink hole abutment #1 right side fifty feet from bridge end.

2' sink hole abutment #1 right side 50' from bridge end.

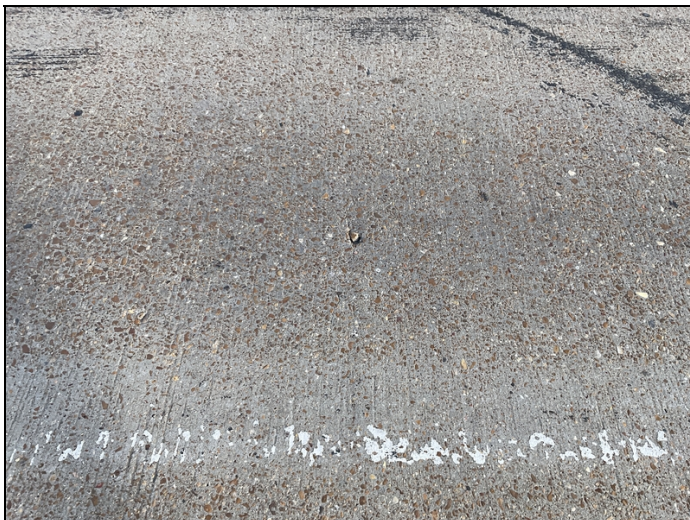
All spans have sealable deck cracks.

Typical deck cracks

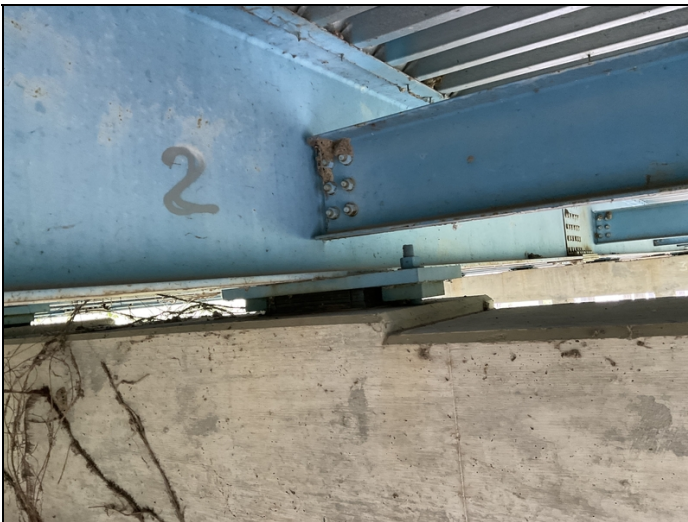
Girders have surface rust full length with no section loss some small areas of paint peeling. Rest of paint is chalky. Corrosion heaviest at bent on bottom flange Span #13 being the worst.

Typical interior paint condition

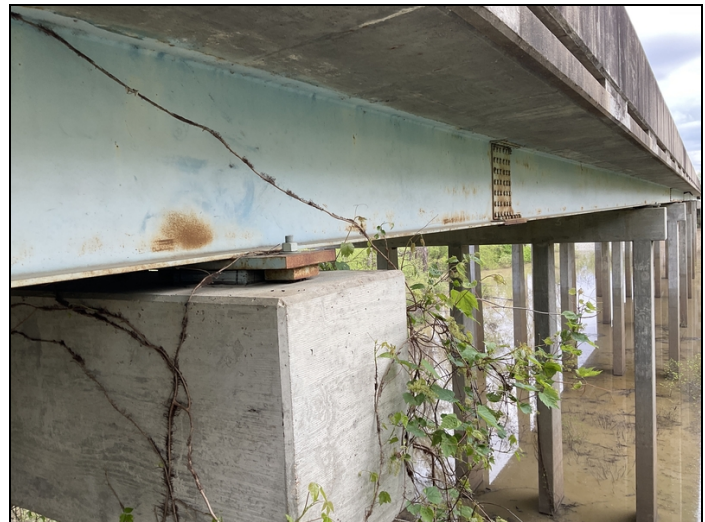
Typical outside girder condition

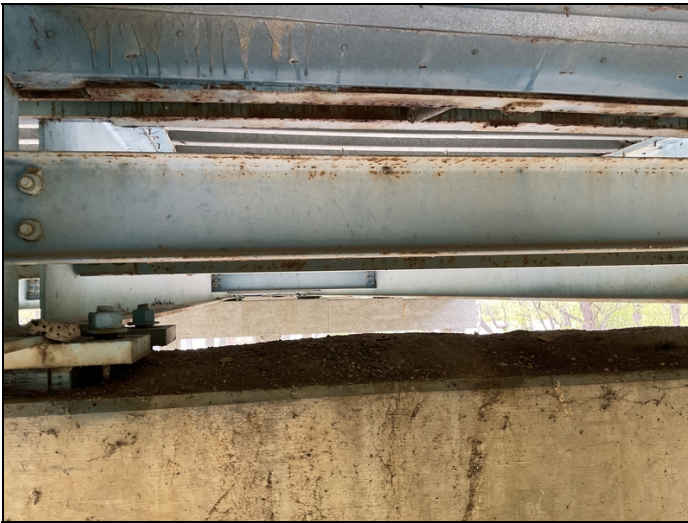
Bent #5 cap has six inches of dirt and debris full length.

Typical debris on cap bent #5

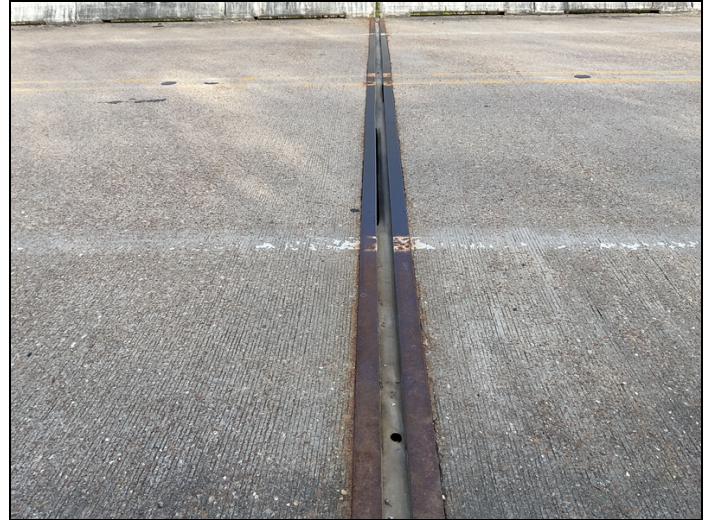
Abutment #1 joint seal has one 6" and a 2" tear in left lane and 1' of lost adhesion at center line.
Bent #5 joint seal has 4' of lost adhesion in right lane 1' of loss of adhesion in center, and 2 small holes.

Bent #5 joint

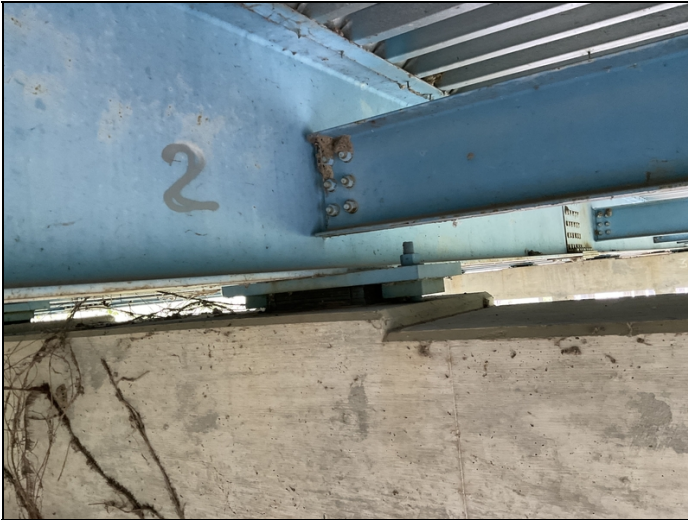
Girders have surface rust full length with no section loss some small areas of paint peeling. Rest of paint is chalky. Corrosion heaviest at bent on bottom flange Span #13 being the worst.

Typical interior paint condition

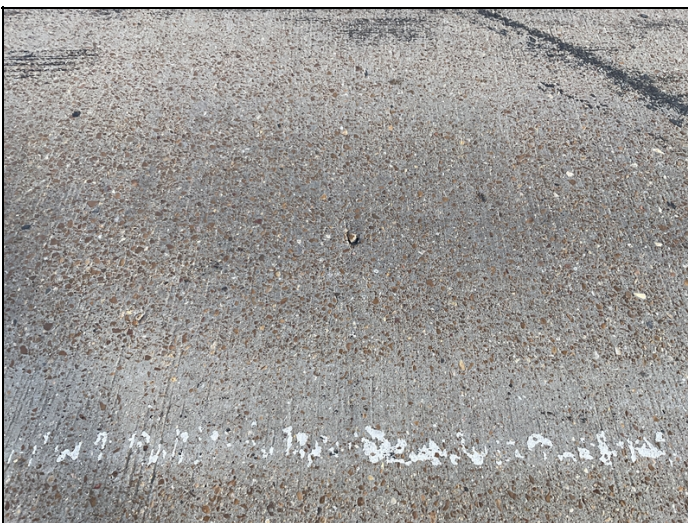
All spans have sealable deck cracks.

Typical deck cracks
