Asset #02534(Other Special Recurring)

Us-79/Sec16/L11.51 over Alligator Bayou

Location: .7 Mi South Of Brickeys

Team Lead: Drew Melton Inspection Date: 11/21/2023

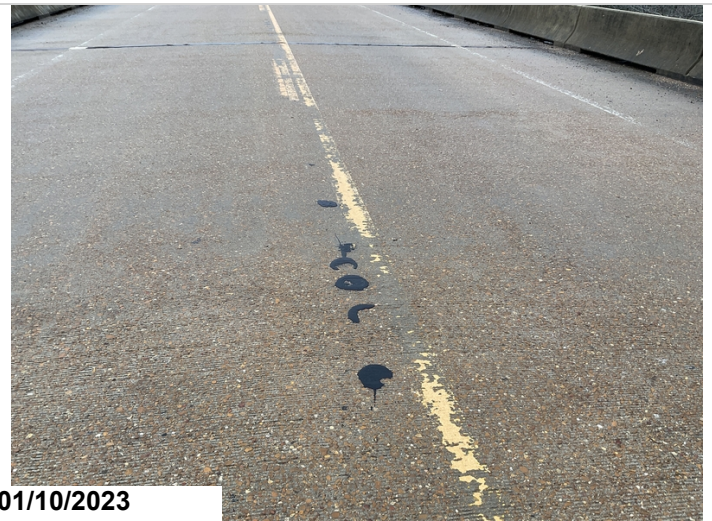
Typical longitudinal deck crack

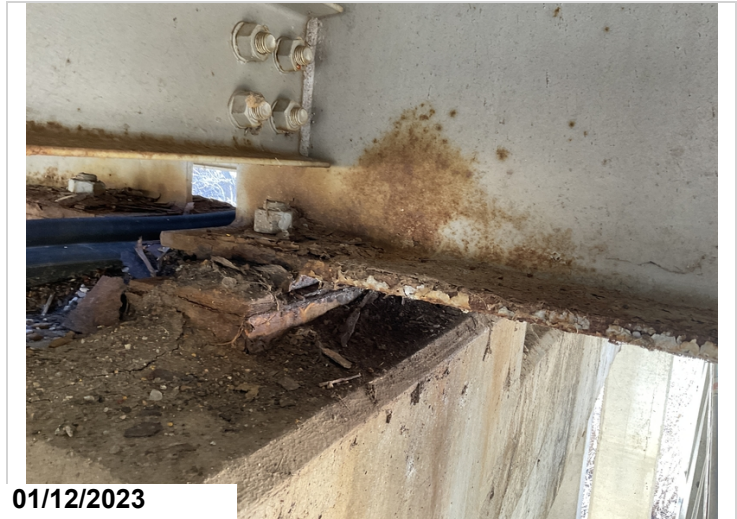
Bent #2 girder #6 bearings are corroded and span #1 and 2 girder #6 bottom flange outside has scaly rust

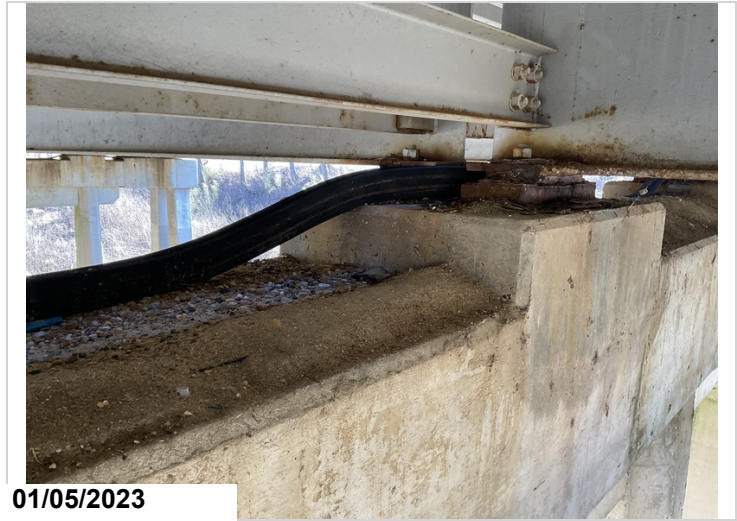
Corrosion on girder ends and bearings at bent #7

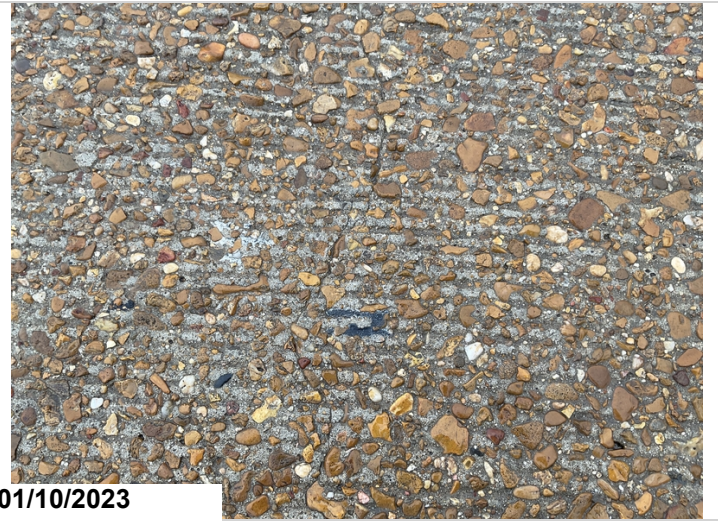
Span #5 deck left lane has one foot spall near mid span

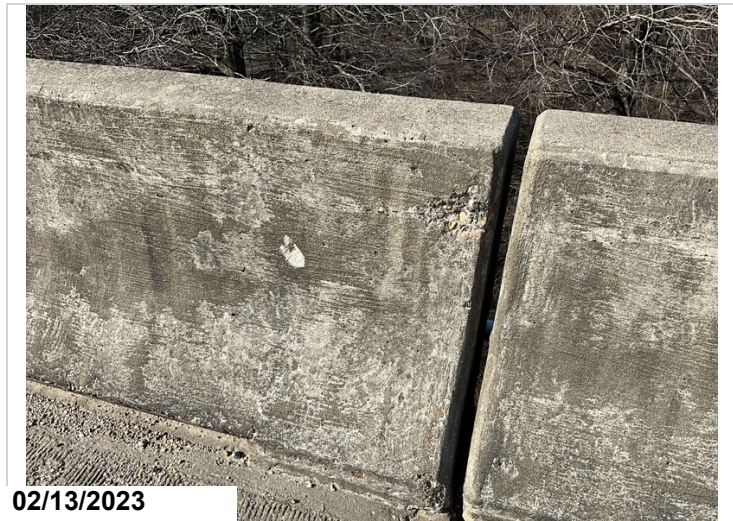
Span 8, right side, crack cs 2.

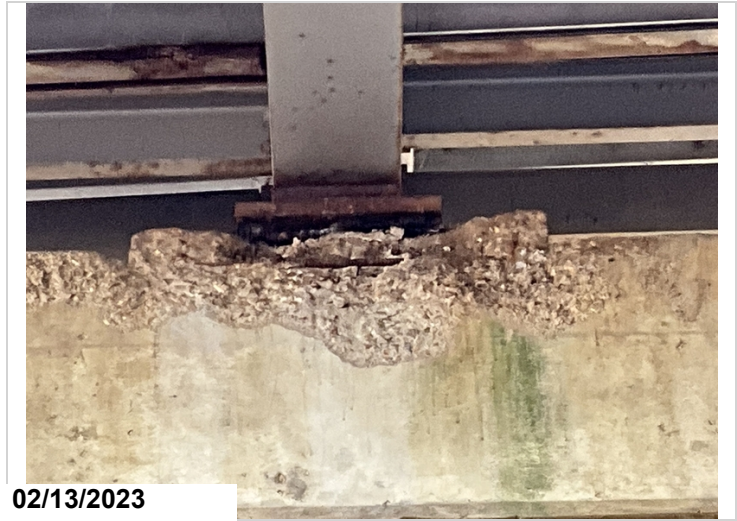
Span 11, right, spall cs 2.

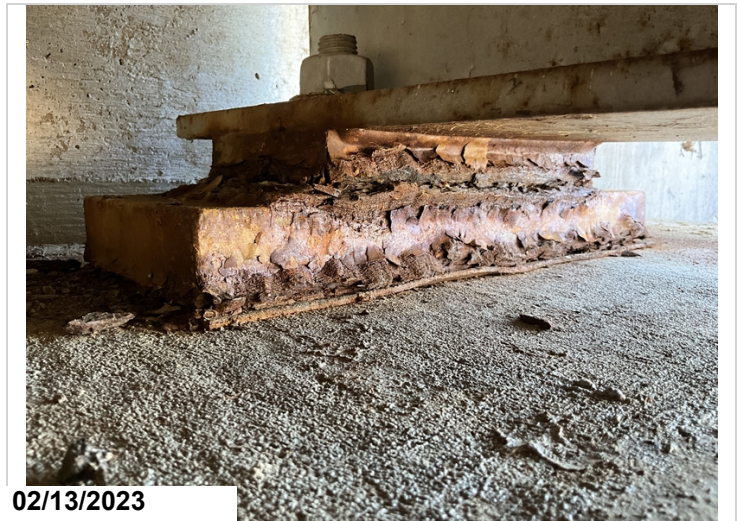
Bent 10 ahead, bearings 2 and 5, loss of bearing area.

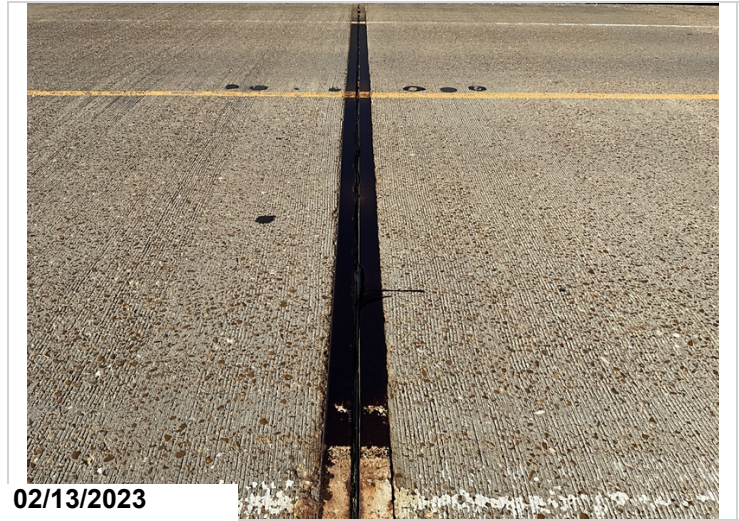
Bent 6, leakage, cs 4. Typical 5

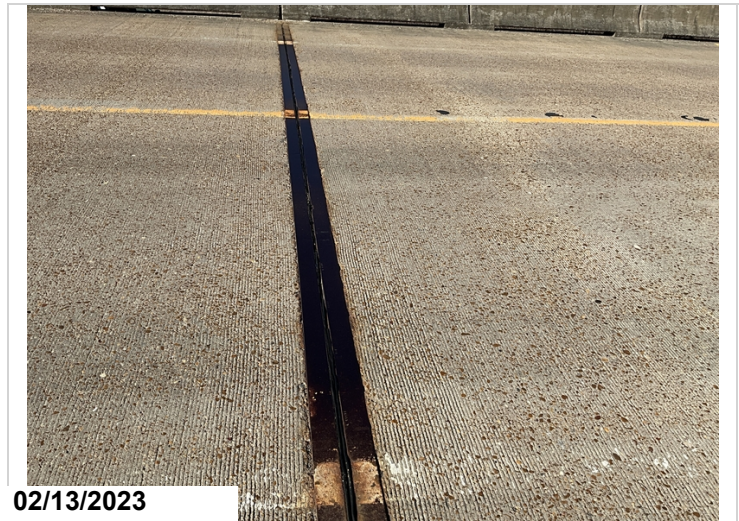
Bent 10, joint fallen out, leakage, cs 4.

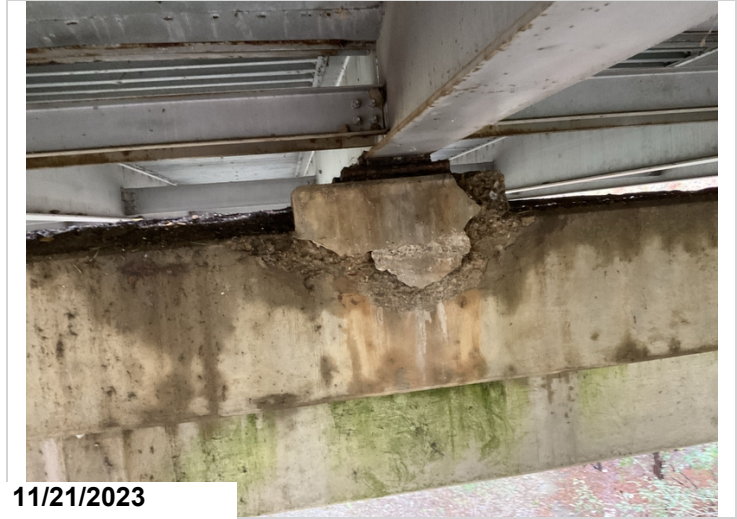
Bent #8 cap ahead face left side bottom corner has a 1' spall with exposed rebar minor section loss.

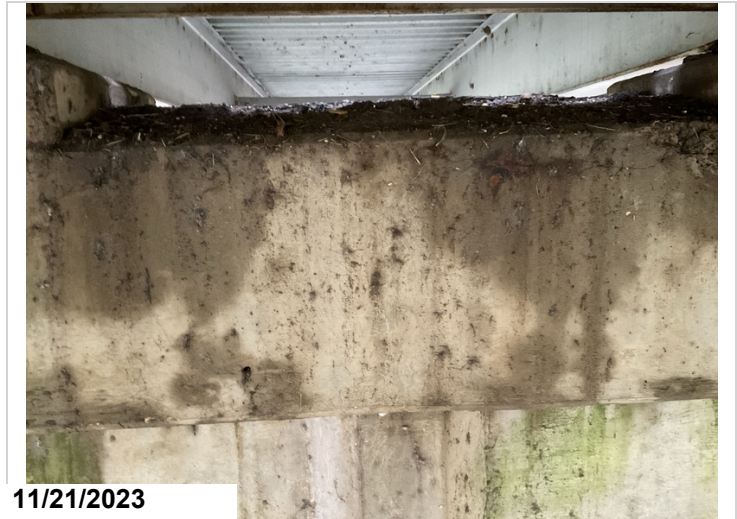
Bent #8 cap ahead face has cracks, delaminated area, and spalled under girder #3 full width of bearing riser.

Bent #8 cap ahead face cracked and delaminated and spalled under girder #3, full width of riser.

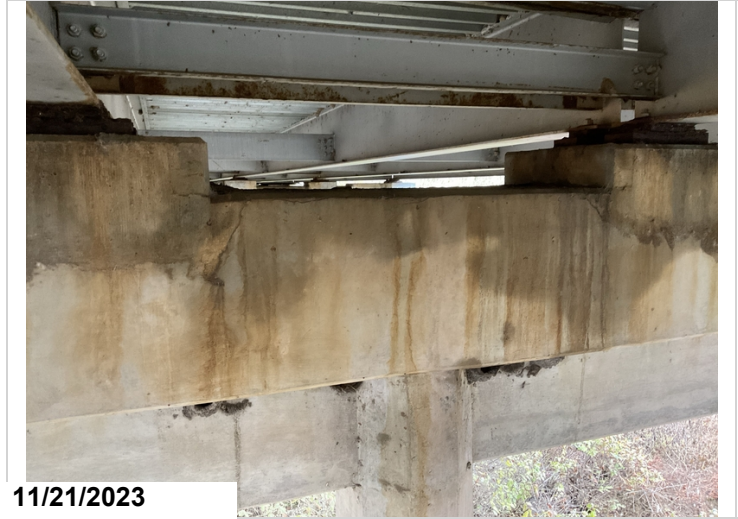
Bent #5 cap right end has 1' of cracking and delaminated area at end of old cap and new cap.

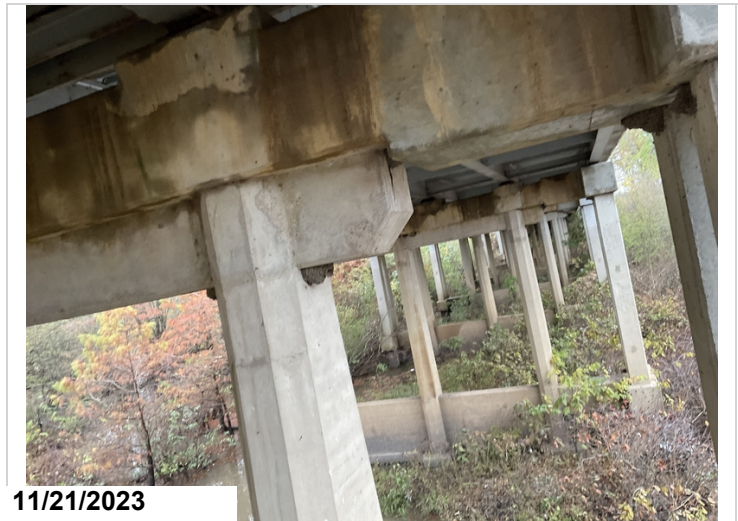
Bent #4 cap ahead face has horizontal cs3 cracks for 20' between girders #2, 5.

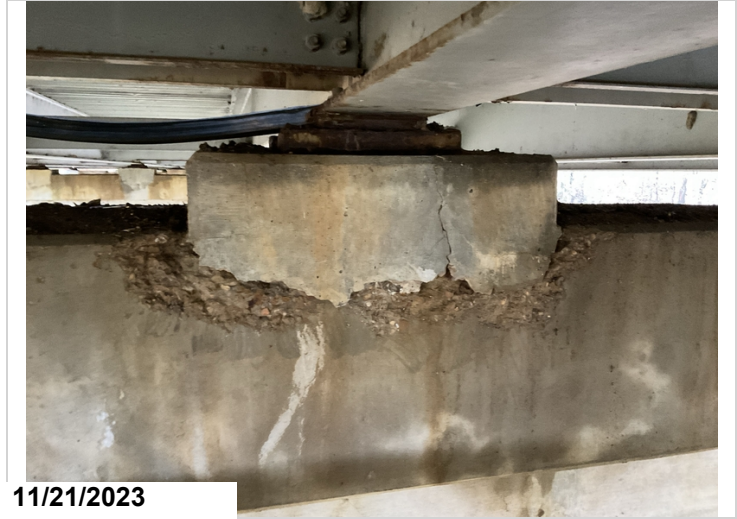
Bent #3 cap back face bearing riser spalled under girder #5 for 3' extending underneath bearing masonry plate up to 1" with exposed rebar moderate section loss.

Bent #3 cap back face spalled under span #2 girder #5 for two feet extending underneath bearing masonry plate up to one inch with exposed rebar

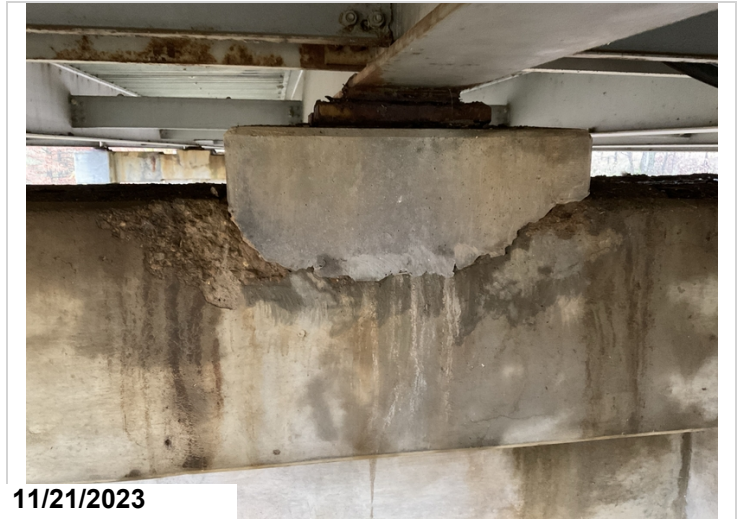
Bent #3 cap back face under girder #4 bearing riser has 3' crack with delamination extending underneath bearing masonry plates.

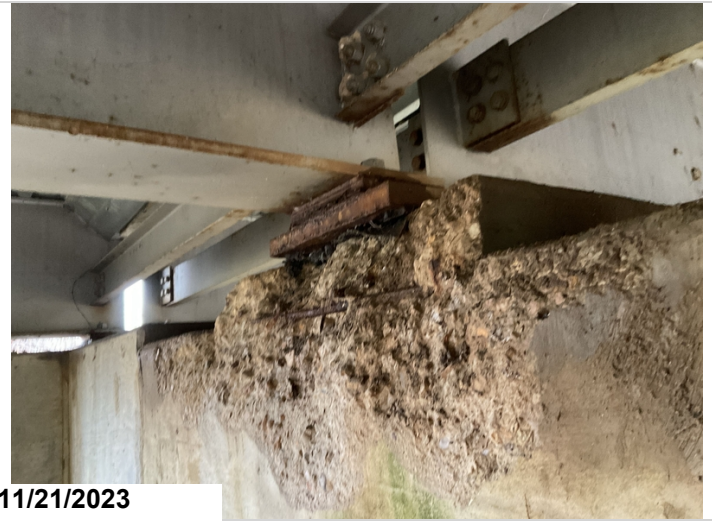
Bent #3 cap back face under girder #3 bearing riser is cracked and spalled for 3' extending under bearing masonry plate.

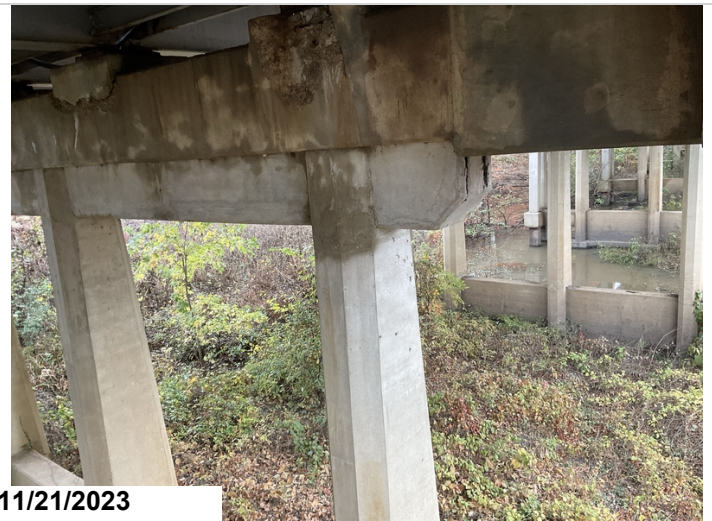
Bent #3 cap back face bearing riser is spalled for approximately 3.5 feet long and 3.5 inches under span #2 girder #2 extending up to 3" underneath bearing masonry plate with exposed rebar moderate section loss.

Bent #3 cap back face spalled for approximately 3.5 feet long under span #2 girder #2 extending up to three inches underneath bearing masonry plate with exposed rebar.

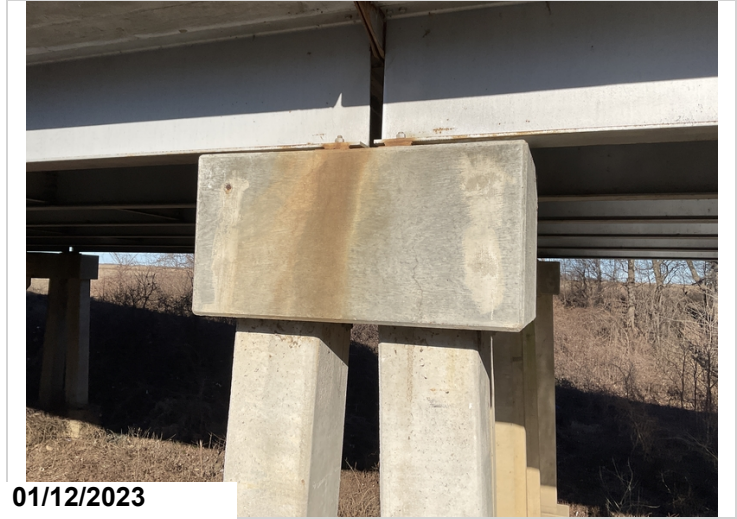
Bent #3 cap left side between pile #1, 2 and column #1 is spalled with exposed rebar moderate section loss (end of original cap).

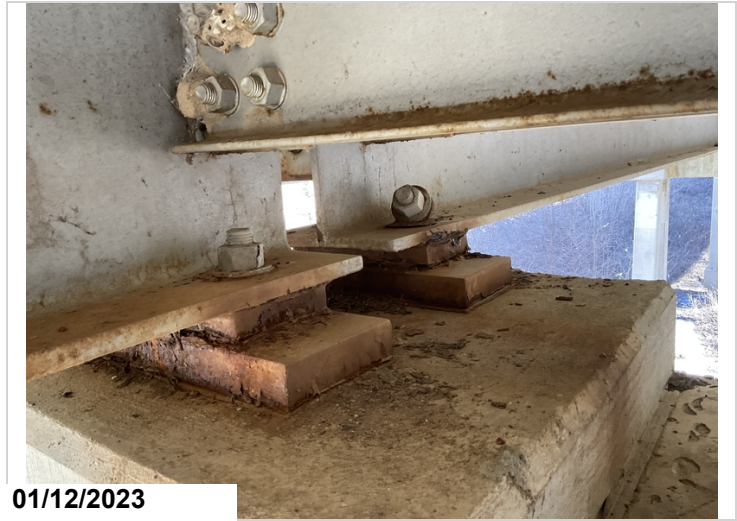
Span #6 bent #6 girder #2 right anchor bolt broken.

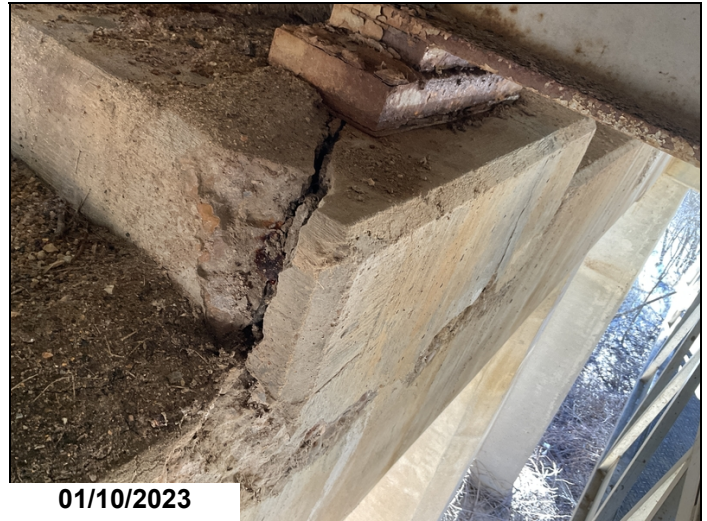
Bent #3 cap back face under girder #3 bearing riser has three foot crack with delamination extending underneath bearing masonry plates.

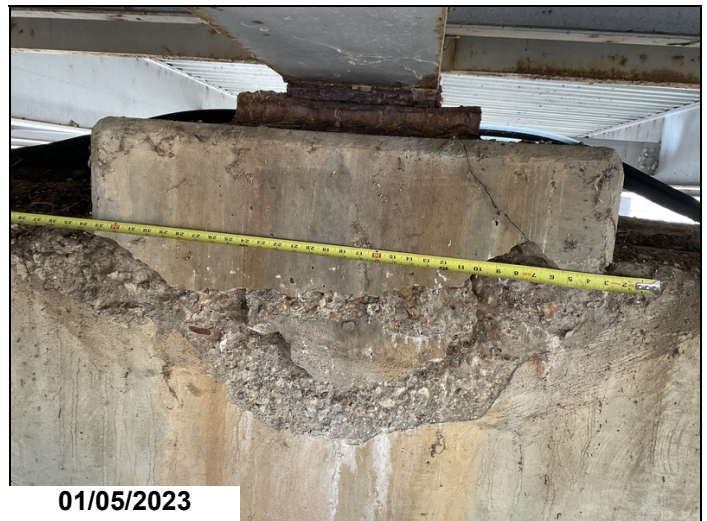
Bent #3 cap back face spalled under girder #5 for two feet extending underneath bearing masonry plate up to one inch with exposed rebar

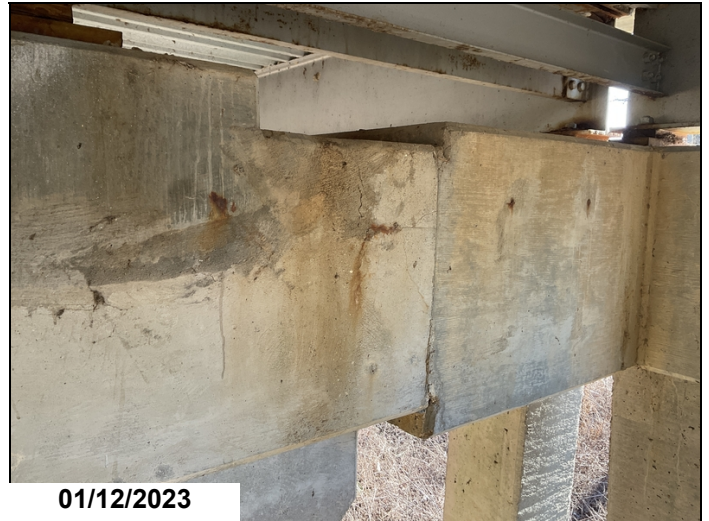
Bent #8 cap ahead face left side bottom corner has one foot spall with exposed rebar

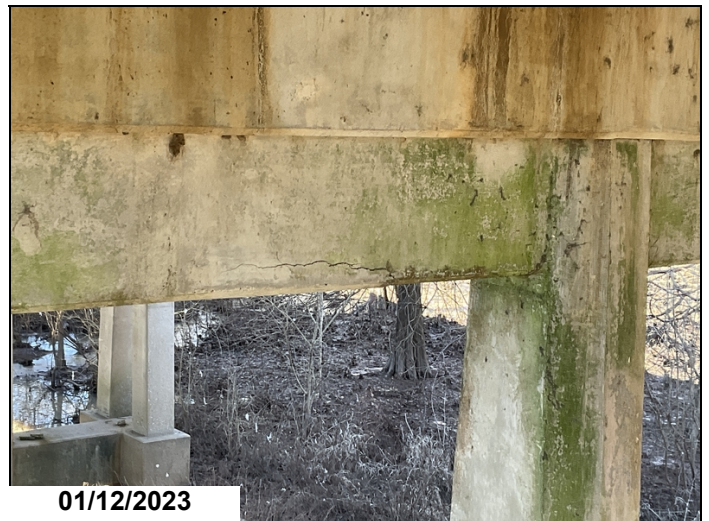
Bent #9 cap ahead face right side cracked and spalled with exposed rebar for two feet

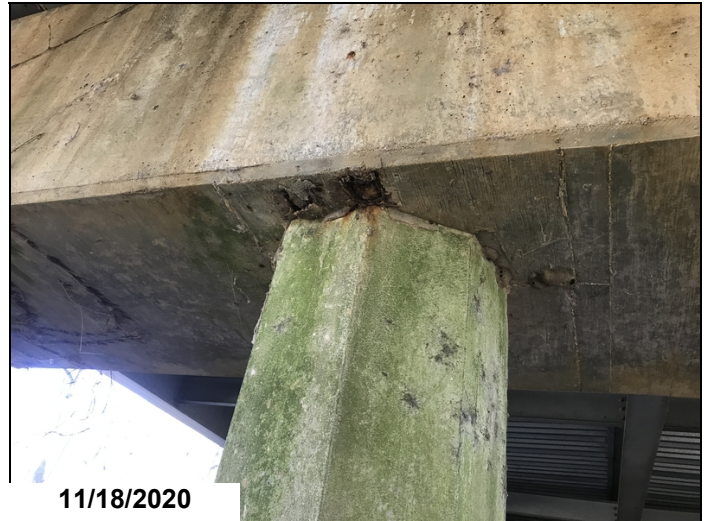
Bent #3 cap left side between pile #1 and column #2
spalled with exposed rebar

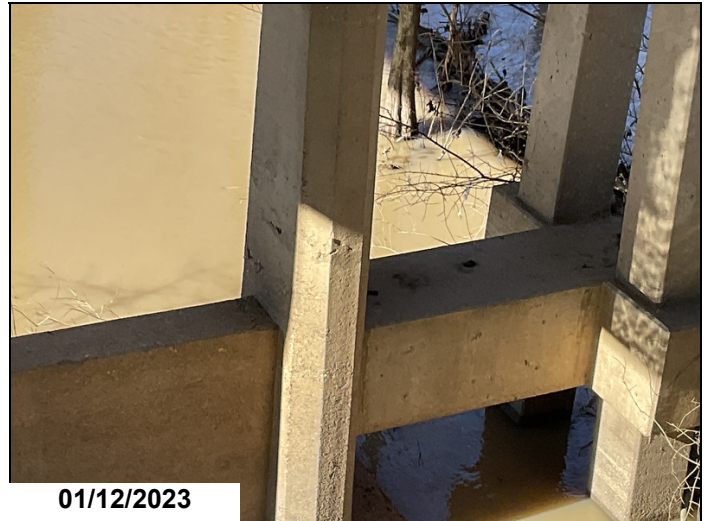
Bent #3 column #2 ahead face has five feet of cracking and delaminated area. Cs3

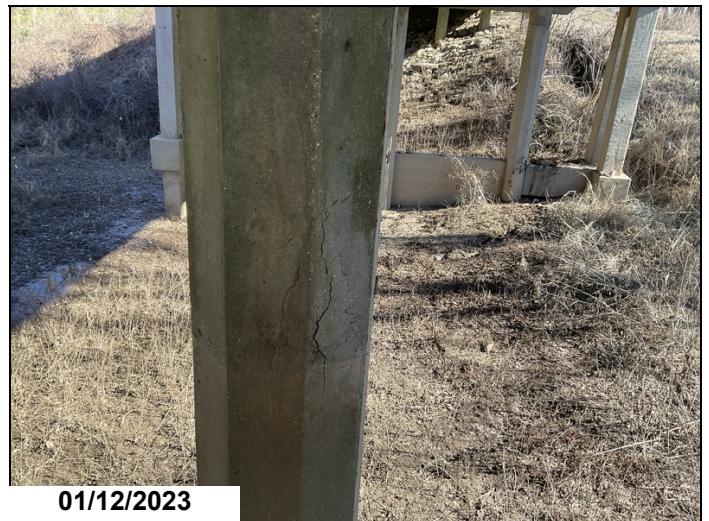
Bent #8 column #3 is spalled on ahead face four foot above ground with five feet of exposed rebar 5% section loss.

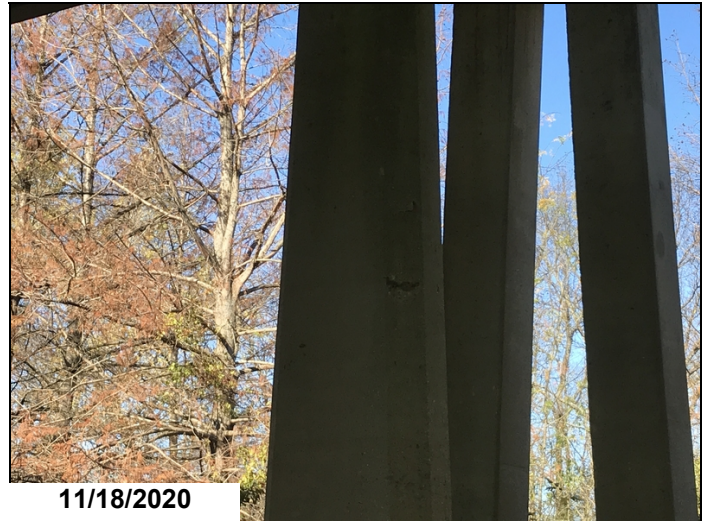
Bent #10 column #3,4,5 have 1' spalls 4' above ground on the back face with rebar exposed 10% section loss.
