Asset #M1466(Routine)

Us-79/Sec16/L10.25 over Ditch

Location: 1.8 Mi South Of Brickeys

Team Lead: Austin Janes Inspection Date: 10/01/2024

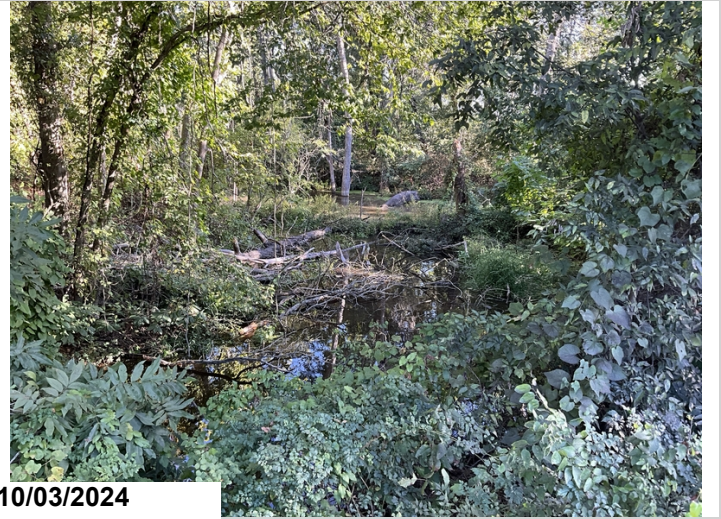
Left side of Culvert: Channel view.

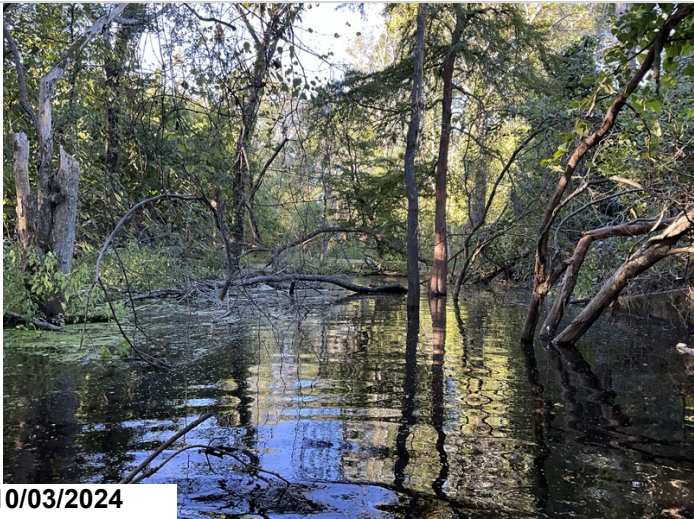
Right side of Culvert: Channel view.

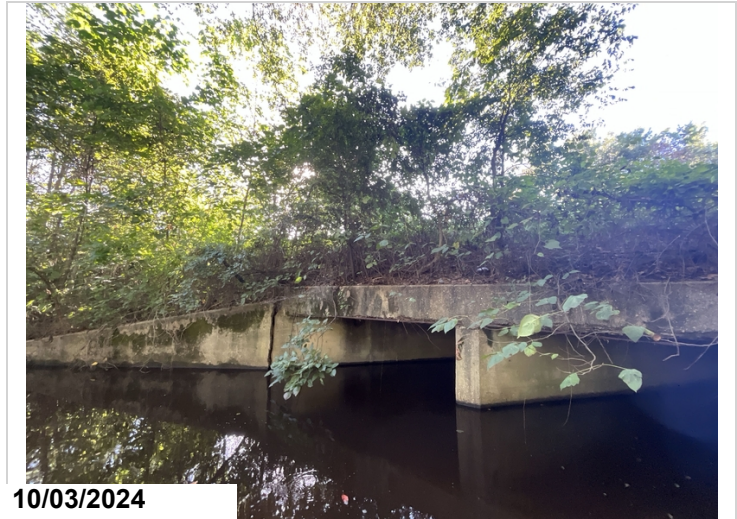
Large vegetation is growing on both sides of box wings and head wall and in channel.

Left side of Culvert: Vegetation growth.

A-64 - Vegetation Removal Requested (Yes)

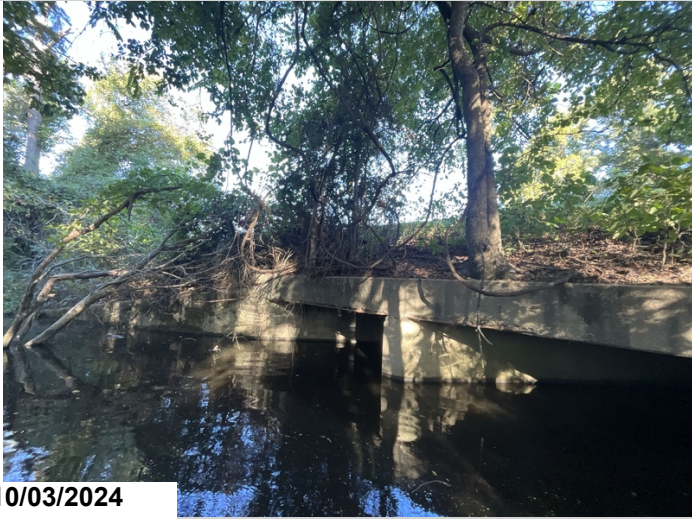
Right side of Culvert: Vegetation growth.

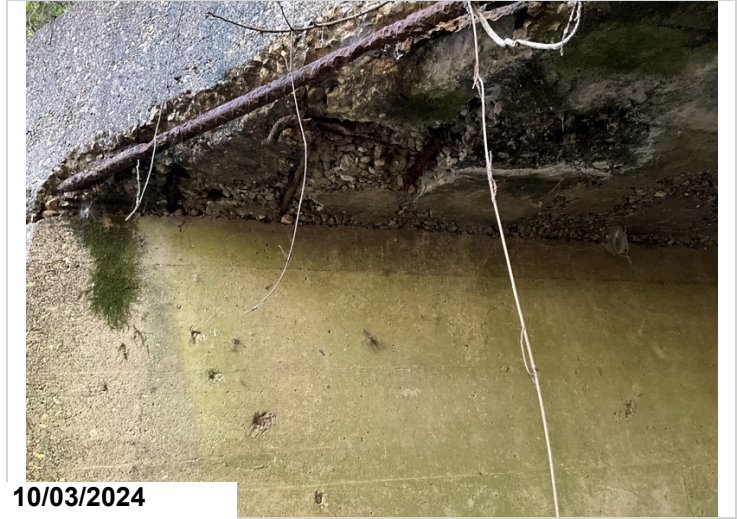
Barrels 1 & 2, Left, Undersurface: Spalling with exposed reinforcing steel. CS3.

Barrels 1 & 2, Left, Undersurface: Spalling with exposed reinforcing steel. 3' CS3.

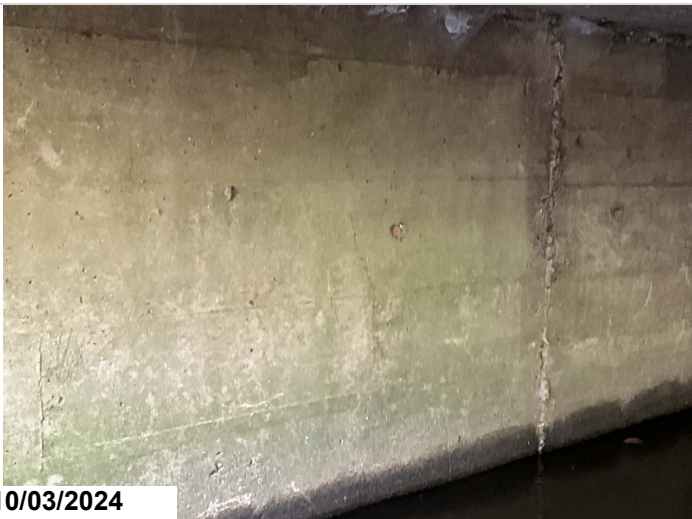
Intermediate Wall: Minor vertical cracking. CS2.

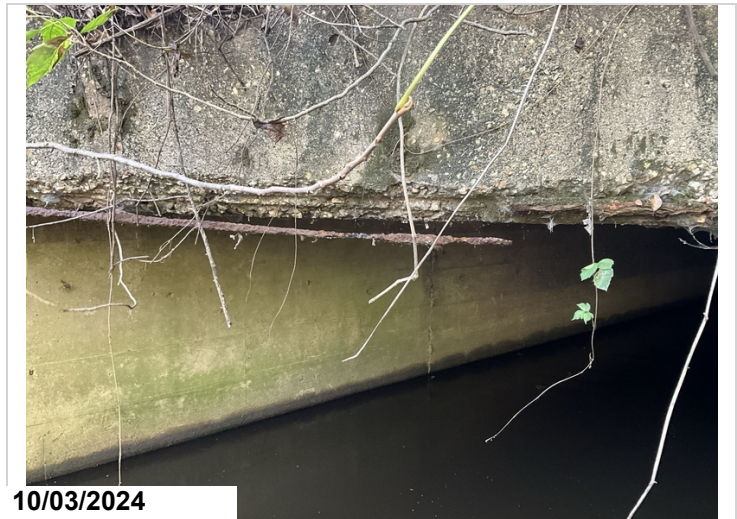
Barrel 1, Left Headwall: Spalling with exposed reinforcing steel with 100% section loss and loss of bond. CS4. 1'.

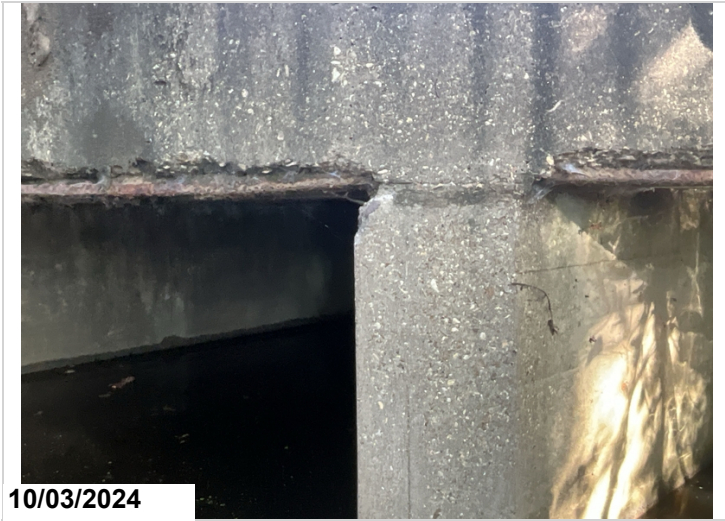
Intermediate wall, Right: Minor spall. CS2.

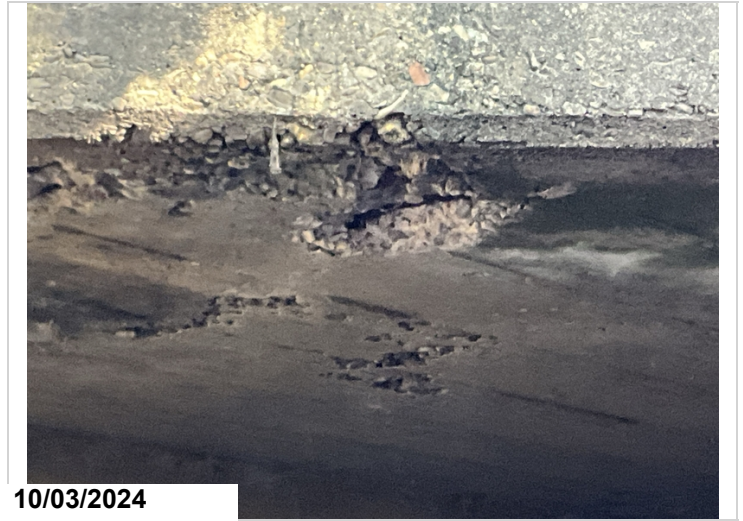
Barrel 2, Right, Undersurface: Spalling with exposed reinforcing steel. CS3.

Barrels 1 & 2, Right, Undersurface: Spalling with exposed reinforcing steel. 3' CS3.

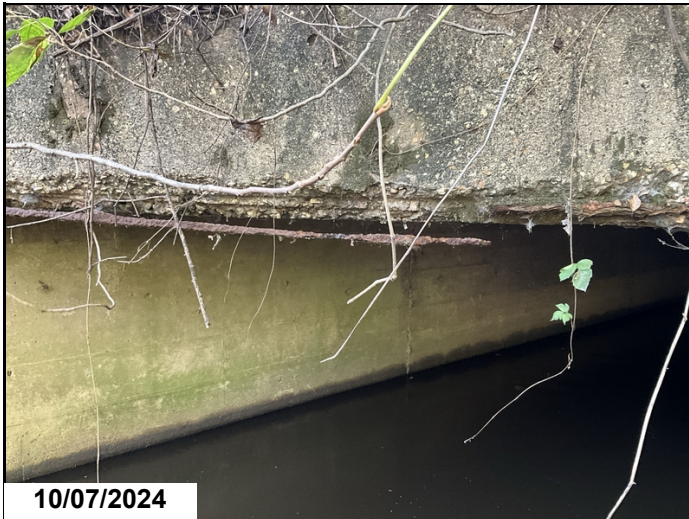
Barrel 1, Left Headwall: Spalling with exposed reinforcing steel with 100% section loss and loss of bond. CS4. 1'.

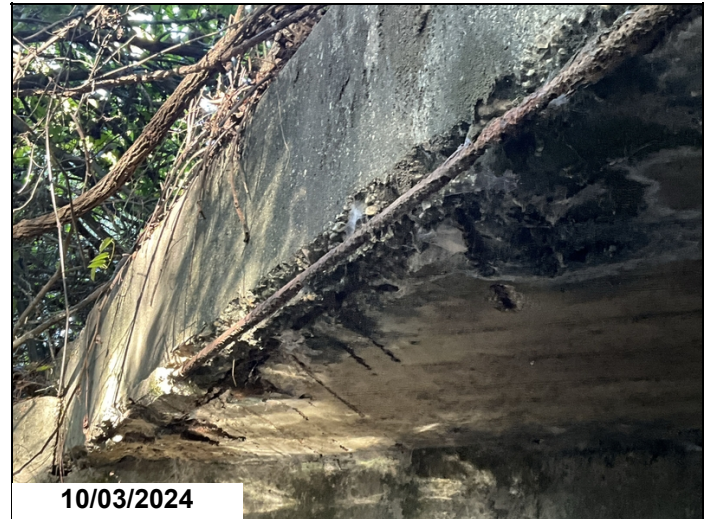
Barrel 1, Right, Undersurface: Spalling with exposed reinforcing steel. CS3.

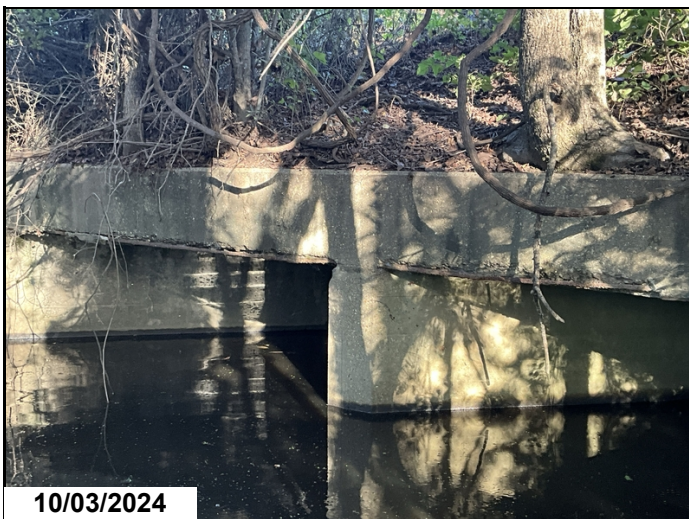
Barrels 1 & 2, Right Headwall: Spalling with exposed reinforcing steel with section loss and loss of bond from concrete. CS4. 2'.

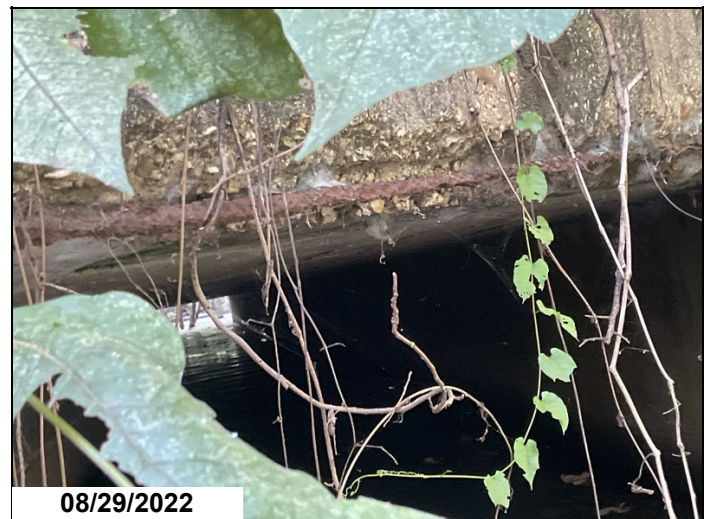
Exposed rebar left side of culvert head wall

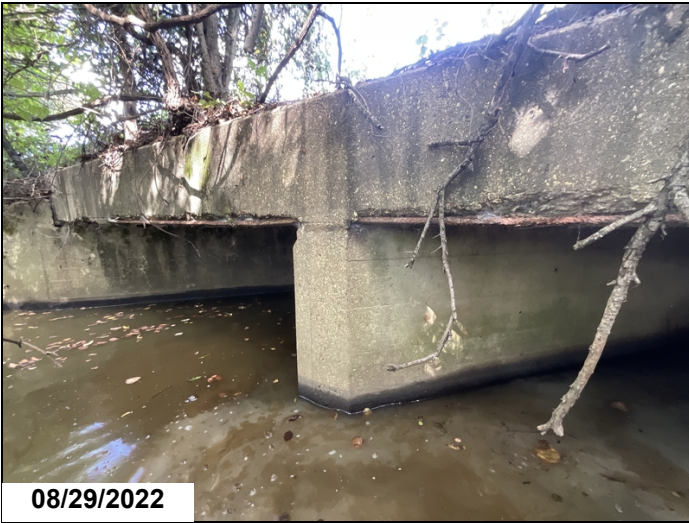
Exposed rebar in right side head wall

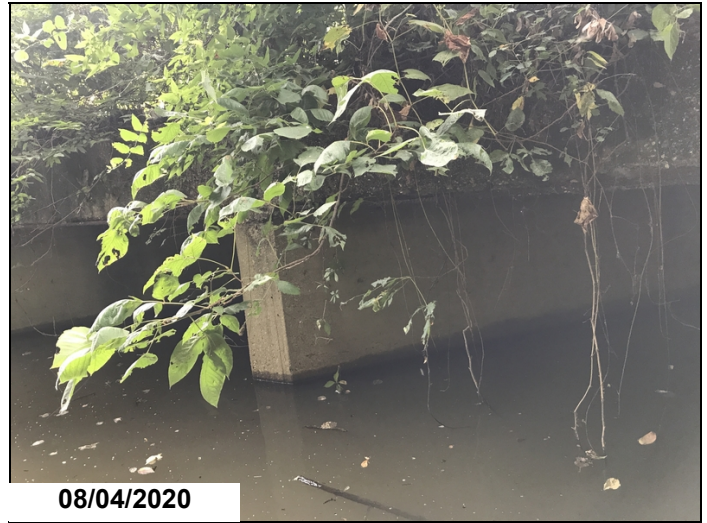
Left side head wall with exposed rebar.

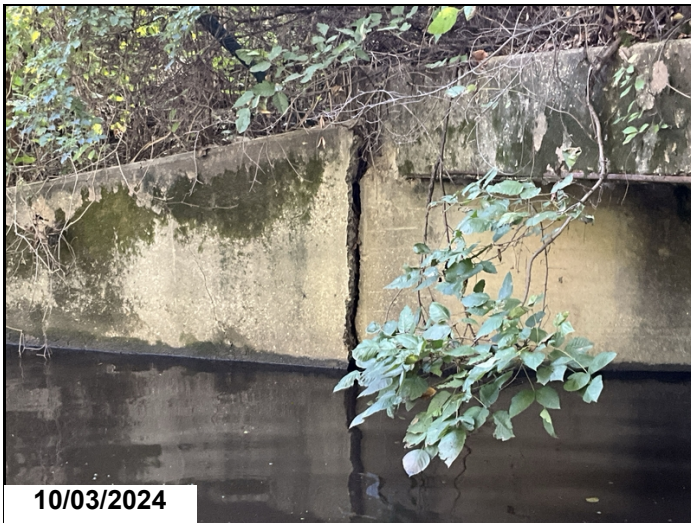
Barrel 2, Left wing wall: 6" of separation from culvert.

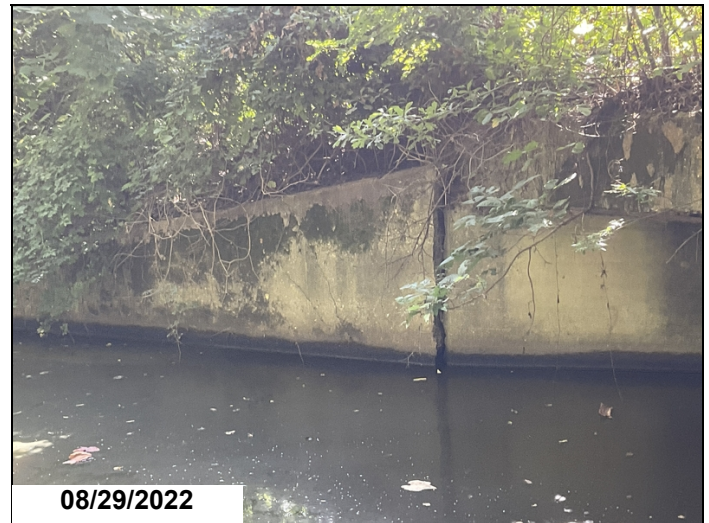
Barrel 2, right end, at wing, has 1/16" crack in wall. left wing is leaning in 6" at top.

Barrel #2 left wing separated and leaning in

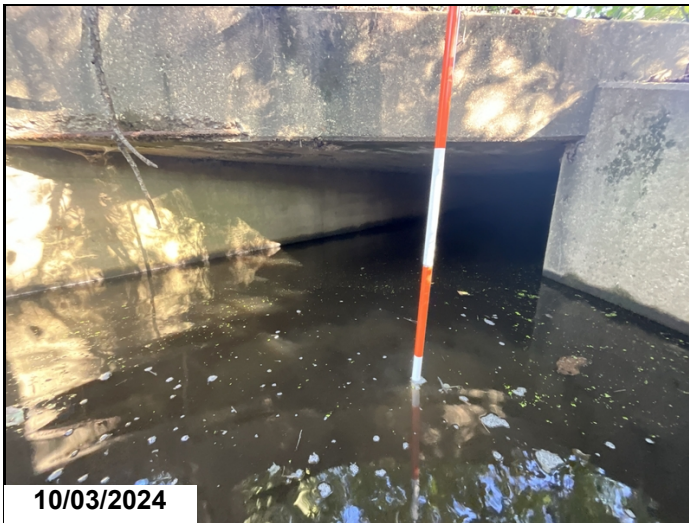
Barrels 1 & 2: 2' of silt build up.

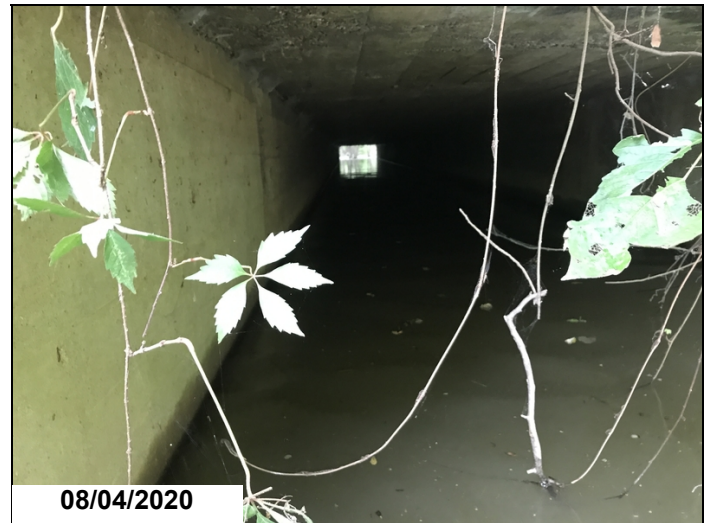
Barrel #1 two feet of silt in barrel full length.

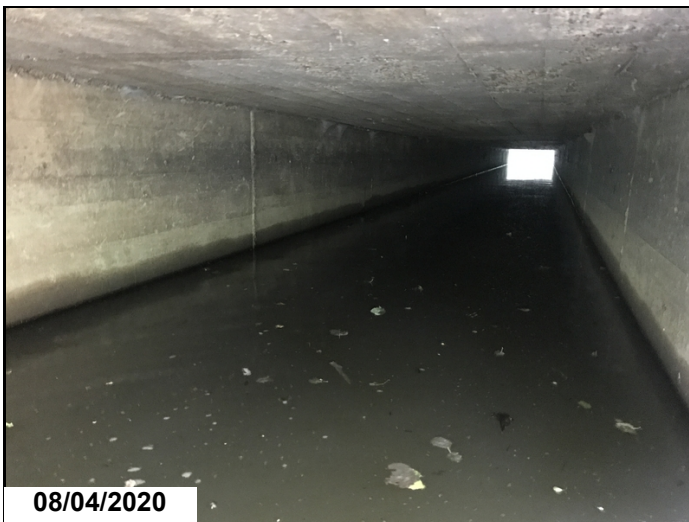
Barrel #2 two feet of silt in barrel full length.

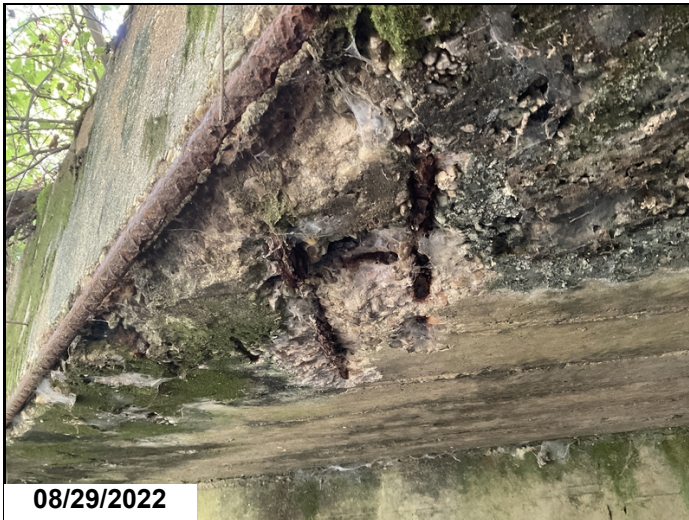
Barrels #1 soffit left and right ends and barrel #2 left end has spalling with exposed rebar two linear feet each with up to 20% section loss.

Exposed rebar in barrel #2 soffit, left side

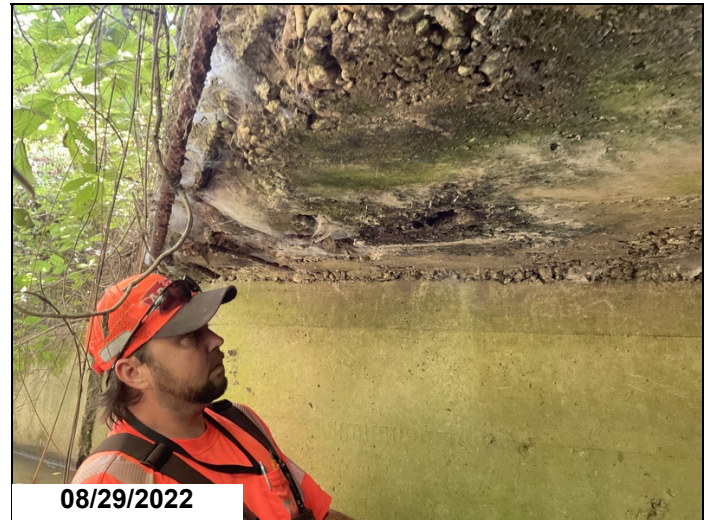
Exposed rebar in barrel #1 soffit, left side

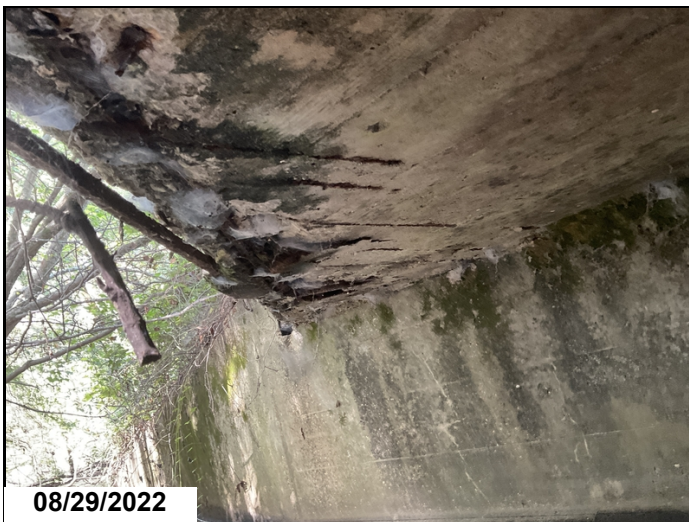
Barrel #1 soffit right side

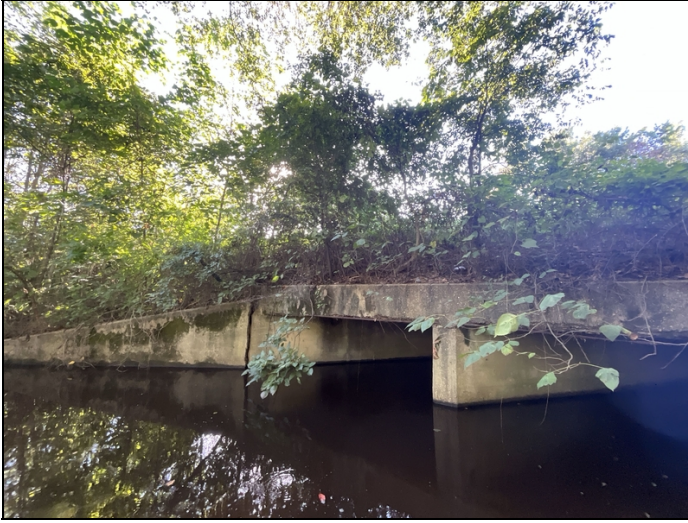
Left side of Culvert: Vegetation growth.

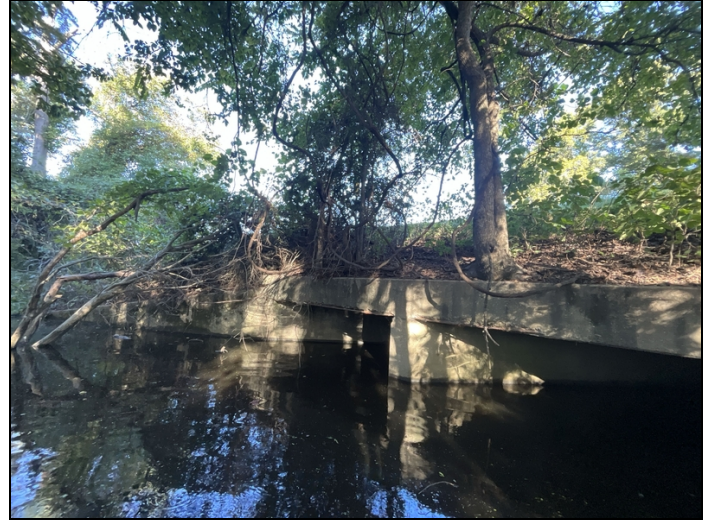
Right side of Culvert: Vegetation growth.
