**Asset #03935**(Routine)

**US 425-03 LM 8.17 over Clear Creek**

**Location: 3.2 Mi S SH172-White Hall**

**Team Lead: Greg Loomis Inspection Date: 07/25/2023**

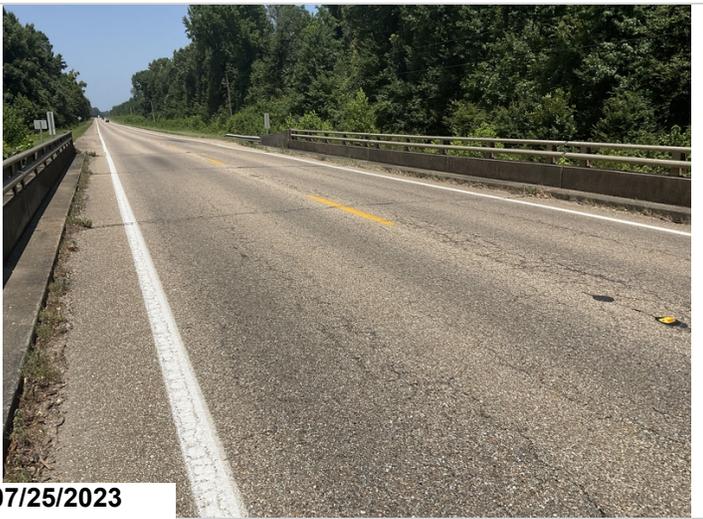
Deck - Spans 1-3: Typical

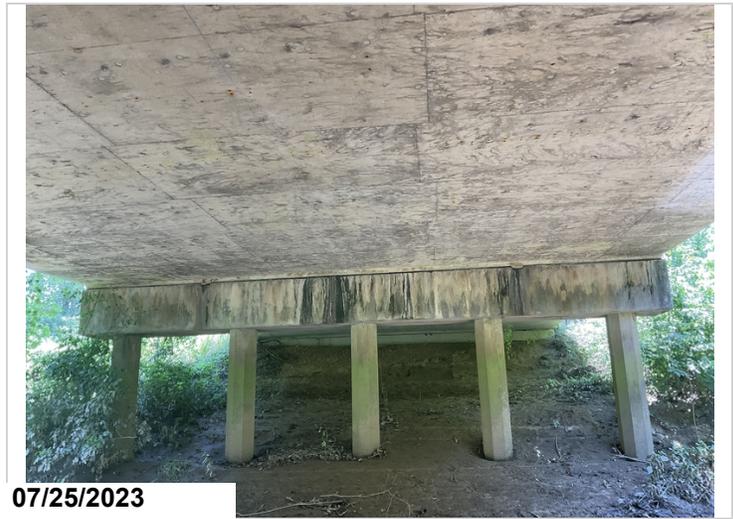
Soffit - Span 2: Typical

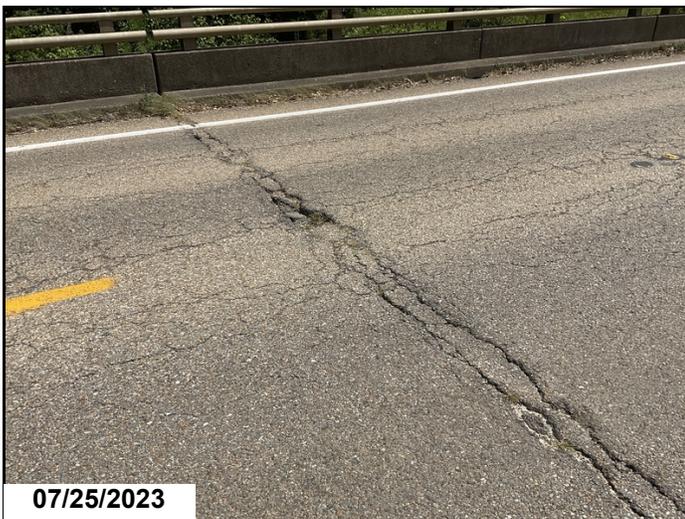
Wearing surface - all spans: Minor- to moderate-sized map cracking throughout travel lanes with some transverse cracking and small potholes (spalling) at joints and bridge ends, especially Bent 3 right.

Wearing surface - Bent 3: Spalling (pothole)

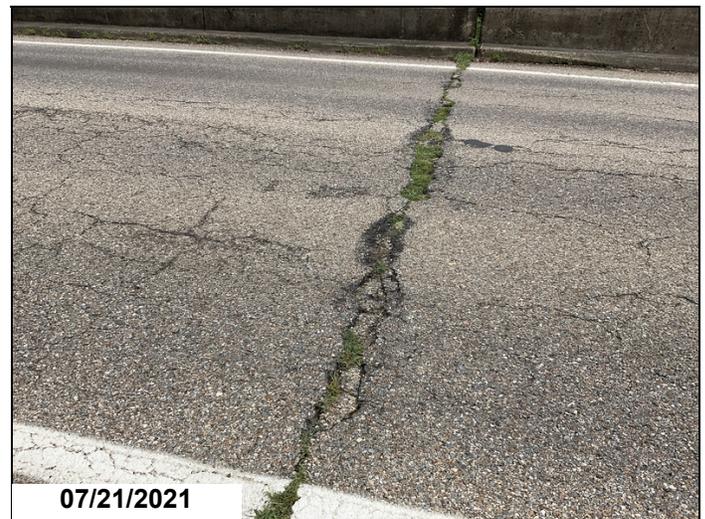
Approach asphalt as spalling.

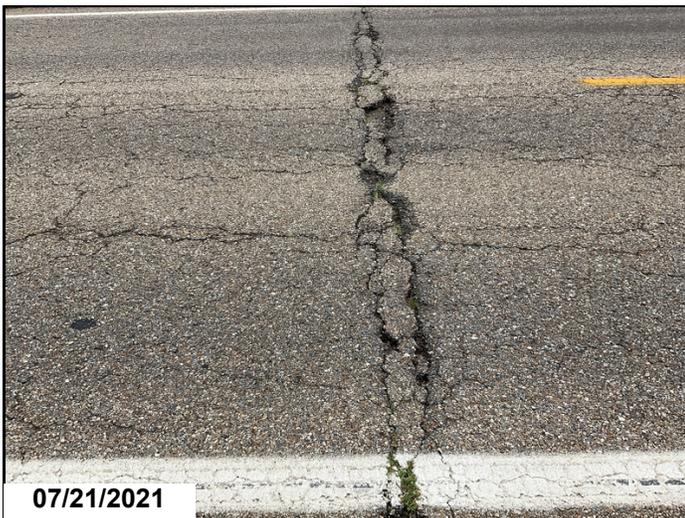
Bent 3 spalling to asphalt wearing surface.
