Asset #X1238(Routine)

U.S. 62-Wash. Co. over Moore Creek

Location: 0.6 Mi E. of Lincoln

Team Lead: Eric West, Inspection Date: 01/08/2024

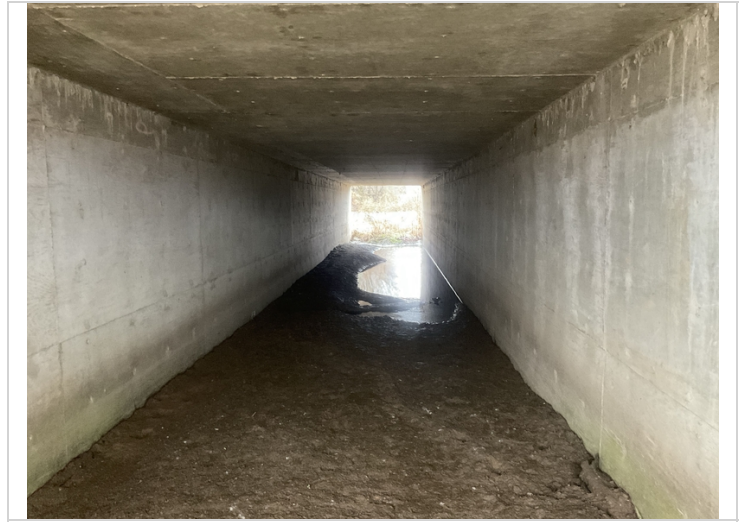
Barrel # 3 typical.

The inlet and outlet ends of channel are restricted by heavy vegetation. The interior of barrel # 3 has up to approximately 24" of streambed material accumulation at this inspection.

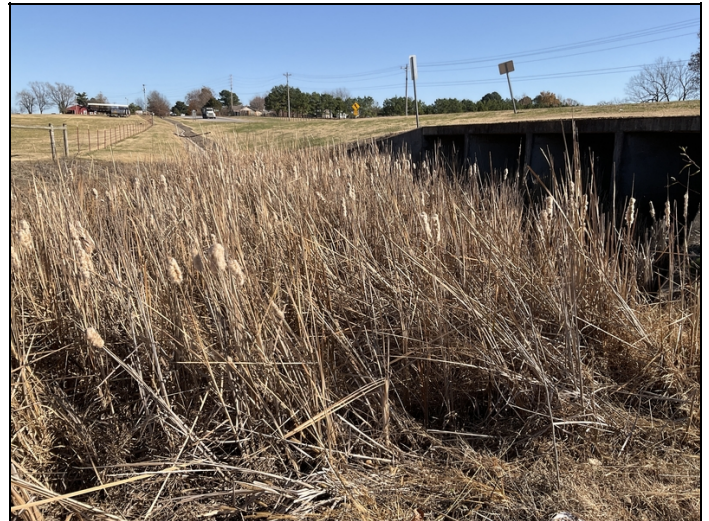
Heavy vegetation in channel on left side.

Type of Work: (Inactive) (Inactive) 1 - Clean
