Asset #A0666(Routine, Underwater type 2)

US 62-Washington over Price Creek

Location: 3.53 Mi East of OK Line

Team Lead: Lee Swan, Inspection Date: 12/07/2022

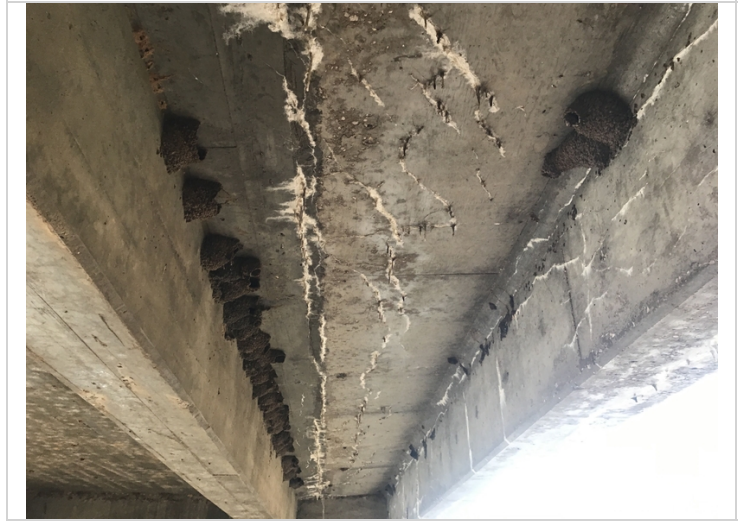
Span 1 bay 3, cracks with efflorescence buildup in the soffit.

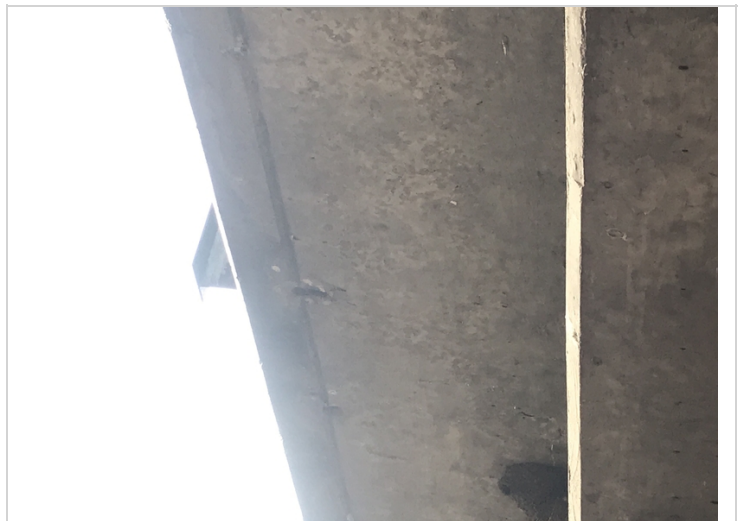
Span 1 left side, exposed rebar in the overhang soffit

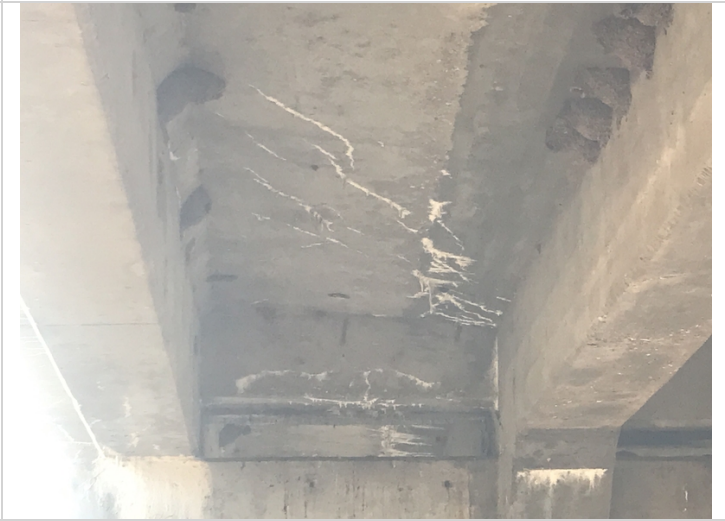
Span 1 bay 1 at bent 2, cracks with efflorescence in the soffit.

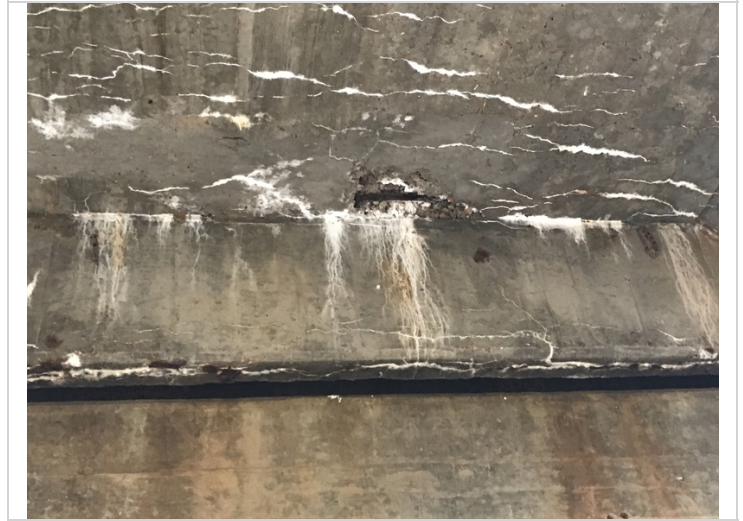
Span 2 bay 2, exposed rebar in soffit near bent 2.

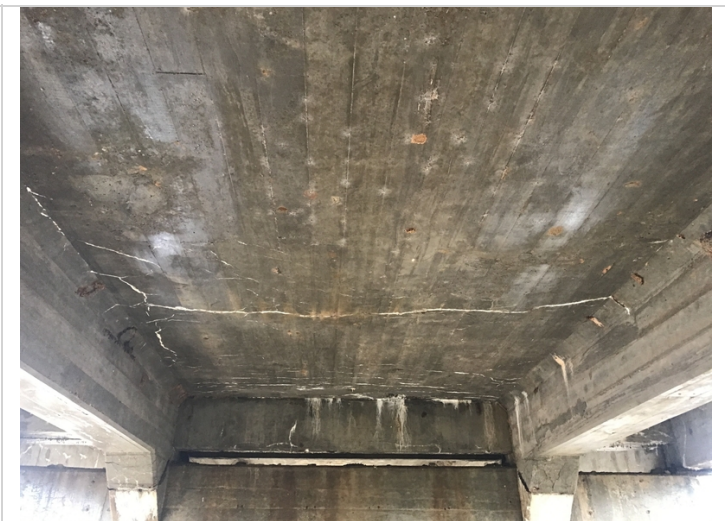
Span 2 bay 2, cracks with efflorescence in the soffit.

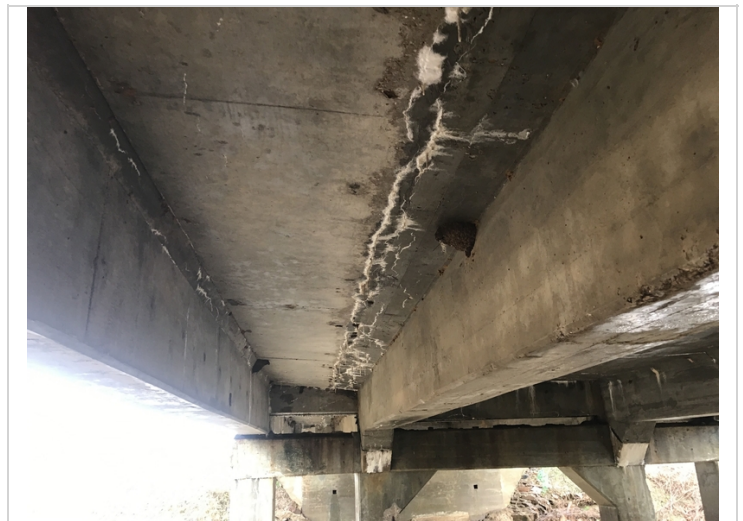
Span 2 bay 3, cracks with efflorescence in the soffit.

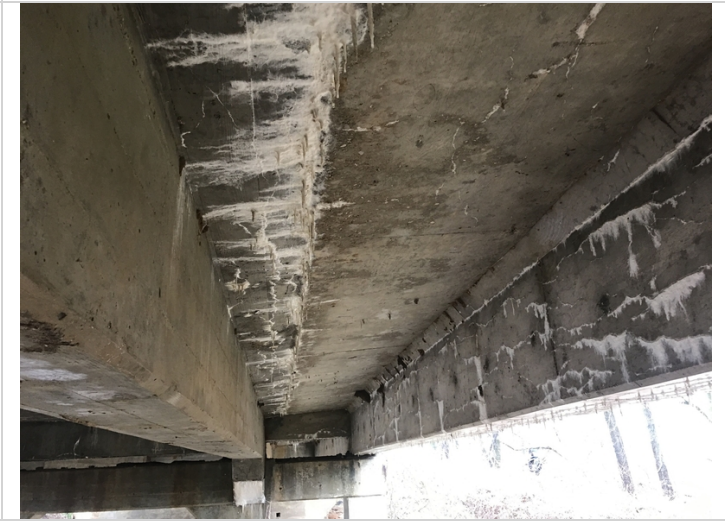
Span 2 bay 1, cracks with efflorescence in the soffit.

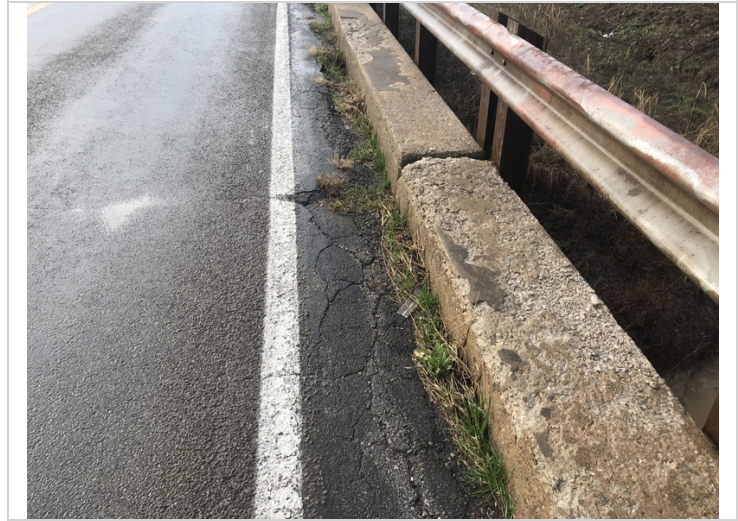
Right side , wearing surface cracked and delaminated.

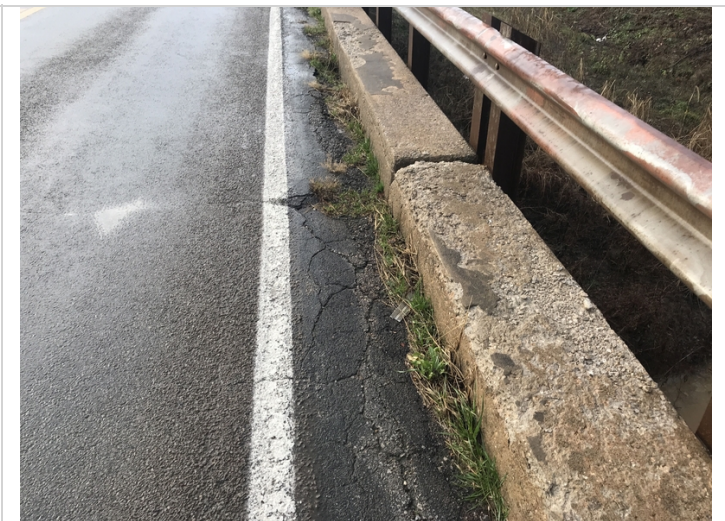
Right side , wearing surface cracked and delaminated.

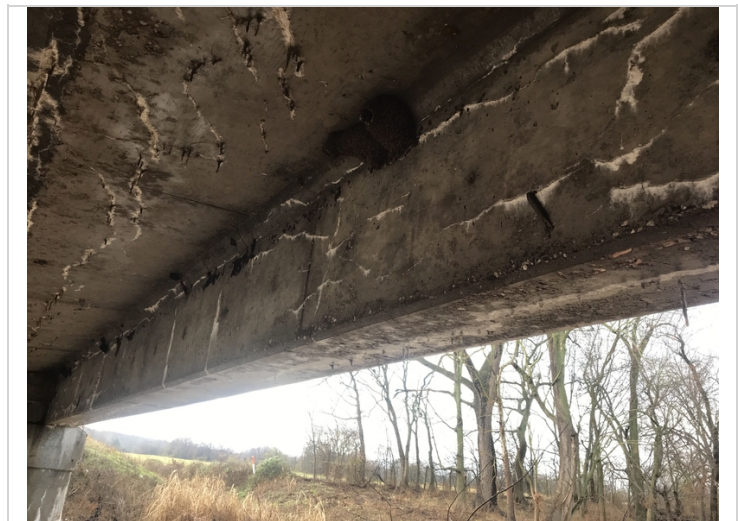
Span 1 girder 4, cracks with efflorescence.

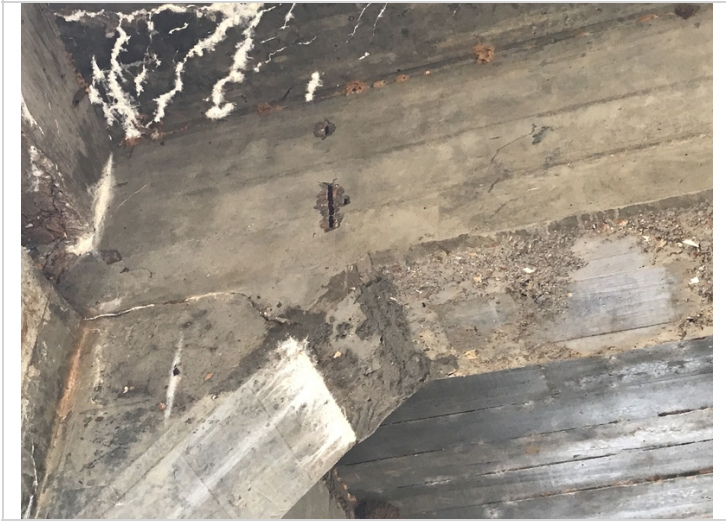
Span 1 girder 2 near bent 2, exposed rebar.

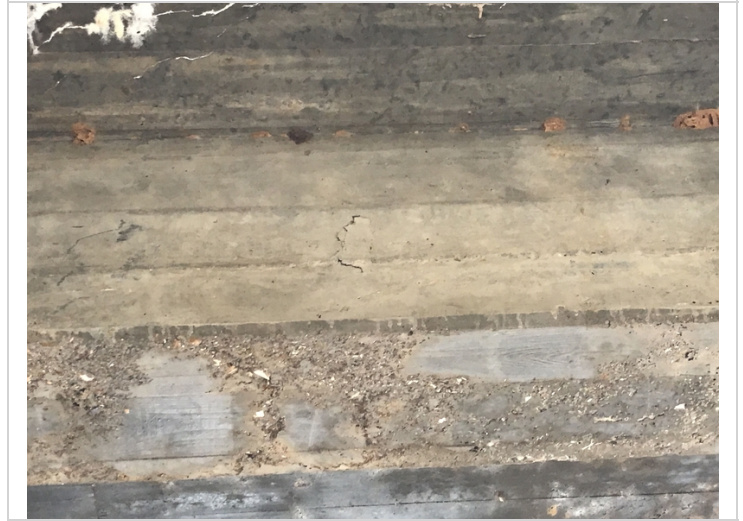
Span 1 girder 2 near bent 2, delaminated area.

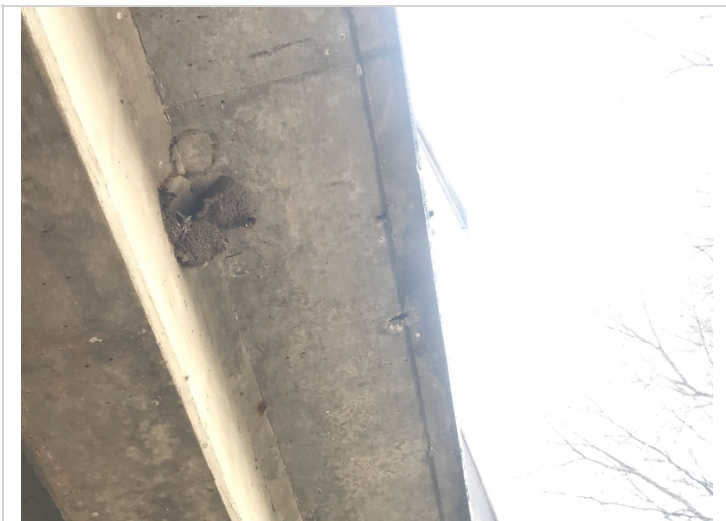
Span 1 left edge, exposed rebar.

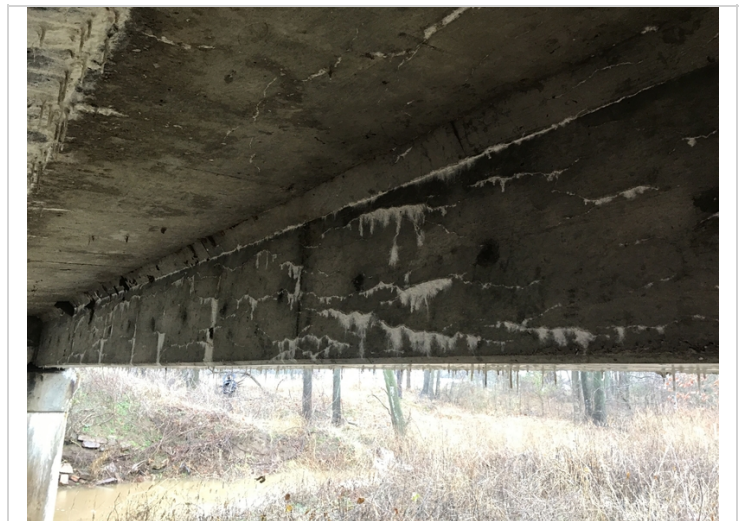
Span 2 girder 1, cracks with efflorescence.

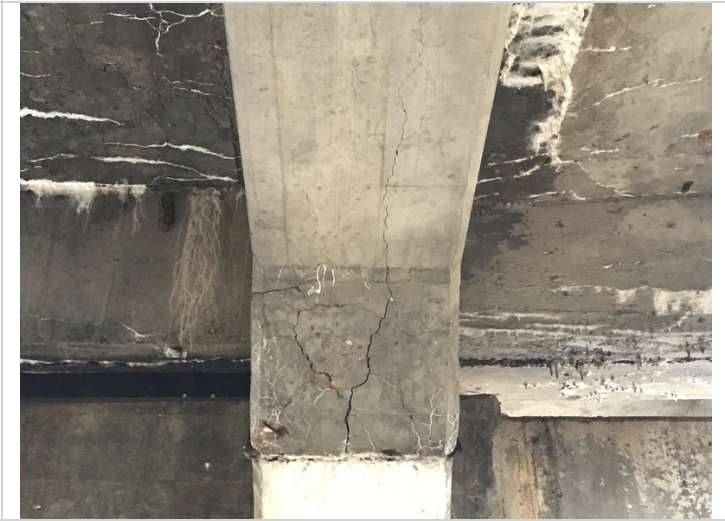
Span 2 girder 2 at bent 2, large crack in the girder.

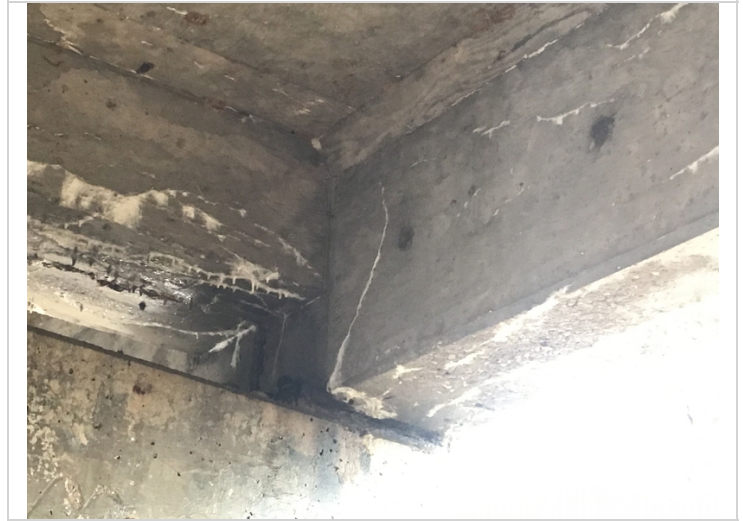
Span 2 girder 1 at bent 2, diagonal crack with efflorescence.

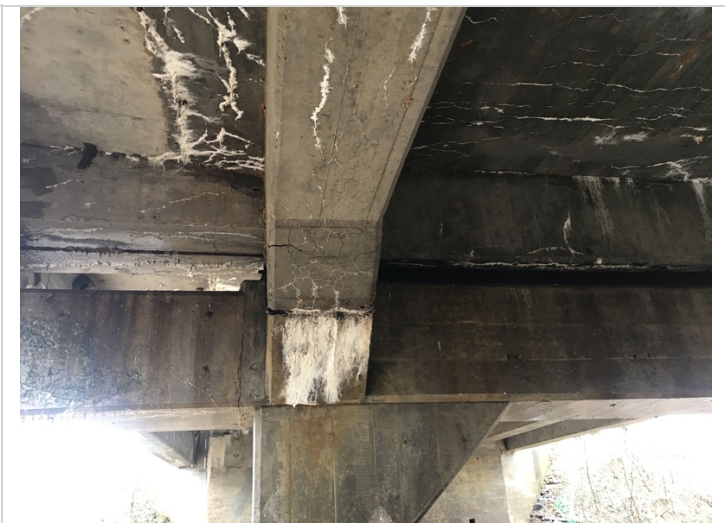
Span 2 girder 3 at bent 2, large cracks in the haunch.

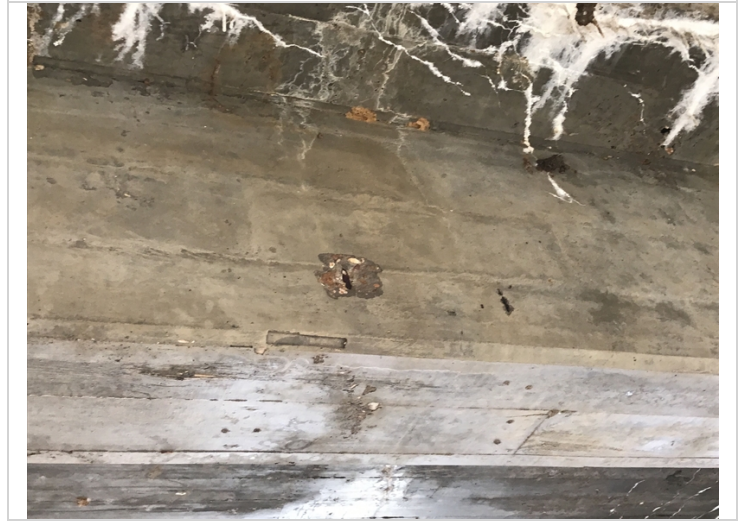
Span 2 girder 2, exposed rebar.

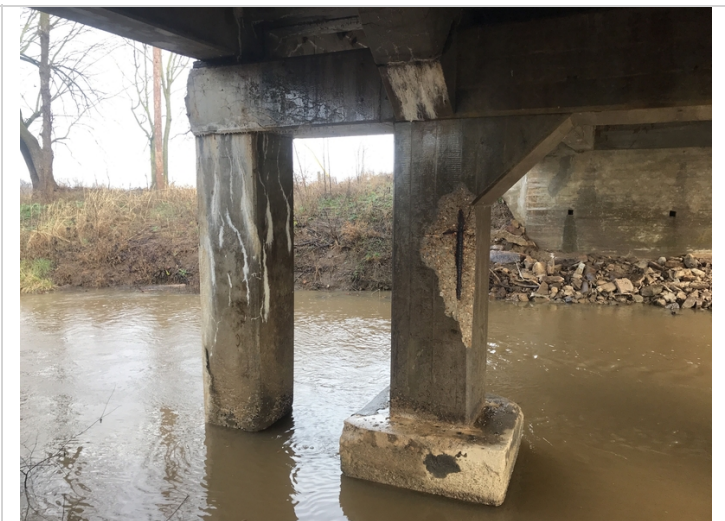
Bent 2 C3 exposed rebar with section Loss  
C4 efflorescence with heavy build up

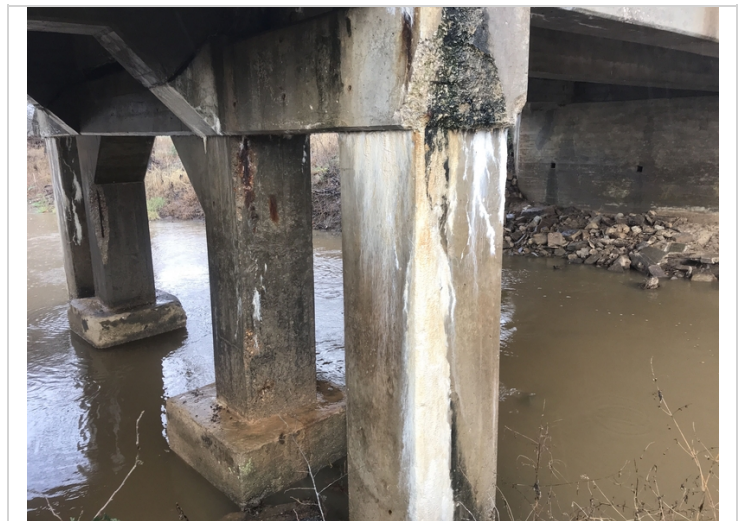
Bent 2 c1 efflorescence with build up  
C2 exposed rebar with section loss

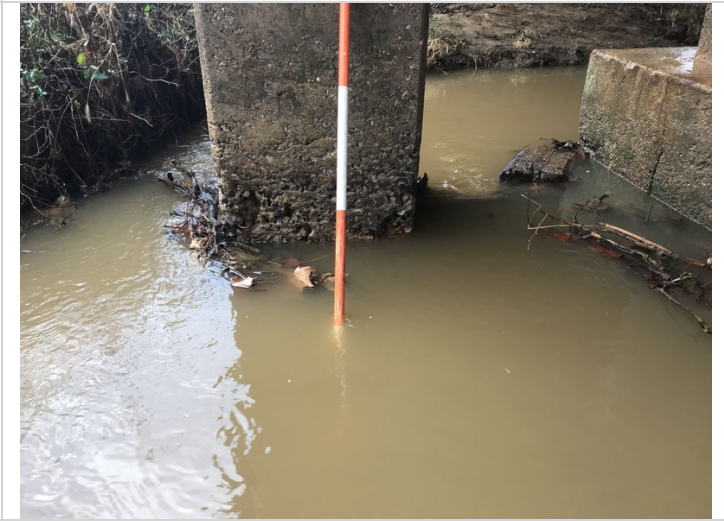
Bent 2 column 1, severe abrasion and exposed rebar.

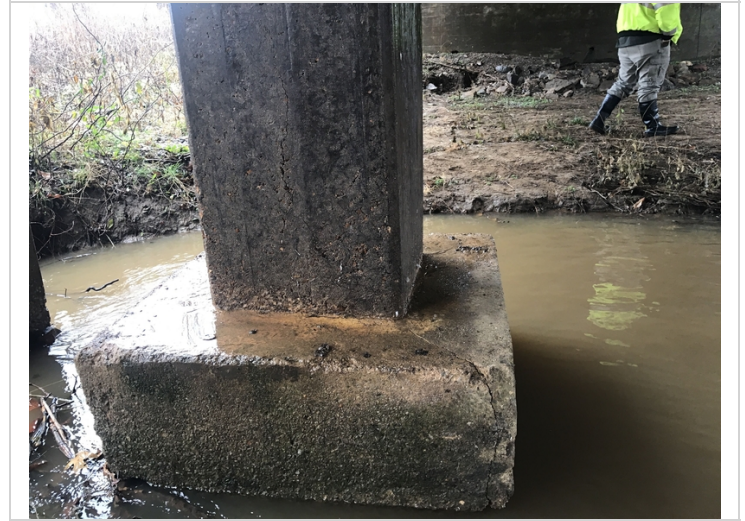
Bent 2 column 2, cracks in the column and collar.

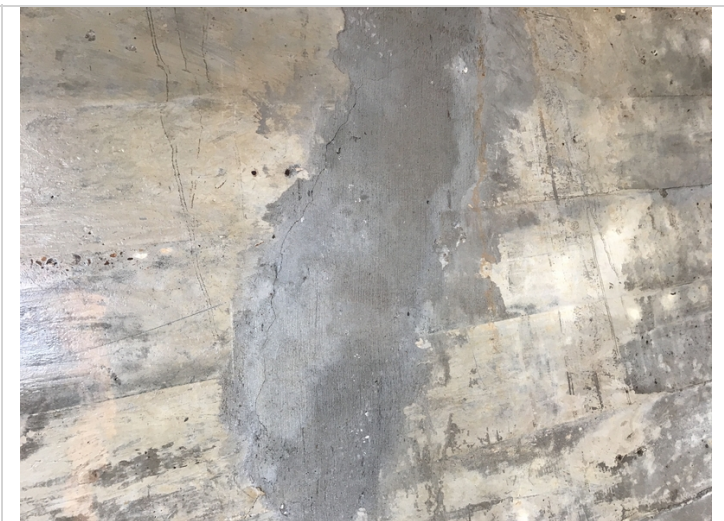
Abutment 1 outside of girder 4, diagonal crack.

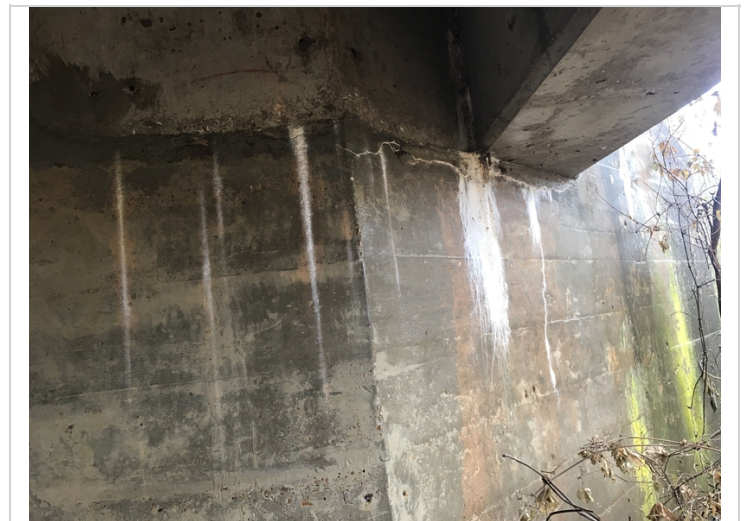
Abutment 2 at girder 4, efflorescence with buildup.

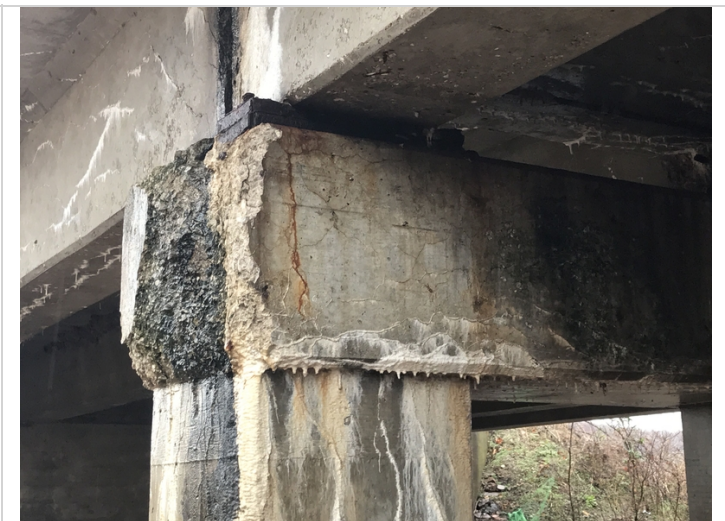
Bent 2 right side, large spall and map cracking with efflorescence.

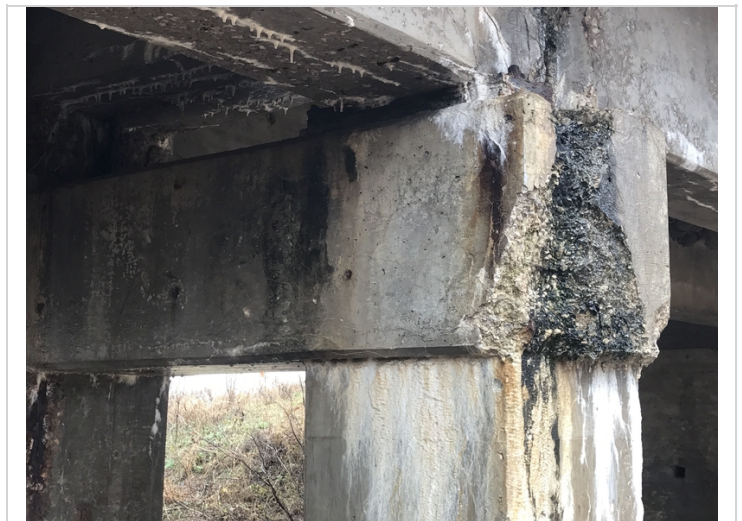
Bent 2 left side, large spall and map cracking.

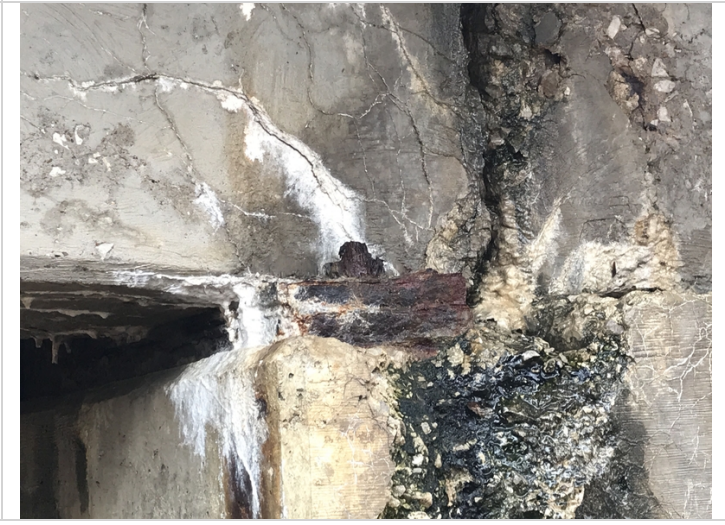
Girder 1 bent 2 ahead side, flaking rust.

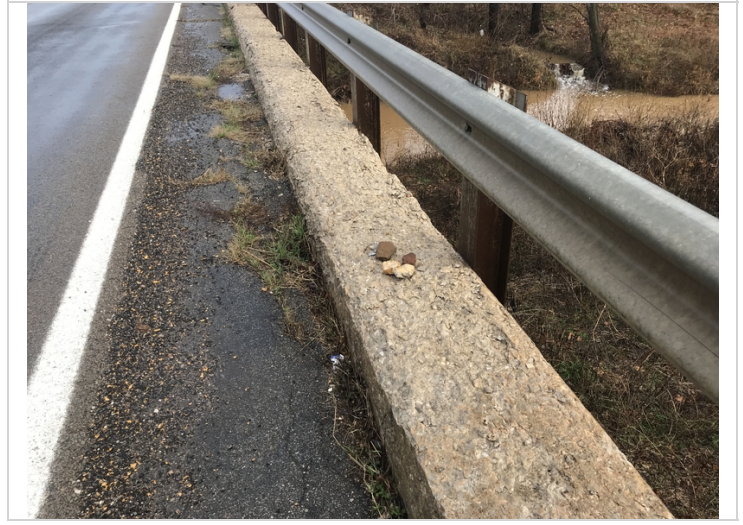
Left curb, concrete deterioration.

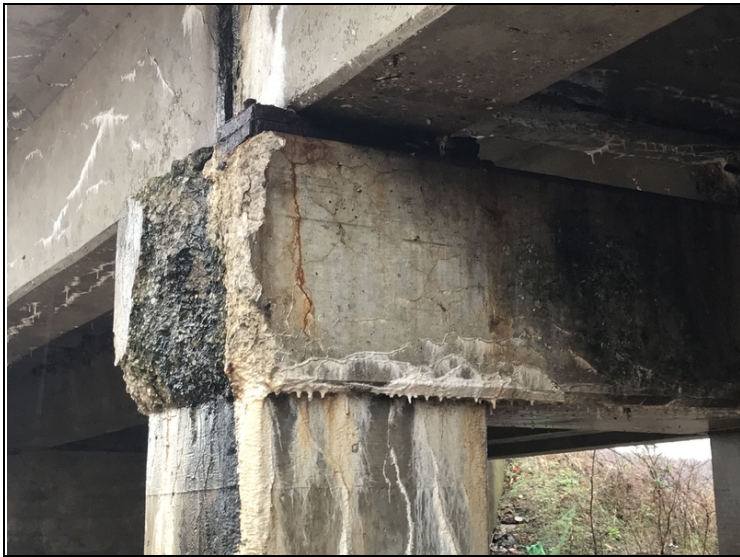
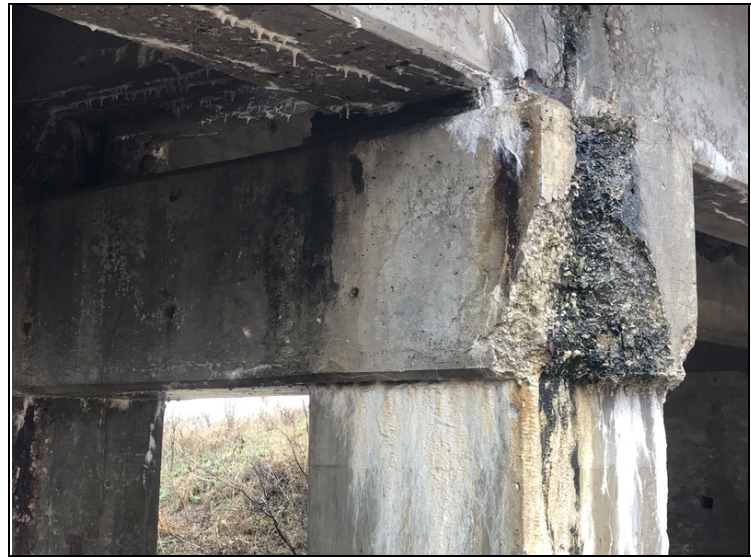
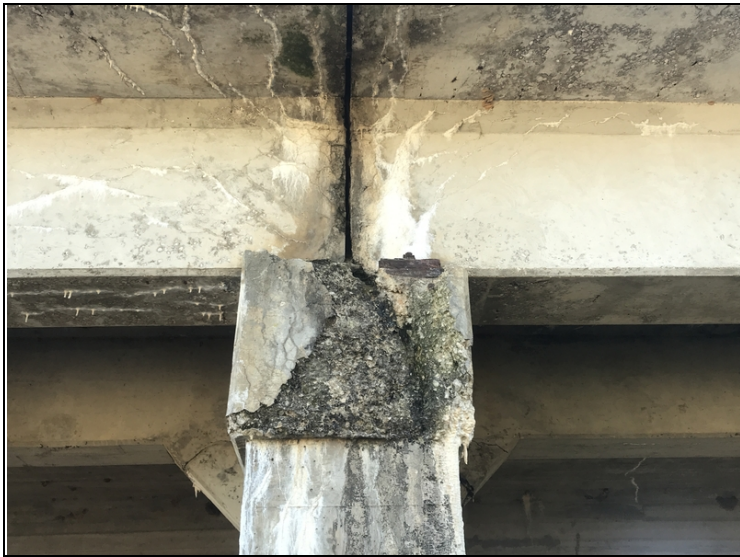
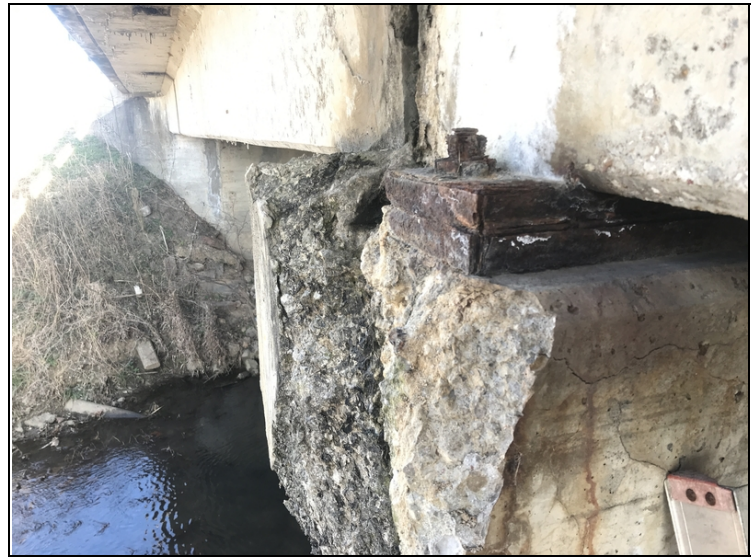
Substructure -  
Concrete deterioration with exposed reinforcing steel on the left and right sides of the Bent # 2 Cap.

Bent 2 right side, large spall and map cracking with efflorescence.

Bent 2 left side, large spall and map cracking.

Bent # 2 cap, right side-Concrete deterioration / spalling.

Bent # 2 cap, right end-Concrete deterioration / spalling.

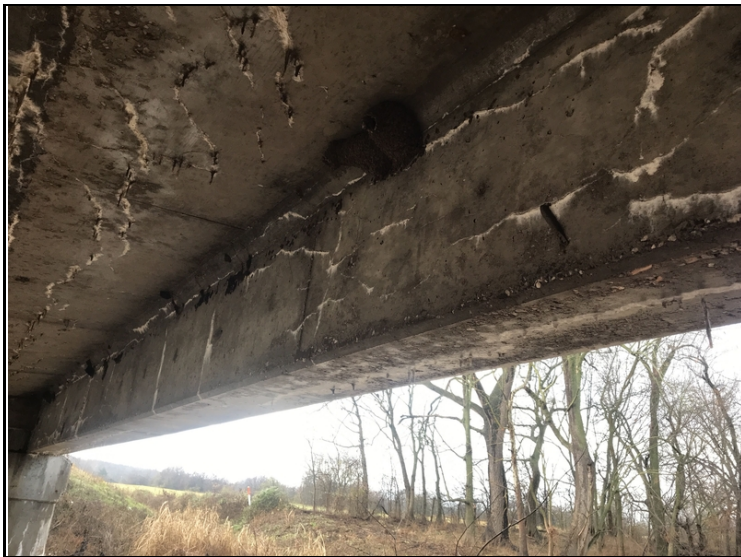
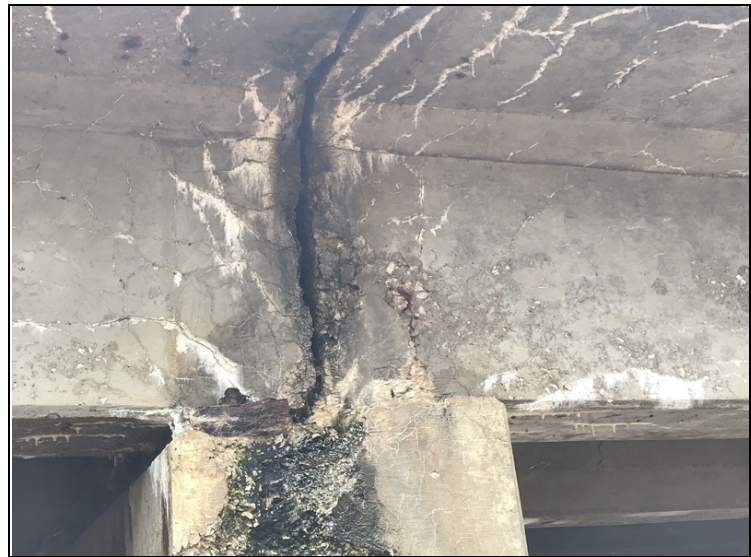
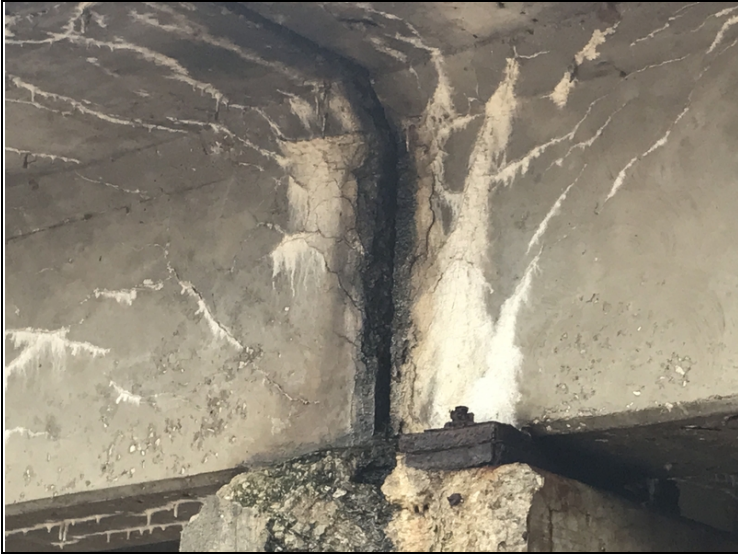
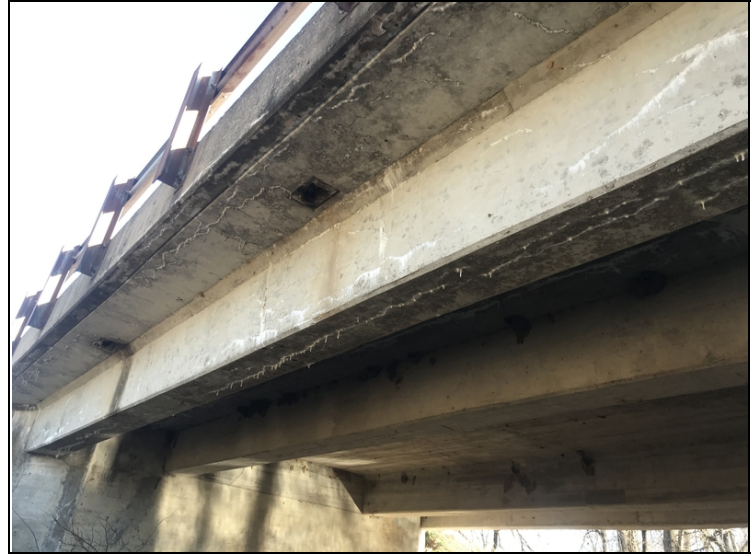
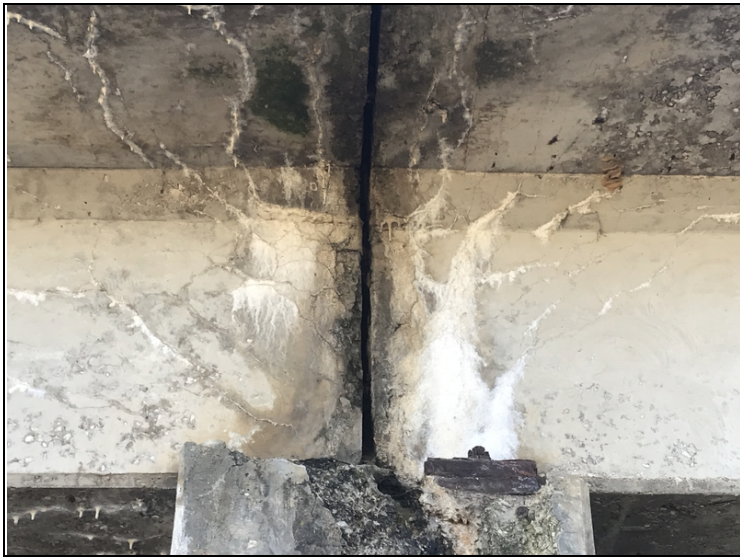
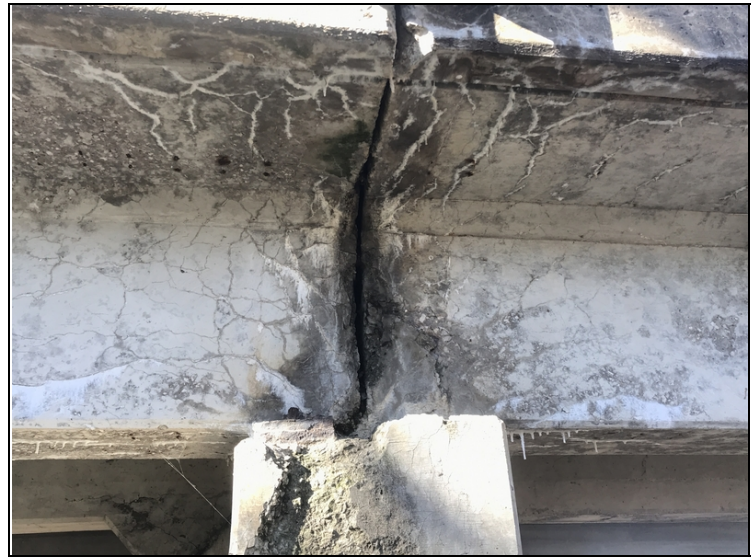
The exterior concrete deck girders have moderate map cracking with efflorescence. The most notable areas of cracking are in the ends of the girders over bent # 2.

Span 1 girder 4, cracks with efflorescence.

Span # 1, girder # 4-Cracking with efflorescence.

Girder # 4 over bent # 2-Cracking with efflorescence.

Girder # 1 over bent # 2-Heavy map cracking.

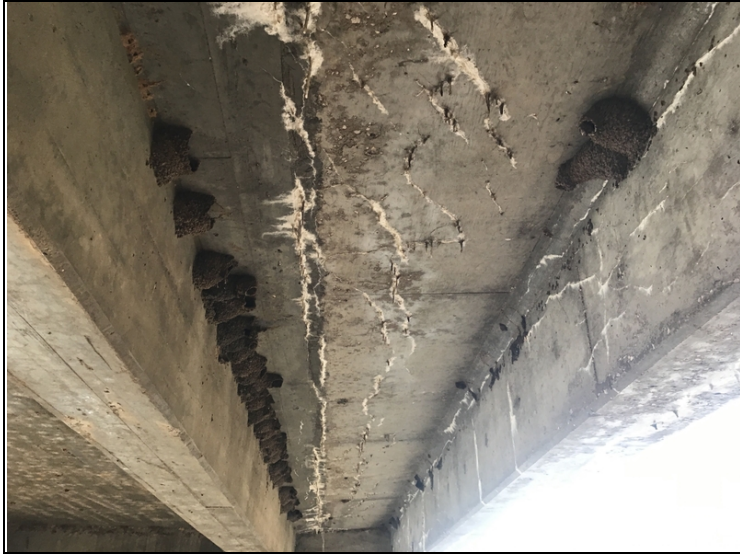
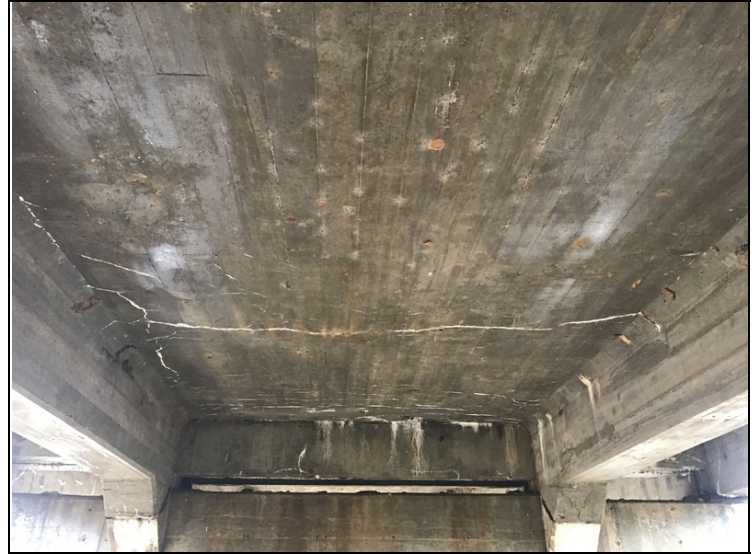
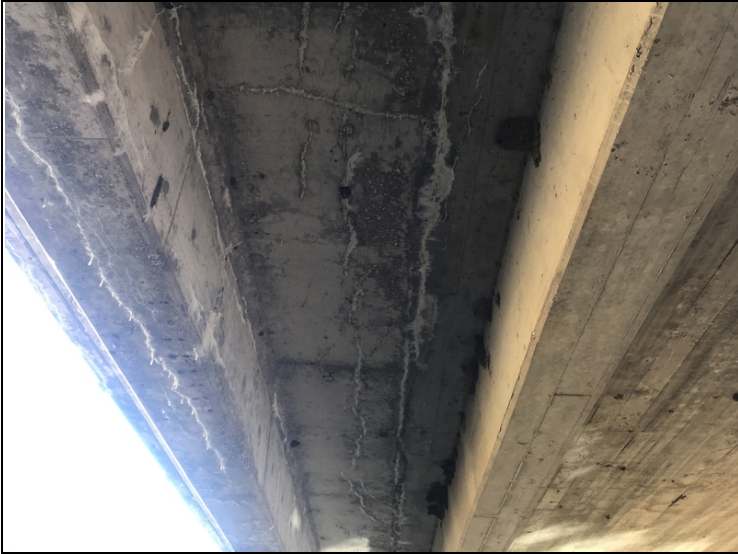
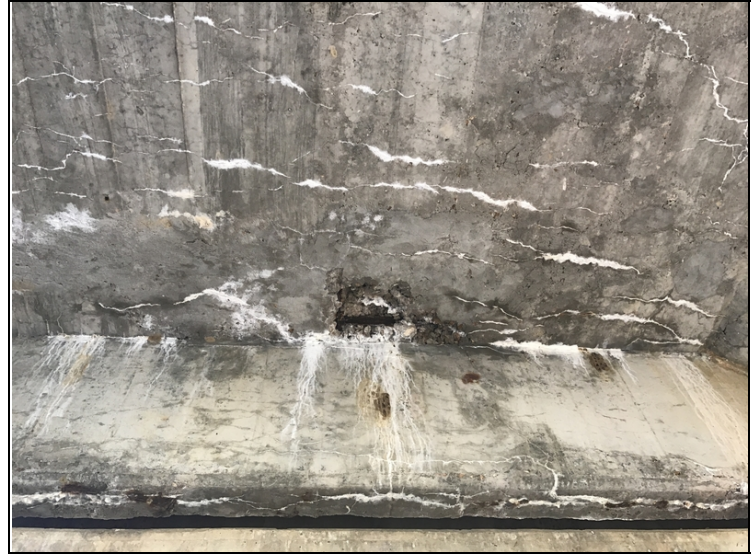
The undersurface of the deck has longitudinal, transverse, and map cracking with efflorescence. The undersurface of bay # 2 in span # 2 has a 5" spall with exposed reinforcing steel adjacent to bent # 2.

Span 1 bay 3, cracks with efflorescence buildup in the soffit.

Span 2 bay 2, cracks with efflorescence in the soffit.

Span # 1, bay # 3-Cracking with efflorescence.

Span # 2, bay # 2 at bent # 2-Spalling with exposed reinforcing steel.

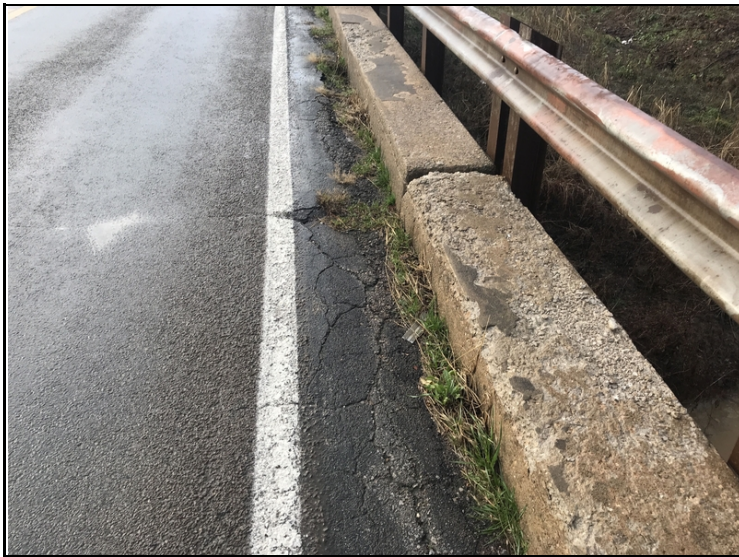
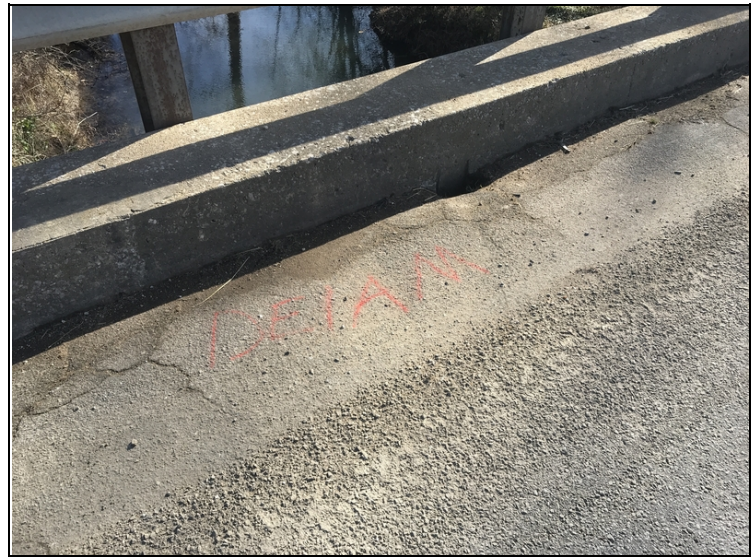
Asphalt Driving Surface -  
The ACHM overlay along the edge of the deck sounds delaminated when sounded.

Right side , wearing surface cracked and delaminated.

Asphalt in shoulders appears to be delaminated when sounded.

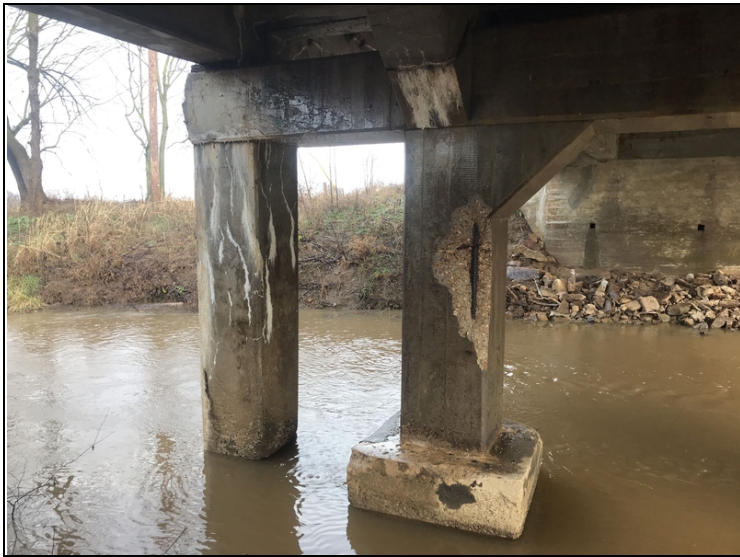
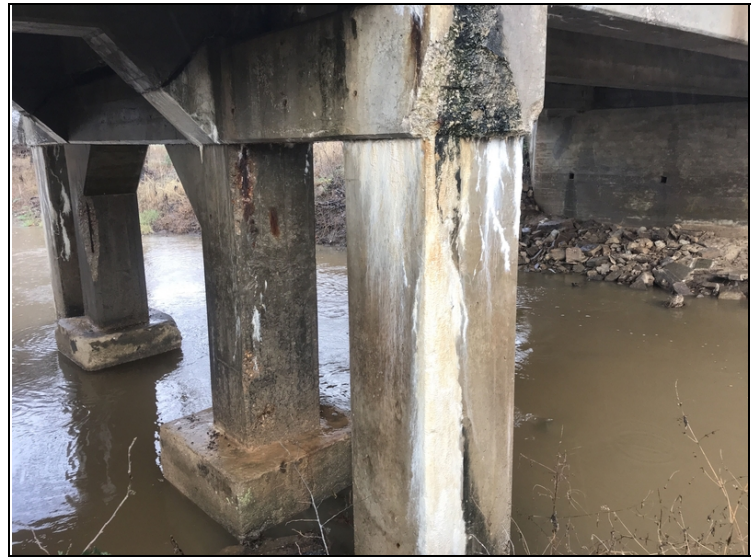
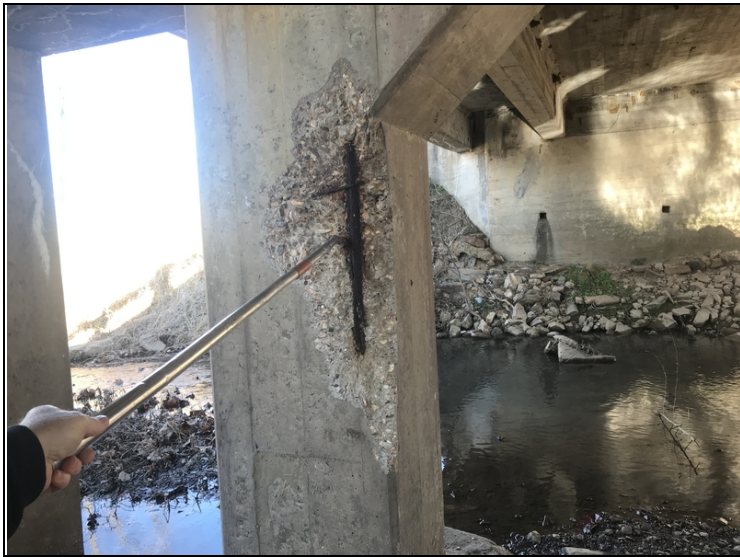
The concrete columns at Bent # 2 have areas of spalling with exposed reinforcing steel that has active corrosion with approximately 1/8" section loss.

Bent 2 C3 exposed rebar with section Loss  
C4 efflorescence with heavy build up

Bent 2 c1 efflorescence with build up  
C2 exposed rebar with section loss

Bent # 2, column # 3-Spalling with exposed reinforcing steel.

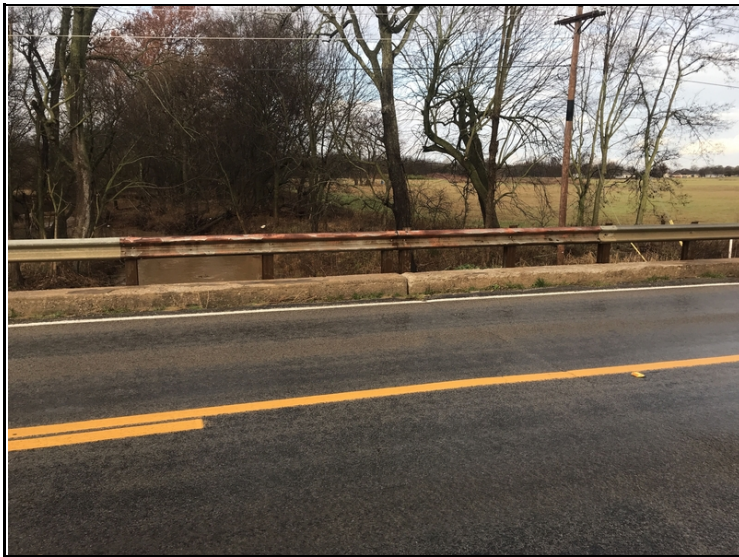
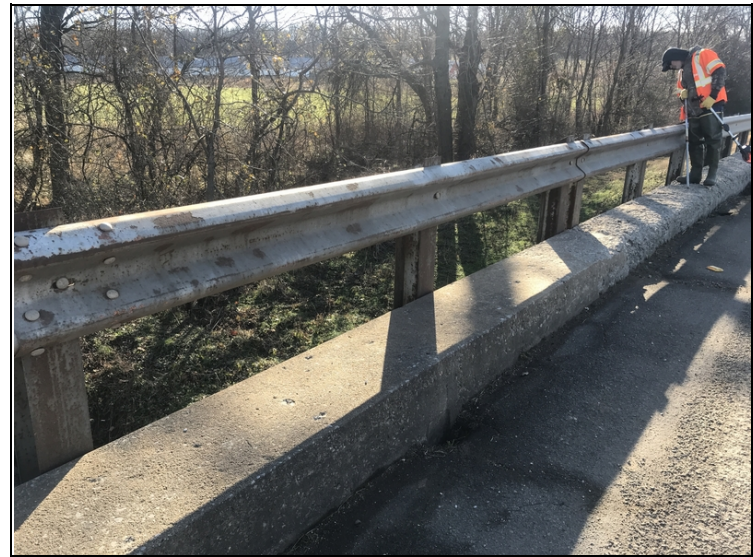
Bridge railing -  
Paint system on the metal bridge rail posts is failing and has a light coating of rust. The bridge railing has rust forming.

Rust forming on bridge railing.

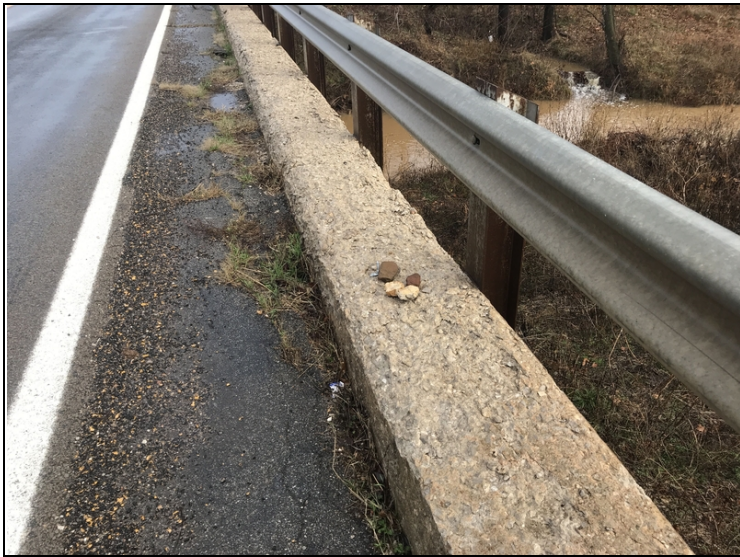
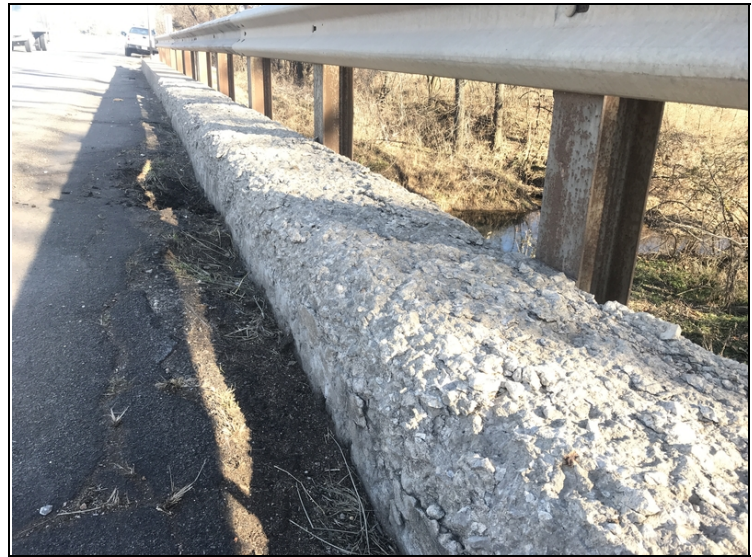
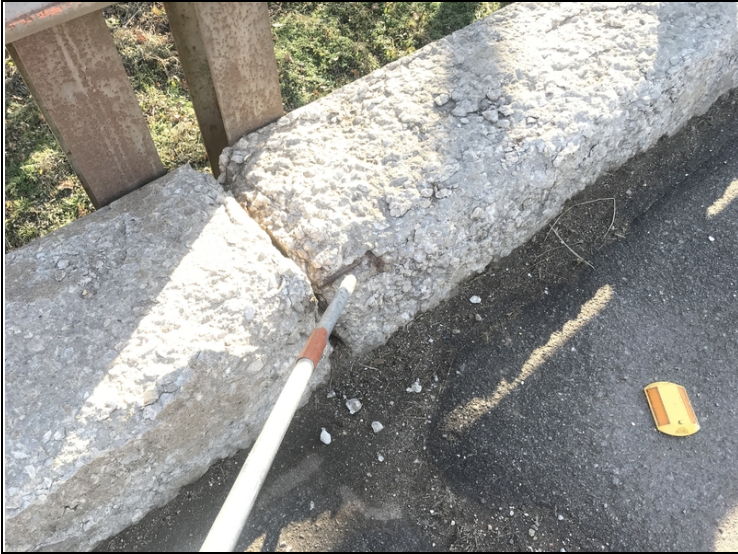
Concrete Curbs -  
The curbs have concrete deterioration with spalling and exposed reinforcing steel.

Left curb, concrete deterioration.

Span 2, left curb-Concrete deterioration / spalling.

Span # 2, left curb at bent # 2-Concrete spalling  
with exposed reinforcing steel.

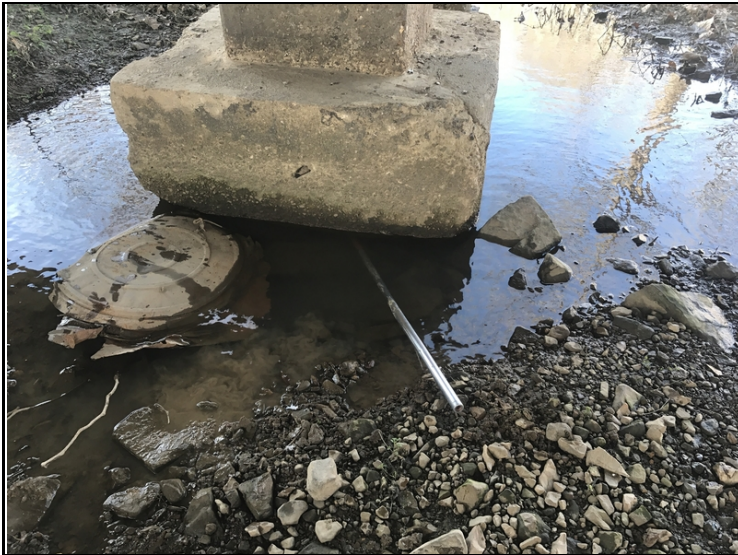
The concrete collars at the base of columns # 2 and # 3 of bent # 2 have undermining. The undermining reaches the face of the columns in some locations.

Bent 2, Column # 3-Undermining that reaches face of column.
