Asset #M1091 (Routine)

US 62-Wash Co. over Ditch

Location: 6.38 M E OF OKLAHOMA SL

Team Lead: Eric West, Inspection Date: 05/18/2023

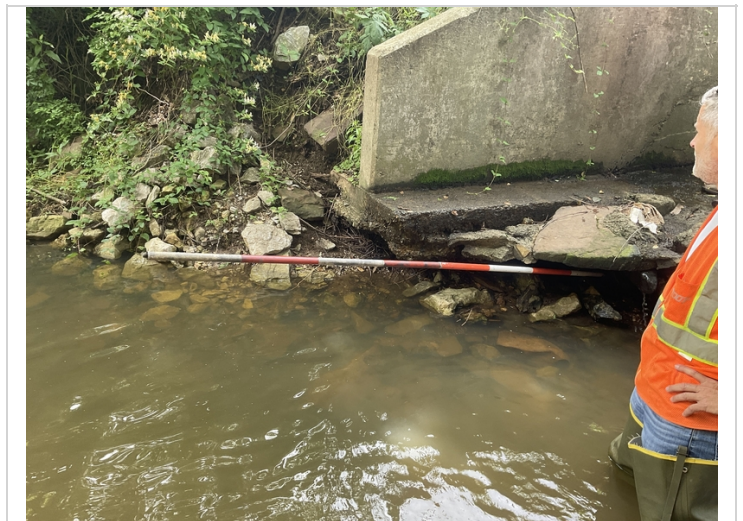
-Barrel # 1 Rt wing wall (outlet end) and the concrete apron is undermined. The end of the wing wall is completely undermined in an area approximately 4' in length measured along the length of the wing wall.  
 -Barrel # 1 Rt has a hairline shear type diagonal crack over the interior wall and a partial height vertical crack over the interior wall.  
 -Barrel # 1 Lt side exterior wall at the wing wall juncture has short duration vertical and diagonal cracks with efflorescence buildup and adjacent to the top slab construction joint has transverse cracks with efflorescence buildup.

Barrel # 1 Rt wing wall undermining.

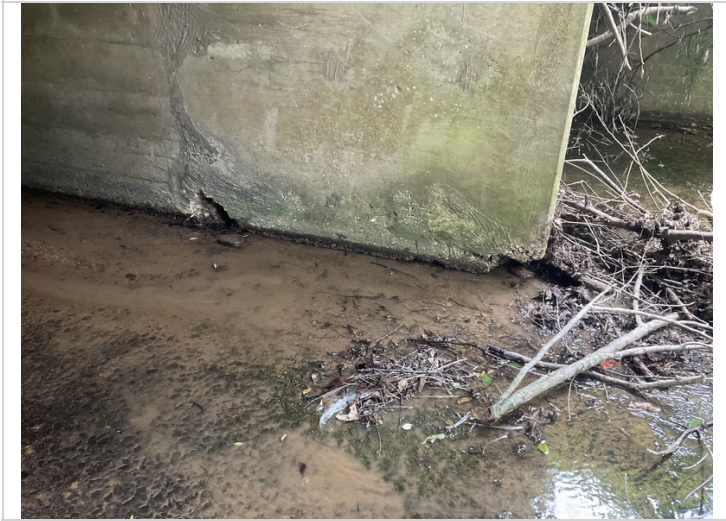
-Barrel # 1 & 2 interior wall has a 10" x 8" hole with exposed reinforcing steel at the base of the center wall located at the construction joint approximately 6' from the Inlet end (left side) of the structure and a 8" x 3" hole with exposed reinforcing steel at the base of the center wall located at the construction joint approximately 6' from the outlet end (right side) of the structure.  
 -Barrel # 1 & 2 interior wall has a 12" x 6" area of concrete section loss located at the base near the Inlet end that has exposed reinforcing steel that has 100% section loss. The holes in the center wall appear to be in the corners of the newer sections where the structure was widened.

Barrel # 2 Lt interior wall concrete deterioration with full depth voids.

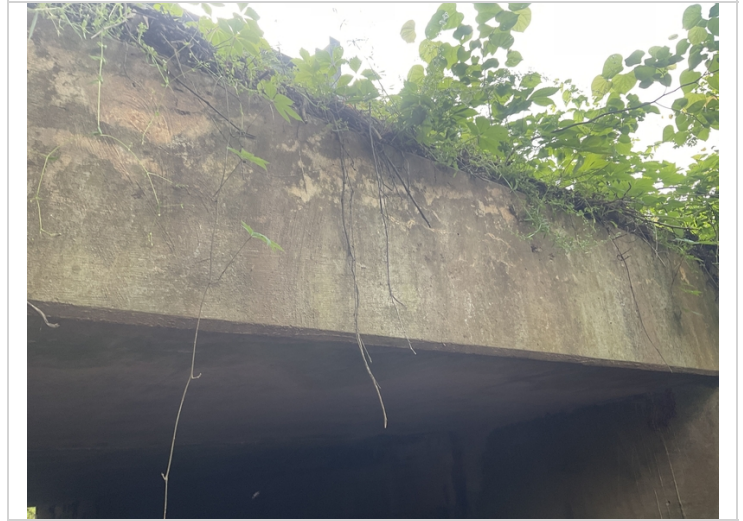
Barrel # 2 Lt headwall map cracking with efflorescence buildup.

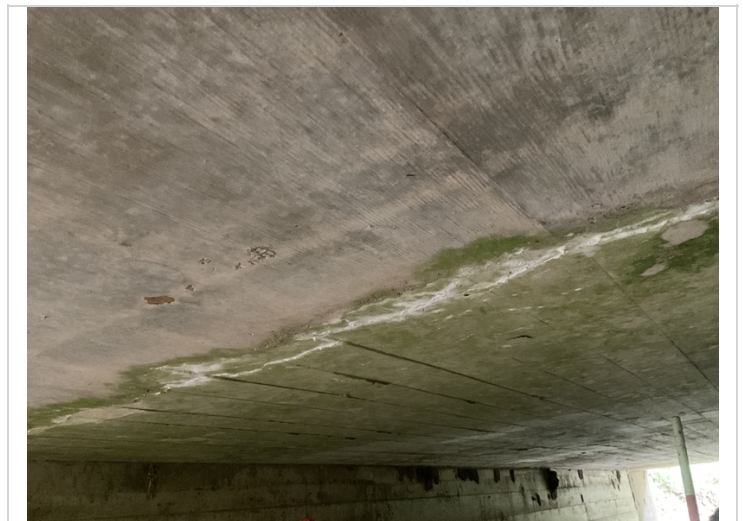
Barrel # 2 Lt top slab transverse cracking with light efflorescence buildup

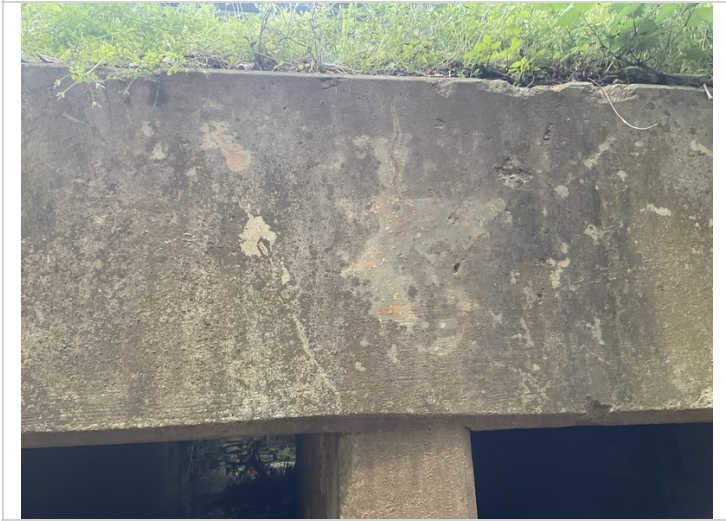
Rt headwall diagonal shear type crack and partial height vertical crack over the interior wall.

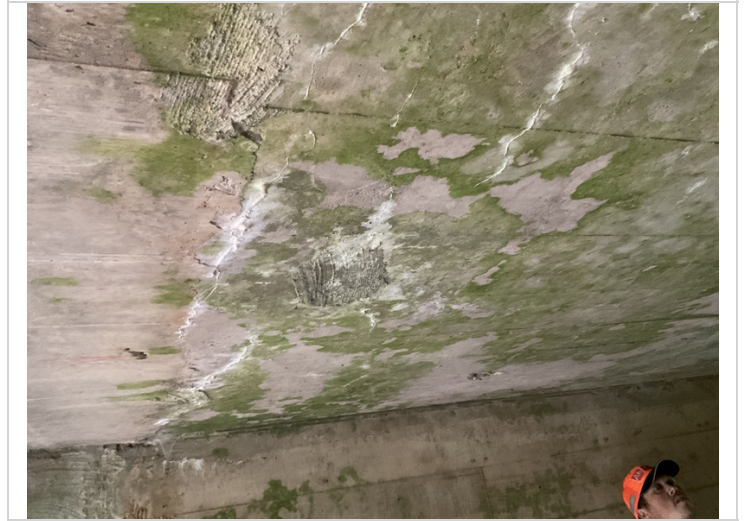
Barrel # 2 Lt top slab cracking with efflorescence buildup.

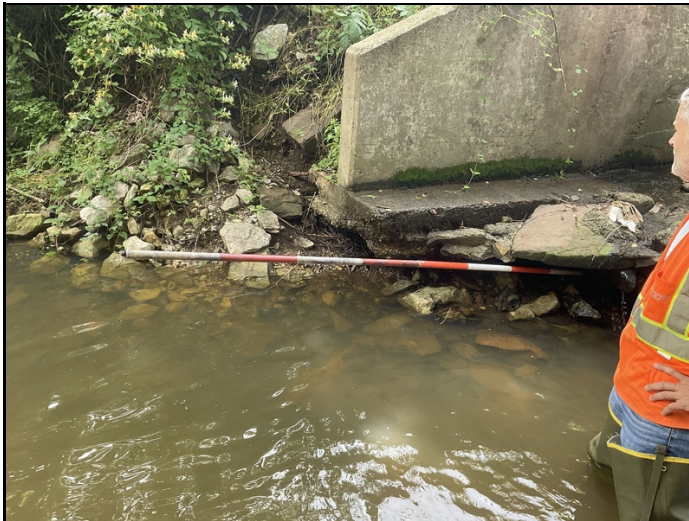
The right wing wall (outlet end) and the concrete apron at barrel # 1 is undermined. The end of the wing wall is completely undermined in an area approximately 4' in length measured along the length of the wing wall.

04/22/2021 - RSM -The undermining has partially silted in since last inspection.

Barrel # 1 Rt wing wall undermining.

**Type of Work:** Repair (General)

**Status:** Monitor

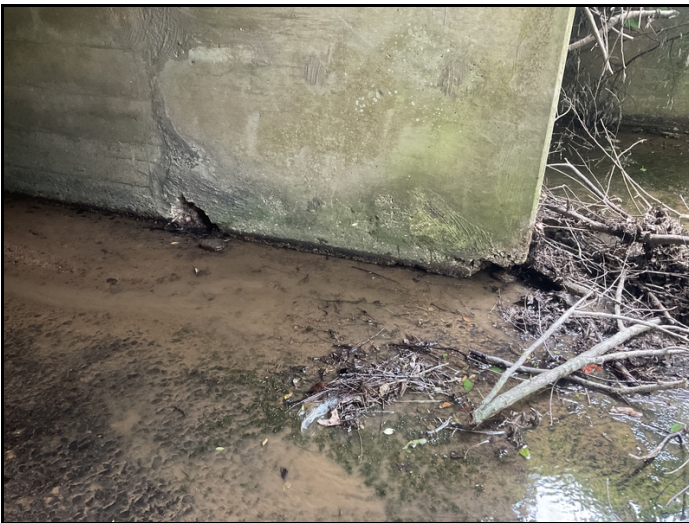
There's a 10" x 8" hole with exposed reinforcing steel at the base of the center wall located at the construction joint approximately 6' from the Inlet end (left side) of the structure, and a 8" x 3" hole with exposed reinforcing steel at the base of the center wall located at the construction joint approximately 6' from the outlet end (right side) of the structure.

The center wall has a 12" x 6" area of concrete section loss located at the base near the Inlet end that has exposed reinforcing steel that has 100% section loss. The holes in the center wall appear to be in the corners of the newer sections where the structure was widened.

Barrel # 2 Lt interior wall concrete deterioration with full depth voids.

Type of Work: Repair (General)

Status: Monitor

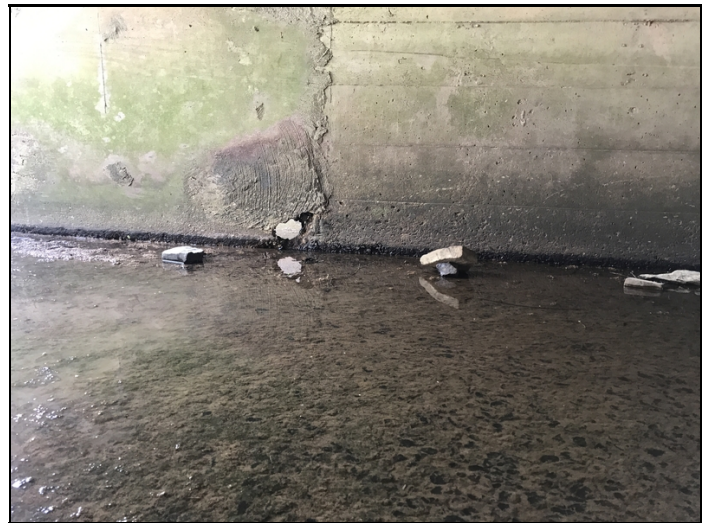
Hole through center wall. Inlet end of structure.
