Asset #B3959(Routine)

U.S. Highway 64 EB over Interstate 540-Crawford

Location: JCT. HWY 64,71 & I540

Team Lead: Bob McEntyre Inspection Date: 09/13/2023

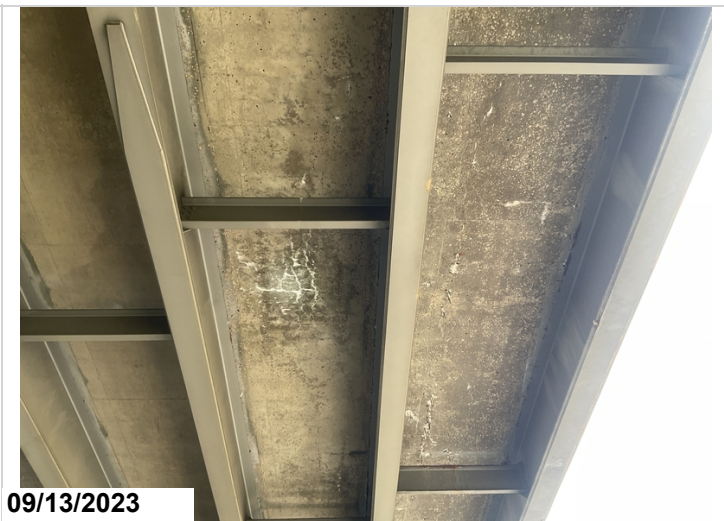
Span # 4 deck undersurface in bay # 5 has an area approximately 30" x 24" of mapcracking with efflorescence, discoloration with leaching. The affected area is over the Northbound inside lane yellow line.

09/13/2023 - RSM & SPC: Span # 4 deck undersurface in bay # 5 has an area approximately 30" x 24" of mapcracking with efflorescence, discoloration with leaching. The affected area is over the yellow line of the Northbound lanes.

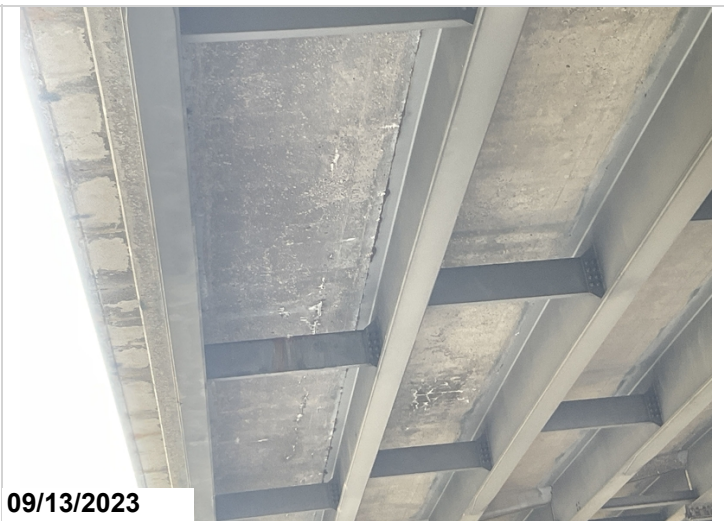
Span # 4 bay # 5-Area of cracking and leaching of efflorescence to the deck undersurface.

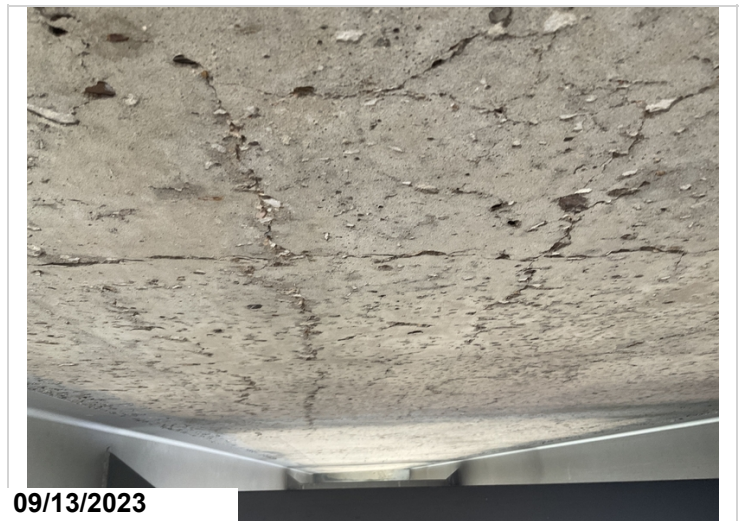
Span # 5 deck undersurface-Scaling and cracking

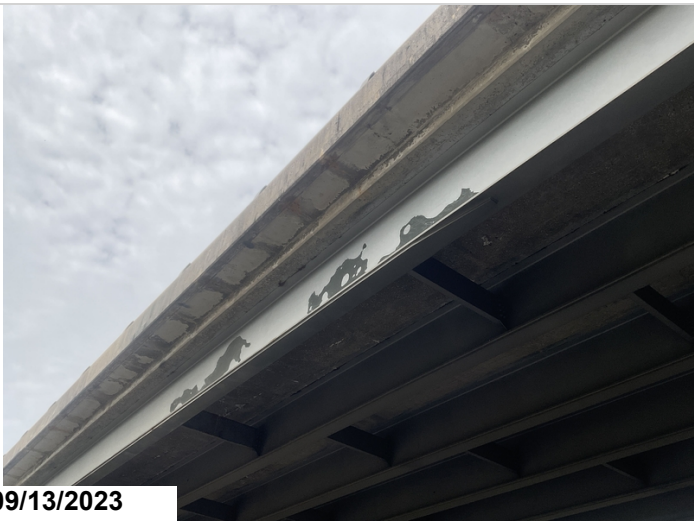
107	Steel Open Girder/Beam	LF	2429	2361	68	0	0
1000	Corrosion	LF	68	0	68	0	0
515	Steel Protective Coating	SF	20856	0	20772	16	68
3420	Peeling/Bubbling/Cracking	LF	16	0	0	16	0
3440	Effectiveness (Steel Protective Coatings)	LF	20840	0	20772	0	68
<p>(107) -Span # 4 exterior beams have paint peeling in areas with exposed primer in the exterior face of beams.</p> <p>-Minor corrosion in the top flange in several of the beams adjacent to the deck drains.</p> <p>-Isolated areas with superficial rust showing through the paint in the top flanges primarily at the full depth cracks and at the</p>

Span # 4 beam # 7 failed paint

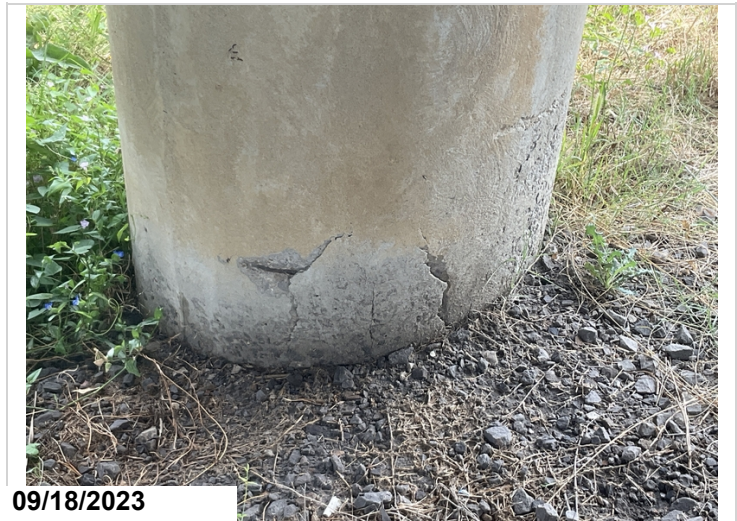
(205) -Bent # 2, column # 3 has a CS3 vertical crack 8' from ground level. -Bent # 3, column # 3 has a 14" delaminated area / spall with exposed reinforcing steel at the base. -Bent # 5, column # has a vertical hairline crack.							
215	Reinforced Concrete Abutment	LF	126	61	65	0	0
1130	Cracking (RC and Other)	LF	65	0	65	0	0

Bent # 3 Column # 3 has a 14" delaminated area / spall with exposed reinforcing steel at the base.

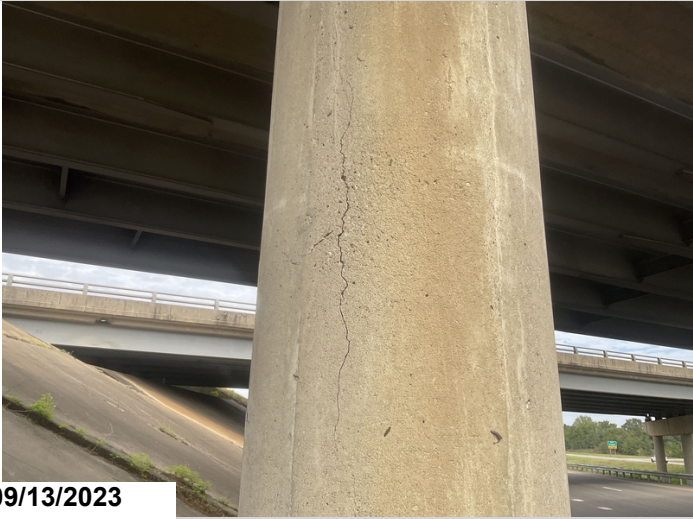
Bent # 2, column # 3 has a CS3 vertical crack 8' from ground level.

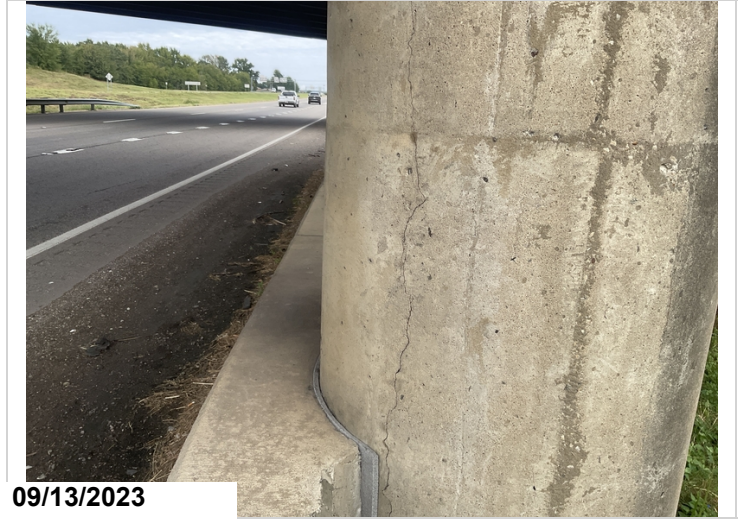
Vertical hairline crack in column at Bent # 5 Column # 3 this inspection.

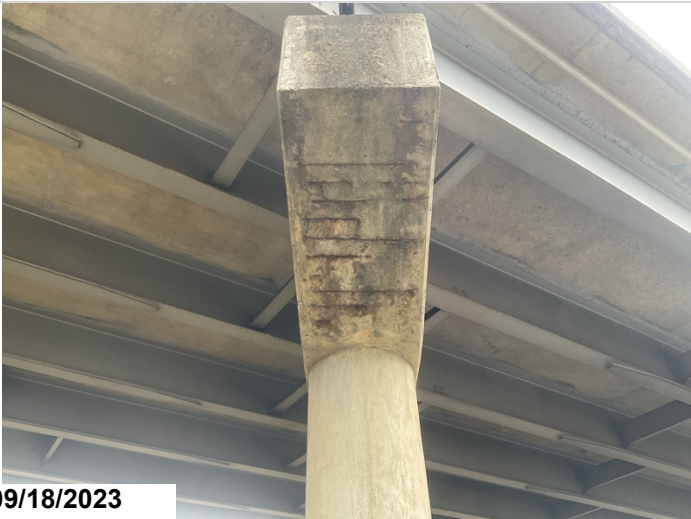
Bent # 5 Left side of cap has a 5' area with concrete spalls with exposed reinforcing steel visible from the undersurface of the cap.

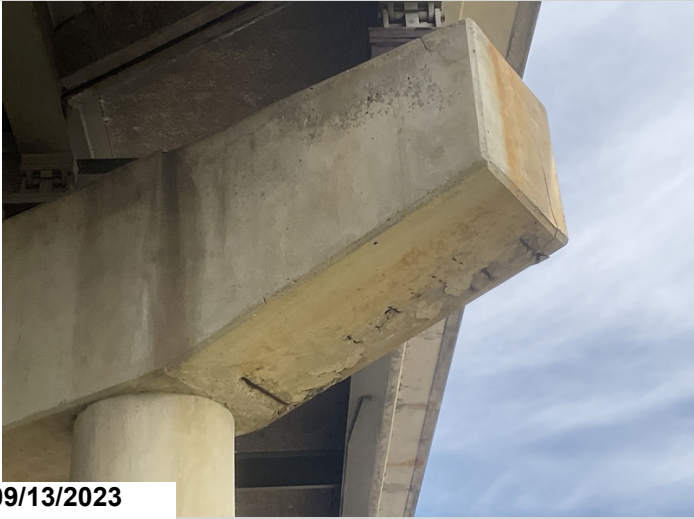
Bent # 4 Right side of cap has a 6' section of spalls with exposed reinforcing steel.

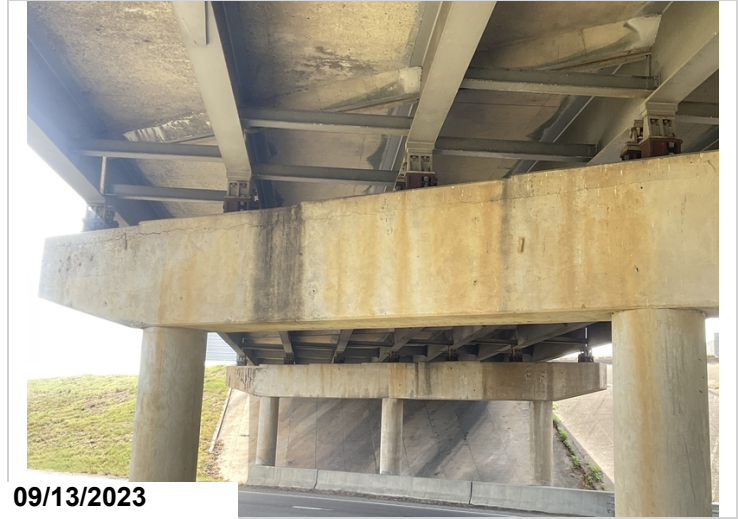
Bent # 3 cap has a horizontal crack that is located approximately 8" below the top of cap for approximately 1/2 the width of the cap.

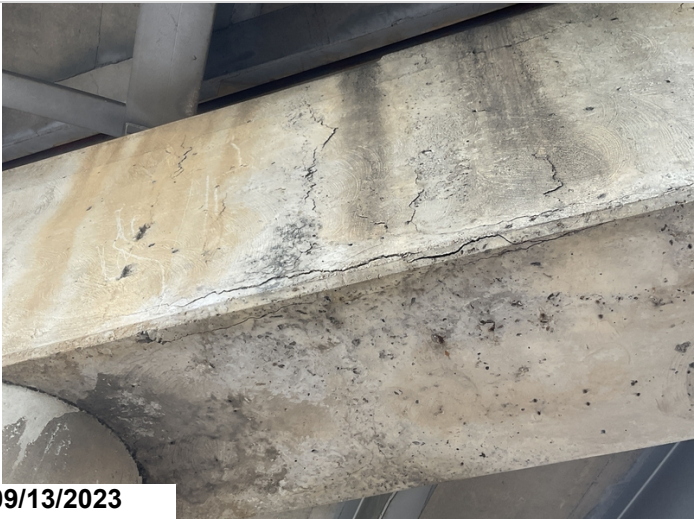
Bent # 2 aheadface has horizontal cracks and areas of map cracking, delaminated areas, and spalling.

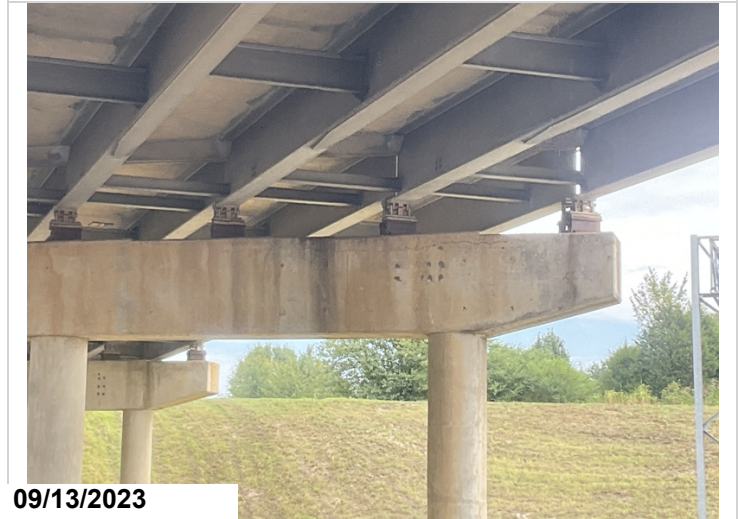
Bent # 3 cap has a horizontal crack that is located approximately 8" below the top of cap for approximately 1/2 the width of the cap.

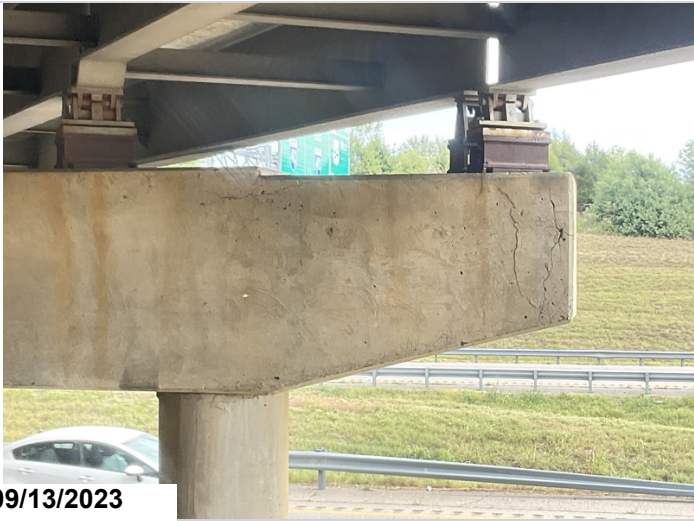
(234) -Bent # 2, right side of cap has horizontal cracks and areas of map cracking, delaminated areas, and spalls with exposed reinforcing steel. -Bent # 2 aheadface of cap has horizontal cracks and areas of map cracking, delaminated areas, and spalling adjacent to column # 2. -Bent # 3 cap has a horizontal crack located approximately 8" below the top of cap that extends approximately 1/2 the length of the cap. -Bent # 3, right side of cap has a 10" spall. -Bent # 4, left side of cap has spalls with exposed reinforcing steel. -Bent # 4, right side of cap has a 6' area of spalls with exposed reinforcing steel. -Bent # 5 cap has horizontal cracking along top edge between bearings # 2 and 3, & 6 and 7. -Bent # 5 cap between columns # 2 and # 3 has a 3' delaminated area. -Bent # 5, left side of cap undersurface has a 5' area with concrete spalls with exposed reinforcing steel. -Bent # 5, right side of cap undersurface has a 2' area with concrete spalls that expose reinforcing steel. Exposed reinforcing steel has initial section loss with areas of active corrosion.

Bent # 2, Right side of cap has horizontal cracks and areas of map cracking, delaminated areas, and spalls with exposed reinforcing steel.

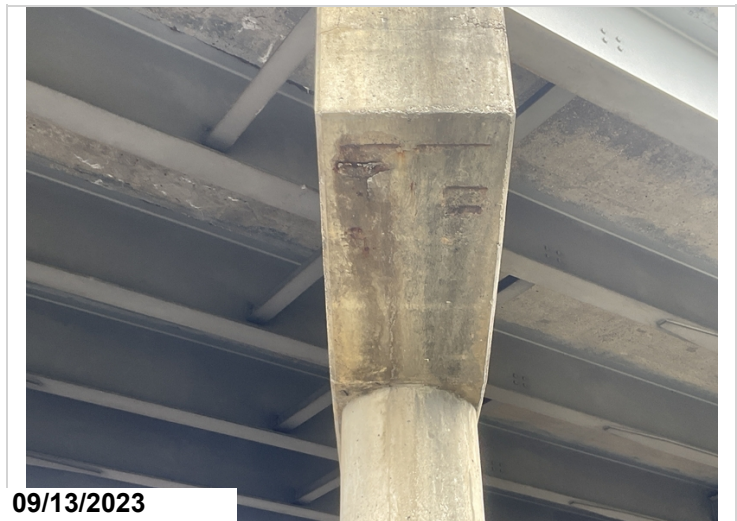
Bent # 5 Right side of cap has a 2' area with concrete spalls with exposed reinforcing steel visible from the undersurface of the cap.

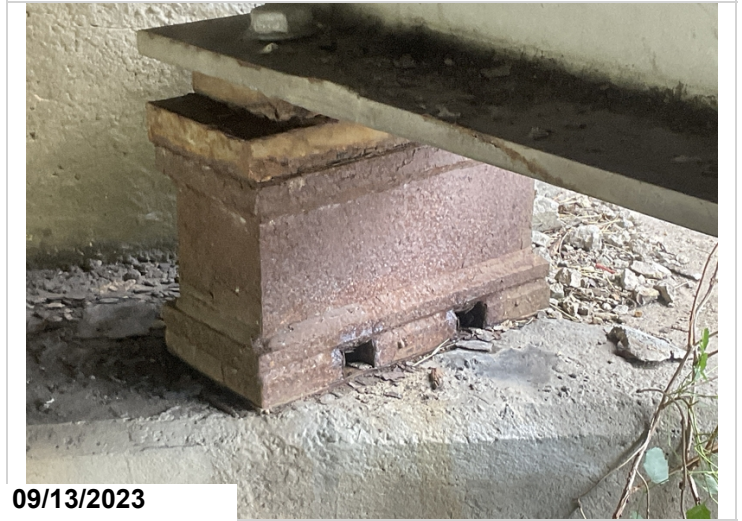
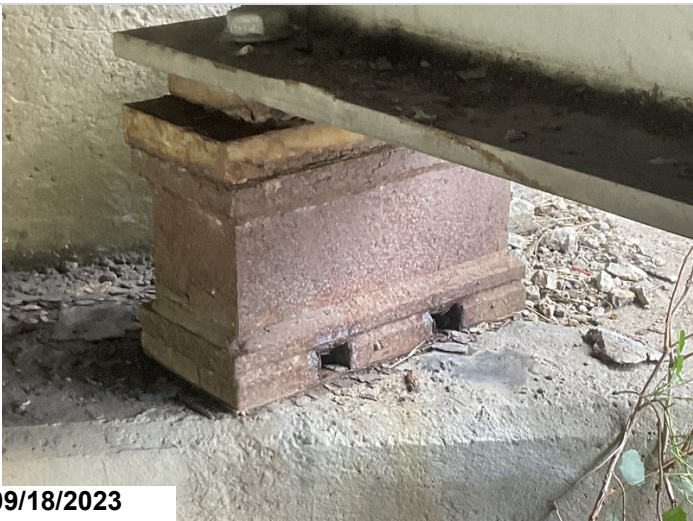
(313) -Bearings are placed on pedestals due to the structure being raised in the past. The pedestals appear to be constructed from weathering steel. A few bearings that have rust under the sole plates. -Abutment # 1, beams # 1 & 2 have light pack rust forming.							
330	Metal Bridge Railing	LF	694	653	41	0	0
1020	Connection	LF	41	0	41	0	0

Abutment # 1 bearing # 1 corrosion

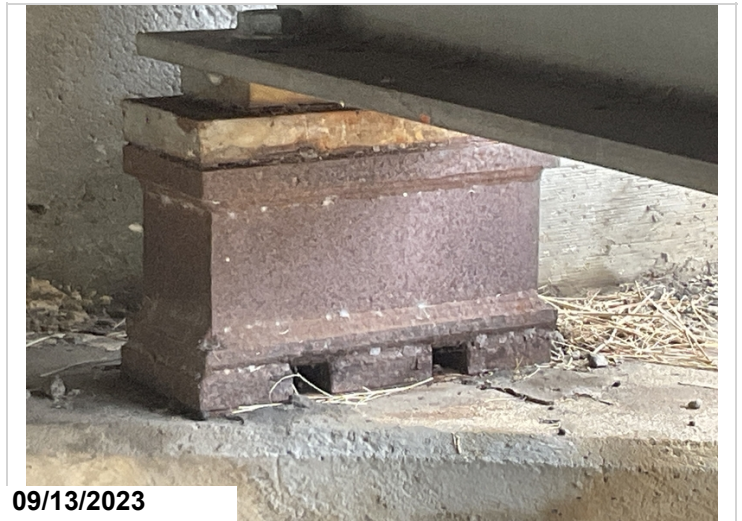
Abutment # 2 bearing # 7 corrosion.

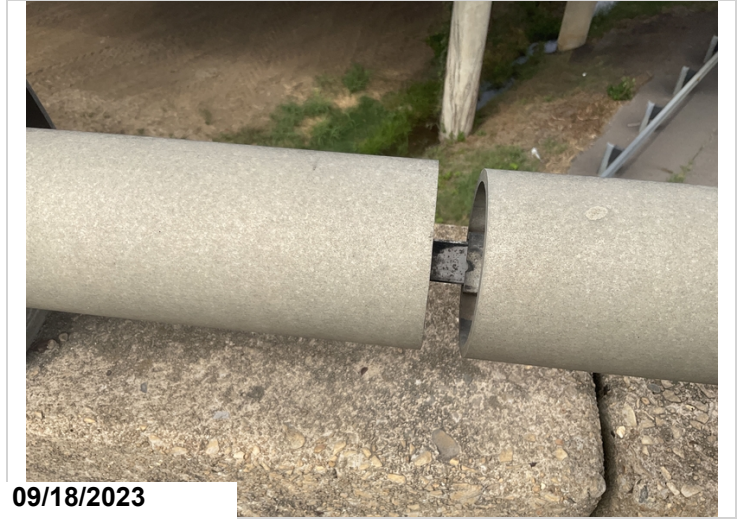
Span 4 left railing-Telescoping connector displaced

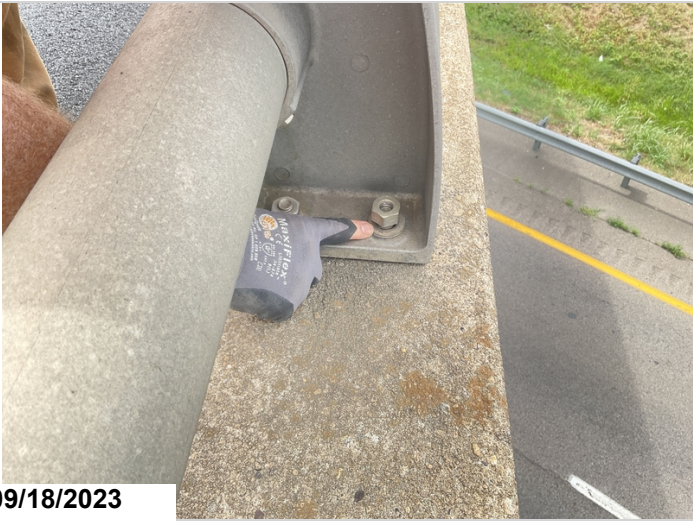
(330) -The bridge railing has numerous loose anchor bolt nuts that attach the metal posts to the top of the concrete bridge rail.							
331	Reinforced Concrete Bridge Railing	LF	694	486	123	85	0
1090	Exposed Rebar	LF	23	0	0	23	0
1120	Efflorescence/Rust Staining	LF	62	0	0	62	0
1130	Cracking (RC and Other)	LF	123	0	123	0	0

Loose nut

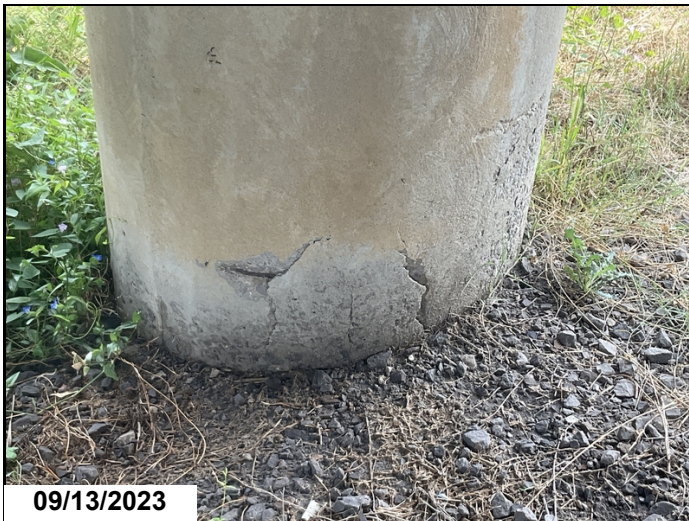
The bent caps have numerous spalls with exposed reinforcing steel, delaminated concrete, and wide cracking from past water leakage through the deck joint seals.

Bent # 3, column # 3 has a 14" delaminated area / spall with exposed reinforcing steel at the base of column.

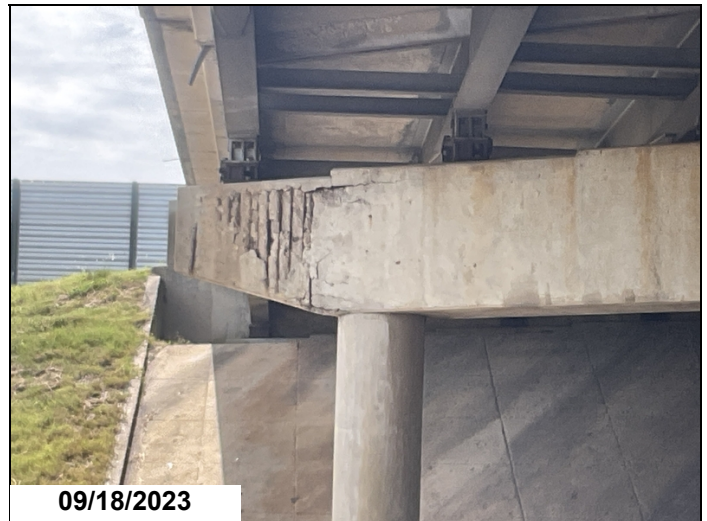
Bent # 2 cap aheadface, right side-Spalling with exposed reinforcing steel.

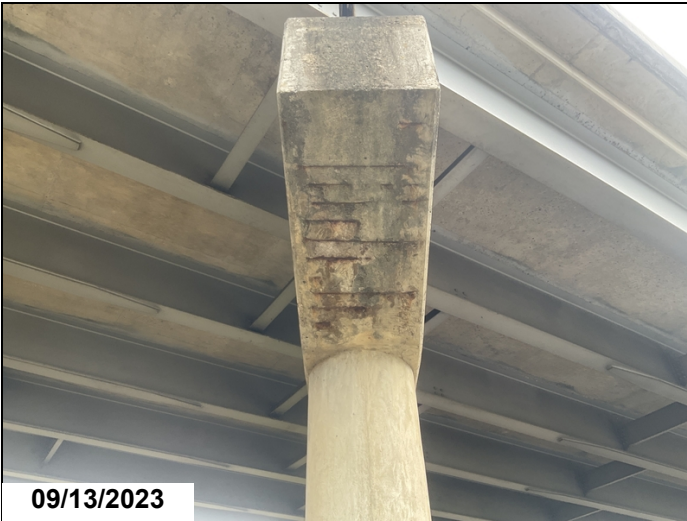
Bent # 5 Left side of cap has a 5' area with concrete spalls with exposed reinforcing steel visible from the undersurface of the cap.

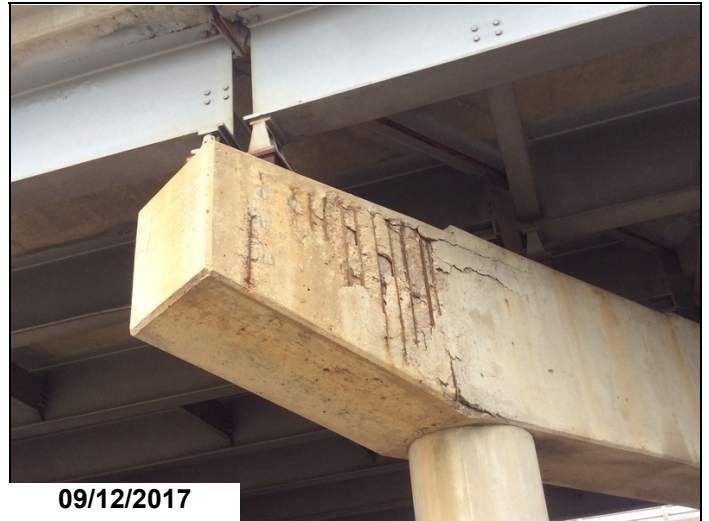
Bent # 2, Right side of cap has a 4' section that has map cracking, delaminated areas, and spalls with exposed reinforcing steel.

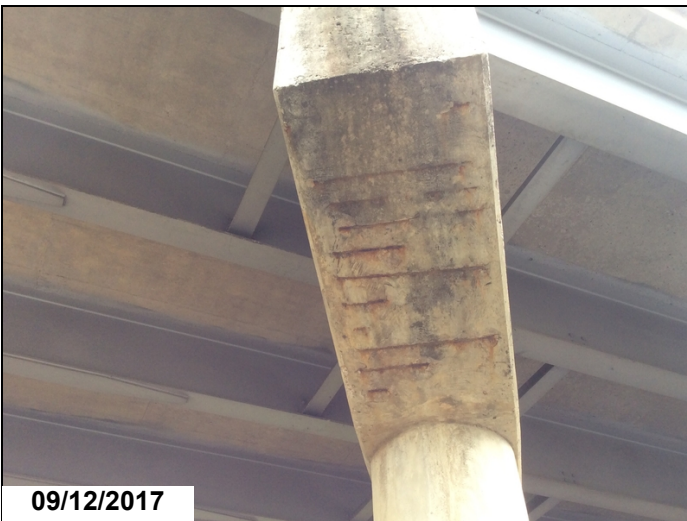
Bent # 5, Left side of cap has a 5' area with concrete spalls with exposed reinforcing steel visible from the undersurface of the cap.

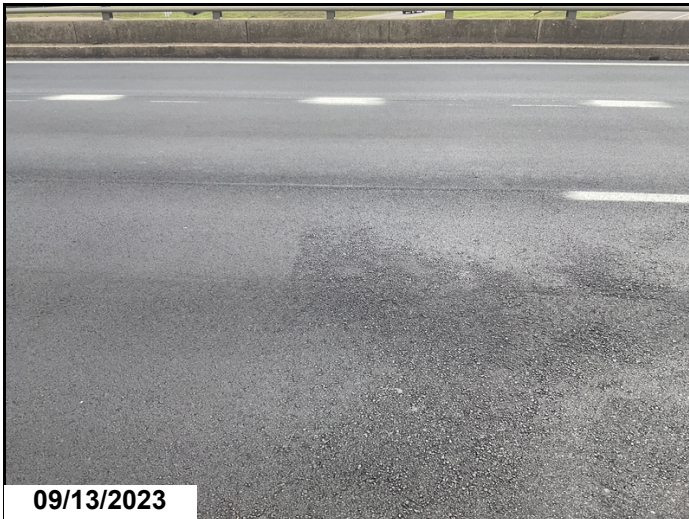
09/13/2023 - RSM - Deficiencies in driving surface of deck still exists but are not visible due to ACHM overlay constructed by State Maintenance Forces since last inspection.

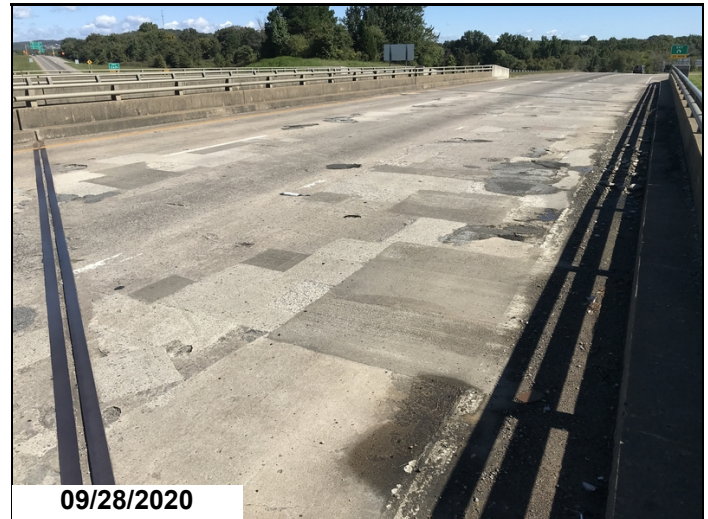
Large areas of scale, concrete deterioration, delaminated concrete, and spalls with exposed reinforcing steel on the driving surface of the deck and in isolated areas of the undersurface. Numerous previous repairs are deteriorating and delaminated. Span # 4 pictured.

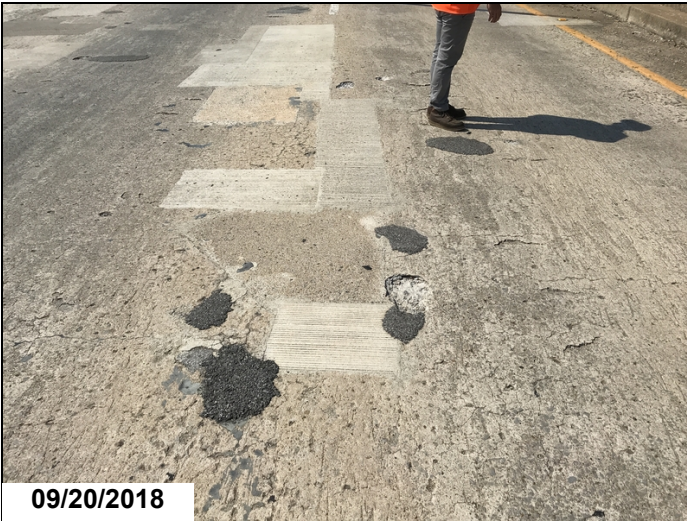
Span # 3 potholes forming on the deck.

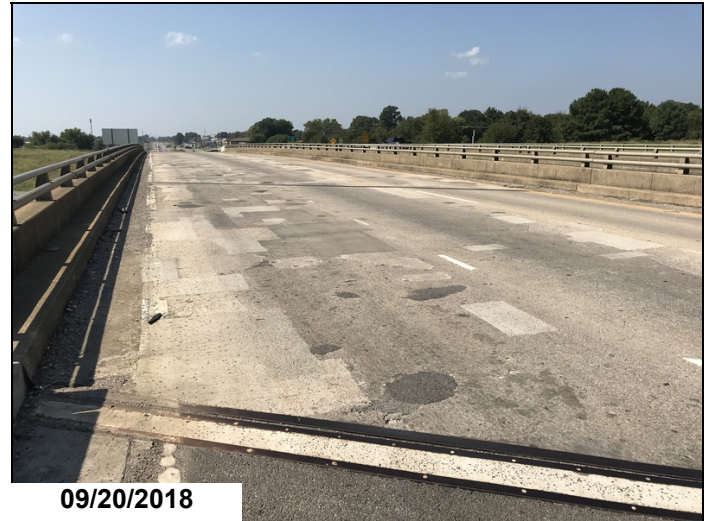
Large areas of scale, concrete deterioration, delaminated concrete, and spalls with exposed reinforcing steel on the driving surface of the deck and in isolated areas of the undersurface. Numerous previous repairs are deteriorating and delaminated.

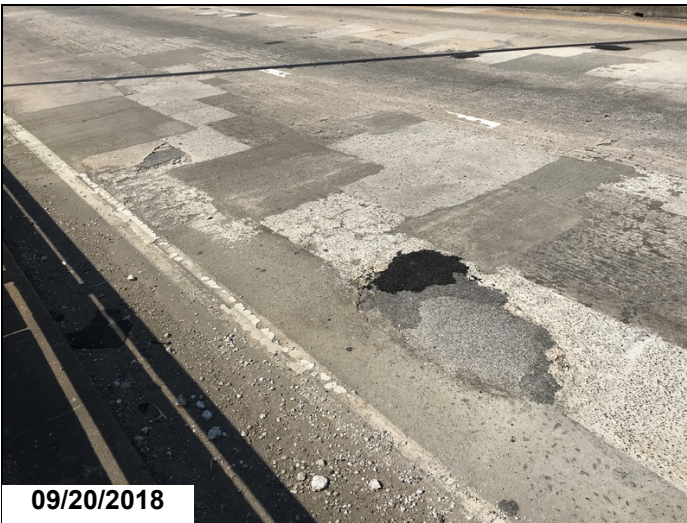
Deterioration of the older repairs.

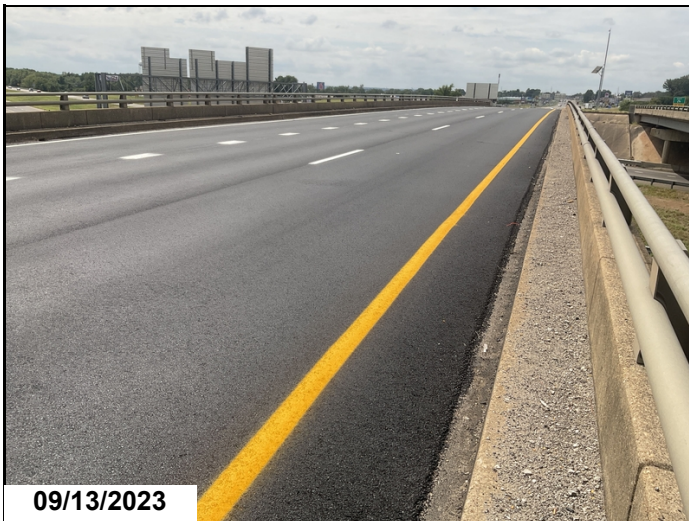
09/13/2023 - RSM - State Maintenance Forces have constructed an ACHM wearing surface on the deck since last inspection.

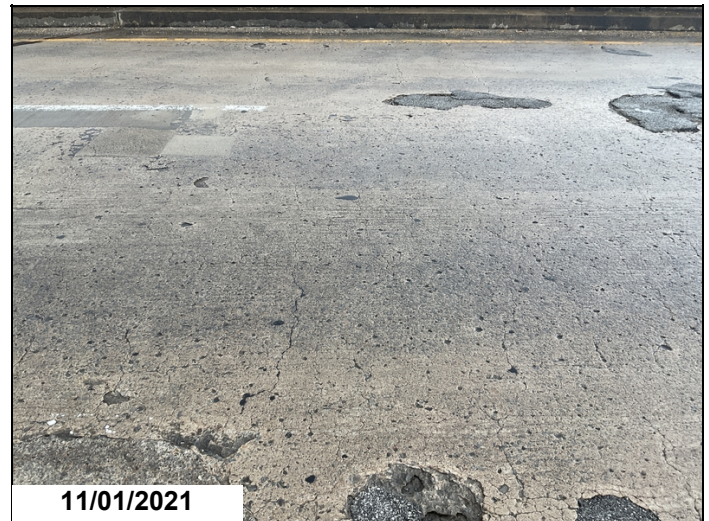
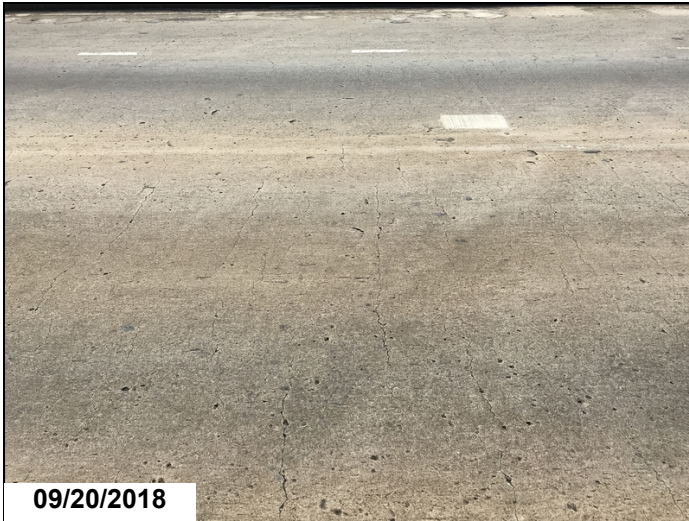
Sealable deck cracking.

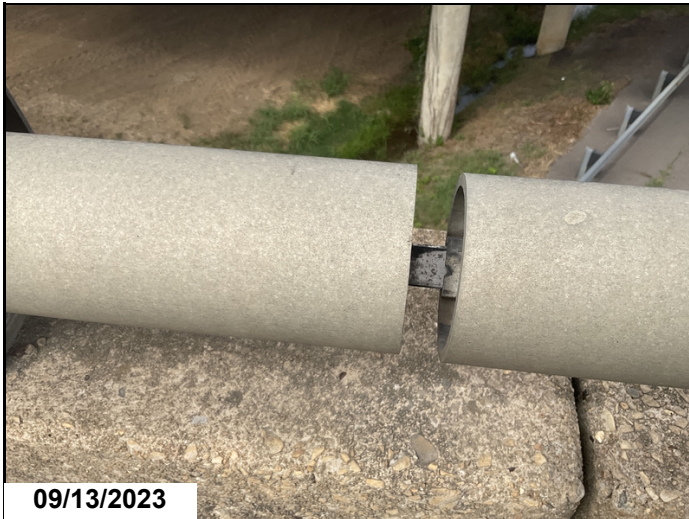
Span # 4 left railing-Telescoping connector vibrated out of position.

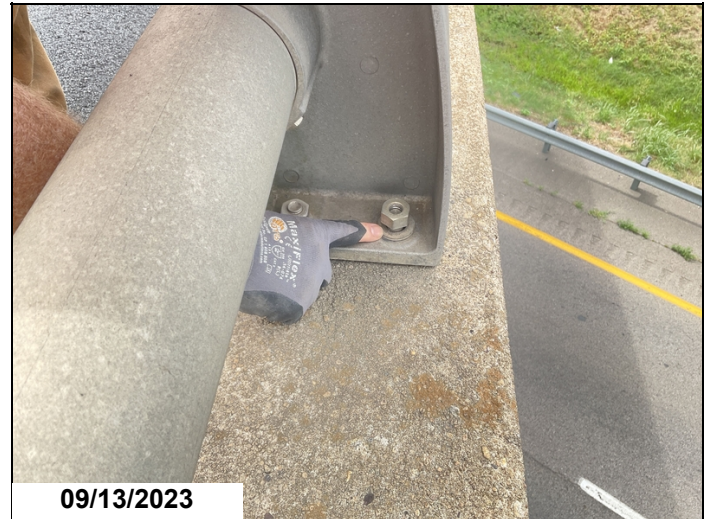
Loose nut on anchor bolt nut that connects railing to concrete bridge railing.

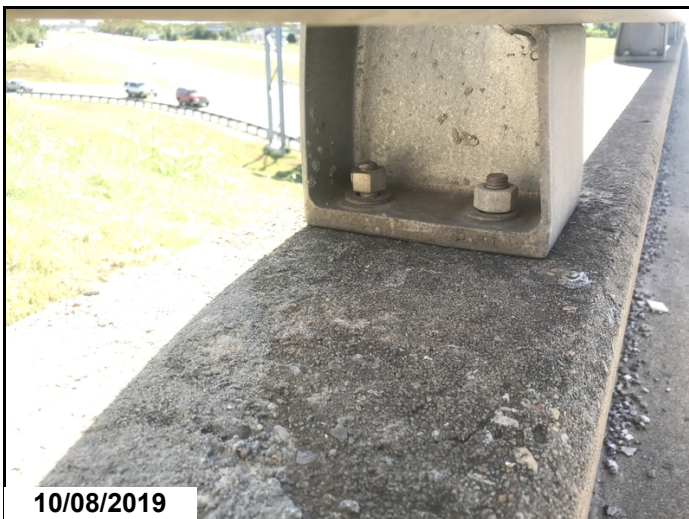
- Several loose anchor bolt nuts that attach the metal rail posts to the top of the concrete bridge rails.
- The metal rails vibrate during heavy truck traffic during this inspection.

Numerous loose anchor bolt nuts.

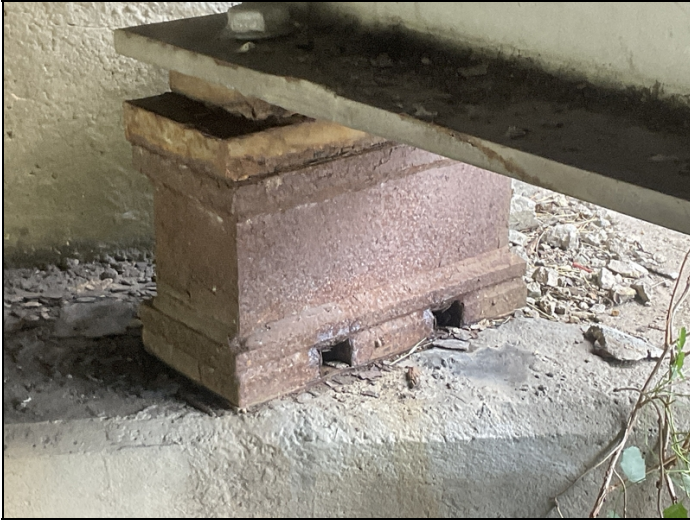
The paint system on the bearings is beginning to fail with light rust showing through and a few isolated areas of active corrosion with pack rust forming between the bearing plates.

Abutment # 1 bearing # 1 corrosion
