Asset #06048(Routine)

State Highway 162 over UNION PAC RR-Crawford Co

Location: 0.6 Mi E Jct US 64

Team Lead: Bob McEntyre Inspection Date: 09/18/2023

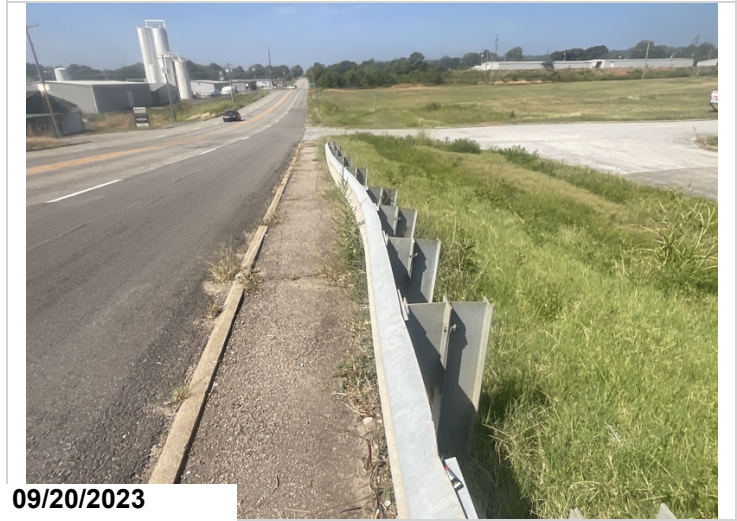
Abutment 1 left approach railing-Collision damage

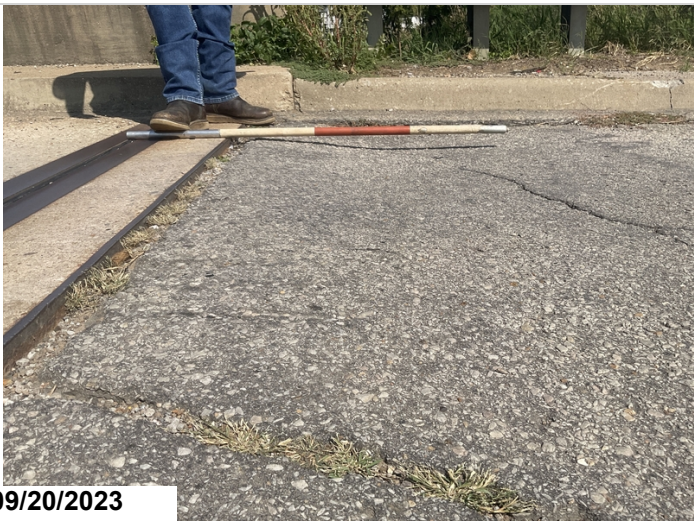
East approach Roadway-Settlement in left lane

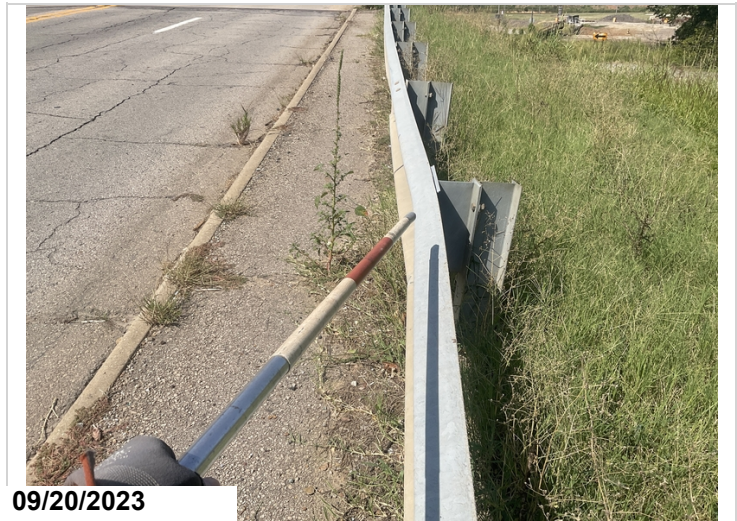
Abutment 2 left approach railing-Collision damage

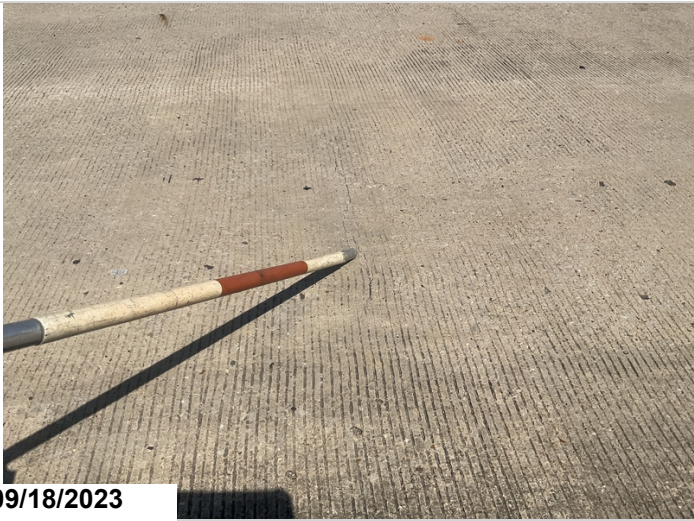
Transverse deck cracking

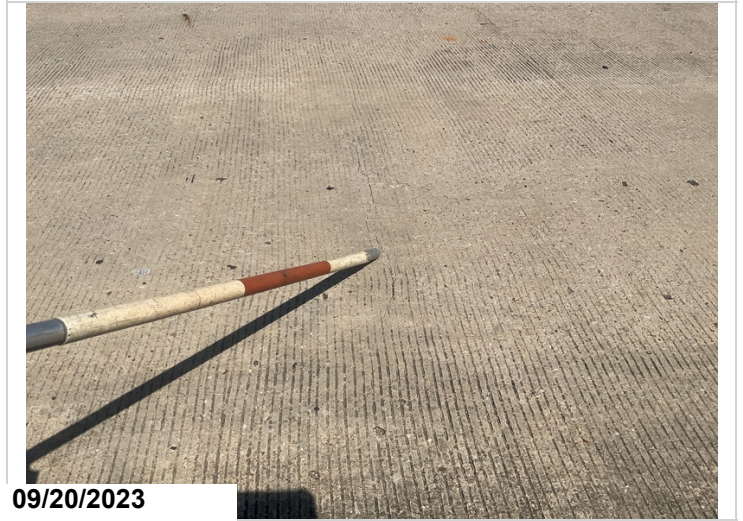
Transverse deck cracking

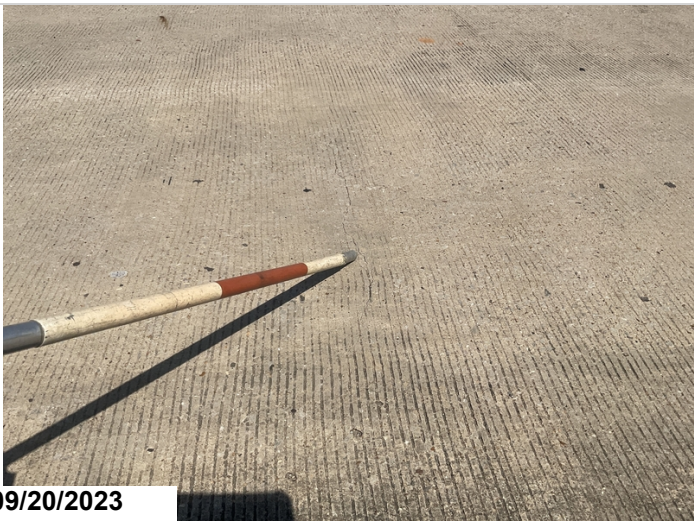
Transverse deck cracking

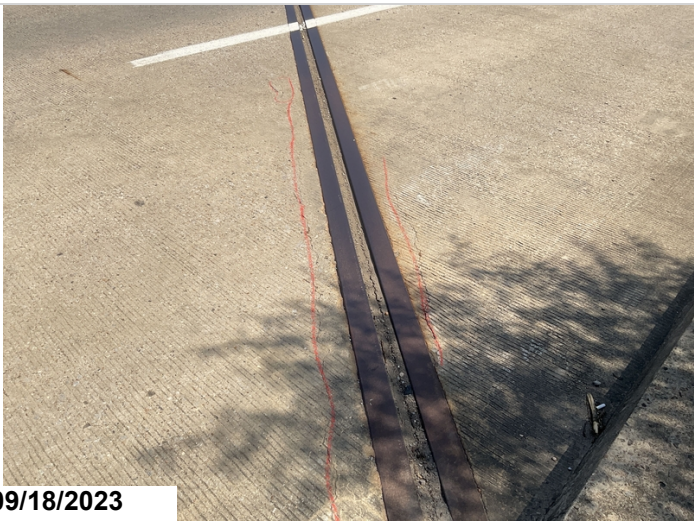
Span 4 right outside lane at bent 5-Transverse cracking with delaminated area adjacent to expansion joint assembly

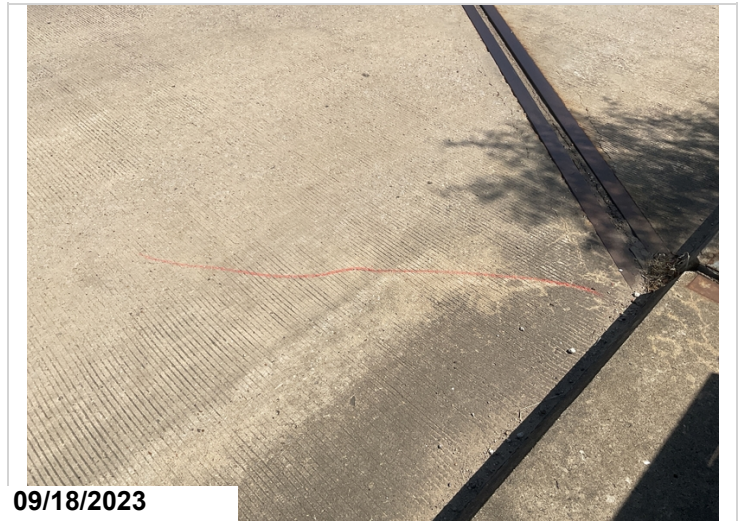
Span 4 has a longitudinal crack (Perpendicular to expansion joints) in right outside lane at bent 5

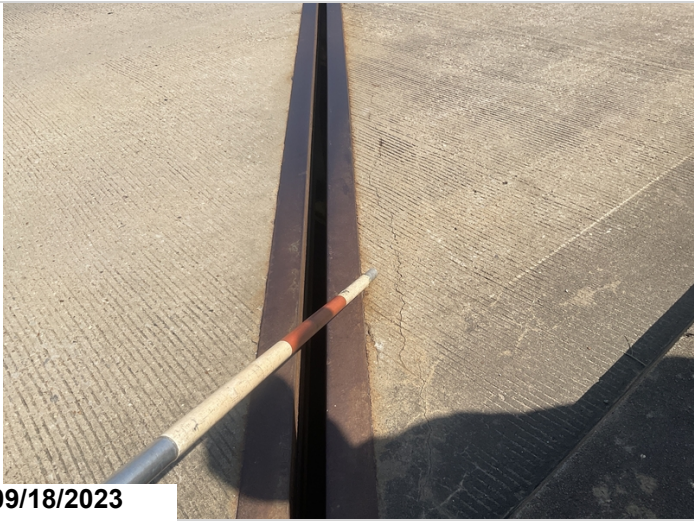
Span 4, right lane adjacent to bent 4-Transverse deck cracking

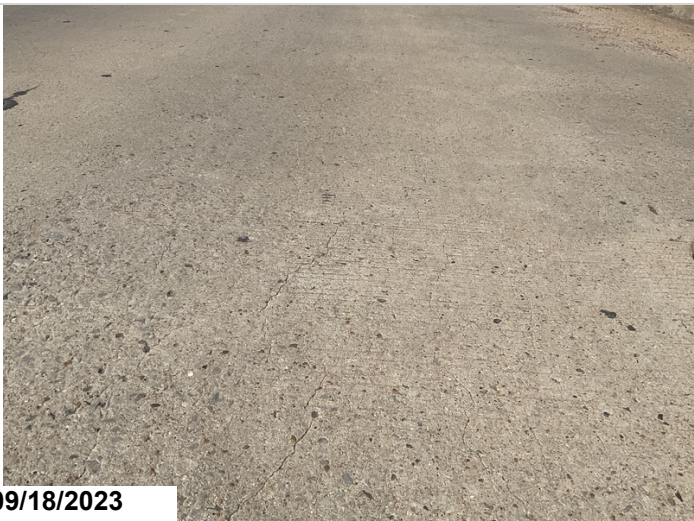
Cracking in wheel path

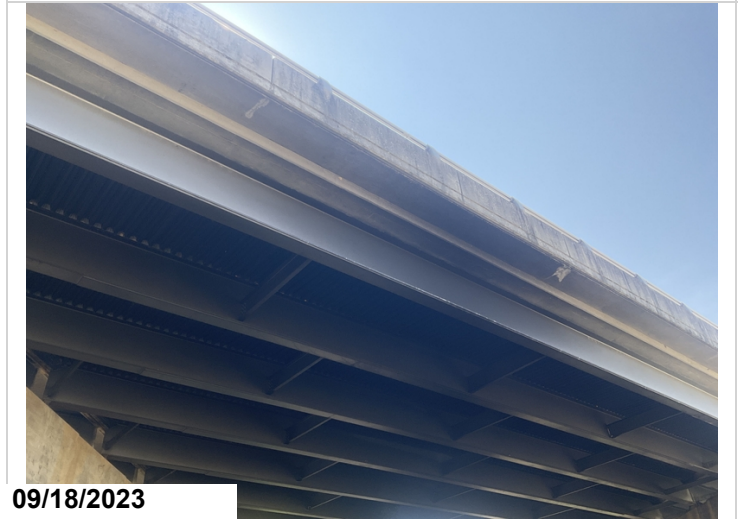
Span # 4 left overhang efflorescence

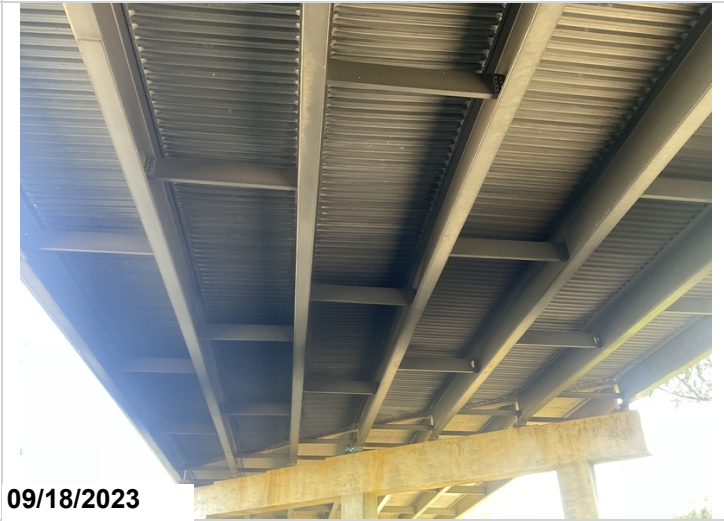
Span # 4 beams have staining from train exhaust.

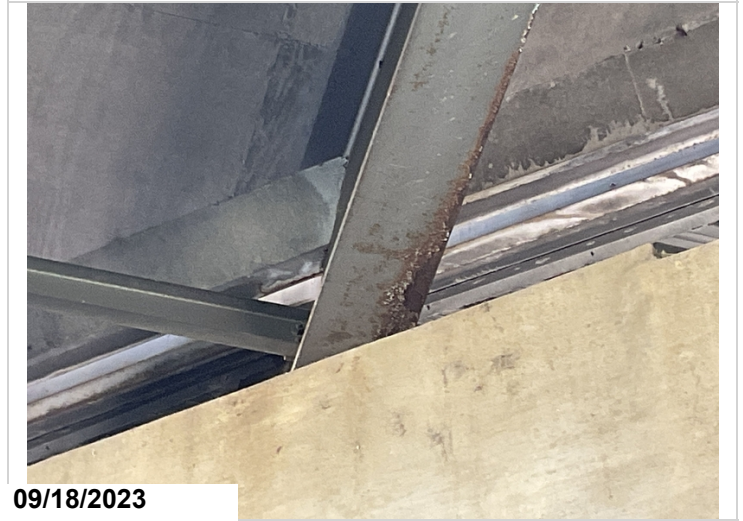
Bent # 4 beam # 4 corrosion

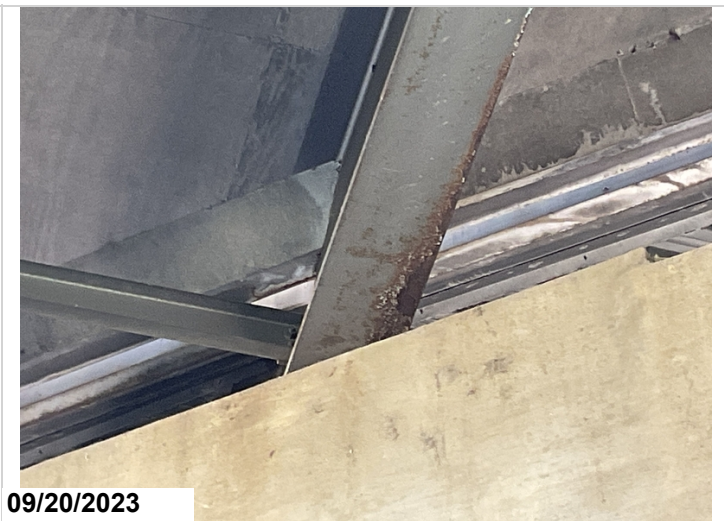
Bent # 4 beam # 4 corrosion

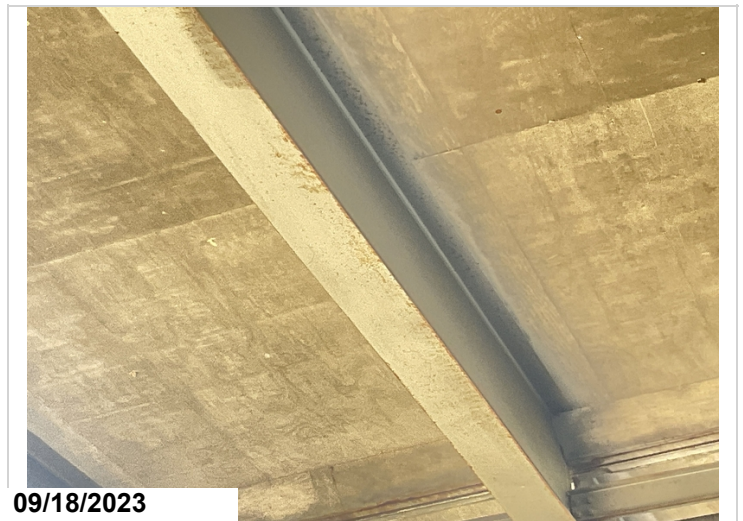
Typical beam corrosion

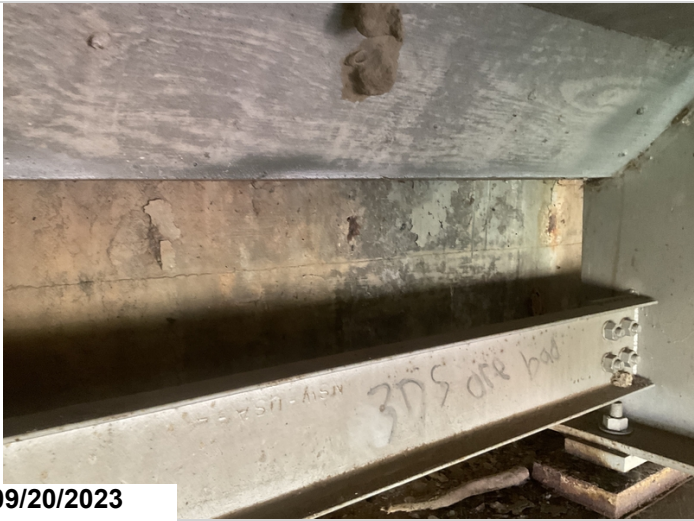
Abutment # 2, East abutment, has several delaminated areas and baseball sized spalls with exposed reinforcing steel.

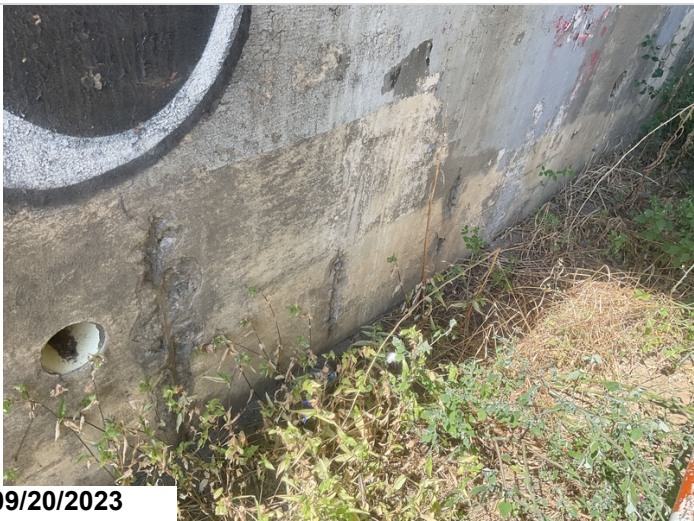
Abutment # 1 stem with 3 spalls that expose reinforcing steel in the base of the bent under bay # 6.

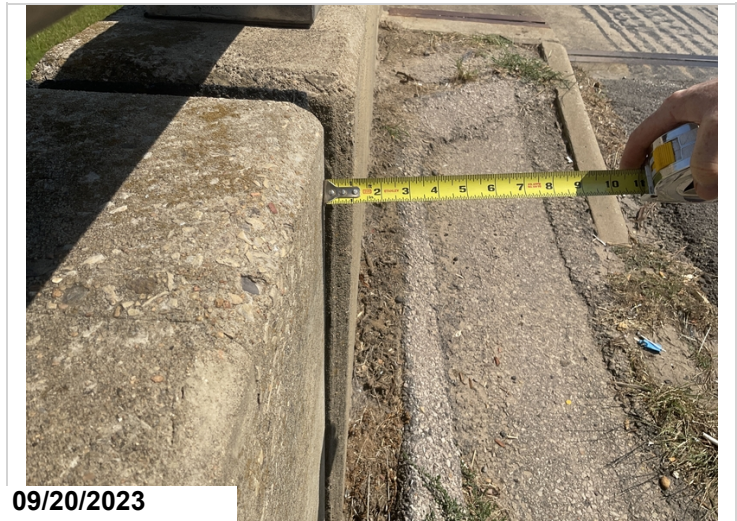
Abutment # 1 left retaining wall-Leaning away from roadway.

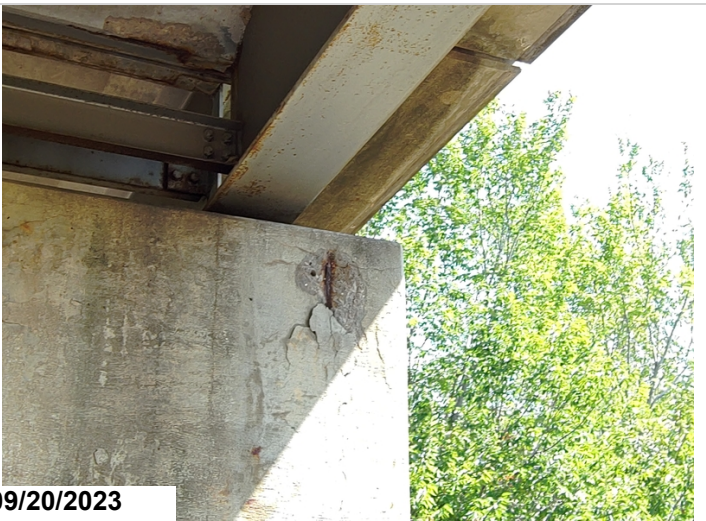
Drone Photo-Spall in bent cap with exposed reinforcing steel.

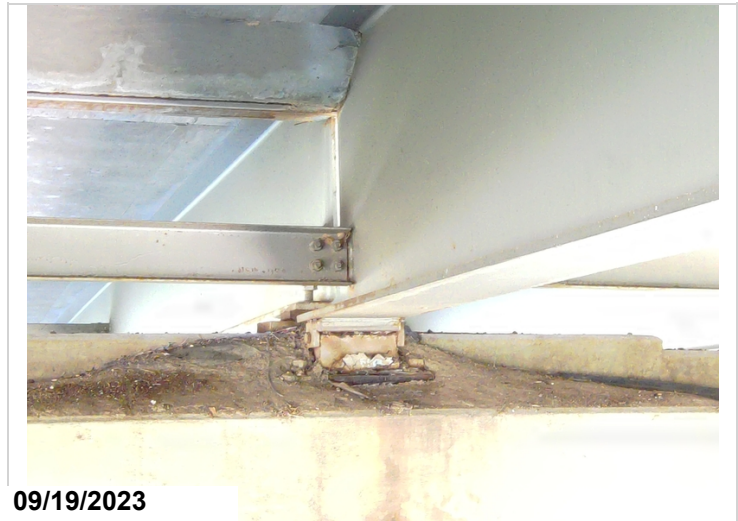
Drone Photo-Heavy dirt and debris accumulation on bent cap

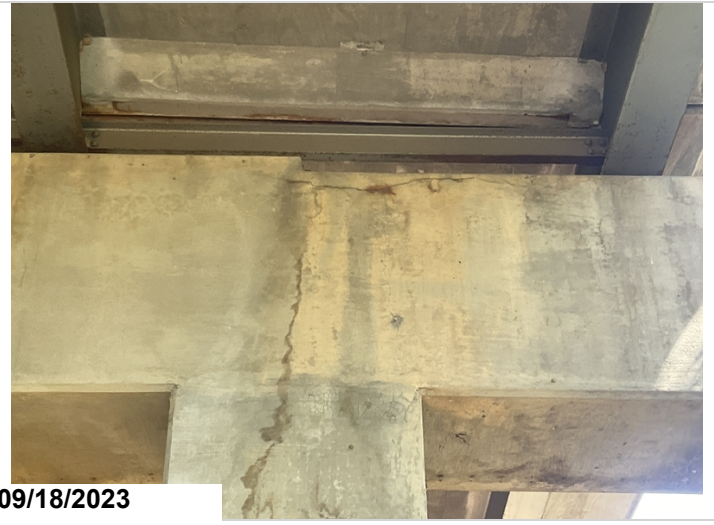
Bent # 8 has a 3' horizontal crack at the top of the cap between beams # 6 & 7.

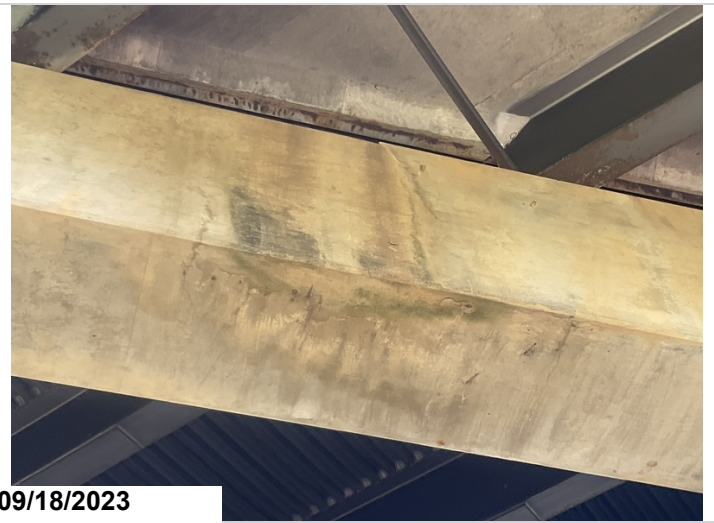
Bent # 5 cap cracking

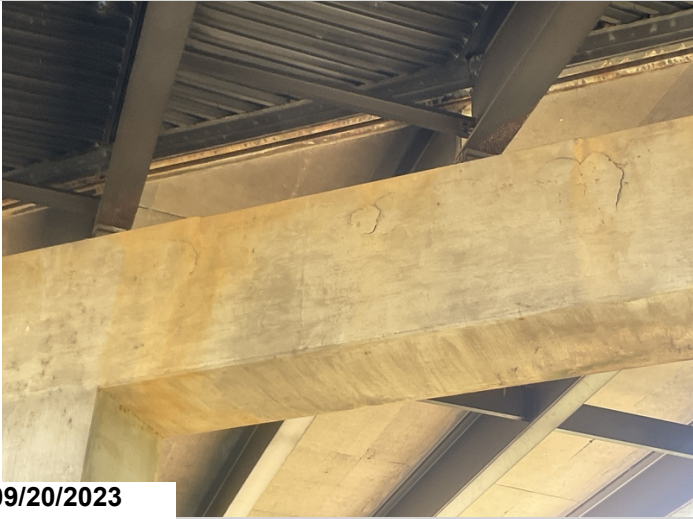
Bent # 5 has multiple delaminated areas on the span # 4 side between columns # 2 & 3.

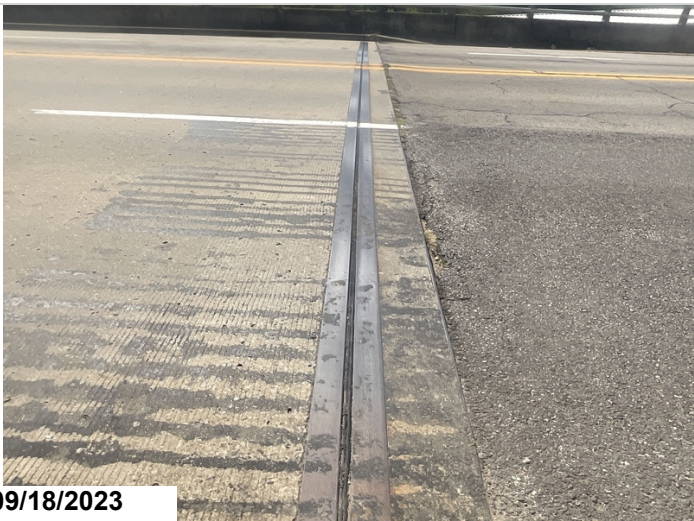
Abutment # 1 expansion joint seal deteriorated.

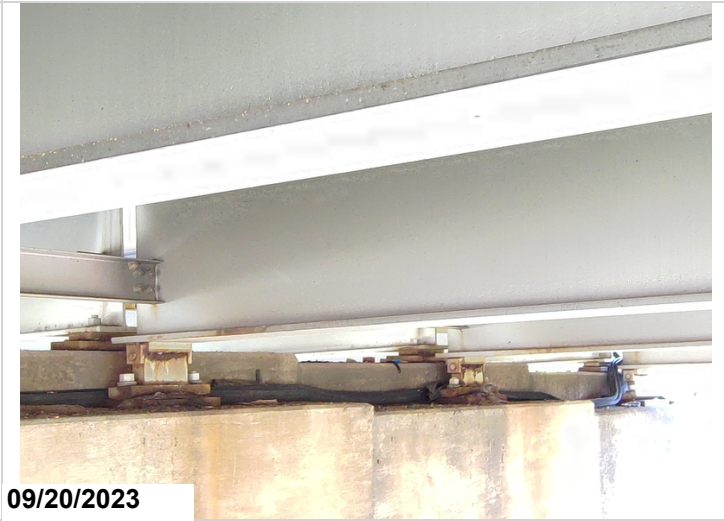
Drone Photo-Corrosion to bearings

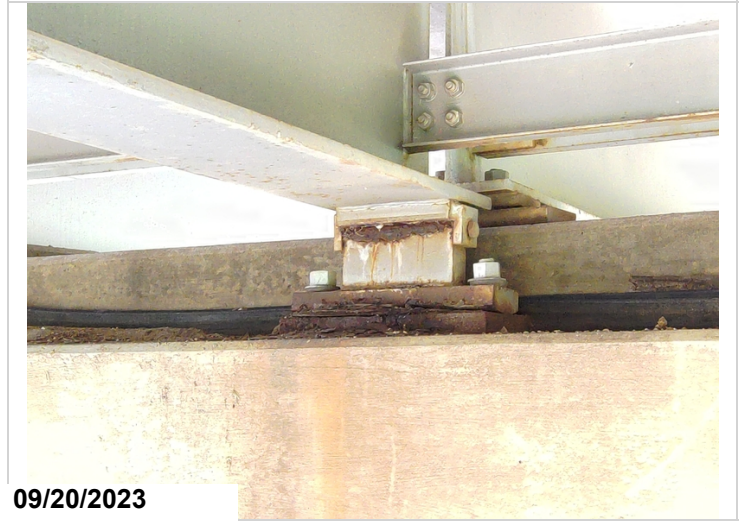
Drone Photo-Corrosion with pack rust between bearing plates.

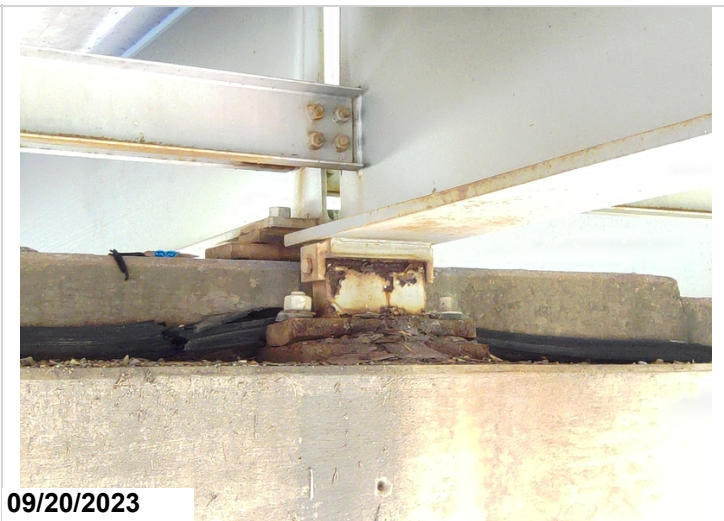
Drone Photo-Heavy corrosion

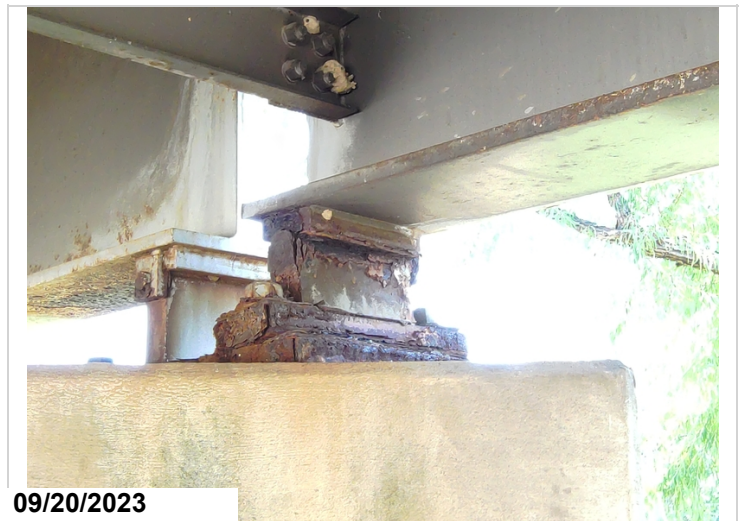
Drone Photo-Heavy corrosion

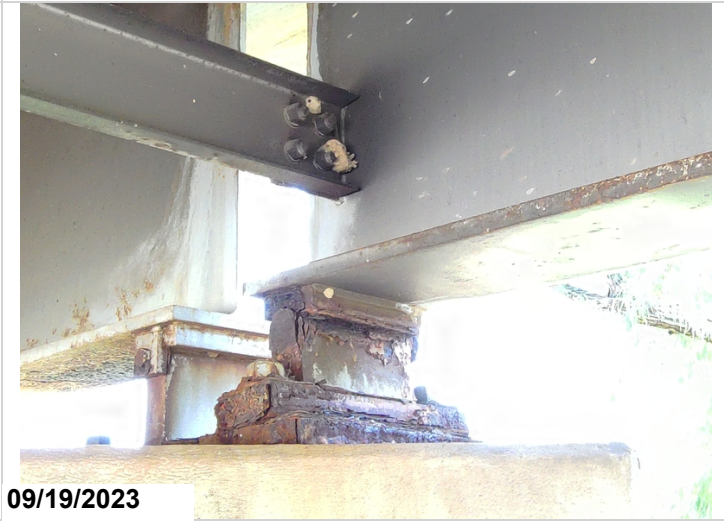
Drone Photo-Heavy corrosion

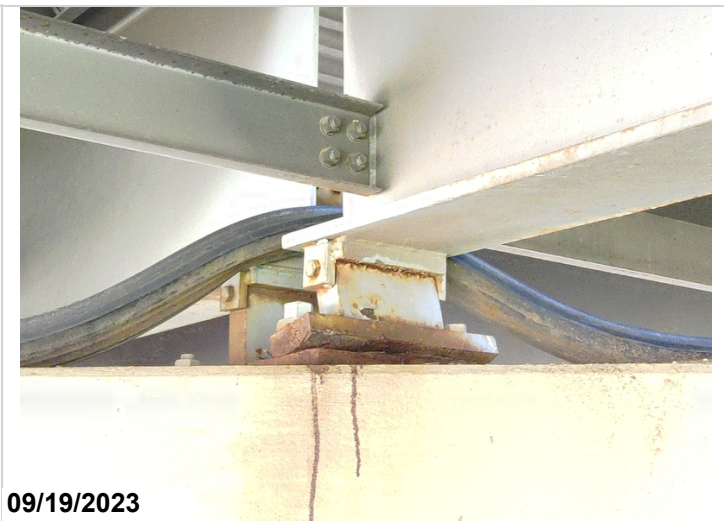
Drone Photo-Corrosion with pack rust between bearing plates.

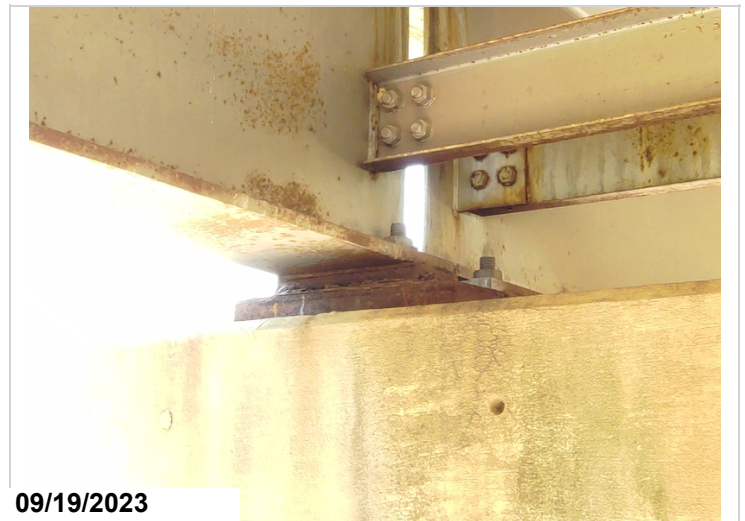
Drone Photo-Corrosion with pack rust between bearing plates.

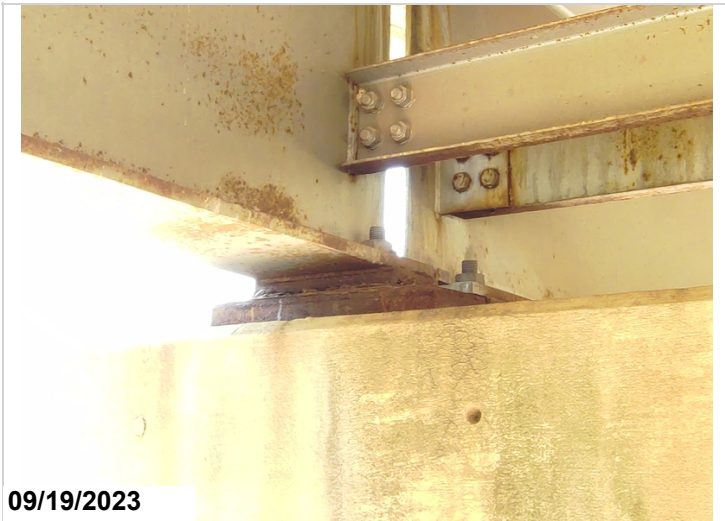
Drone Photo-Bearing corrosion with pack rust between bearing plates.

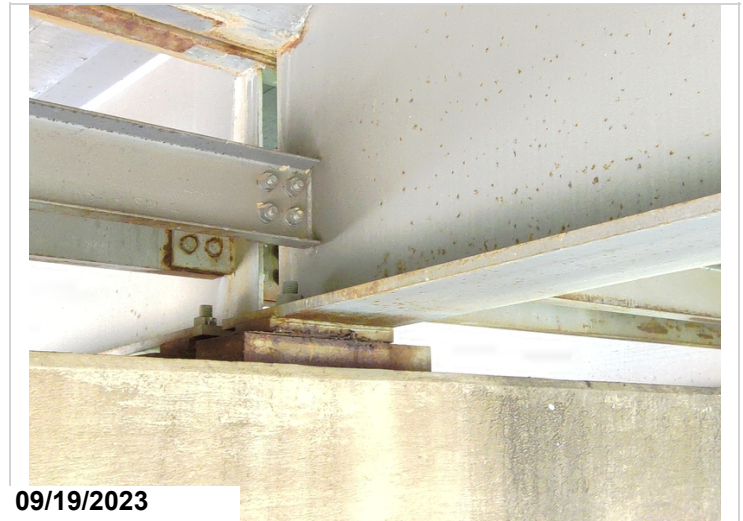
Drone Photo-Bent # 2, corrosion to bearing

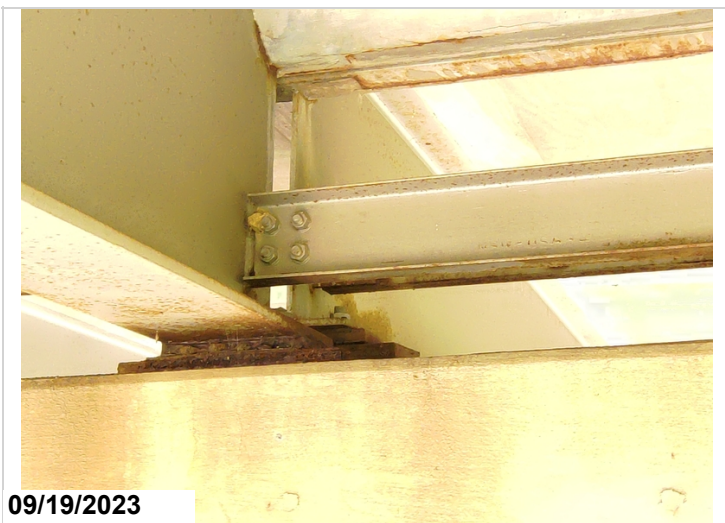
Drone Photo-Corrosion to bearing

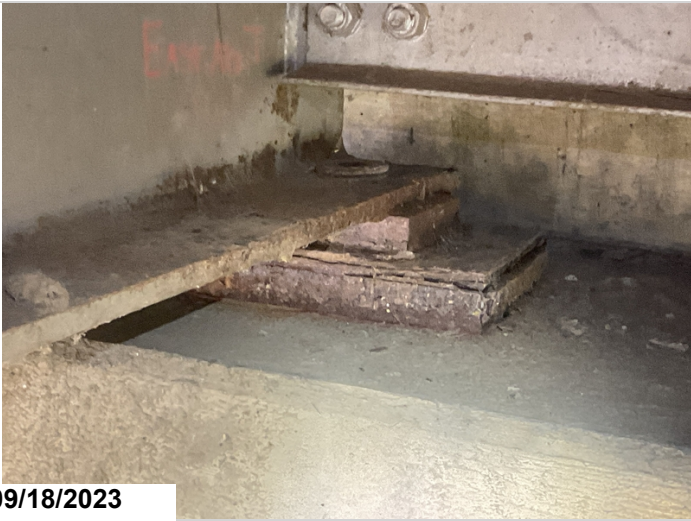
Abutment # 2, Beam # 5, has 1 fractured anchor bolt.

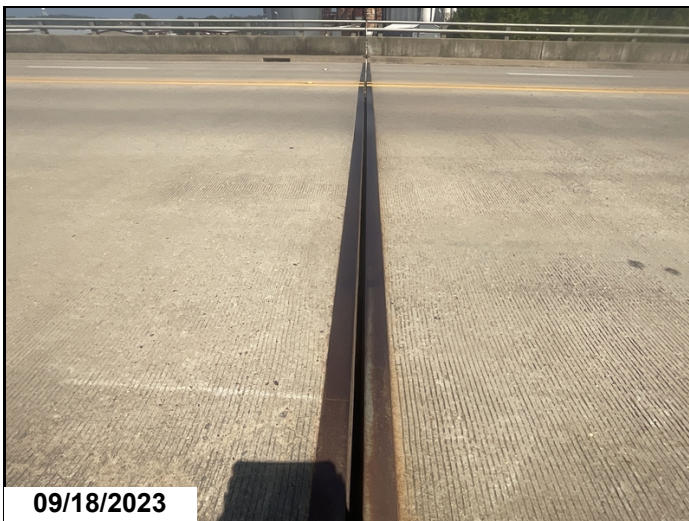
The compression joint seals at bents # 4 and 6 have fallen out of position and are laying on the caps below. The open joints are allowing water, dirt, and debris to leak onto the substructure causing corrosion to the bearings. The remaining joint seals are deteriorated and appear to leak water in numerous locations.

Bent # 6 expansion joint seal has fallen out of the assembly.

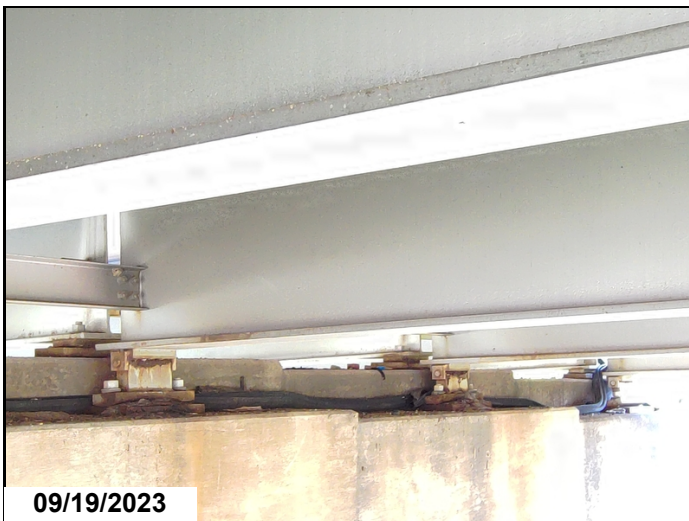
Bearings have a failing paint system with numerous areas of active corrosion, layers of flaking rust, and minor section loss between the sole plates and masonry plates.

Drone Photo-Corrosion to bearings.

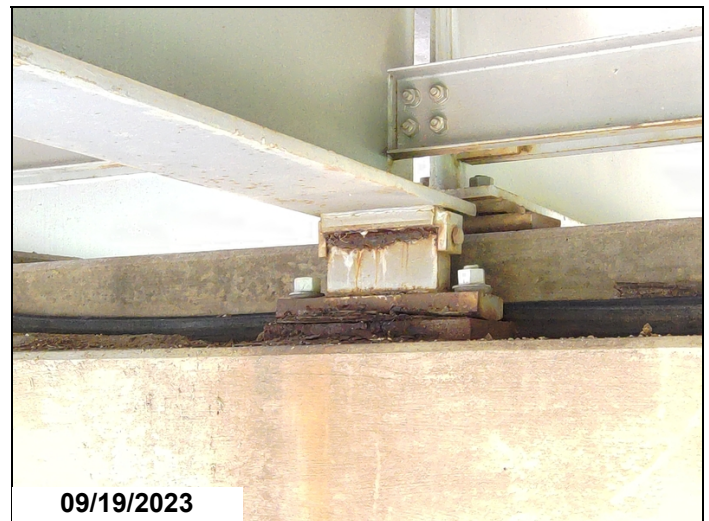
Drone Photo-Corrosion with pack rust between bearing plates.

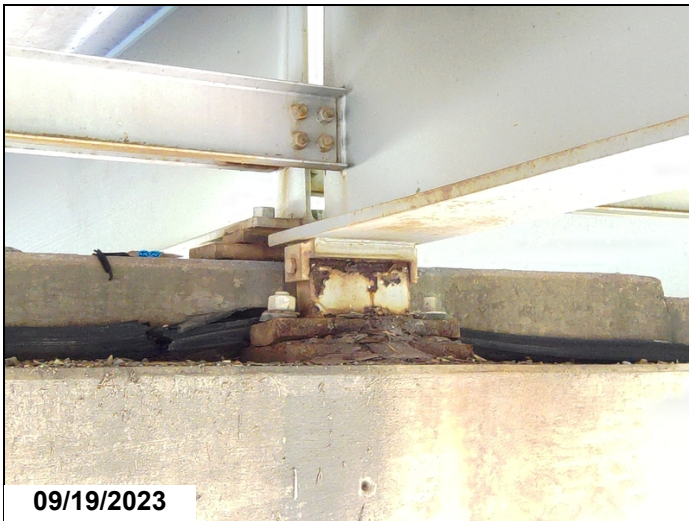
Drone Photo-Heavy corrosion to bearings.

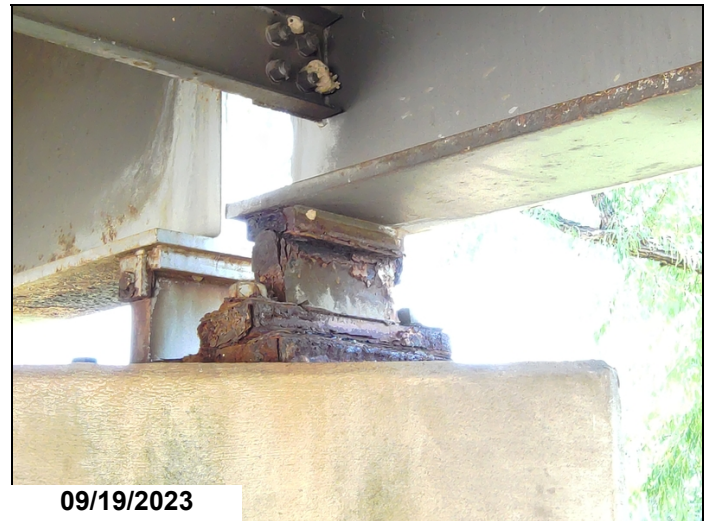
Drone Photo-Heavy corrosion to bearings.

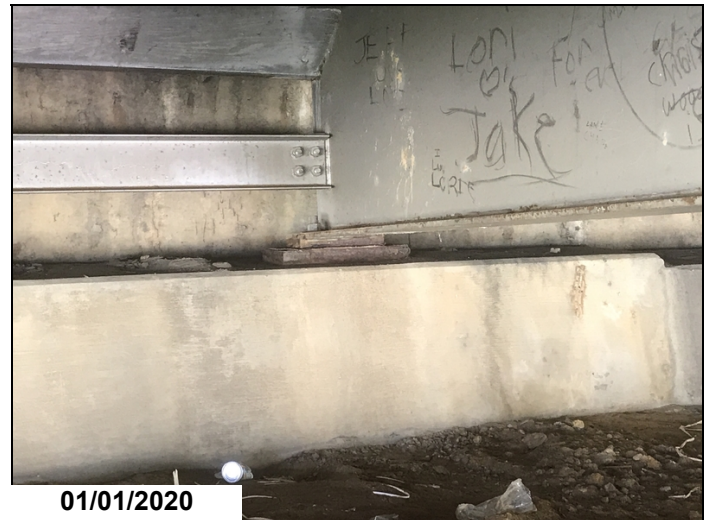
Bent # 9 bearings with active corrosion and layers of flaking rust on the bearings.

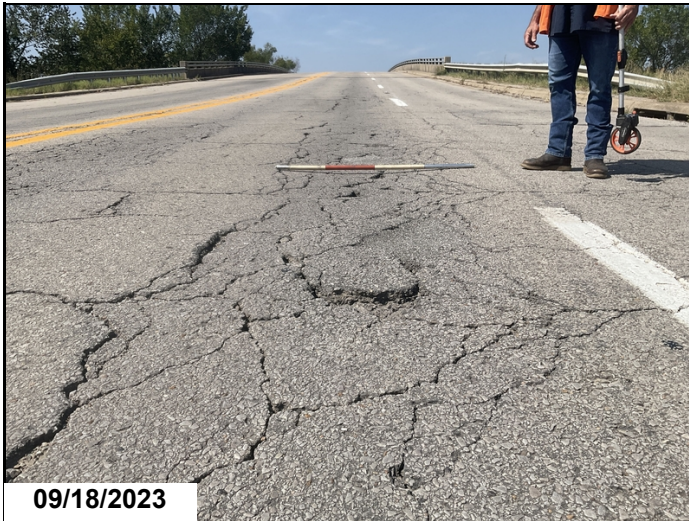
The asphalt at the approaches has settlement and is deteriorating with potholes forming in the driving surface. The East approach has heavy rutting in the wheel paths.

East approach roadway has rutting in the Eastbound lanes with potholes forming.

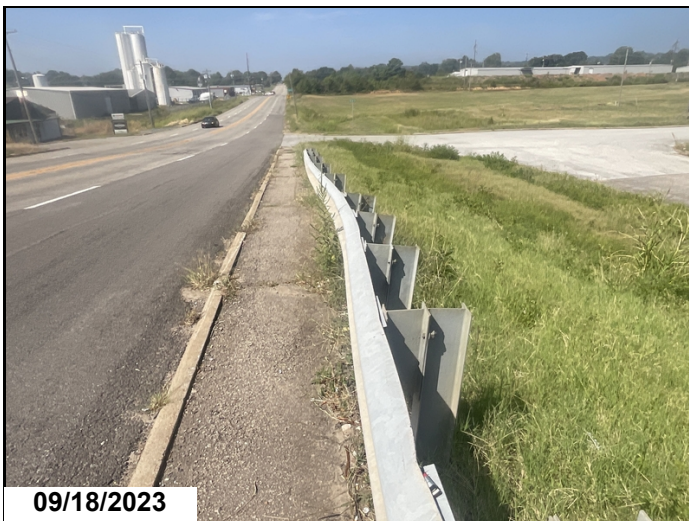
Abutment # 1 left approach railing-Collision damage.

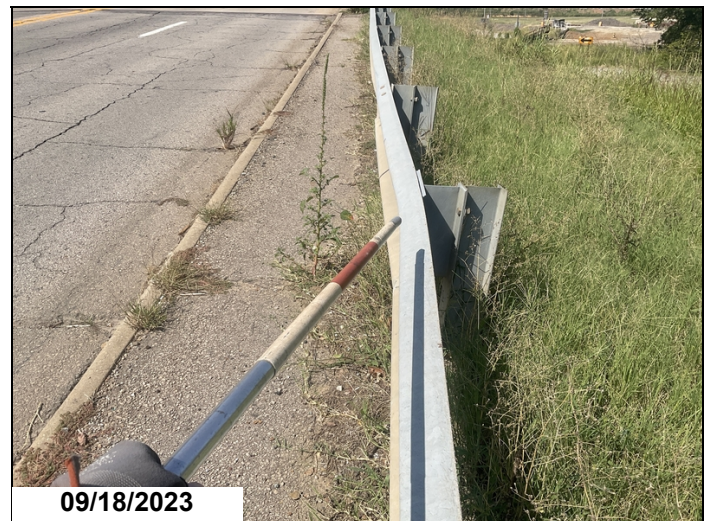
Abutment # 2 left approach railing-Collision damage.

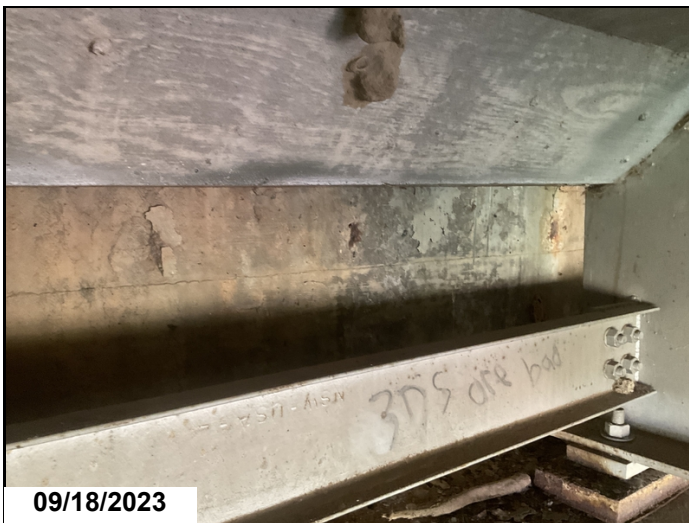
Abutment # 2, East abutment, has several delaminated areas and baseball sized spalls with exposed reinforcing steel.

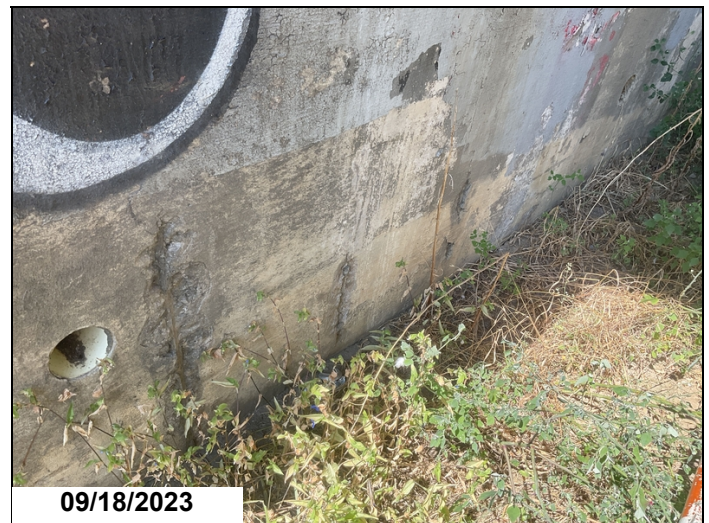
Abutment # 1 stem with 3 spalls that expose reinforcing steel in the base of the bent under bay # 6.

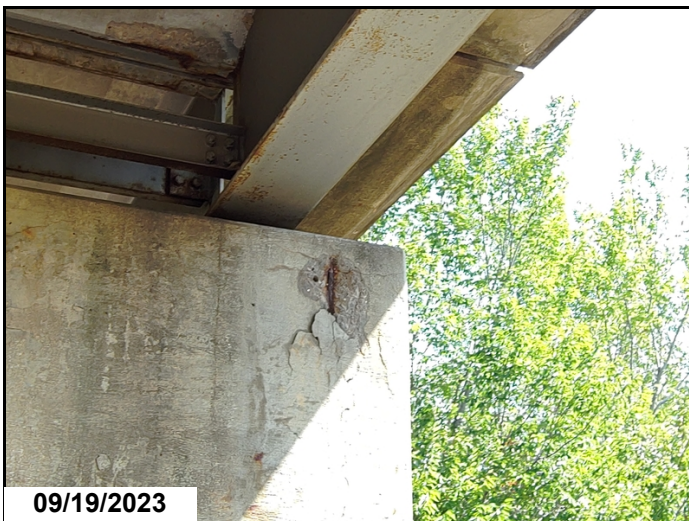
Drone Photo-Spall in bent cap with exposed reinforcing steel.

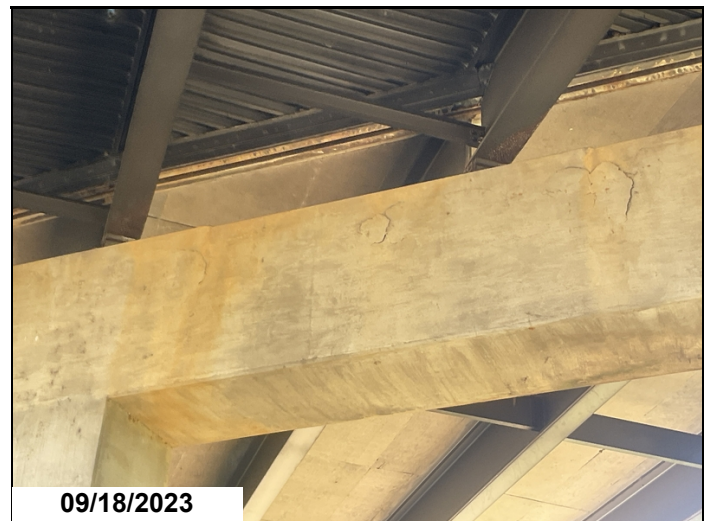
Bent # 5 cap has multiple delaminated areas on the span # 4 side between columns # 2 & 3.

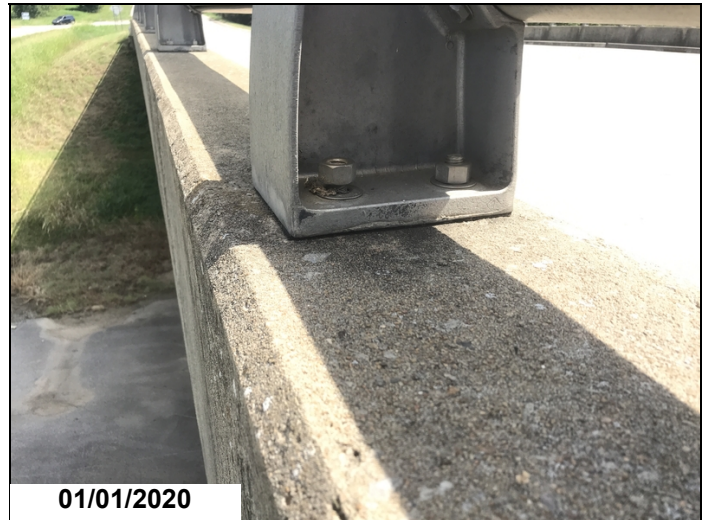
The metal bridge railing anchored to the top of concrete railing has numerous loose anchor bolt nuts in random locations.

Numerous loose anchor bolt nuts on the bridge rail.

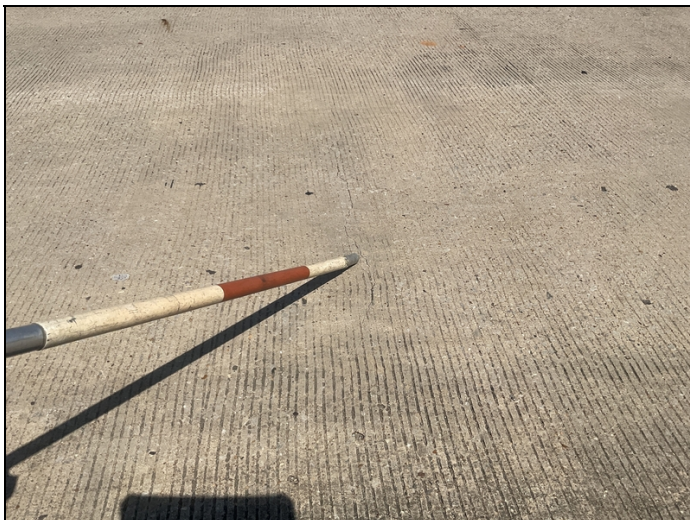
Transverse deck cracking

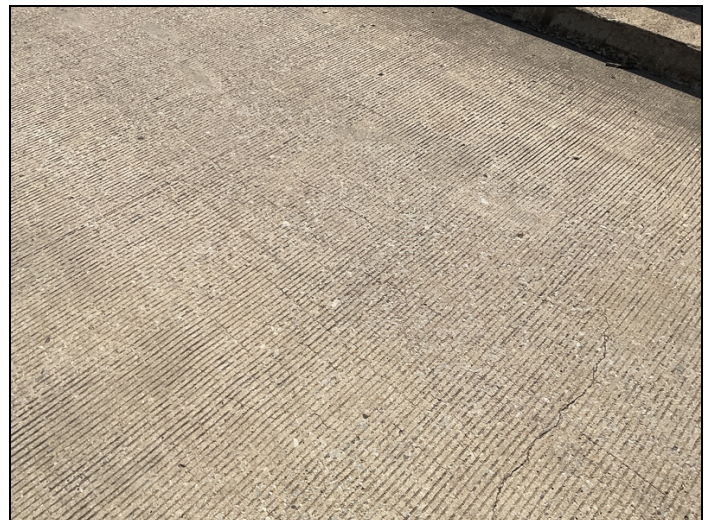
Span 5, right outside lane-Mapcracking in wheel path

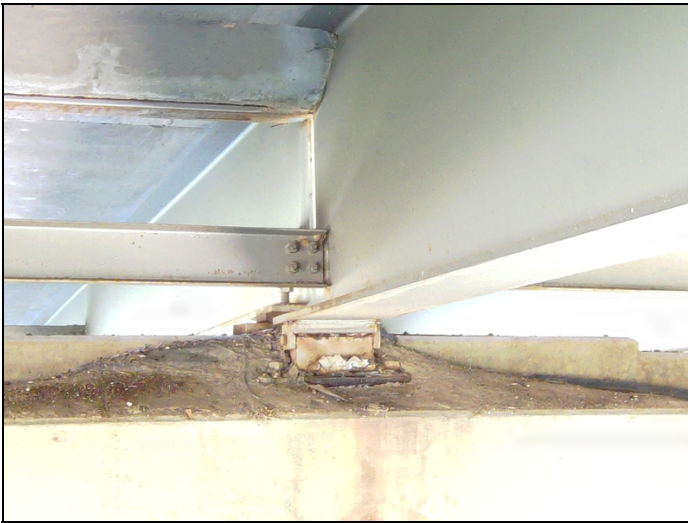
Drone Photo-Heavy dirt and debris accumulation on bent cap

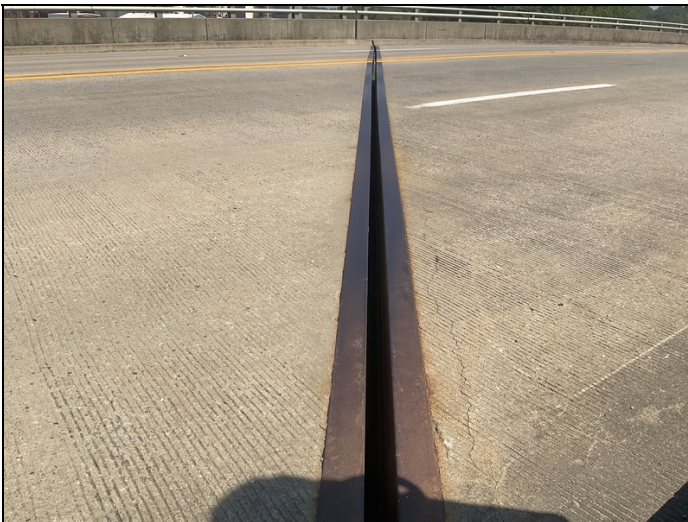
Bent # 4 expansion joint seal has fallen out of the assembly.

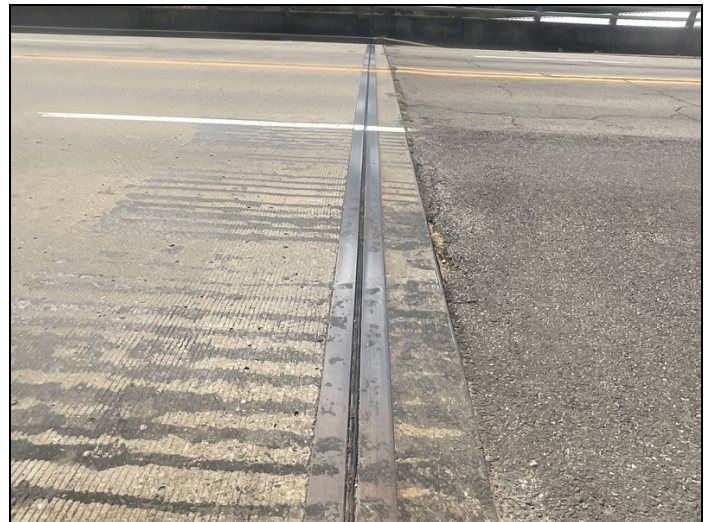
Abutment # 1 expansion joint seal deteriorated.

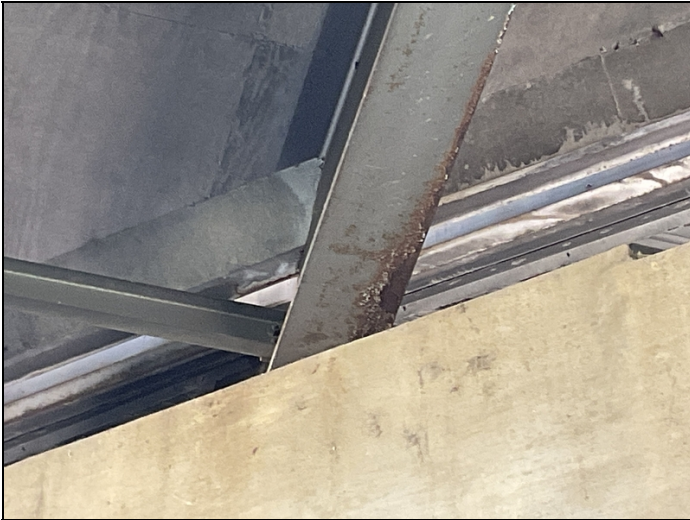
Bent # 4 beam # 4 corrosion

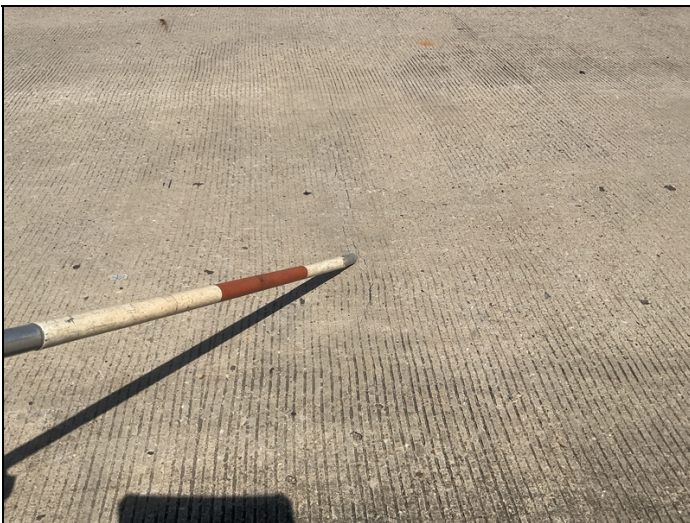
09/18/2023 - RSM & SPC: The driving surface of the deck has sealable cracking throughout. This structure appears to be a good candidate for a polymer wearing surface based on the condition of the deck at time of inspection.

Transverse deck cracking
