Route:162 Section:01 Log:0.95

**Asset #03960**(Routine, Underwater type 2)  
**State Highway 162 over Flat RockCk-Crawford Co.**  
**Location: 0.95 MI E JCT US 64 & 162**  
**Team Lead: Bob McEntyre Inspection Date: 09/18/2023**

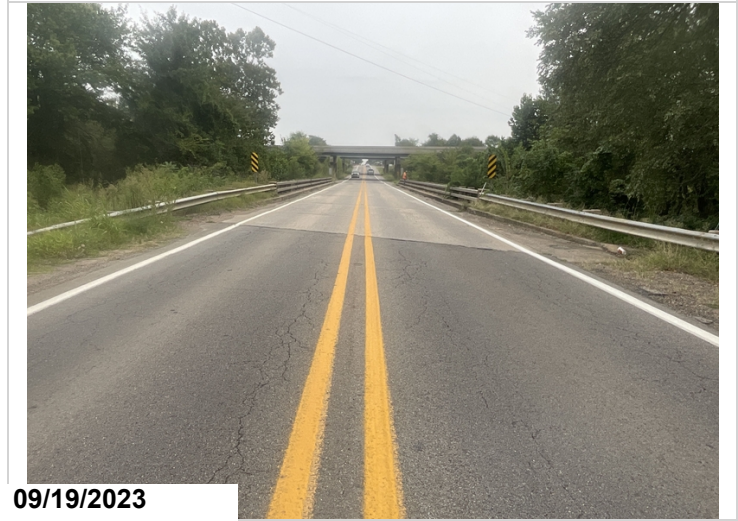
Inventory 1 looking East

Misalignment of spans

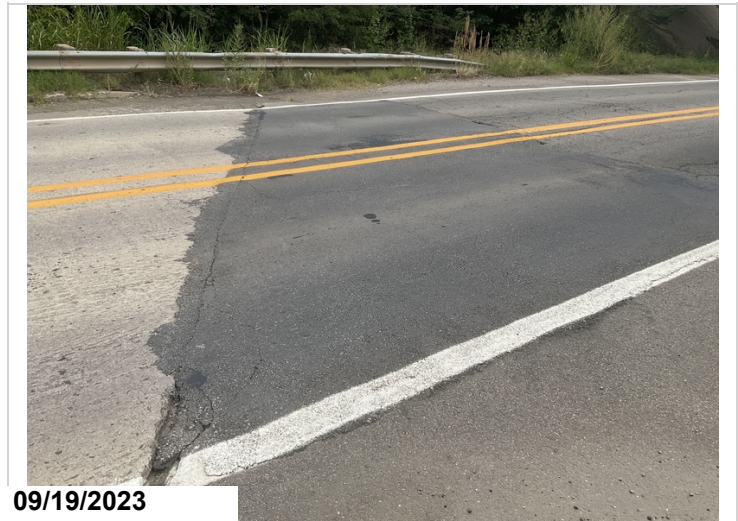
Repairs to East approach roadway

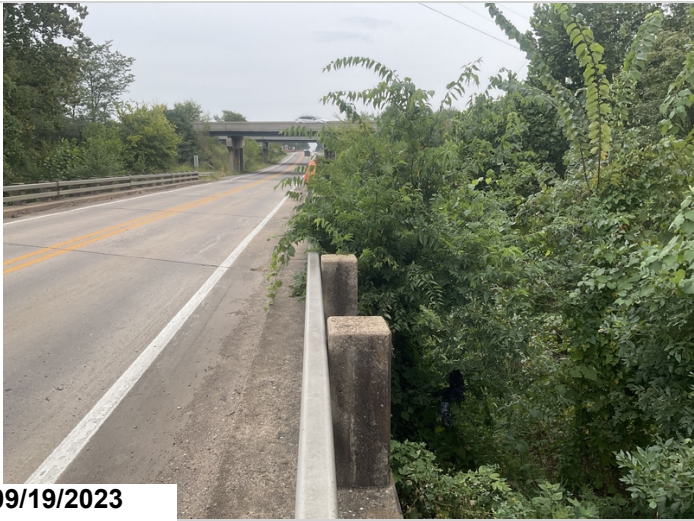
Vegetation growing over right bridge railing.

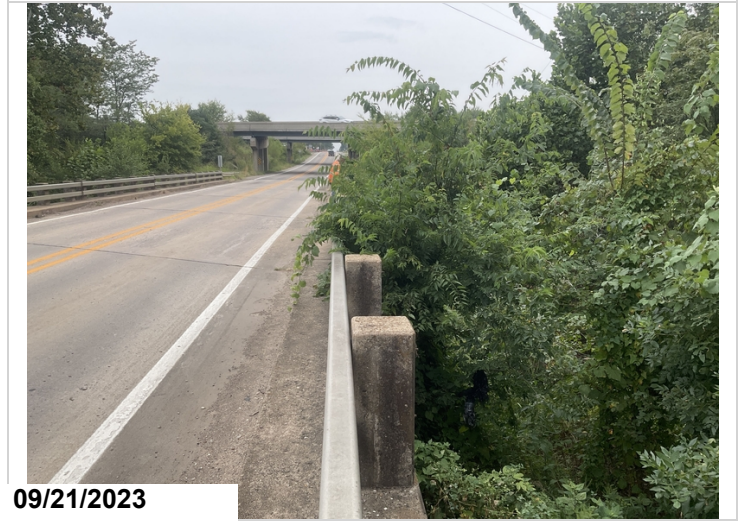
Vegetation growing over right bridge railing

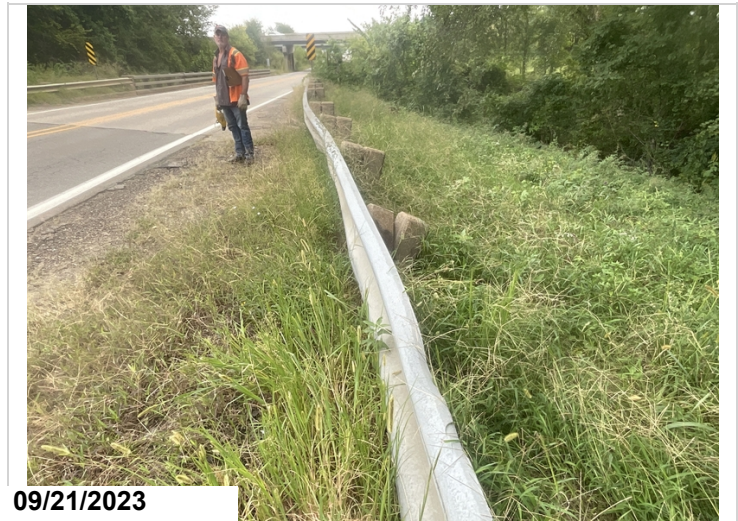
Abutment 1 right approach railing-Collision damage

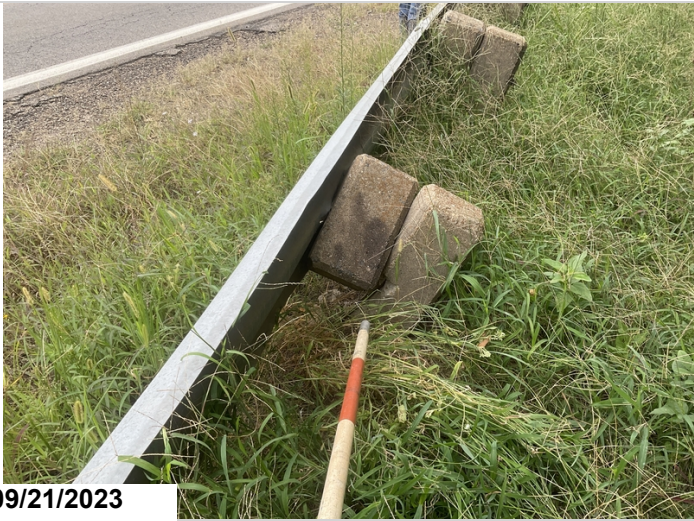
Abutment 1 right approach railing-Collision damage

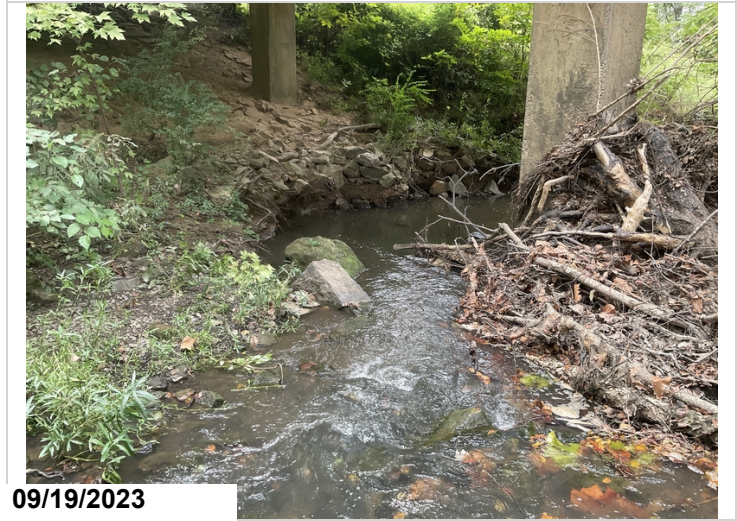
Heavy drift accumulation causing embankment erosion to East embankment.

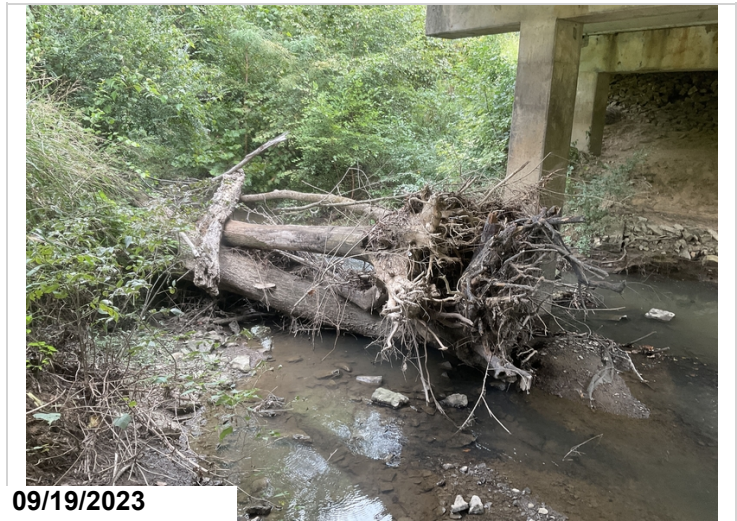
Channel has heavy drift accumulation/ large trees at bent #  
2.

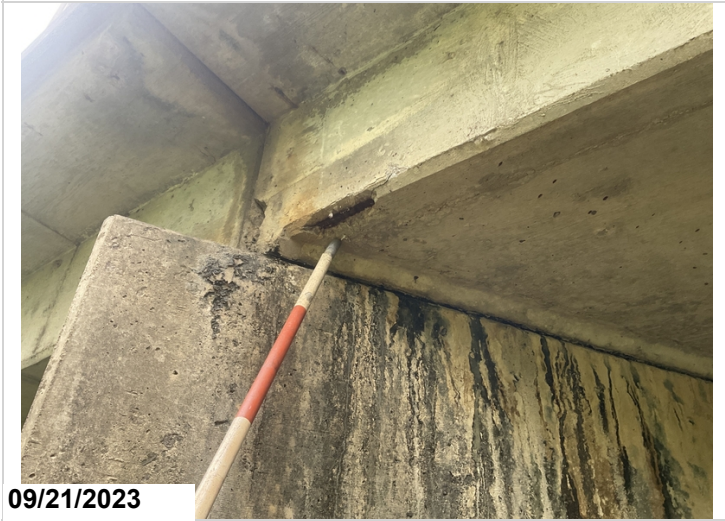
Span # 1 left exterior side adjacent to bent # 2 has an 8" spall with exposed reinforcing steel in bottom edge.

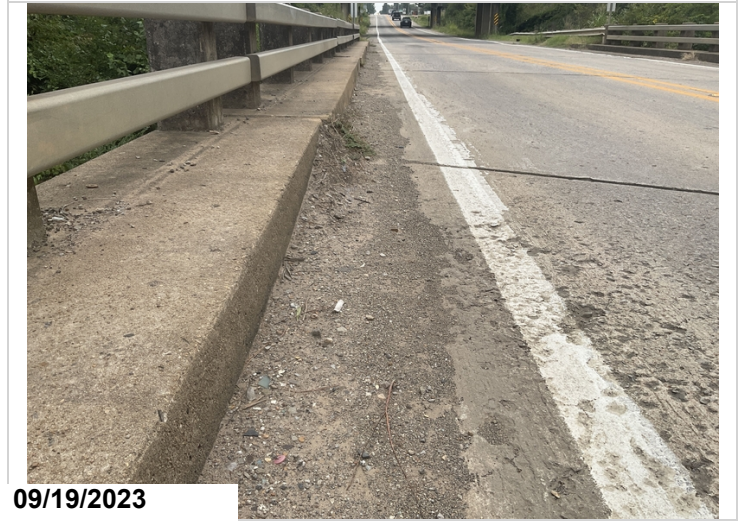
Heavy dirt and debris in gutters

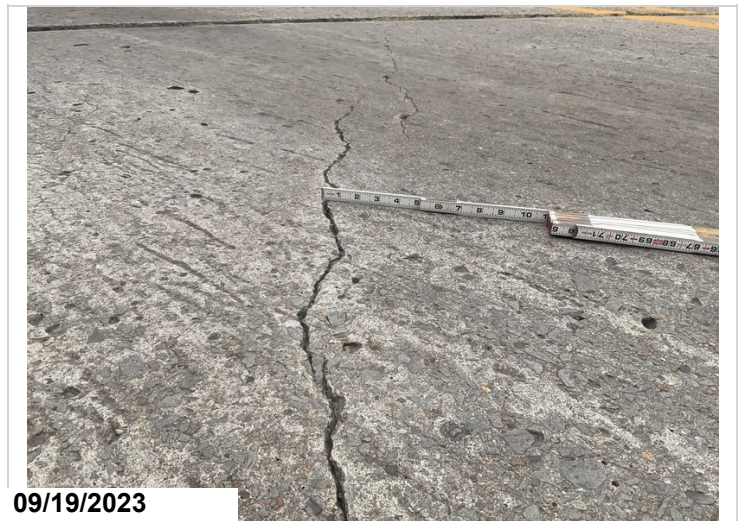
Span # 5, left lane at abutment # 2 has wide diagonal cracking.

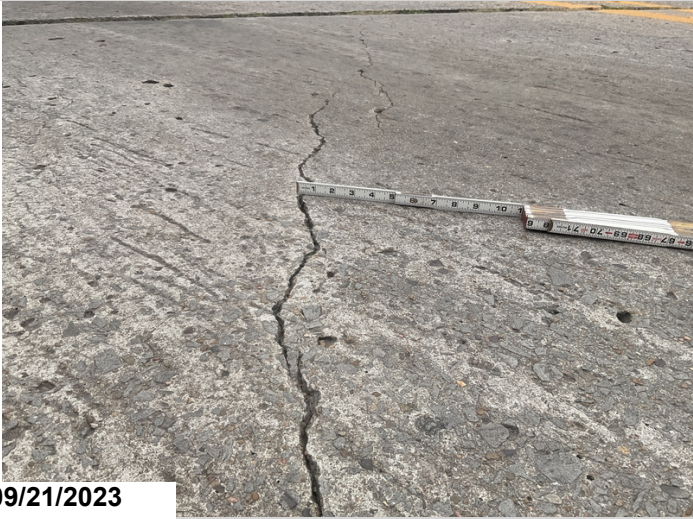
Span # 5, left lane at abutment # 2 has wide diagonal cracking.

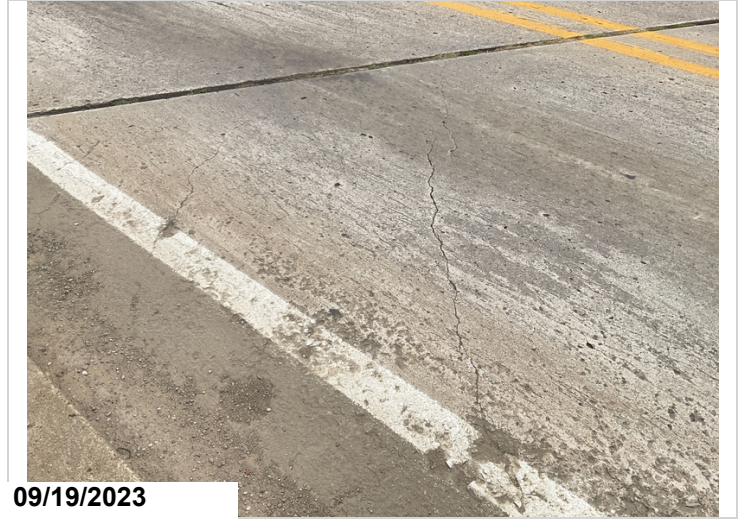
Span # 5, left lane at abutment # 2 has wide diagonal cracking.

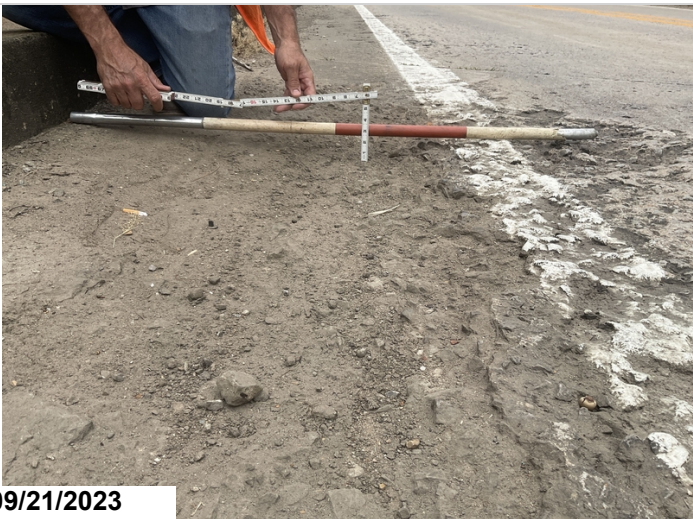
Span # 5, right shoulder has heavy scaling up to approximately 2" deep

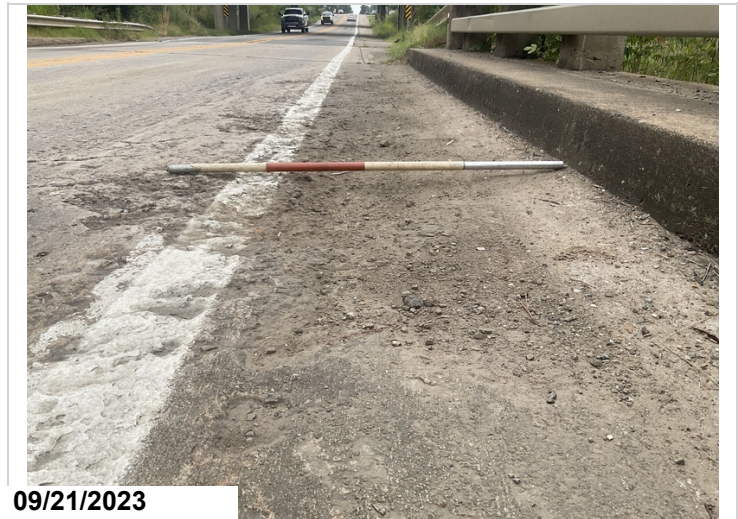
Span # 5, right shoulder has heavy scaling up to approximately 2" deep

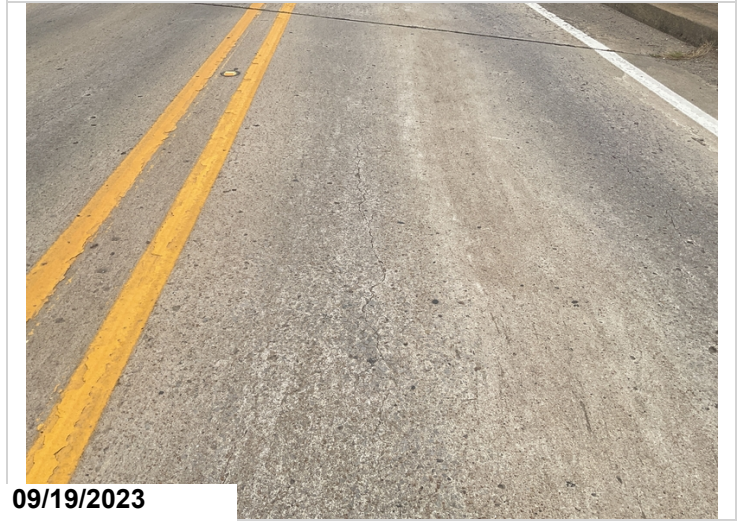
Span # 3 driving surface of right lane has diagonal cracks adjacent to bent # 3 and a longitudinal crack near the centerline.

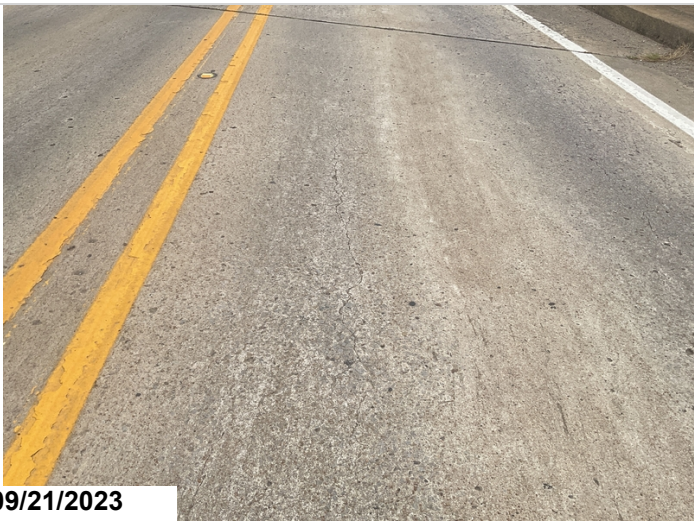
Span # 3 driving surface of right lane has diagonal cracks adjacent to bent # 3 and a longitudinal crack near the centerline.

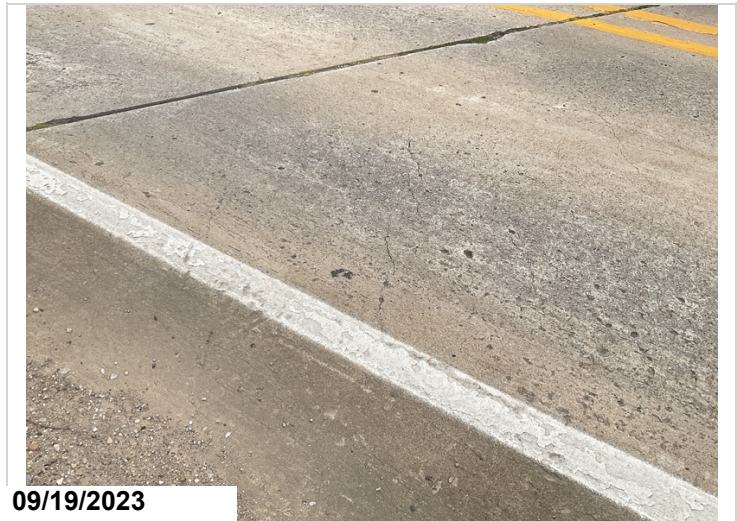
Span 3, right lane-diagonal cracks adjacent to bent 3

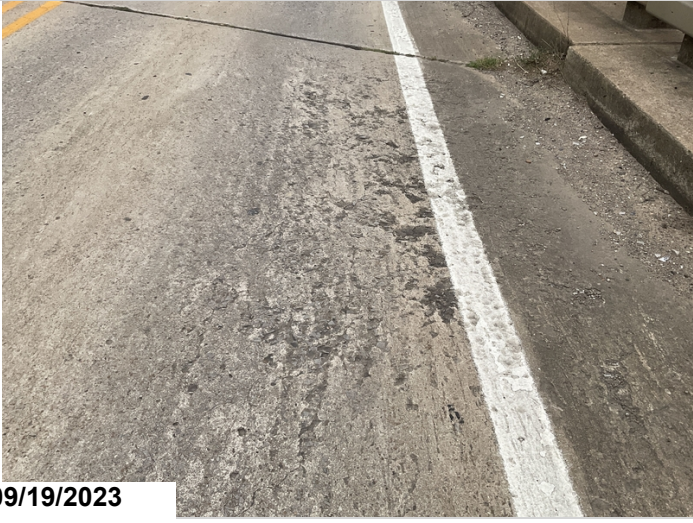
Span 2, right lane-Medium scaling

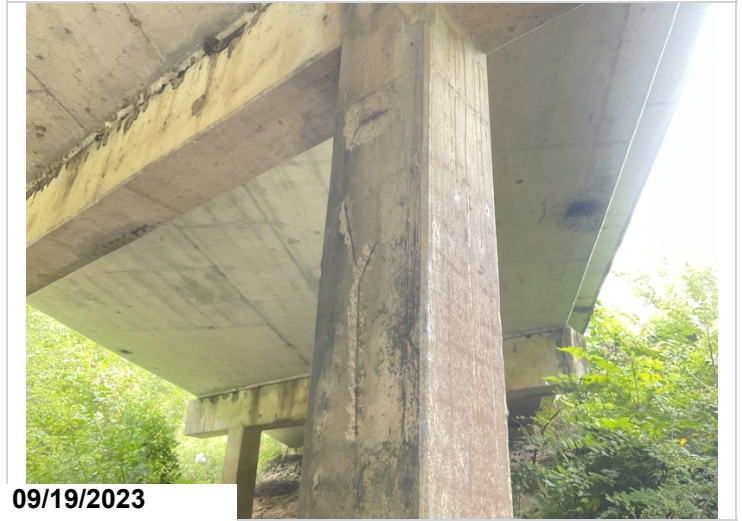
Bent # 4, column # 2-Spalling with exposed reinforcing steel

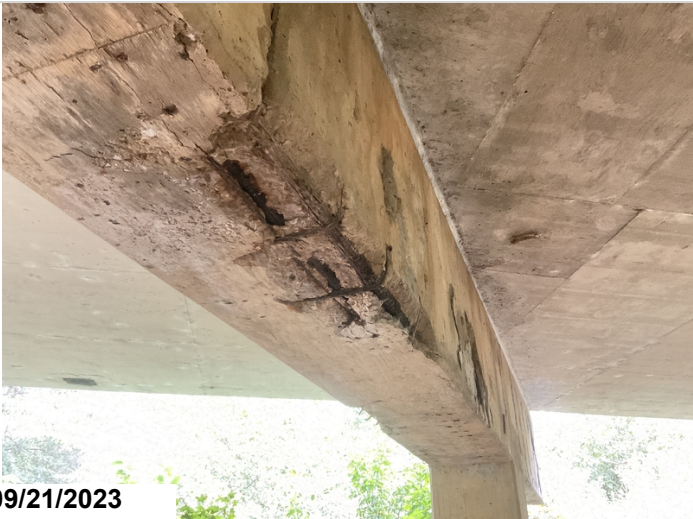
Bent # 5 cap aheadface has numerous The spalls with exposed reinforcing steel and delaminated areas. The cap undersurface near centerline has a spalled area approximately 4' long x 12" wide that exposes several stirrups and two of the primary reinforcing bars. Exposed primary bars have heavy corrosion with thick flaking rust and an estimated 1/8" section loss.

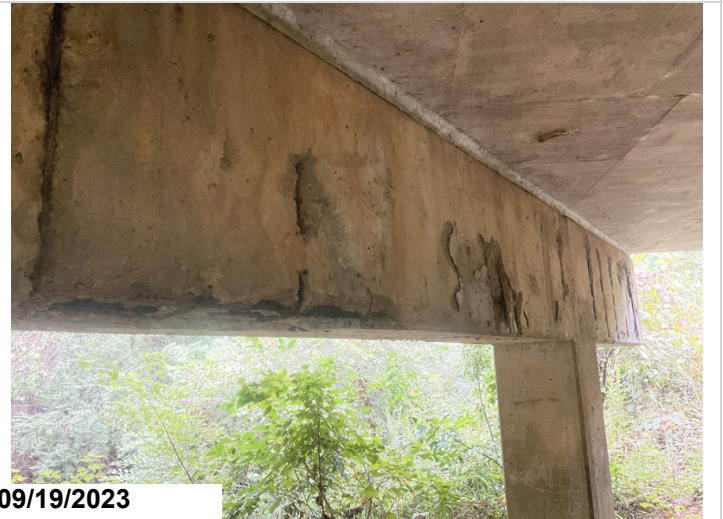
Bent 5 cap aheadface-Numerous spalls with exposed reinforcing steel

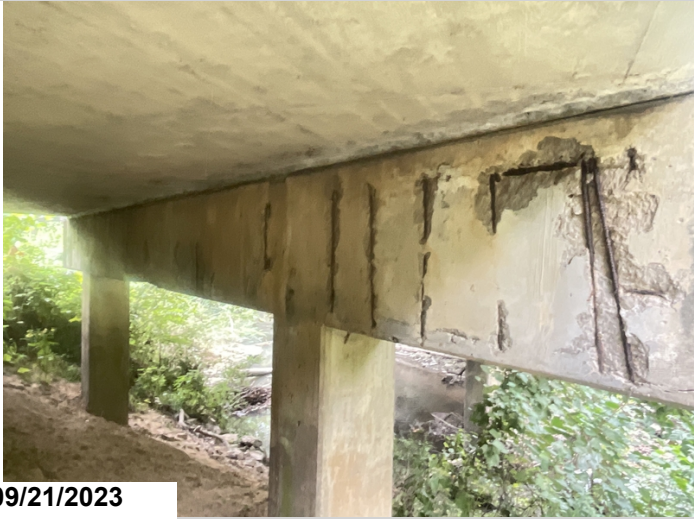
Bent 5 cap aheadface-Numerous spalls with exposed reinforcing steel

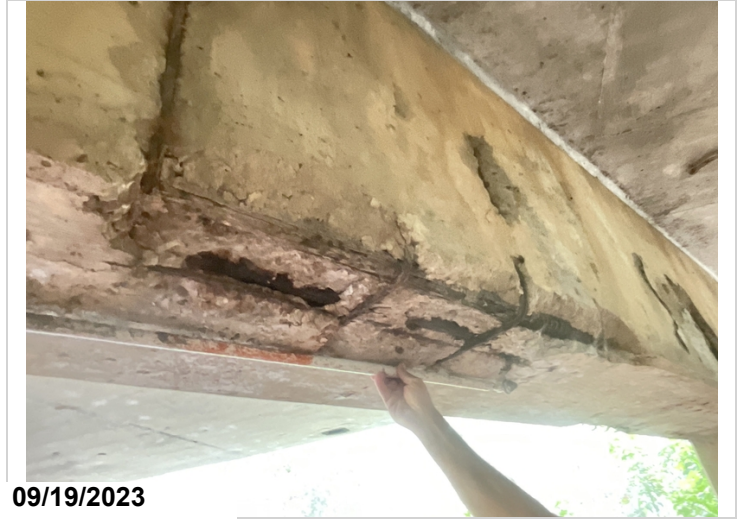
Bent # 5 cap aheadface has numerous The spalls with exposed reinforcing steel and delaminated areas. The cap undersurface near centerline has a spalled area approximately 4' long x 12" wide that exposes several stirrups and two of the primary reinforcing bars. Exposed primary bars have heavy corrosion with thick flaking rust and an estimated 1/8" section loss.

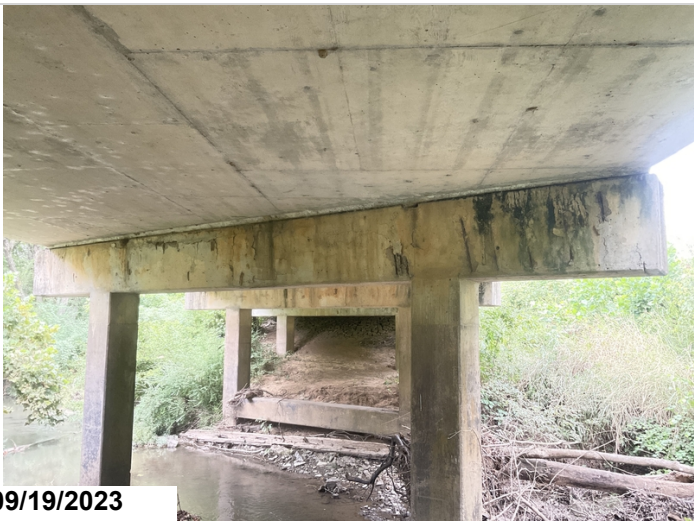
Bent # 4 cap aheadface has numerous spalls with exposed reinforcing steel and delaminated areas.

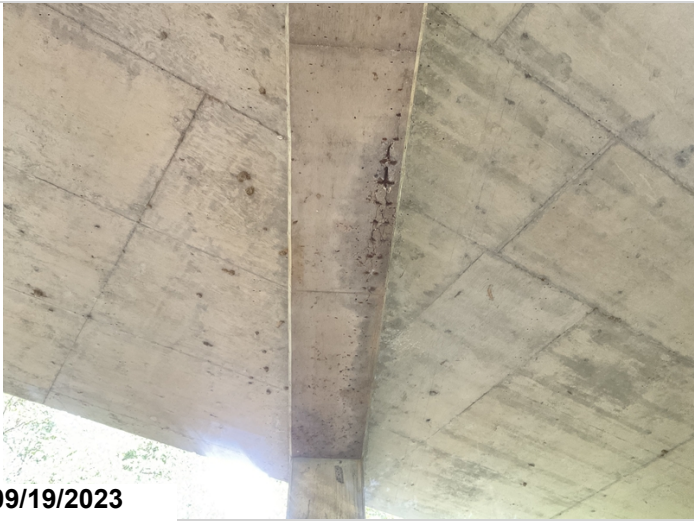
Bent 4 cap undersurface-Spalling/ delaminated areas with exposed reinforcing steel

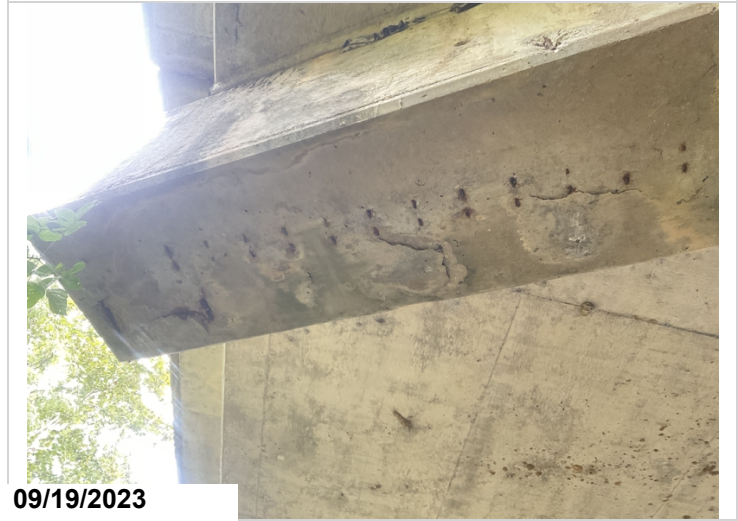
Bent # 3 cap left undersurface-Shallow spalls with exposed reinforcing steel

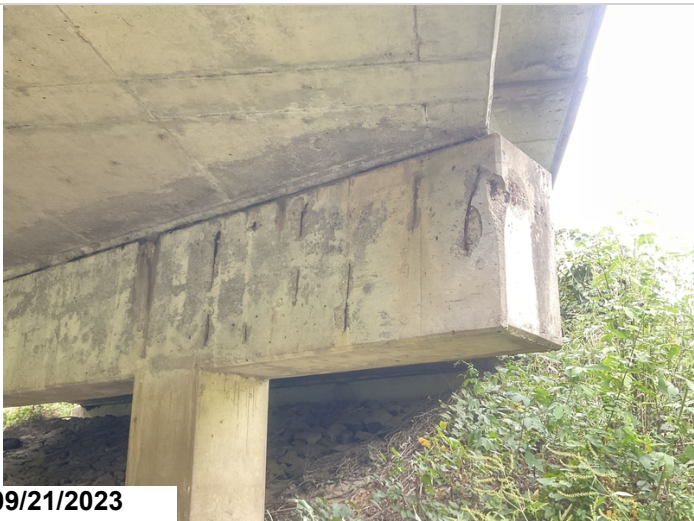
Bent # 2 cap aheadface on left side has numerous shallow spalls with exposed reinforcing steel.

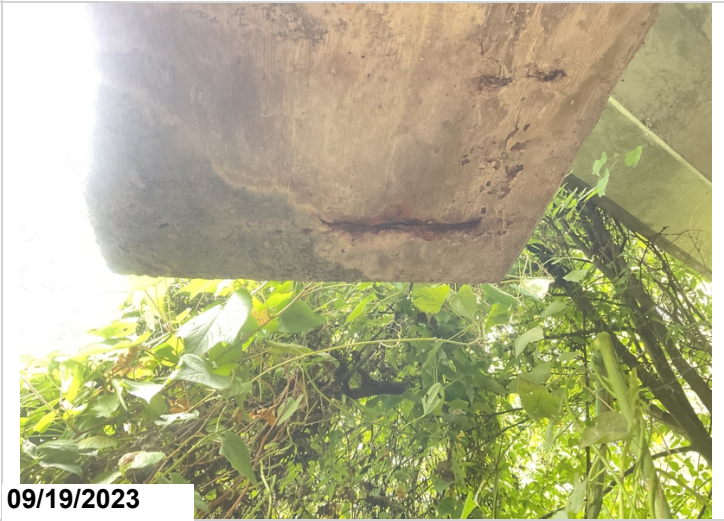
Bent 2 cap undersurface on right side-Spall with exposed reinforcing steel

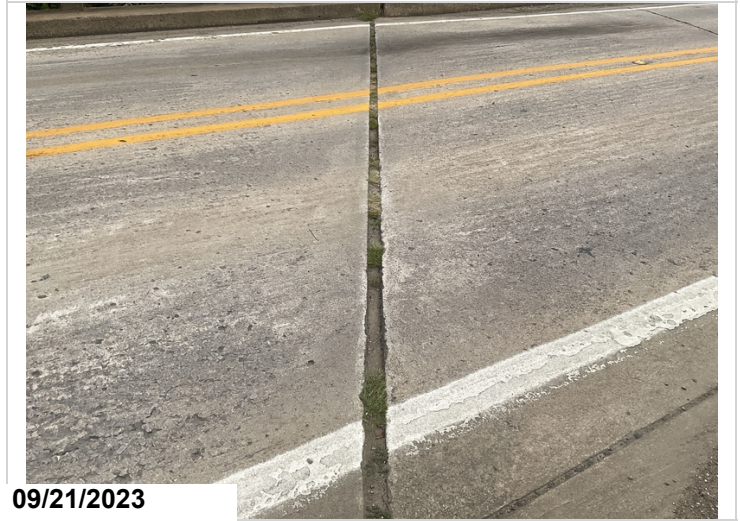
Abutment 2 expansion joint-Debris impaction

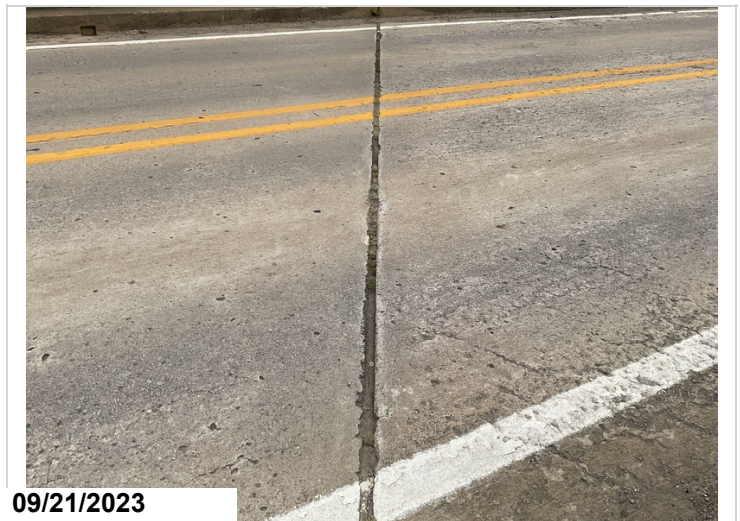
09/19/2023 - RSM & SPC: Slab expansion joint sealant is deteriorated/ missing with incompressible material in the joints.

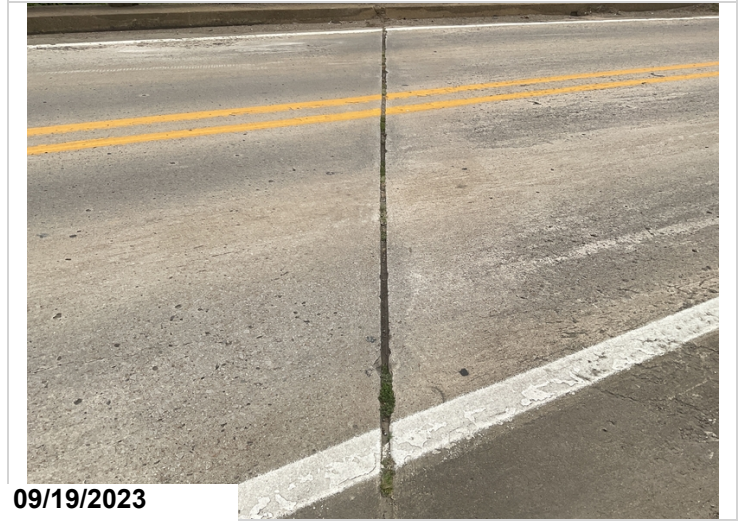
Bent 2 expansion joint-Debris impaction

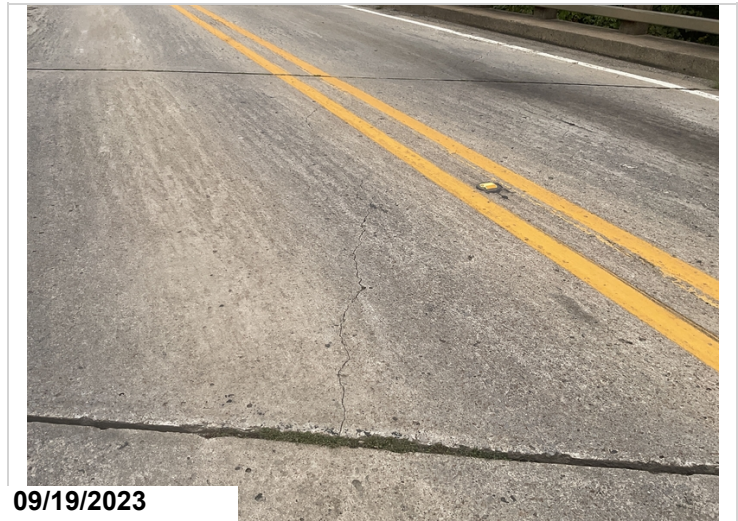
Abutment 2 approach slab-Longitudinal cracking.

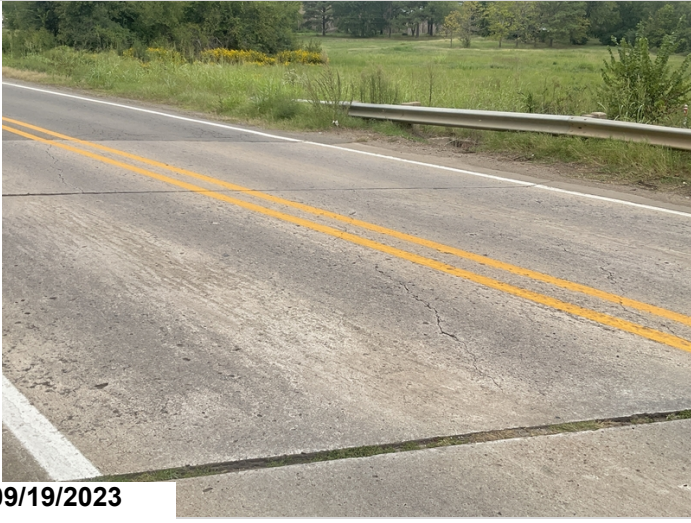
Abutment 1 approach slab-Wide longitudinal cracking

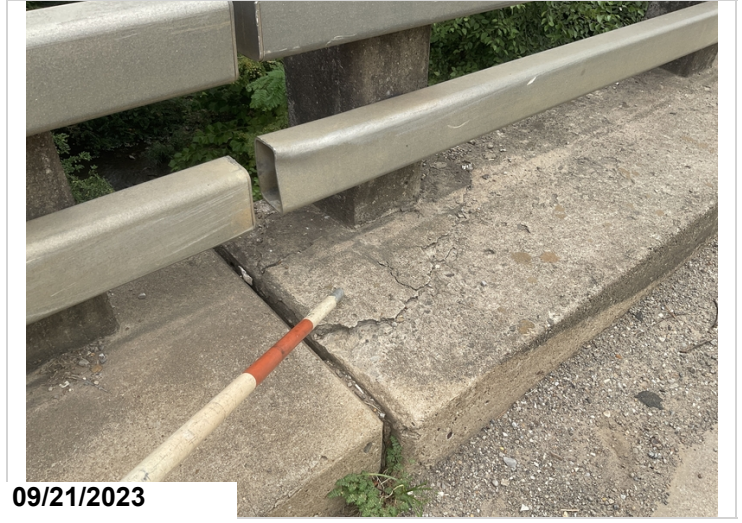
Span 4, post 1-Collision damage

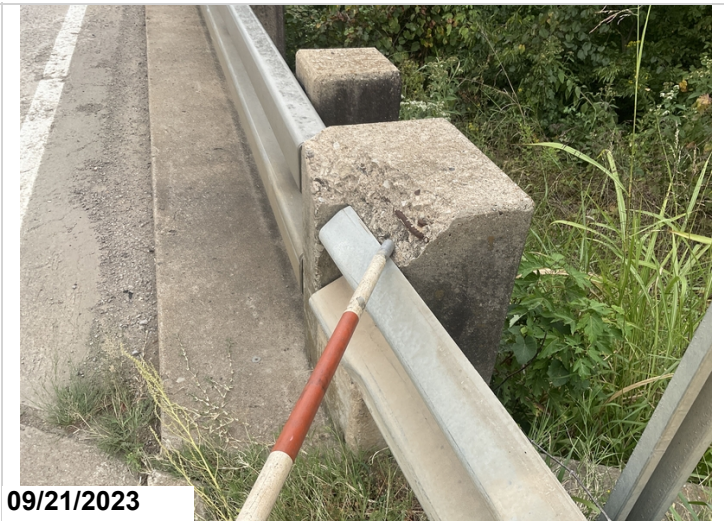
Abutment 2, left end post-Collision damage

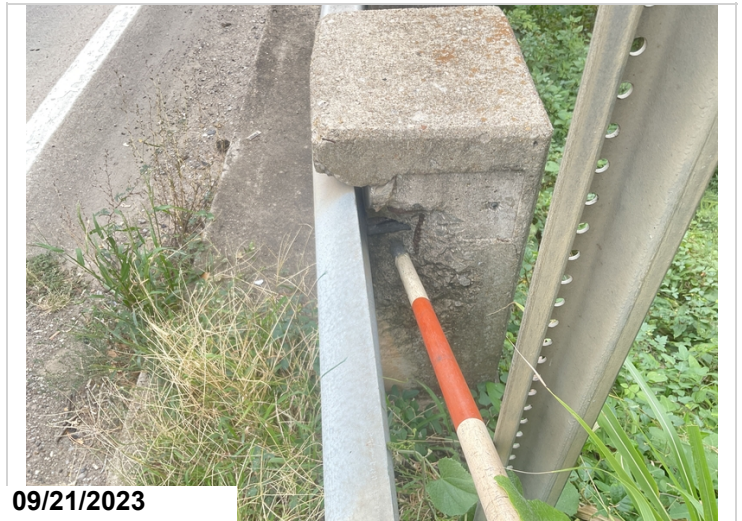
Abutment 1 right end post-Collision damage

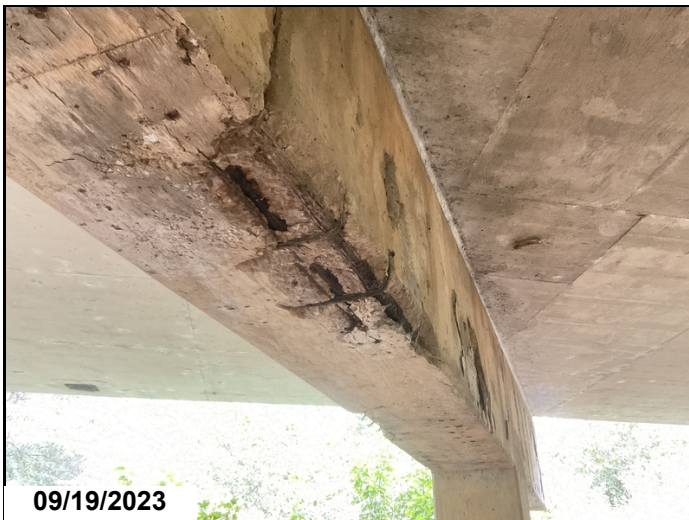
Bent # 5 cap aheadface has numerous The spalls with exposed reinforcing steel and delaminated areas. The cap undersurface near centerline has a spalled area approximately 4' long x 12" wide that exposes several stirrups and two of the primary reinforcing bars. Exposed primary bars have heavy corrosion with thick flaking rust and an estimated 1/8" section loss.

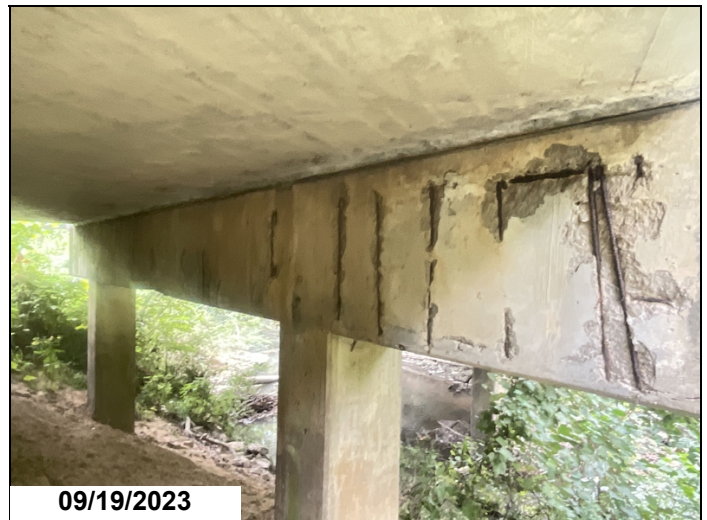
Bent # 5 cap aheadface-Numerous spalls with exposed reinforcing steel.

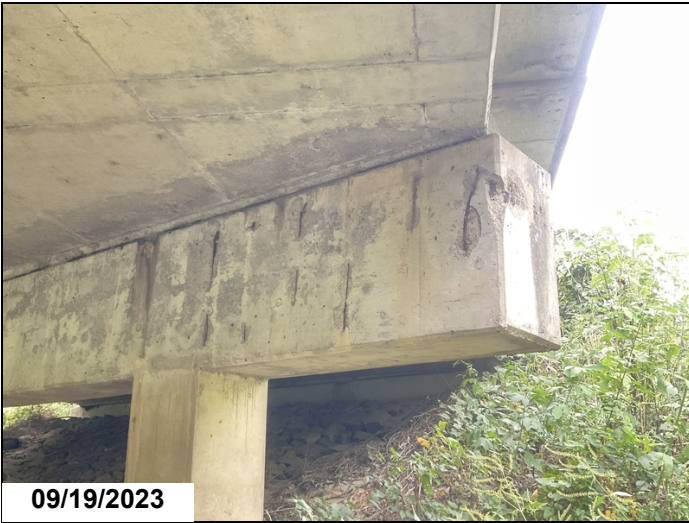
Bent # 2 cap aheadface on left side has numerous shallow spalls with exposed reinforcing steel.

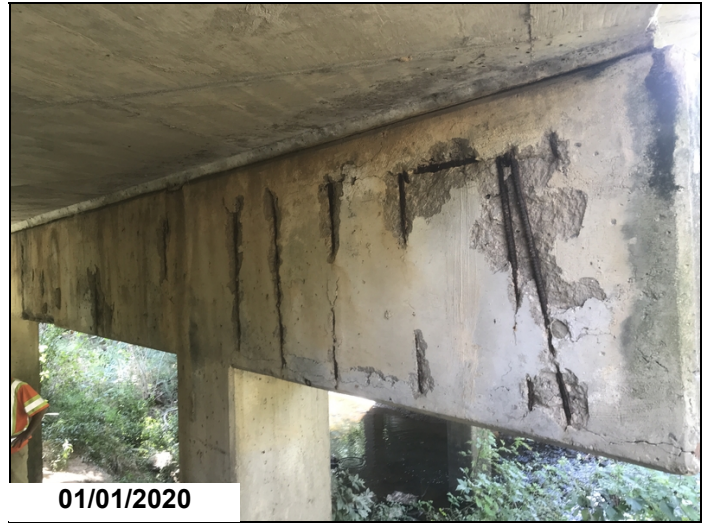
Bent # 5 Span # 5 shallow spalling with exposed reinforcing steel with approximately 25% section loss to the secondary reinforcing steel and approximately 10% to the primary reinforcing steel.

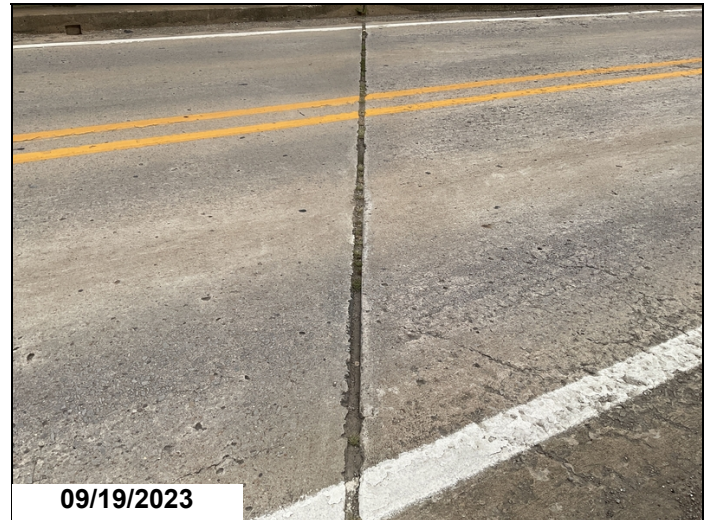
09/19/2023  
Deck joint sealant is deteriorated with the joints compacted with incompressible materials.

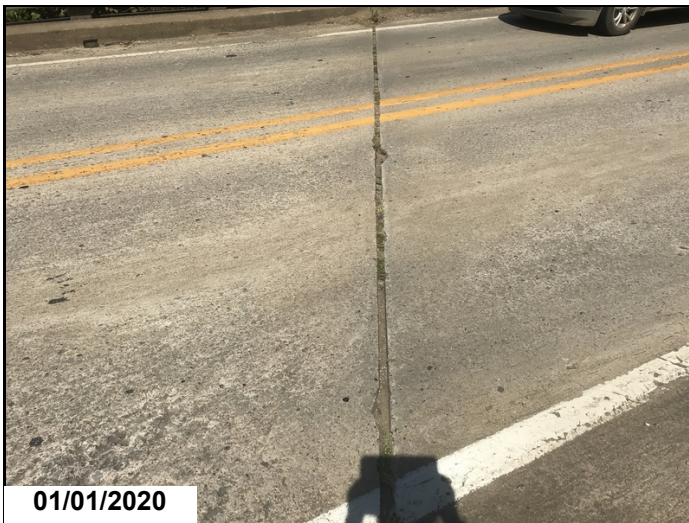
01/01/2020  
Deck joint sealant is deteriorated with the joints compacted with incompressible materials.

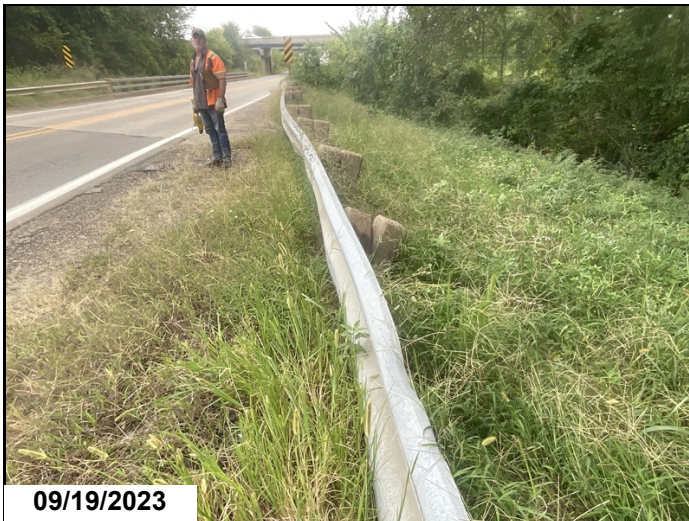
Abutment # 1 right approach railing-Collision damage.

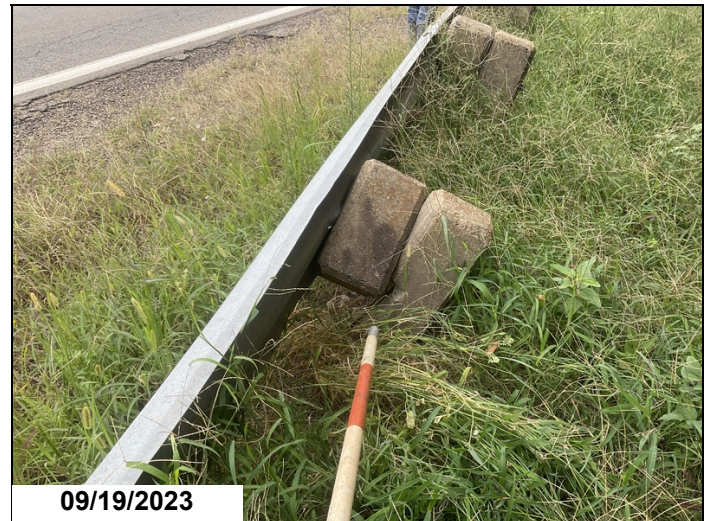
Abutment # 1 right approach railing-Collision damage.

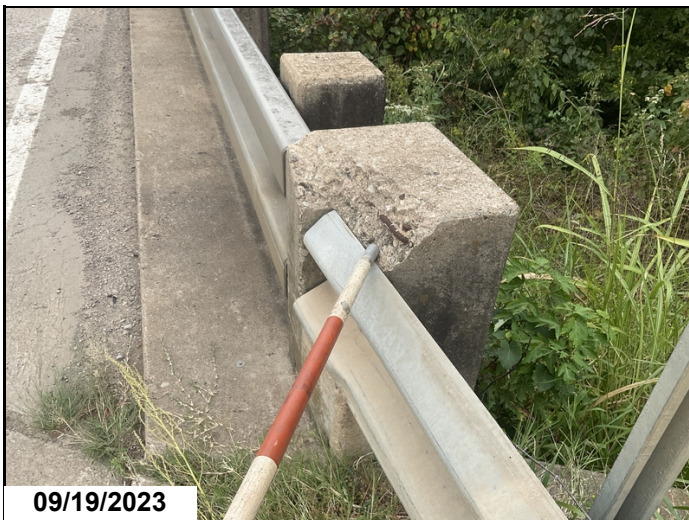
Abutment # 2, left end post-Collision damage.

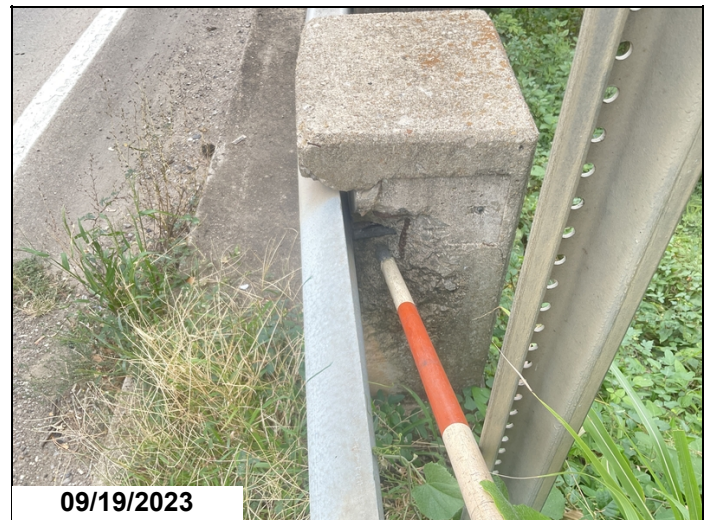
Abutment # 1 right end post-Collision damage.

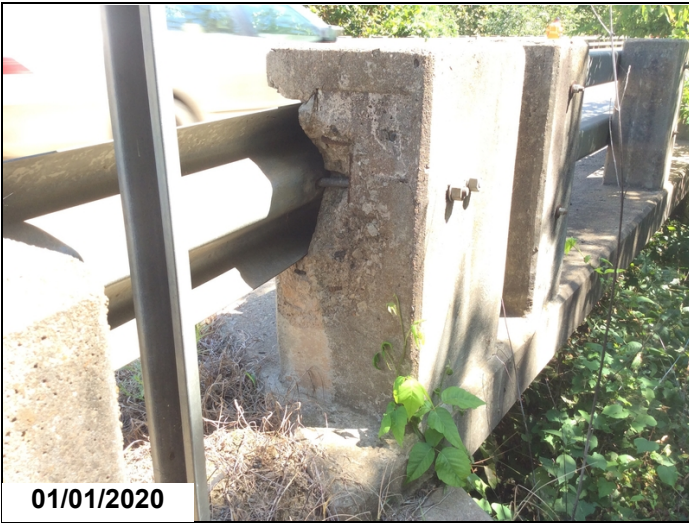
Abutment # 1 right end post-Collision damage.

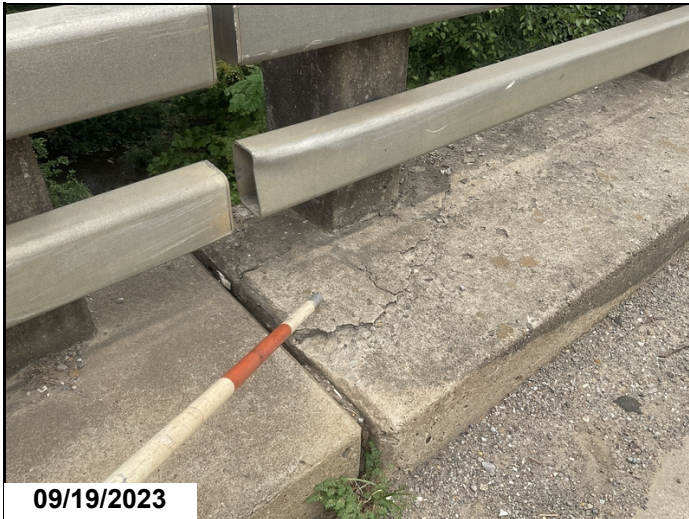
The left bridge railing has collision damage that has fractured the curb/ deck overhang that the supports post # 1 of span # 4.

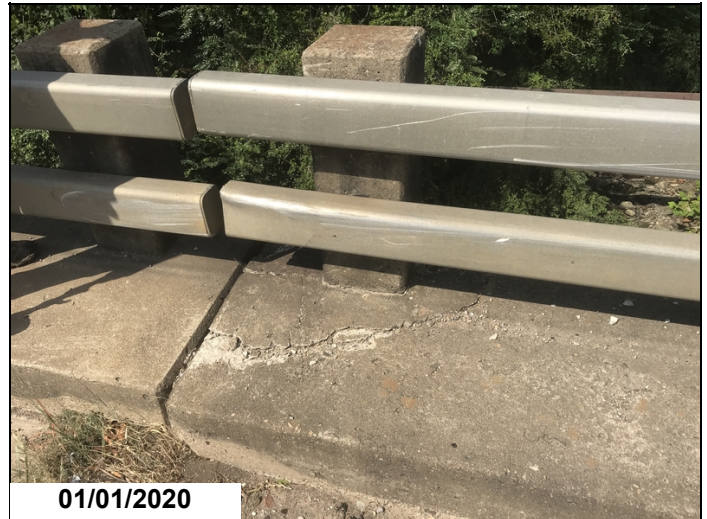
The left bridge railing has collision damage that has fractured the curb/ deck overhang that the supports post # 1 of span # 4.

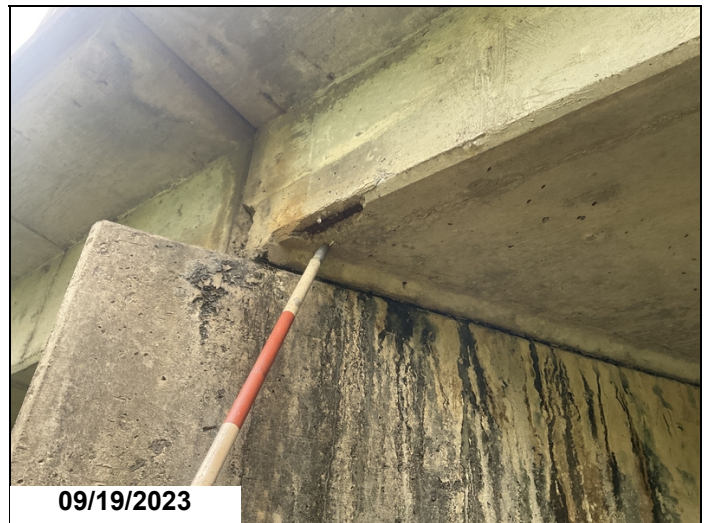
Span # 1 left exterior side adjacent to bent # 2 has an 8" spall with exposed reinforcing steel in bottom edge.

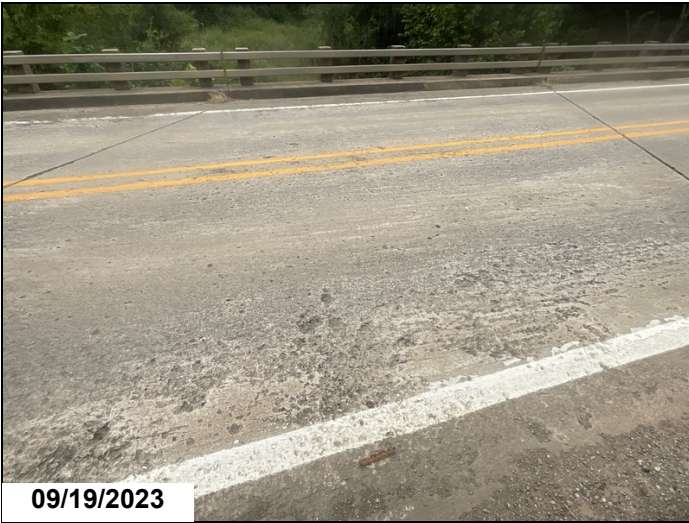
Span #4 driving surface-Scaling.

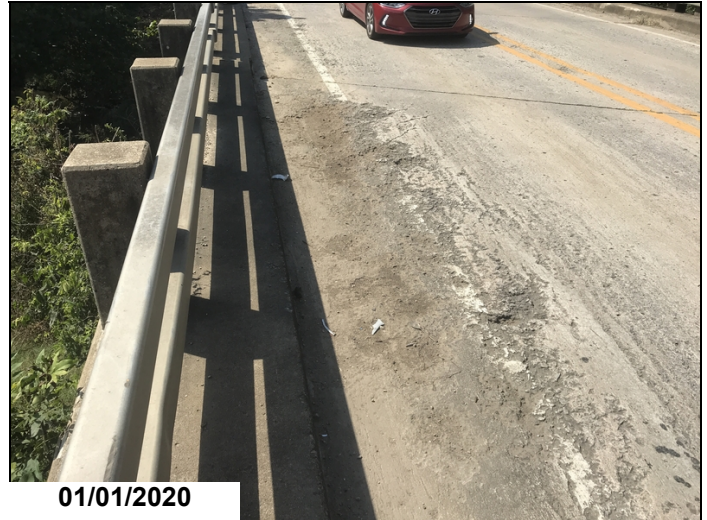
Span # 4 & 5 left concrete deterioration with section loss.

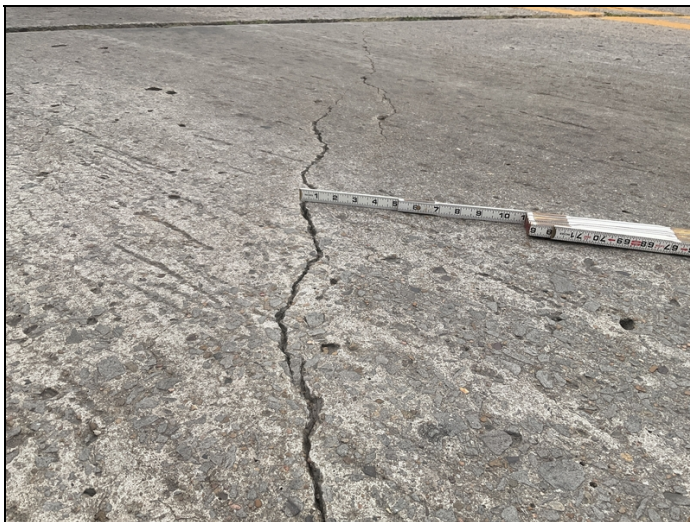
Span # 5, left lane at abutment # 2 has wide diagonal cracking.

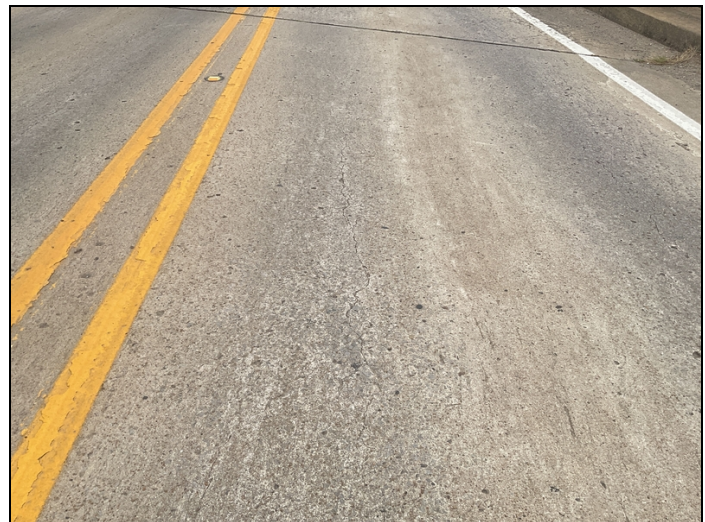
Span # 3 driving surface of right lane has diagonal cracks adjacent to bent # 3 and a longitudinal crack near the centerline.

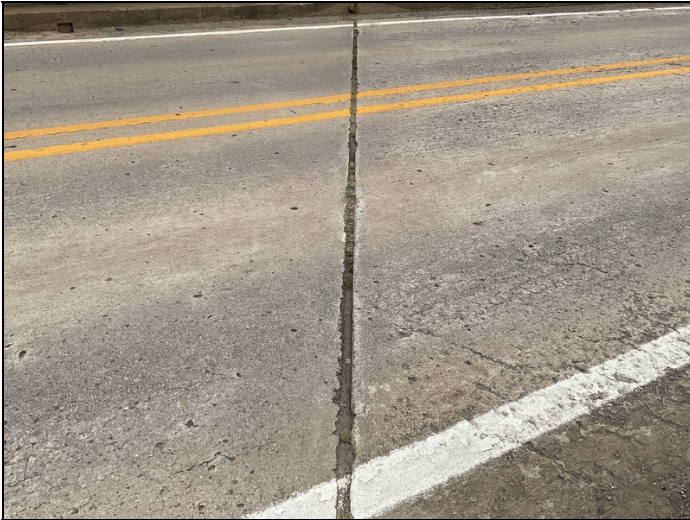
09/19/2023 - RSM & SPC: Slab expansion joint sealant is deteriorated/ missing with incompressible material in the joints.
