Asset #05122(Routine, Underwater type 2)

Sh-191/Sec-1/L0.99 over Creek

Location: 0.99 Mile North Jct Sh 70

Team Lead: Drew Melton Inspection Date: 01/08/2024

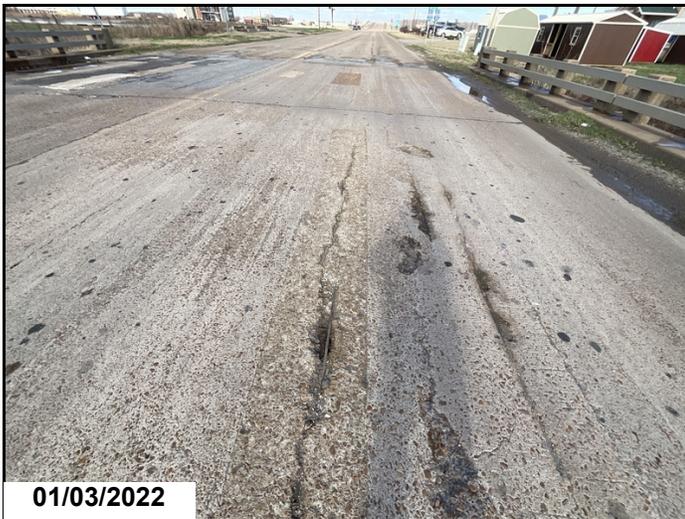
Deck has several open longitudinal wide cracks each span.

Span #2 exposed rebar in right lane

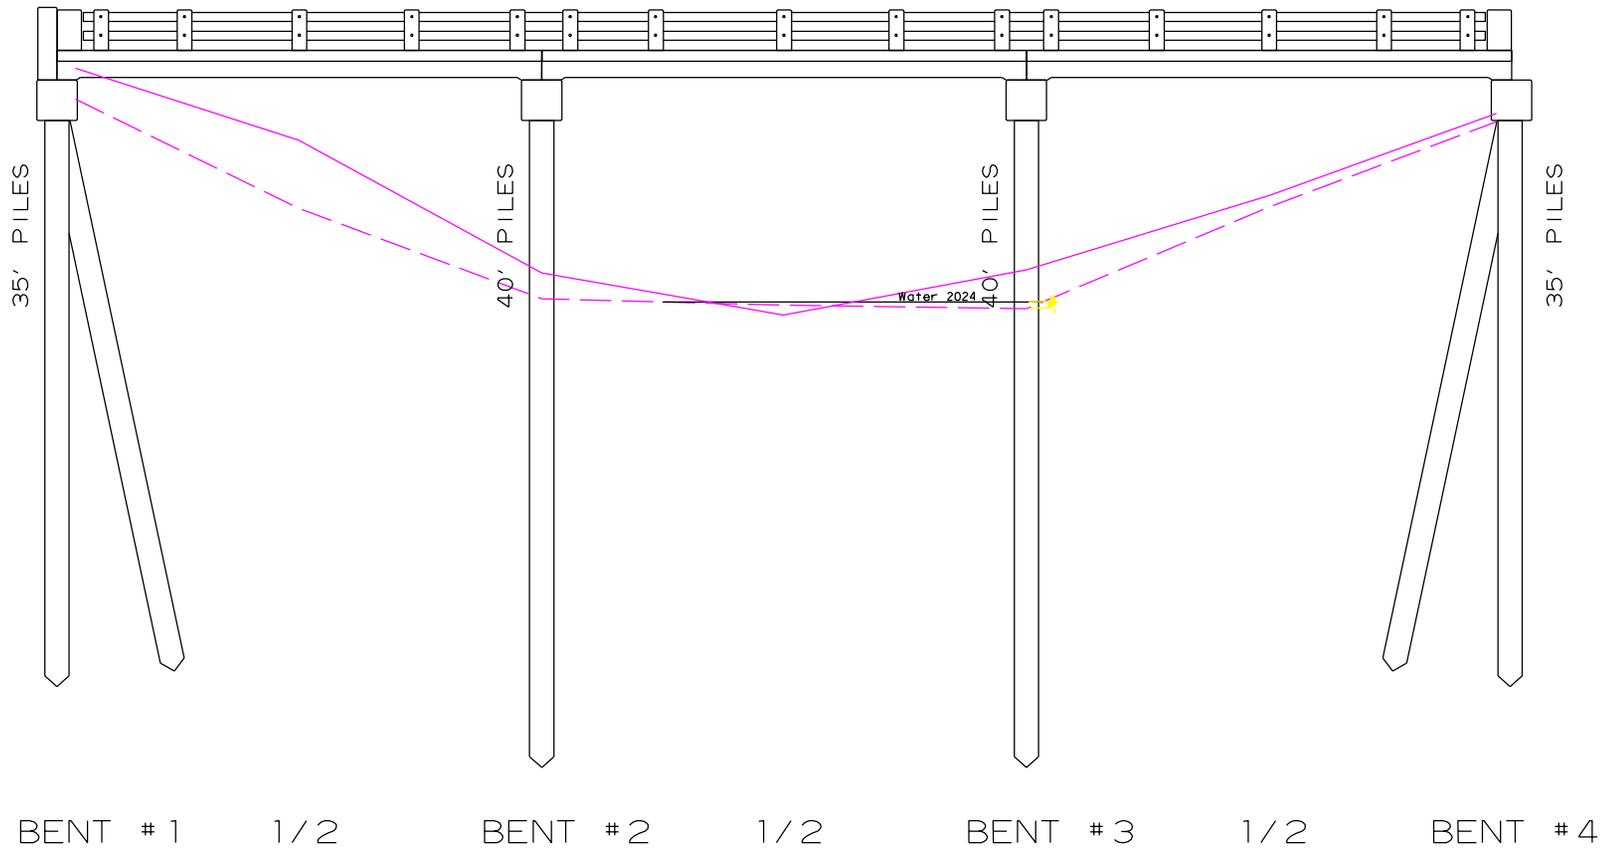
READINGS TAKEN FROM SIDE OF BRIDGE, TOP OF BRIDGE RAIL

01/08/2024 Left    5.5'    12.1'    17.7'    18.1'    18.3'    12.0'    6.9'
