Asset #02594(Routine)

SH 14-14- LM 5.46 over DITCH 1

Location: 4.57 M E SH 1

Team Lead: Richard Jones Inspection Date: 05/20/2024

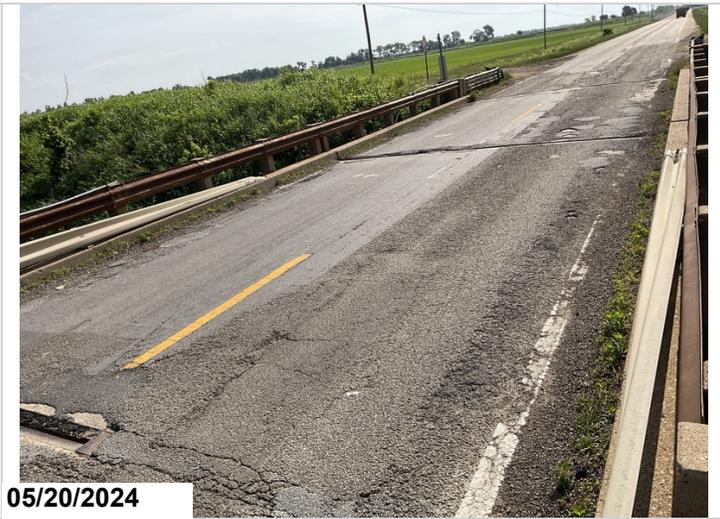
Wearing surface

Approach roadways are severely cracked and spalled.
Asphalt wearing surface has several cracks and spalls. Asphalt is raveling out along gutters and over joints.

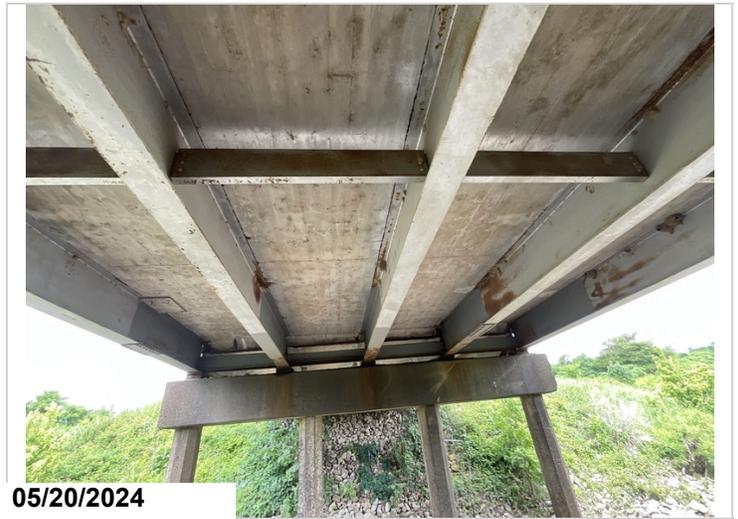
Under surface

Deck is in mostly satisfactory condition. See elements

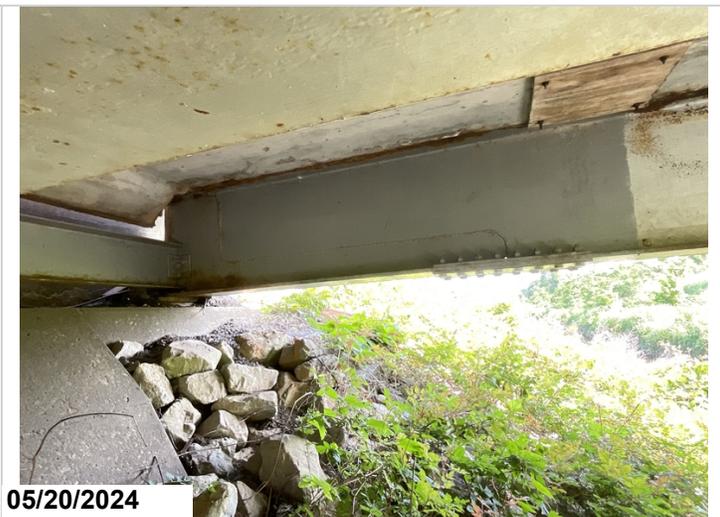
Span 1 bent 1 girder 1

Several girder ends were repaired in 2022.

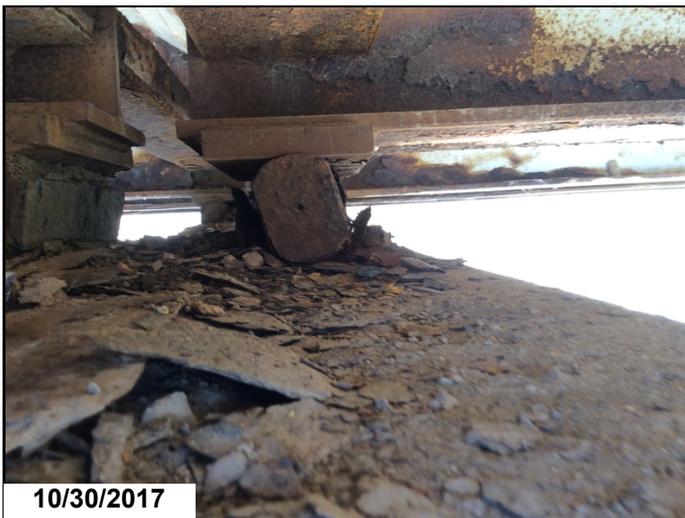
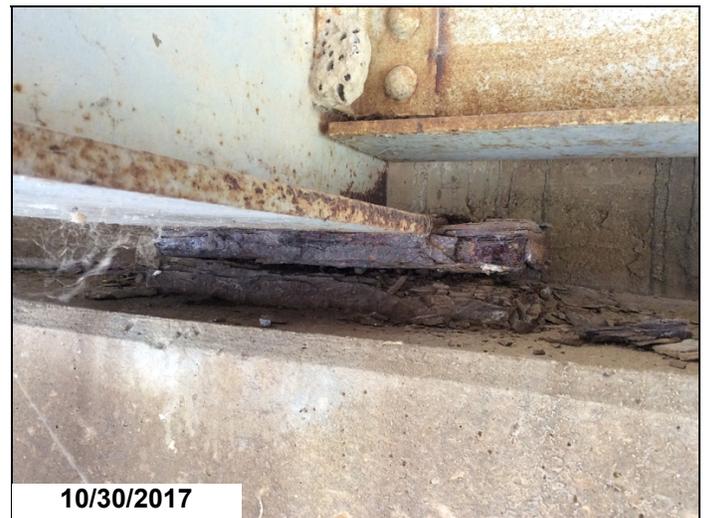
10/30/2017

Span 2 bent 2 bearings 3 and 4 have advanced rotation. Bearing 4 rocker is loose.

Type of Work: Bearing Repair/Replacement
