**Asset #05726**(Routine, Underwater type 2)

**US 412-06B-LM 2.18 over SWAN POND DITCH**

**Location: 2.18 MI E US 63**

**Team Lead: Richard Jones Inspection Date: 07/05/2023**

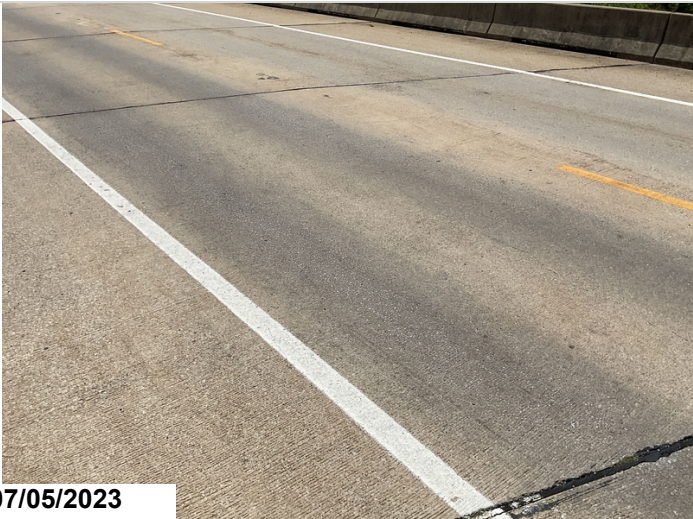
Deck

Slabs have minor deterioration. See elements

(38) Top of slabs have several unsealed longitudinal cracks. Slabs have widespread abrasion, especially in wheel paths.							
Soffit portion of slabs has several delaminated areas or spalls with rebar exposed along edges. Slabs have a few longitudinal cracks with efflorescence or rust stains.							
215	Reinforced Concrete Abutment	LF	104	11	0	93	0
6000	Scour	LF	93	0	0	93	0

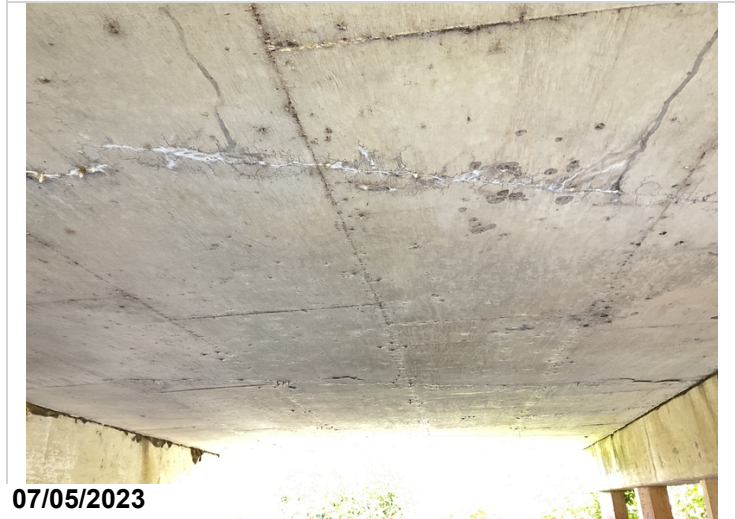
Span 2

Slab soffit has minor deterioration. See elements

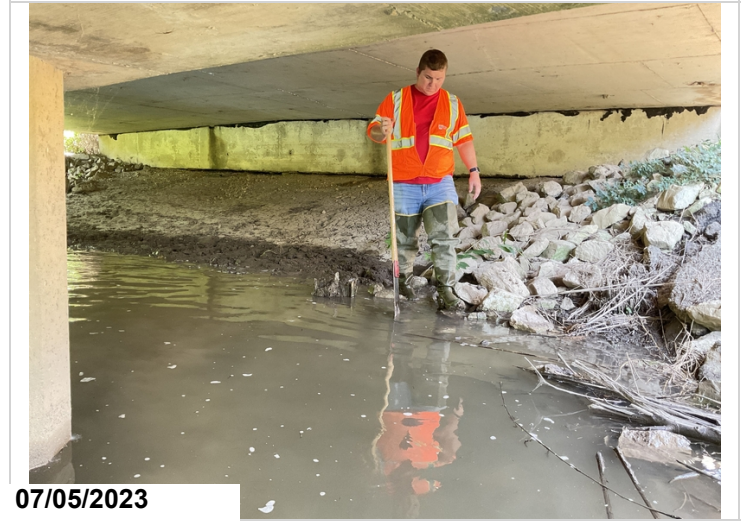
Bent 1

(215) End bents have some minor undermining under bridge. Rip rap was placed near abutment ends sometime in the past.							
227	Reinforced Concrete Pile	EA	12	9	1	2	0
1080	Delamination/Spall/Patched Area	EA	3	0	1	2	0

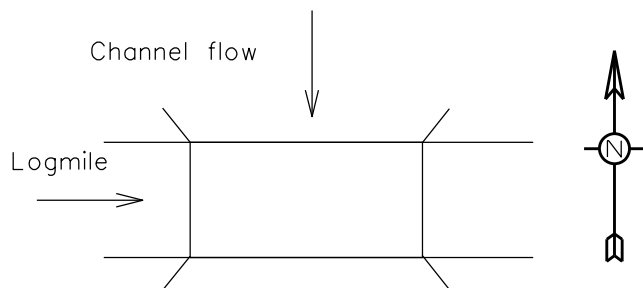
05726 Overall Length=75.0'

Channel Sounded From Top of Deck, UPSTREAM, LEFT SIDE  
 Green Sounding Readings are From Lay Out Sheet  
 Blue Sounding Readings are From 8-20-1990 (First Time)  
 Gold Sounding Readings are From 7-23-2009  
 Red Sounding Readings are From 7-03-2014  
 Purple Sounding Readings are From 7-8-2019  
 Light Blue Sounding taken 7-5-2023
