Route:412 Section:06 Log:0.89

Arnold Road ID:38x412x6BxA, Arnold Log mile:0.892

**Asset #05725**(Routine, Underwater type 2)  
**US 412-06B-LM 0.89 over RUNNING WATER CREEK**  
**Location: .89 MI E US 63**  
**Team Lead: Richard Jones Inspection Date: 07/05/2023**

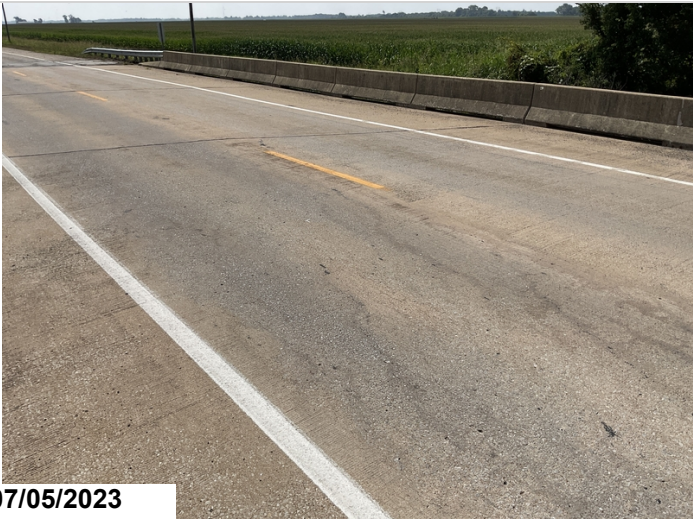
Deck

**58 - Deck** (7 - GOOD CONDITION - some minor problems.)  
few minor problems. See elements

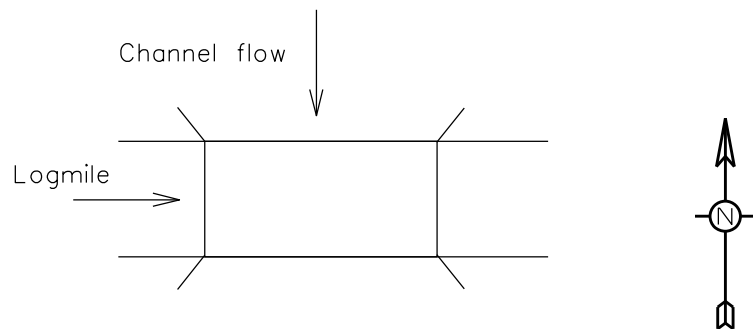
05725 Overall Length=105.0'

Channel Sounded From Top of Deck, LEFT SIDE, UPSTREAM  
 Green Sounding Readings are From Lay Out Sheet  
 Blue Sounding Readings are From 8-20-1990 (First Time)  
 Gold Sounding Readings are From 7-23-2009  
 Red Sounding Readings are From 7-03-2014  
 Loss of Pile Penetration Since 2009: Bt.1=2.9', Bt. 4=2.9'  
 Purple Sounding Readings are From 7-8-2019  
 Light Blue Sounding taken 7-5-2023

Dash water level taken 7-5-2023
