Asset #05748(Routine, Underwater type 2)

Sh147/Sec-1/L10.23 over Ten Mile Bayou

Team Lead: Drew Melton Inspection Date: 01/08/2024

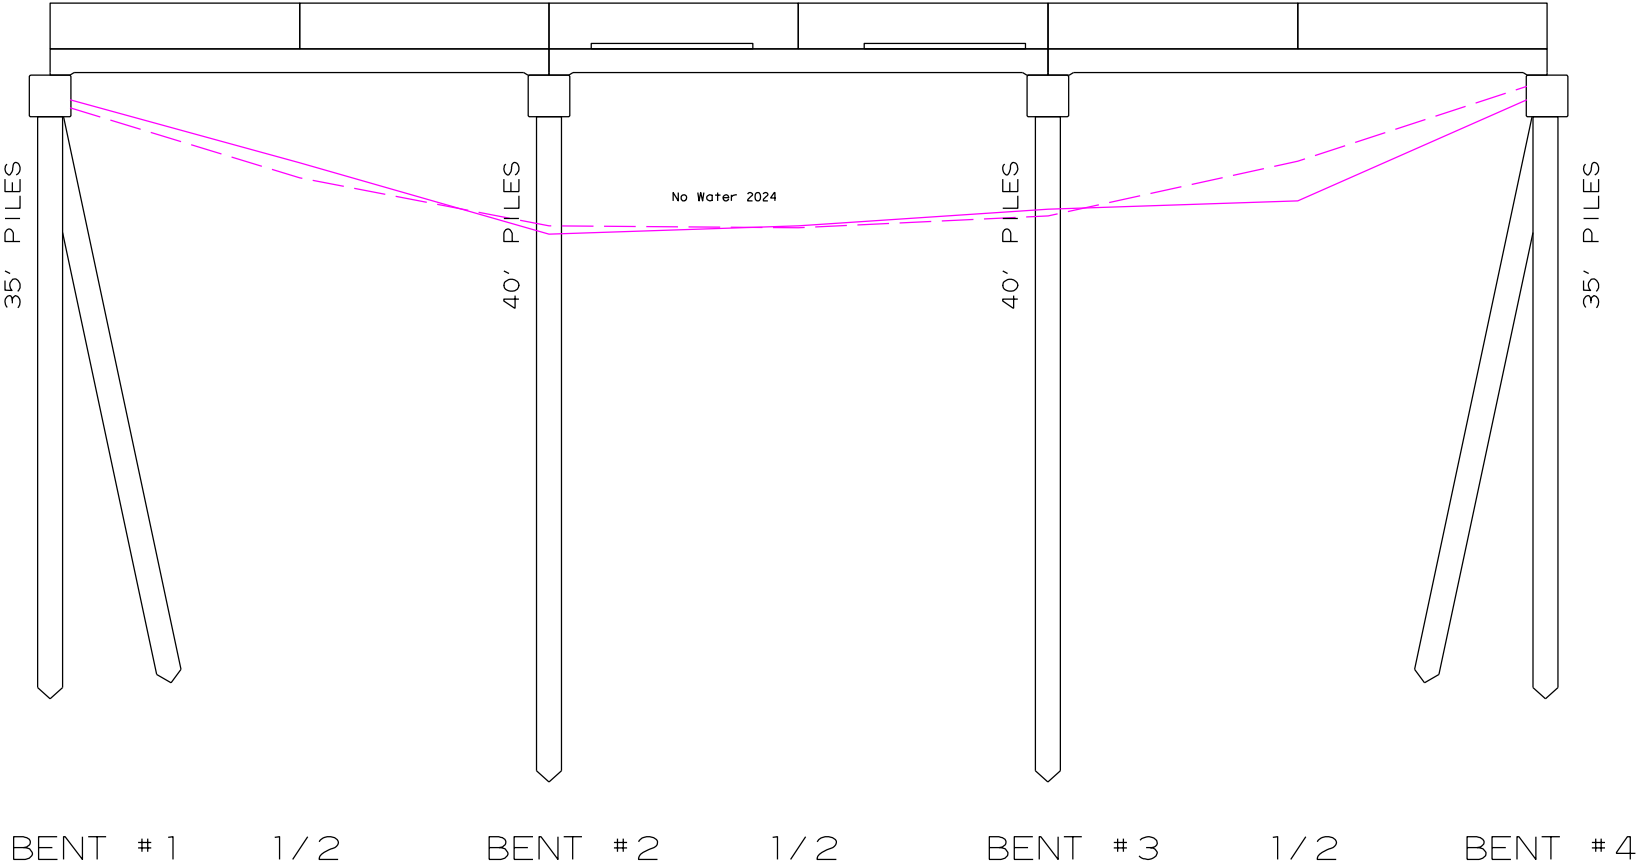
READINGS TAKEN FROM SIDE OF BRIDGE, TOP OF BRIDGE RAIL

01/08/2024 Left	6.3'	10.5'	13.4'	13.5'	12.8'	9.5'	5.0'
01/08/2024 Right	5.8'	9.6'	13.9'	13.4'	12.4'	11.9'	5.8'
