Asset #M3138(Routine)

Sh-38/Sec-2/L-2.44 over Grine Lake

Location: 2.44 Mi East Jct Sh 33

Team Lead: Drew Melton, Inspection Date: 08/03/2022

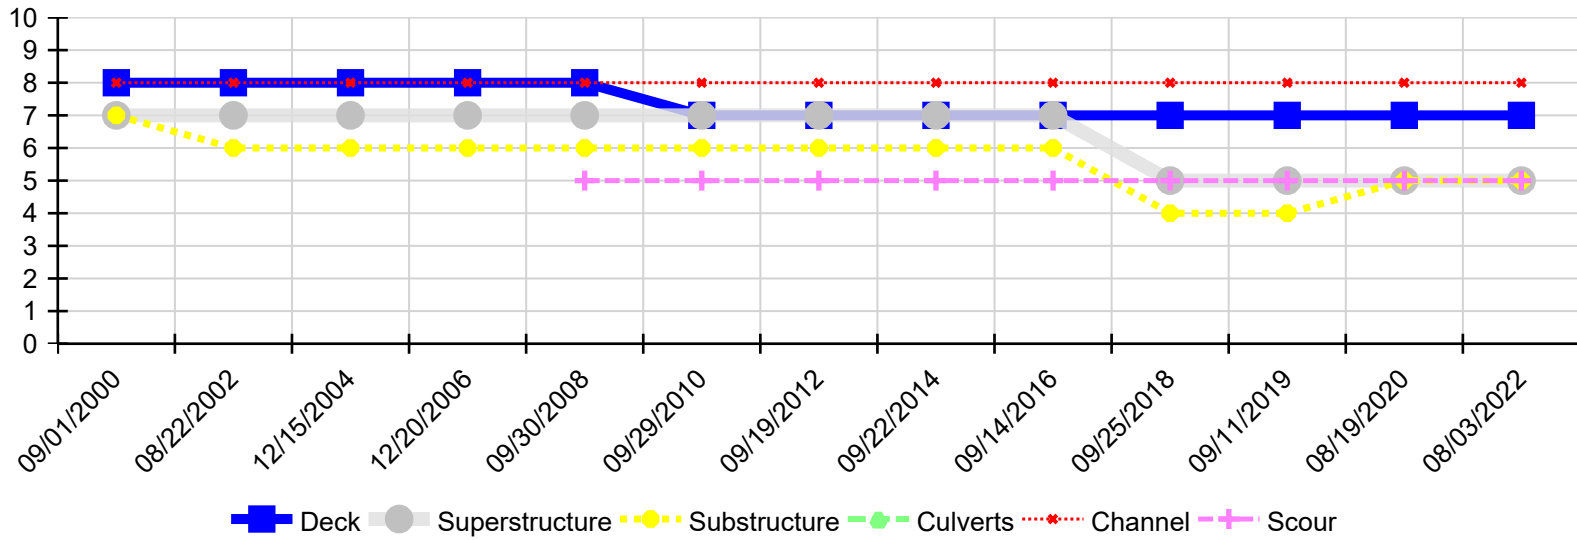
Condition History

Inspection Date	Deck	Superstructure	Substructure	Culverts	Channel	Scour
08/03/2022	7	5	5	N	8	5
08/19/2020	7	5	5	N	8	5
09/11/2019	7	5	4	N	8	5
09/25/2018	7	5	4	N	8	5
09/14/2016	7	7	6	N	8	5
09/22/2014	7	7	6	N	8	5
09/19/2012	7	7	6	N	8	5
09/29/2010	7	7	6	N	8	5
09/30/2008	8	7	6	N	8	5
12/20/2006	8	7	6	N	8	N
12/15/2004	8	7	6	N	8	N
08/22/2002	8	7	6	N	8	N
09/01/2000	8	7	7	N	8	N
