Asset #A0666(Routine, Underwater type 2)

US 62-Washington over Price Creek

Location: 3.53 Mi East of OK Line

Team Lead: Lee Swan, Inspection Date: 12/07/2022

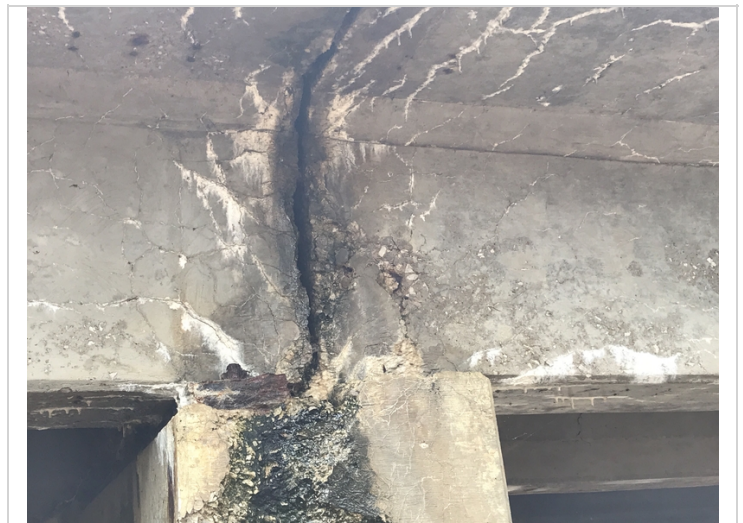
Girder 1 at bent 2.

110	Reinforced Concrete Open Girder/Beam	LF	276	118	74	80	4
1080	Delamination/Spall/Patched Area	LF	10	0	10	0	0
1090	Exposed Rebar	LF	2	0	0	2	0
1120	Efflorescence/Rust Staining	LF	97	0	19	78	0
1130	Cracking (RC and Other)	LF	49	0	45	0	4
<p>(110) 12/08/2022-RLS &amp; ALT -No noteworthy changes a this inspection.</p> <p>-There are hairline shear cracks and map cracking in Girder # 1 of both spans over Bent # 2.</p> <p>-Map cracking with heavy efflorescence in Span # 1, Girder # 4 and Span # 2, Girder # 1.</p> <p>-Span # 1, Girders # 2 &amp; 3 have map cracking in the haunches over Bent # 2 cap.</p> <p>-Map and diagonal cracking with efflorescence in the exterior girders over Bent # 2.</p> <p>-Span # 2, Girder # 4 has longitudinal cracking at the girder / deck juncture and vertical cracks at random spacing.</p> <p>-Span # 2, Girder # 4 has a 12" delaminated area in the Bearing area at Bent # 2.</p>

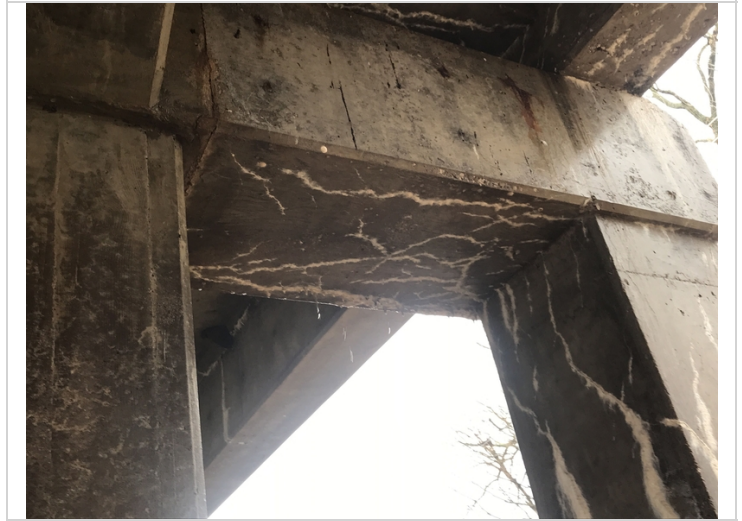
ELEMENTS	DESCRIPTION	UNITS	TOTAL	CS1	CS2	CS3	CS4
1120	Efflorescence/Rust Staining	EA	1	0	0	1	0
(205) 12/08/2022-RLS & ALT - There is local scour around columns 3 and 4. No other noteworthy changes at this inspection.							
-The concrete collars placed around the base of Columns # 2 & 4 are undermined up to 10" at this inspection. -Bent # 2, Column # 1 has heavy abrasion with an area of concrete section loss near the base. -Bent # 2, Column # 2 has exposed vertical reinforcing steel near top of column with approximately 1/8" section loss. -Bent # 2, Column # 2 has vertical cracks on the Left and Right face of the column. -Bent # 2, Column # 3 has a 24" x 12" vertical spalled area with exposed reinforcing steel with approx. 1/8" section loss. -Bent # 2, Column # 4 has vertical cracks with efflorescence adjacent to the cap.							
215	Reinforced Concrete Abutment	LF	99	50	36	13	0
1080	Delamination/Spall/Patched Area	LF	4	0	4	0	0

Bent 2 underside beneath column 3 and 4.

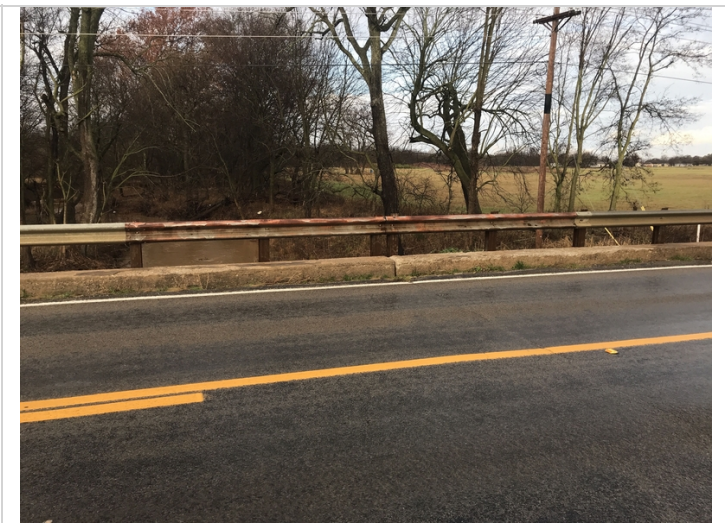
Right bridge rail.

ELEMENTS	DESCRIPTION	UNITS	TOTAL	CS1	CS2	CS3	CS4
(515-311) 12/08/2022-RLS & ALT - The protective coating has failed.							
330	Metal Bridge Railing	LF	138	68	70	0	0
1000	Corrosion	LF	64	0	64	0	0
1020	Connection	LF	6	0	6	0	0
515	Steel Protective Coating	SF	756	617	46	46	47
3440	Effectiveness (Steel Protective Coatings)	LF	139	0	46	46	47
(330) 12/08/2022-RLS & ALT - No noteworthy changes at this inspection.							
-Portions of the the railing and posts have a light coating of rust.							
-The left bridge railing has several loose nuts at the bolted connections that attach the railing to the posts.
