Asset #B3959(Routine)

U.S. Highway 64 EB over Interstate 540-Crawford

Location: JCT. HWY 64,71 & I540

Team Lead: Bob McEntyre Inspection Date: 09/13/2023

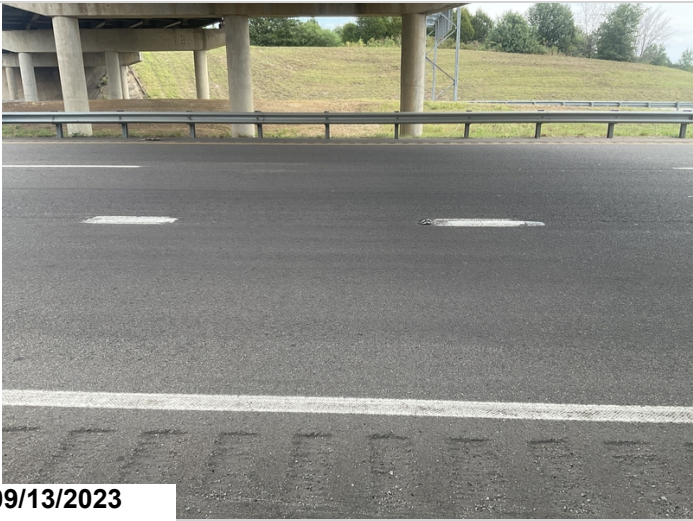
Southbound I-540 driving surface

09/13/2023 - RSM & SPC: Deck is in serious condition with numerous delaminated and spalled areas throughout the driving surface. Undersurface has leaching, scaling and delaminated/spalled areas. Deficiencies in the driving surface are no longer visible due to ACHM wearing surface approximately 0.75" thick installed by State Maintenance Forces since last inspection.

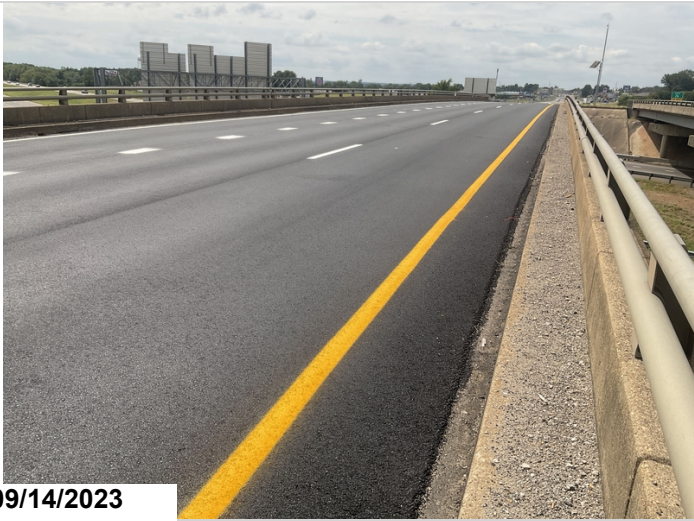
General view of asphalt wearing surface

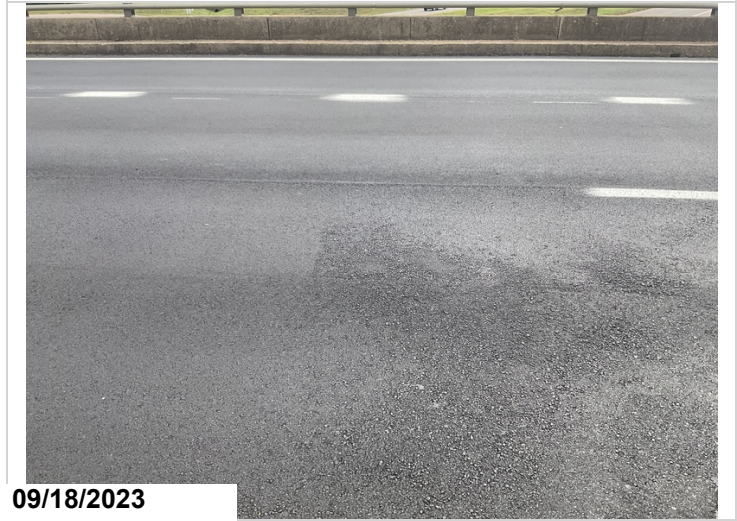
Asphalt wearing surface

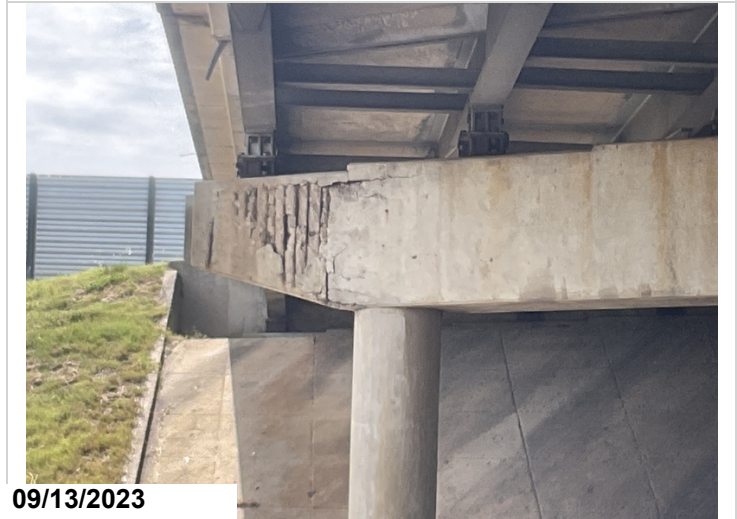
Bent 2 aheadface, right end

(234) -Bent # 2, right side of cap has horizontal cracks and areas of map cracking, delaminated areas, and spalls with exposed reinforcing steel. -Bent # 2 aheadface of cap has horizontal cracks and areas of map cracking, delaminated areas, and spalling adjacent to column # 2. -Bent # 3 cap has a horizontal crack located approximately 8" below the top of cap that extends approximately 1/2 the length of the cap. -Bent # 3, right side of cap has a 10" spall. -Bent # 4, left side of cap has spalls with exposed reinforcing steel. -Bent # 4, right side of cap has a 6' area of spalls with exposed reinforcing steel. -Bent # 5 cap has horizontal cracking along top edge between bearings # 2 and 3, & 6 and 7. -Bent # 5 cap between columns # 2 and # 3 has a 3' delaminated area. -Bent # 5, left side of cap undersurface has a 5' area with concrete spalls with exposed reinforcing steel. -Bent # 5, right side of cap undersurface has a 2' area with concrete spalls that expose reinforcing steel. Exposed reinforcing steel has initial section loss with areas of active corrosion.

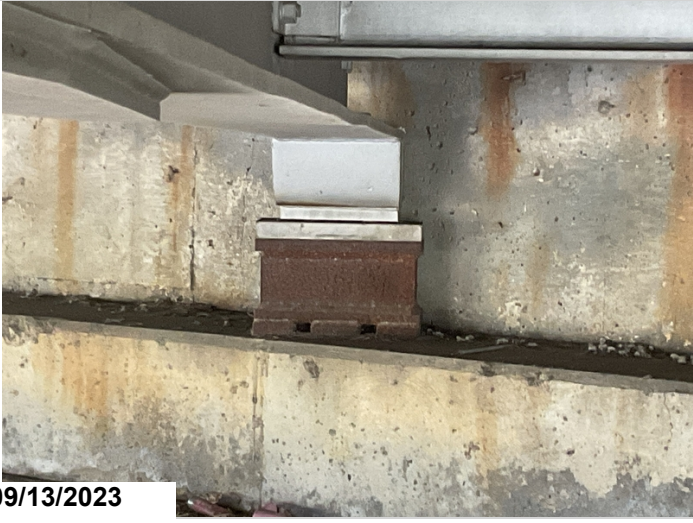
Abutment # 2 typical bearing

The paint system on the bearings is beginning to fail with light rust showing through and a few isolated areas of active corrosion with pack rust forming between the bearing plates.
