**Asset #05600**(Routine, NSTM)  
**SH 109 over ARKANSAS RIVER**  
**Location: 1.5 MI SO JCT 194**

**Team Lead: Casey Pratt Inspection Date: 04/15/2024**

Routine and NSTM inspections of 05600 were conducted on these dates from South to North utilizing the Aspen A 62-t under bridge inspection unit. All spans were inspected using the UBI unit except for 29-40. Due to the bridge's low clearance and heavy vegetation in these spans, the snooper's access was limited, and the inspection was conducted on foot from the ground. All defects were noted and quantified in the "elements" section of the report, and all components were rated according to their condition at the time of this inspection.

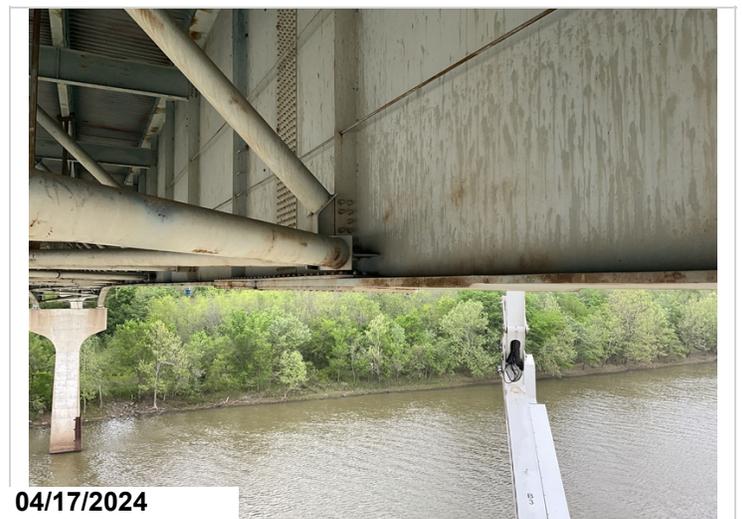
E details main span. Lateral brace to girder welds. Main spans. These details were checked for CIF susceptibility. They are fully welded all the way around, eliminating the crack-like detail that would put them in a CIF category.

E details on the Main span.

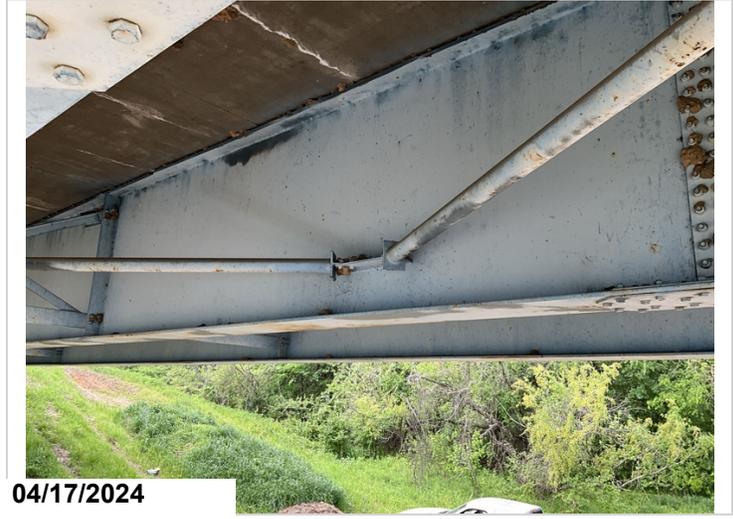
E details: lateral bracing to girder web welds approach spans.

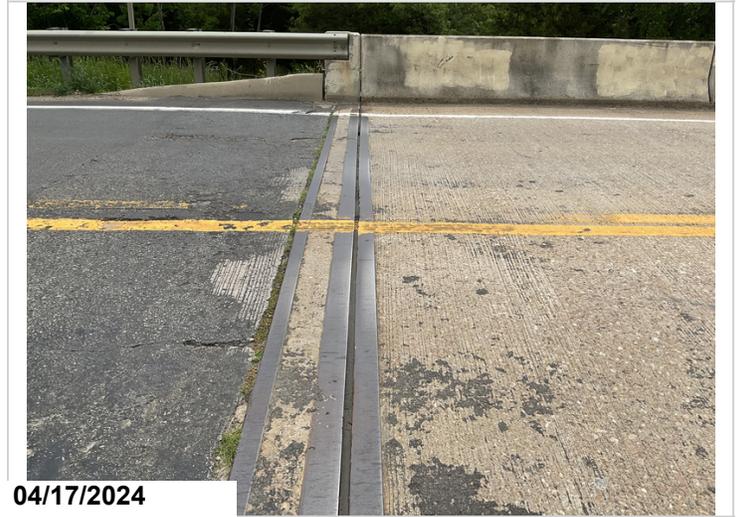
Typical joint condition over abutments.

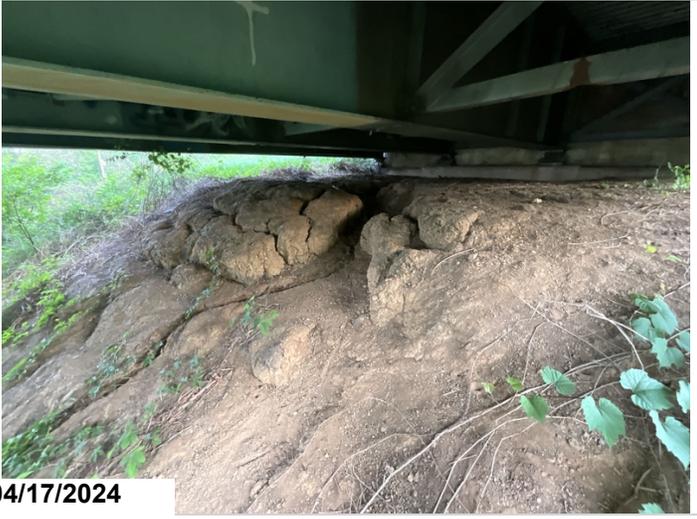
Abutment 2: has minor erosion. No exposure of the face.

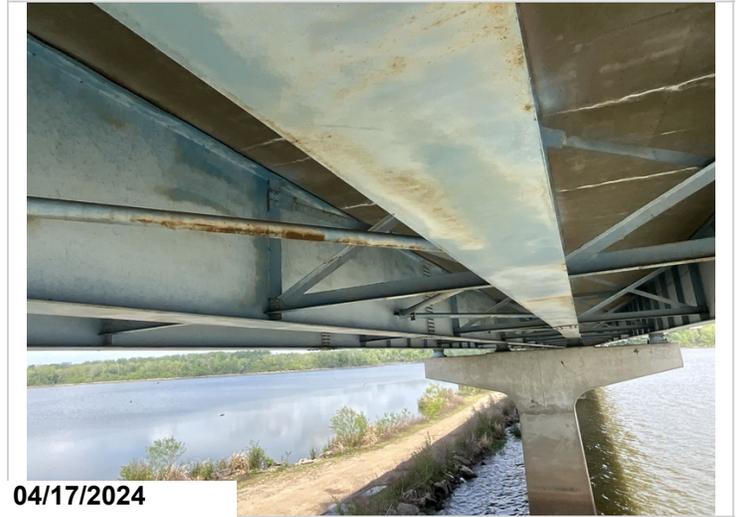
Surface rust on the webs and bottom flanges of the exterior girders. Pack rust has formed at the field splices. The paint system is failing. Primer coat and bare metal are exposed in many areas. The paint has failed at the expansion joints.

Typical paint condition approach span girders.

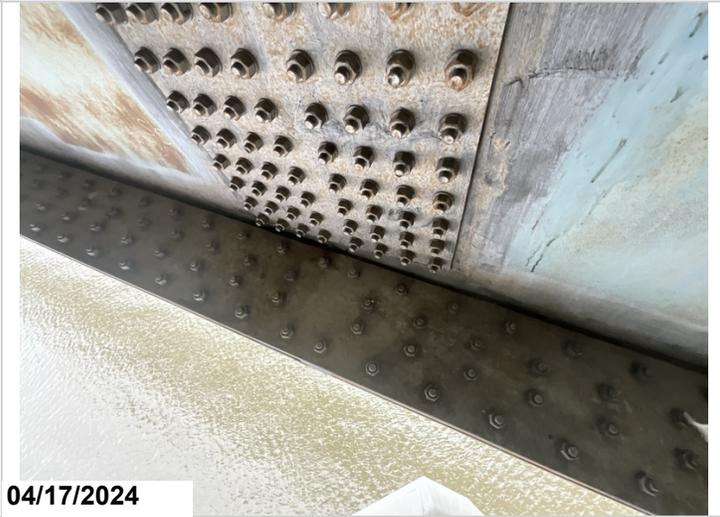
Span 56, girder 1, right, 3rd splice: Has minor section loss at splice connection up to 1/8". 1LF CS3

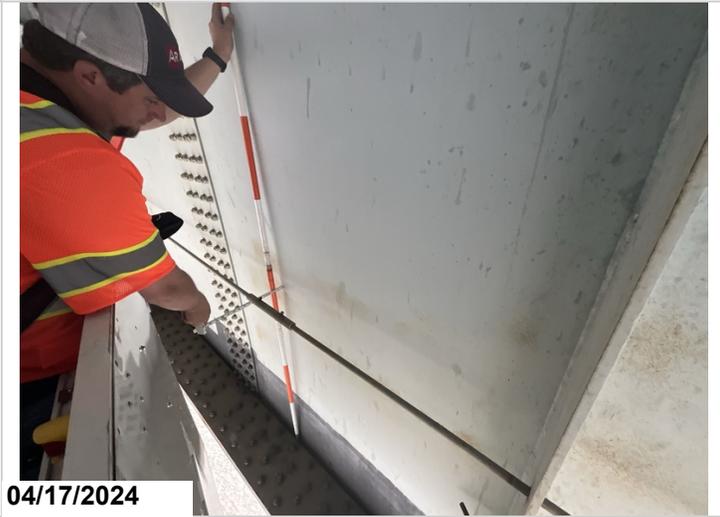
Overall, the superstructure was found to be in satisfactory condition. Minor surface corrosion is common throughout, and isolated instances of section loss up to 1/4" are present. Out-of-plane bending is also present in girders 1 and 2 in span 56. Due to these findings, the superstructure was rated 6.

Span 56, girder 2, left, 1st splice: 1.5" out of plane bending to girder web. 5 LFCS2

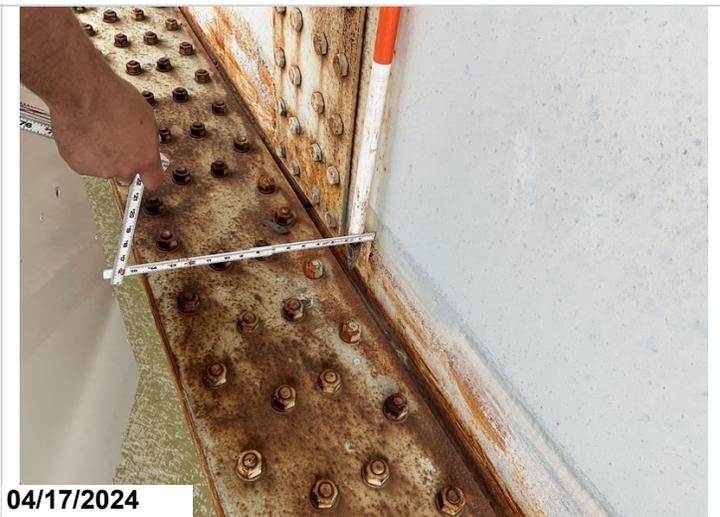
Span 56, girder 1, 1st splice: Out of plane bending of web. The middle section of the web measures 3/4" out and increases to 1" at the bottom. 6LF CS2

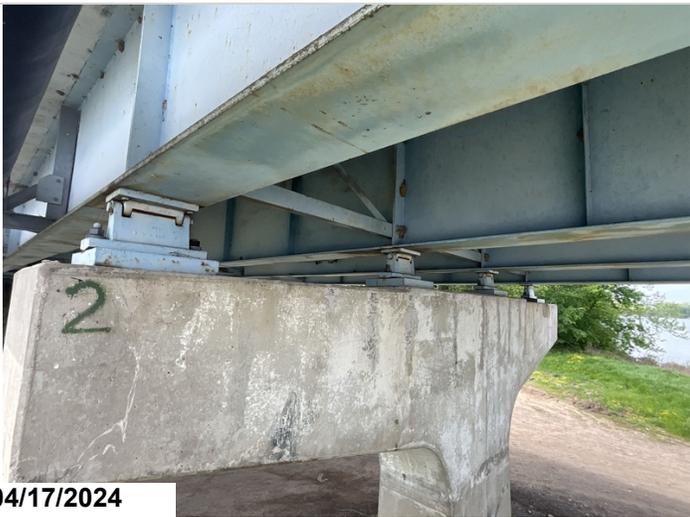
Abutment 2: All bearings fully extended to the north. 4EA CS3

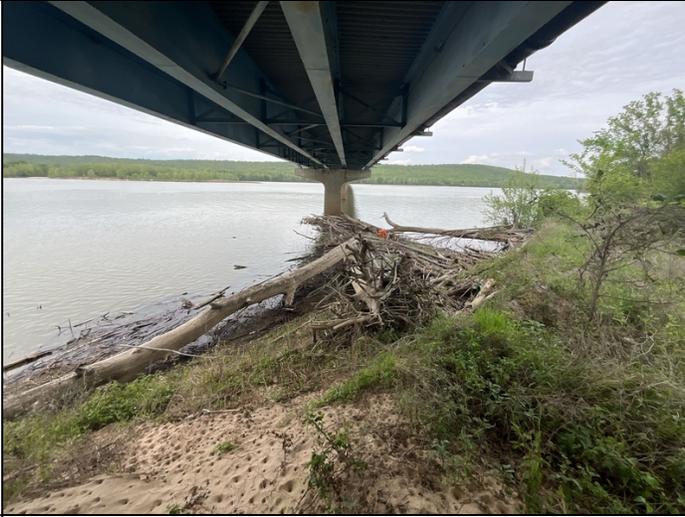
Span 41: Has debris and cutting of the channel bank.
