Route:28 Section:02 Log:6.938

Arnold Road ID:63x28x2xA, Arnold Log mile:6.93

District 04, 127 - Scott County

(4) Place Code	0
(6) Features Intersected	Fourche La Fave River
(7) Facility Carried	State Highway 28
(9) Location	6.94 MI E OF US 71 JCT
(11) Mile Point	6.938 mi

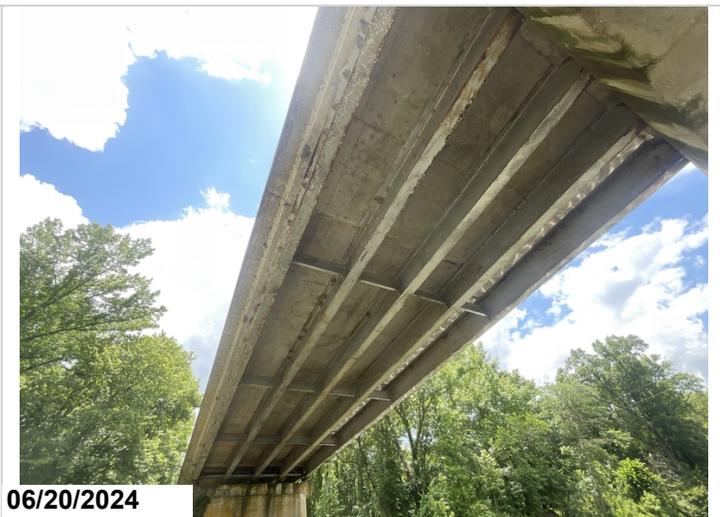
Undersurface, Span # 8: typical.

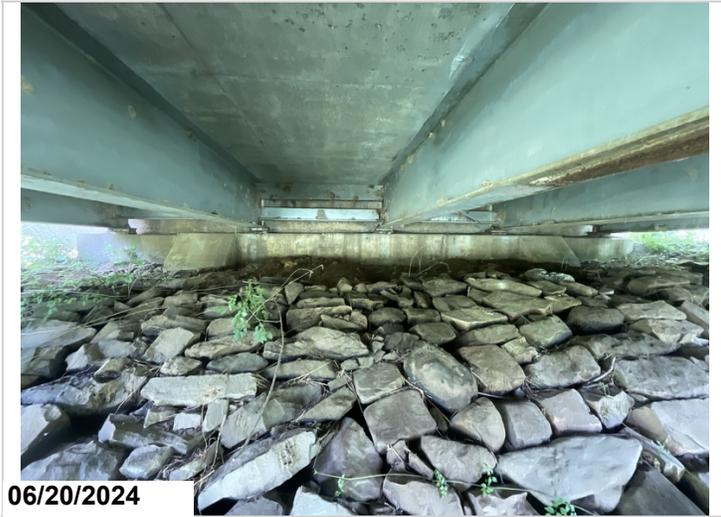
Abutment # 1: typical.

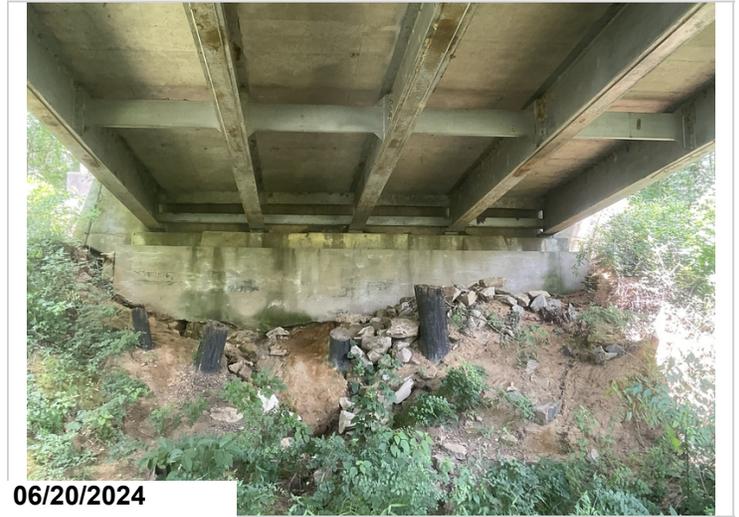
Abutment # 2: typical.

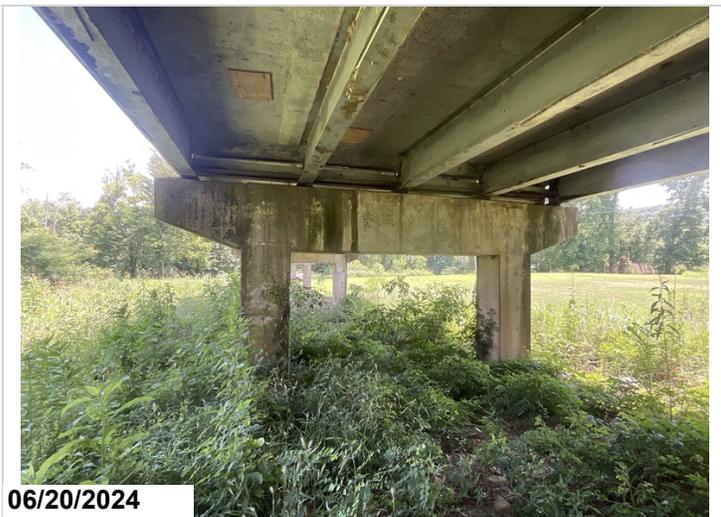
Bent # 2: typical.

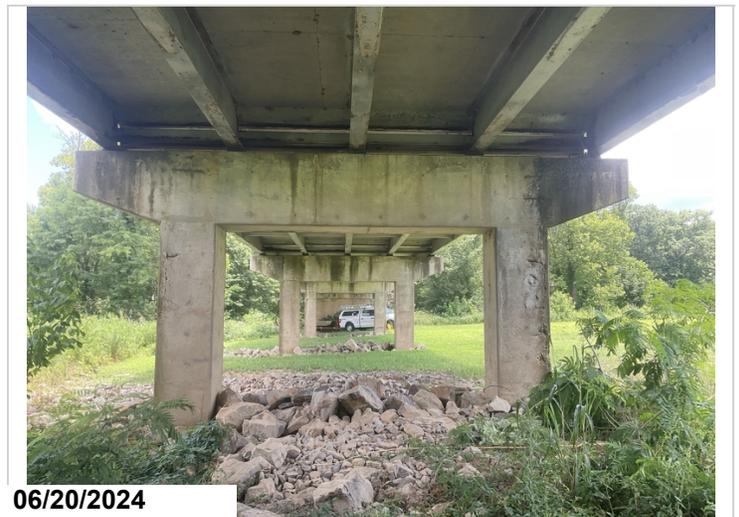
Bent # 3: typical.

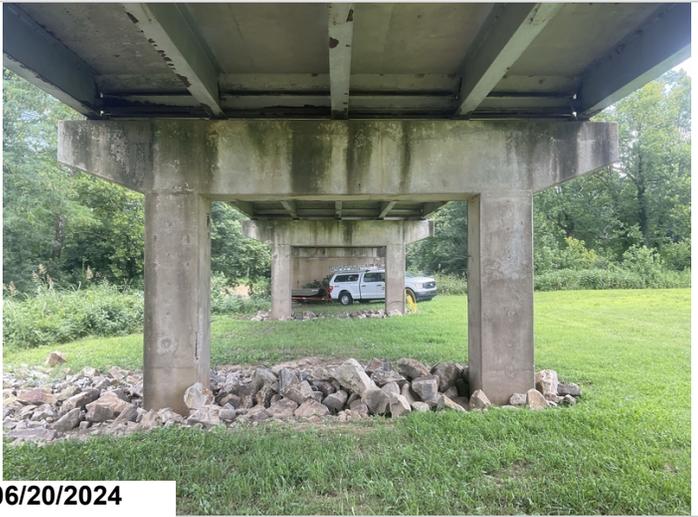
Bent # 4: typical.

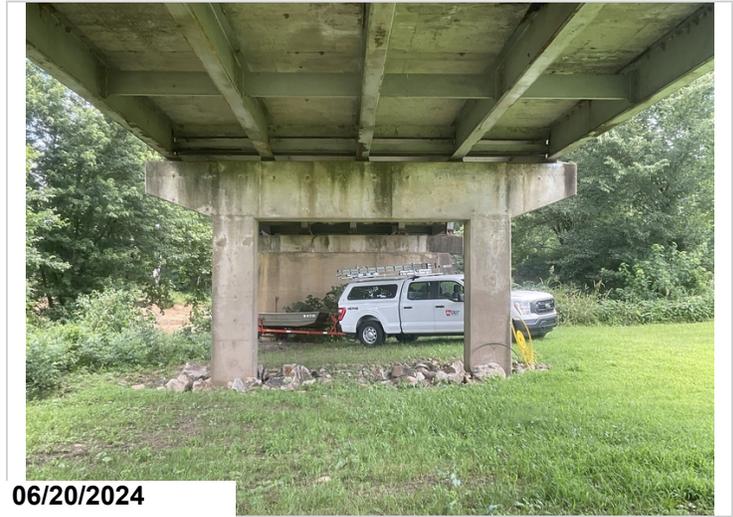
Bent # 5: typical.

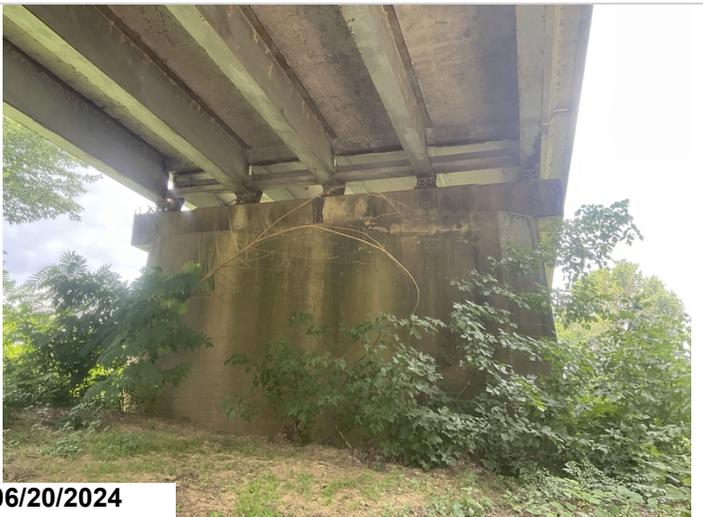
Bent # 6: typical.

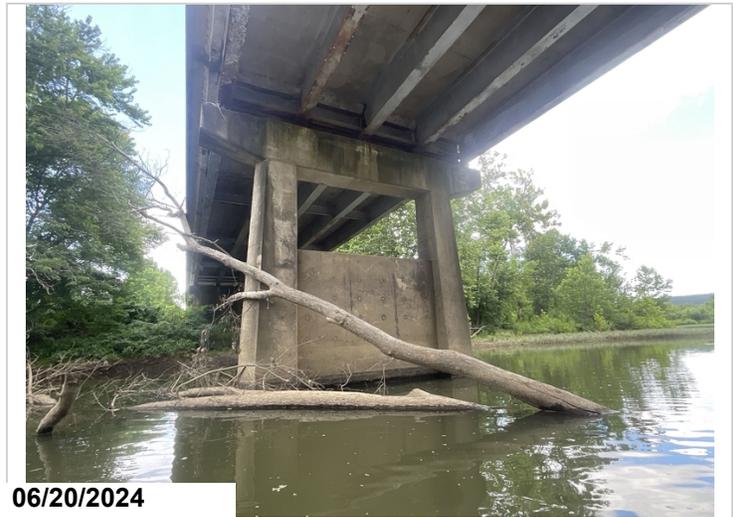
Bent # 7: typical.

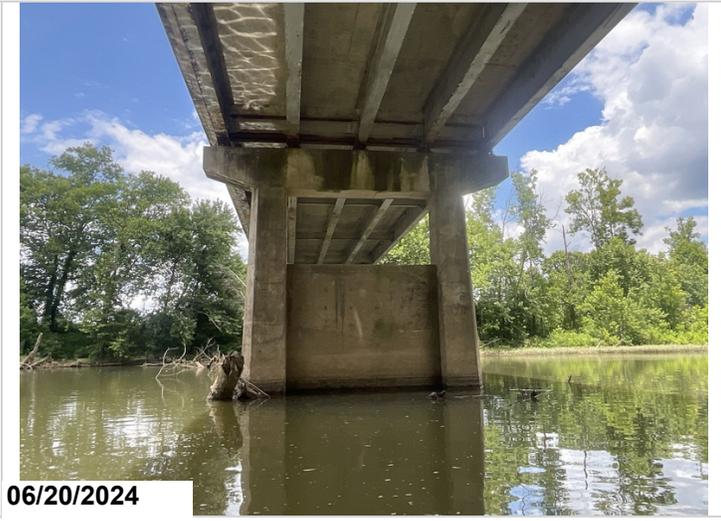
Bent # 8: typical.

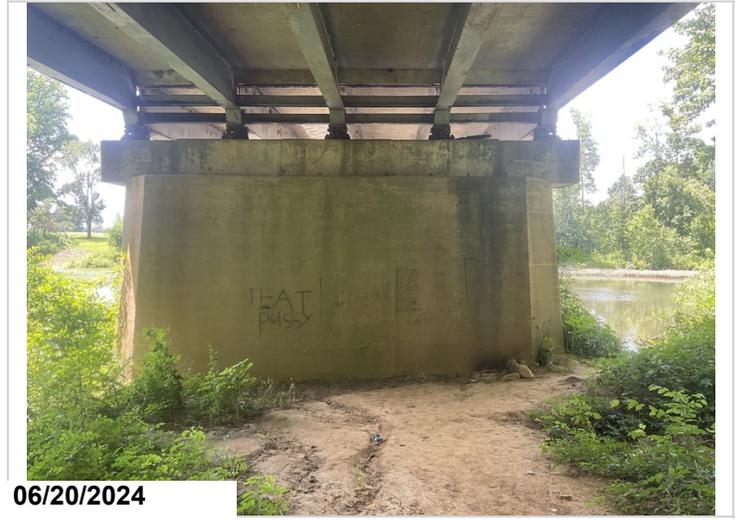
Bent # 9: typical.

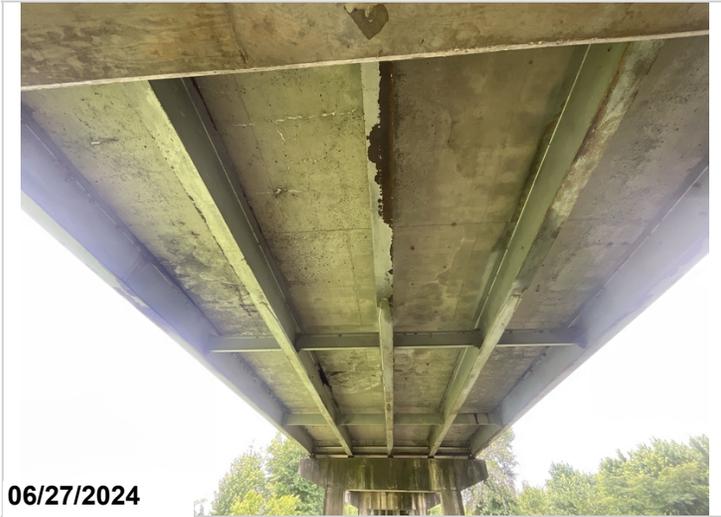
Undersurface, span # 4: typical.

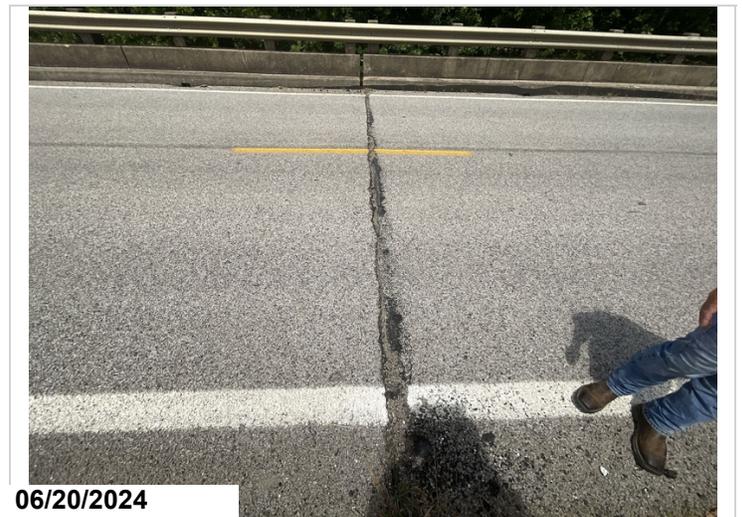
Bent # 6: typical.

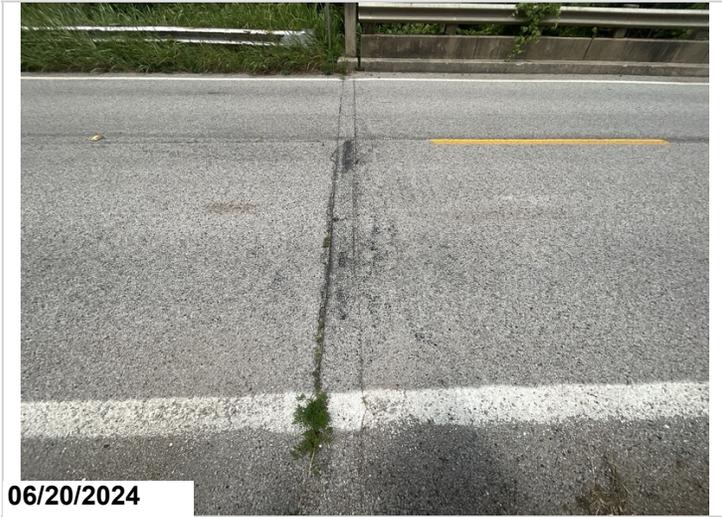
Abutment # 1: typical.

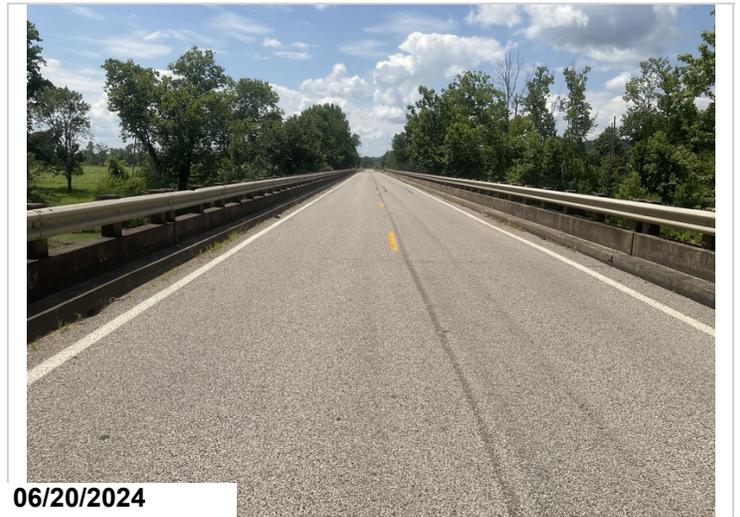
Metal bridge rail: typical.

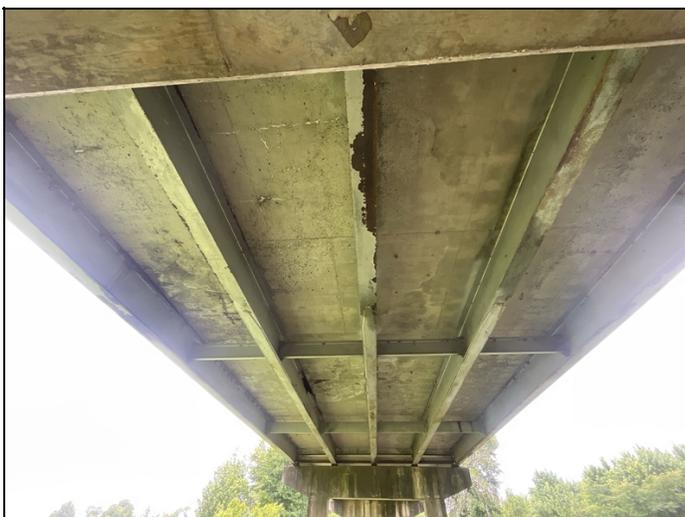
Undersurface, span # 4: typical.
