Asset #02466(Routine, NSTM)

US 79-B S-4 LM 2.2 over OUACHITA RIVER

Location: 1.08 MI NE JCT SH 7

Team Lead: Anthony Wood Inspection Date: 10/03/2022

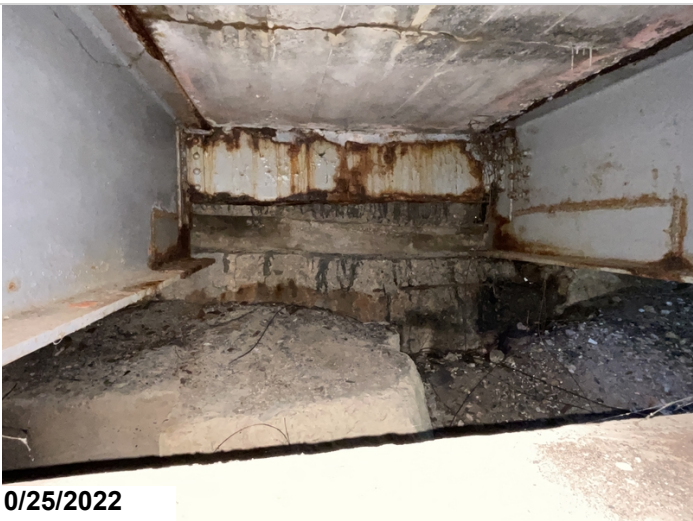
Bent 1, Back: Girders are suspended.

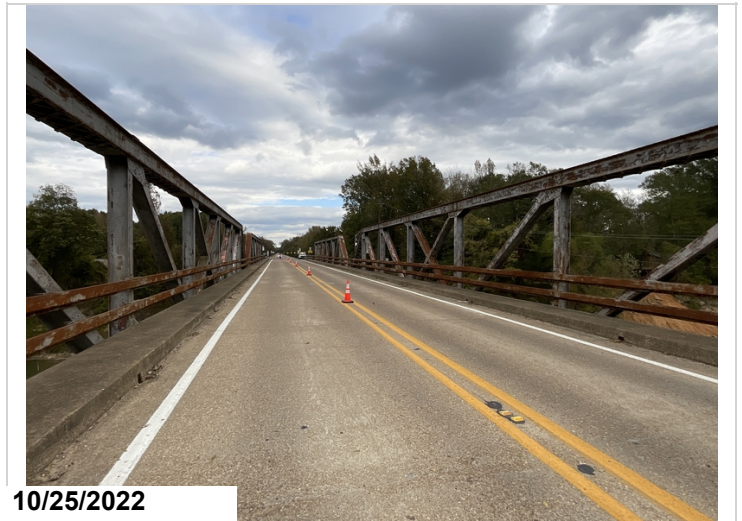
Truss Spans: Typical paint.

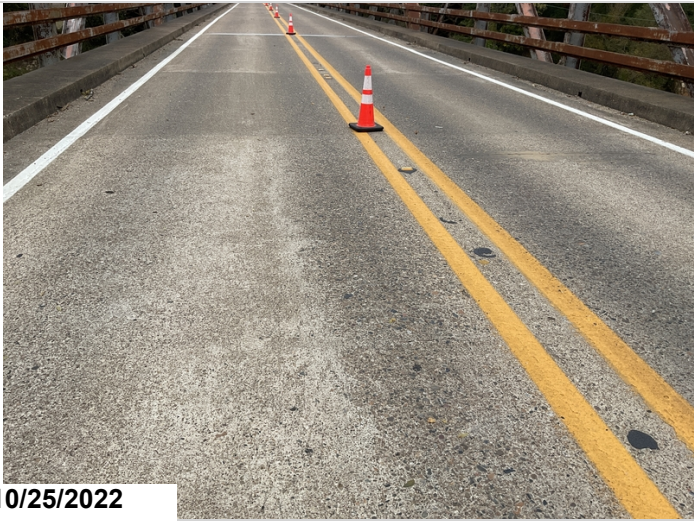
Truss Spans: Typical deck.

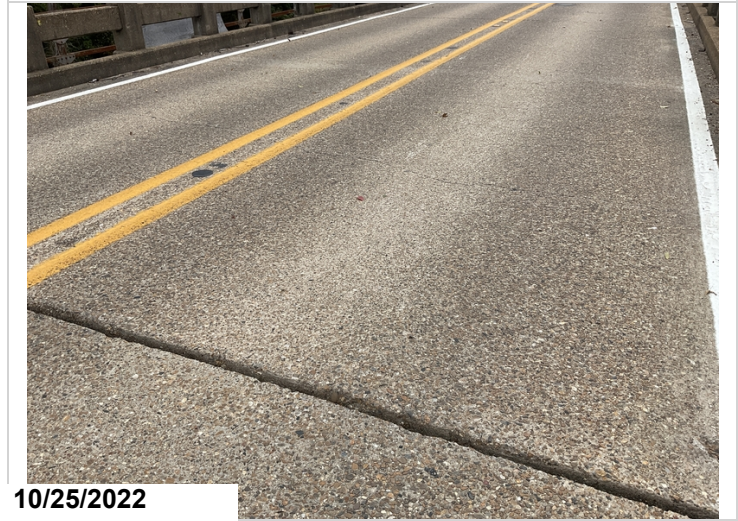
Multi-Girder Spans: Typical deck.

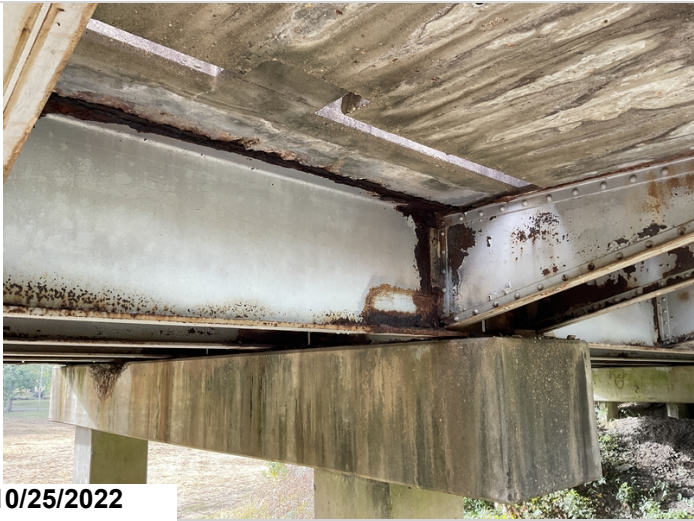
Span 2, Girder 1, Deck: Floating.

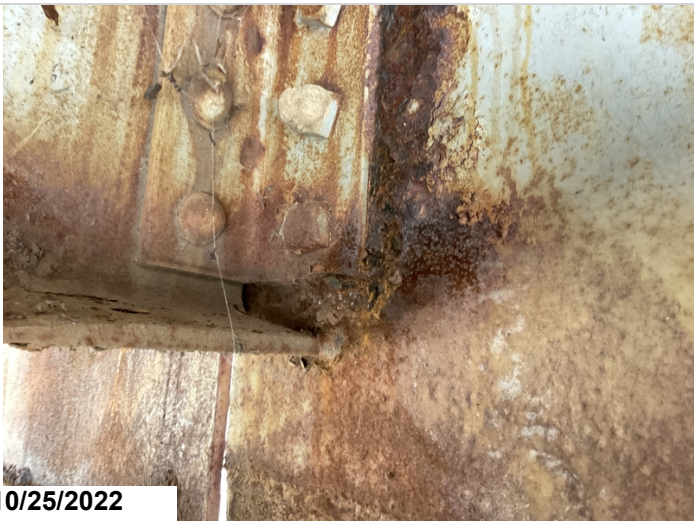
Bent 8, Girder 3, Right: 7/16" section loss, 3" long X 1" tall.

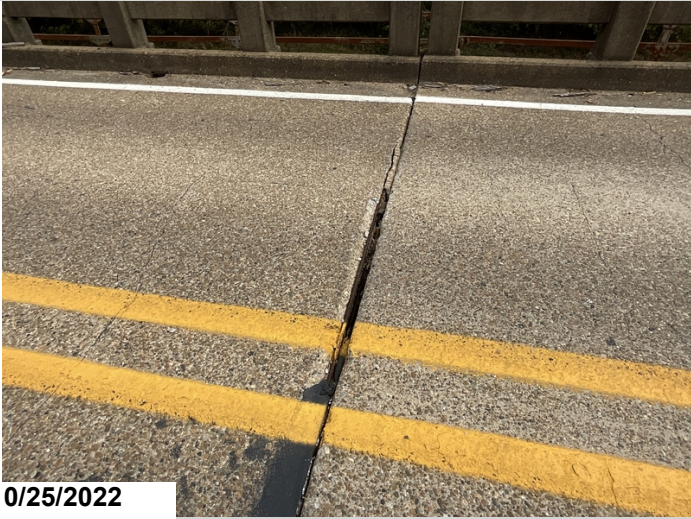
Bent 10, Span 10: Spalling with exposed reinforcing steel with section loss.

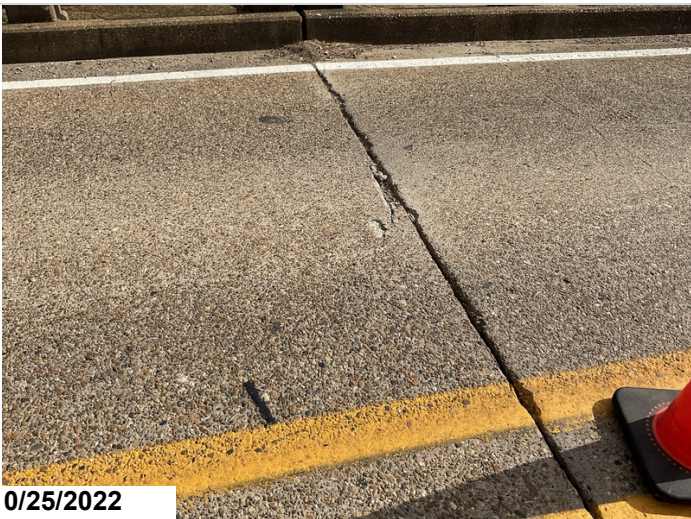
Bent 2: Spalling.

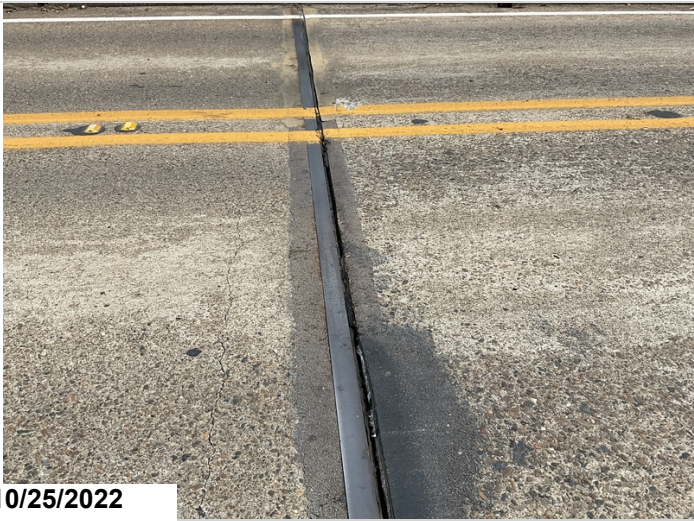
Bent 16, Joint: Loss of adhesion.

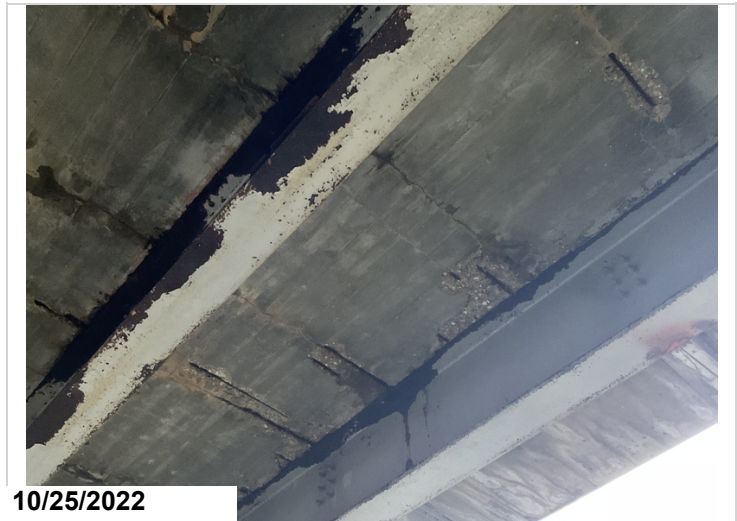
Typical exposed reinforcing steel with section loss in multi-girder spans.

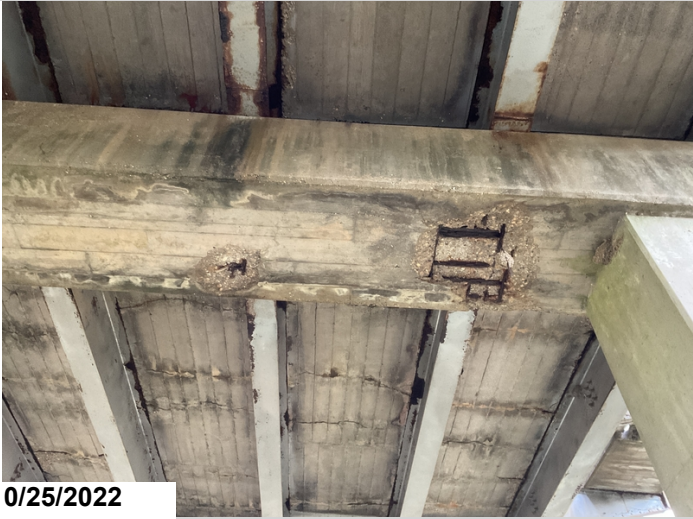
Bent 11: Spalling with exposed reinforcing steel with section loss.

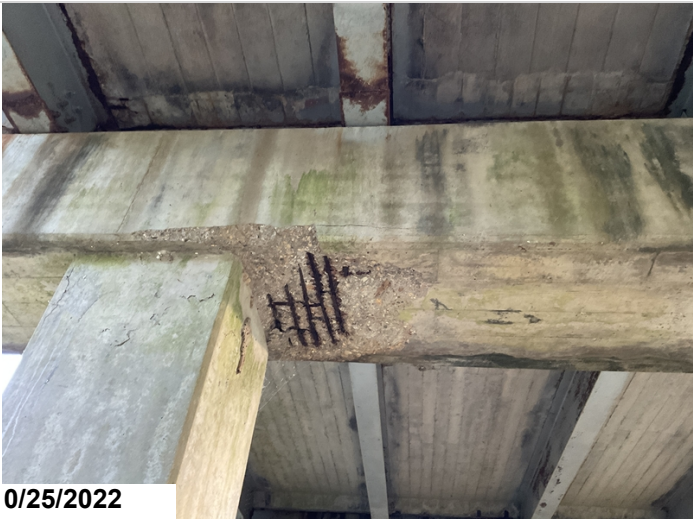
Bent 15, Spalling with exposed reinforcing steel with section loss.

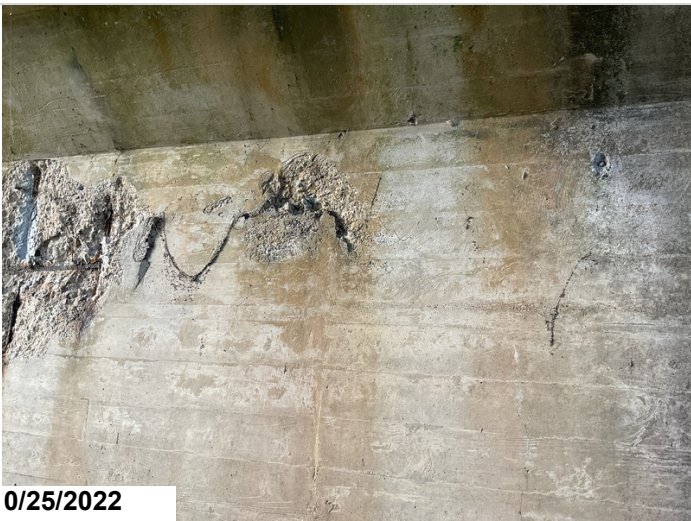
Pier wall # 1 (ahead side) has large spalls with exposed steel, up to 100% section loss to the outer bands of steel. Pier walls 2 and 3 have vertical cracks that emanate below the water level up to the top of the pier wall. Approach spans have several spalled places with some exposed steel.

Pier 1, Ahead: Spalling.

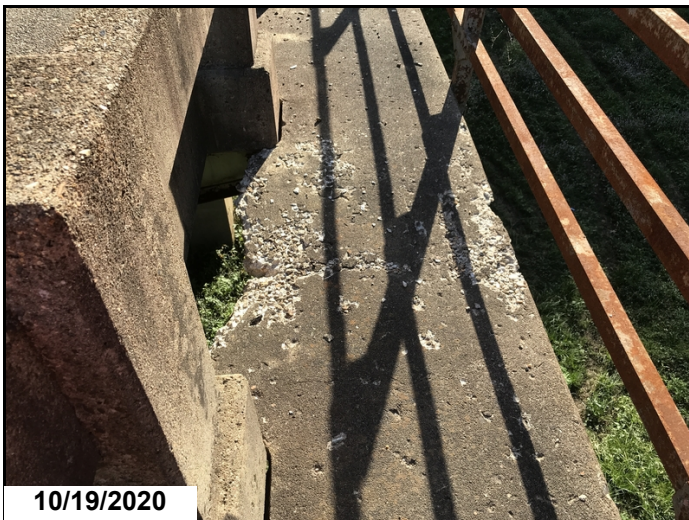
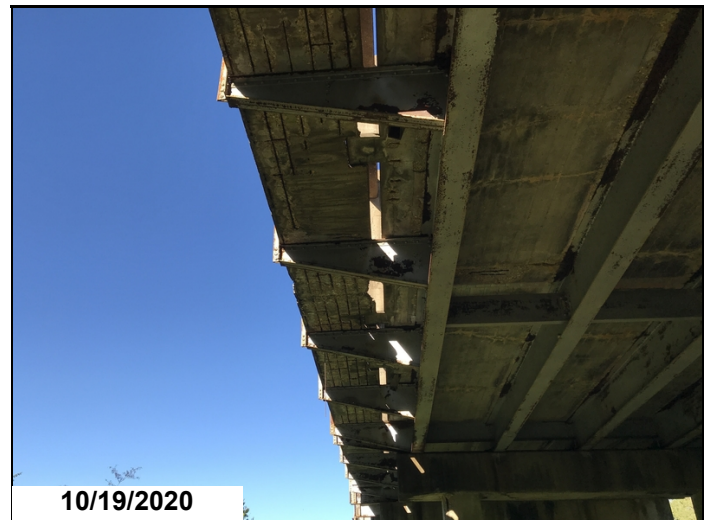
Side Walk is closed at this inspection.

Typical undersurface of the sidewalk

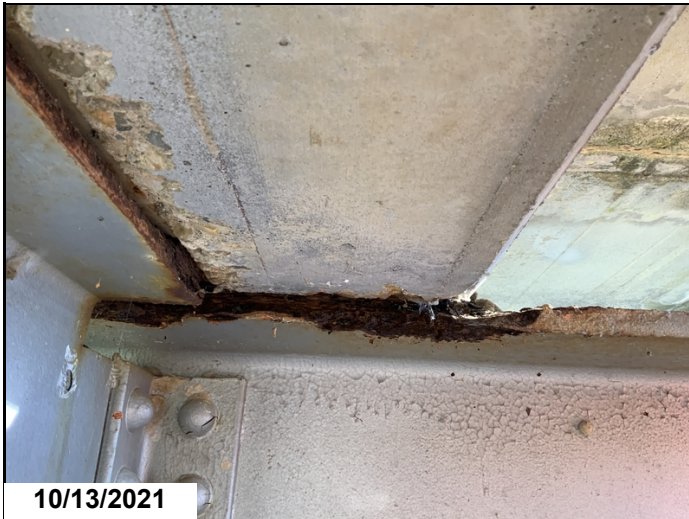
Span 16 Floor beam 5 right side knife edge section

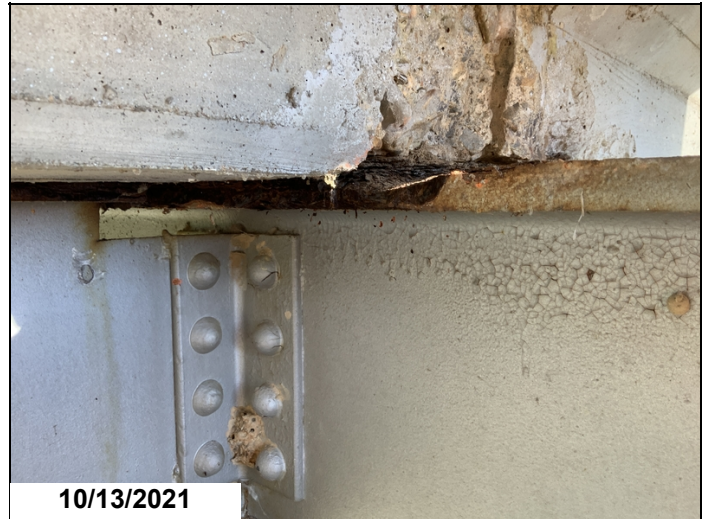
Span 16 Floor beam 5 Knife edge section loos.

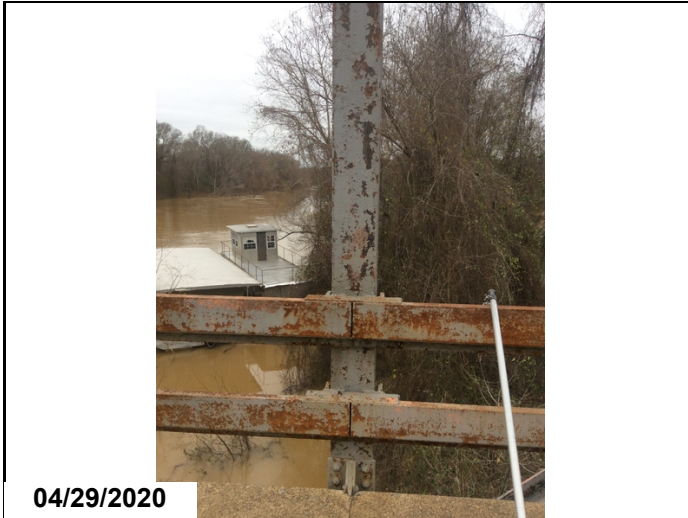
Paint system is failing on truss spans, chalky and some red lead is exposed. Some rusting @ areas where debris have accumulated on floor beam connections and flanges. 12/20/2017 JPR -- Bare metal with some pack rust and section loss present on the truss span

PP 5 left truss 3 showing paint condition. Typical of all truss components.

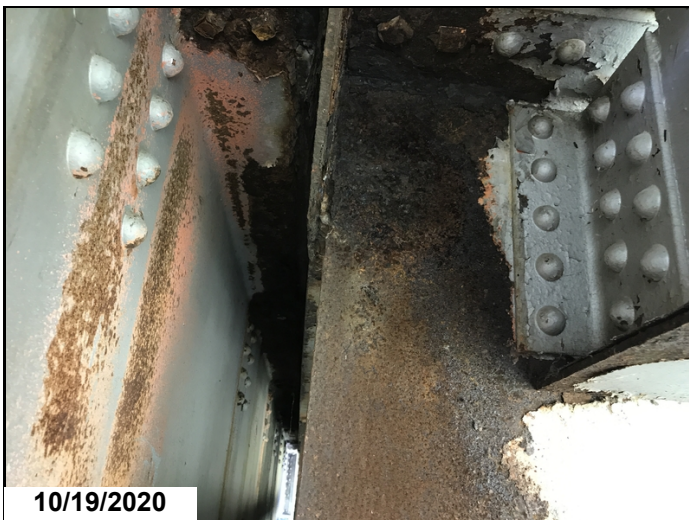
Pier 4 (AHD) has approximately 1/4" section loss

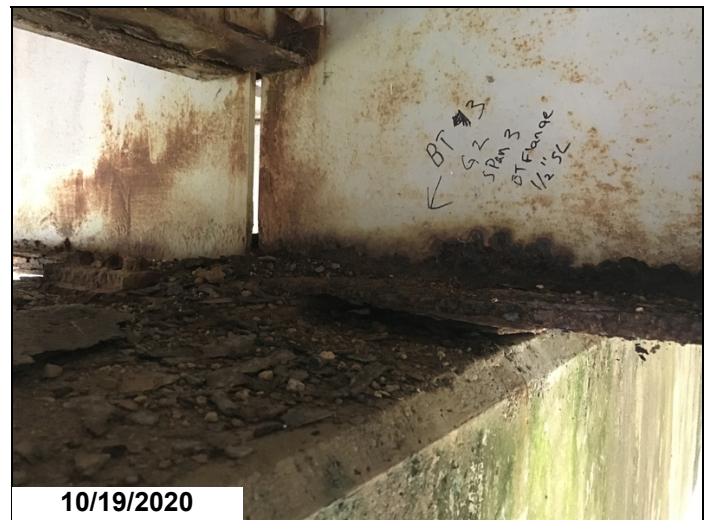
Bent 3 girder 2 1/2" section loss bottom flange

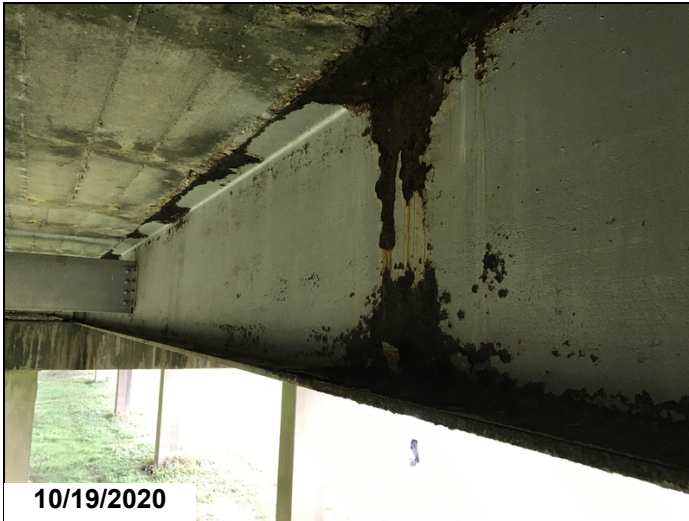
Typical corrosion along the webs in various locations

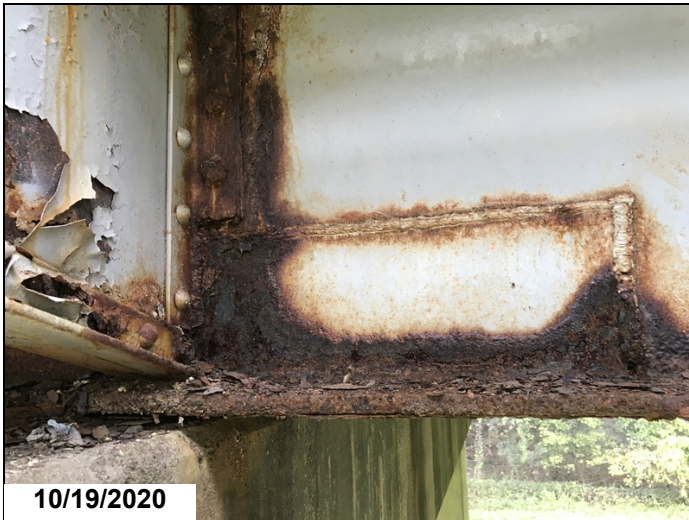
Typical corrosion along the beam ends

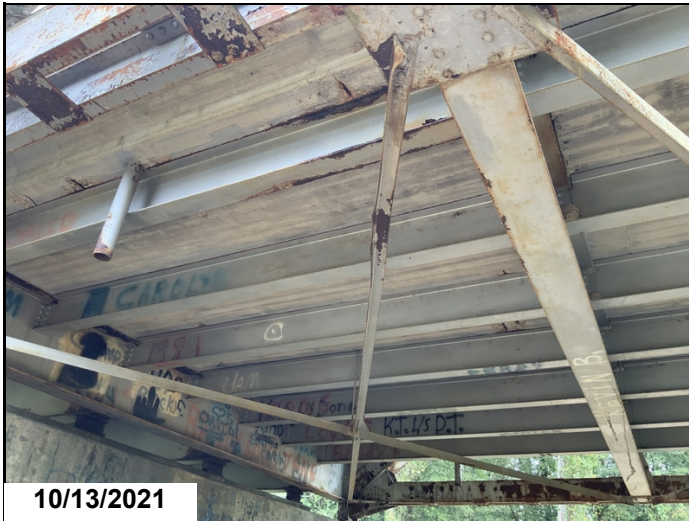
Collision damage

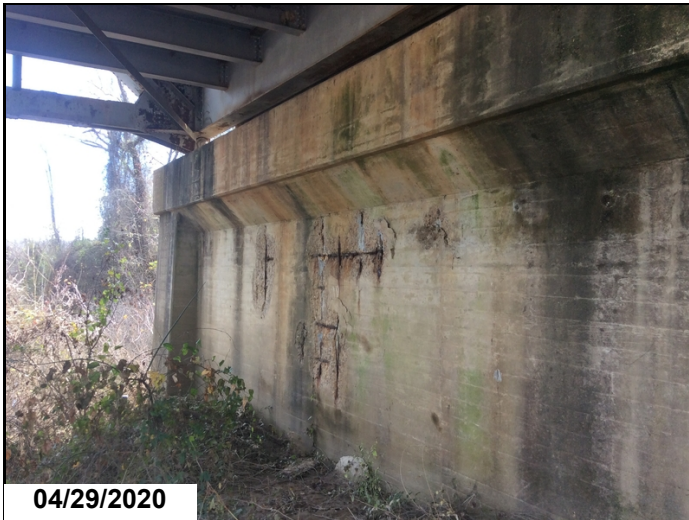
02466 Spalls with exposed steel. Pier wall 1 ahead side.

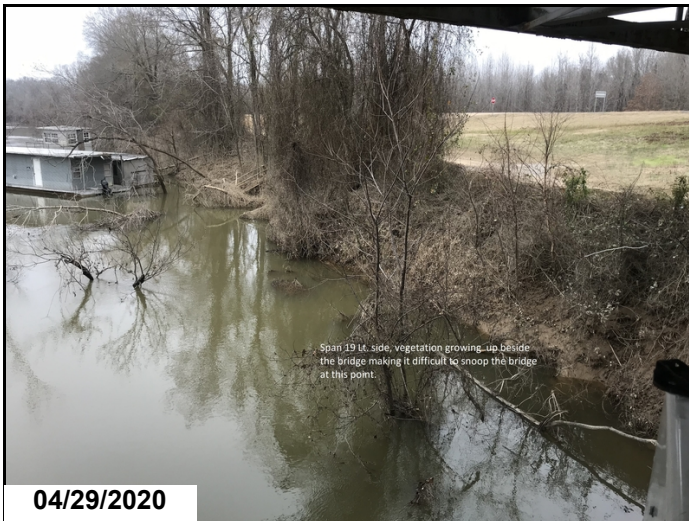
Span 19 Lt. side there are some trees growing up beside the bridge, making it hard to snoop the bridge.
