Asset #03476(Routine)

SH 53 SEC.02-0.001 over LITTLE MISSOURI RIVER

Location: 2.8 MI NE JCT SH 53 & 24

Team Lead: Jared Kegley Inspection Date: 02/26/2024

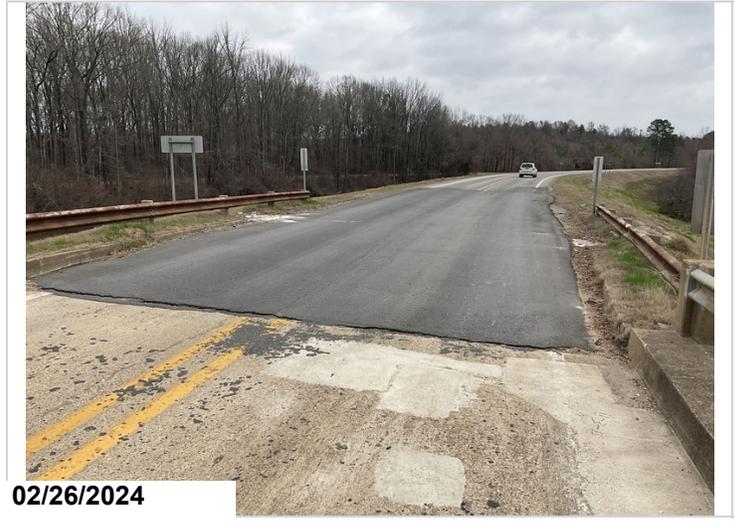
Asphalt overlay butted up to the end of bridge.

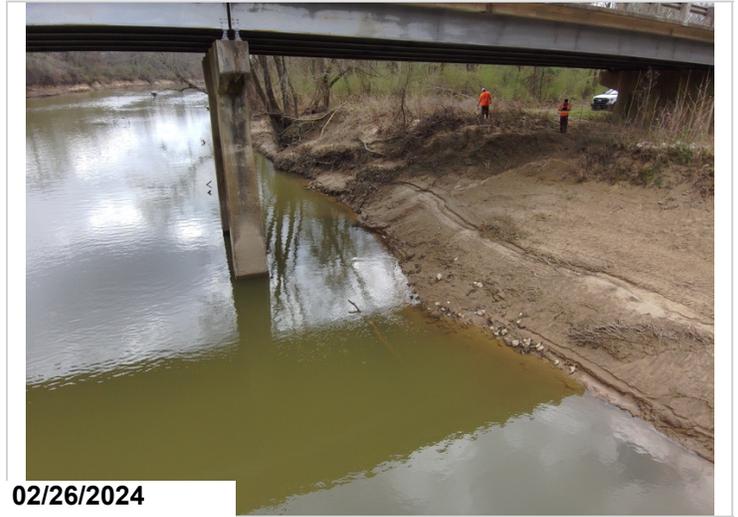
Erosion around pier 2 channel bank

(HBM) 03/2022 It is recommended to install engineered countermeasures along the north bank to mitigate additional erosion and help contain flow through the bridge site.

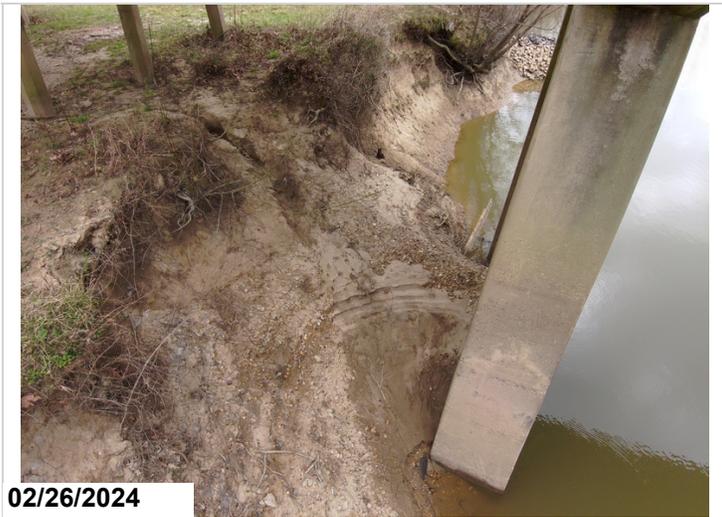
According to available bridge drawings, dated 1963, Piers 1 through 4 are founded on piles and concrete pile caps. A comparison of field observations to the bridge drawings indicates that 4' to 6' of general scour has occurred throughout the original channel, exposing the Pier 3 pile cap up to 12"H. Up to 20' of scour/bank erosion has occurred at Pier 4, exposing the pile cap up to 6"H, and exposing the pier to normal channel flow.

Erosion around pier 4

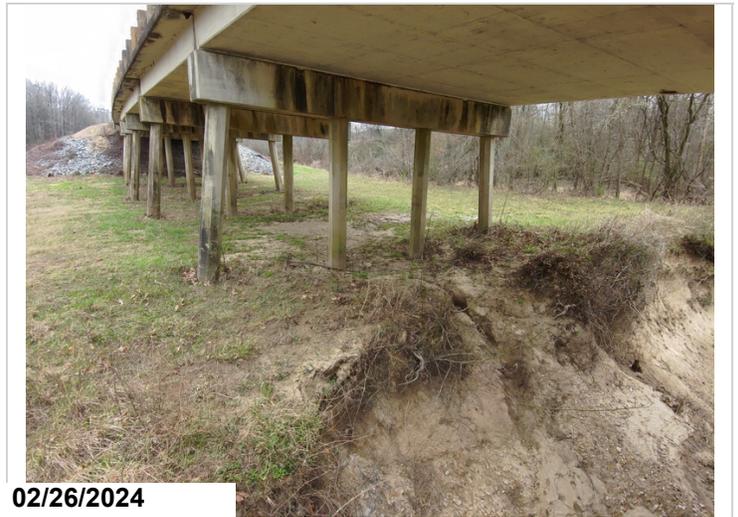
Erosion between pier 4 and bent 24

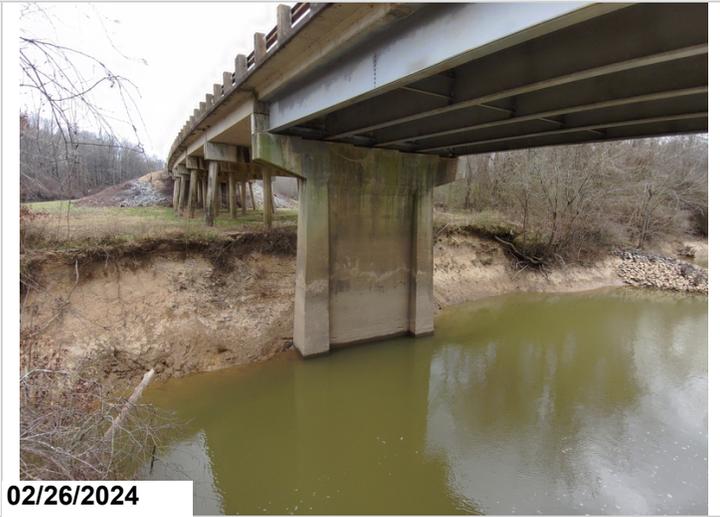
Erosion around pier 4

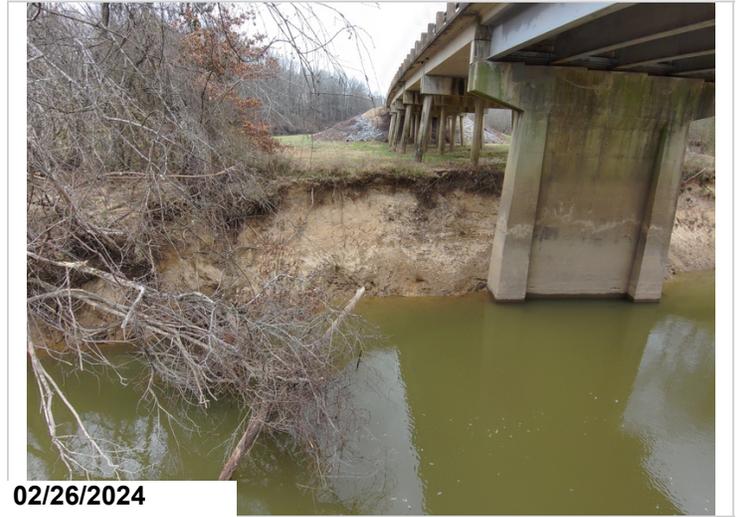
Erosion around pier 4

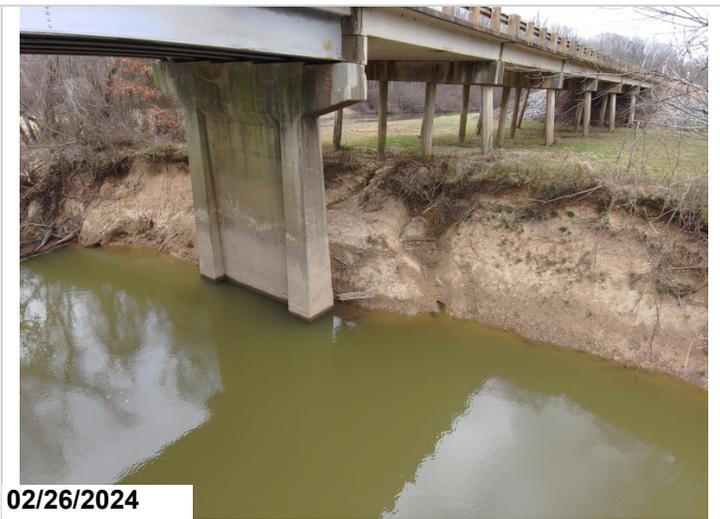
Erosion around pier 4

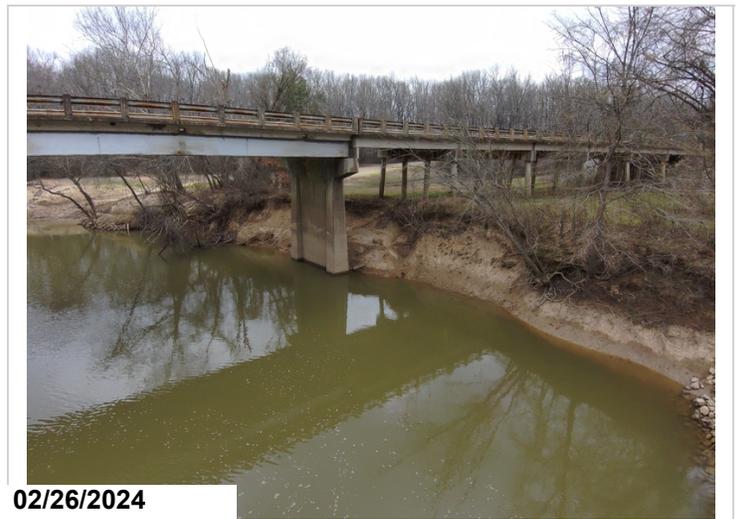
Erosion around pier 4

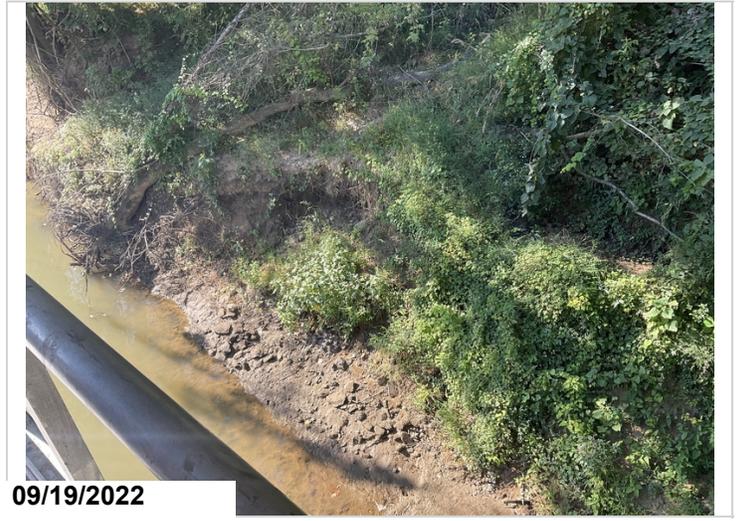
Overall, the channel is in fair condition. The bridge is located downstream of a 90 degree bend that causes flow to approach the substructure units at an approximate 20 degree angle. Based on the 1963 plans, general scour has lowered the channel bottom between 4' and 6' since construction. This degradation and channel migration to the north have led to extensive erosion and displacement of the bank material. Since construction, the north bank has migrated approximately 30 feet to the north exposing Pier 4 to normal channel flow. There is moderate timber debris along the south faces of Piers 2 and 3, as well as the upstream nose of Pier 3. The banks upstream and downstream of the bridge display signs of moderate undercutting/slumping on the outer bends, uprooting large trees in some areas. The south bank under the bridge is generally stable with light vegetation. There is a cut bank on the north shoreline at Pier 4, as described above. It is recommended to lower the Item 61 rating to 5, based on the condition of the north bank. It is also recommended to install engineered countermeasures along the north bank to mitigate additional erosion and help contain flow through the bridge site.

Bank erosion

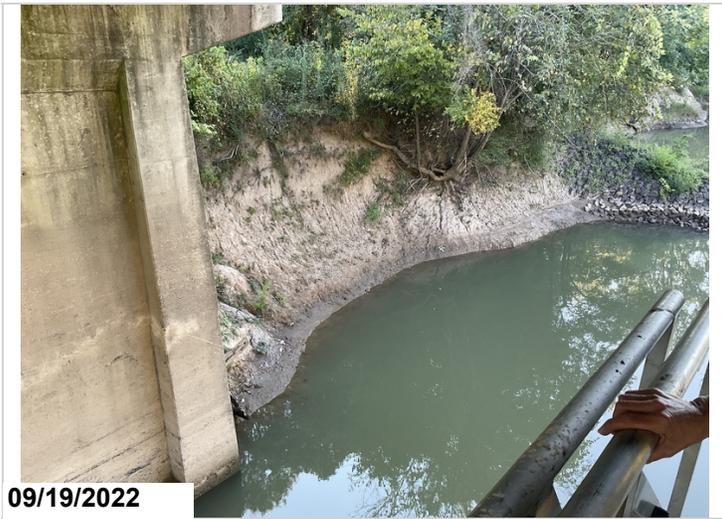
Bank erosion

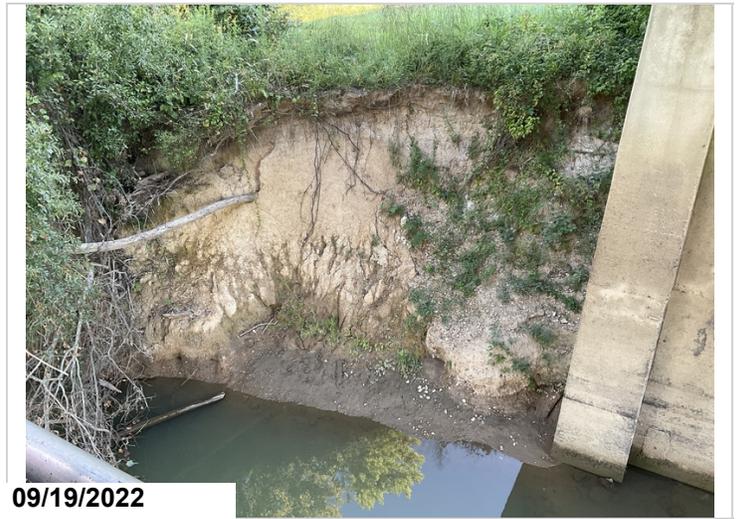
Bank erosion

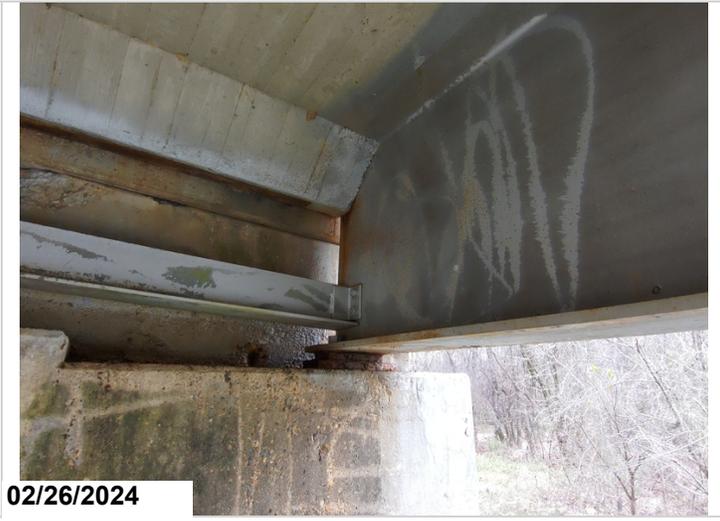
Superstructure is rated a 5 this inspection due to corrosion with section loss on end of beam 5 above pier 1. Various locations of spalling with rebar exposed that has minor section loss on bottom side of slab.

All beam ends need to be painted.

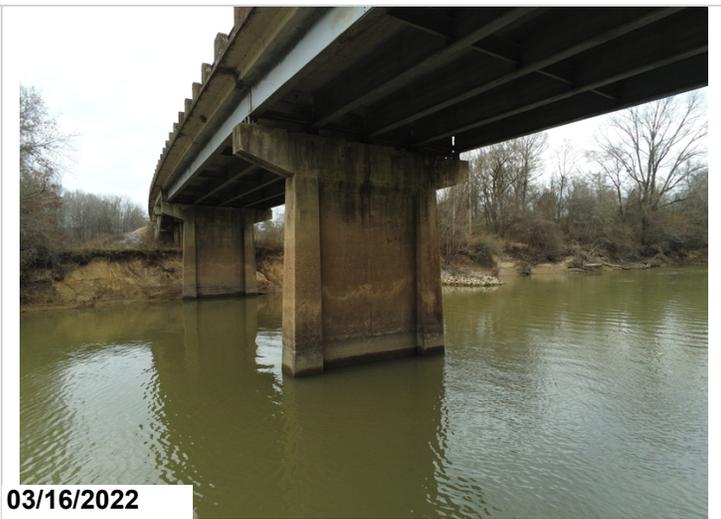
PIER 3

Overall the substructure units are in good condition with minor to moderate scaling located throughout the columns and web walls and partially exposed footings at Piers 3 and 4. These defects are quantified in the element level portion of this report.

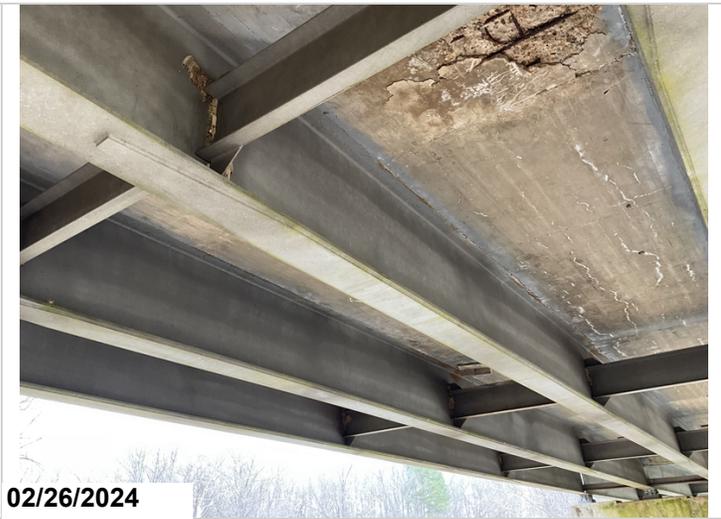
Welded cover plates on steel beams

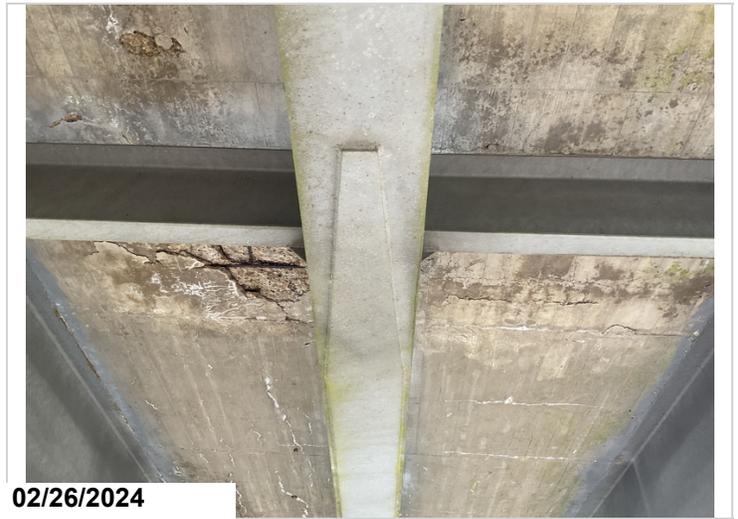
Welded cover plates

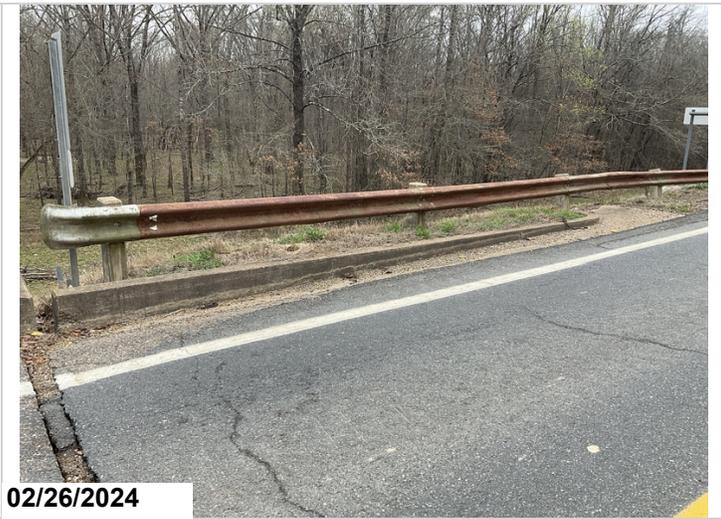
Corrosion and minor damage to bridge railing transition, typical in various locations

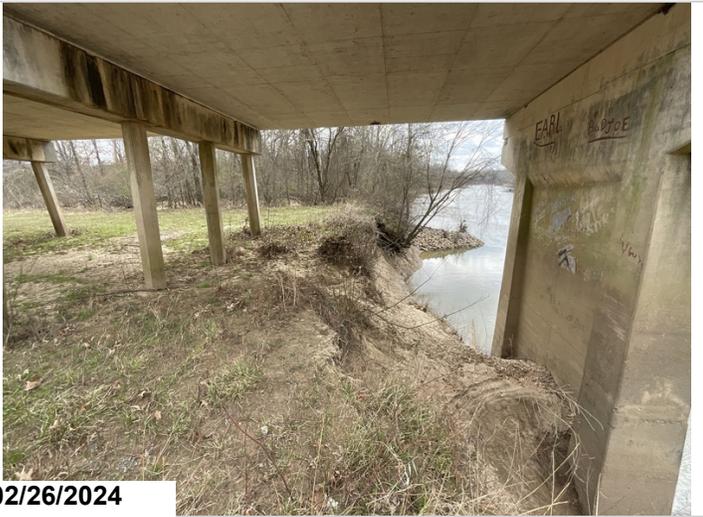
Scour around Pier 4, Scour is approximately 8' from reaching Bent 25 pile

(HBM) 03/2022 It is recommended to install engineered countermeasures along the north bank to mitigate additional erosion and help contain flow through the bridge site.

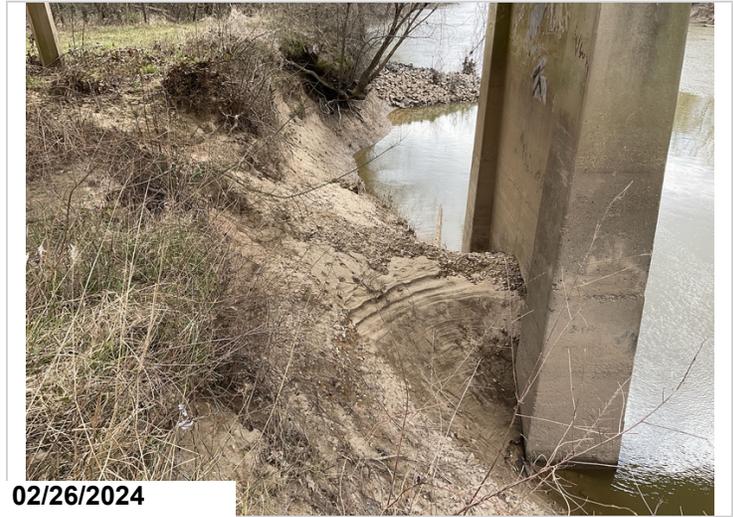
Scour around Pier 4, Scour is approximately 8' from reaching Bent 25 pile

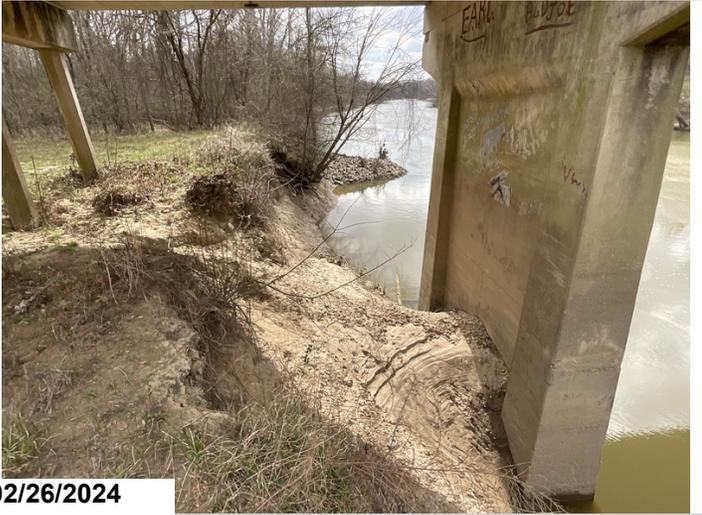
Scour around Pier 4, Scour is approximately 8' from reaching Bent 25 pile

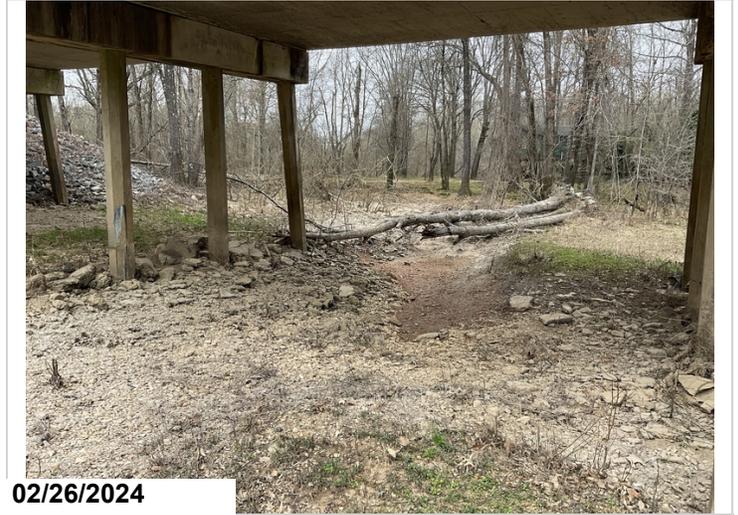
Scour around Pier 4, Scour is approximately 8' from reaching Bent 25 pile

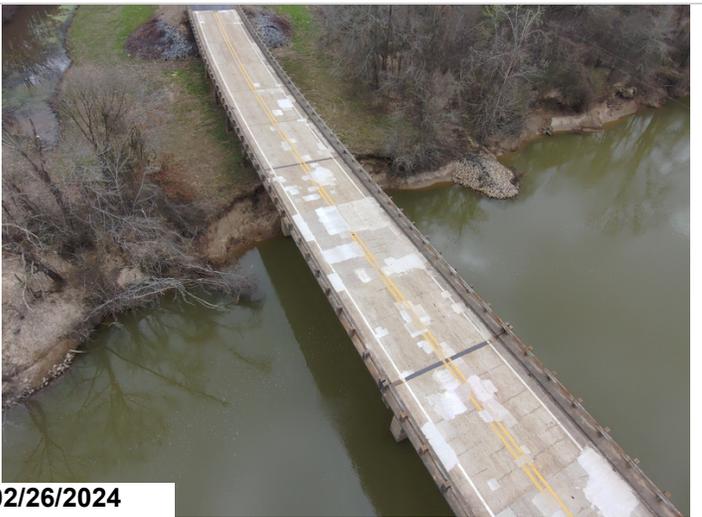
Minor scour between bents 3 & 4 in approach span

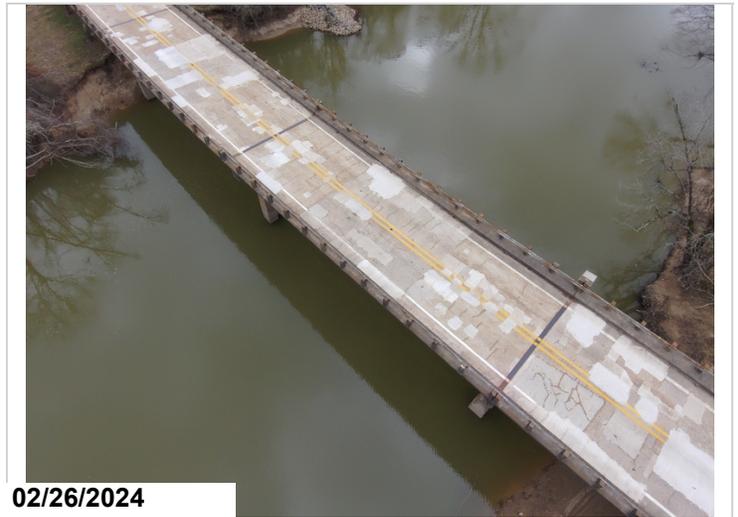
Main span, Deck Patching, CS2 & CS3

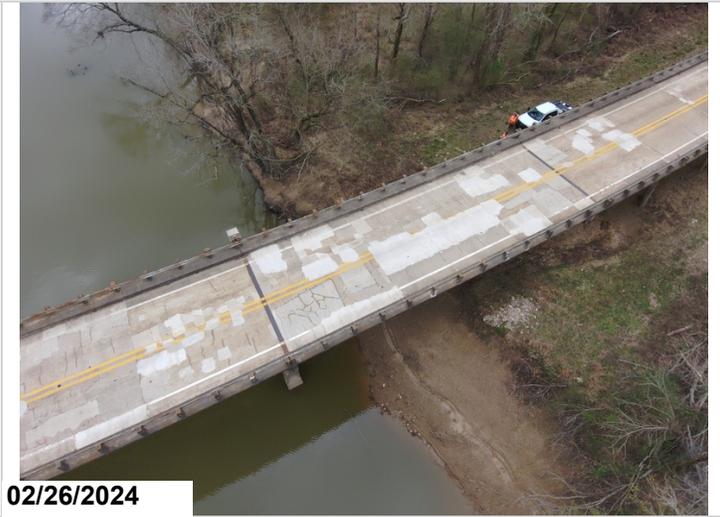
Main Span, Deck Patching, CS2 & CS3

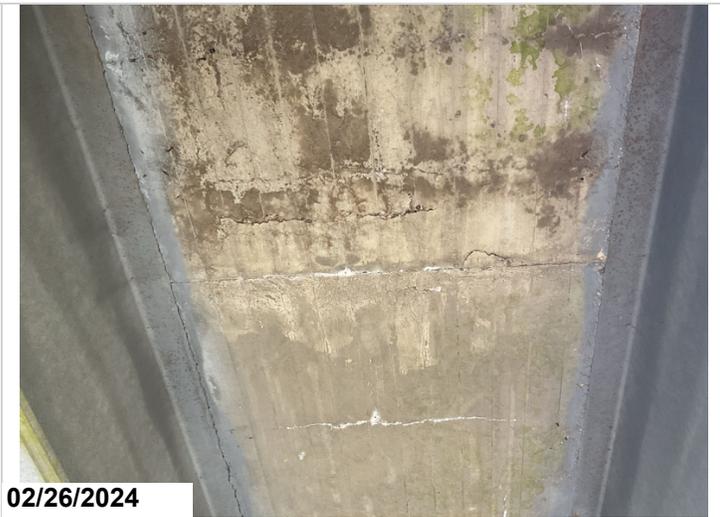
Main span 1, Underside of deck at right side, Rebar exposed at drain, 1 Sq Ft, CS3

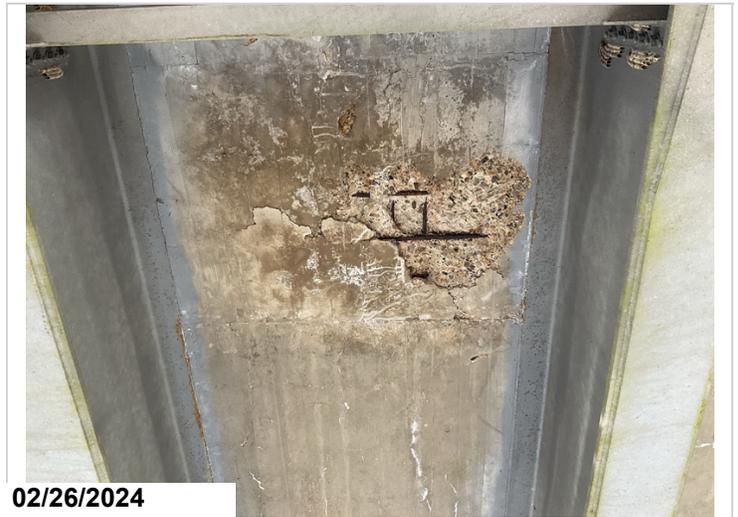
Main span 1, Underside of deck, Delam in bay 4, 3 Sq Ft, CS2

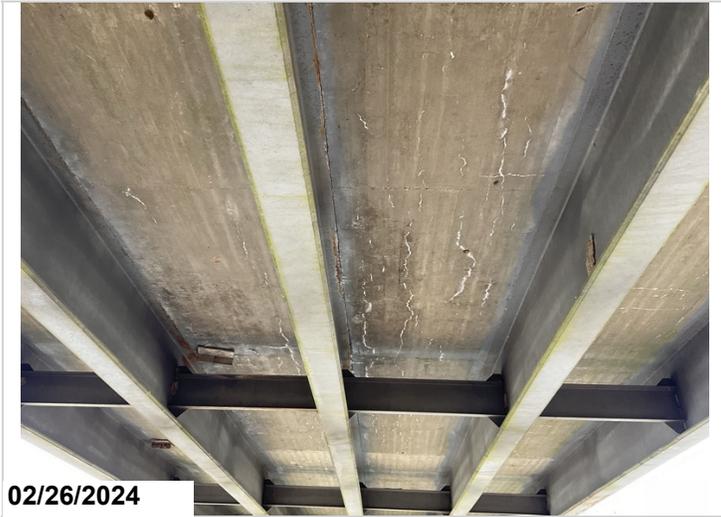
Main span 1, Underside of deck, Rebar exposed in bay 3, 2 Sq Ft, CS3

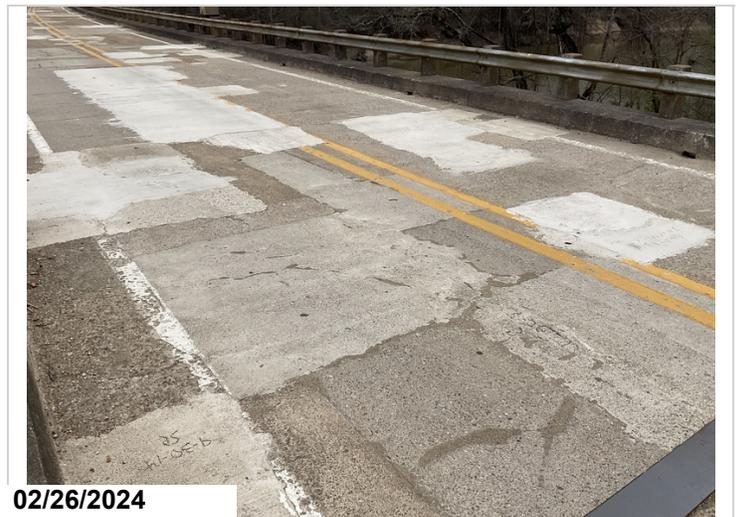
Main span 1, Southbound Lane, Large patched area, 63 Sq Ft, CS2

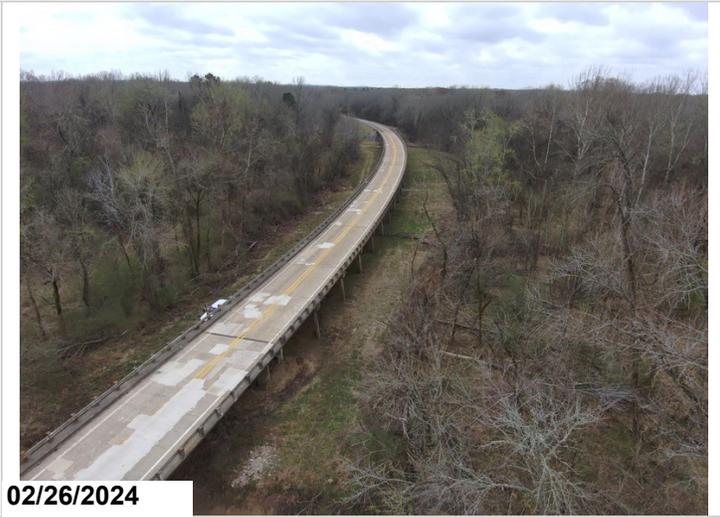
Main span 1, Both North and Southbound lanes, Patched areas, CS2 & CS3

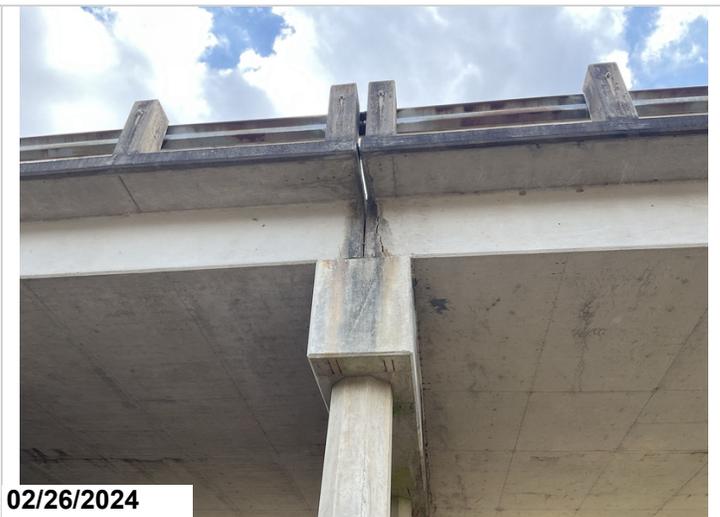
Approach span, Bent 28, Looking back, Delam on right side,
1 Sq Ft, CS3

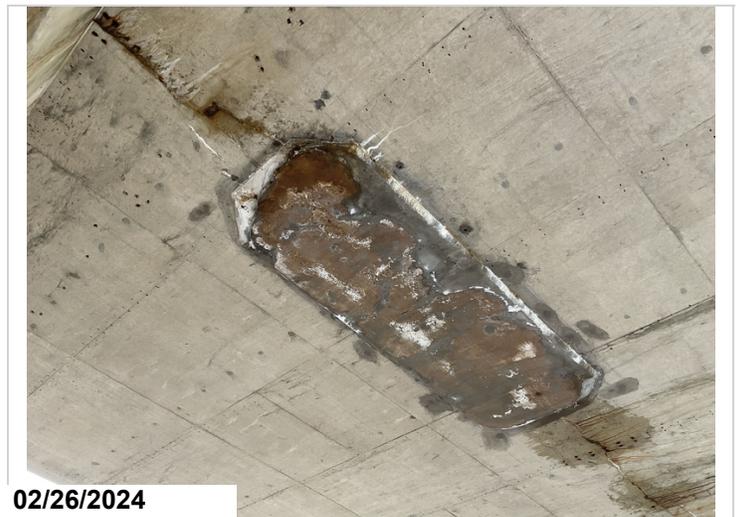
Approach span, Bent 28, Delam on left side, CS3

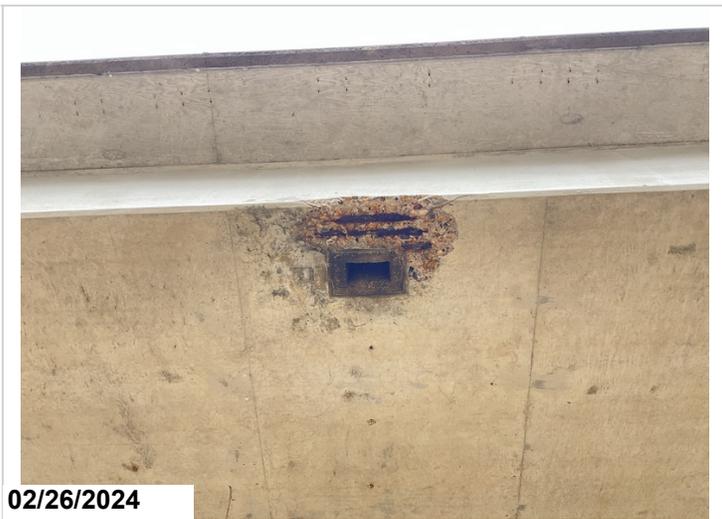
Approach span 3, Underside of deck, Right side, Exposed rebar at drain, 1 Sq Ft, CS3

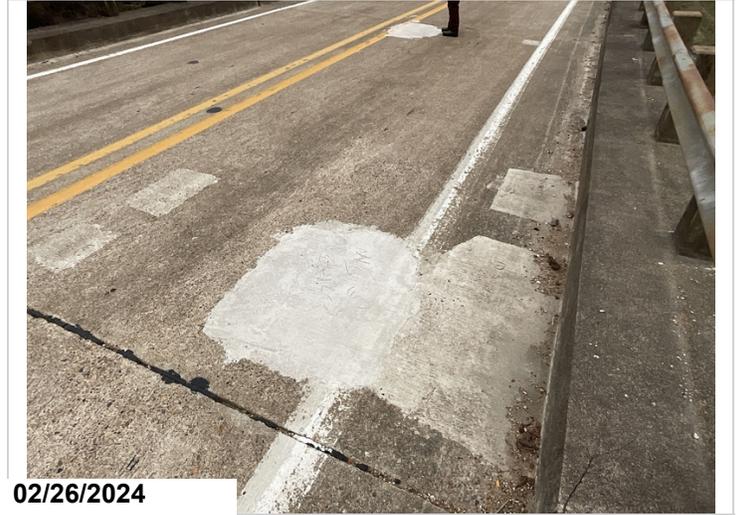
Approach span 15, Northbound lane, Patched areas, CS2

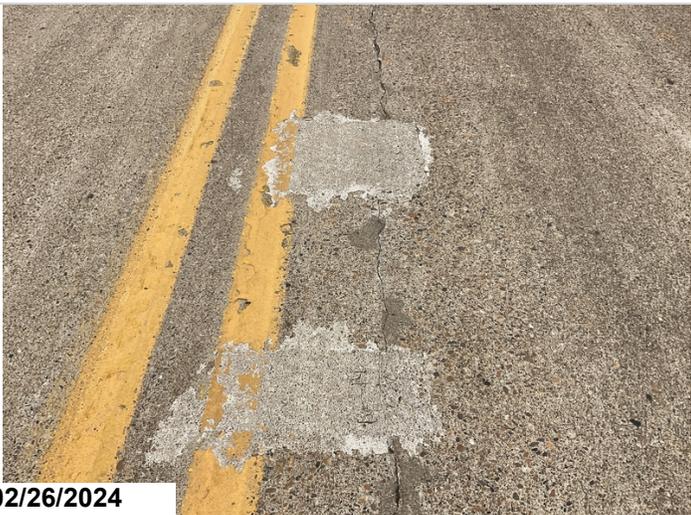
Approach span 6, Northbound Lane, Patched areas, 8 Sq Ft, CS2

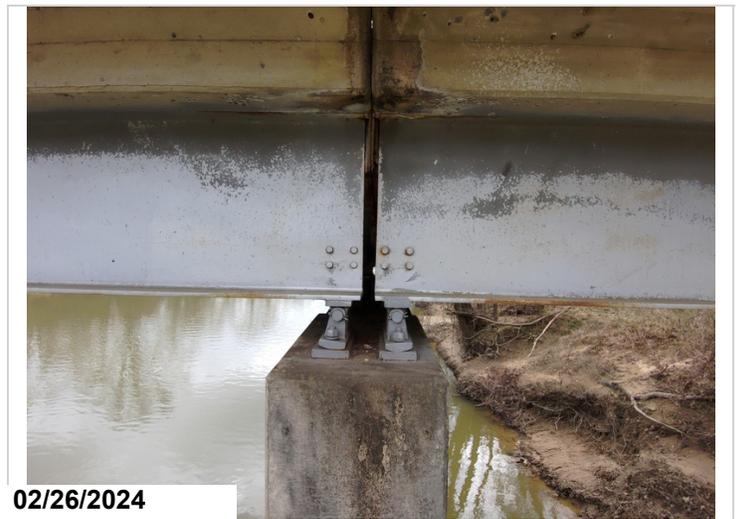
Pier 2 beam end corrosion, CS2.

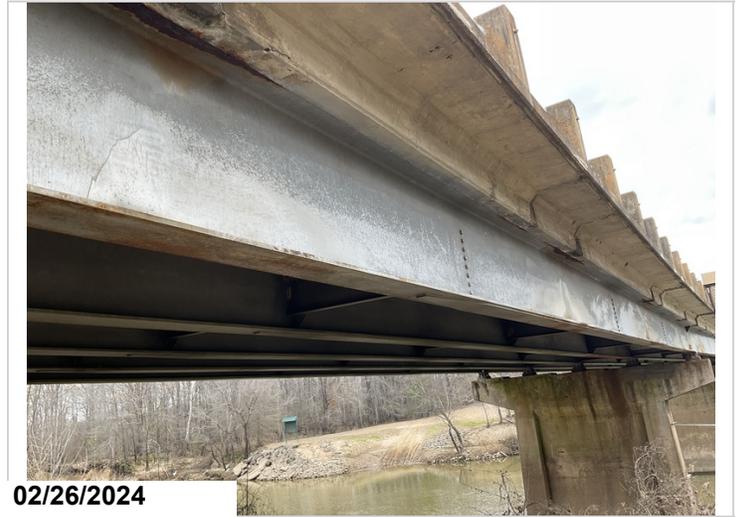
Main span 1, Outside of beam 5, Loss of effectiveness, 1 Sq Ft, CS4

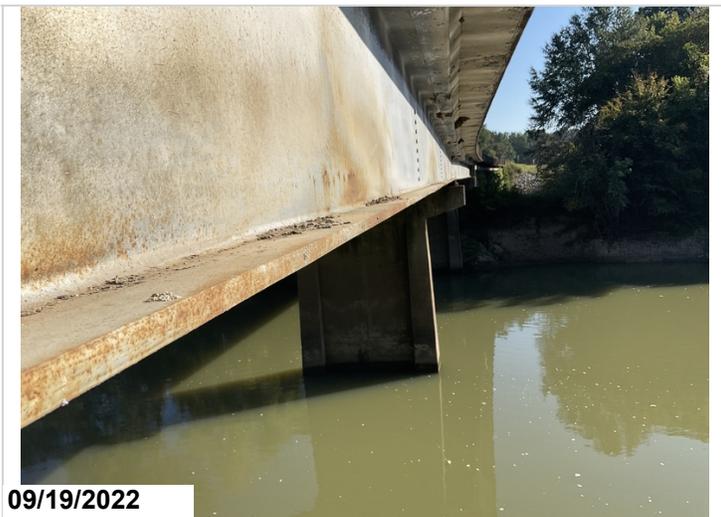
Main span 1, Outside of beam 5, Chalking, CS2

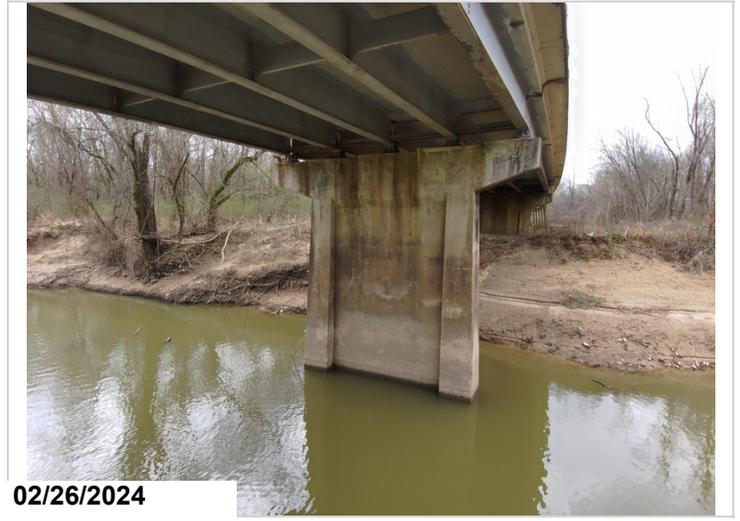
Main span, Pier 2, Looking ahead, Abrasion to both columns 1 & 2, CS2

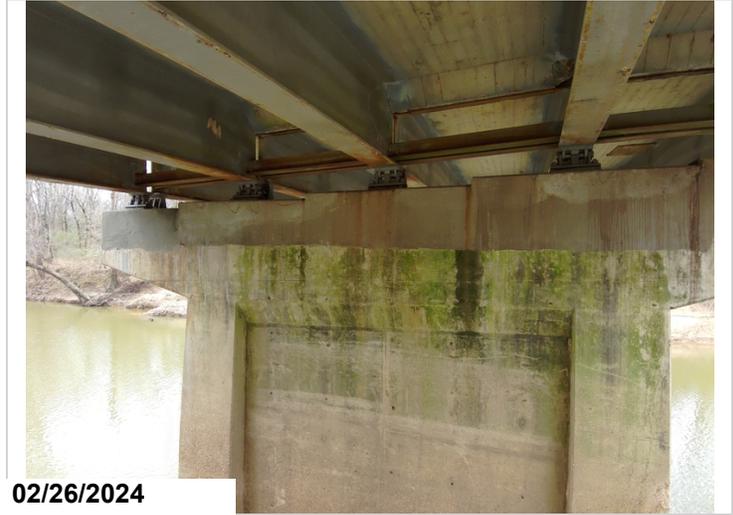
Approach span, Bent 2, Pier Cap, Exposed rebar on underside of cap, CS2

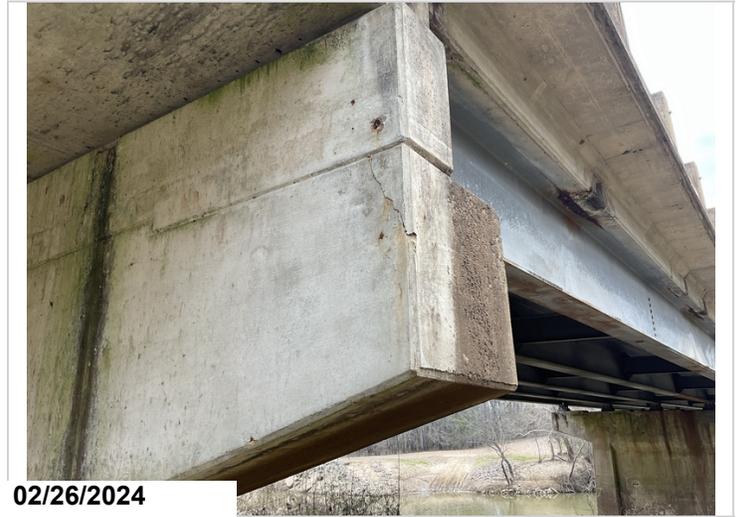
Main span, Pier 4, Looking back, Rebar exposed on right side, 1 LF, CS3

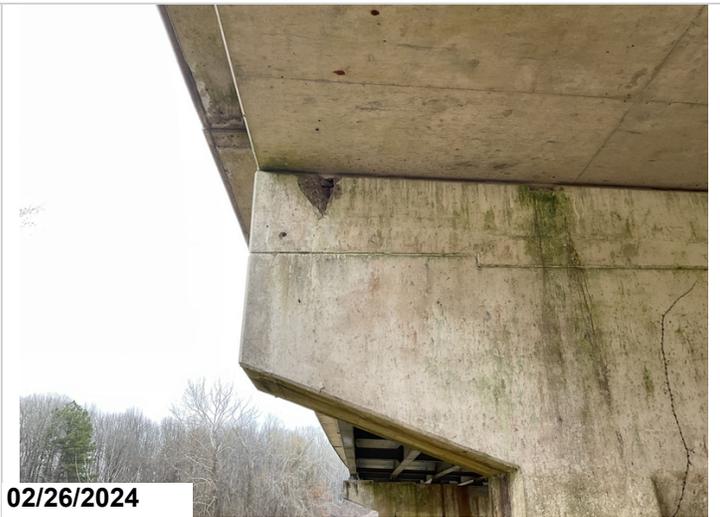
Main span, Pier 1, Looking ahead, Delam to right side of cap, 1 LF, CS2

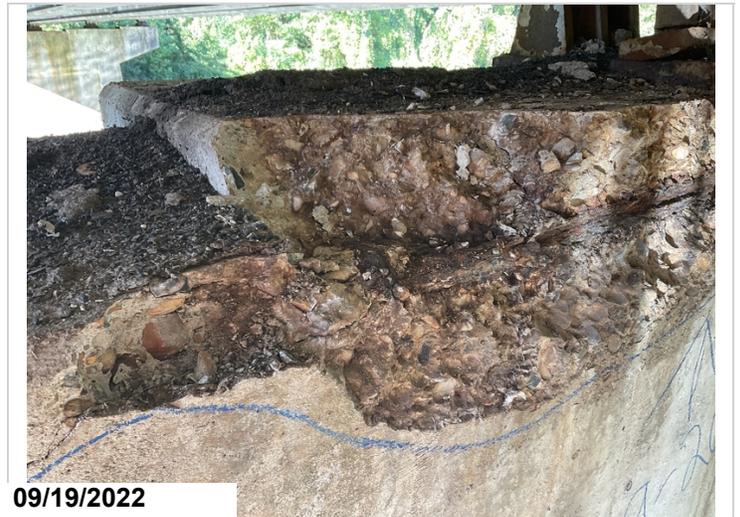
Main span, Pier 1, Looking ahead, Rebar exposed to left side of cap, 1 LF, CS3

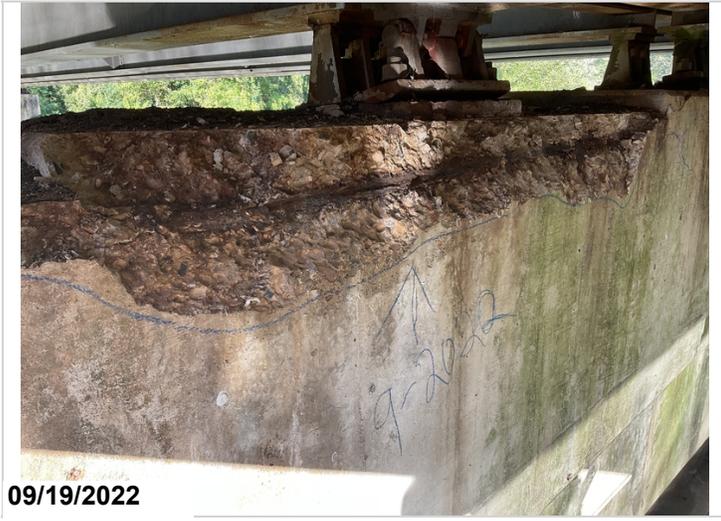
09/19/2022

Main span, Pier 2, Rebar exposed near bearing area, CS3

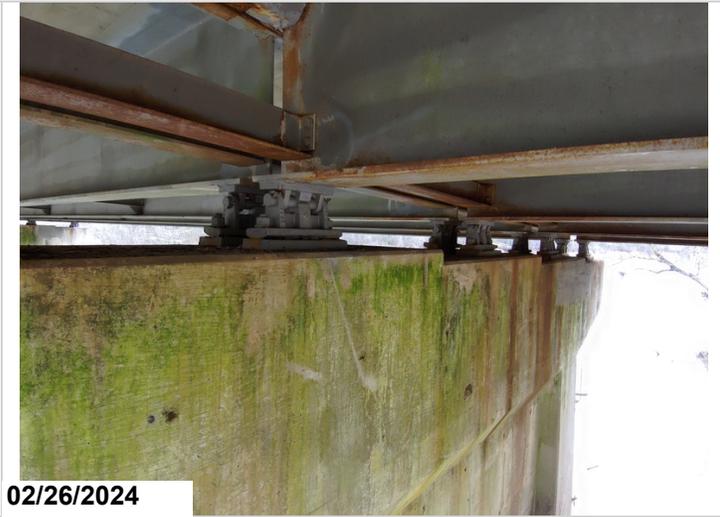
Bearings at pier 2

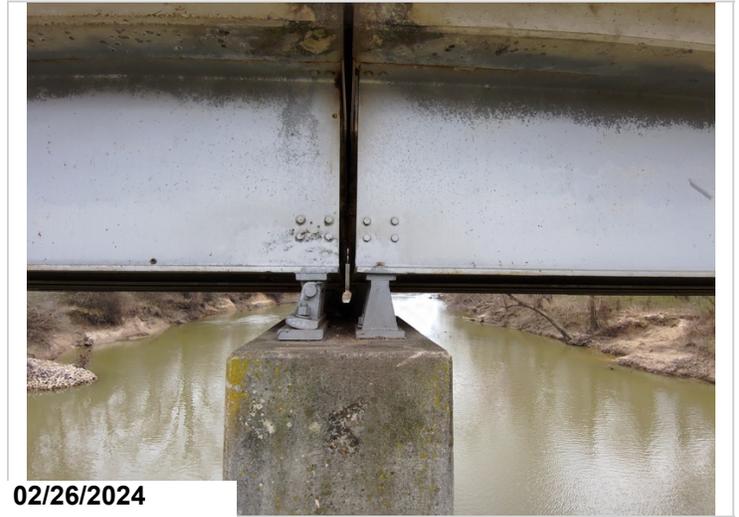
Pier 3 movable bearing

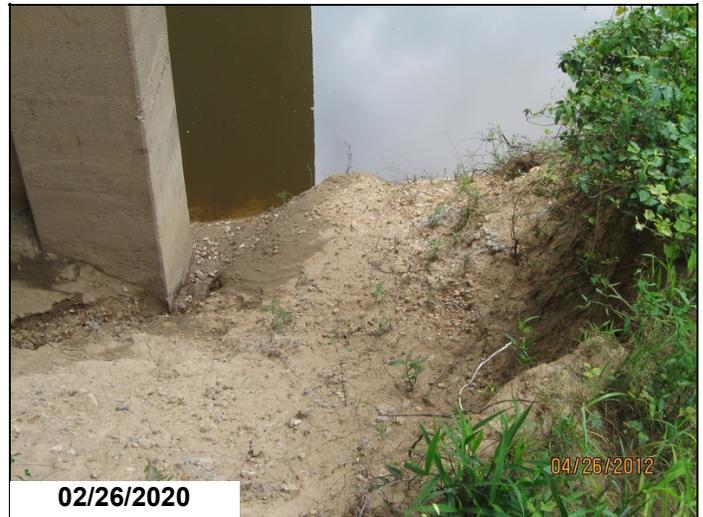
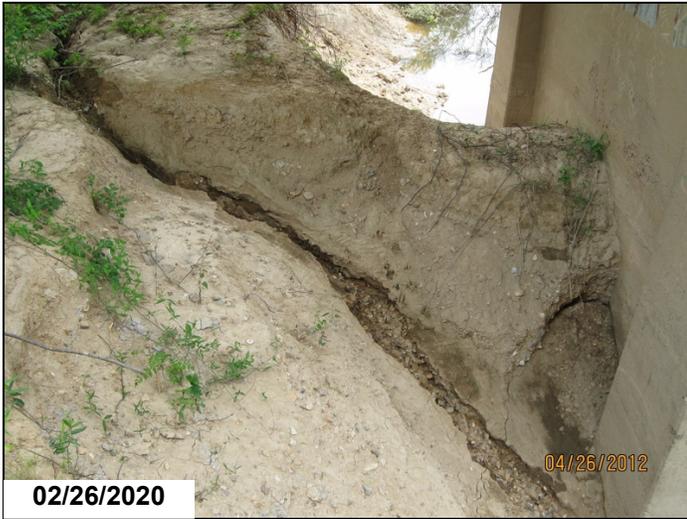
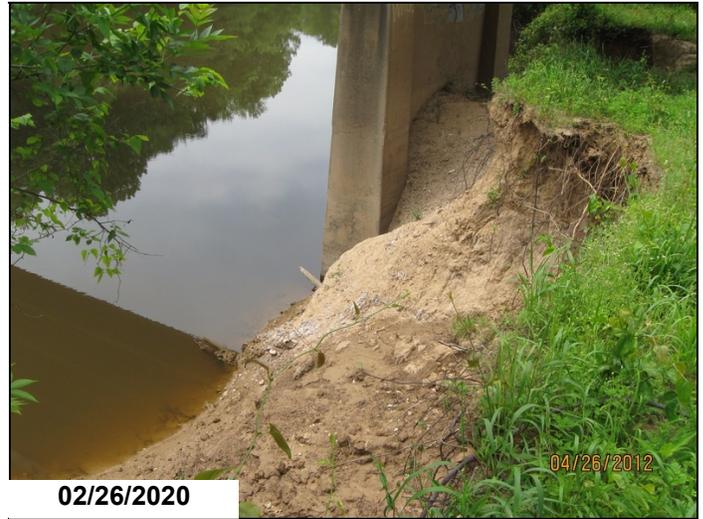
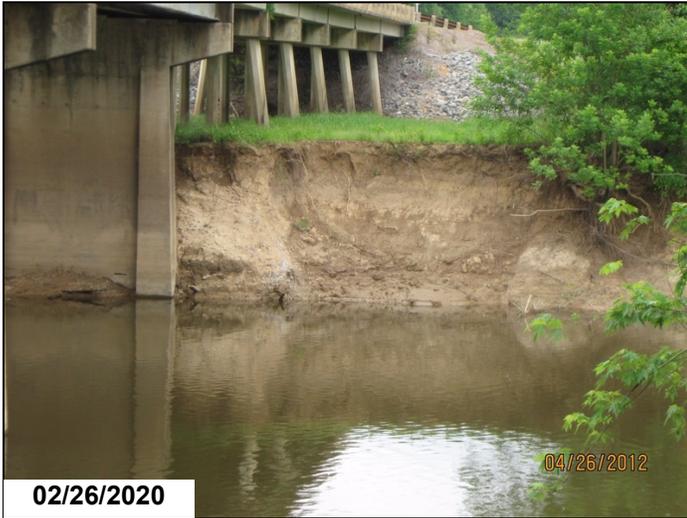
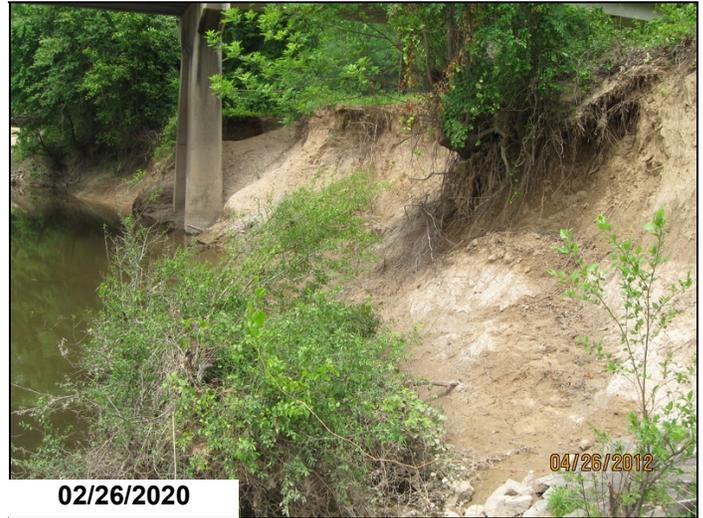
EROSION AT PIER #1&3 HAS STARTED AROUND AND BEHIND COLUMNS/WALLS.

(HBM) 03/2022 It is recommended to install engineered countermeasures along the north bank to mitigate additional erosion and help contain flow through the bridge site.

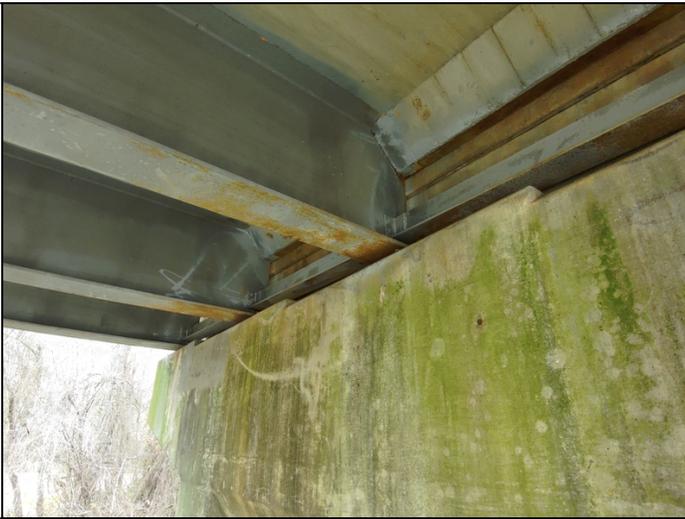
All beam ends need to be painted.

A-57 - Girder End and Bearing Painting Needed (Yes)
All steel beam ends in all spans need to be painted.

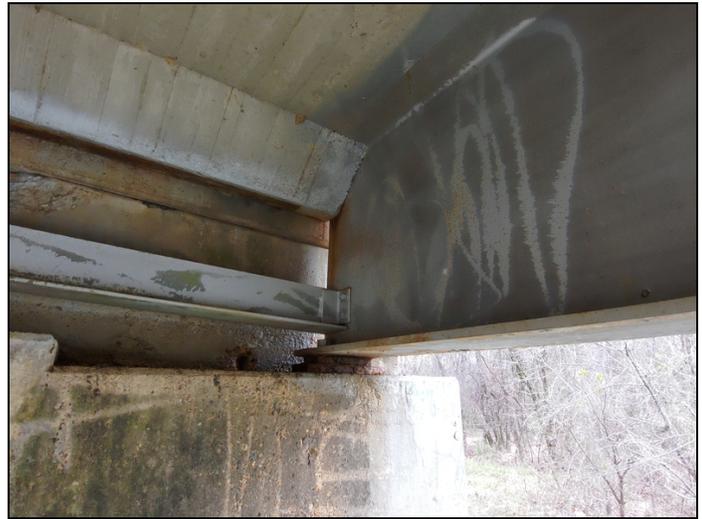
All beam ends need to be painted.

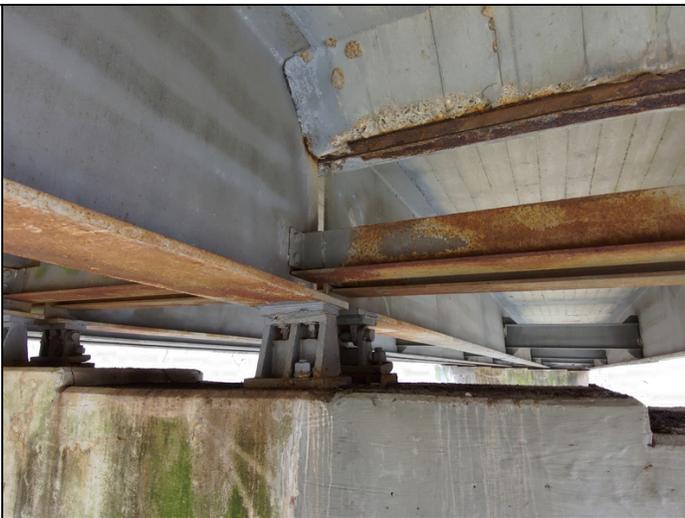
All beam ends need to be painted.

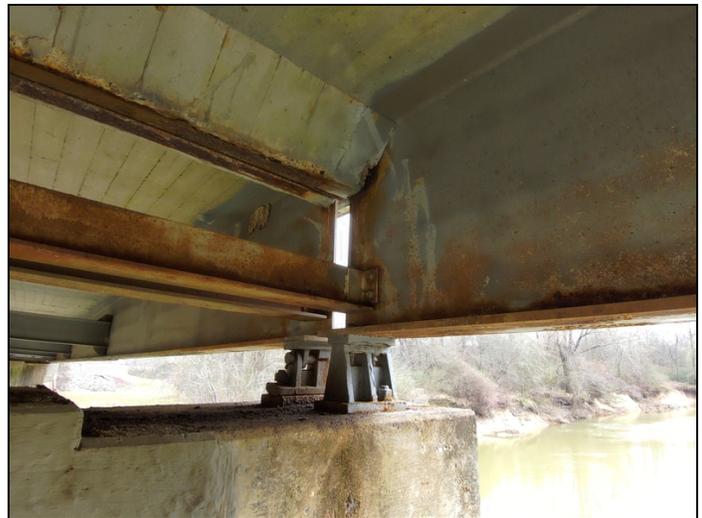
All beam ends need to be painted.

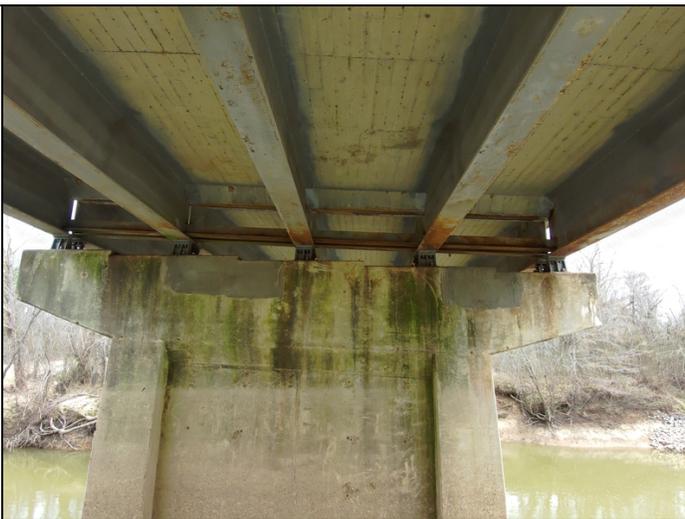
All beam ends need to be painted.
