Asset #A3424(Routine)

I-30 WB Log 97.06 over Ouachita Rvr& Riverview

Location: 1.0 MI SO I-30 & 270

Team Lead: Chris Doggett Inspection Date: 07/22/2024

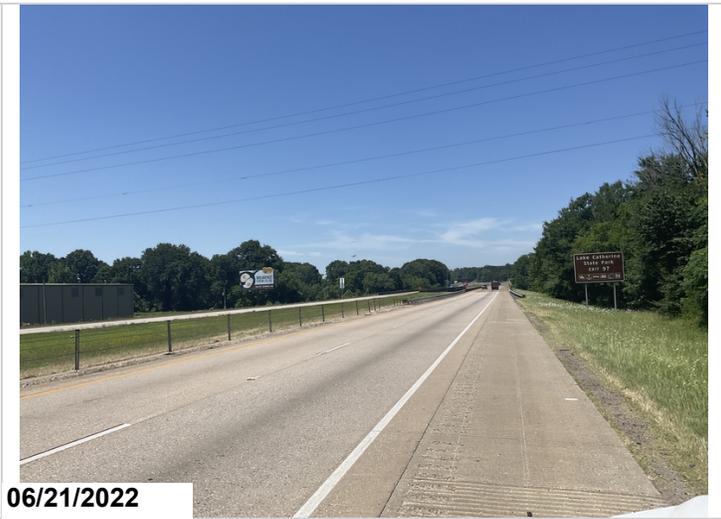
Approach westbound

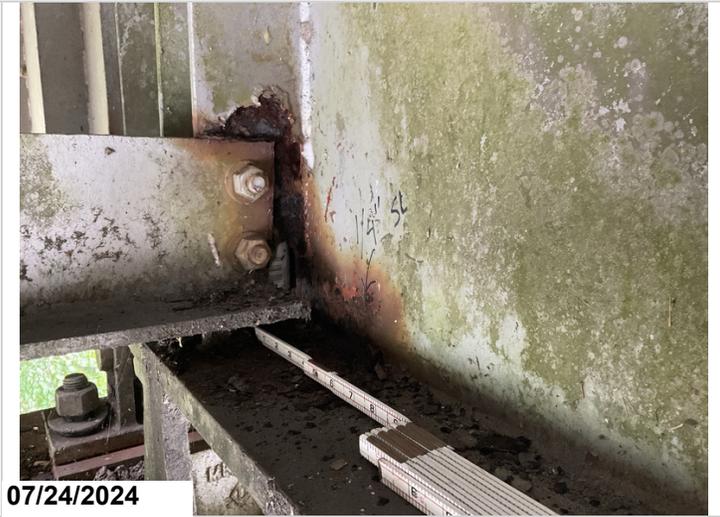
Girder 2, Pier 2, span 4: up to 1/4" section loss to the lower web. (4"x2" area) Large hole in the adjacent stiffener. CS3-1'

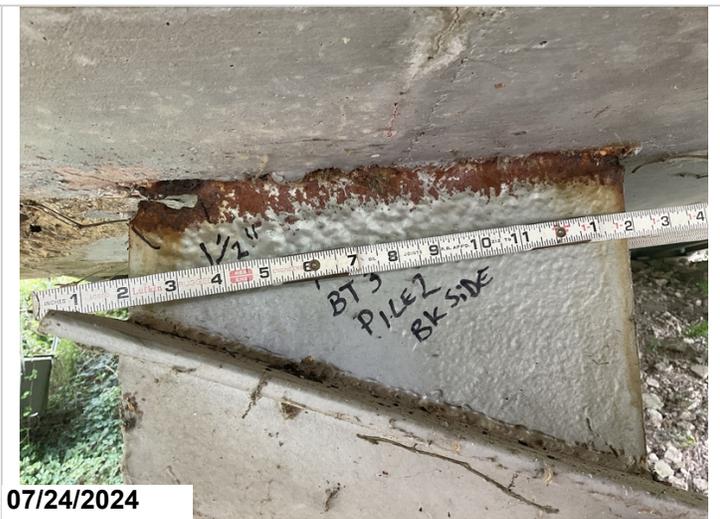
Bent 3, pile 2 backside: The flange has a 1 1/2" hole. CS4-1

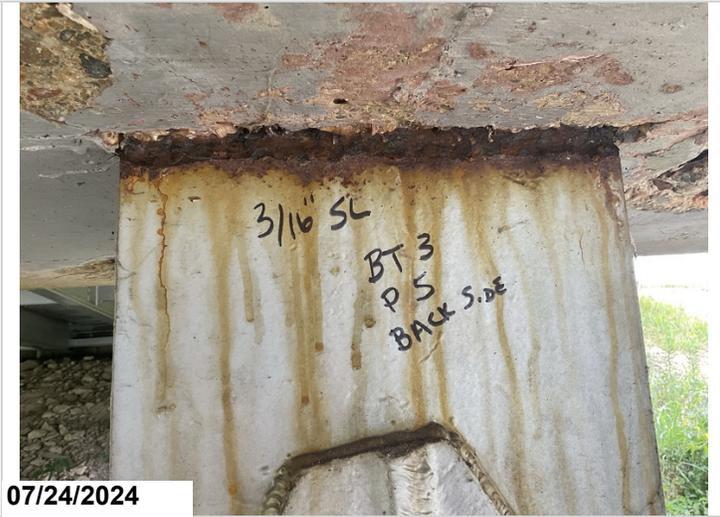
Bent 3, pile 5 backside: the entire flange adjacent to the cap has up to 3/16" section loss. CS3-1

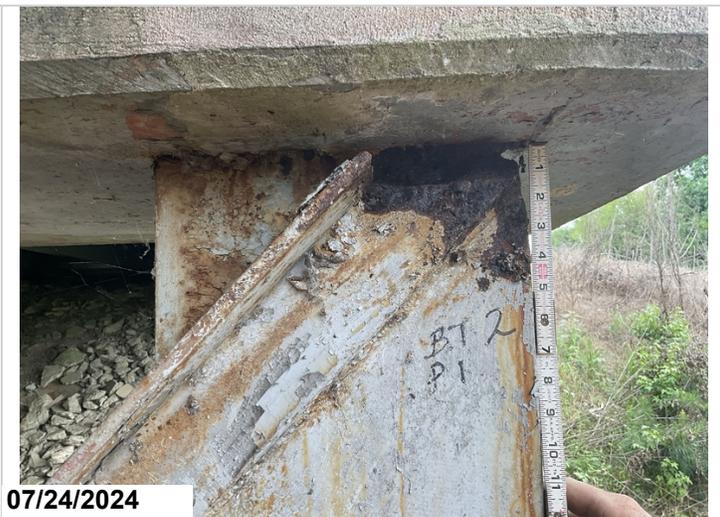
Bent 2, pier 1: the flange has a 1/2' hole on the edge and approximately 4" of section loss up to 3/16" adjacent to the cap. CS3-1

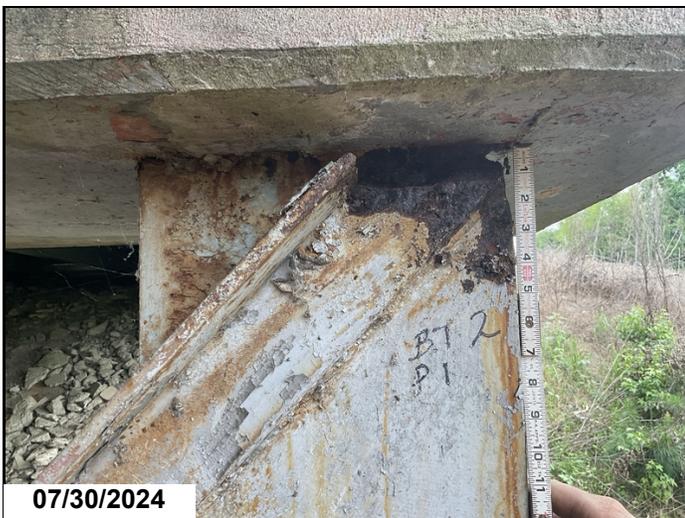
Bent 2, pier 1: the flange has a 1/2" hole on the edge and approximately 4" of section loss up to 3/16" adjacent to the cap. CS3-1

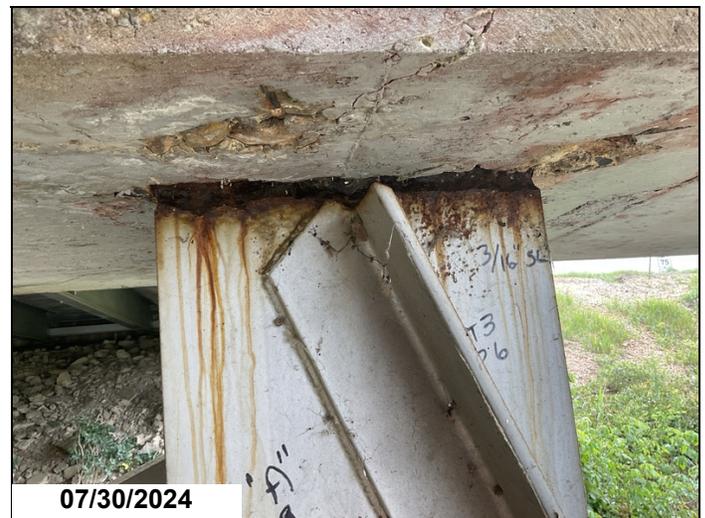
Bent 3, pile 6 backside: the entire flange adjacent to the cap has up to 3/16" section loss. CS3-1

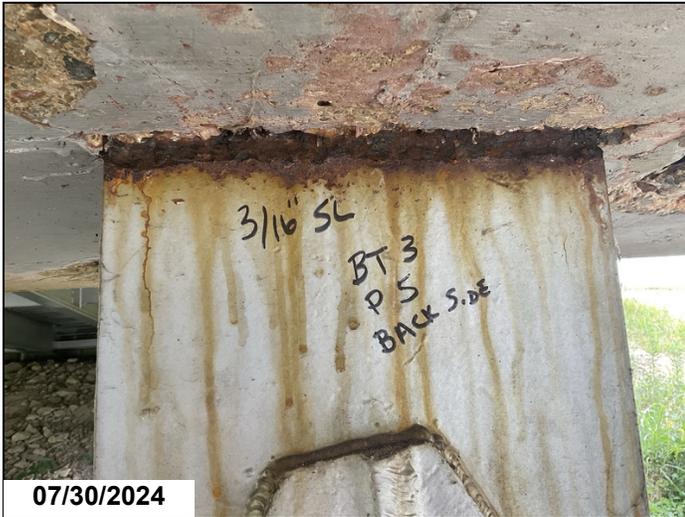
Bent 3, pile 5 backside: the entire flange adjacent to the cap has up to 3/16" section loss. CS3-1

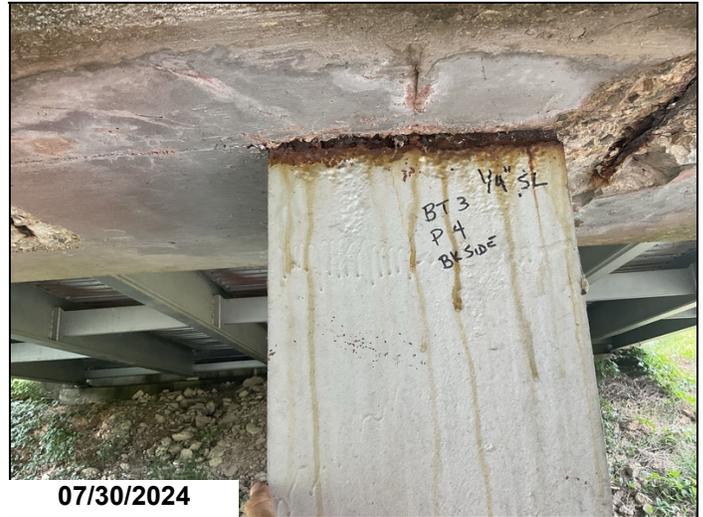
Bent 3, pile 4 backside: the entire flange adjacent to the cap has up to 1/4" section loss. CS3-1

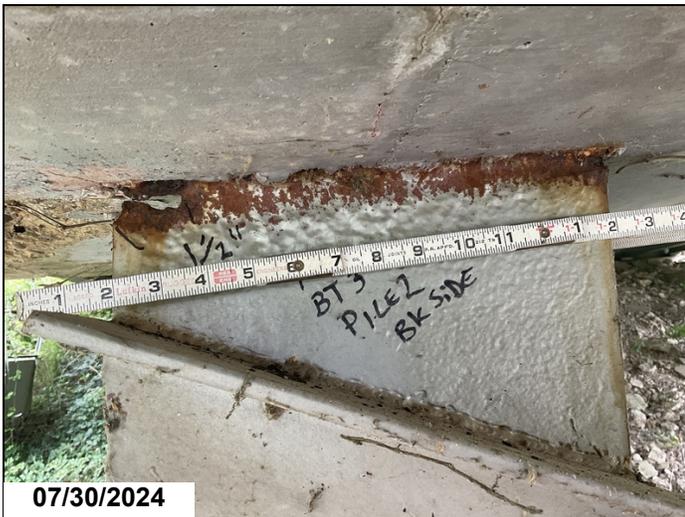
Bent 3, pile 2 backside: The flange has a 1 1/2" hole. CS4-1

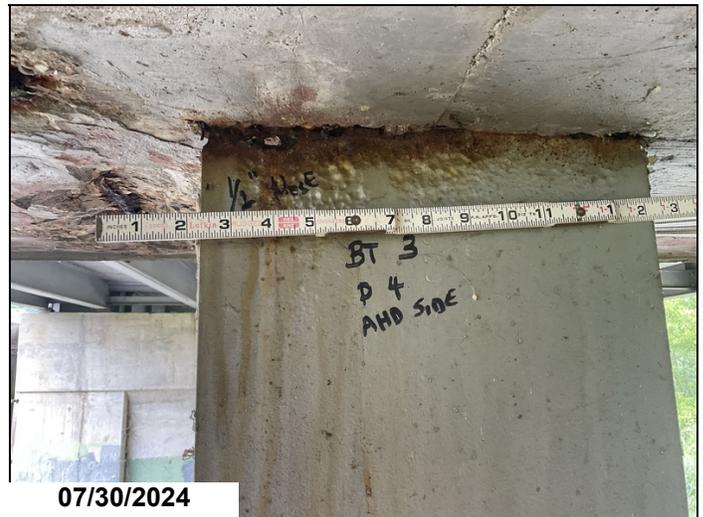
Bent 3, pile 4 ahead: The flange has a 1/2" hole and the remainder has approximately 3/16" section loss adjacent from the cap. CS4-1

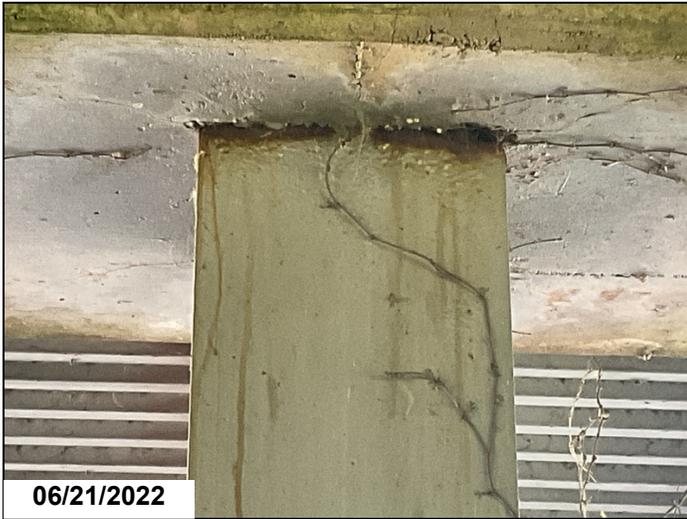
Bent 3 steel pile 3 deep pitting to flange at cap.

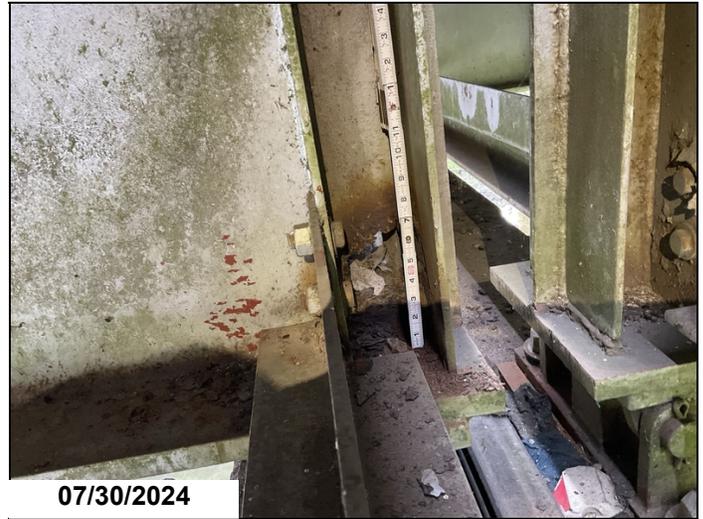
Girder 4: 3"x 3" hole in the web between the stiffeners above the bearing at pier 2. CS4-1'

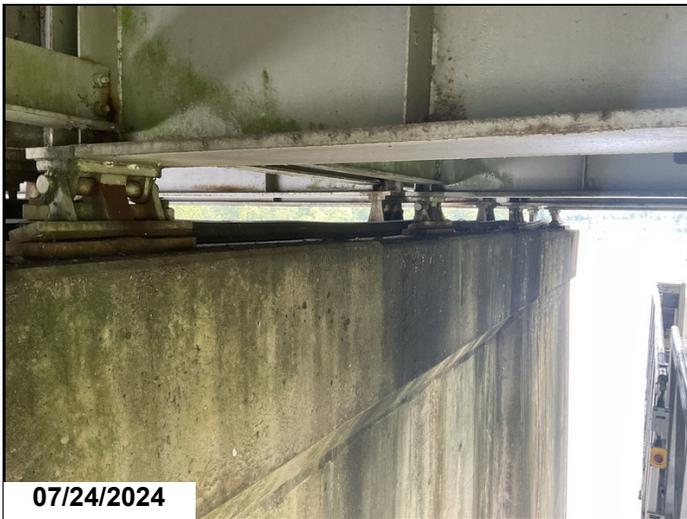
Pier 5: Joint seal has fallen out and I'd sitting atop the pier

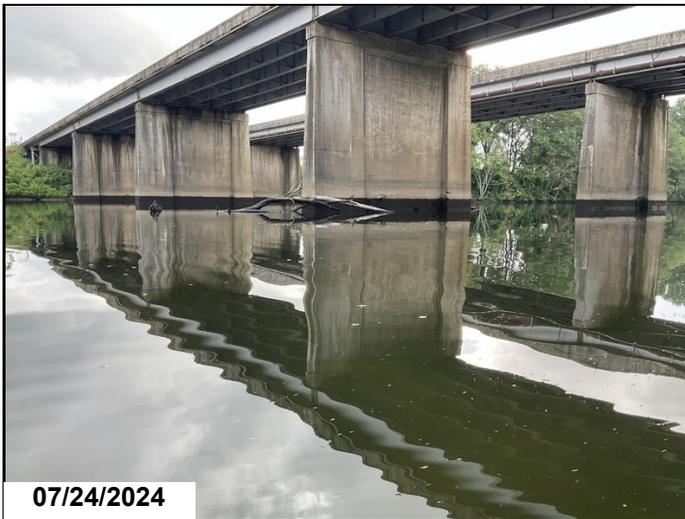
Pier 3: drift has accumulated on the upstream end of pier.

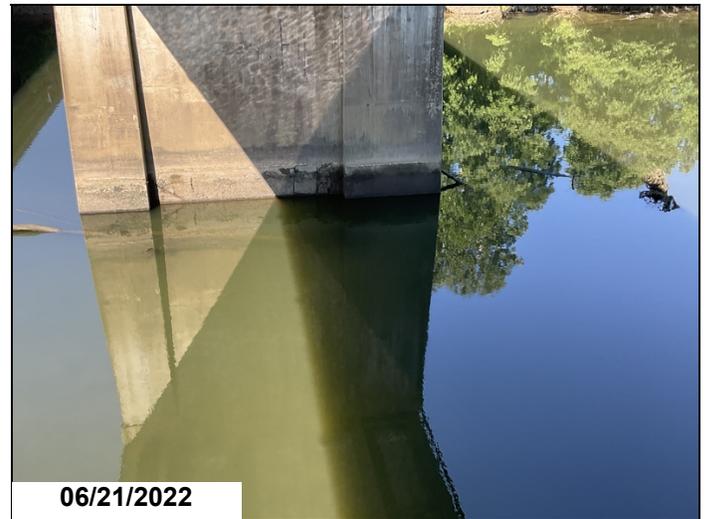
Pier 3 logs against bent.

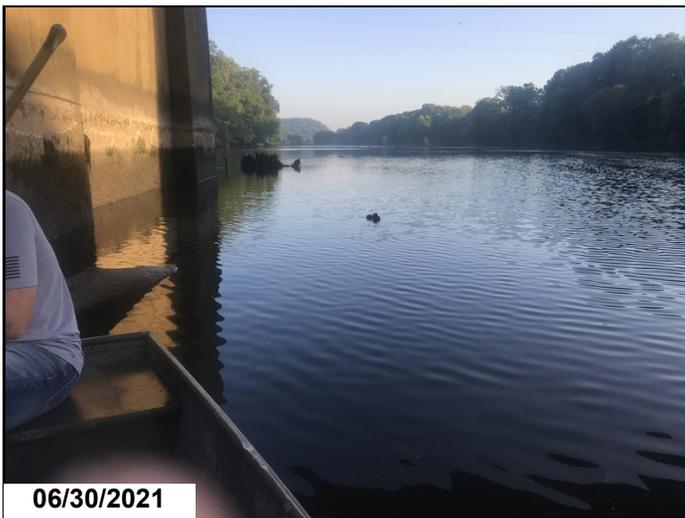
Pier 3 tree lodge against bent.

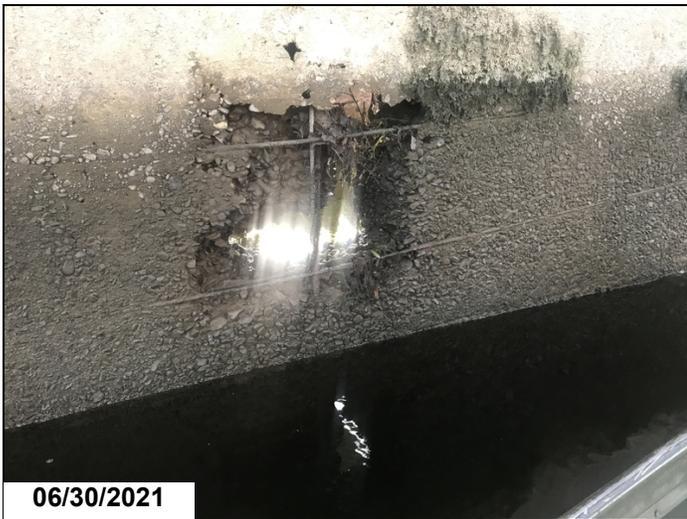
Pier wall 5 has severe abrasion with exposed rebar.
