Asset #05952(Routine, Underwater type 2)

Us-79/Sec-16/L9.44 over St Francis River

Location: 2 Miles Sw Jct Sh 131

Team Lead: Drew Melton Inspection Date: 04/10/2023

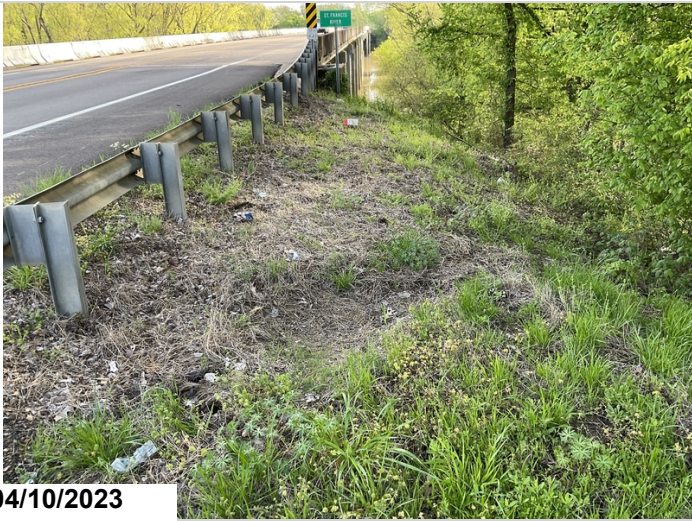
Two foot sink hole abutment #1 right side fifty feet from bridge end.

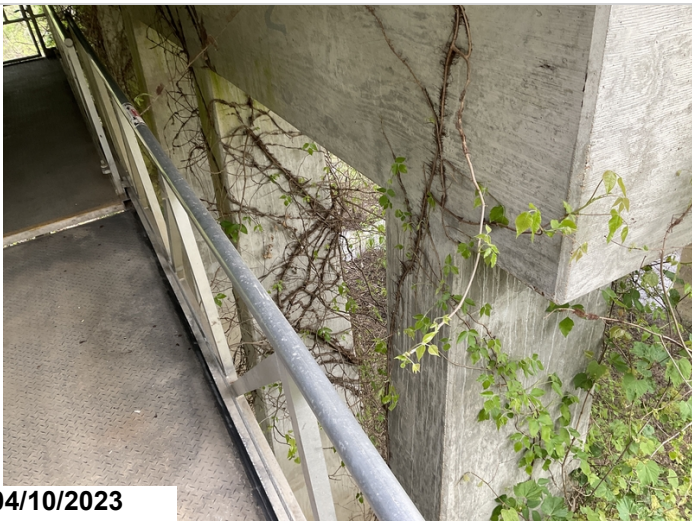
Typical vines growing on bent

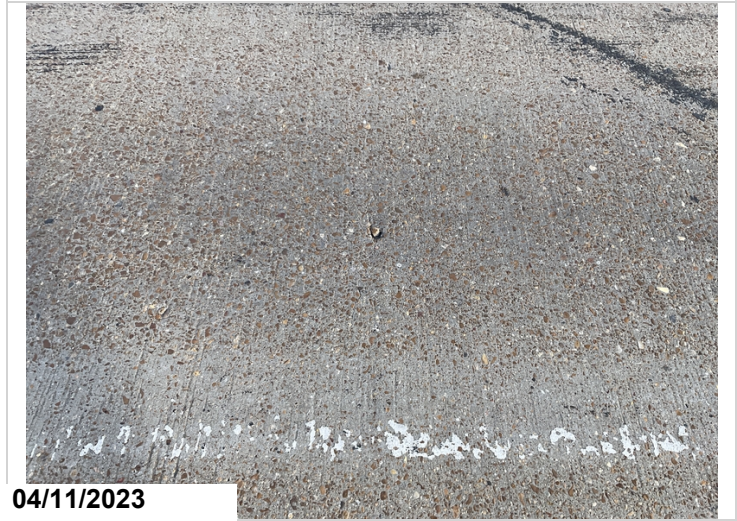
Typical deck cracks

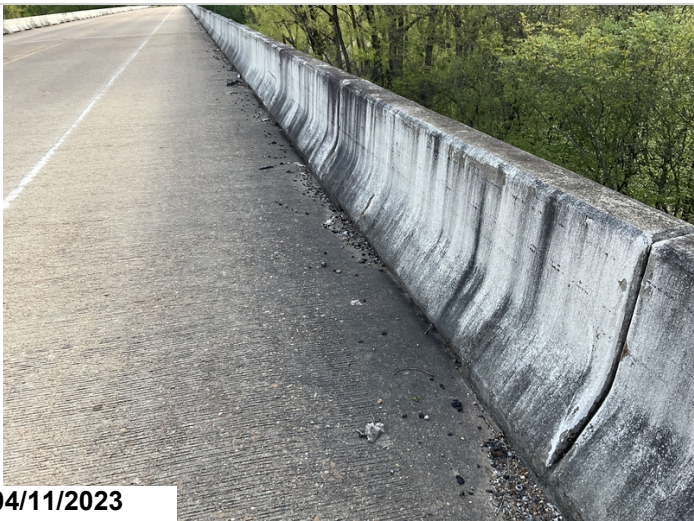
Typical debris in gutters

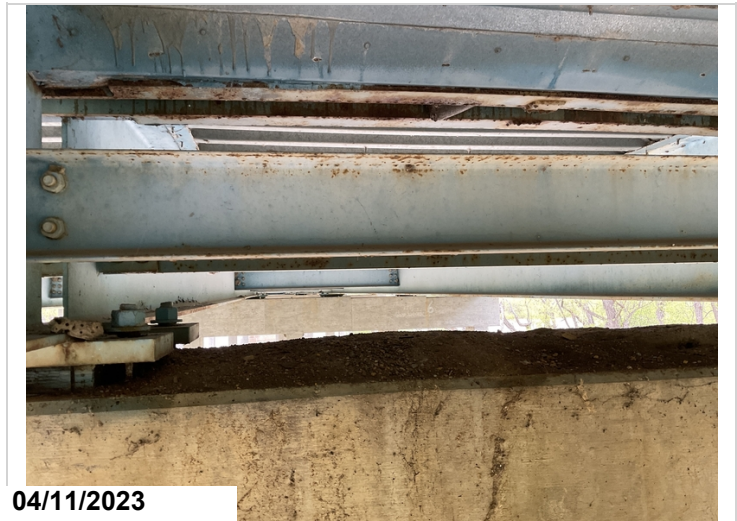
Typical debris on cap bent #5

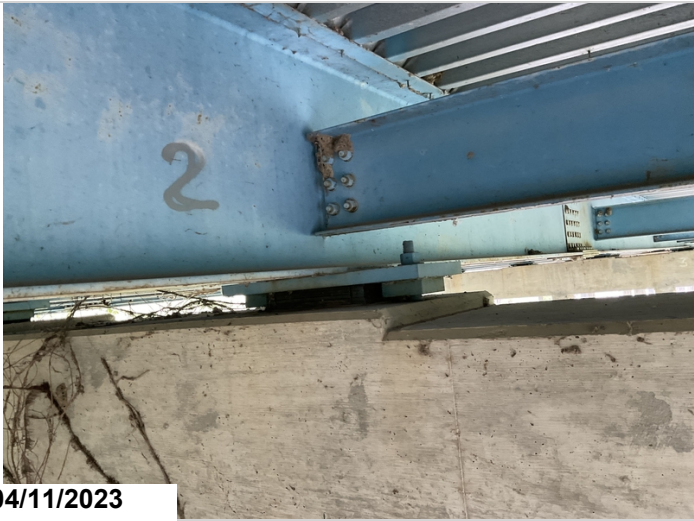
Girders have surface rust full length with no section loss some small areas of paint peeling. Rest of paint is chalky. Corrosion heaviest at bent on bottom flange Span #13 being the worst.

Typical interior paint condition

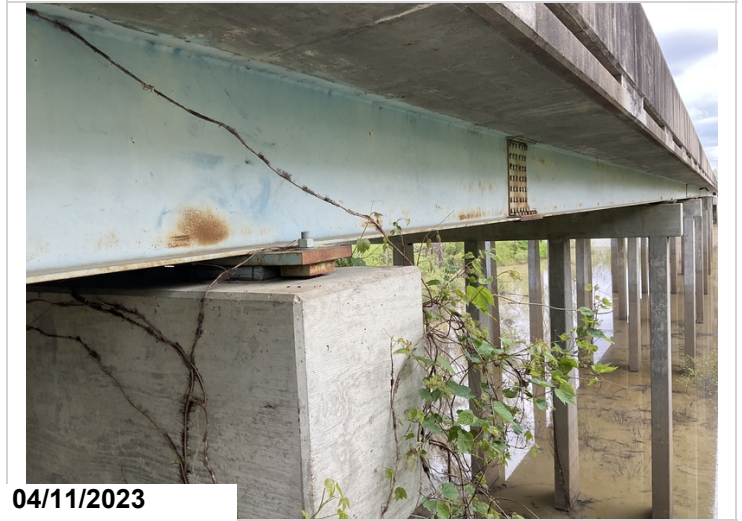
Typical outside girder condition

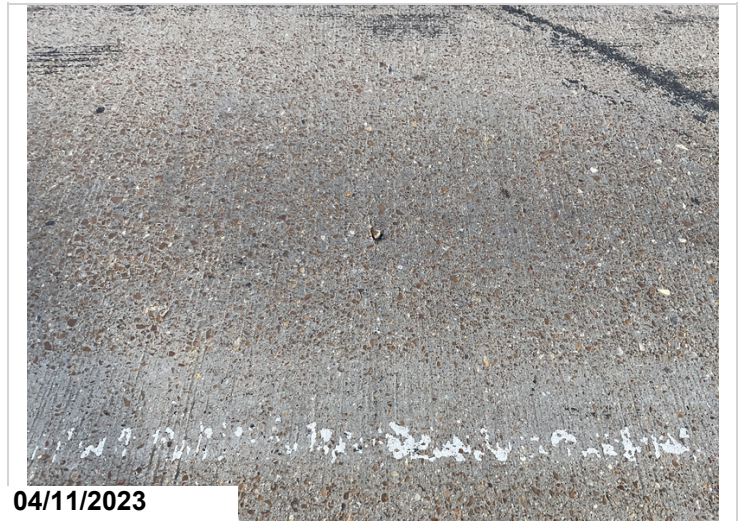
Typical deck cracks

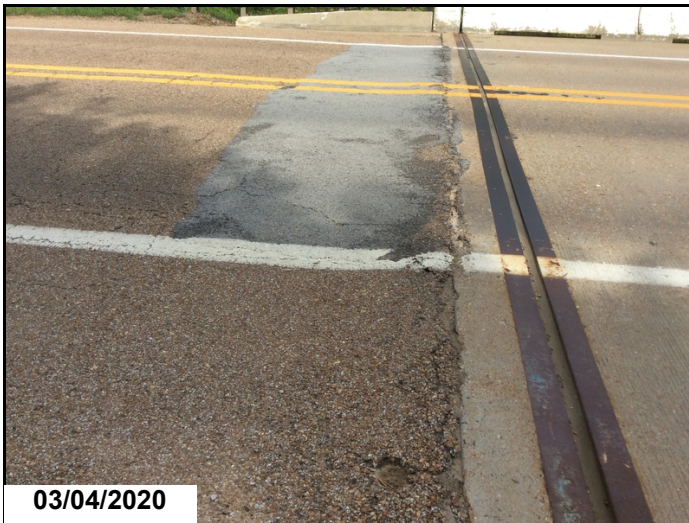
Abutment #1 approach roadway has settled 1"-2" increasing impact loading on bridge.

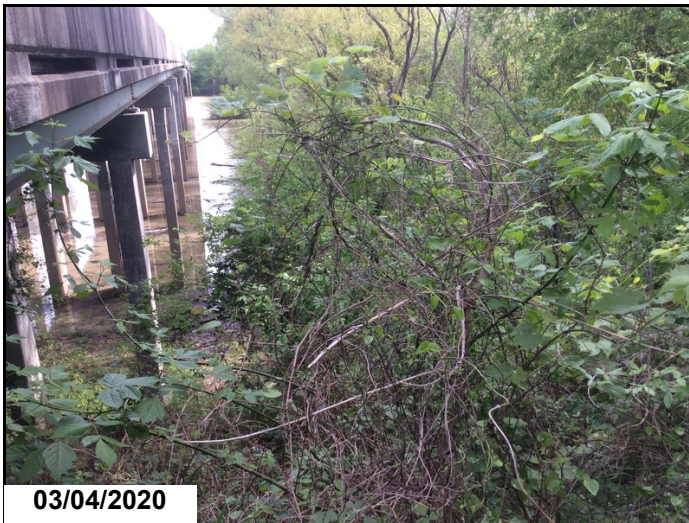
Small trees and vegetation are growing beside and under bridge.

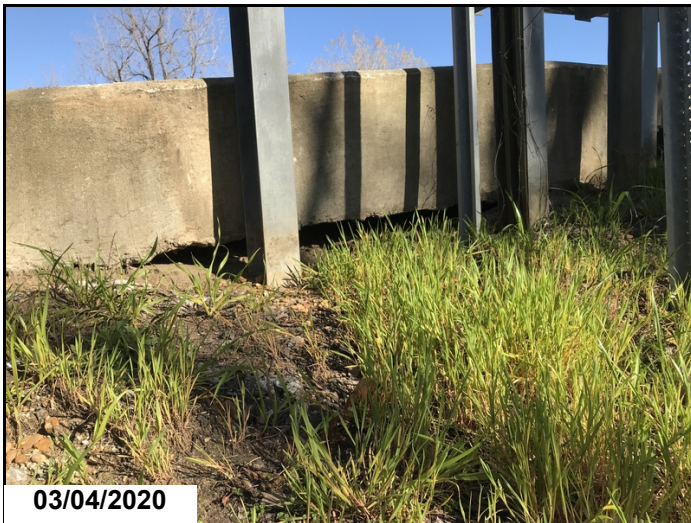
Approach gutter abutment #1 right side has large void under it and has settled.

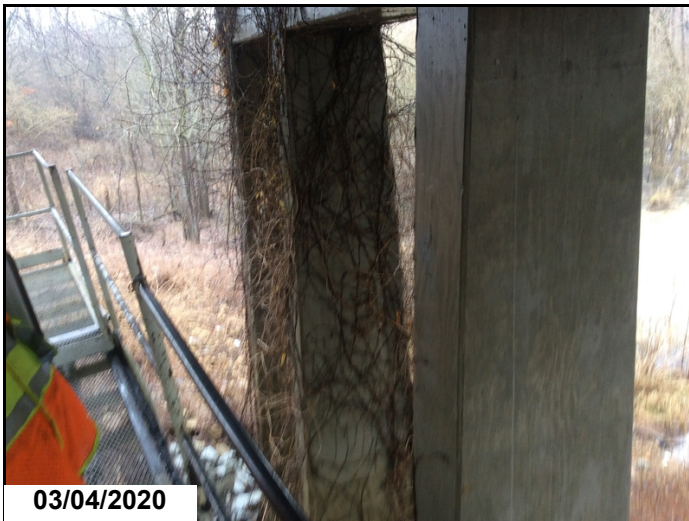
Bents # 2,14 back side have vines growing on columns and cap.

Typical vegetation growing on bents

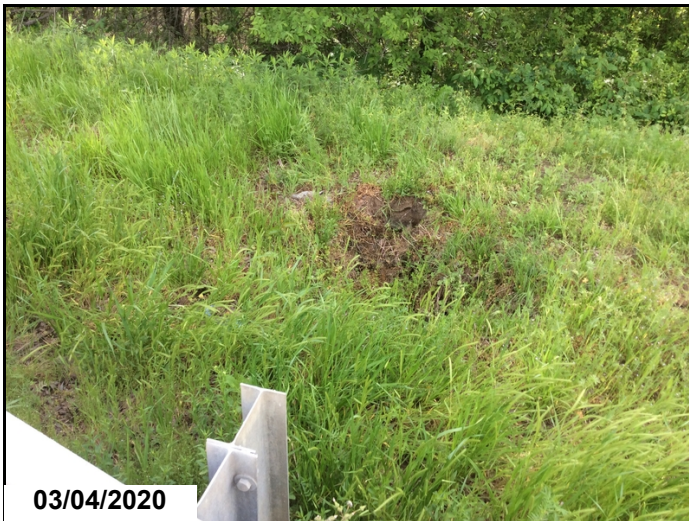
2' sink hole abutment #1 right side 50' from bridge end.

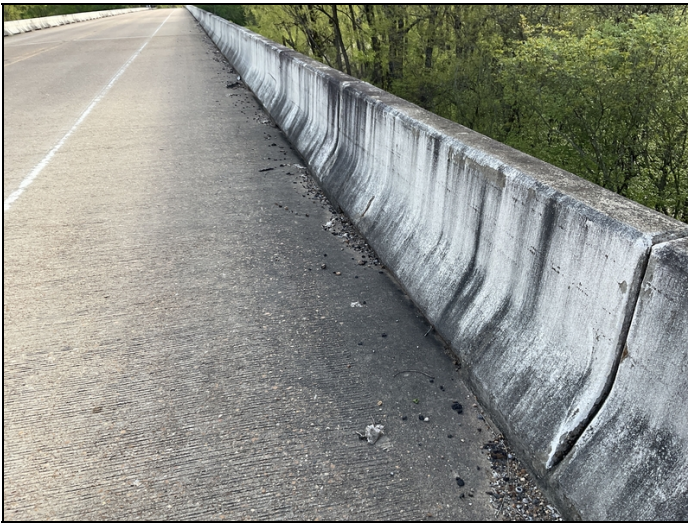
Deck has a small amount of debris in gutters.

Typical debris in gutters

A-55 - Deck Washing Needed (Yes)

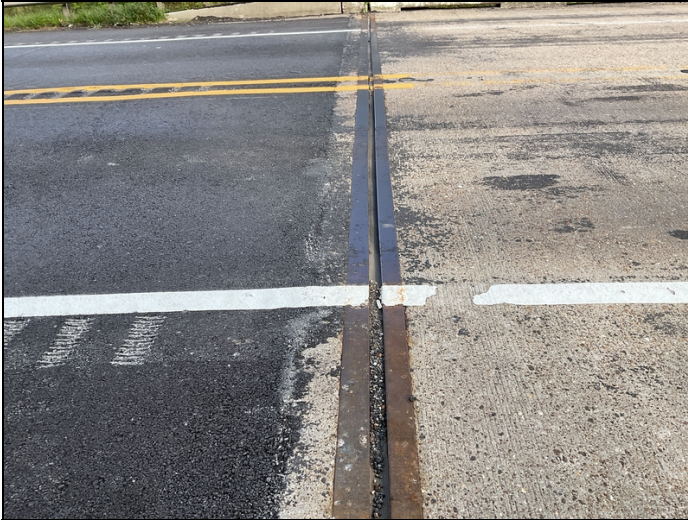
Abutment #1 joint seal has one 6" and a 2" tear in left lane and 1' of lost adhesion at center line.
Bent #5 joint seal has 4' of lost adhesion in right lane 1' of loss of adhesion in center, and 2 small holes.

A-59 - Joint Repair Needed (Yes)

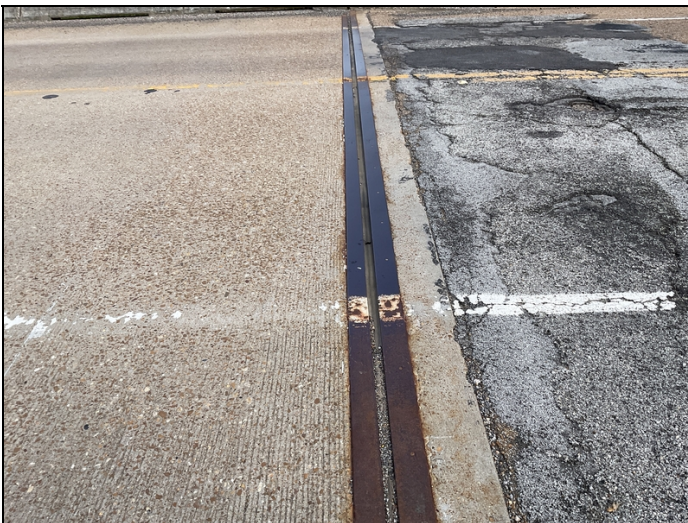
Abutment #2 joint

Abutment #2 pourable joint seal has a 1" hole in right lane.

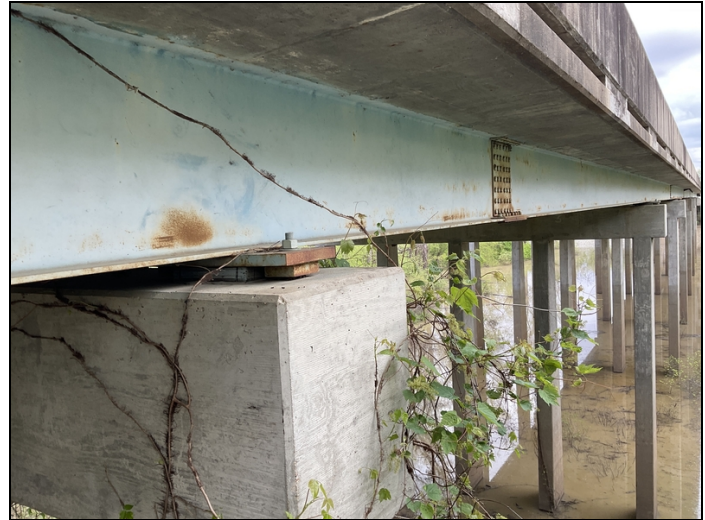
Girders have surface rust full length with no section loss some small areas of paint peeling. Rest of paint is chalky. Corrosion heaviest at bent on bottom flange Span #13 being the worst.

Typical outside girder condition

A-60 - Full Girder Painting Needed (Yes)
