Asset #02534(Other Special Recurring)

Us-79/Sec16/L11.51 over Alligator Bayou

Location: .7 Mi South Of Brickeys

Team Lead: Drew Melton Inspection Date: 11/21/2023

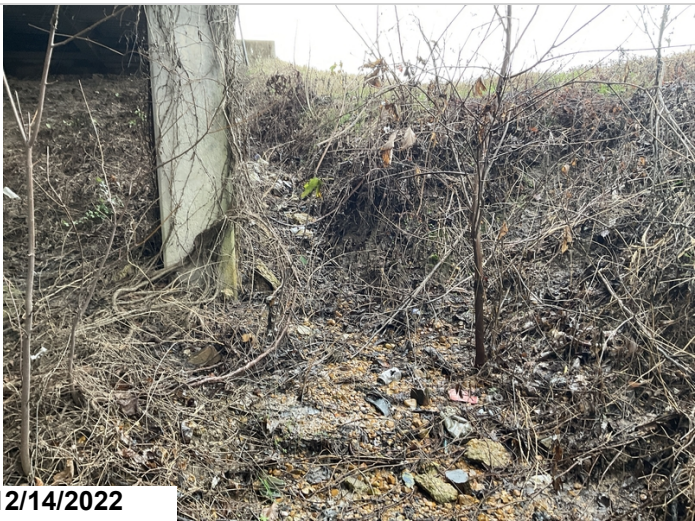
Spans #1 and 2 left slope eroded up to three feet beside bridge

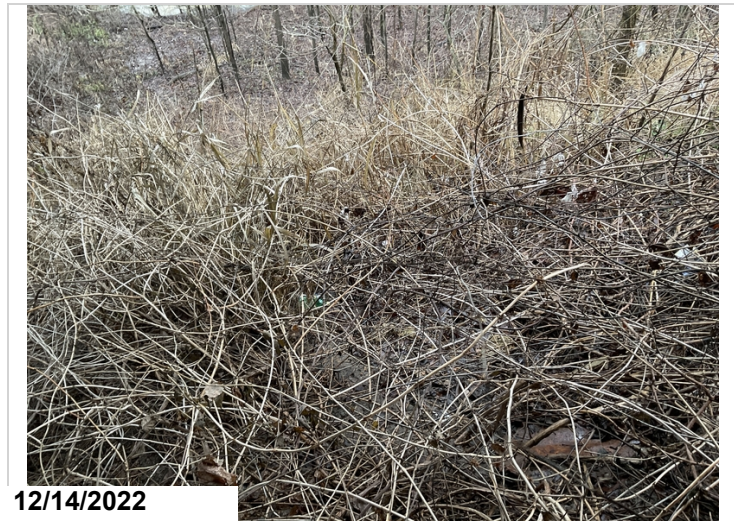
Channel is in fair condition, trees and brush are growing in channel and there is moderate erosion under deck drains of end spans due to run-off.

Span #1 right slope has minor erosion under deck drains

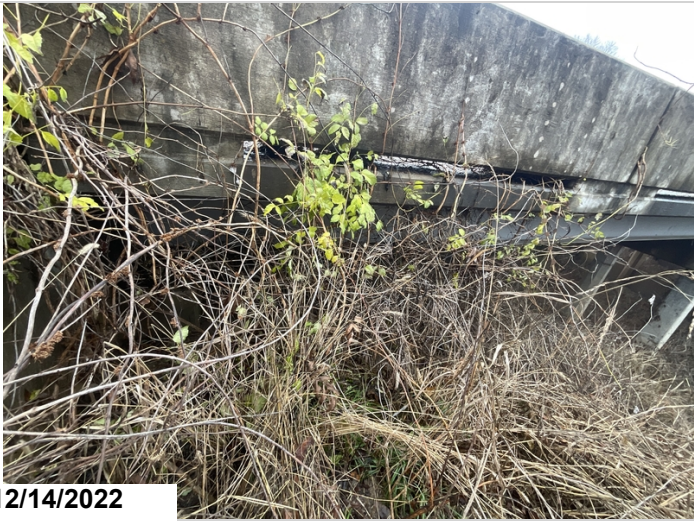
Vines growing onto bridge abutment #1 right side

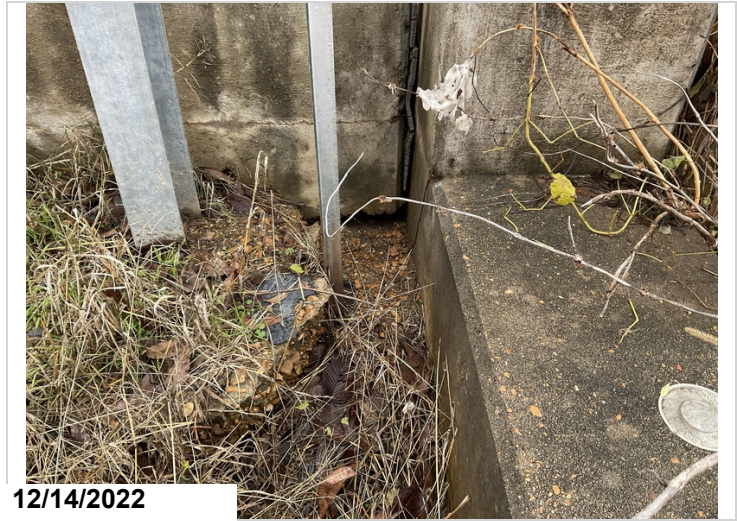
Abutment #1 right approach gutter has small void underneath at bridge end

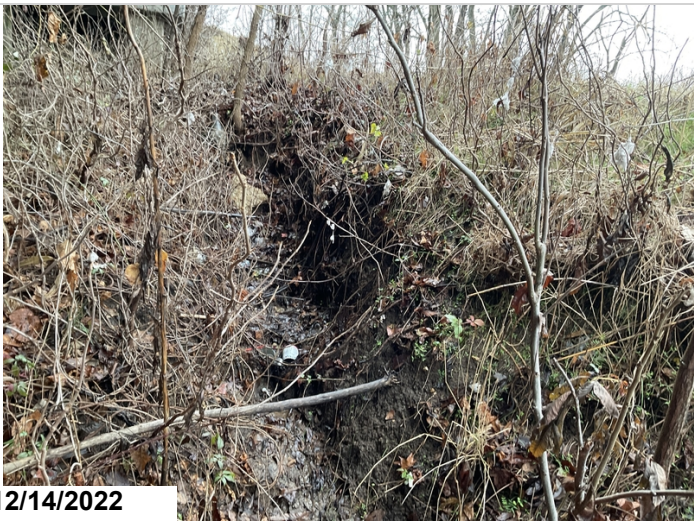
Span #10 slope right side eroded up to three feet deep under deck drains

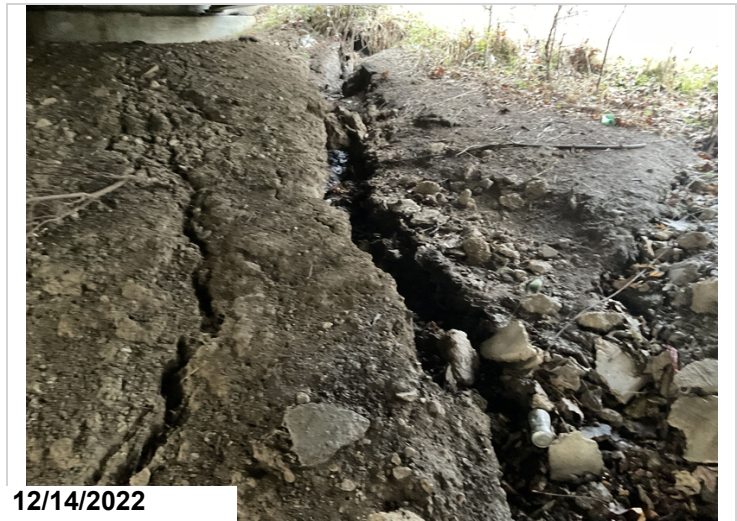
Abutment #2 slope right side has erosion vein up to 2' deep due to roadway runoff

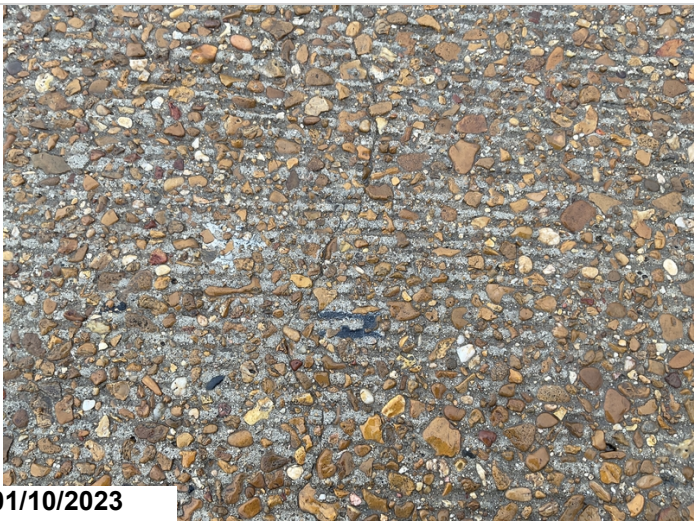
Deck each span has cs2 transverse and longitudinal cracks.

Typical longitudinal deck crack

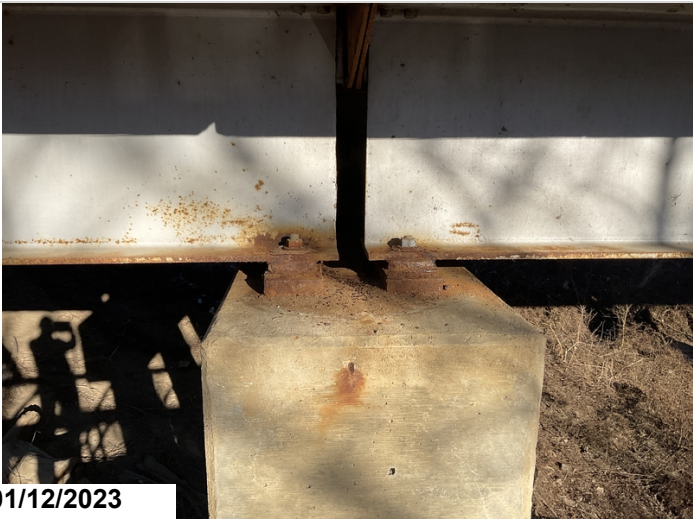
Multiple girder end and bearings have moderate corrosion.

Bent #2 girder #6 bearings are corroded and span #1 and 2 girder #6 bottom flange outside has scaly rust

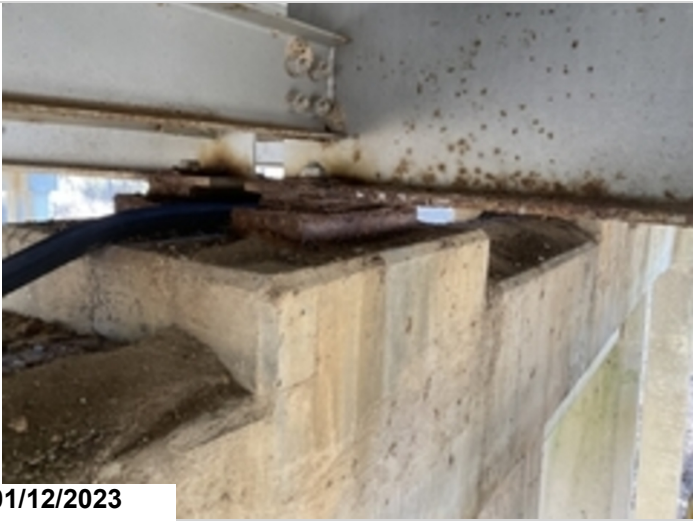
Corrosion on girder ends and bearings at bent #7

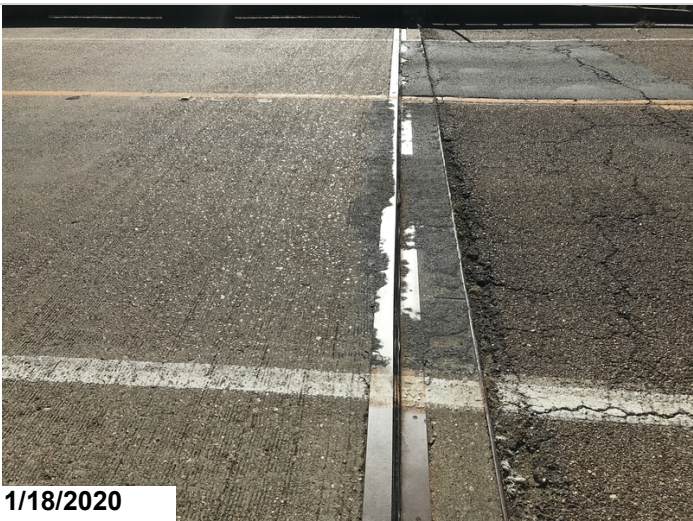
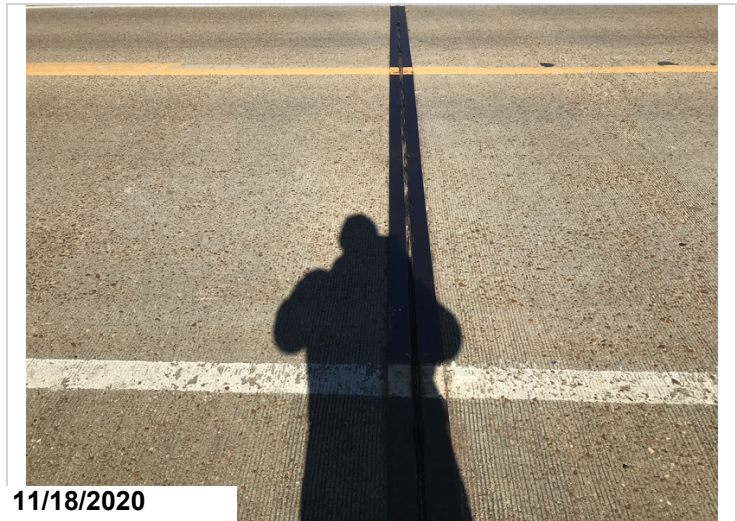
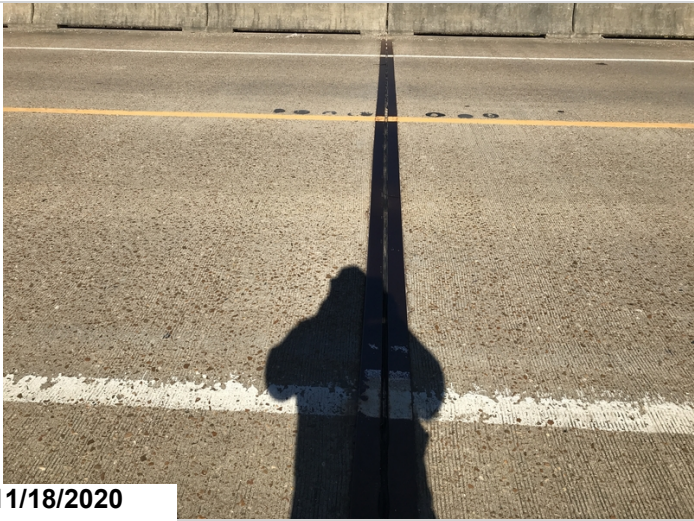
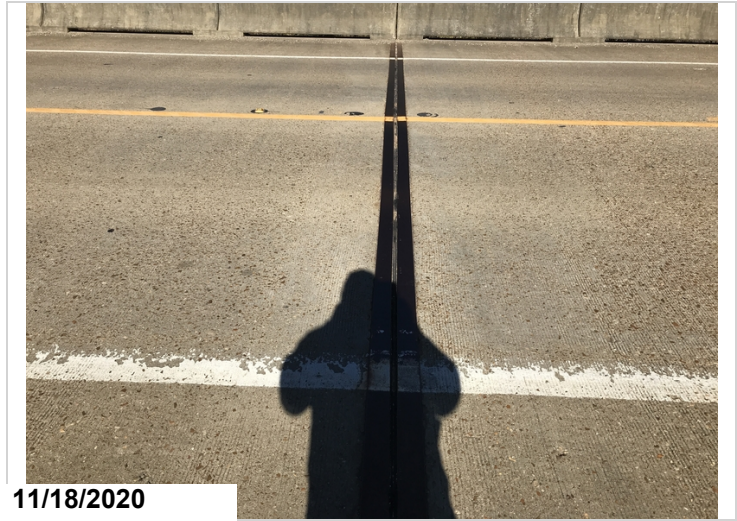
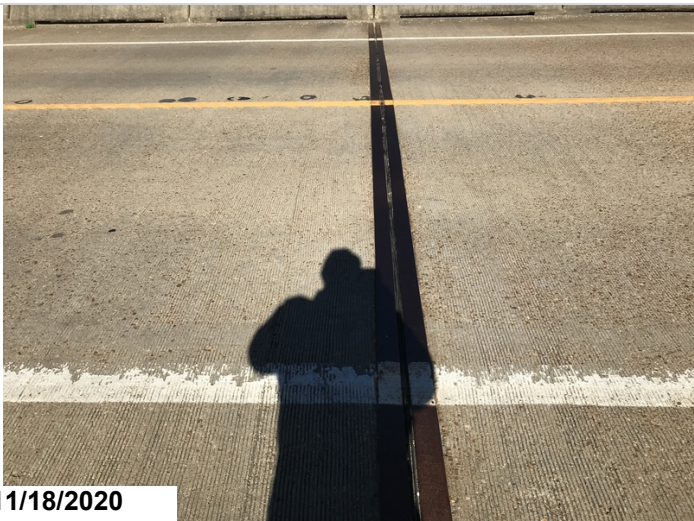
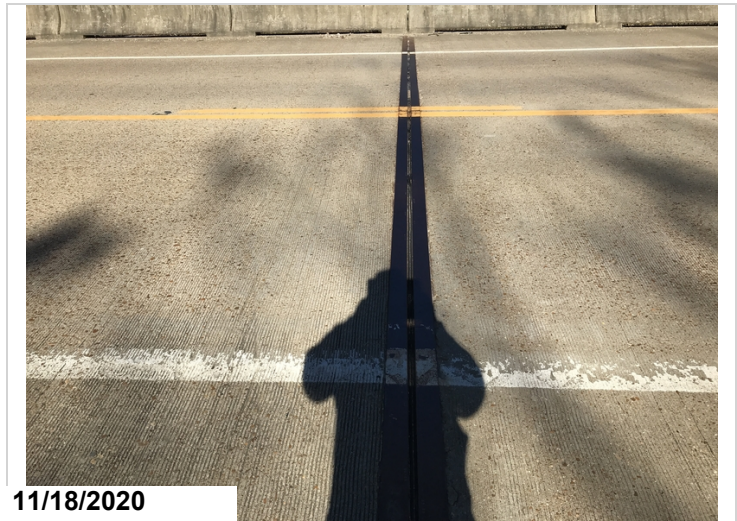
Compression joint seals are weathered and cracked.

302	Compression Joint Seal	LF	480	0	390	10	80
2310	Leakage	LF	90	0	0	10	80
2340	Seal Cracking	LF	390	0	390	0	0
<p>(302) Compression joint seals are weathered and cracked. Joint steel on deck has no paint left. Joint seal at bent #3 is hanging down for ten feet in the center and 8' lost adhesion and sagging. Joint seals at bents #7,8 have failed and fallen down onto cap.</p>							
311	Movable Bearing	EA	66	0	0	66	0
1000	Corrosion	EA	66	0	0	66	0
515	Steel Protective Coating	SF	132	0	0	0	132
3440	Effectiveness (Steel Protective Coatings)	EA	132	0	0	0	132
<p>(311) Bearings are corroded with laminations up to minor section loss. Little to no paint left on bearings.</p>							
313	Fixed Bearing	EA	66	0	0	66	0
1000	Corrosion	EA	65	0	0	65	0
1020	Connection	EA	1	0	0	1	0
515	Steel Protective Coating	SF	132	0	0	0	132

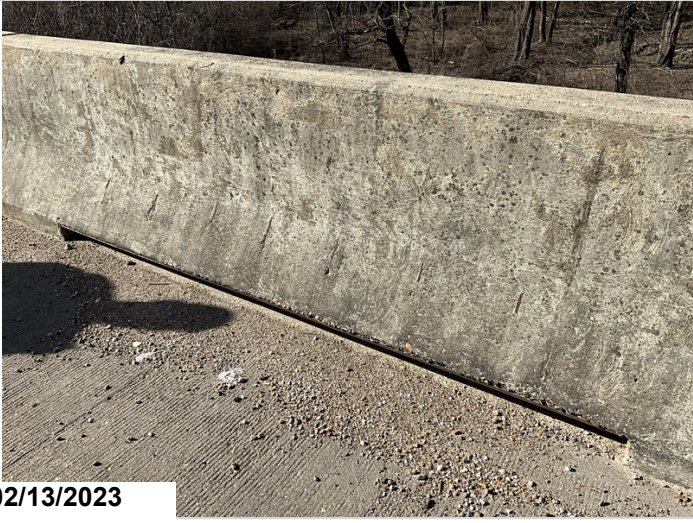
Span 5, right , spall cs 2. Typical 6, 7

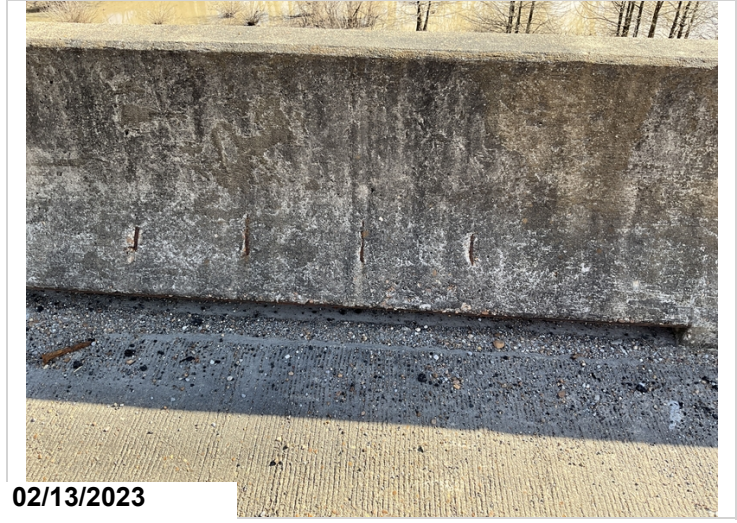
Span 1, right, exposed reinforcing steel, cs 2. Typical 2,3,4, 5, 6, 9

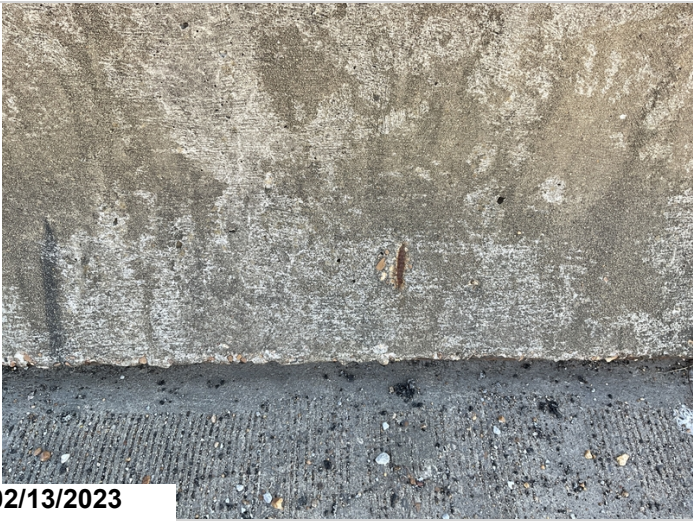
Span 8, left, exposed reinforcing steel, cs 2. Typical 7 , 6 , 4 , 3 , 2, 1.

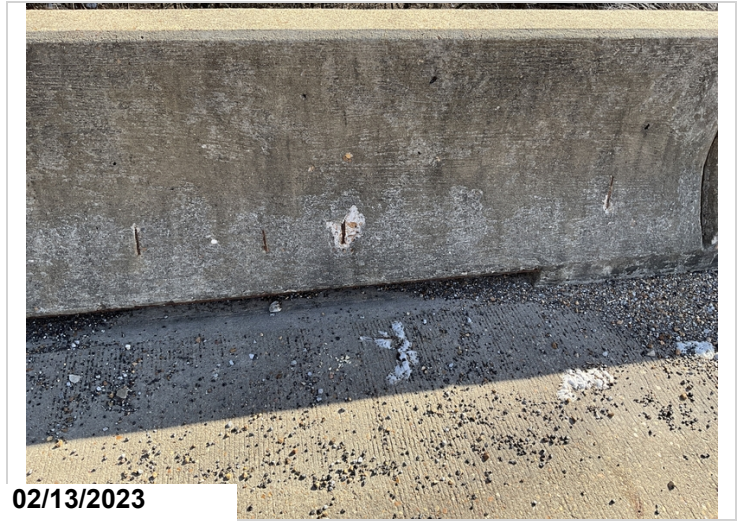
Span 9, left , exposed rebar, cs 2.

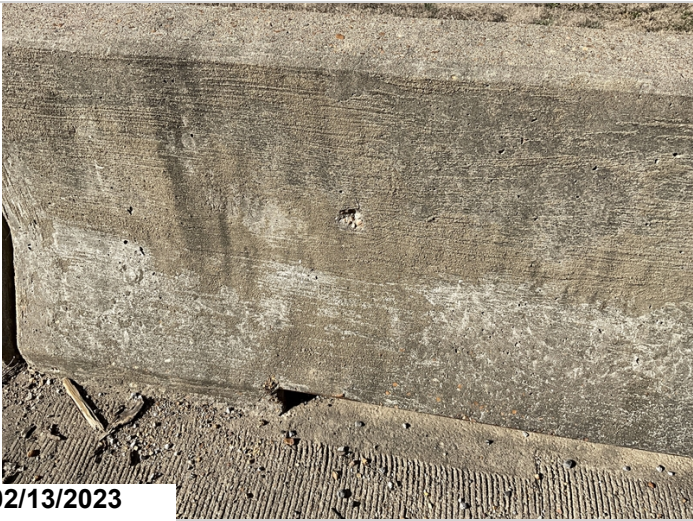
Span 11, left, exposed reinforcing steel, cs 2.

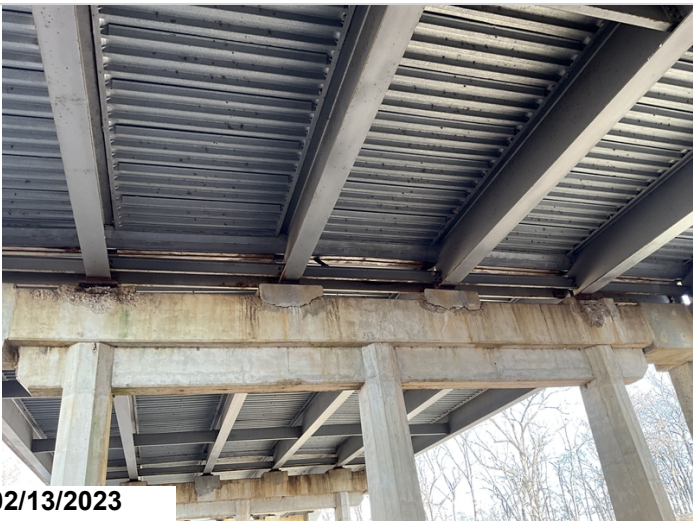
Bent 10 ahead bearing 5, loss of bearing area cs 3. 30%.

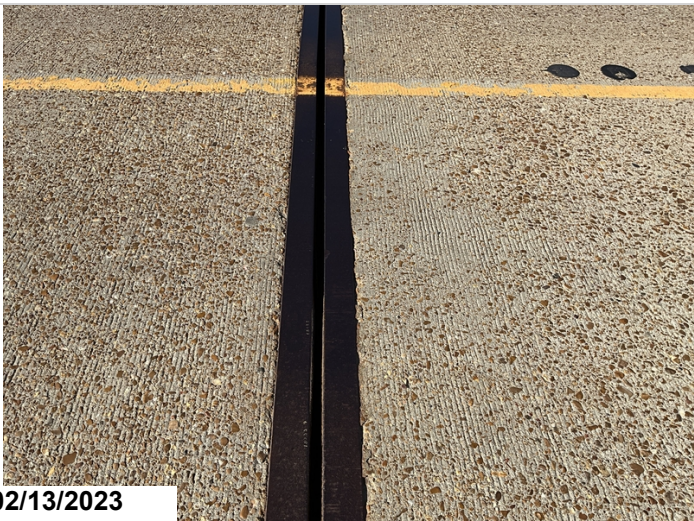
Bent 9, torn seal, cs 3.

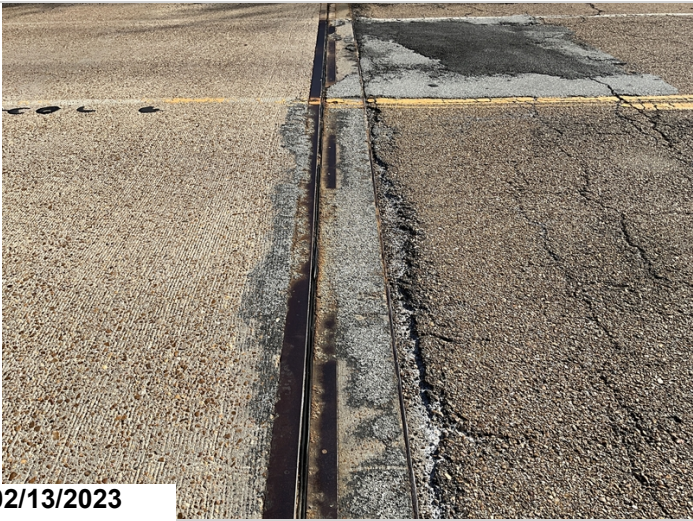
Bent 11, torn seal, cs 3.

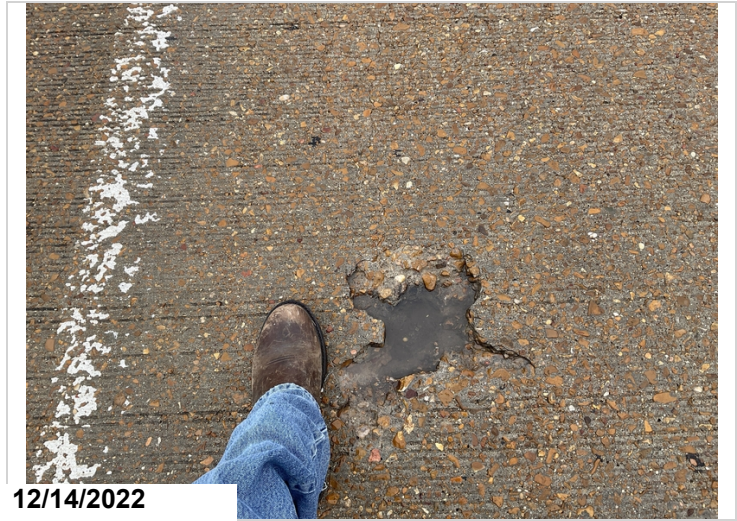
Bent 12, damage to joint seal, cs 2.

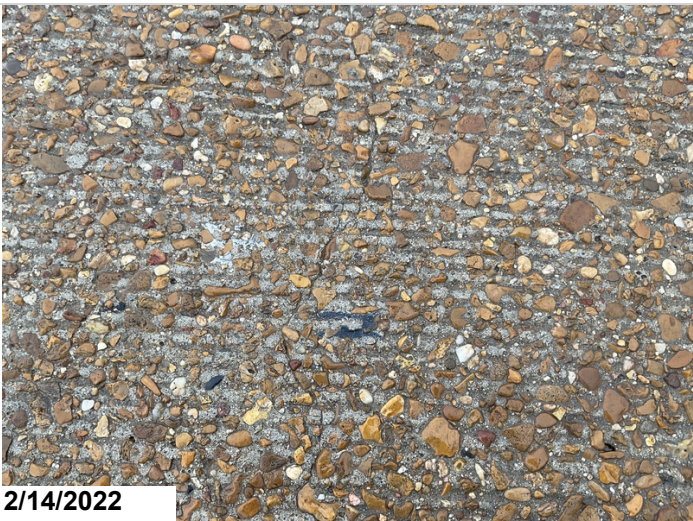
Span #5 deck left lane has one foot spall near mid span

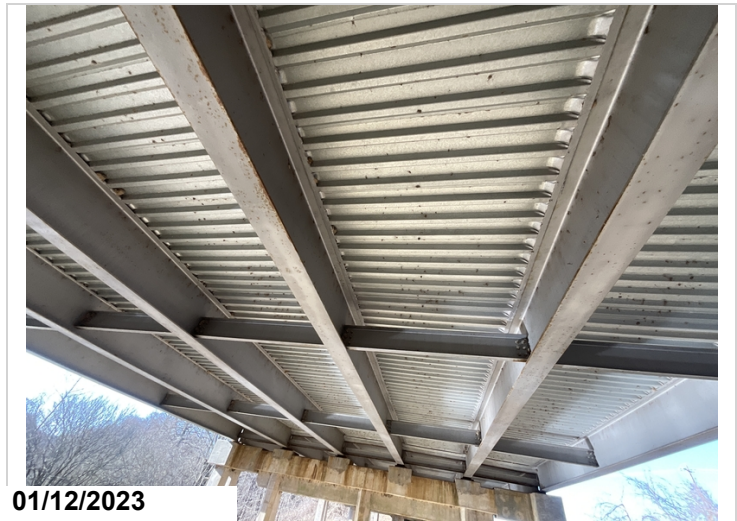
Typical longitudinal deck crack

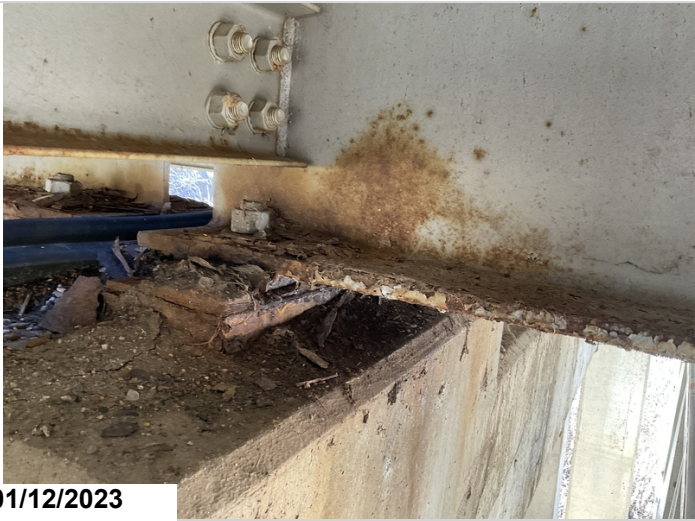
Typical girders

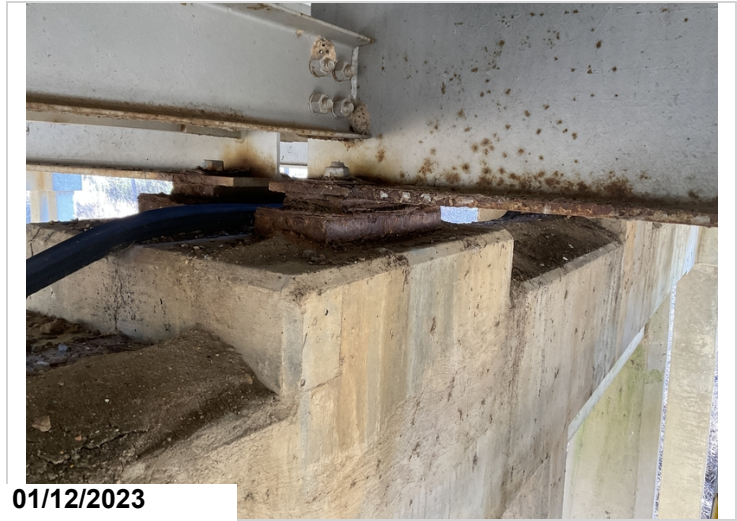
Corrosion on bearings and girder ends

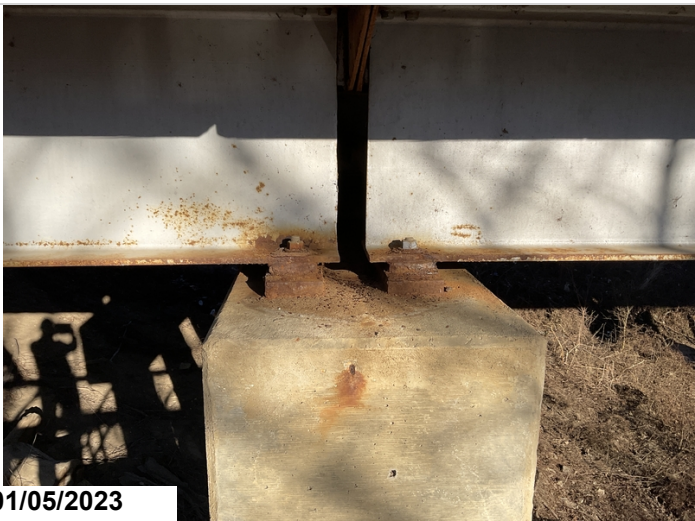
Bent #7 corrosion on girder ends and bearing.

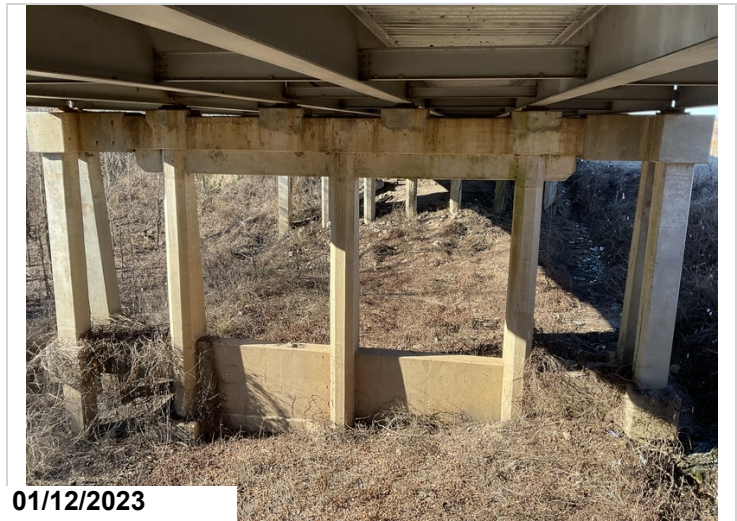
Bent #2 girder #6 bearings are corroded and span #1 and 2 girder #6 bottom flange outside has scaly rust

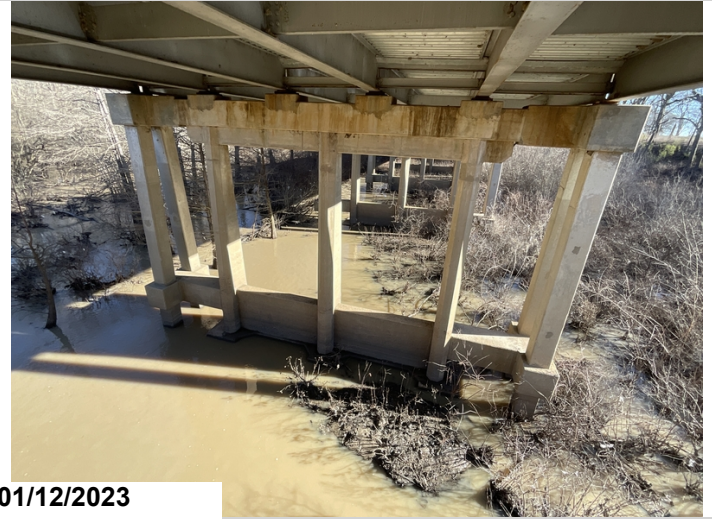
Bent #4 column #2 has one foot of vertical cracking near top.
Cs2

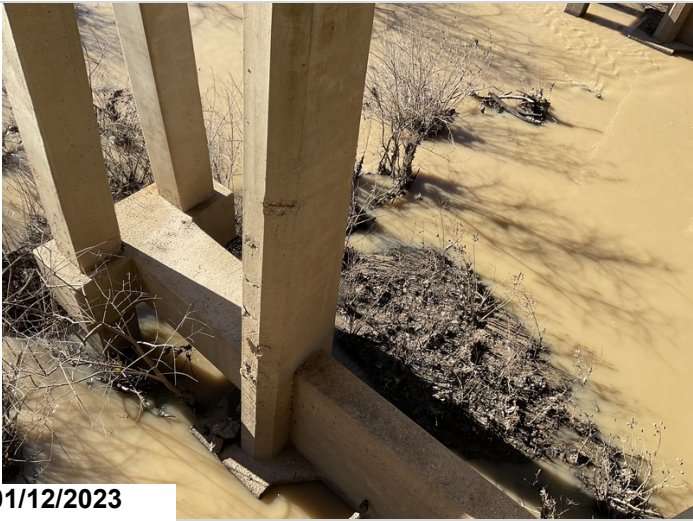
Bent #4 column #1 ahead face has one foot delaminated
area with spalling at footing.

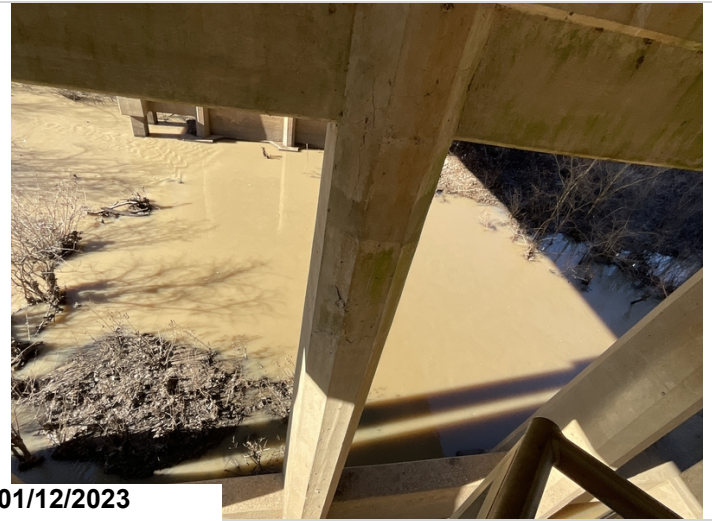
Bent #5 column #3 ahead face has several exposed rebar areas due to poor concrete coverage 5% section loss.

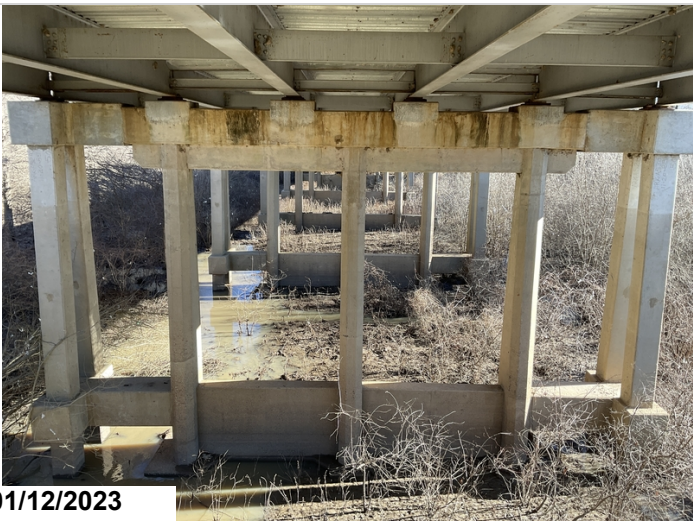
Bent #3 column #2 ahead face has five feet of cracking and delaminated area. Cs3

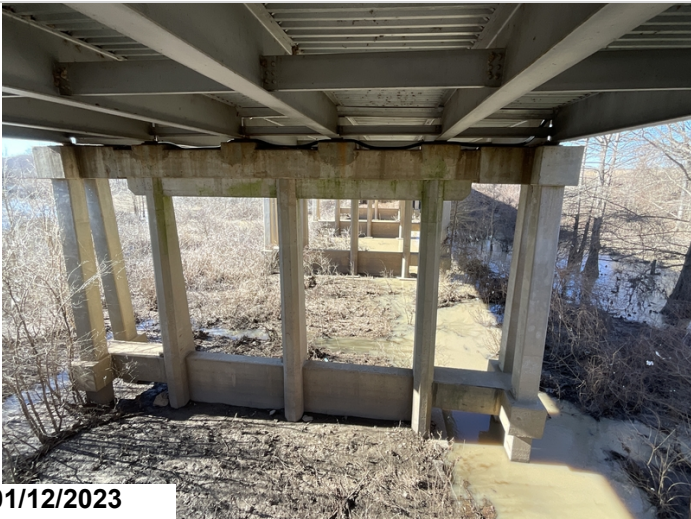
Bent #6 column #1 ahead face and right side above web wall has two spalls with exposed rebar and one delaminated area. Cs3

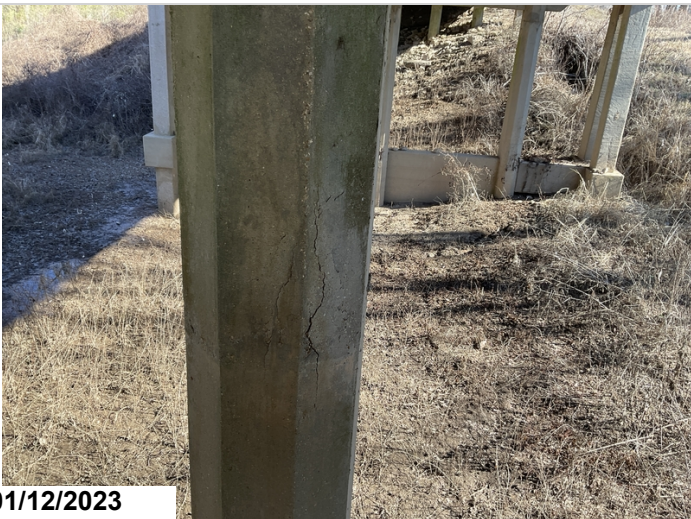
Bent #8 column #3 is spalled on ahead face four foot above ground with five feet of exposed rebar 5% section loss.

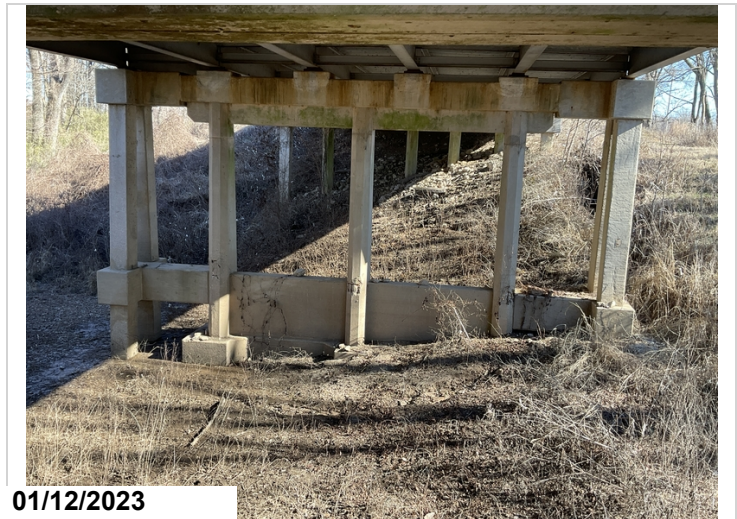
Bent #9 column #2 back face has two foot delaminated area.

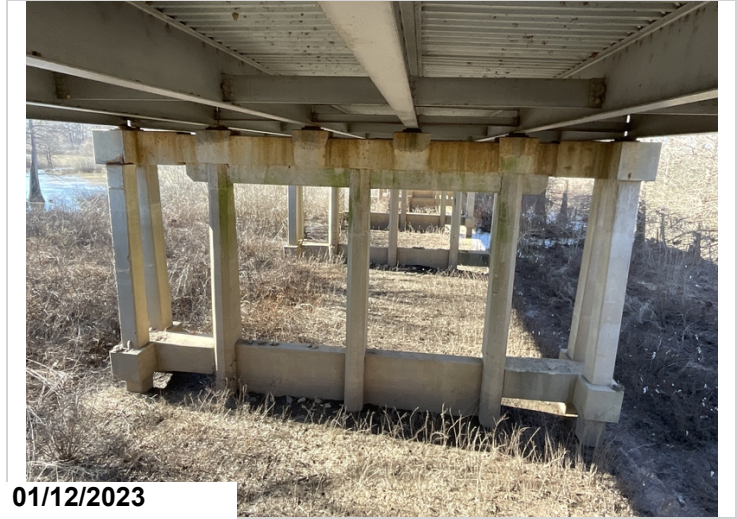
Bent #10 column #1, 2, 3 each have one foot spalls four foot above ground on the back face with rebar exposed 10% section loss.

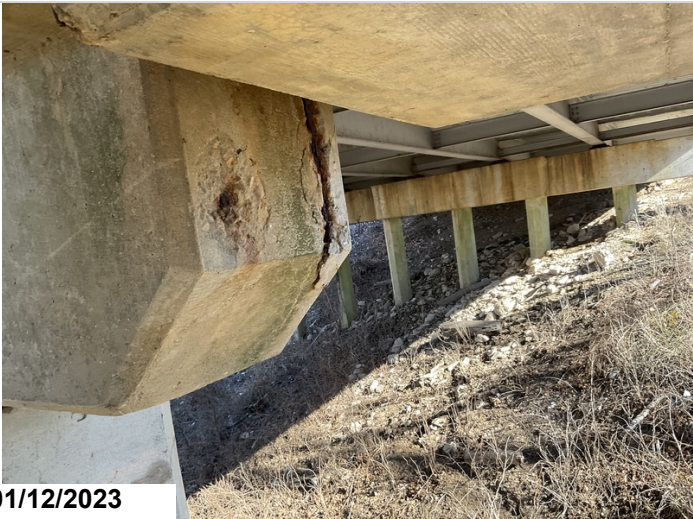
Bent #10 cap ahead face right side has a six inch delamination and a four inch spall with exposed rebar with 10% section loss.

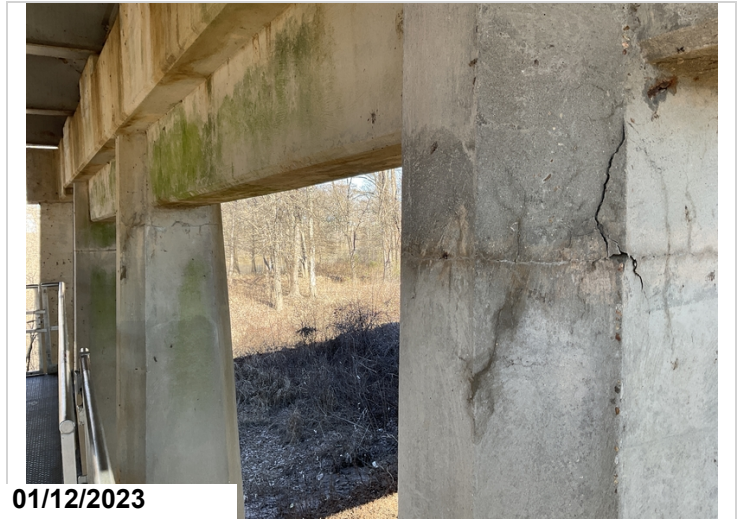
Bent #10 columns #1, 2, 3 have horizontal cracking with light efflorescence six inches to one foot below cap.

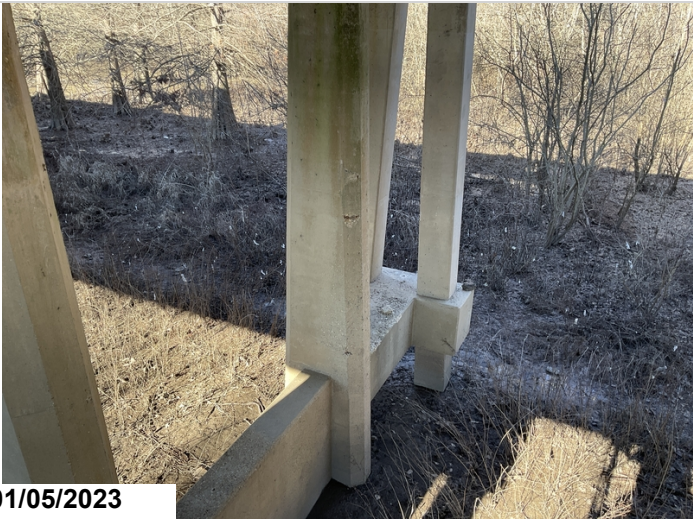
Bent #9 column #3 ahead face has one six inch spall, and one six inch delaminated area.

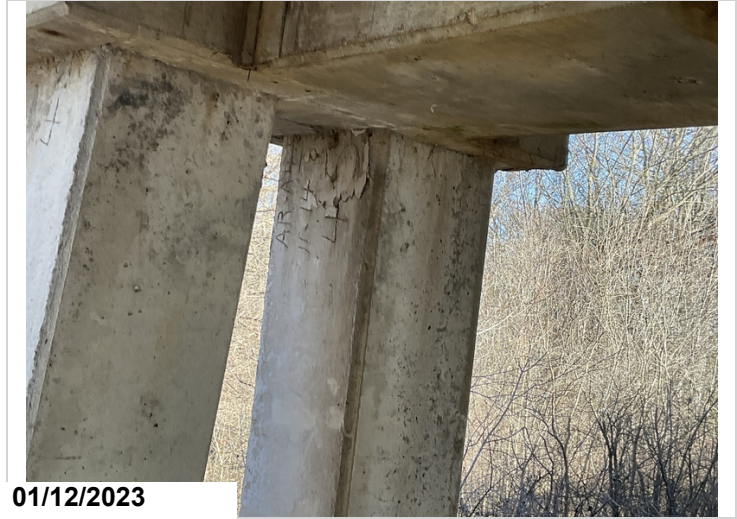
Bent #7 pile #2 has 1' shallow delaminated area at top back face.

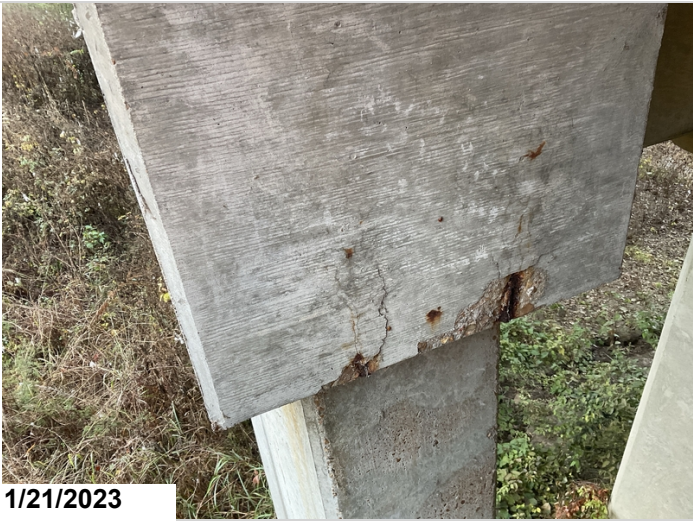
Bent #10 cap ahead face right side has a 6" delaminated area, and a 4" spall with exposed rebar with moderate section loss.

Bent #10 cap ahead face right side has a six inch delamination and a four inch spall with exposed rebar with 10% section loss.

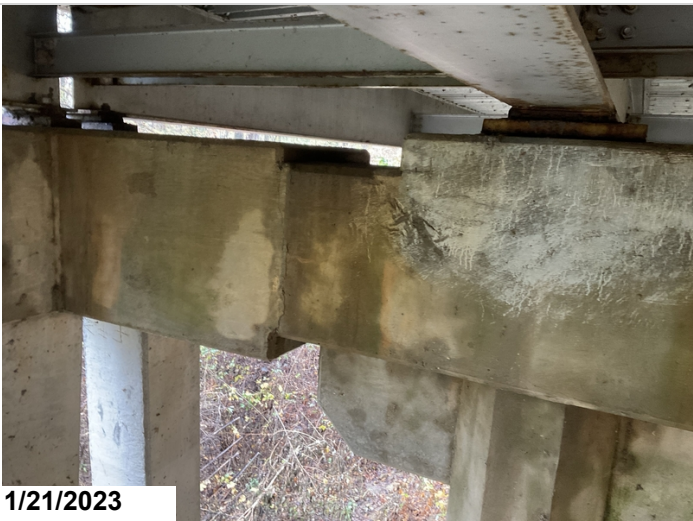
Typical vertical crack at construction joint.

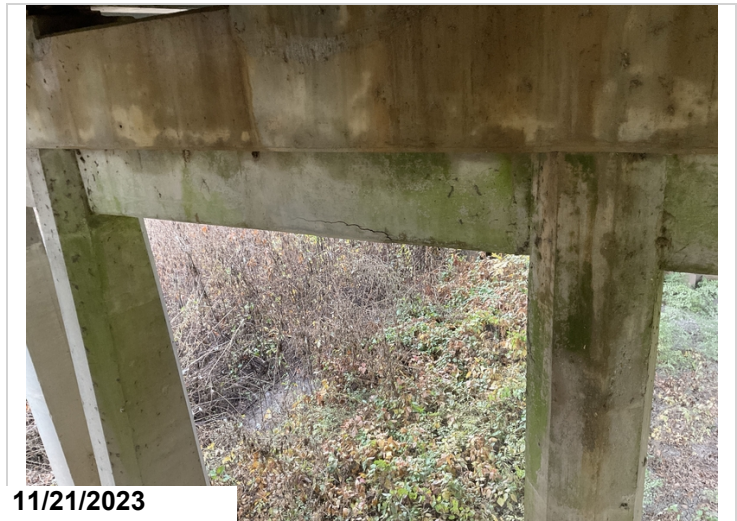
Bent #9 cap ahead face has cs3 cracks and delaminated area for 2' between columns #2, 3.

Bent #9 ahead face has two foot cracked and delaminated area between columns #2 and 3. Cs3
Bent #9 cap ahead face right side cracked and spalled with exposed rebar for two feet
Bent #9 back face right side between girders #5 and 6 has one foot cracked / delaminated area with rust staining
Bent #9 cap bottom between columns #4 and #5 has two foot long area crack and delamination.
Bent #9 cap has two foot spall right end with exposed rebar 10% section loss on bottom cord, and also back face left end.
Bent #10 cap ahead face right side has a six inch delamination and a four inch spall with exposed rebar with 10% section loss.
Bent #10 back face under girder #5 has two feet of horizontal cracking with light efflorescence
Bent #11 cap back face bottom chord of cap at pile #3 has six inch spall with exposed rebar with 20% section loss.

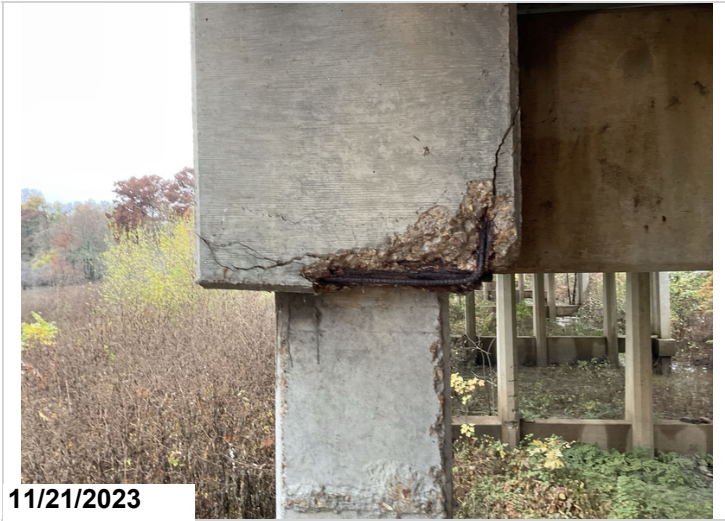
Bent #9 cap ahead face right side has cracks and spalled with exposed rebar minor section loss for 2'.

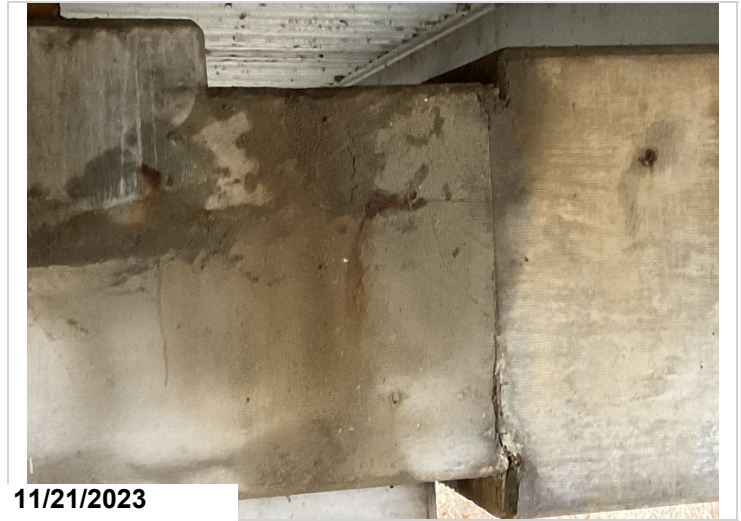
Bent #9 back face right side has a 1' crack/delaminated area with rust staining between girders #5, 6.

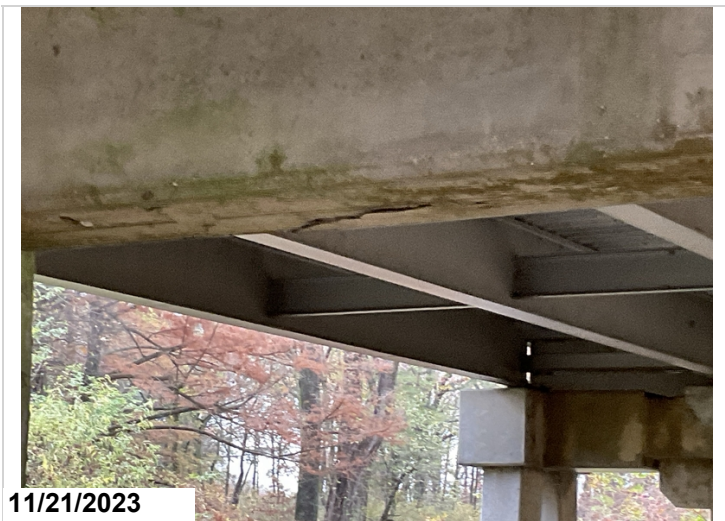
Bent #9 cap bottom has cracks and delaminated area for 2' between columns #4 and #5.

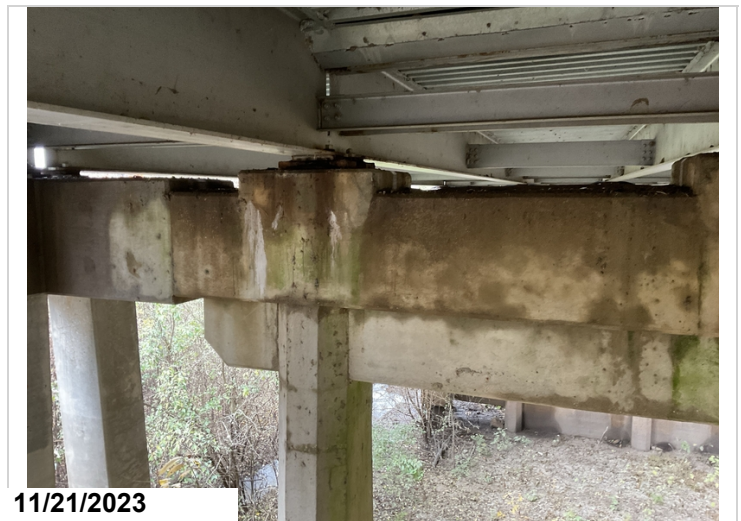
Bent #8 cap ahead face under girder #5 has several hairline cracks with light efflorescence.

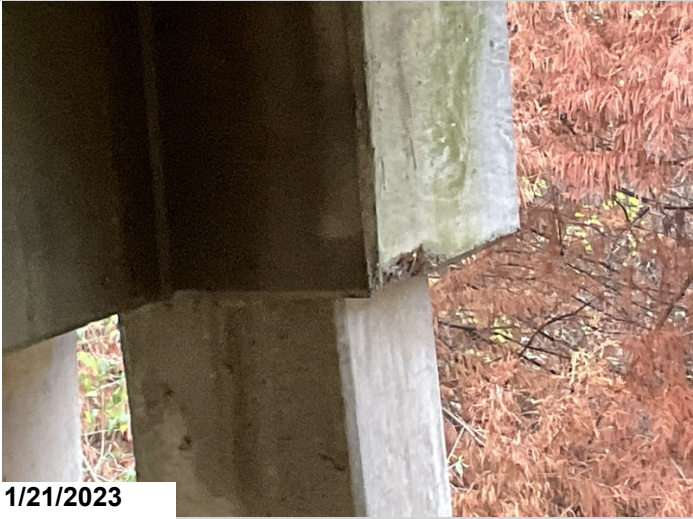
Bent #8 cap ahead face left side bottom corner has a 1' spall with exposed rebar minor section loss.

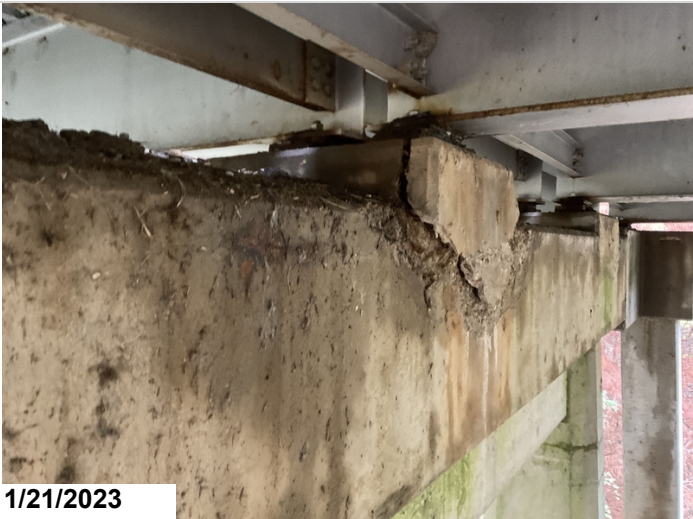
Bent #8 cap ahead face has cracks, delaminated area, and spalled under girder #3 full width of bearing riser.

Bent #8 cap ahead face cracked and delaminated and spalled under girder #3, full width of riser.

Bent #8 cap ahead face bearing riser cracked and delaminated and spalled under girder #3.

Bent #8 cap ahead face cracked and delaminated and spalled under girder #3.

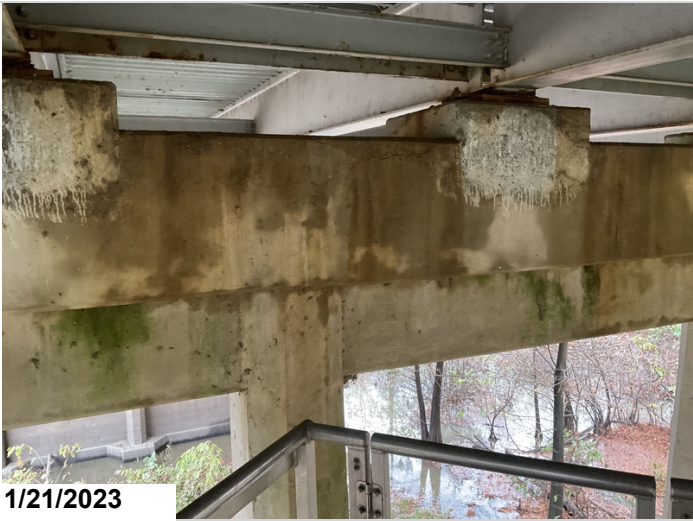
Bent #6 cap ahead face has cs3 cracks horizontally for 4' between girders #3, 4.

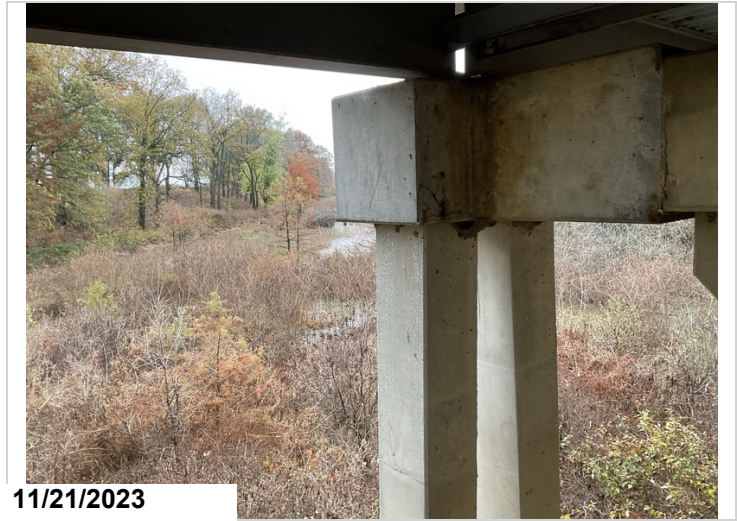
Bent #6 cap ahead face right side under girder #6 has cracks and delaminated for 1' with exposed rebar minor section loss.

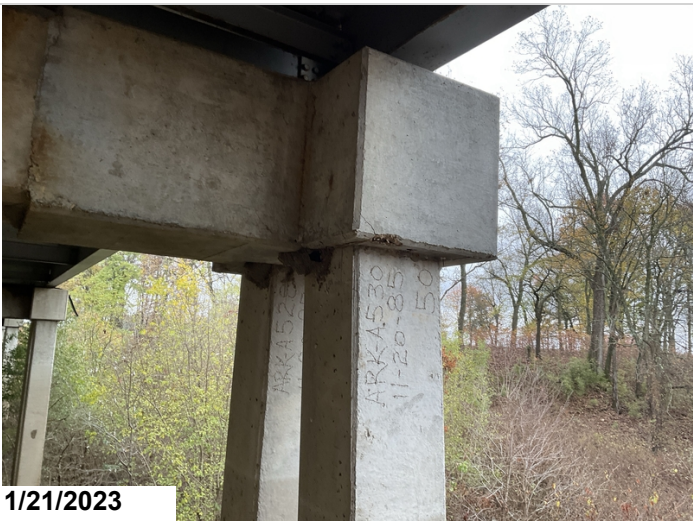
Bent #6 cap back face right side has small spall on corner with exposed rebar minor section loss.

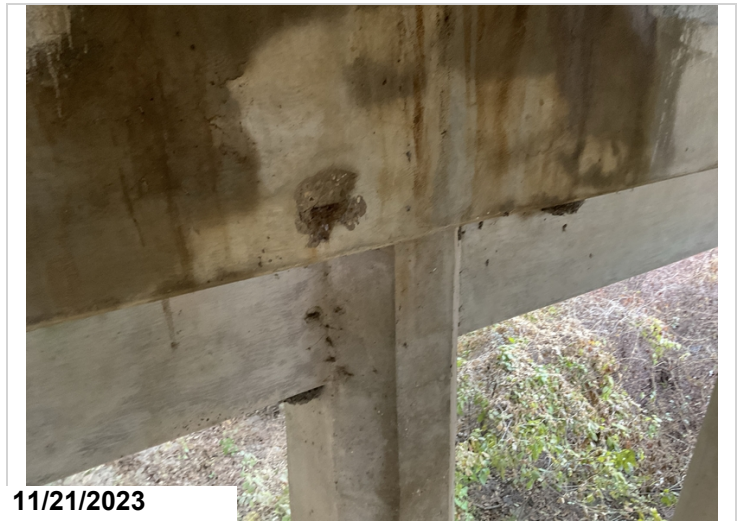
Back #6 cap back face has 6" spall with exposed rebar minor section loss above column #2.

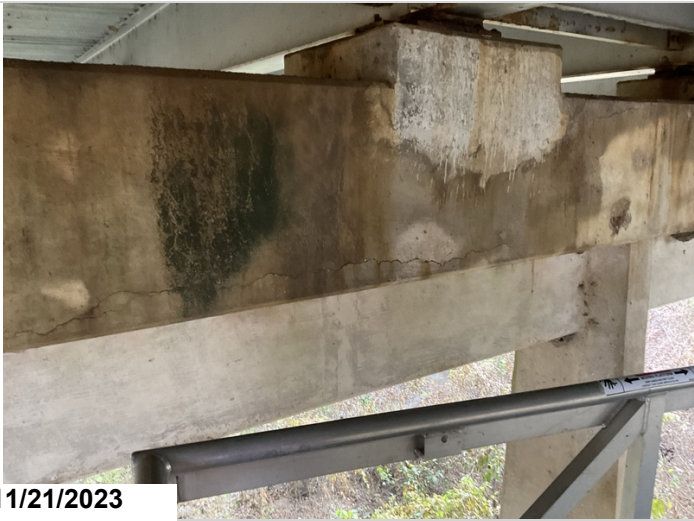
Bent #6 cap back face has cs3 cracks for 10' between girders #2, 5.

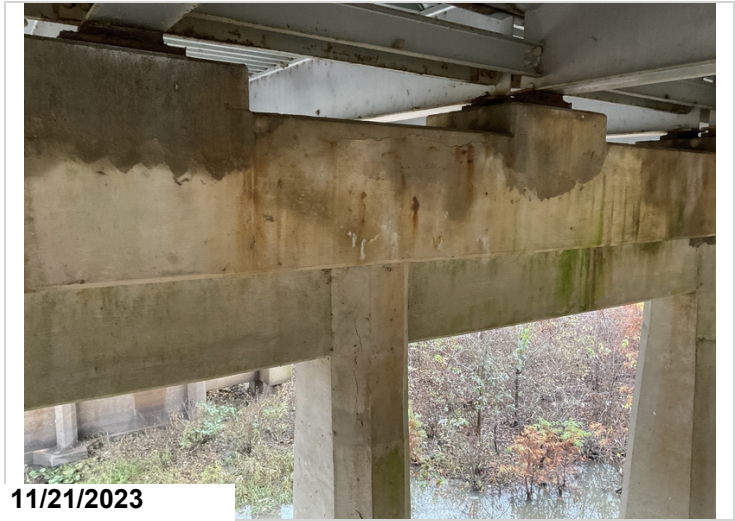
Bent #5 ahead face has cs3 cracks horizontally for 20' between girders #3, 5.
